# SKEP III Home Office Support Site Visit Report

| Consultant | Wahib Medanat Consultant Engineer | Rep No. | 23-27072021 |
| Contractor | Dijlah Establishment Constr. Contracting | Tender No. | (11/2019/USAID/SKEP/3/S) Schools for a Knowledge Economy Project (SKEP) - Phase (3) Package (1, 2) |
| Site Name | Jumana Bint Abit Taleb Basic Mixed School - Jerash | Day/ Date | Tus. 27/07/2021 |

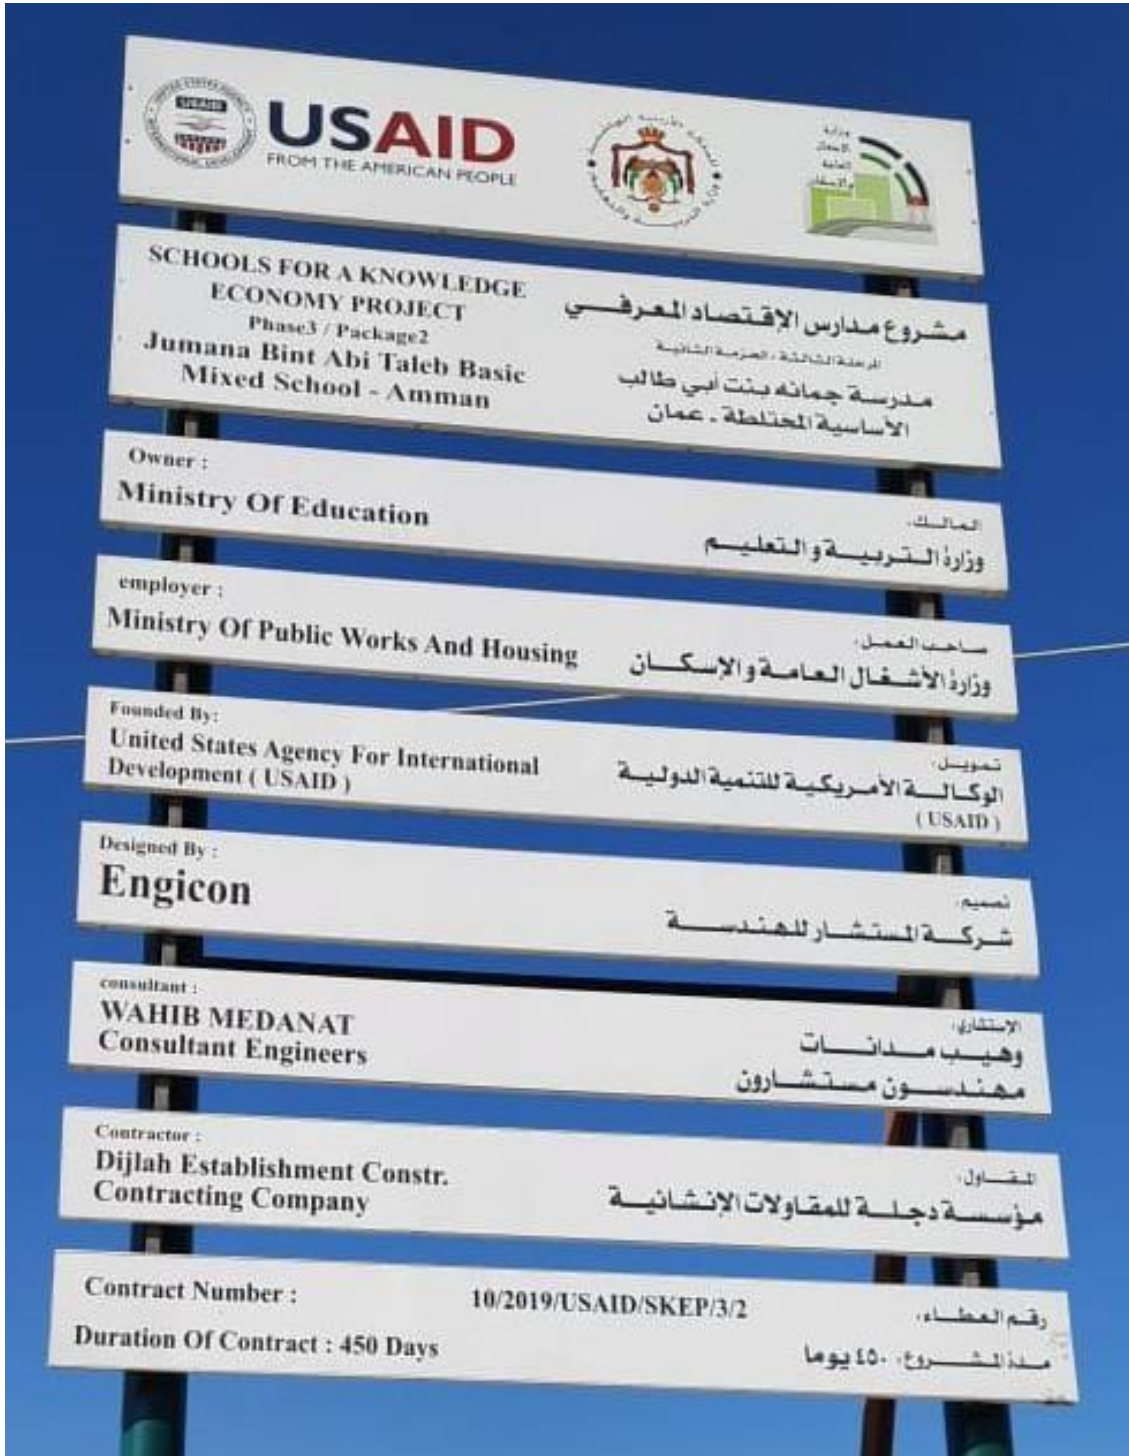
Project ID  
Sign on  
Site

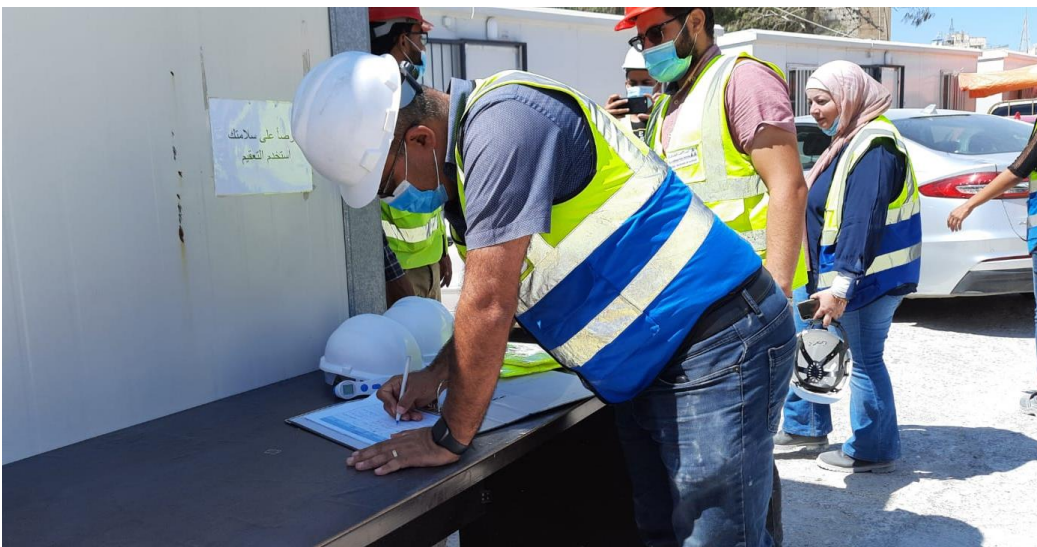
Sterilization and signing visitors' attendance sheet at the entrance of the site, complying with Covid-19 Protocol

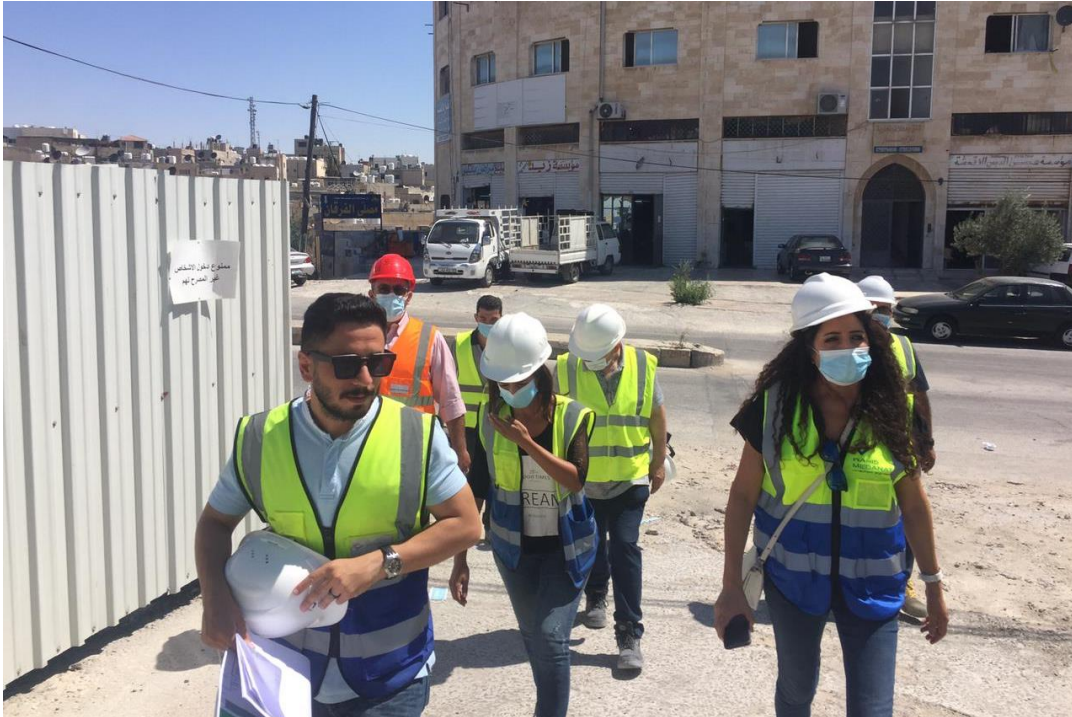
| No. | Description |
|---|--|
| 2 | The supervision site engineer gave a brief on the safe routes at the site. |

The supervision site engineer gave a brief on the safe routes at the site.

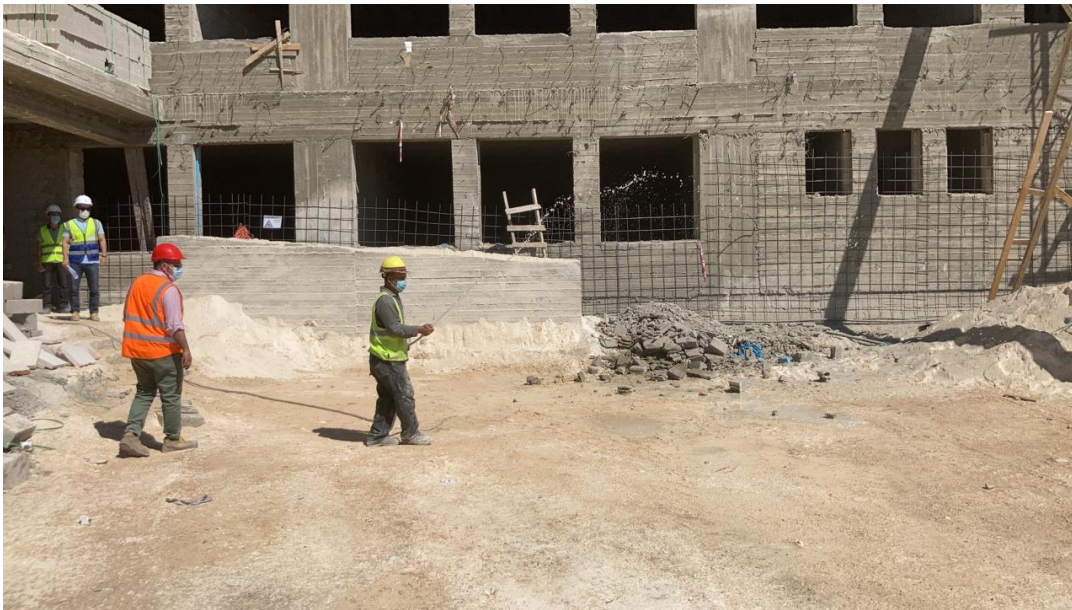
| No. | Description |
|---|--|
| 3 | Spraying water at the sand areas in the site for the purpose of dust control. |

Spraying water at the sand areas in the site for the purpose of dust control

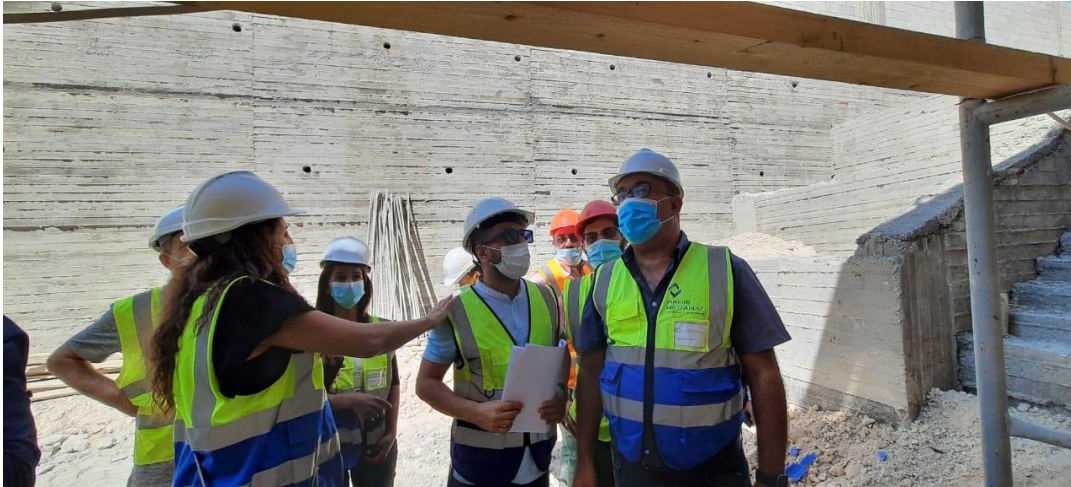
| No. | Description |
|---|--|
| 1 | The supervision site engineer gave a brief on the work progress and the current stages and the function of each part |

Yousef Omar/  
supervision  
site engineer  
gave a brief  
on work  
progress, the  
current stages  
and the  
function of  
each part

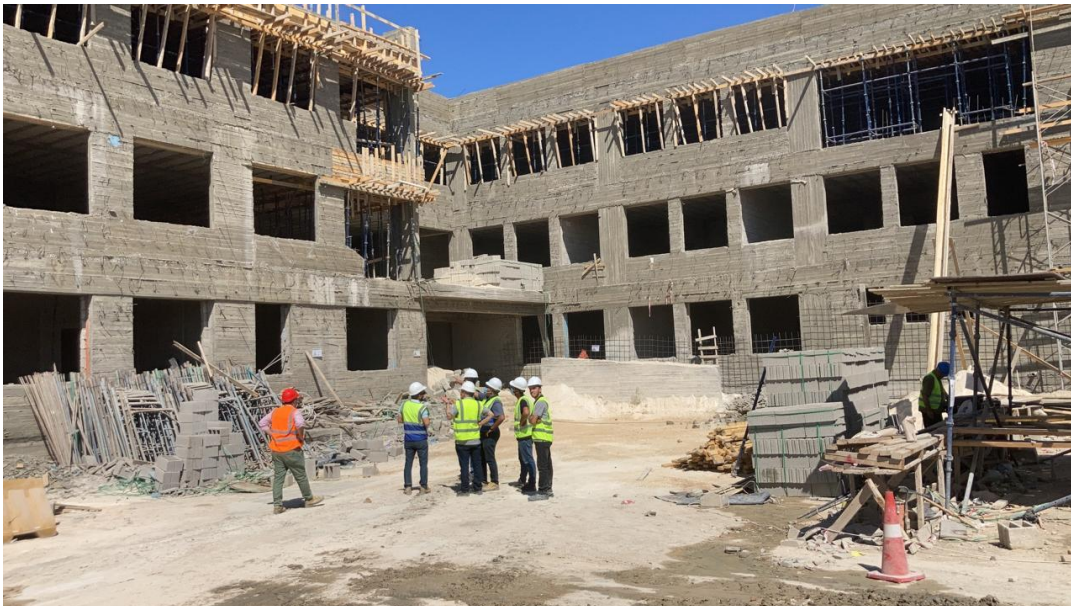
| No. | Description |
|---|--|
| 6 | The quality of concrete work, block work and plastering is acceptable in general. |

The quality of  
concrete  
work is  
acceptable in  
general

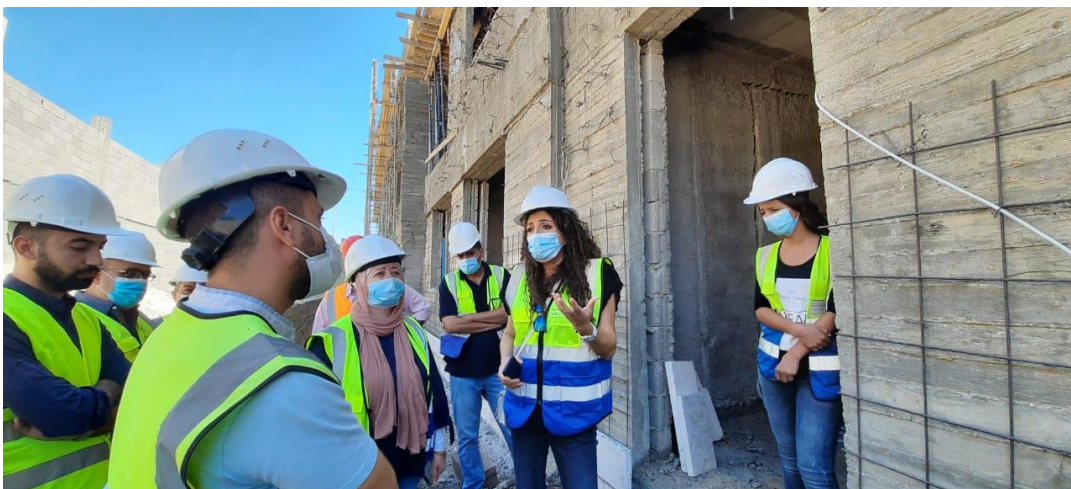
| No. | Description |
|---|--|
| 8 | Discussing the relation between door jambs and stone building. |

Discussing the  
relation  
between door  
jambs and  
stone building

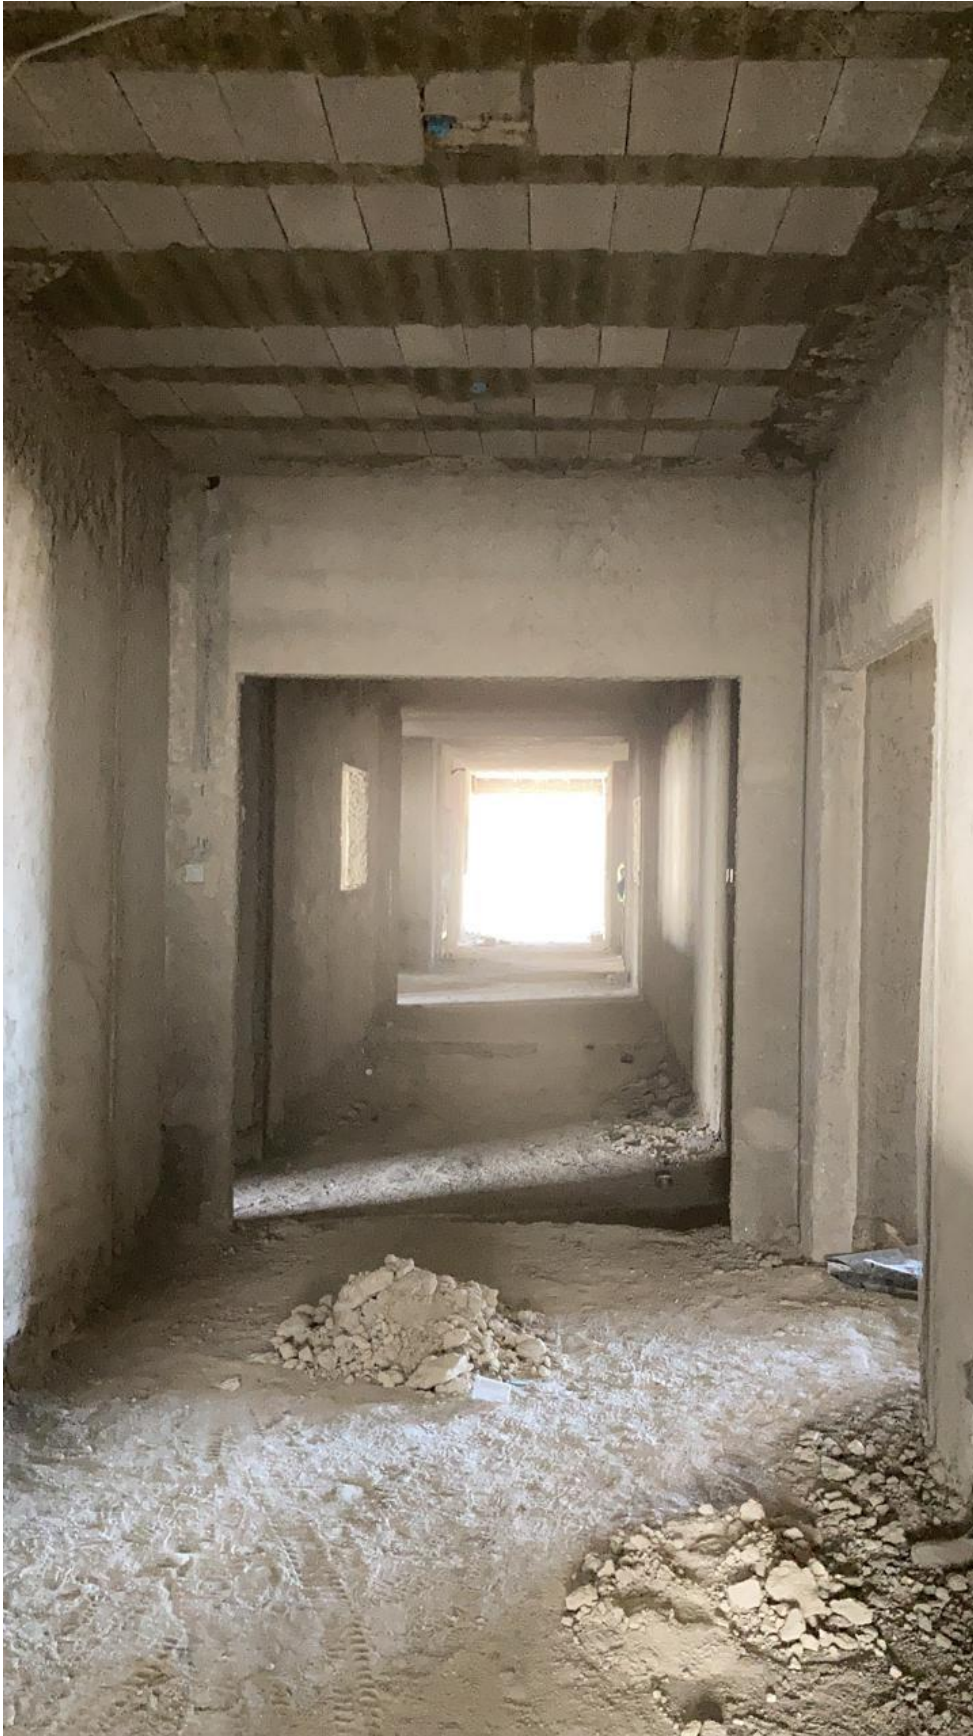
The quality of blockwork and plastering is acceptable in general

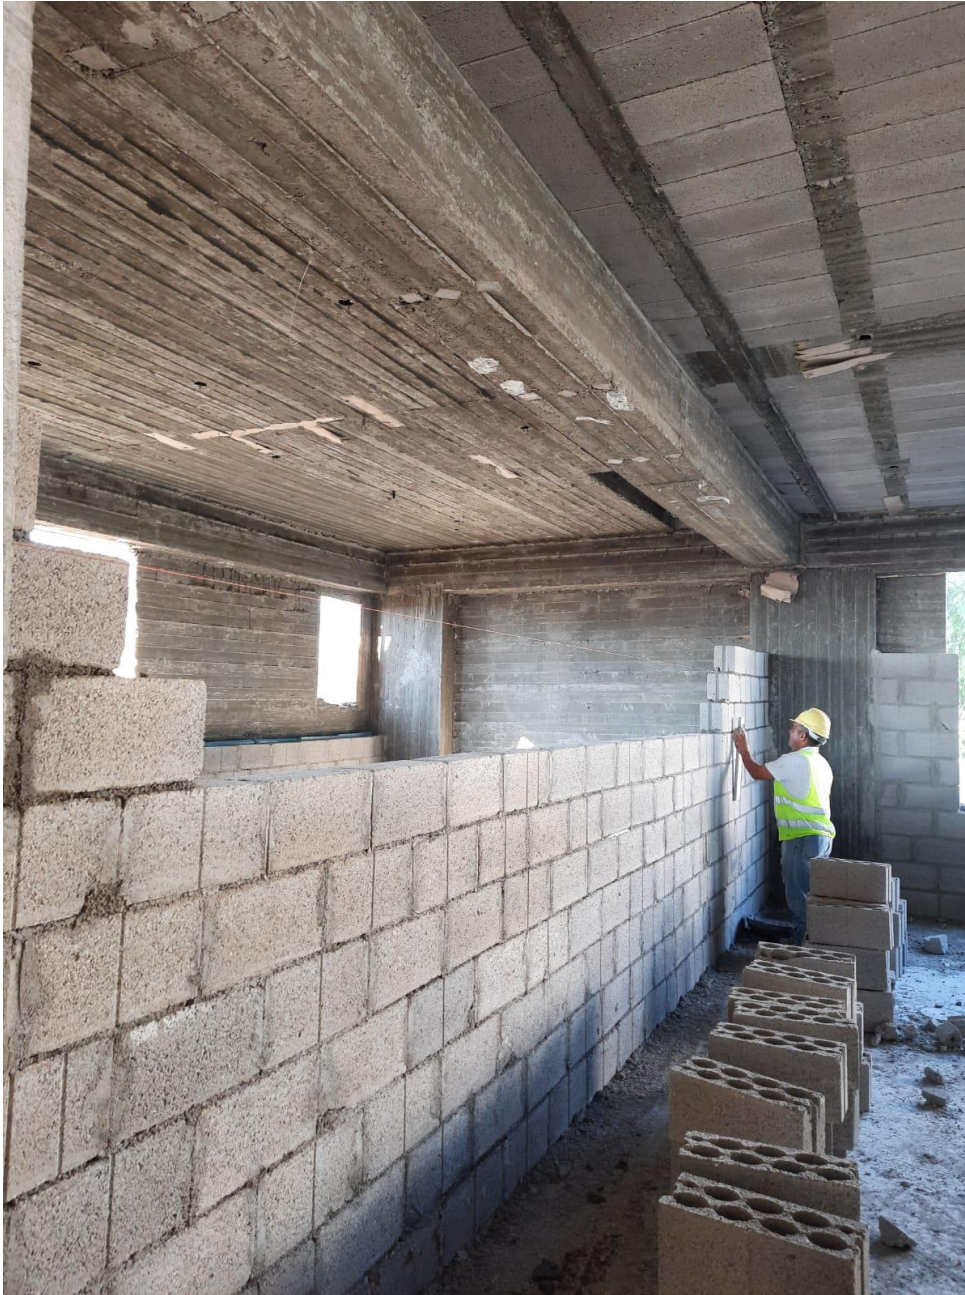
The quality of blockwork is acceptable in general

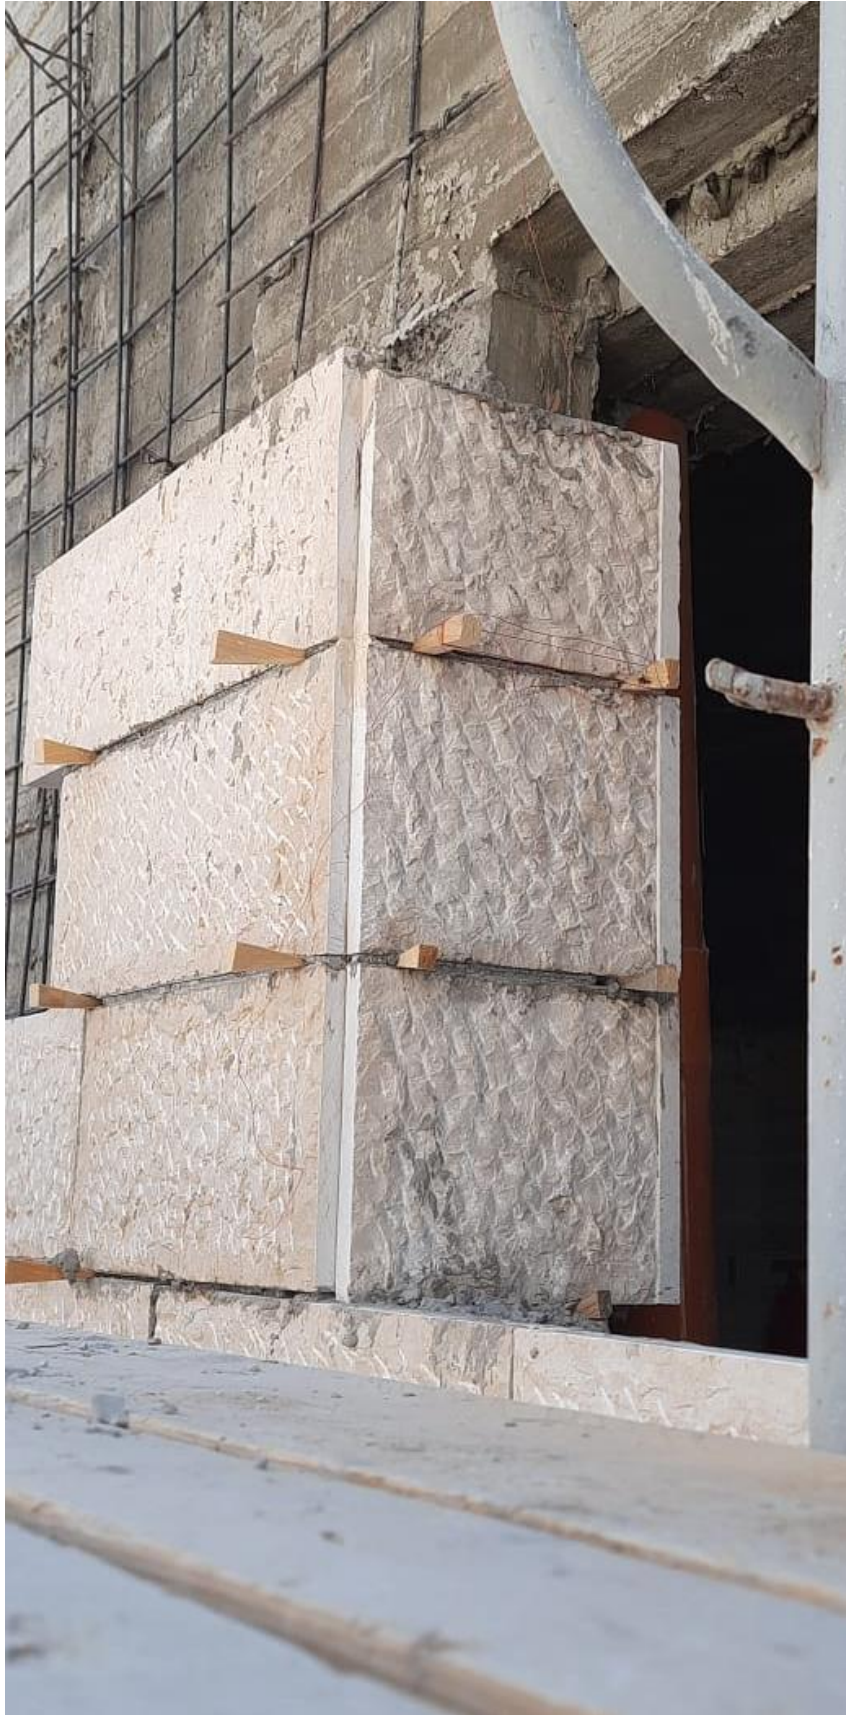
| No. | Description |
|---|--|
| 7 | Preparing window jambs has been discussed for the purpose to receive aluminum sections. |

Preparing window  
jambs has been  
discussed for the  
purpose to receive  
aluminum sections

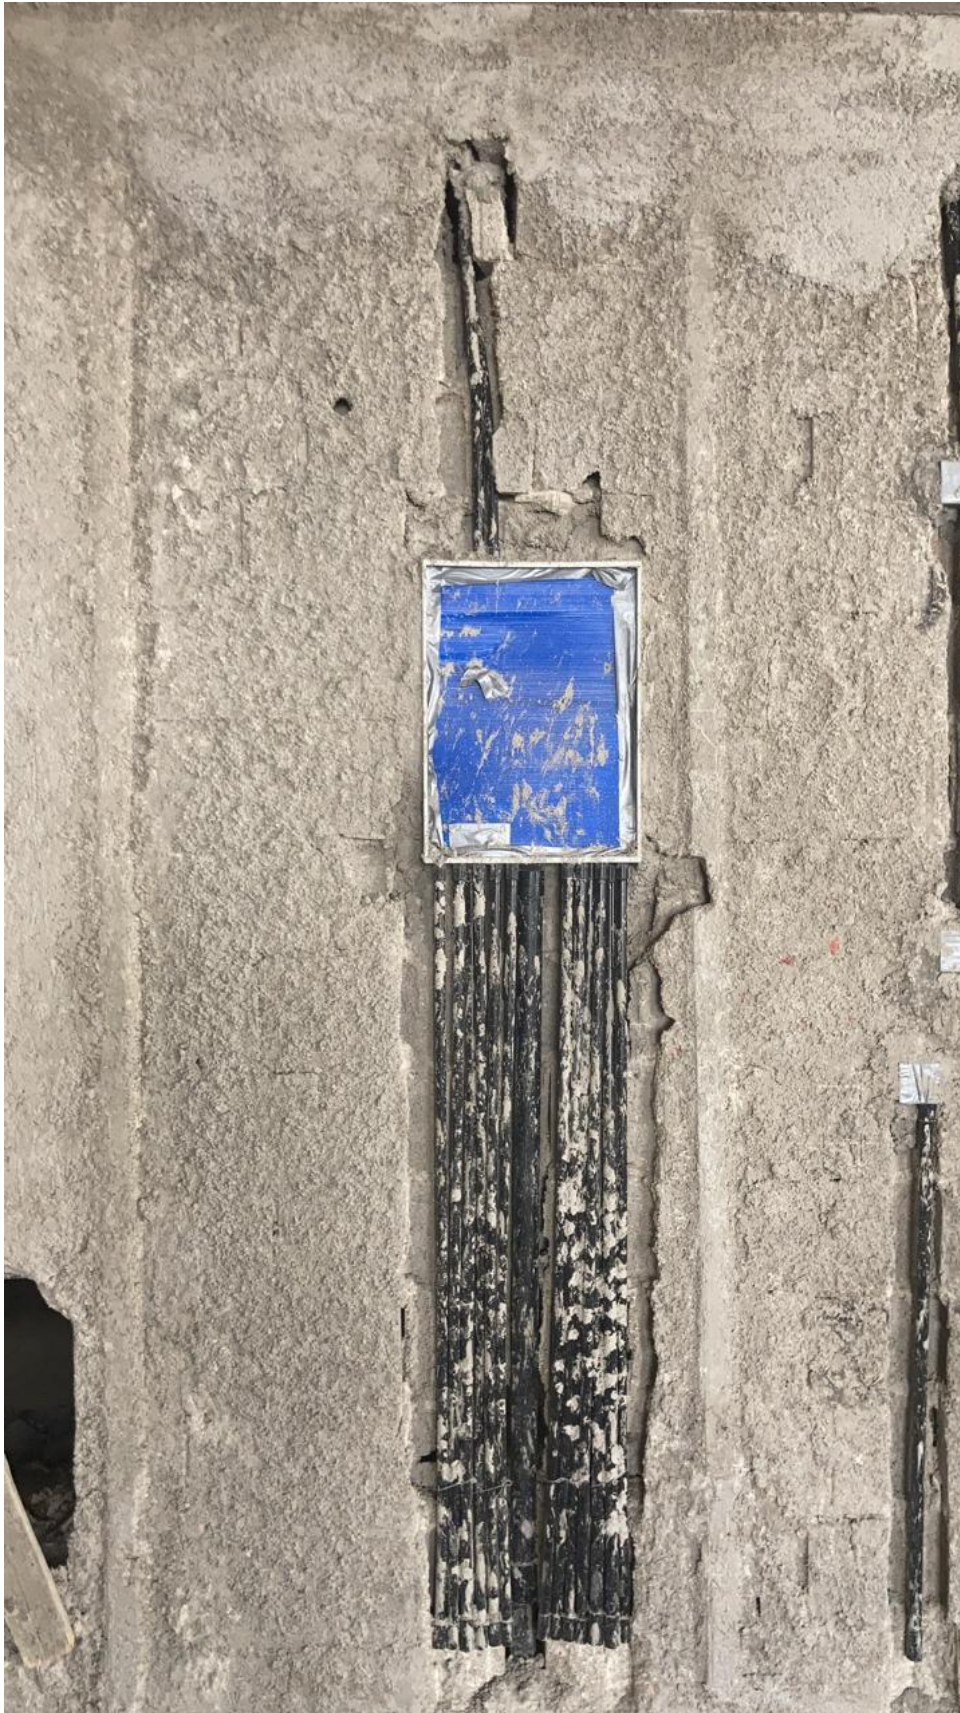
| No. | Description |
|---|--|
| 5 | The Contractor inserts the MEP installation inside saw-cut grooves at the pipes tracks. |

The Contractor inserts the MEP installation inside saw-cut grooves at the pipes tracks.

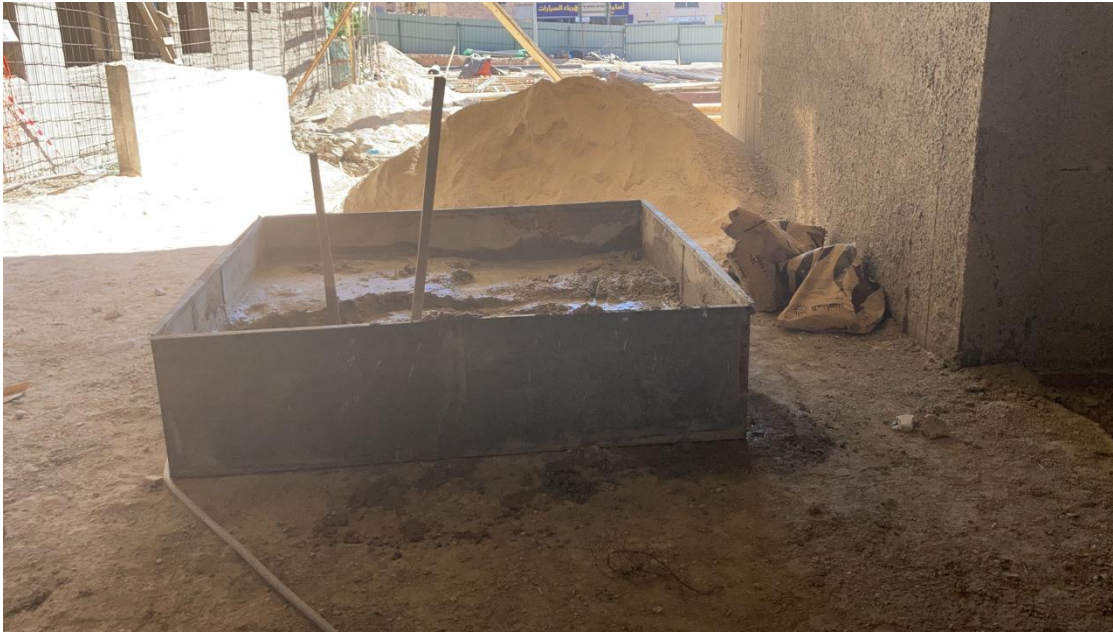
| No. | Description |
|---|--|
| 4 | The Contractor is using special container the prepare mortar mix for blockwork and plastering work. |

The Contractor is using special container the prepare mortar mix for blockwork and plastering work

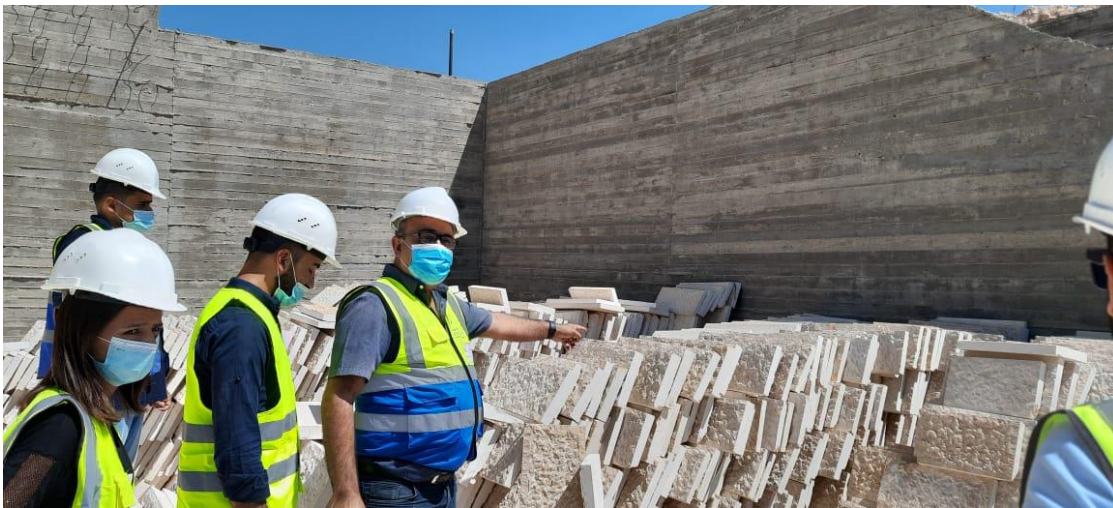
Visual inspection has been conducted at the delivered building stone. The chiseling for number of observed stones is not accepted. The texture should be applied to the whole stone up to edges

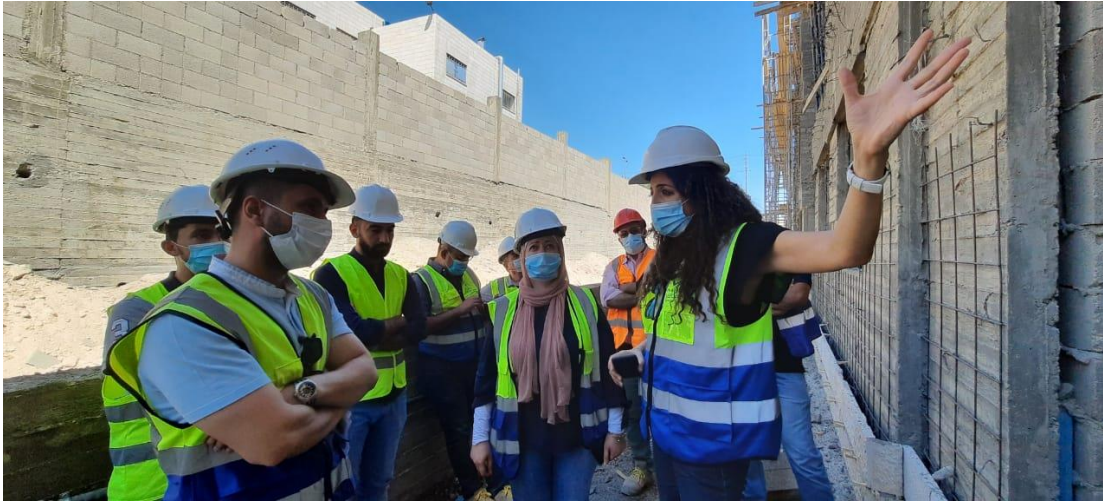
| No. | Description |
|---|--|
| 7 | Stone Work: <ul style="list-style-type: none"><li>• Visual inspection to the stone was done by spraying water and general check on the delivered quantities.</li><li>• The following remarks have been observed on the built stone on the facades:<ul style="list-style-type: none"><li>- Limited number of stones have broken edges.</li><li>- Gaps between stones, vertical/horizontal need to be unified at some locations. (this is due to the difference in stone widths).</li><li>- Chiseling pattern has to be unified for all stones according to the approved sample.</li><li>- The wooden wedges inside should be removed before concrete behind stone.</li><li>- The steel ties number is not enough, should be increased at each vertical gap between stones. Used accessories should be as book of details and to the consent of the Engineer representative.</li></ul></li></ul> |

Remarks have been observed on the built stone on the facades and a discussion was made

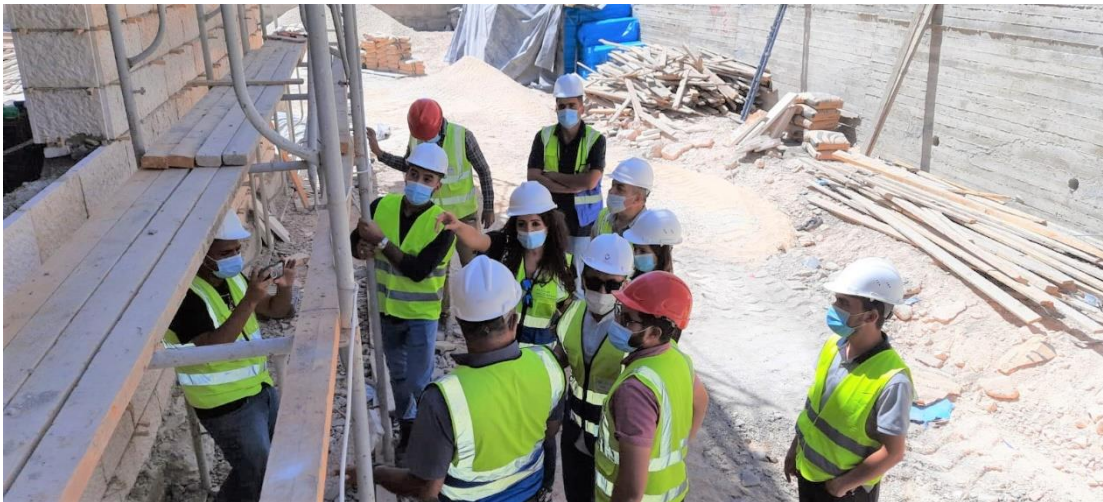
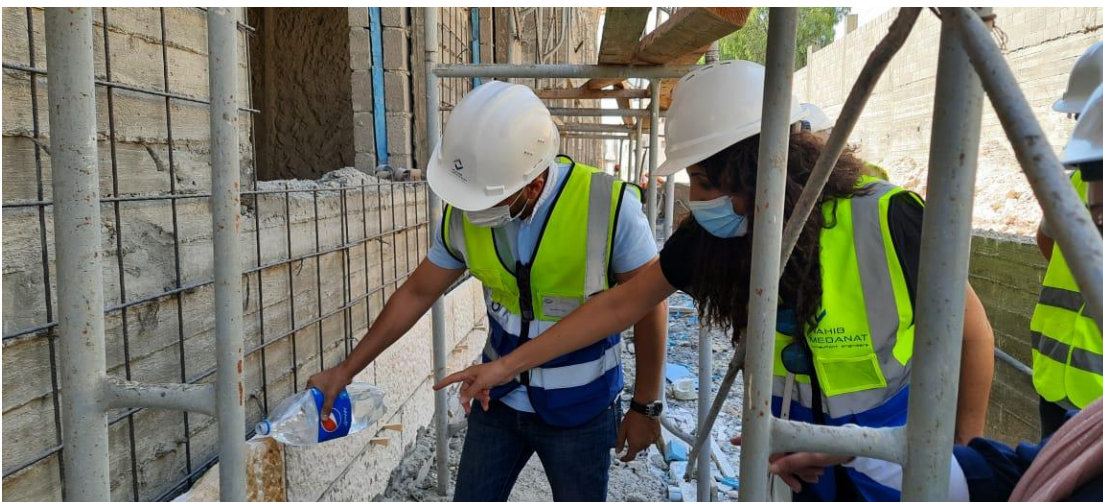
Visual inspection to the stone was done by spraying water

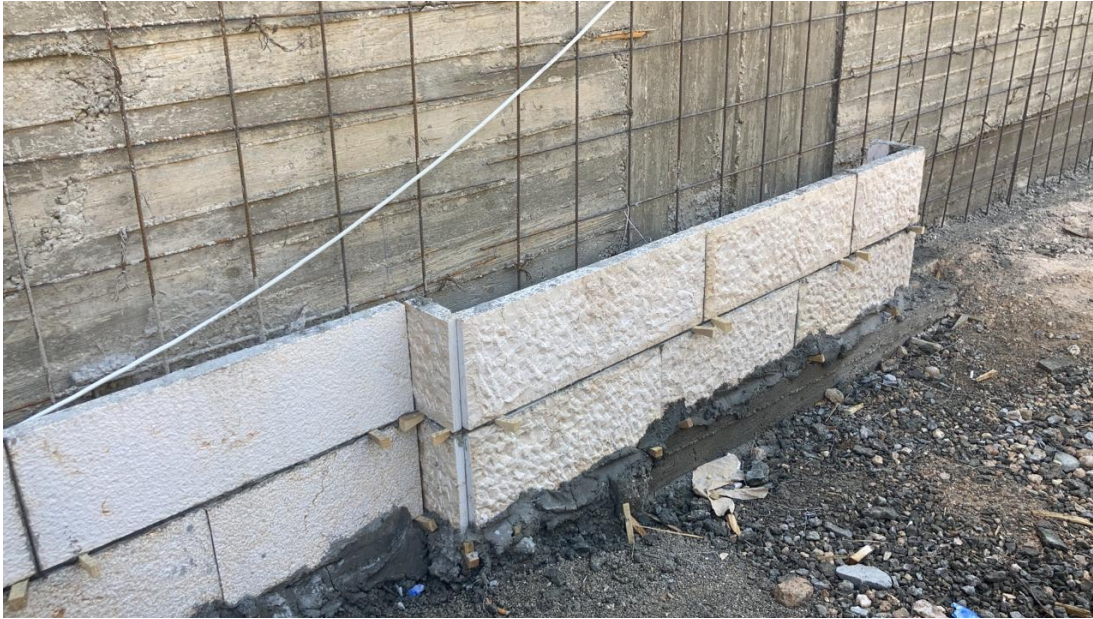
An example of stone work complying with the approved sample and specifications

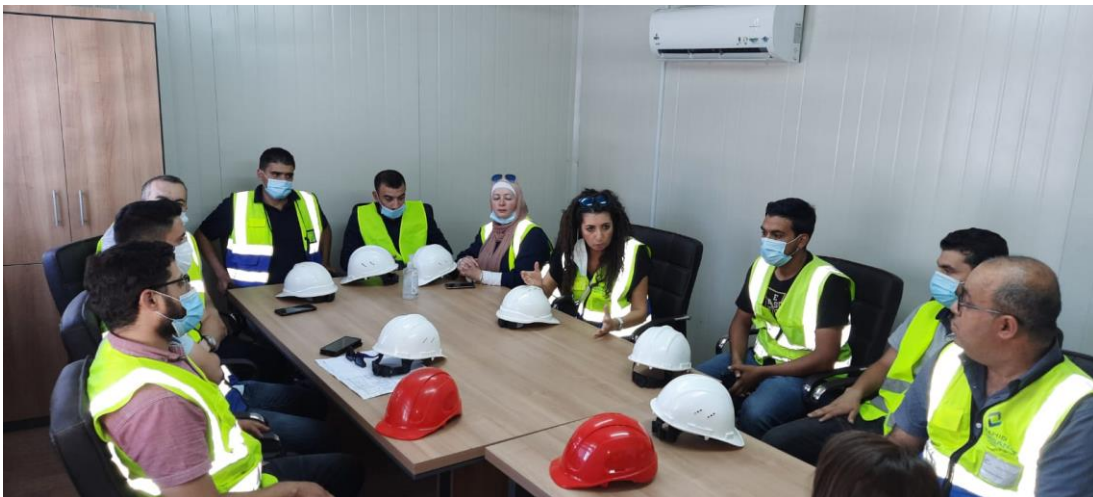
| No. | Description |
|---|--|
| 9 | A meeting was held in the site offices in the presence of Engineer's representatives and Contractor's representatives. |

After the site visit a meeting was held in the site offices in the presence of Engineer's representatives and Contractor's representatives to discuss work progress, quality and safety issues
