Consultant	Wahib Medanat Consultant Engineer	Rep No.	11-07092021
Contractor	Derar Saraireh & Sons for Engineering & Contracting	Tender No.	(11/2019/USAID/SKEP/3/S) Schools for a Knowledge Economy Project (SKEP) - Phase (3) Package (1, 2)
Site Name	Um Al Dananir Basic Mixed School- Al Balqa	Day/ Date	Tue. 07/09/2021
Duration of Project	450 Calendar Days	Total Project Budget	9,789,417.840 JD

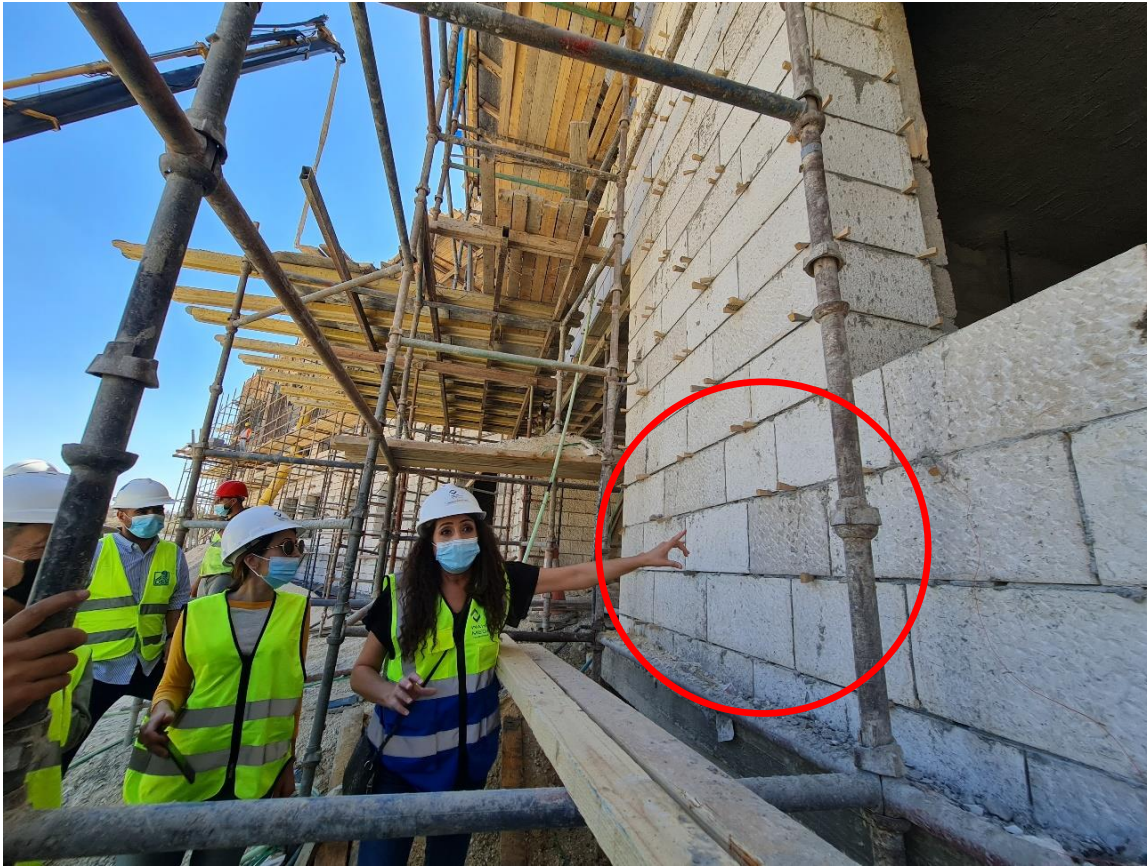
(Figure: 03)

The office support team checked the quality of executed stone works at school elevation. The team noticed that a number of stones do not comply with the approved sample and requested the Contractor to replace

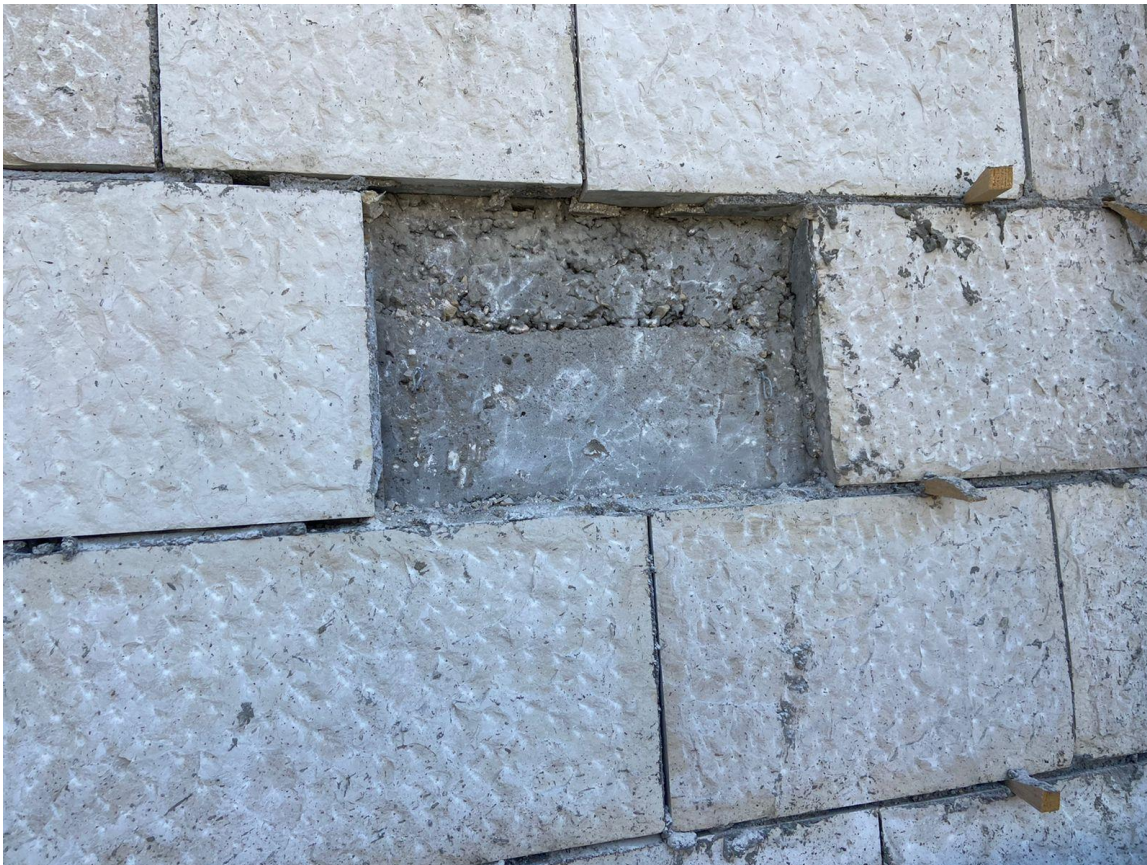
(Figure: 04)

An immediate action has been taken by the contractor

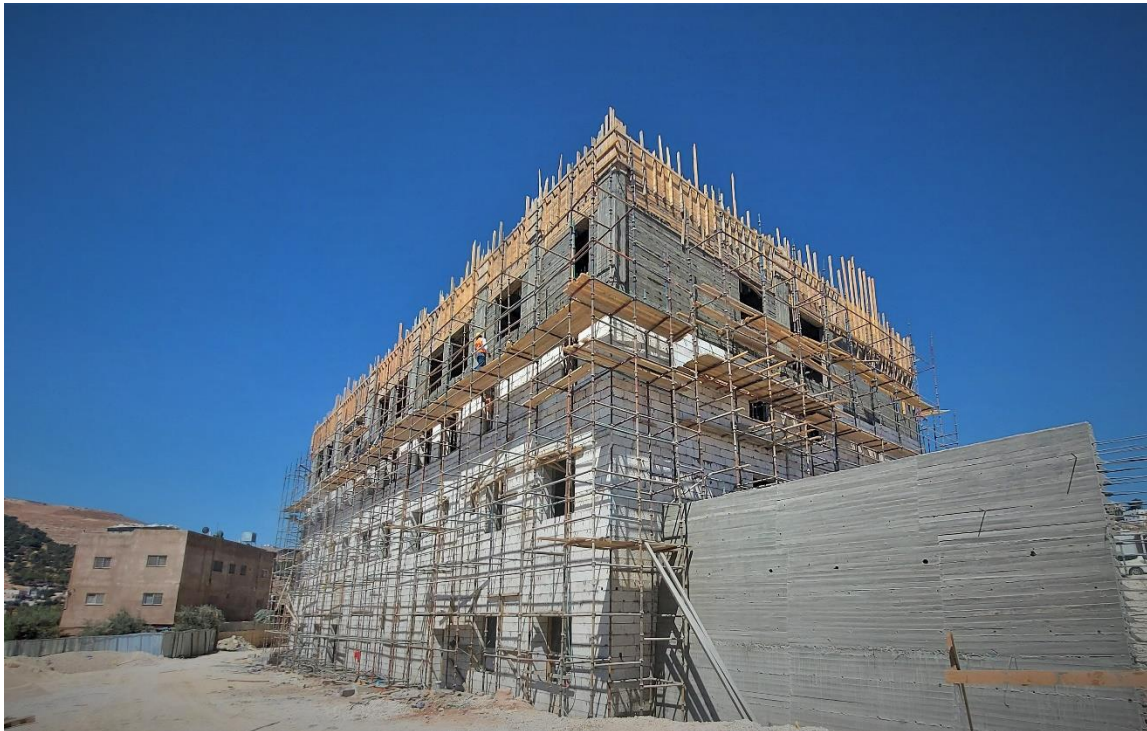
(Figure: 05)

Checking the quality of executed stone works at school elevation

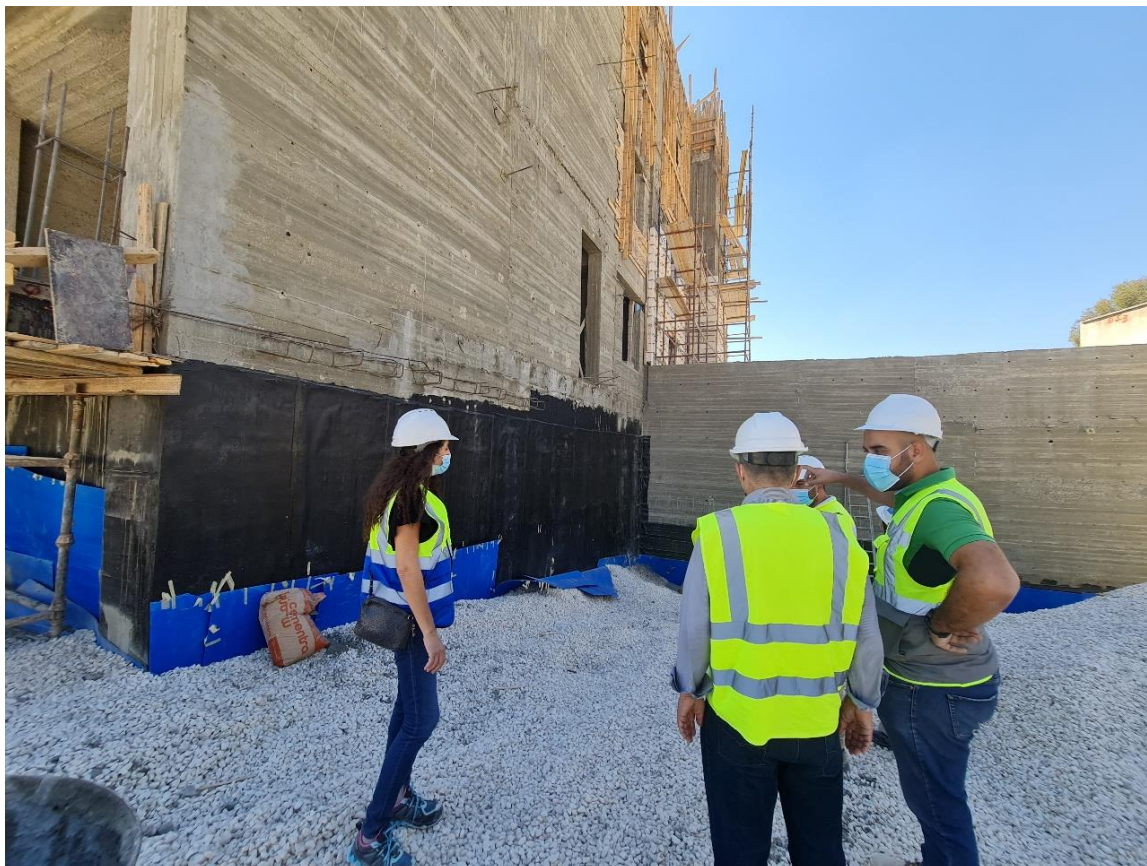
(Figure: 06)

Remedy works were done by the Contractor

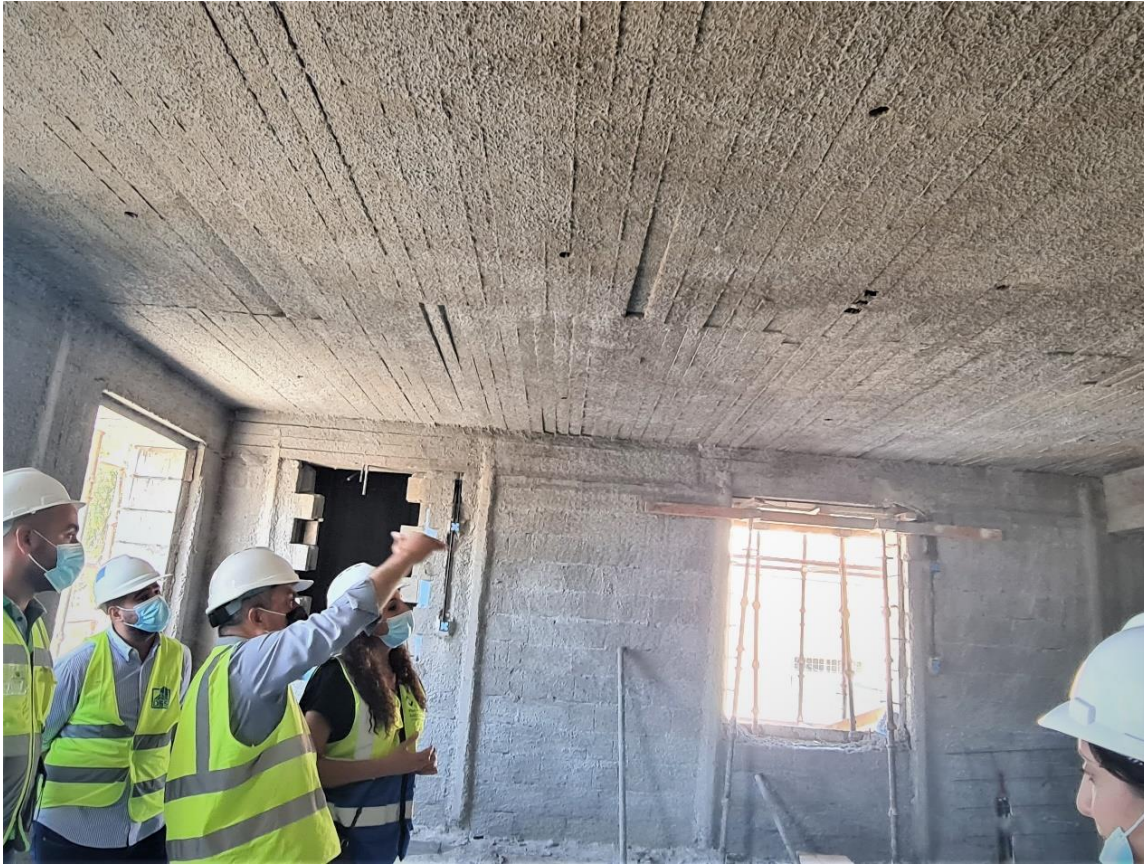
(Figure: 07)

Plaster works have been checked at both the basement and ground floors. The team observed that some parts of the ceiling at basement need applying one more layer of plastering to recover the difference in concrete face as a result of irregularity in formwork

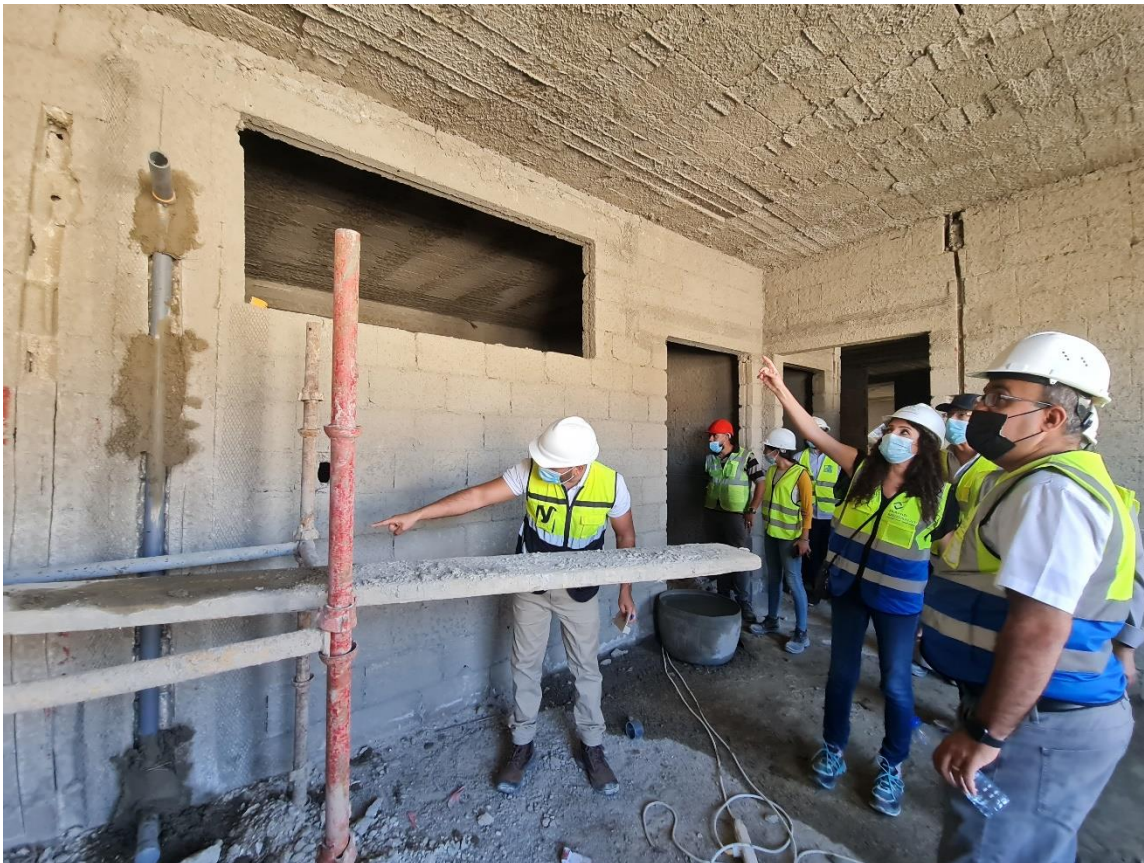
(Figure: 08)

First fix for electromechanical works were checked for ground floor zone B to maintain the required levels coordinated with architecture

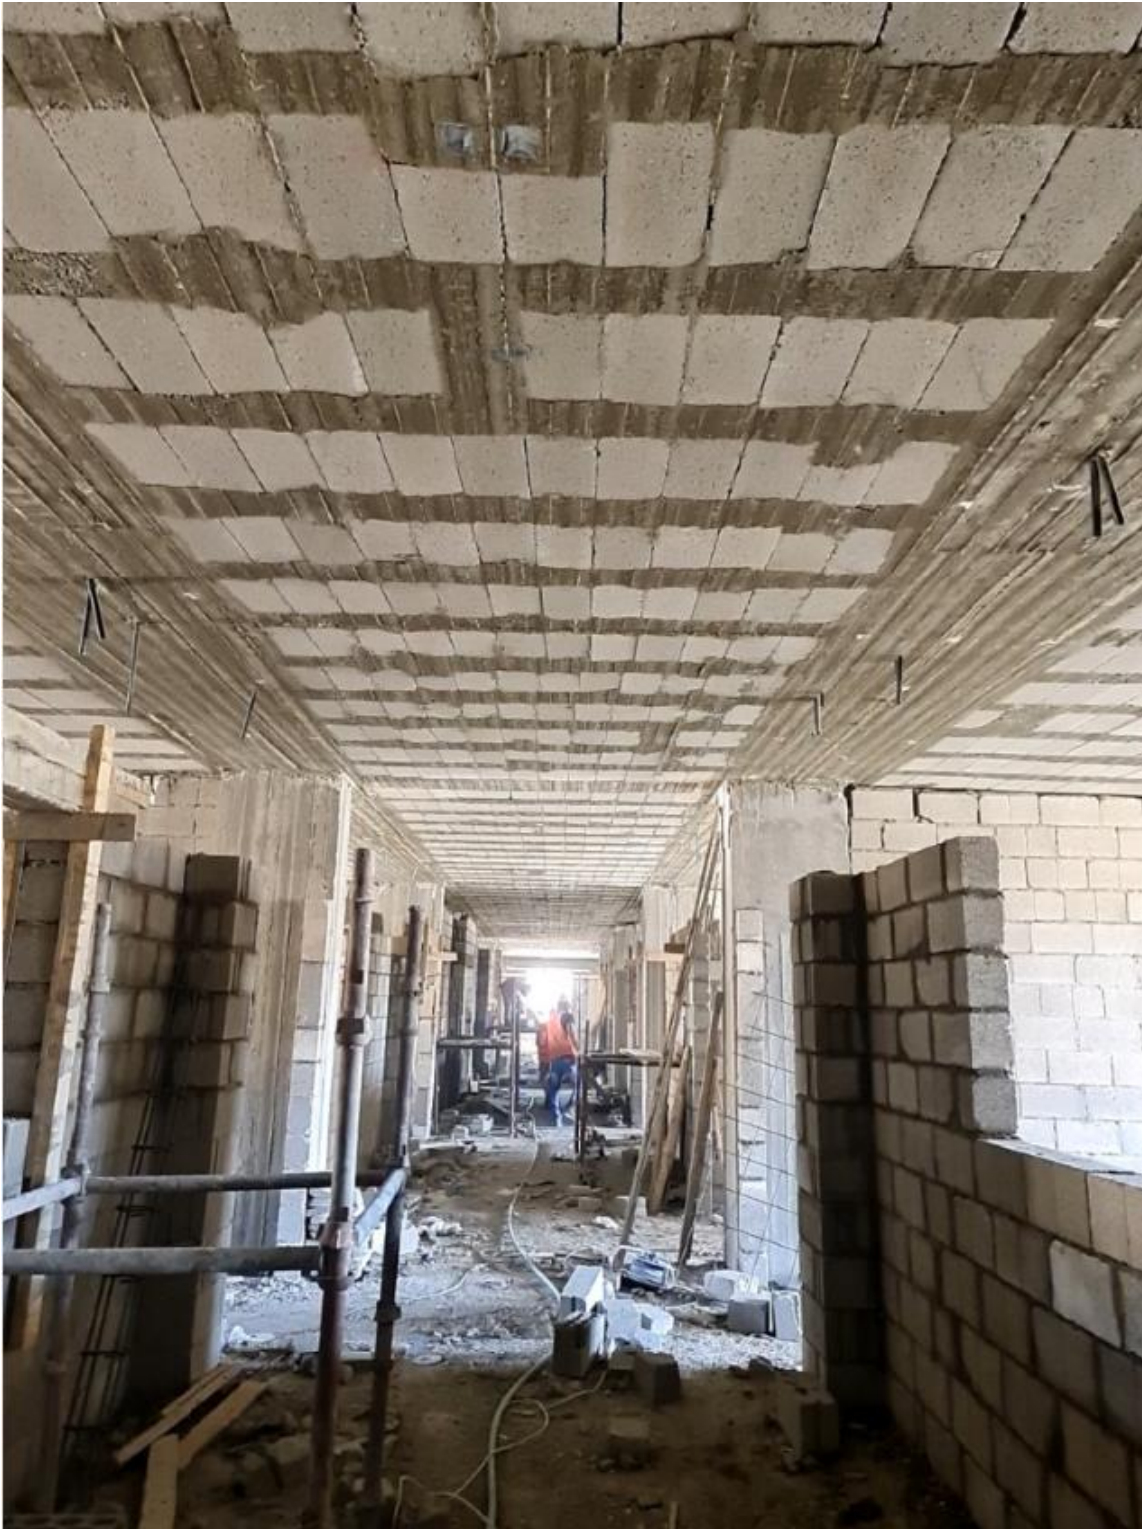
(Figure: 09)

Blockwork have been checked at ground and first floors

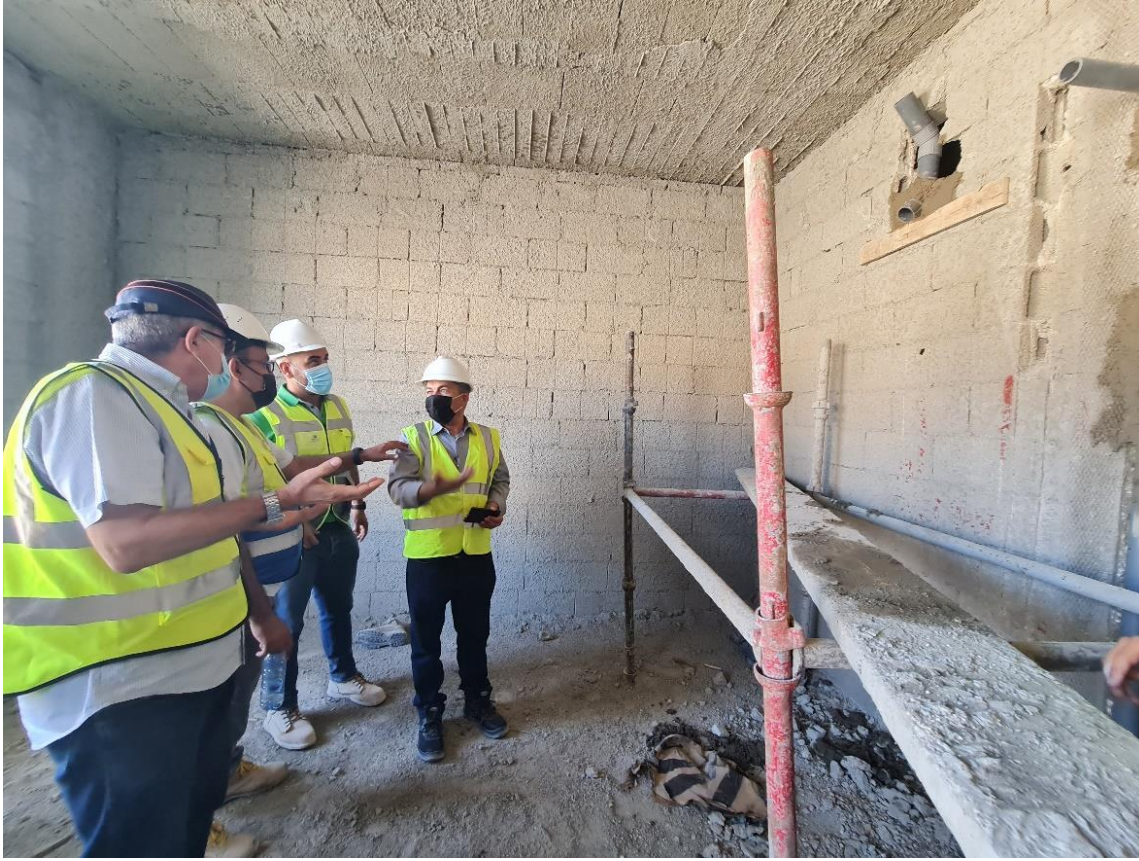
(Figure: 10)

The level of sleeves for A/C and the relation with the false ceiling level were discussed

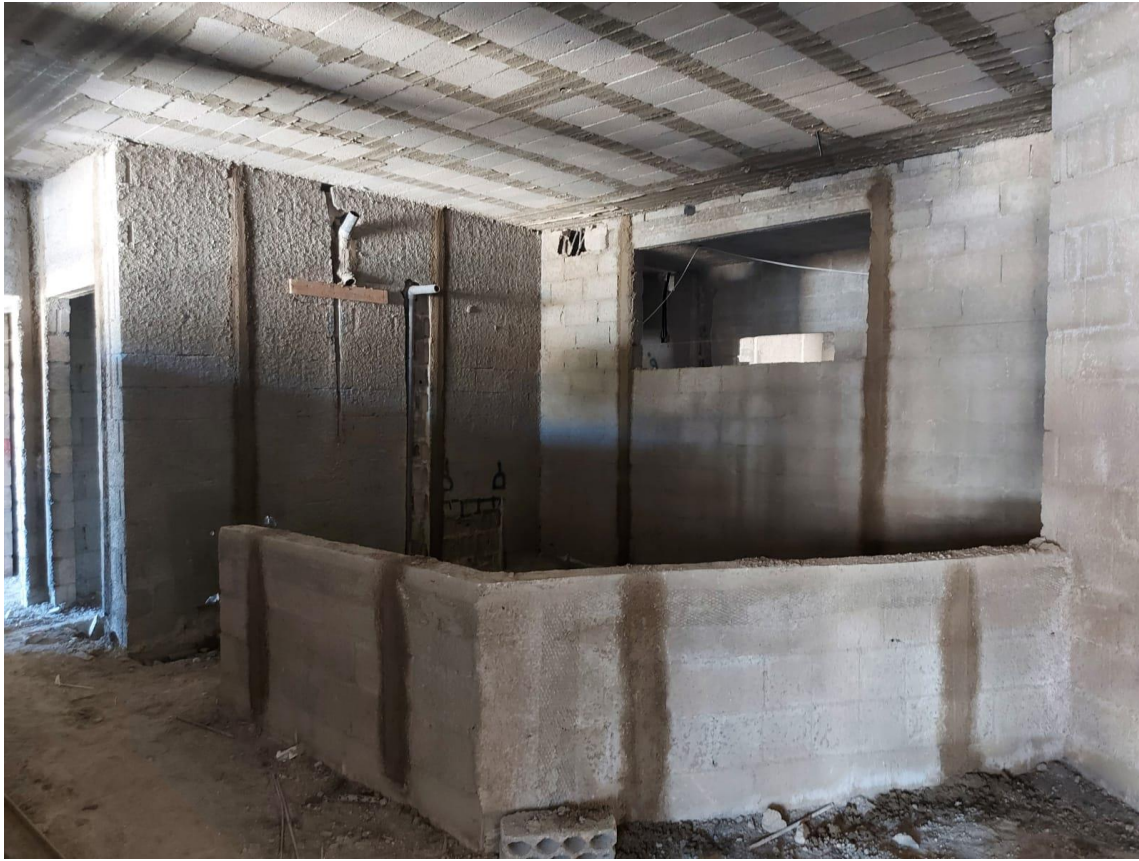
(Figure: 12)

Medanat team observed that near the entrance, there is an aluminum partition with a height of 2.20m, while the height of the false ceiling is 20.70m. Consultation shall be made with the Designer civil engineer home office support to feedback about closing the 0.50m difference

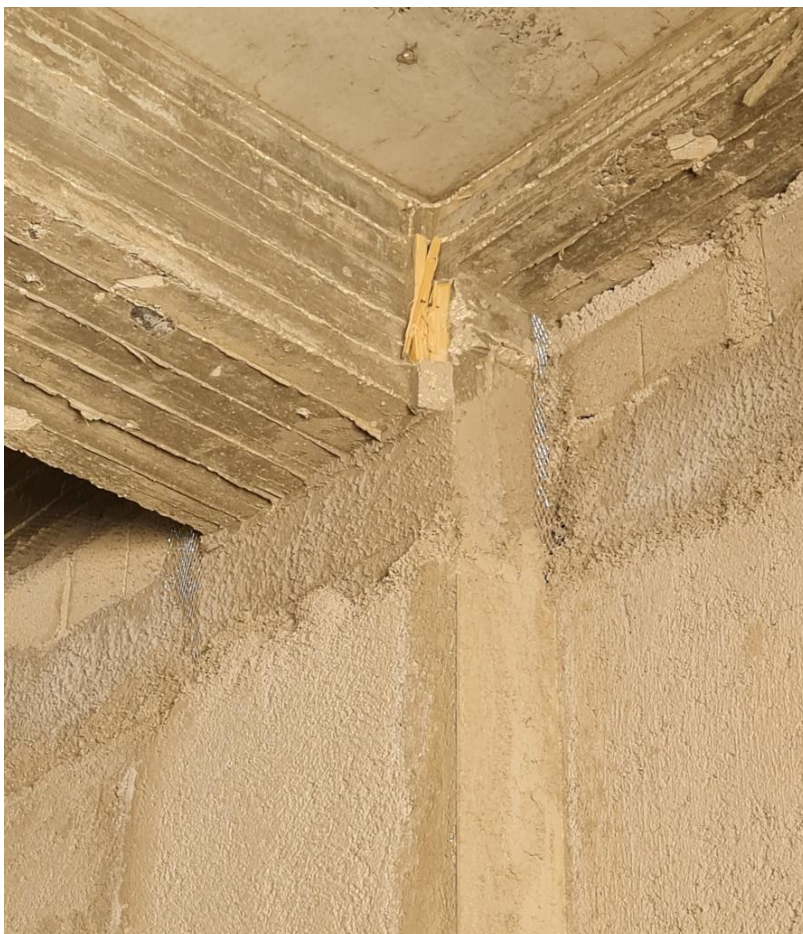
(Figure: 15)

A comment was given about the left wooden pieces at the structure elements (mainly the slab). The Contractor promised to remove those pieces before plastering

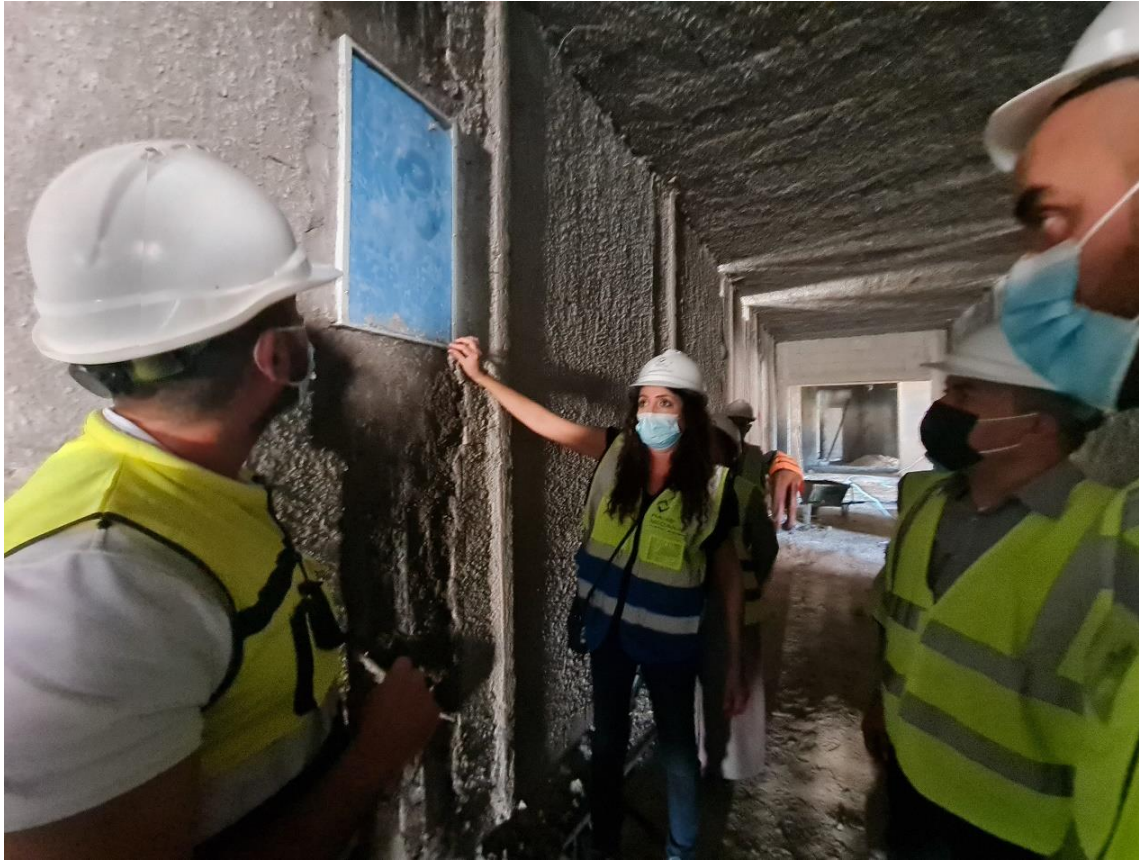
(Figure: 16)

Engineer representatives noticed that the status of the cabinets is not acceptable due to the mortar on these cabinets which might cause defects, noting that this a final finish and should be protected

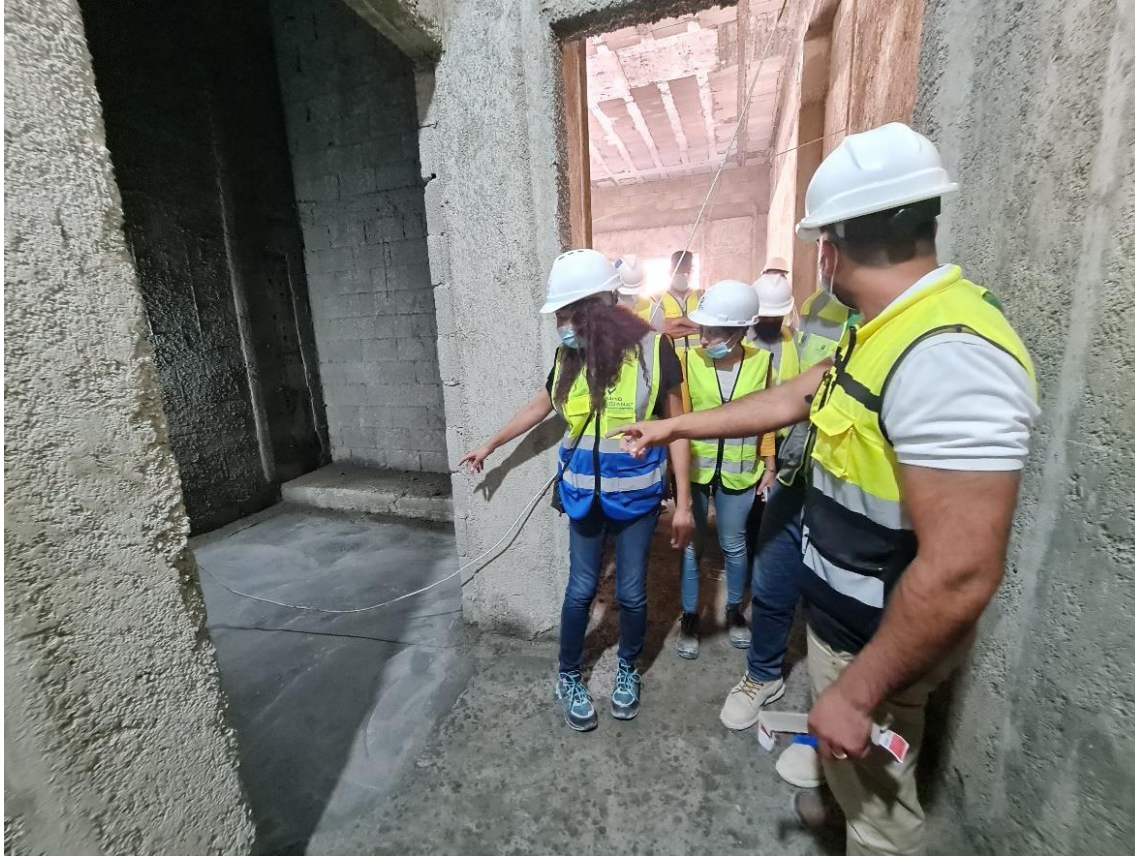
(Figure: 18)

The quality control manager checked the quality of floor surface before receiving the cementitious insulation layers

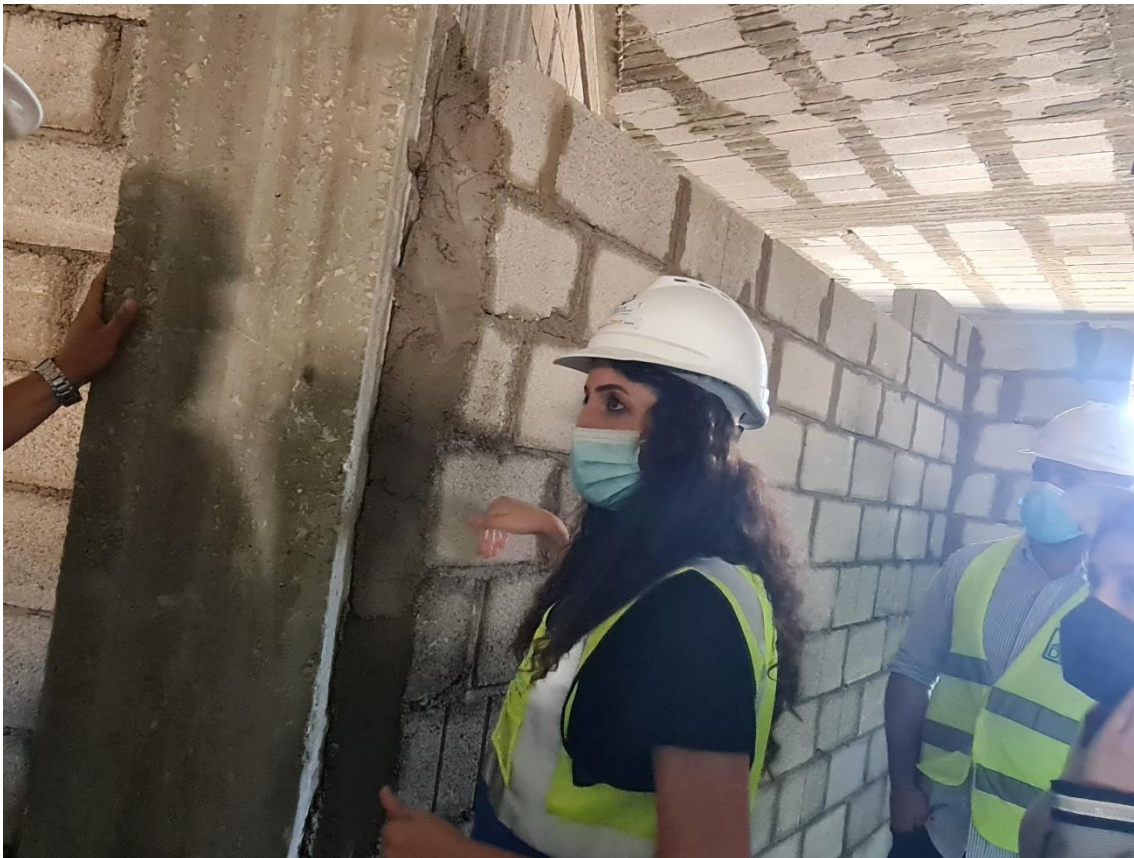
(Figure: 21)

Engineer representatives requested that the inclined block wall at the corridor in the basement floor should be flushed with the column to avoid double angles

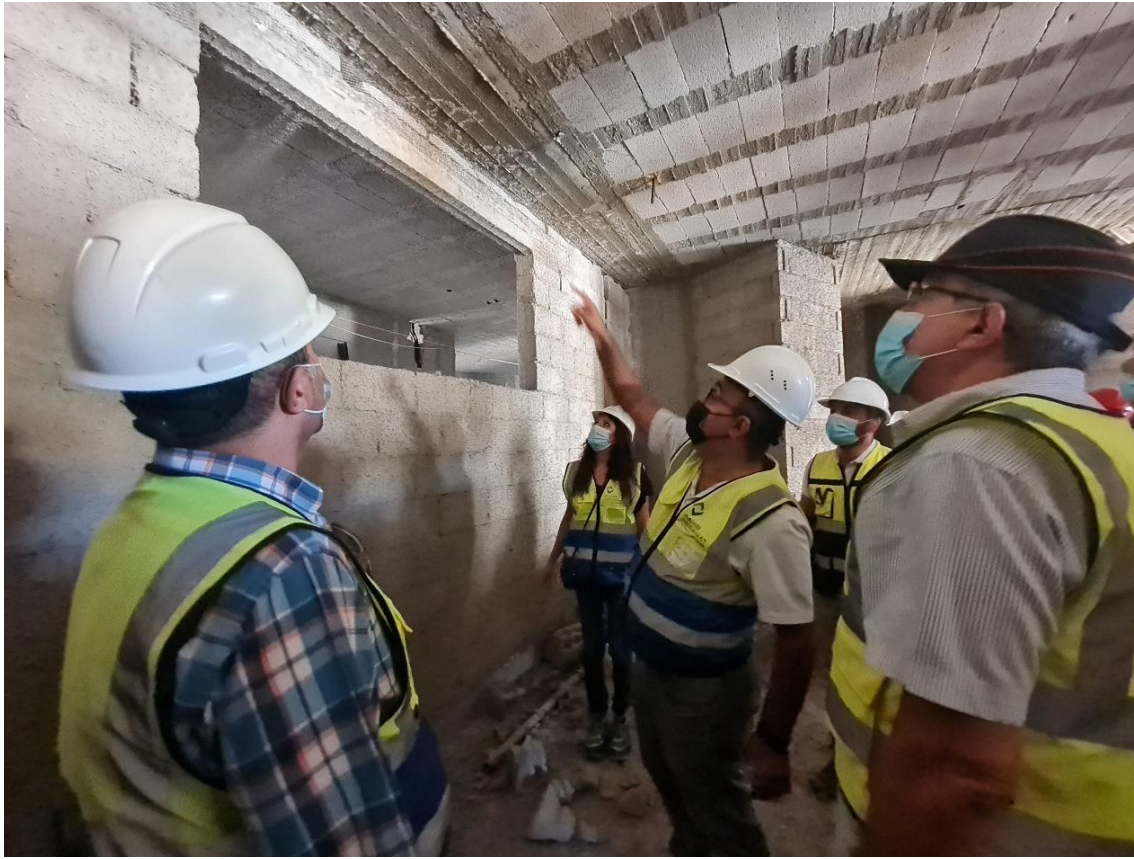
(Figure: 22)

Medanat team observed an electrical pipe coming down from the slab over one window. The Contractor stated that the said pipe is cancelled. The team requested the Contractor to confirm the cancellation and the way of closing the space around the pipe was discussed

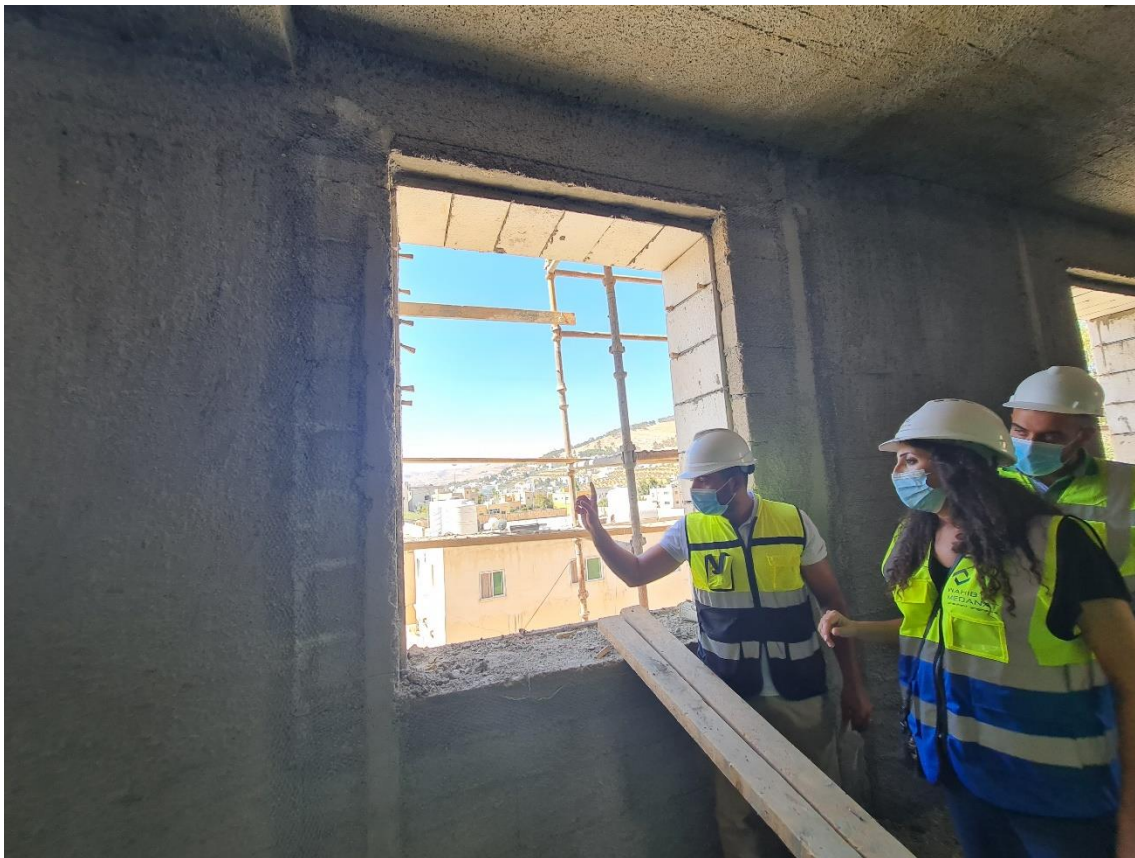
(Figure: 25)

The erection of stone for the window frame at the top and for the two sides were discussed

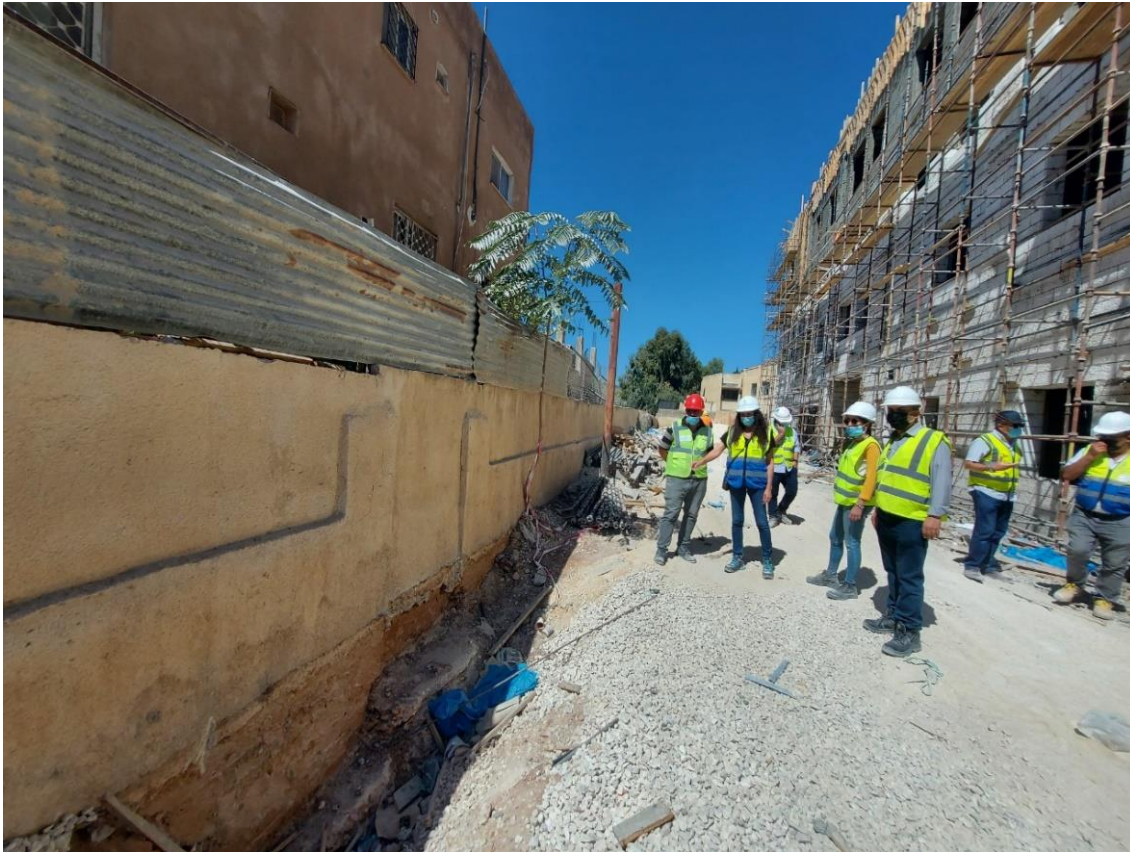
(Figure: 26)

The Contractor has not started the work in the adjacent wall to the existing neighbors' wall (encroaching wall) at the south-western side
