SKEP III Home Office Support Site Visit Report

Consultant	Wahib Medanat Consultant Engineer	Rep No.	12-08062021
Contractor	Derar Saraireh & Sons for Engineering & Contracting	Tender No.	(11/2019/USAID/SKEP/3/S) Schools for a Knowledge Economy Project (SKEP) - Phase (3) Package (1, 2)
Site Name	Al Khansa' Basic Mixed School- Al Balqa	Day/ Date	Tue. 08/06/2021
Duration of Project	450 Calendar Days	Total Project Budget	9,789,417.840 JD

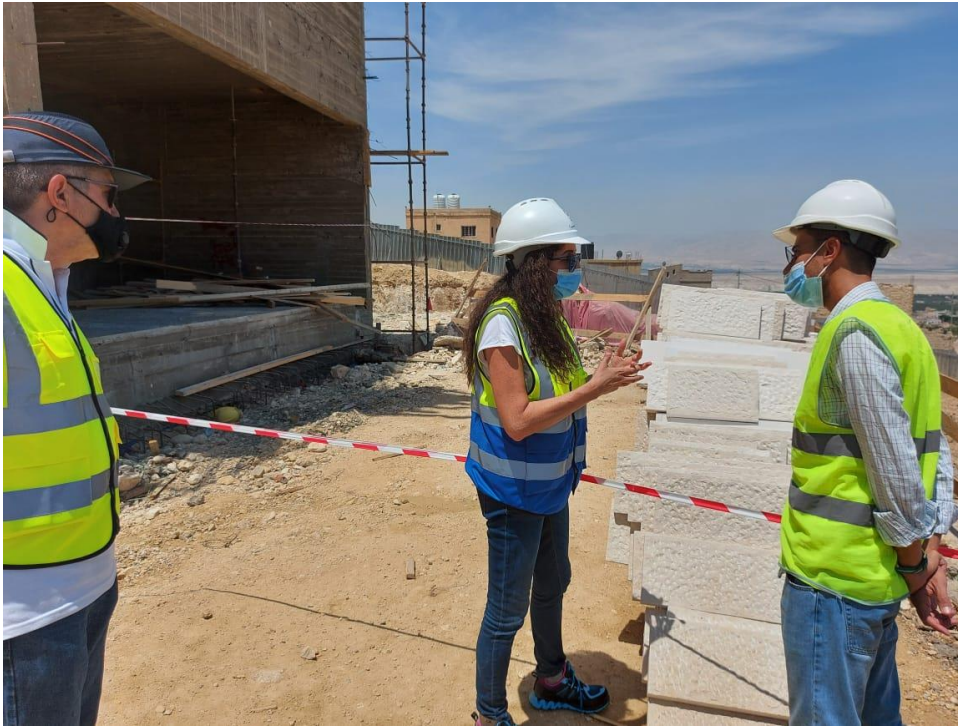
No.	Description
1	Visual inspection has been conducted at the delivered building stone. The chiseling for number of observed stones is not accepted. The texture should be applied to the whole stone up to edges.
2	Open ribs blocks should be closed to avoid filling those blocks with concrete during roof casting.
3	The contractor was informed that once the first stone layer is checked and approved, stone building can continue up to the level of window sills to avoid delay during the checking of the workshop drawings.

Visual inspection has been conducted at the delivered building stone. The chiseling for number of observed stones is not accepted. The texture should be applied to the whole stone up to edges

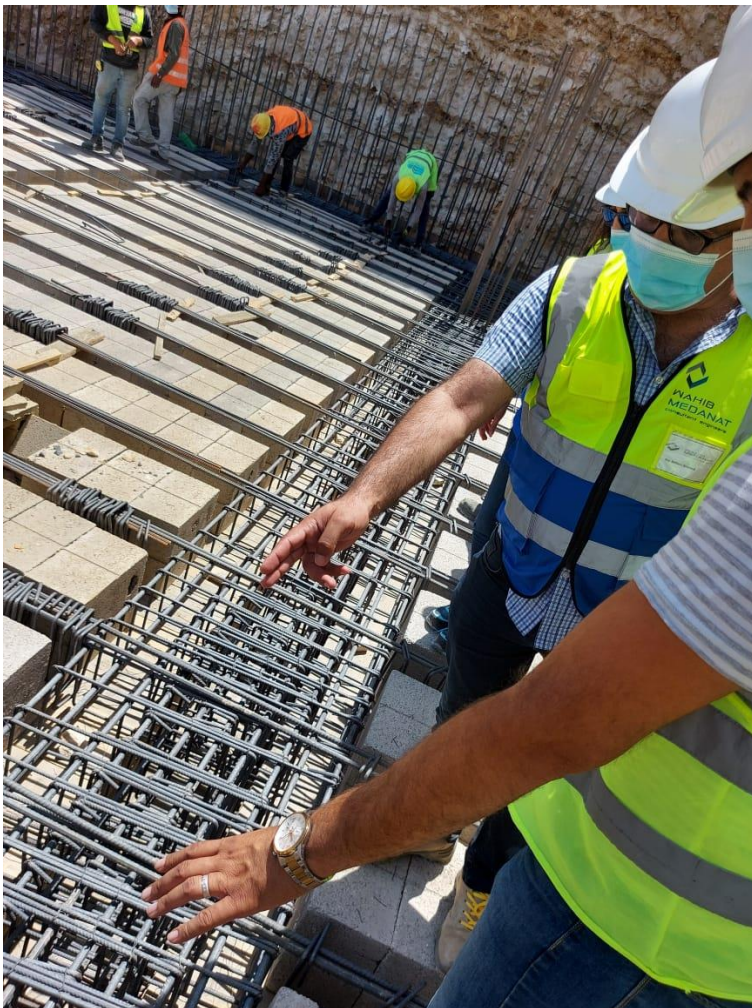
Open ribs blocks should be closed to avoid filling those blocks with concrete during roof casting and number of steel reinforcement bars needed more arrangement and tying

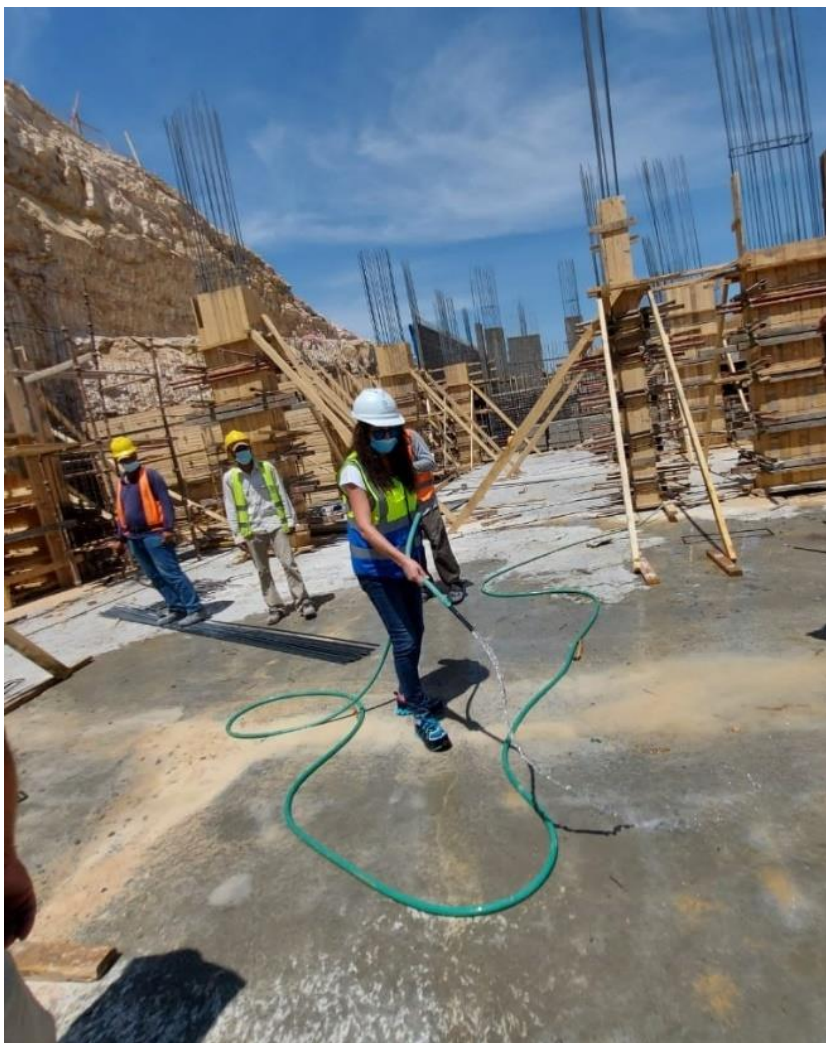
The consultant stressed on the issue of curing. More preparations and care should be implemented

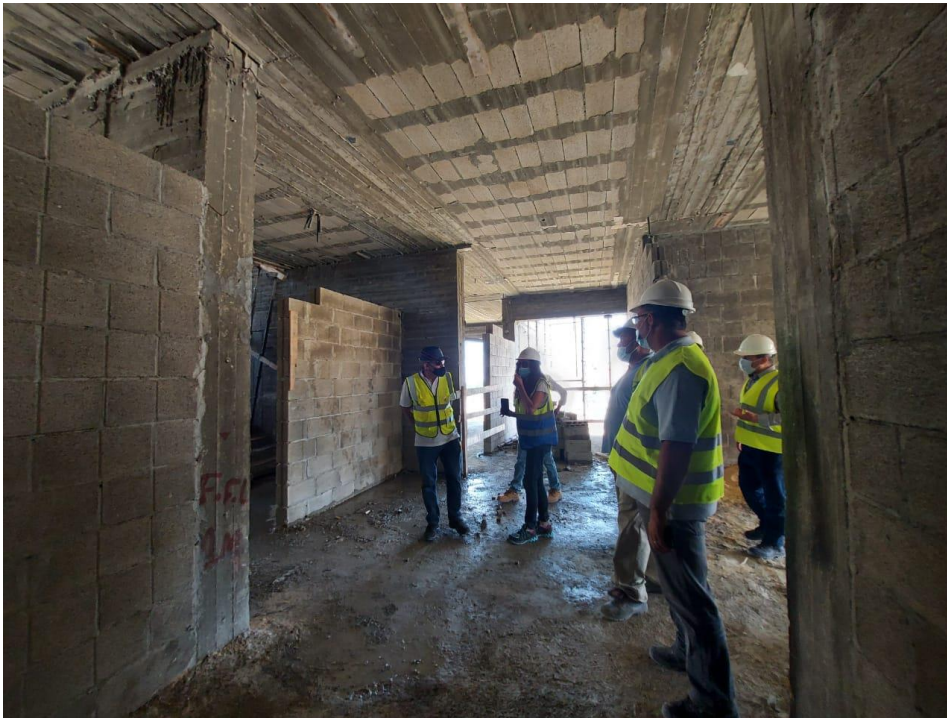
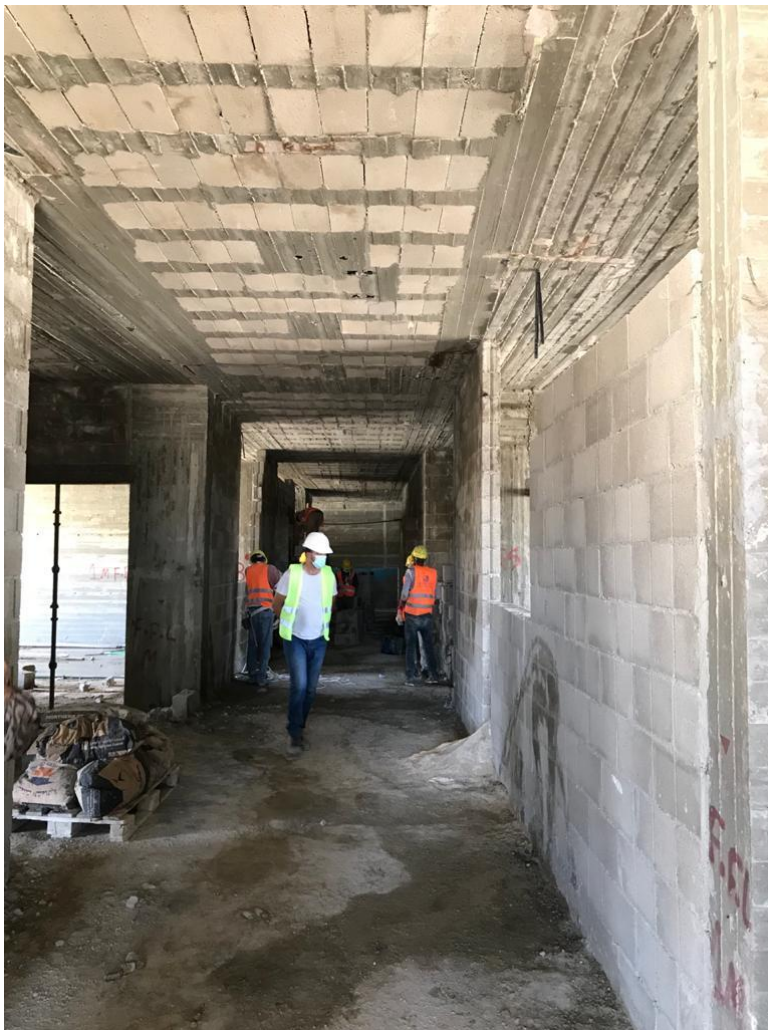
It was observed at more than one location that casted columns and block walls are not in line together. Deviations reach few centimeters in some cases were observed. The Contractor was requested to take care and avoid more defects specially in plastering work

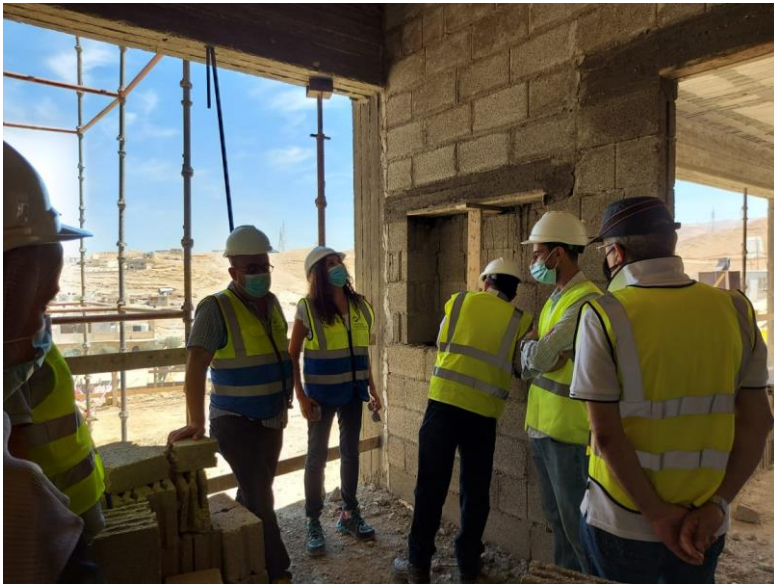
One location of "Fire Hose Rail Cabinet" was checked and remarks were given to Contractor regarding the finishing of the double wall

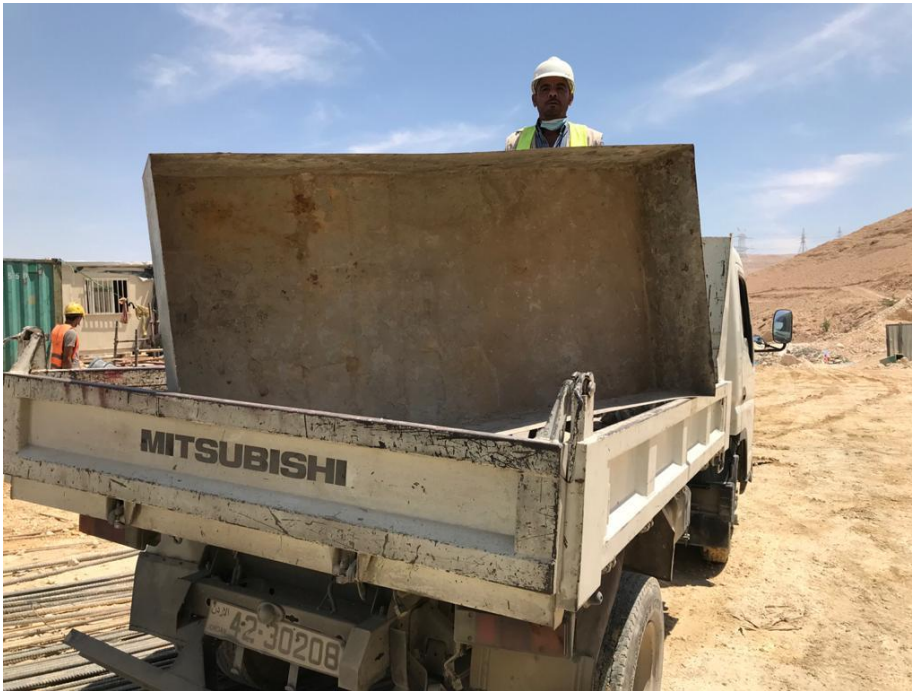
It was observed that the Contractor provided special container for mixing mortar used for block work building
