SKEP III Home Office Support Site Visit Report

Consultant	Wahib Medanat Consultant Engineer	Rep No.	21-27102021
Contractor	Dijlah Establishment Constr. Contracting	Tender No.	(11/2019/USAID/SKEP/3/S) Schools for a Knowledge Economy Project (SKEP) - Phase (3) Package (1, 2)
Site Name	Hay Al Iskan Basic Mixed School- Jerash	Day/ Date	Wed. 27/10/2021
Duration of Project	450 Calendar Days	Total Project Budget	8,314,983.735 JD

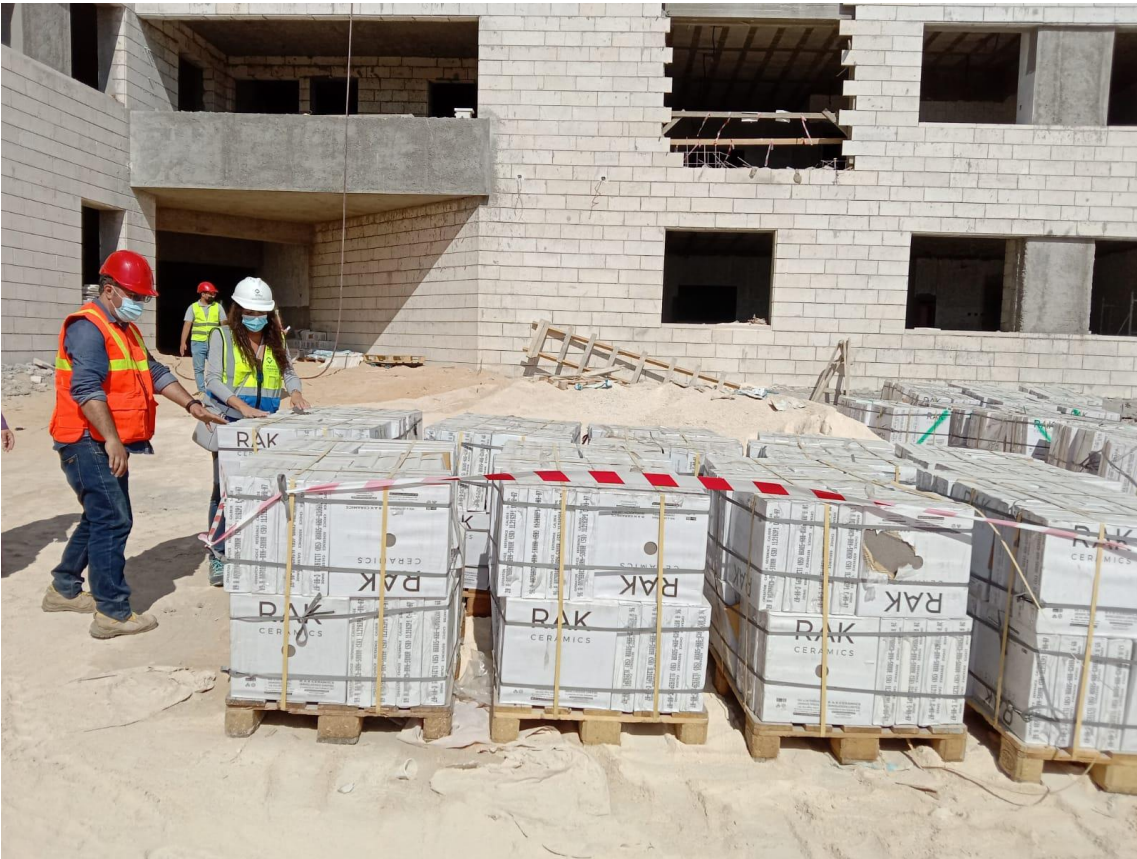
(figure:04)

The Supervision team inspected the imported porcelain floor tiles

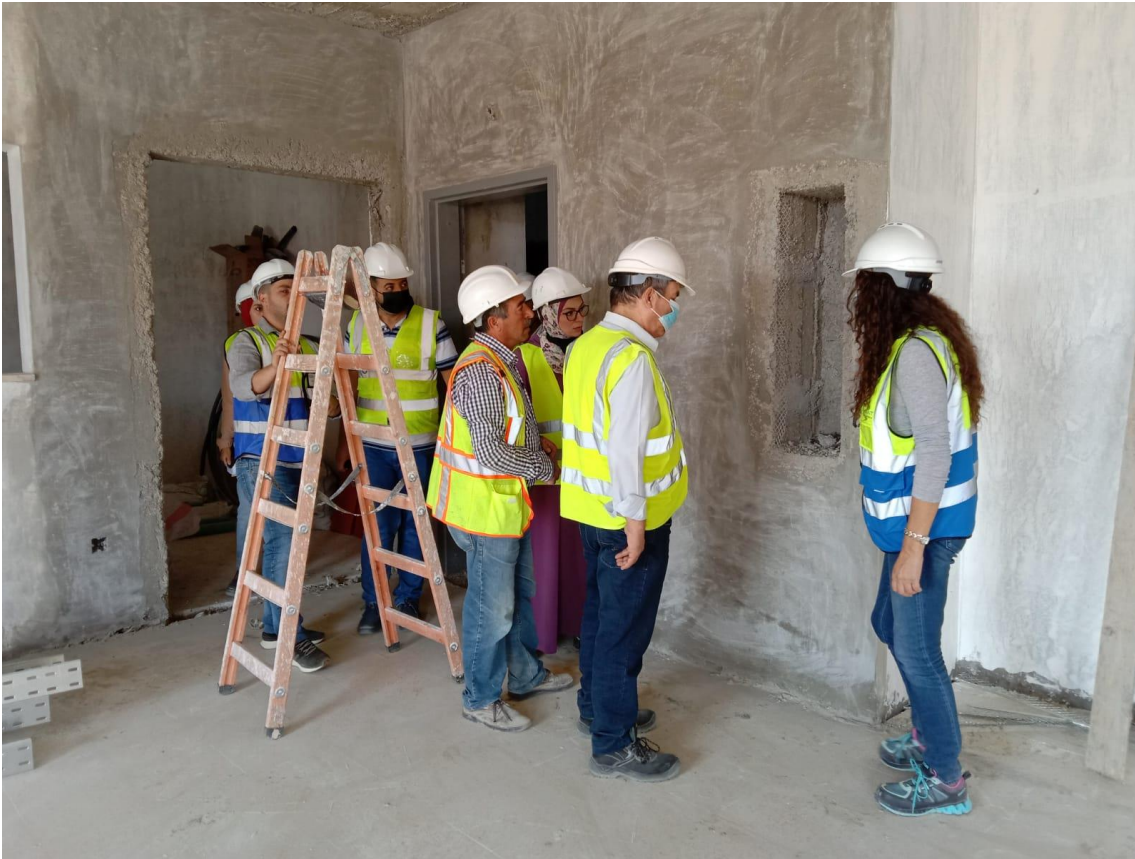
(figure:05)

The supervision checked the location of the fire extinguishers in general

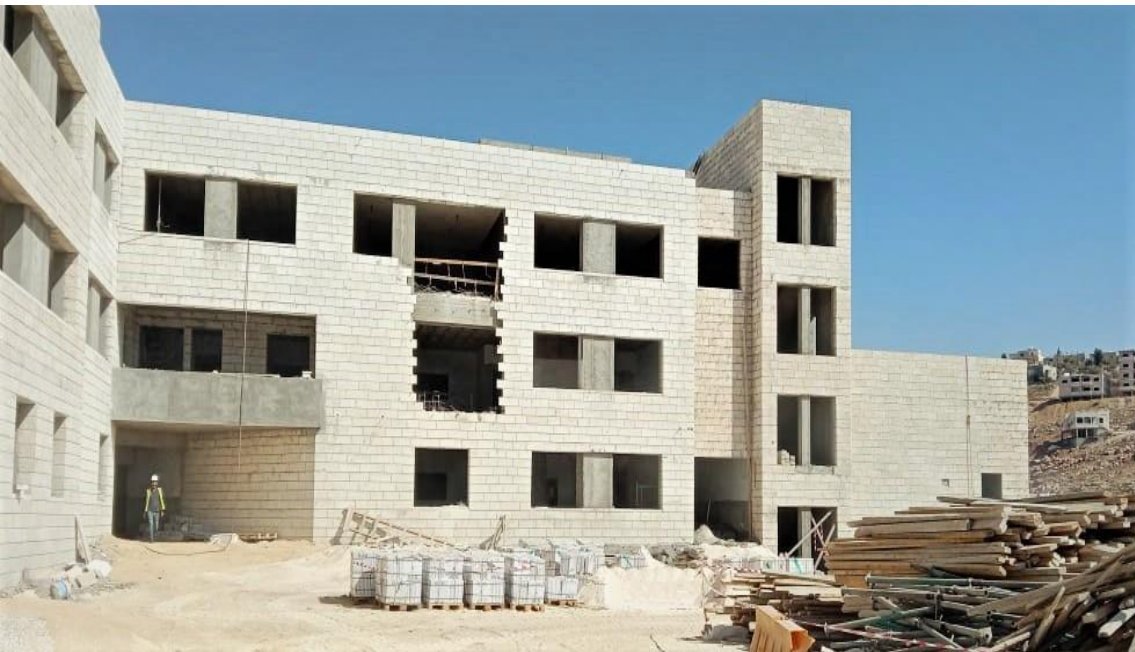
(figure:06)

10	General check of the stone facades and window stone lintels.
11	The granite coping at the corridors and the relation with fire extinguisher cabinets was discussed.
12	Upon the inspection of the executed wall tiles, it was observed that two tiled walls have defects related to workmanship. It was agreed that the Contractor will remove the defected areas and re-fix tiles correctly.
13	The supervision checked the location of the fire hose cabinets in general.
14	After the site tour, a site meeting was held at the supervision staff offices and the following issues were discussed: <ul style="list-style-type: none"> - The latest invoice submitted by the Contractor. - General issues related to mechanical works. - the Contractor was requested to have the final location of cabinets at the corridors and the relation with the wall porcelain tiling. The supervision requested the Contractor to submit workshop drawings for this purpose.

General check of the stone facades and window stone lintels

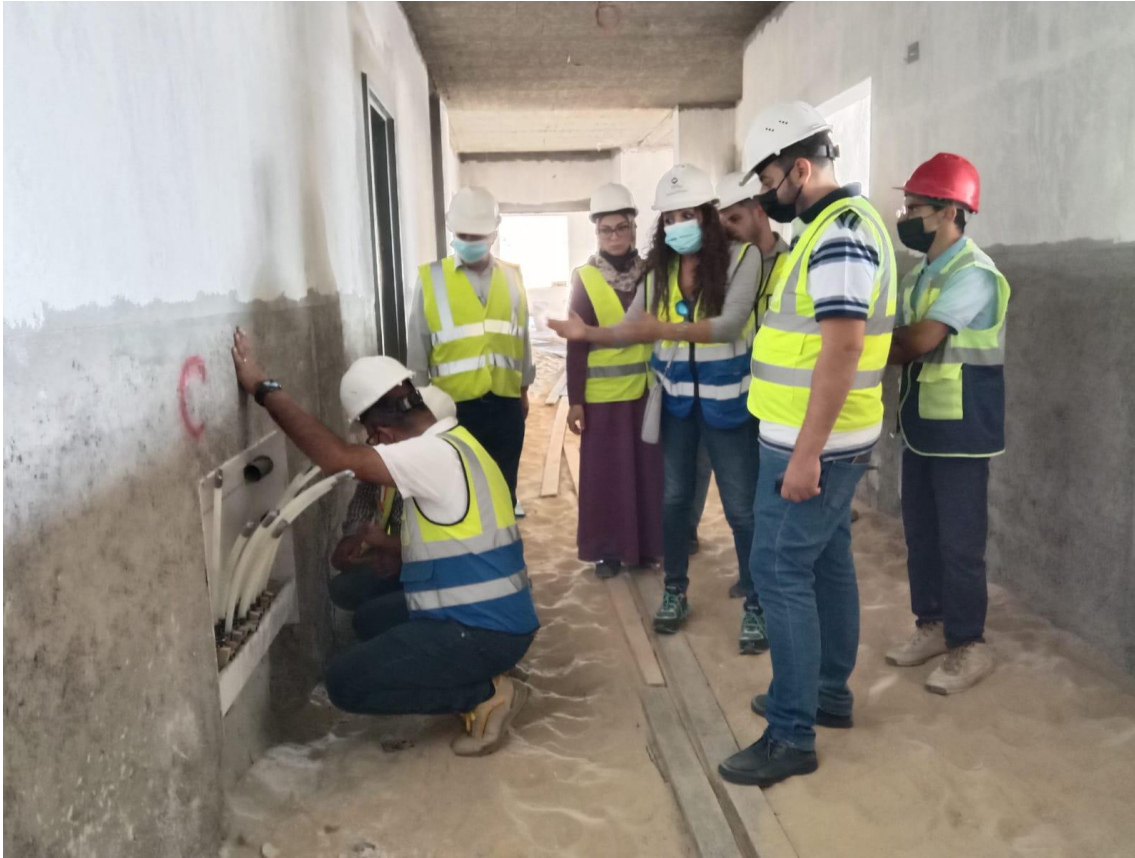
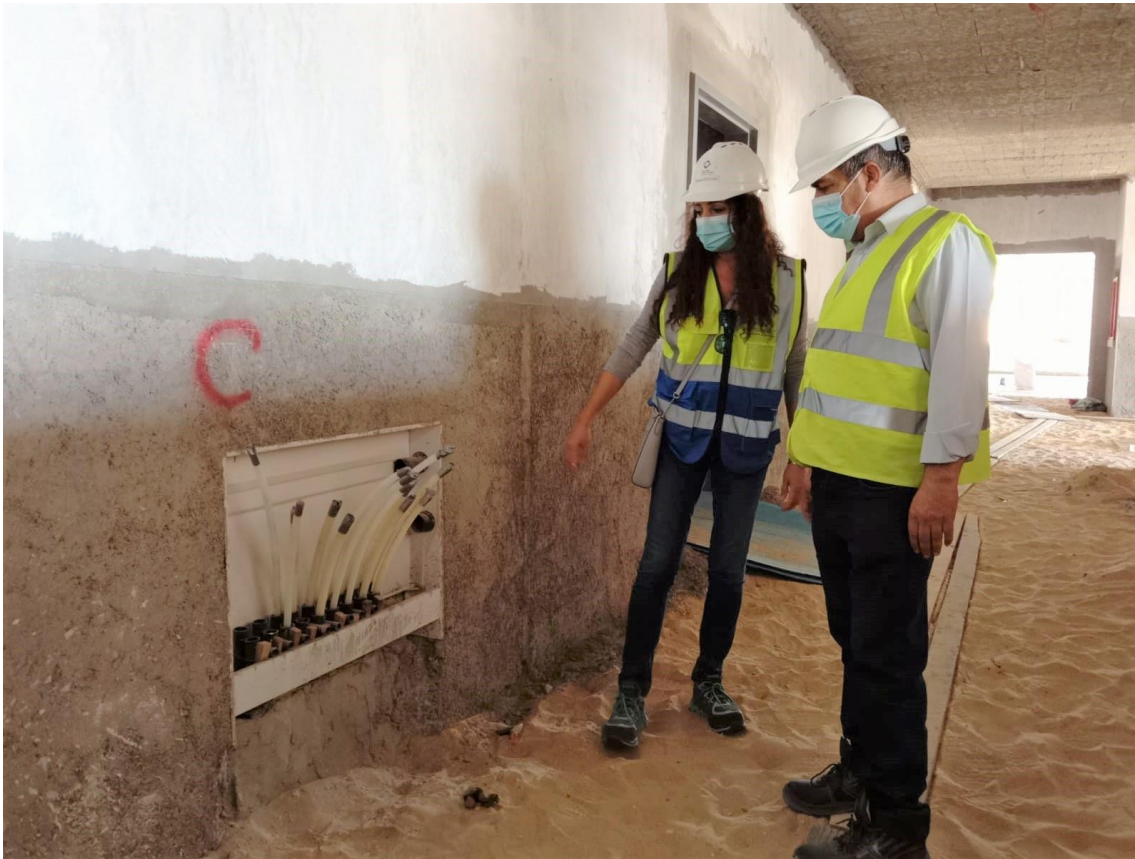
(figure:07 & 08)

The installation of mechanical cabinets was checked at the corridors

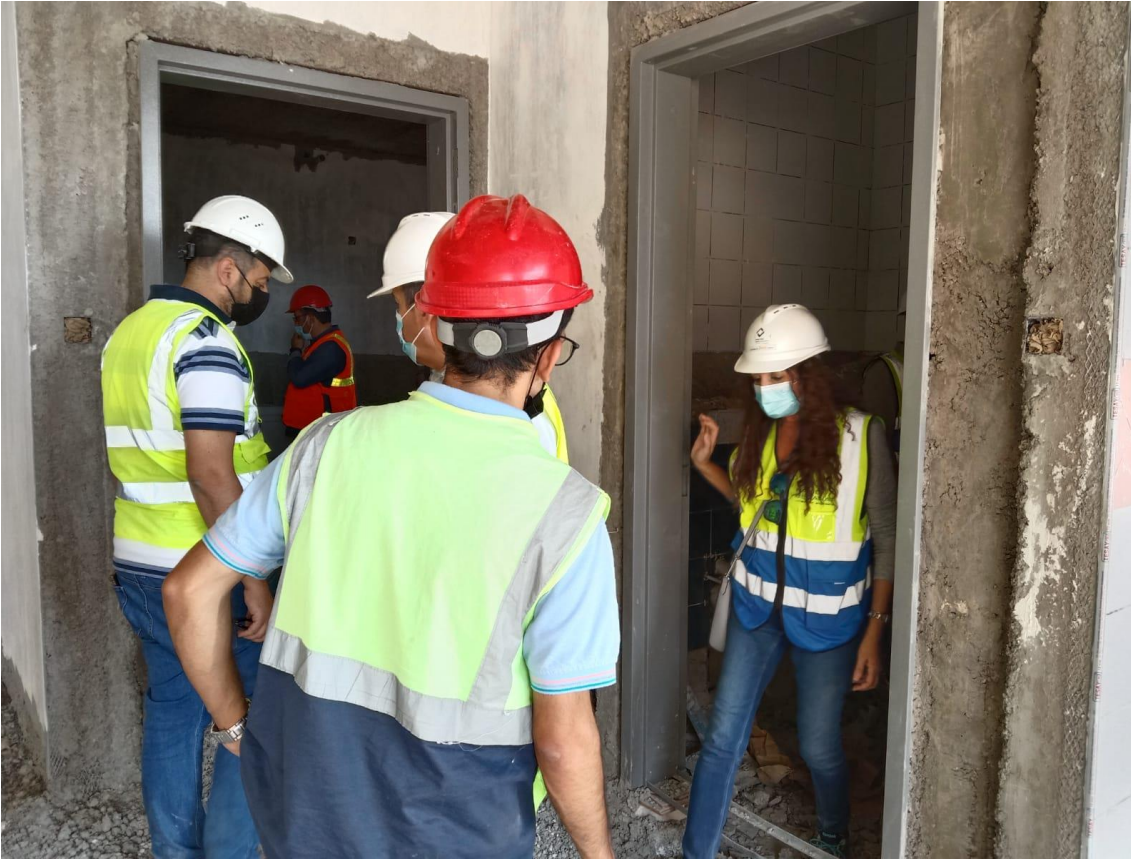
(figure:11)

The installed steel door frames were checked and the Contractor was requested to protect those frames from any defects during the construction work

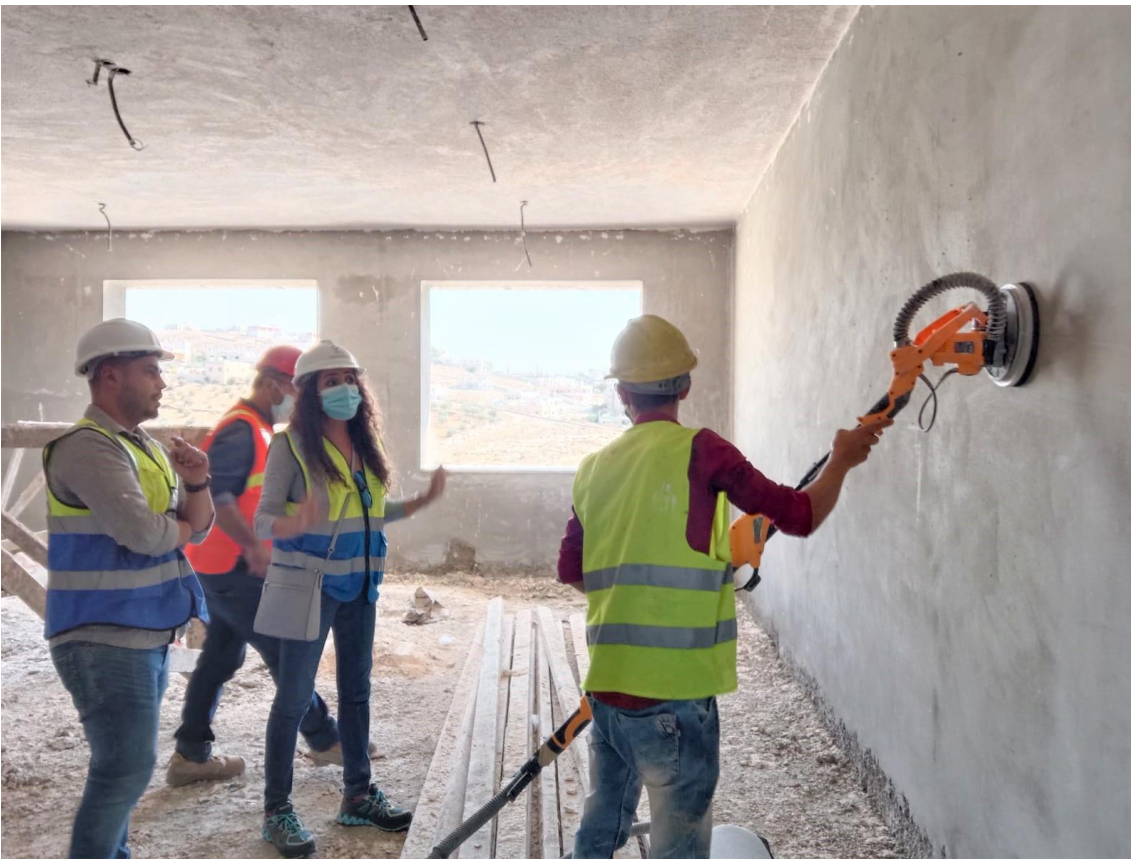
(figure:12)

Final Coat plastering

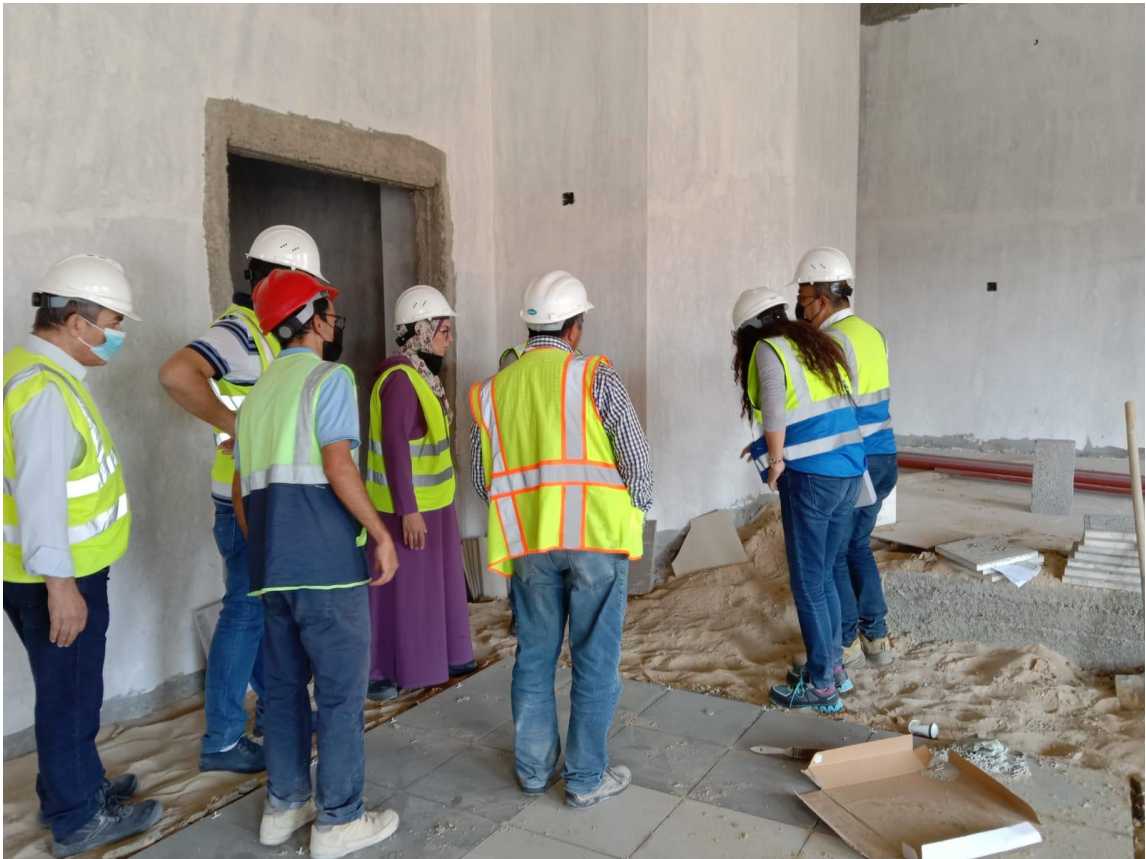
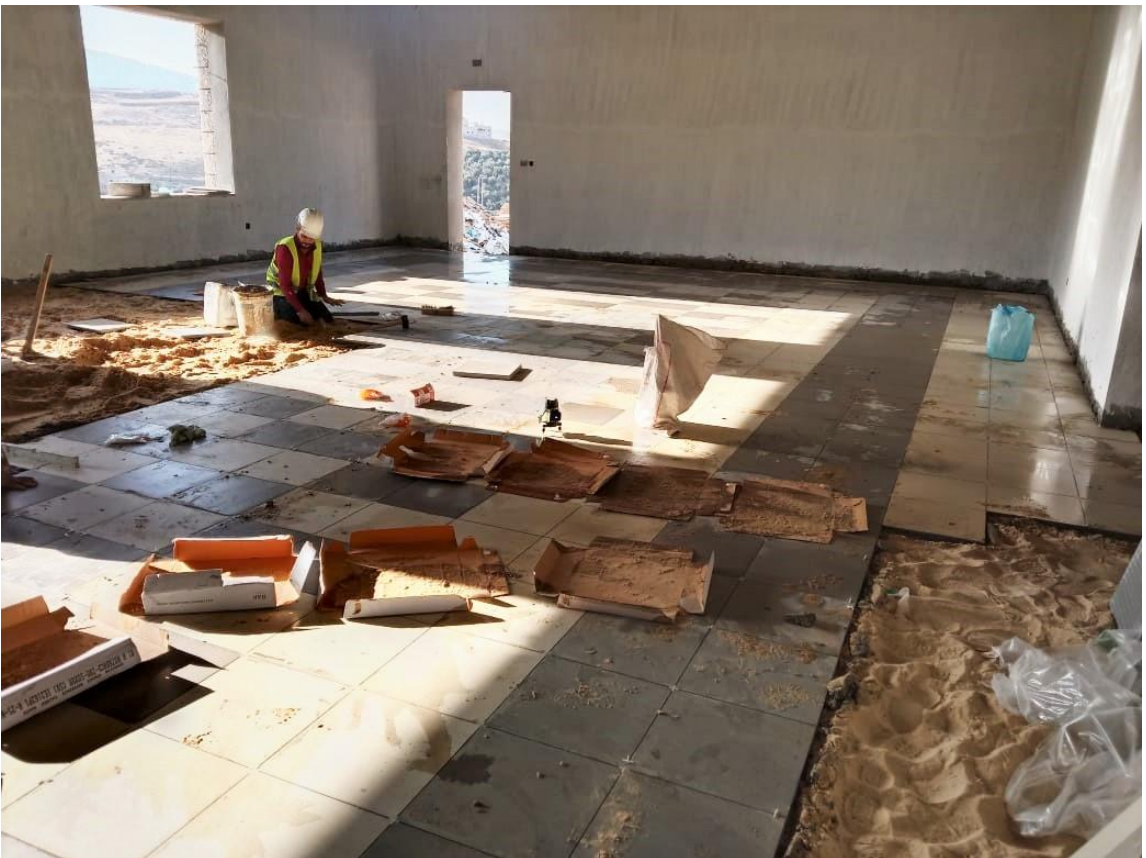
(figure:13 & 14)

It was observed that the Contractor started with the execution of the porcelain floor tiles and general remarks were given to the Contractor. The Contractor was requested to protect the executed tiles in a convenient way

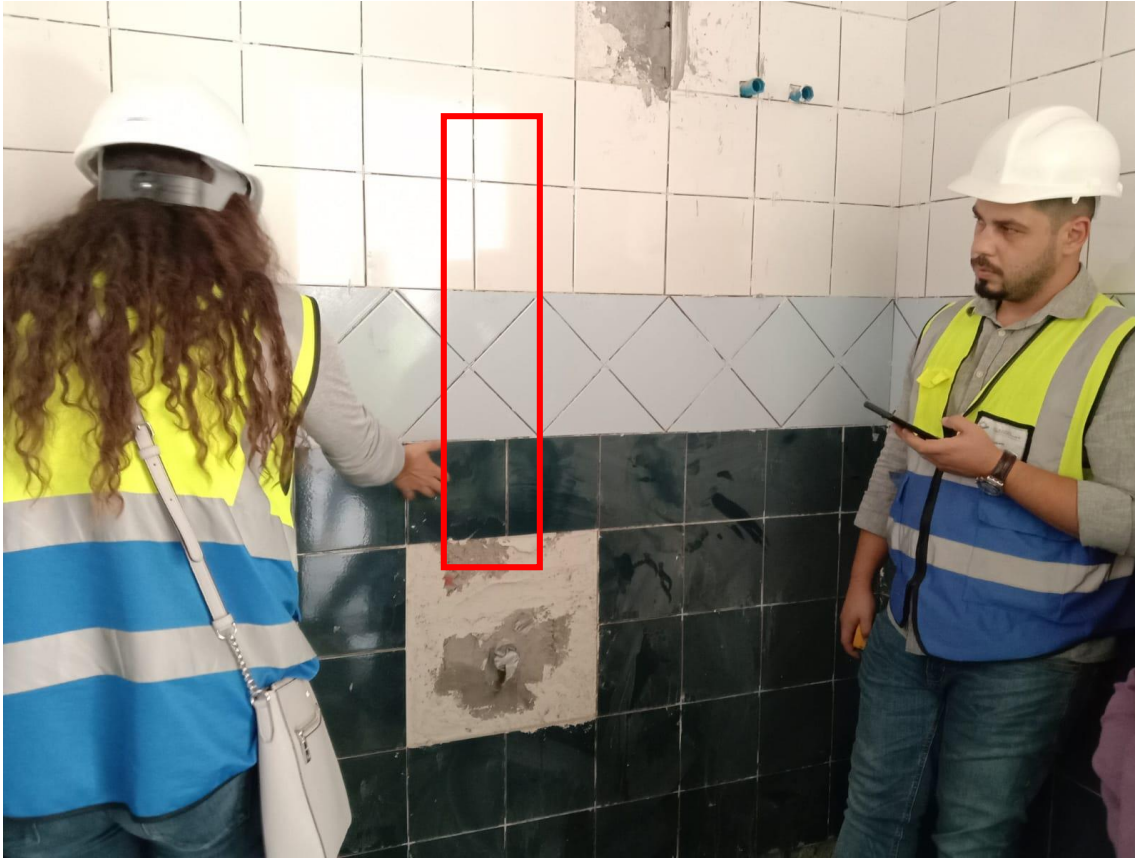
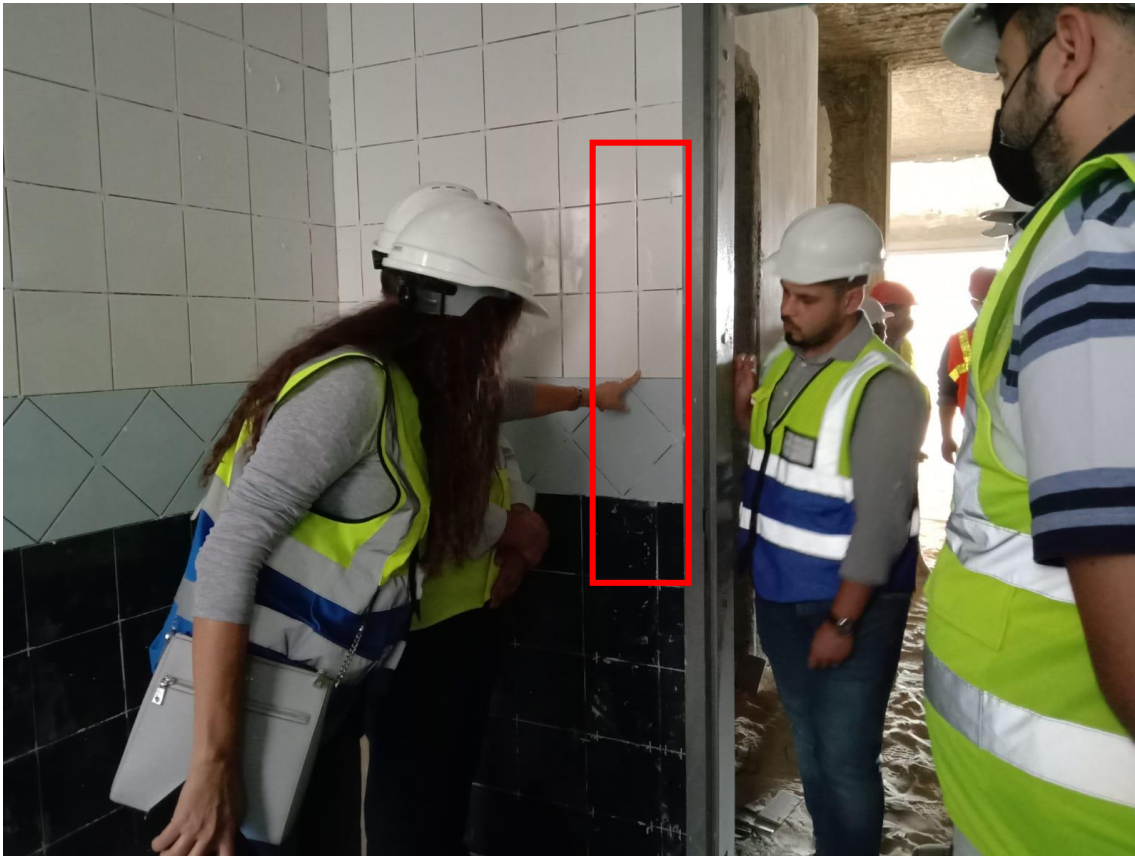
(figure:15 & 16)

Upon the inspection of the executed wall tiles, it was observed that two tiled walls have defects related to workmanship. It was agreed that the Contractor will remove the defected areas and re-fix tiles correct

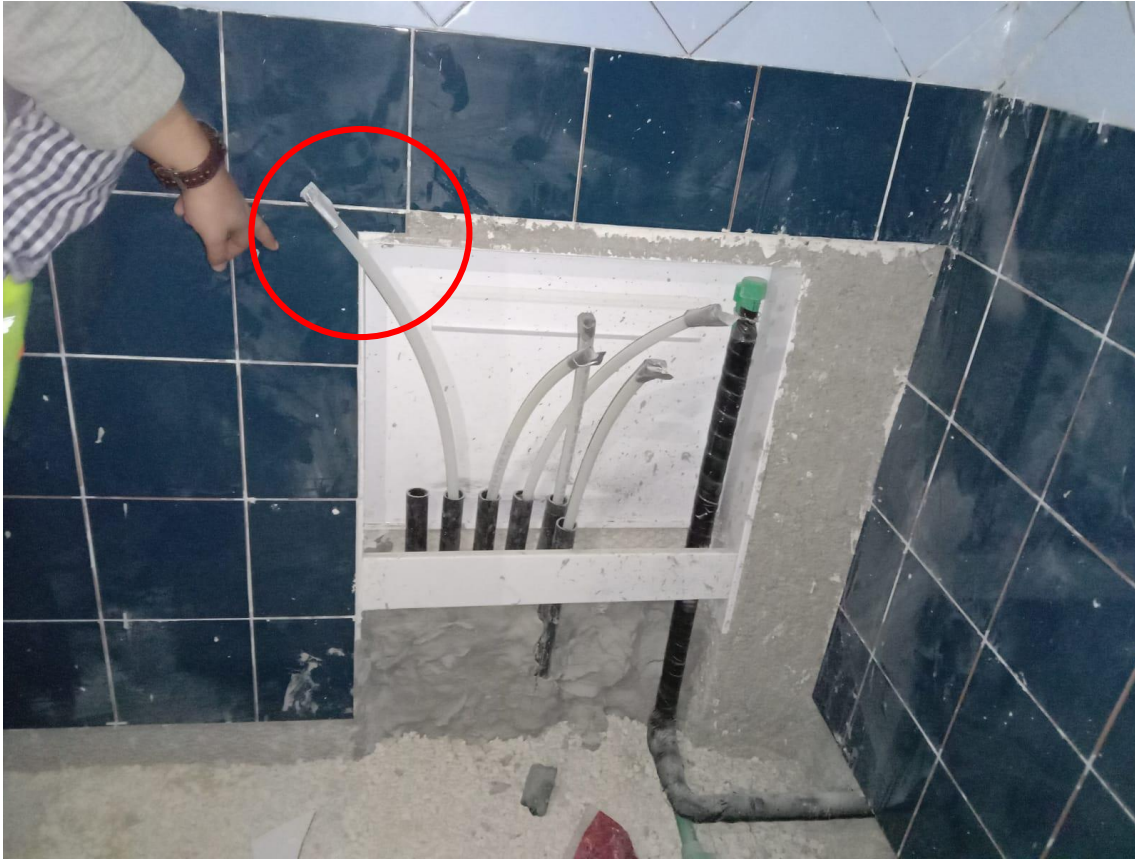
(figure:17)

The installation of mechanical cabinets was checked after execution of the ceramic wall tiles. It was agreed that the cabinets shall be moved slightly higher to avoid small cut off pieces of ceramic

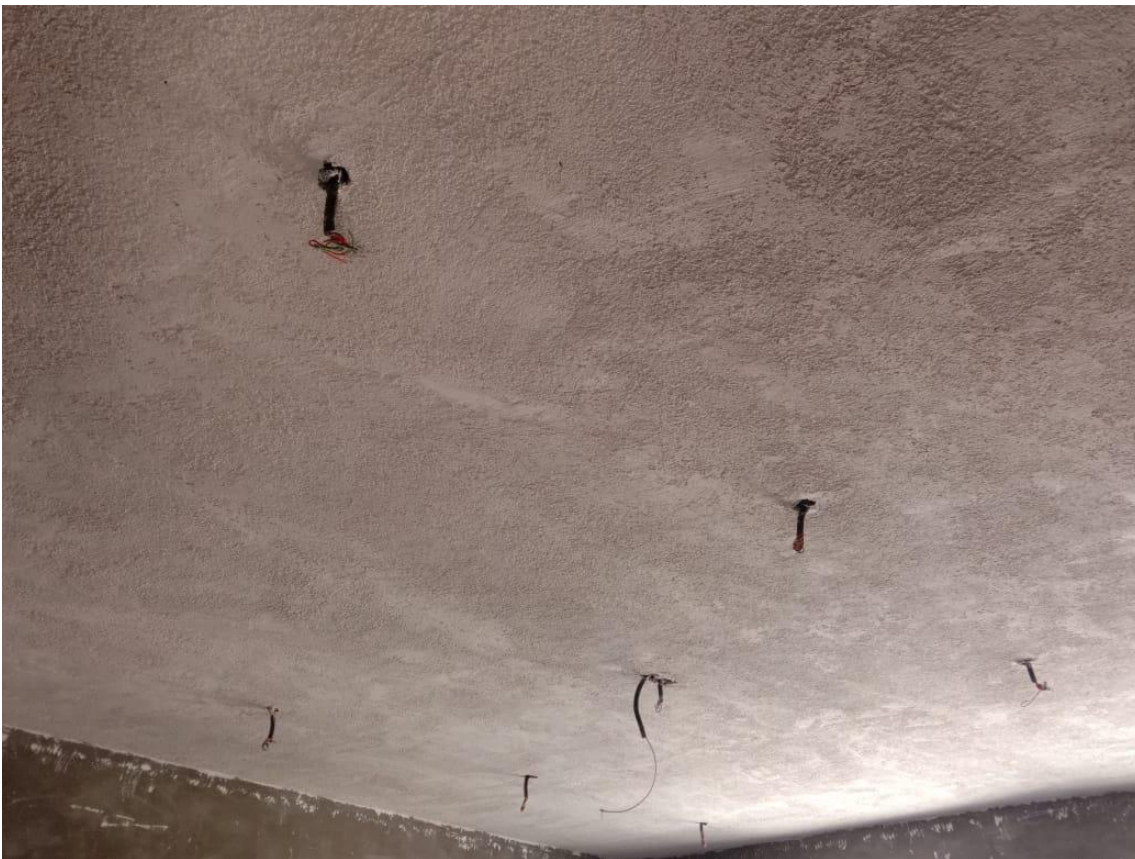
(figure:18)

The acoustical plastering for ceilings were checked and general remarks were given to the Contractor

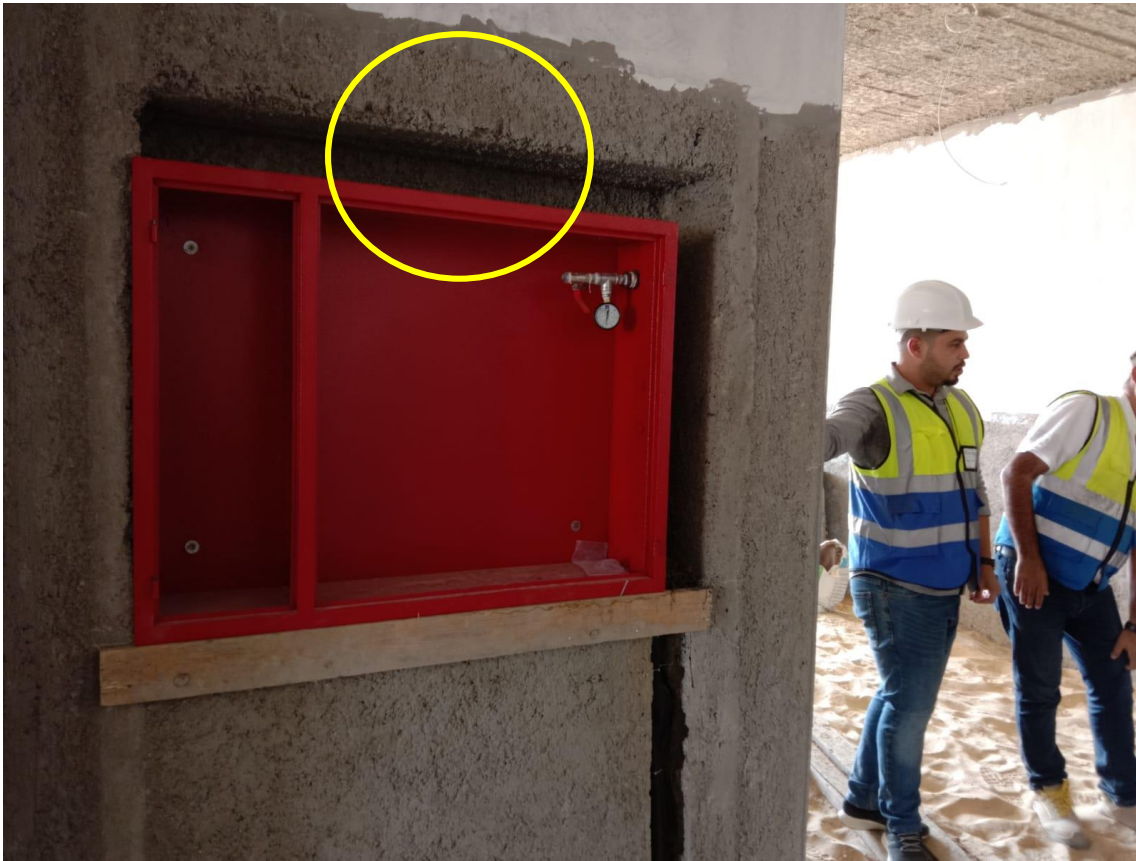
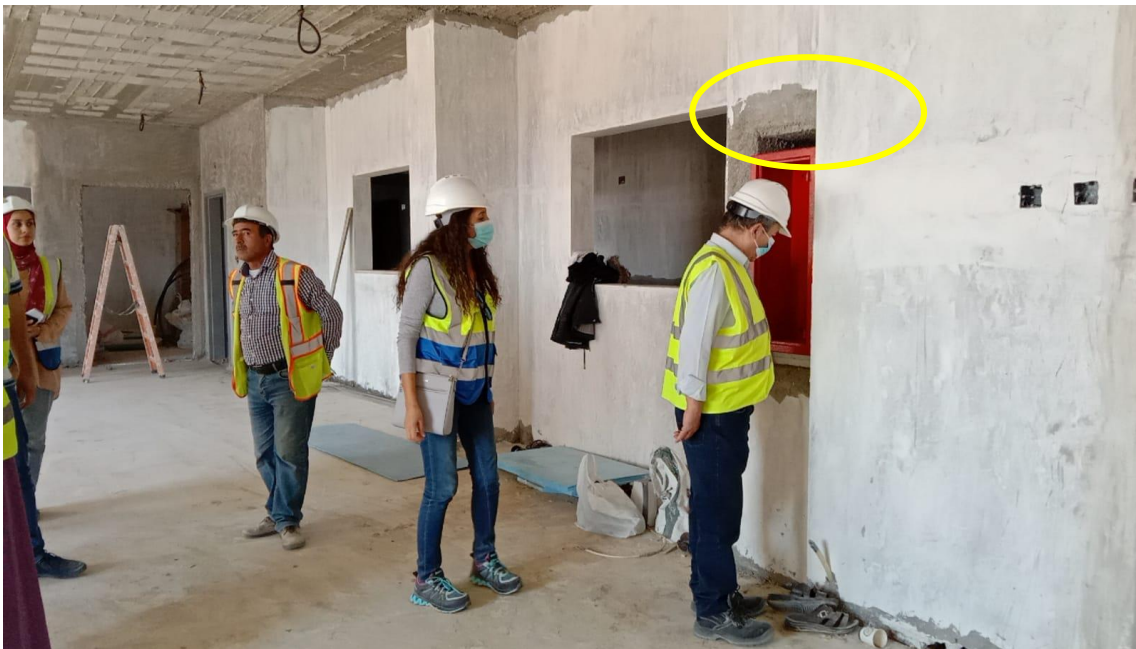
(figure:19 & 20)

The installation of the fire hose cabinets was discussed regarding the closing at the top of cabinets in a way not to exert concrete load on those cabinets
