Consultant	Wahib Medanat Consultant Engineer	Rep No.	13-14092021
Contractor	Derar Saraireh & Sons for Engineering & Contracting	Tender No.	(11/2019/USAID/SKEP/3/S) Schools for a Knowledge Economy Project (SKEP) - Phase (3) Package (1, 2)
Site Name	Khadija Bint Khwailed Basic Mixed School- Shouna Janoubia	Day/ Date	Tue. 14/09/2021
Duration of Project	450 Calendar Days	Total Project Budget	9,789,417.840 JD

Visit Notes

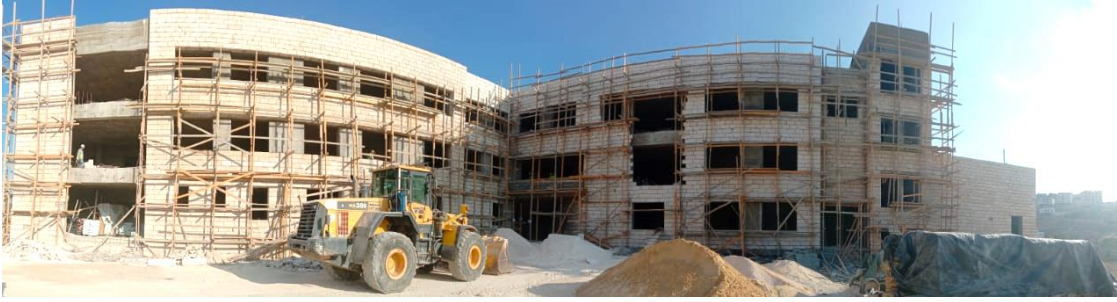
(Figure: 01)

General view of the casted slab of the third floor

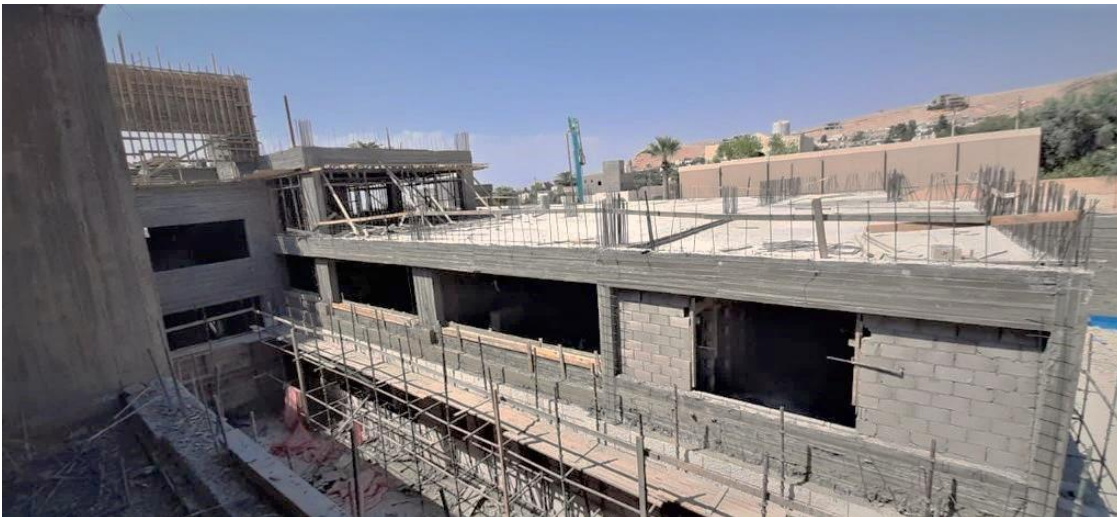
(Figure: 03)

General view of the casted roof slab

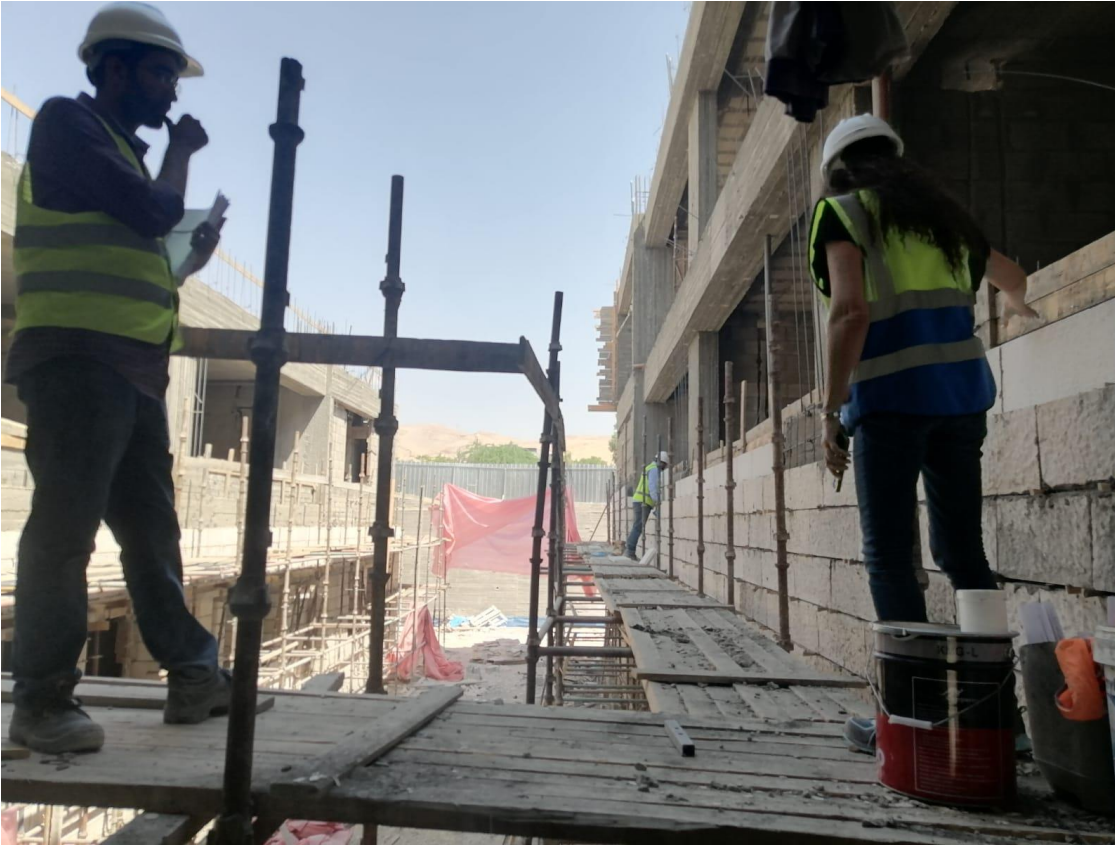
(Figure: 06)

Inspecting the
executed stone
work

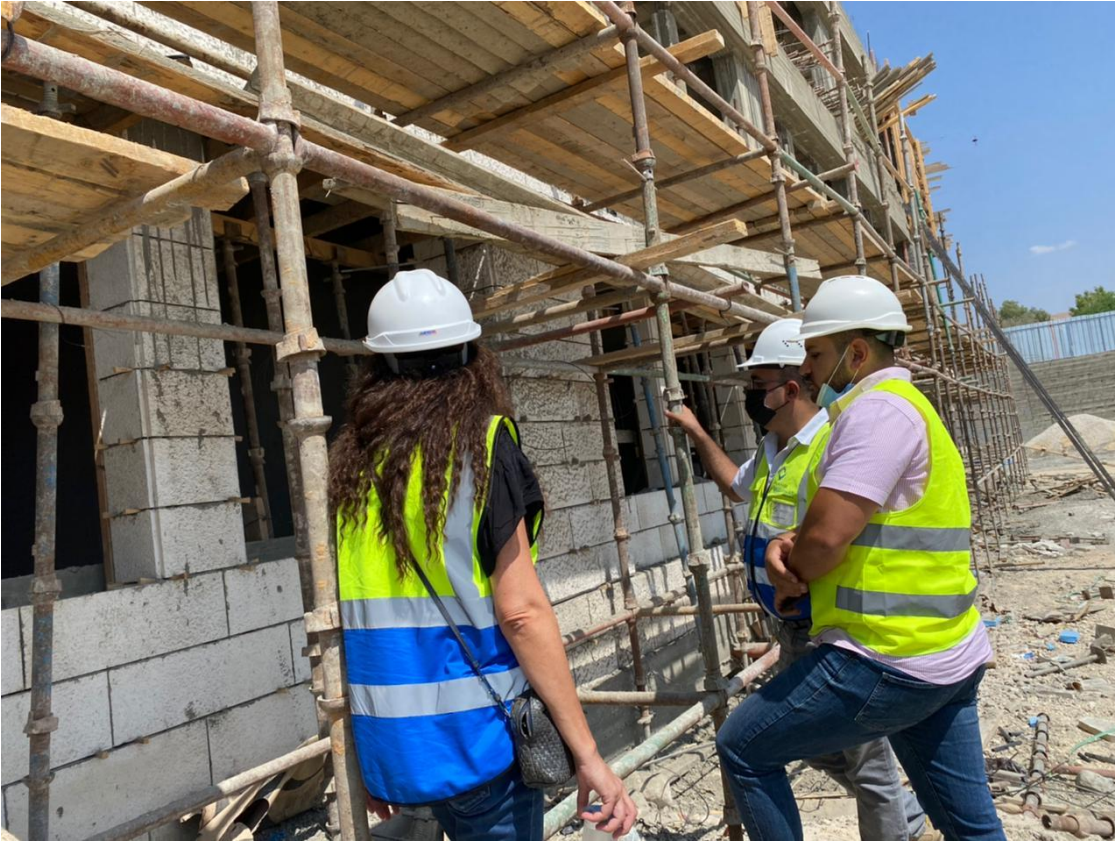
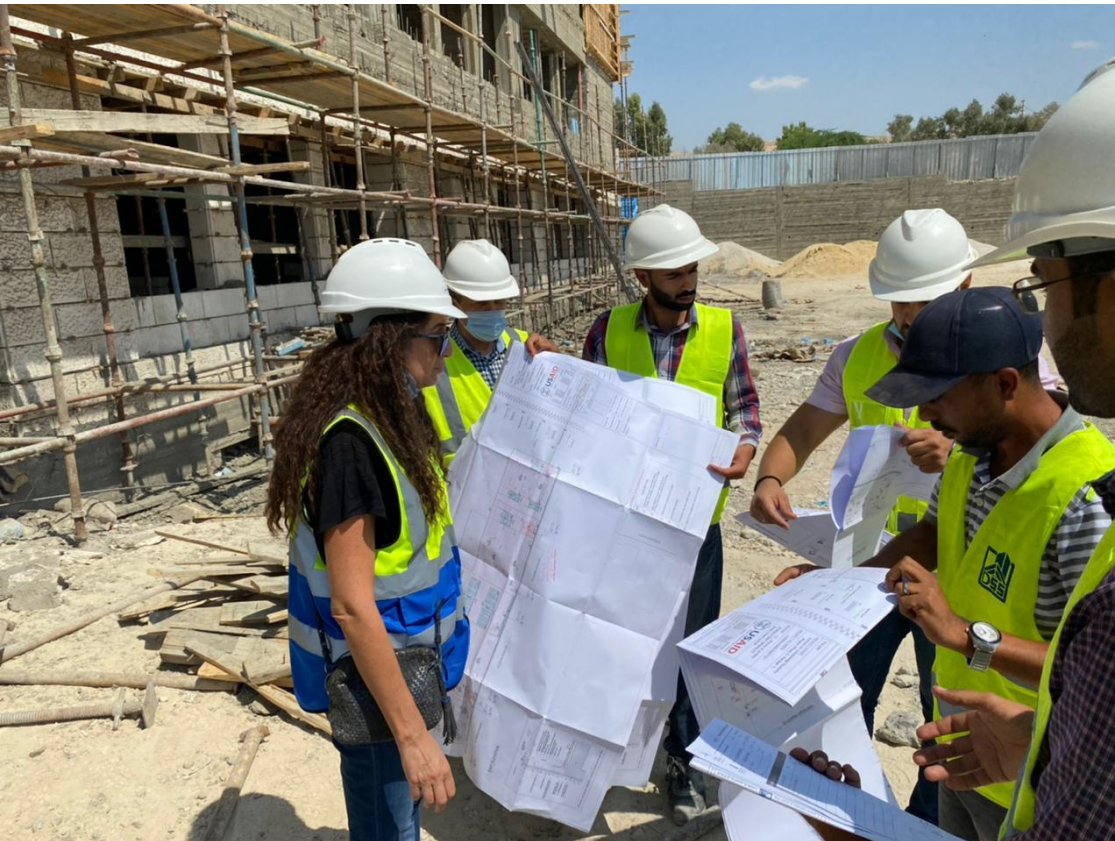
(Figure: 08 & 09)

The Executed stone work was inspected and the supervision team stressed on the necessity of matching the executed works with the approved workshop drawings and with the building process

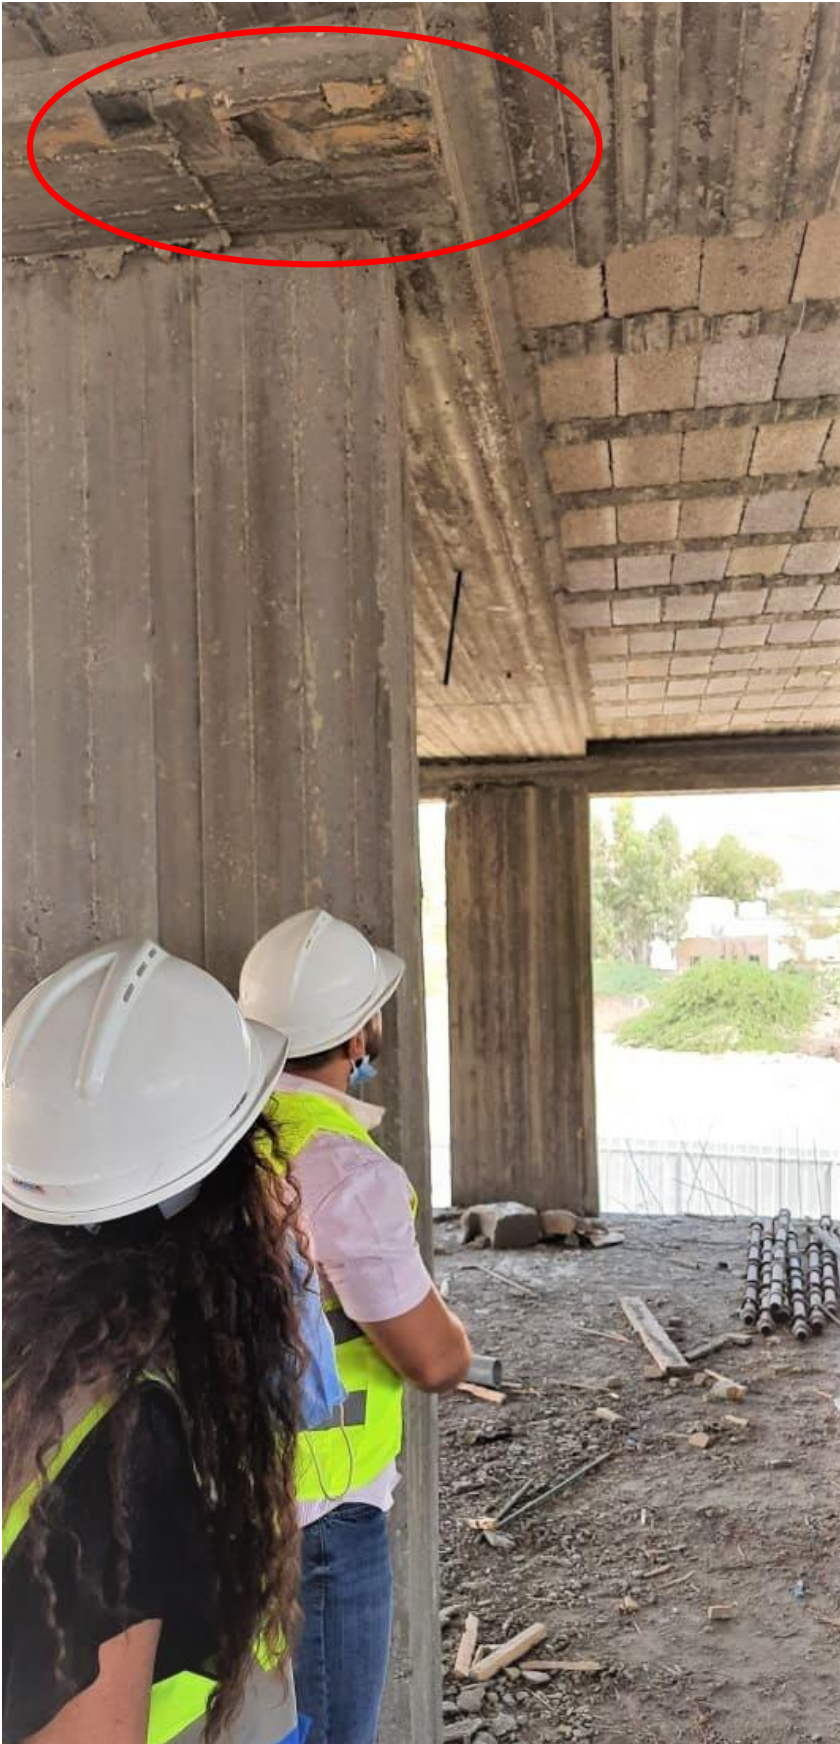
(Figure: 10)

A comment was given about the left wooden pieces at the structure elements (mainly the slab). The Contractor promised to remove those pieces before plastering

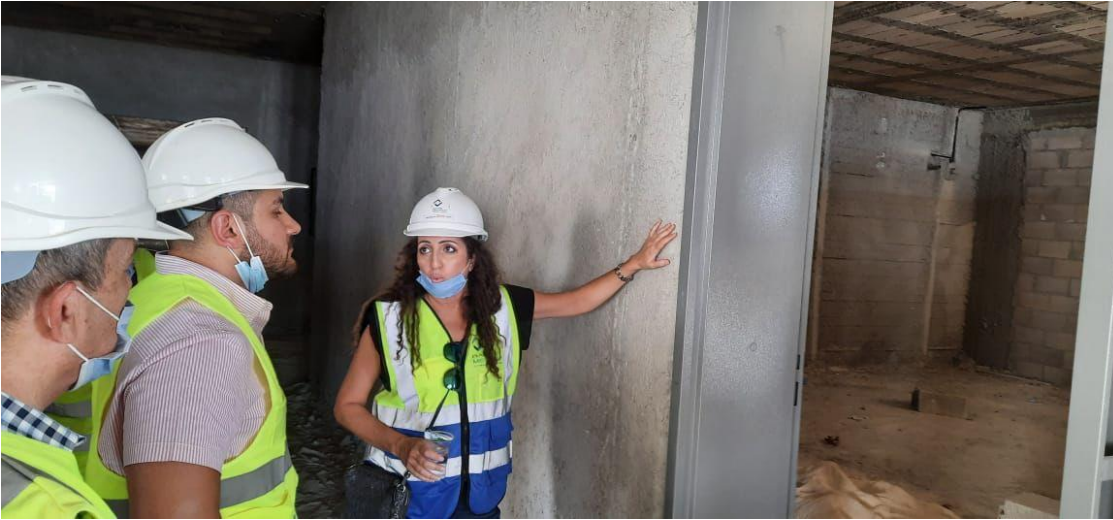
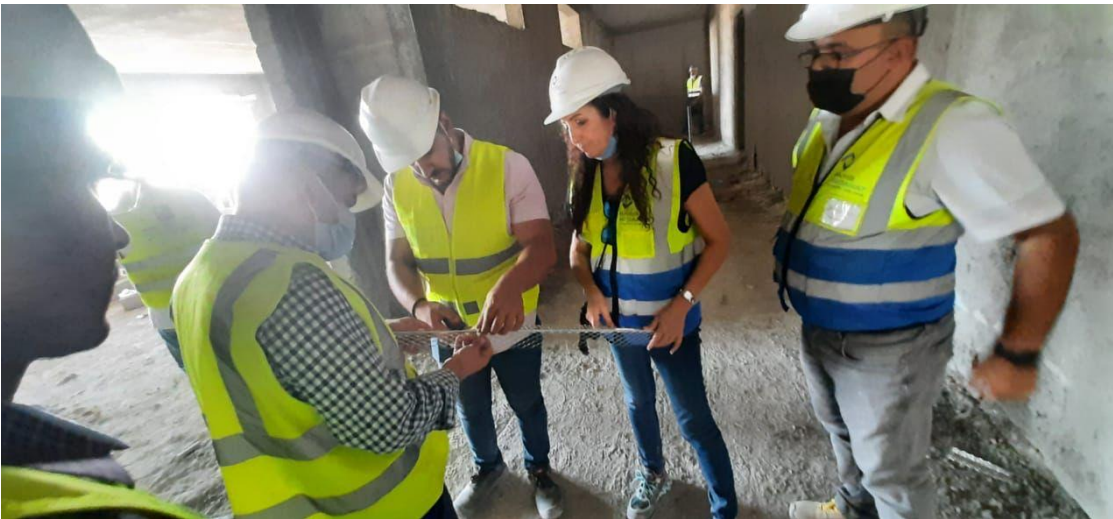
(Figure: 11 & 12)

The dimensions of used plastering beads were checked and considered as complying with the requirements

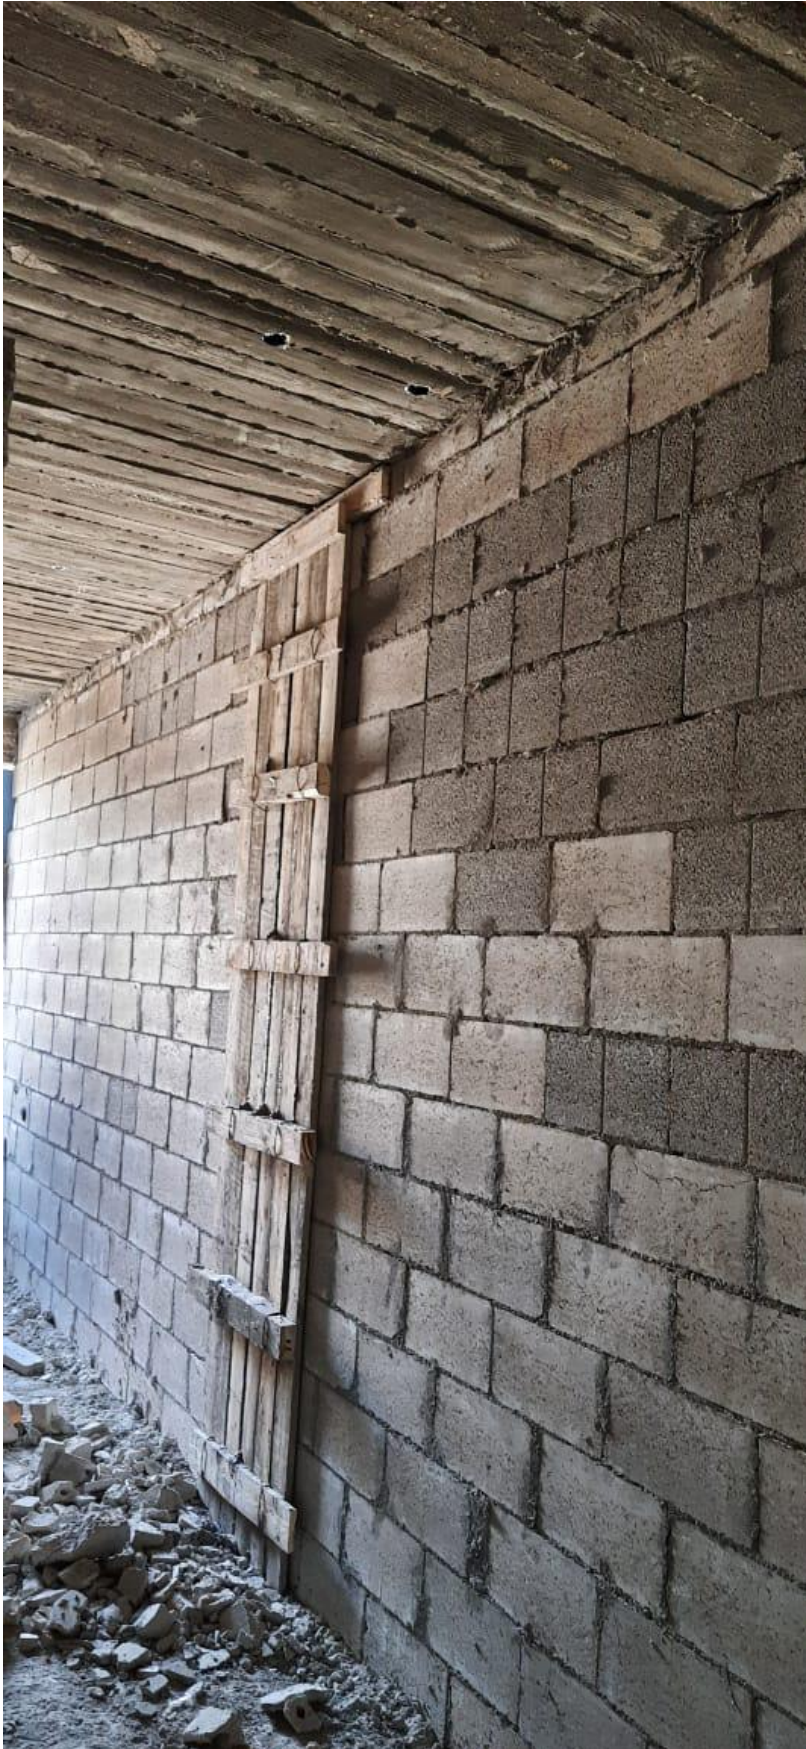
(Figure: 13)

It was observed that the Contractor executed a stiffener column within a long block wall in accordance to previous remark by the supervision team

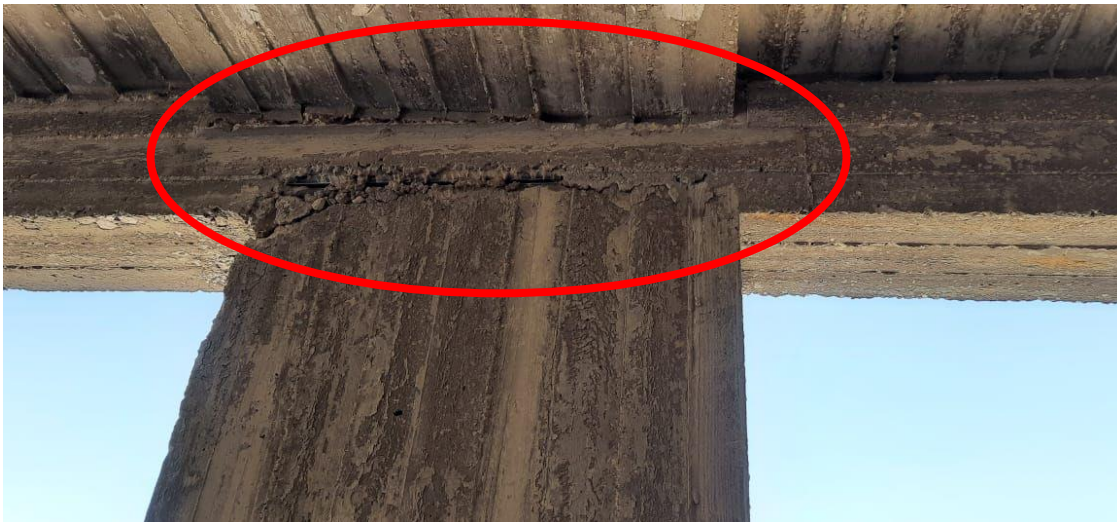
(Figure: 15)

A roughness was observed at the soffit of the lately casted third floor slab. The Contractor was instructed to remedy the observed parts and any similar parts

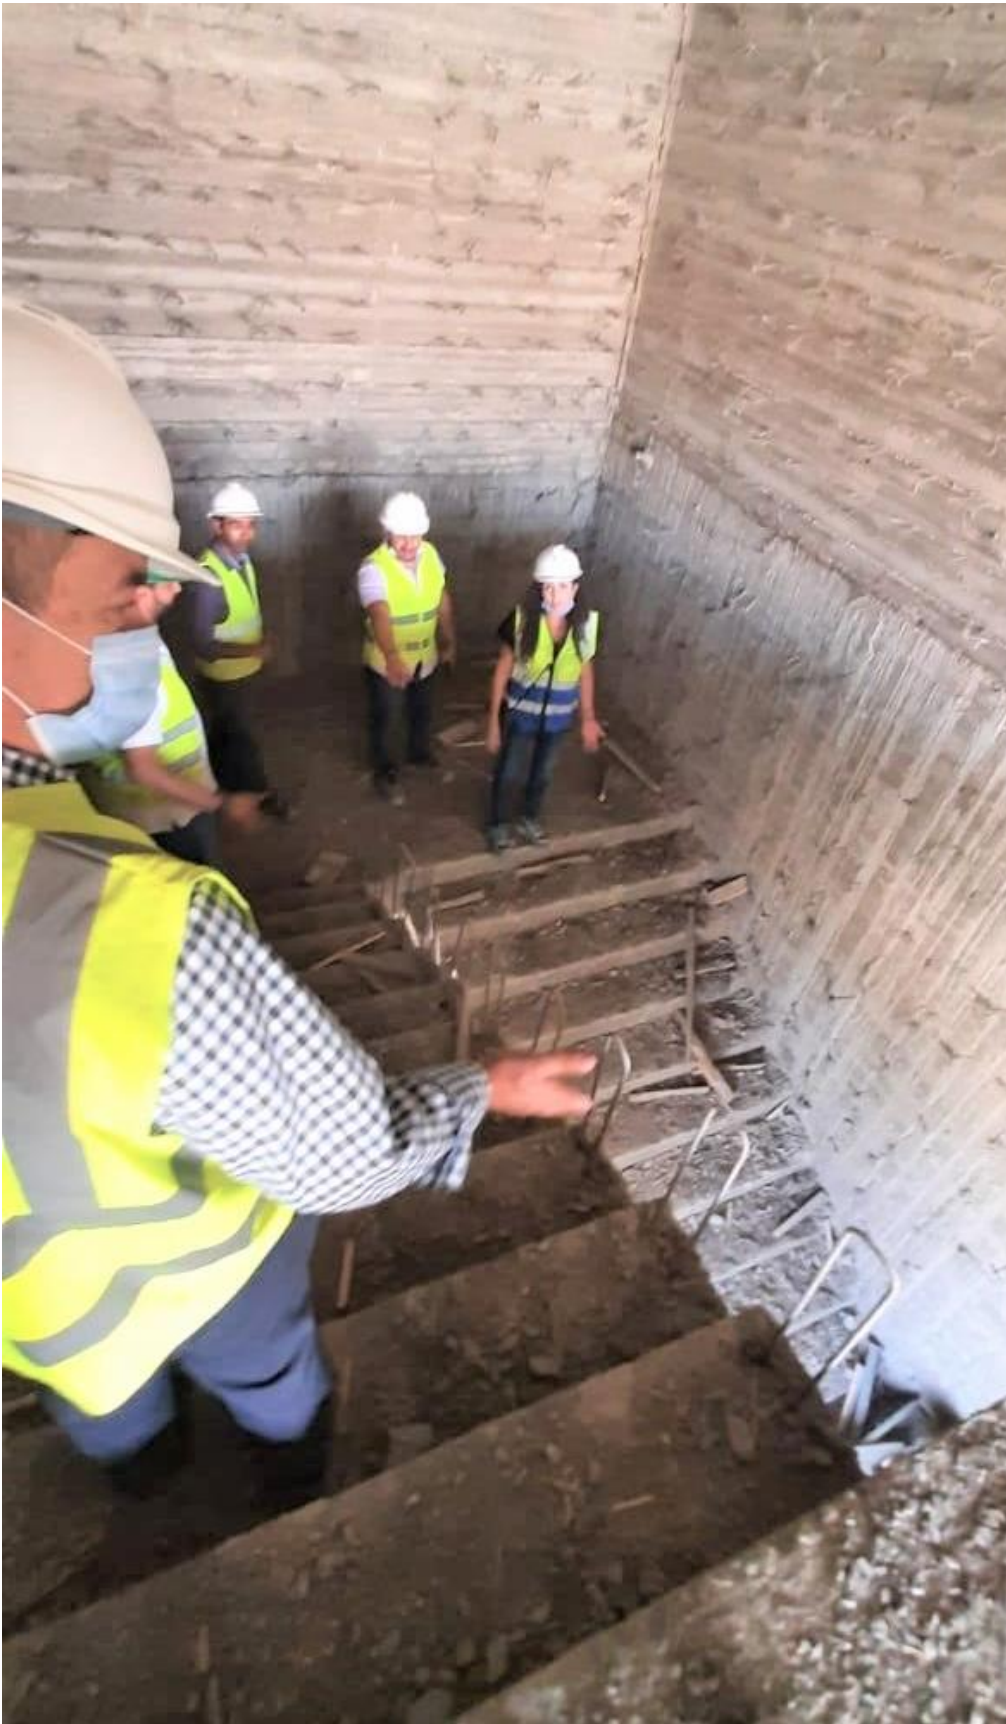
(Figure: 16)

The supervision team observed that a part of the main staircase needs safety precautions to avoid accidents. The Contractor promised to take action

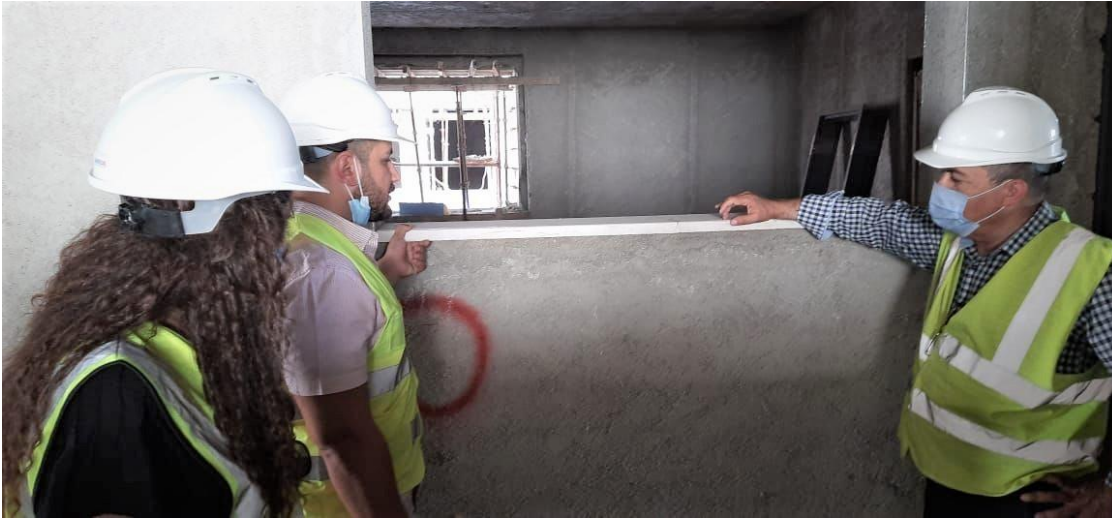
(Figure: 18)

It was observed that the bottom edge of window sills (Ajloun marble) is toothed and not straight

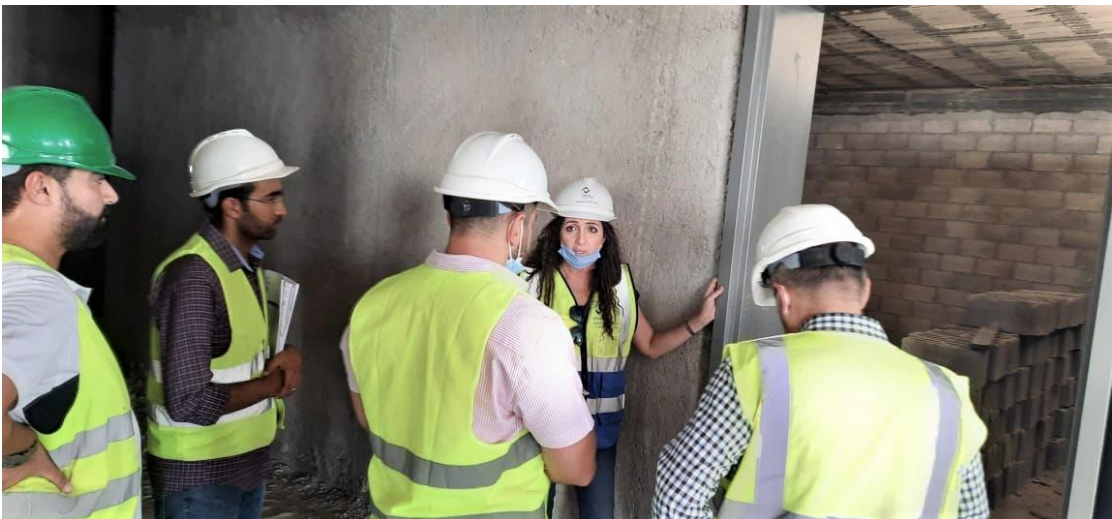
(Figure: 19)

The installed steel door frame at the corridor was inspected and was stressed to match it with the finished floor level

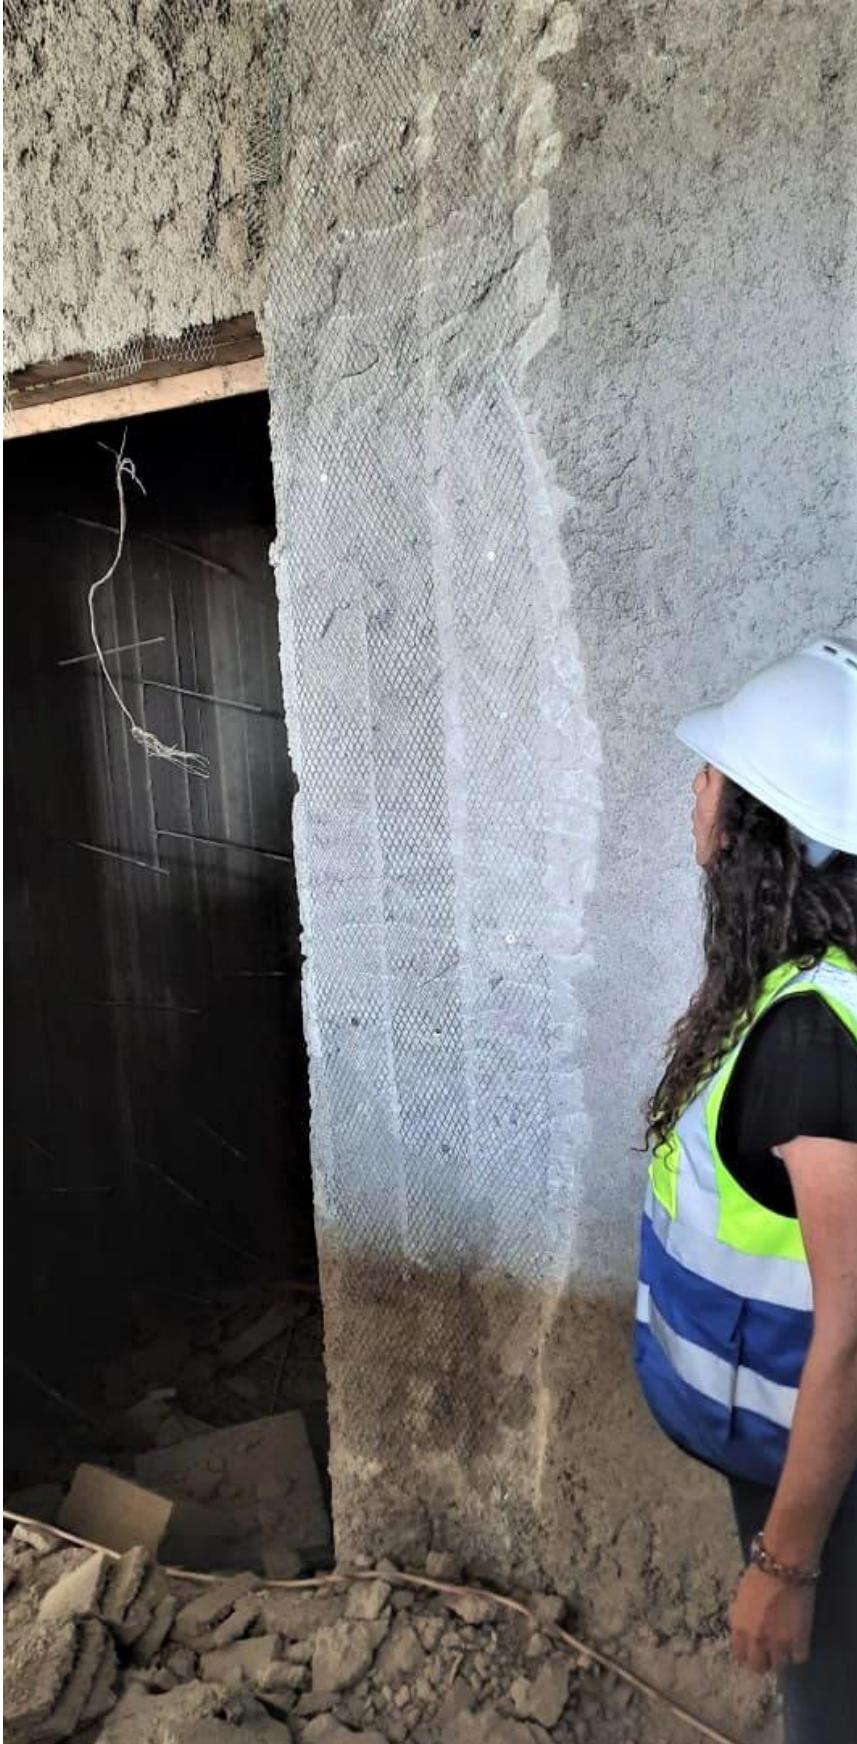
(Figure: 20)

It was observed that the Contractor rectified the previous remark by the supervision team regarding the block wall which was not matching with the concrete wall by casting a concrete strip with the use of fixing accessories appropriate to the said case
