# SKEP III Home Office Support Site Visit Report

Consultant	Wahib Medanat Consultant Engineer	Rep No.	13-16082021
Contractor	Derar Saraireh & Sons for Engineering & Contracting	Tender No.	(11/2019/USAID/SKEP/3/S) Schools for a Knowledge Economy Project (SKEP) - Phase (3) Package (1, 2)
Site Name	Khadija Bint Khwailed Basic Mixed School- Shouna Janoubia	Day/ Date	Mon. 16/08/2021
Duration of Project	450 Calendar Days	Total Project Budget	9,789,417.840 JD

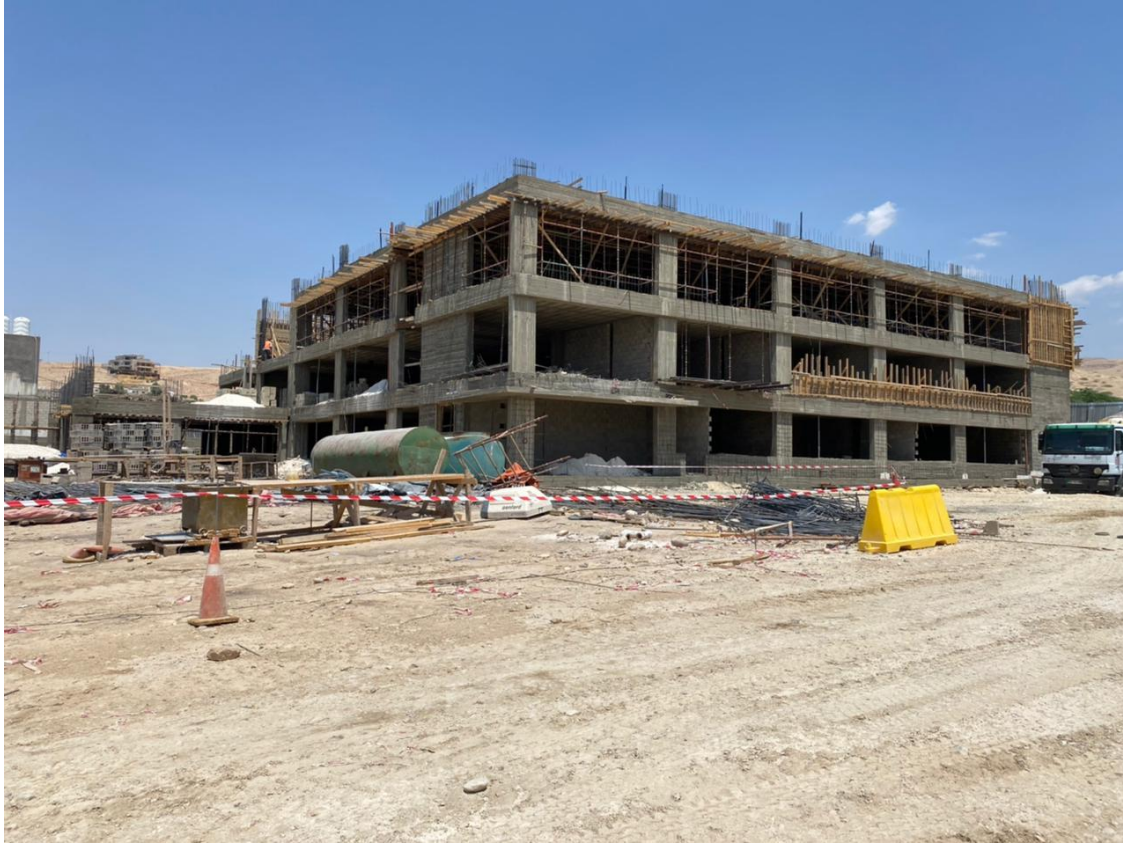
(Figure: 01)

General view of the casted slab of the third floor

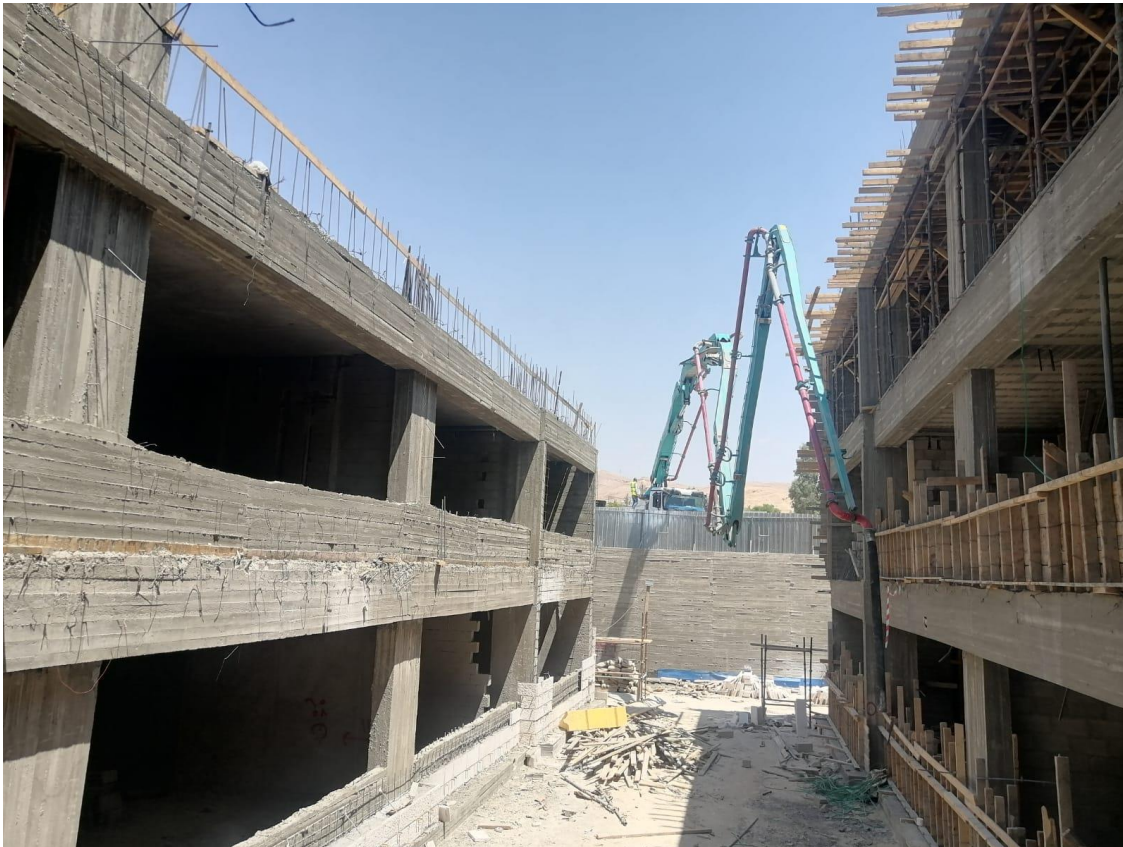
(Figure: 02)

Backing concrete for stone façade has been witnessed at the ground floor between zone "A" and zone "B"

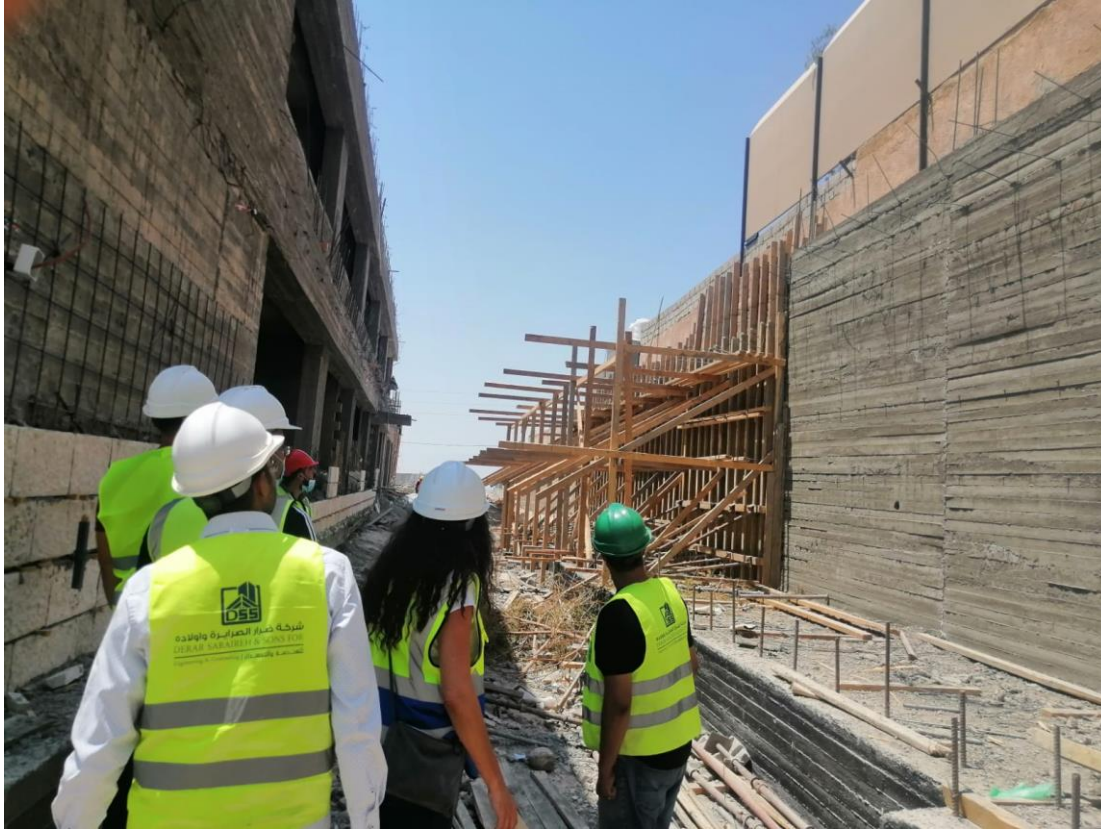
(Figure: 03)

The boundary wall adjacent to the encroaching neighbor wall has been inspected and found out that 90% of the wall is already completed

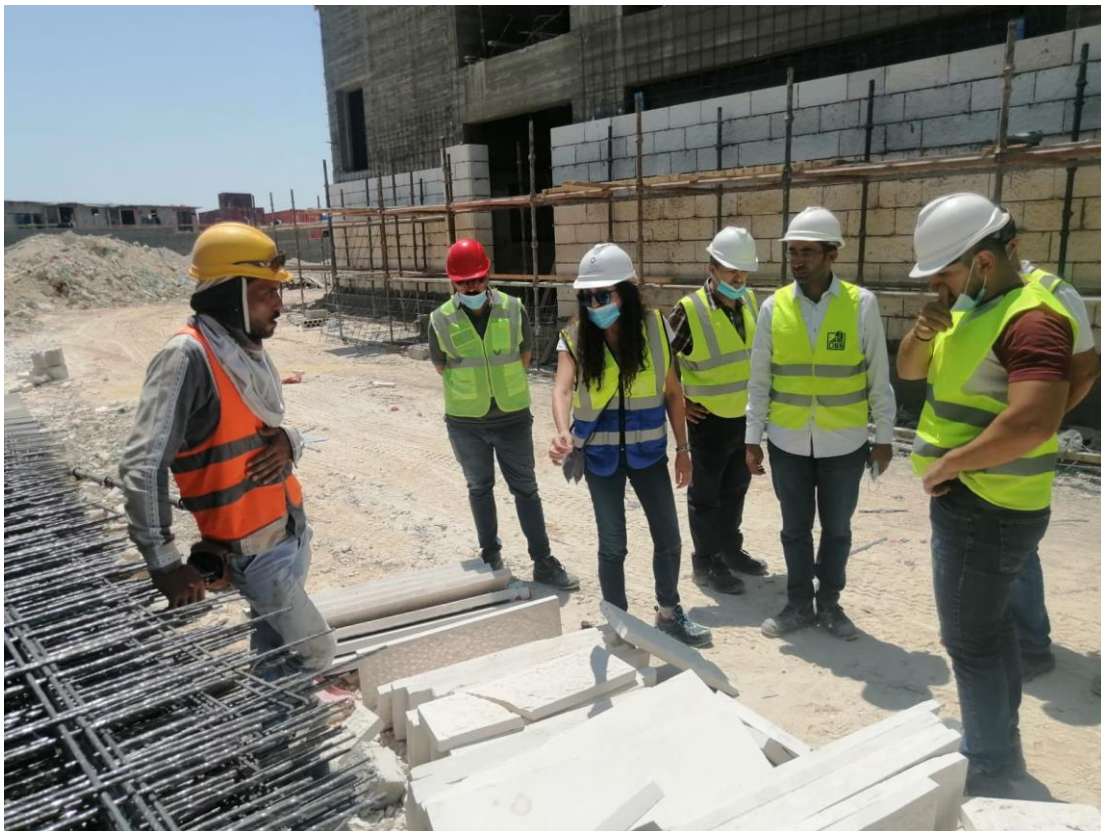
(Figure: 04)

A visual inspection has been conducted on the delivered quantities of building stones and the Contractor was reminded with number of remarks related to the compliance of stones

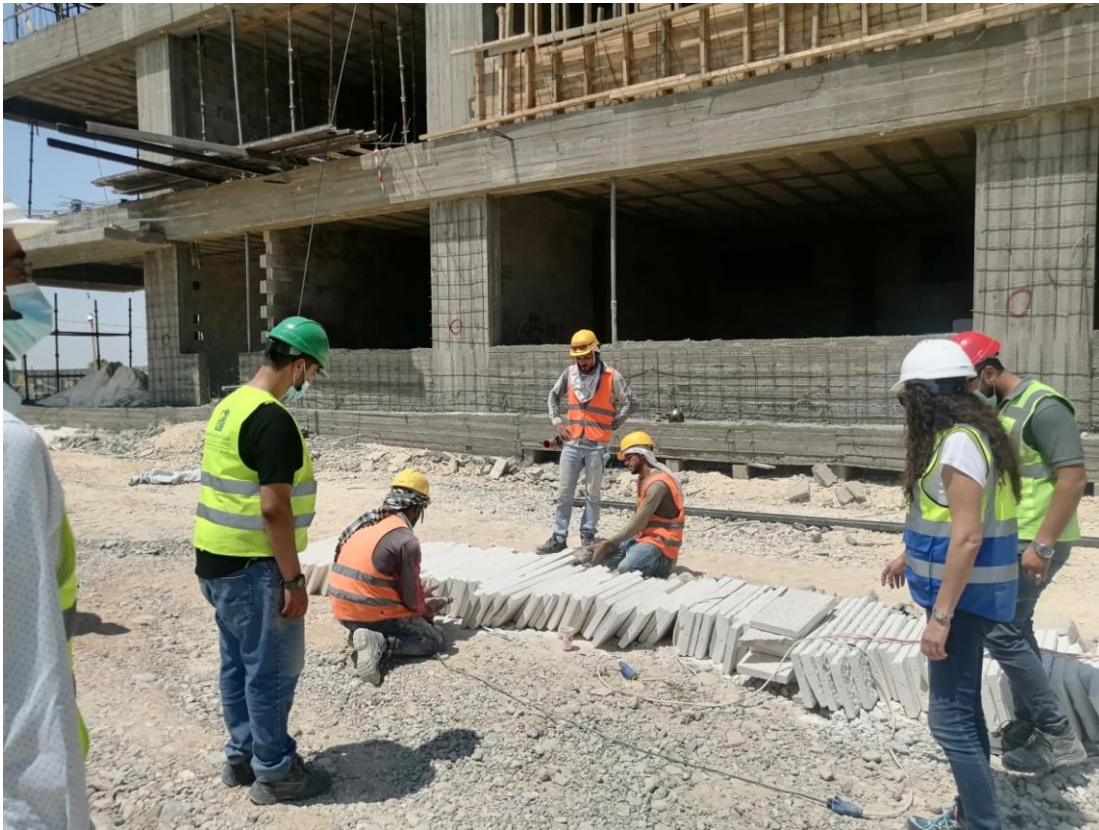
(Figure: 05)

Preparing the stone for fixation at the facades

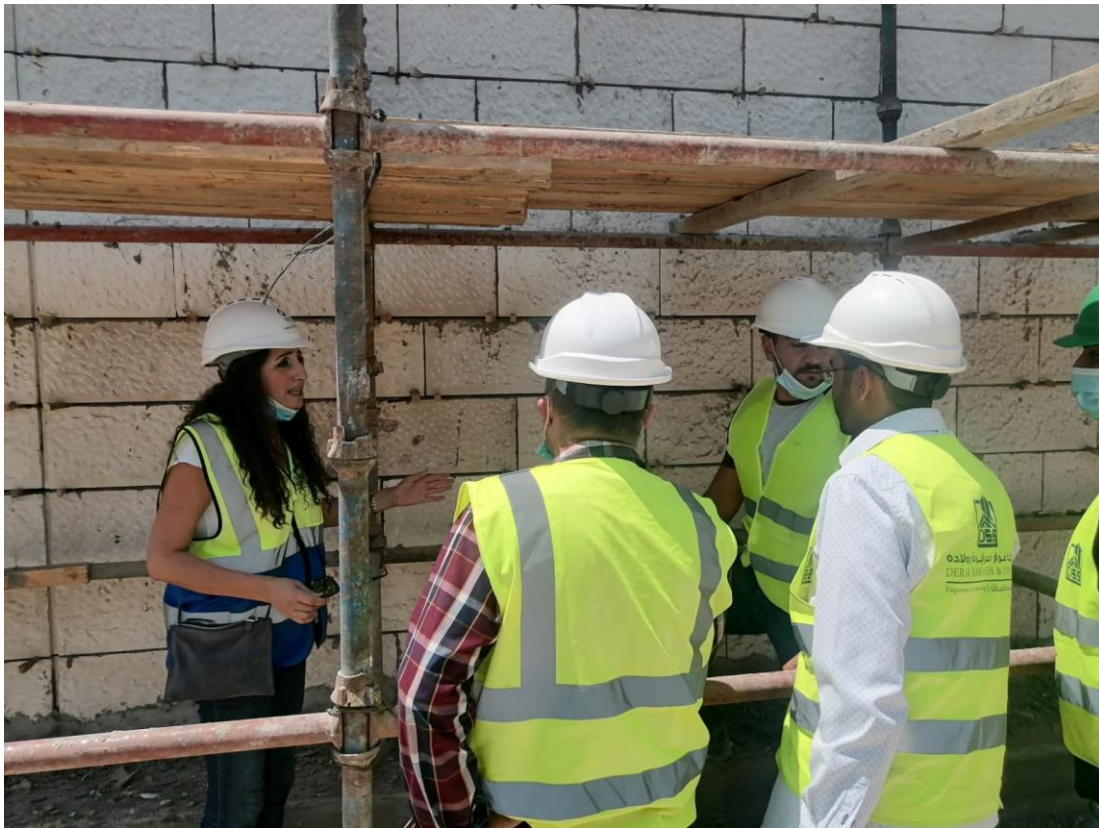
(Figure: 06)

An inspection has been conducted on the built stones courses at the front and side elevations. Part of the built stones at the side elevations has been built without using the appropriate stiffeners for fixation

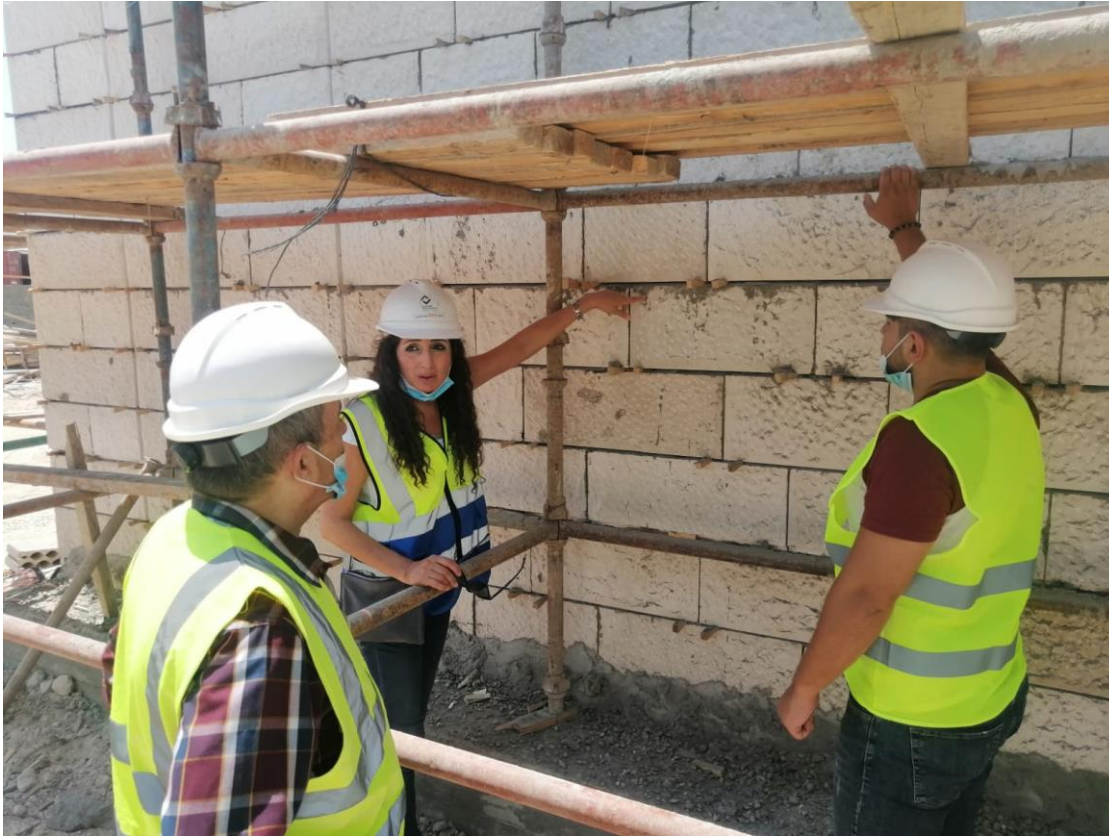
(Figure: 07)

Remarks regarding non-complying stone texture with the approved sample were noticed and given to the Contractor

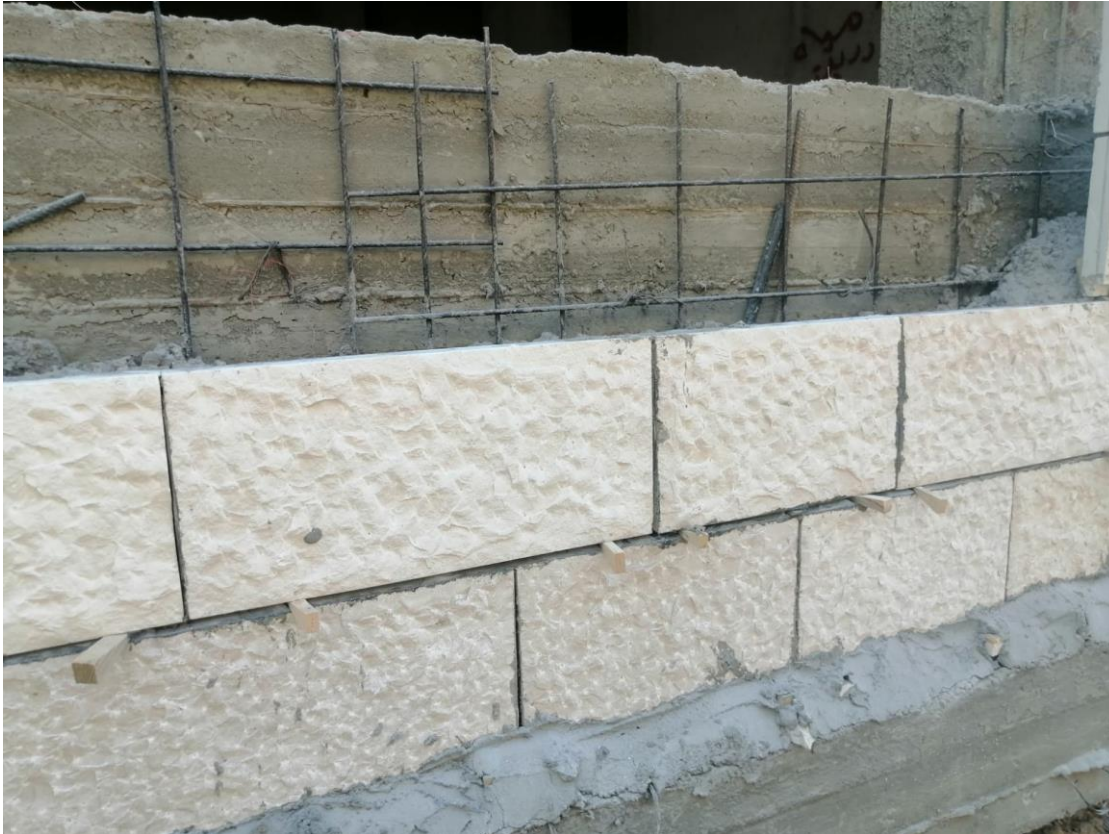
(Figure: 08)

An example of stone work complying with the approved sample and specifications

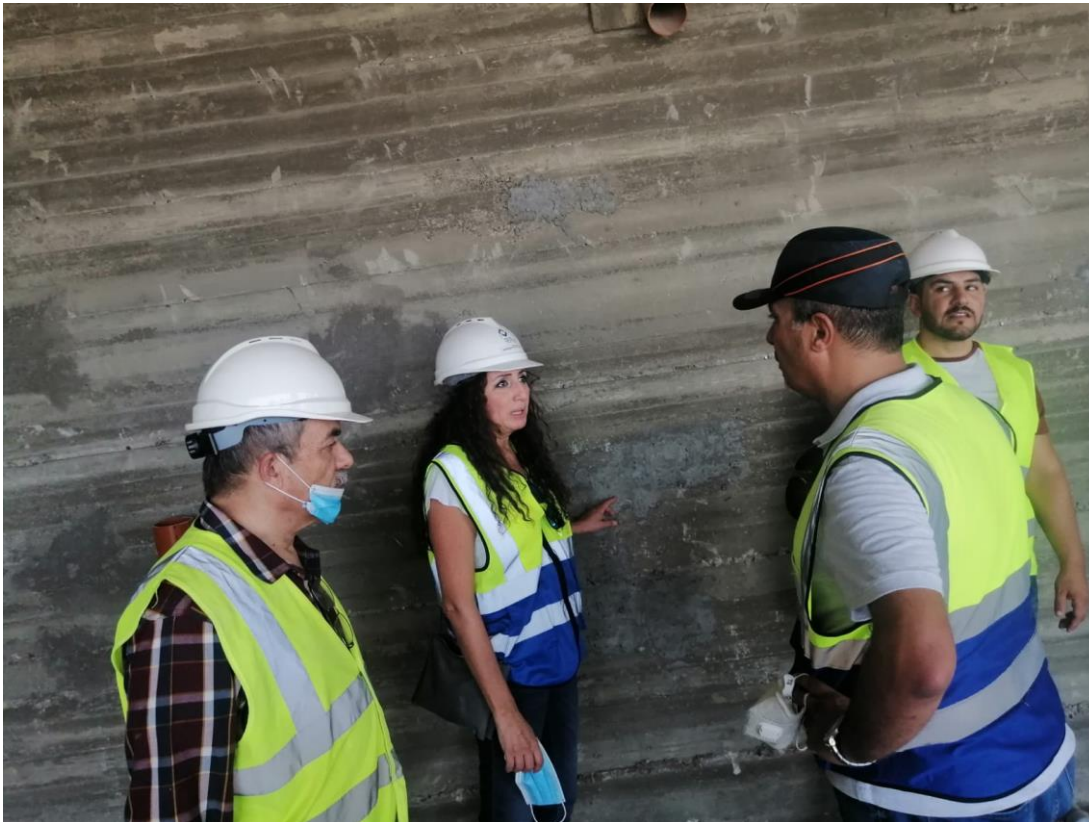
(Figure: 09)

It was observed that the Contractor followed the right procedure in rectifying the defects in casted concrete for walls using the approved repair materials

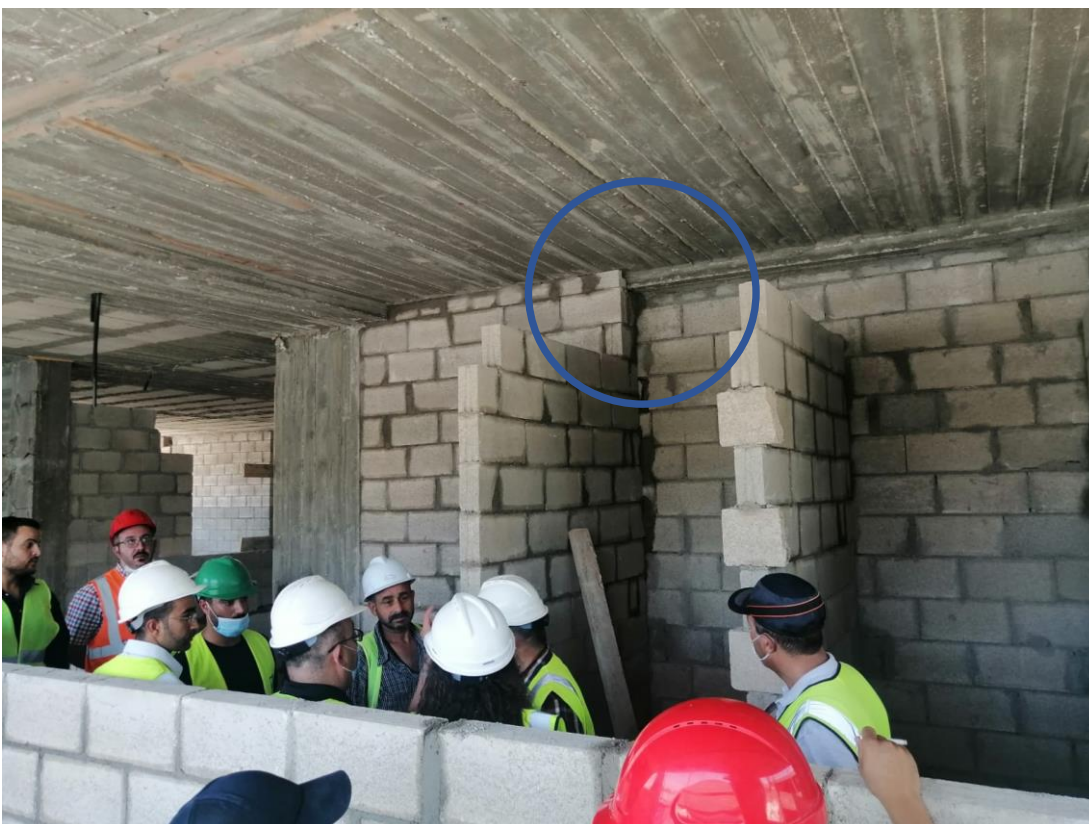
(Figure: 10)

The block partitions at the wet area in the ground floor have been inspected

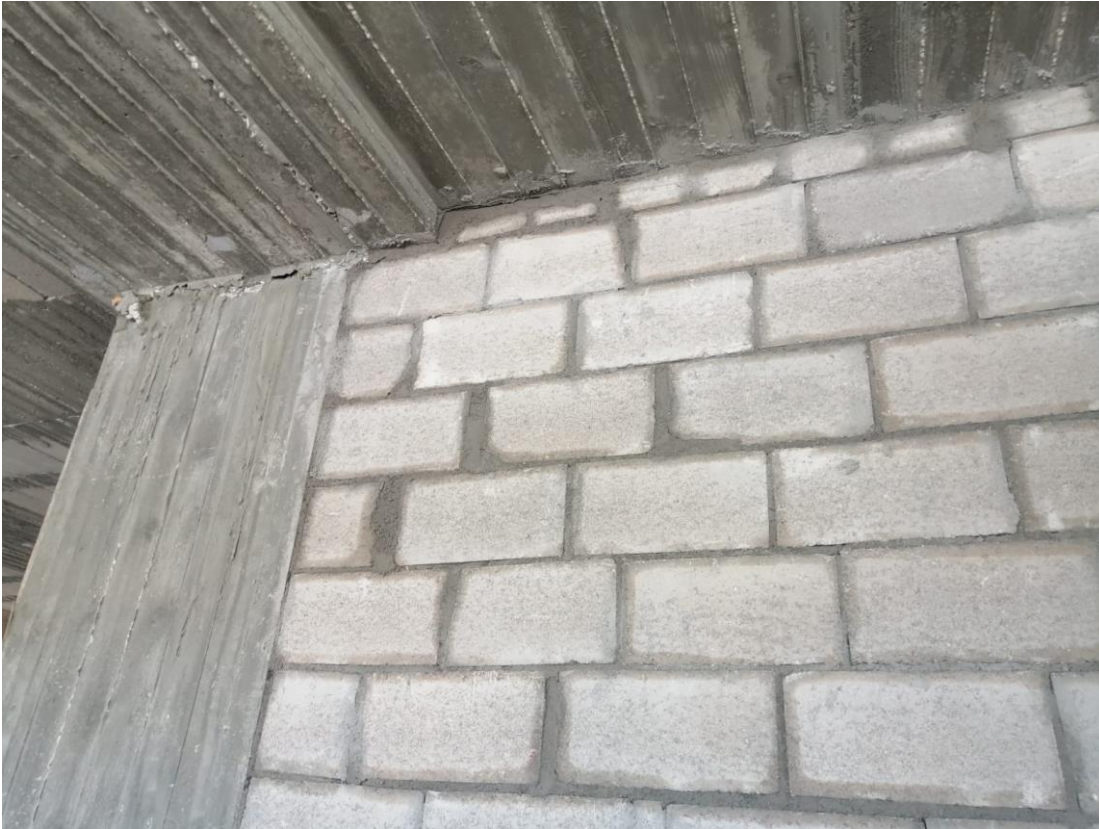
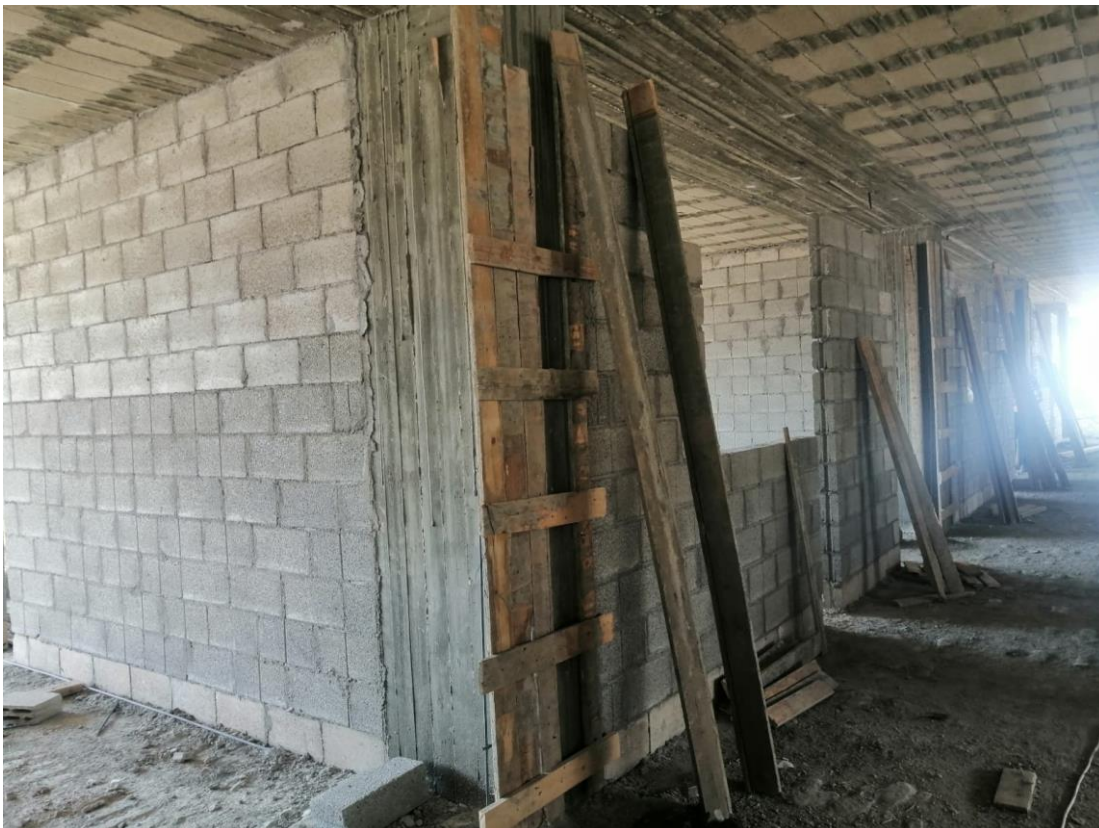
(Figure: 11)

The blockwork in general is acceptable, but during inspection minor part was observed to have wider joints over the specified width of 1cm. the Contractor was requested to rectify the said defects and avoid such remark in the other walls

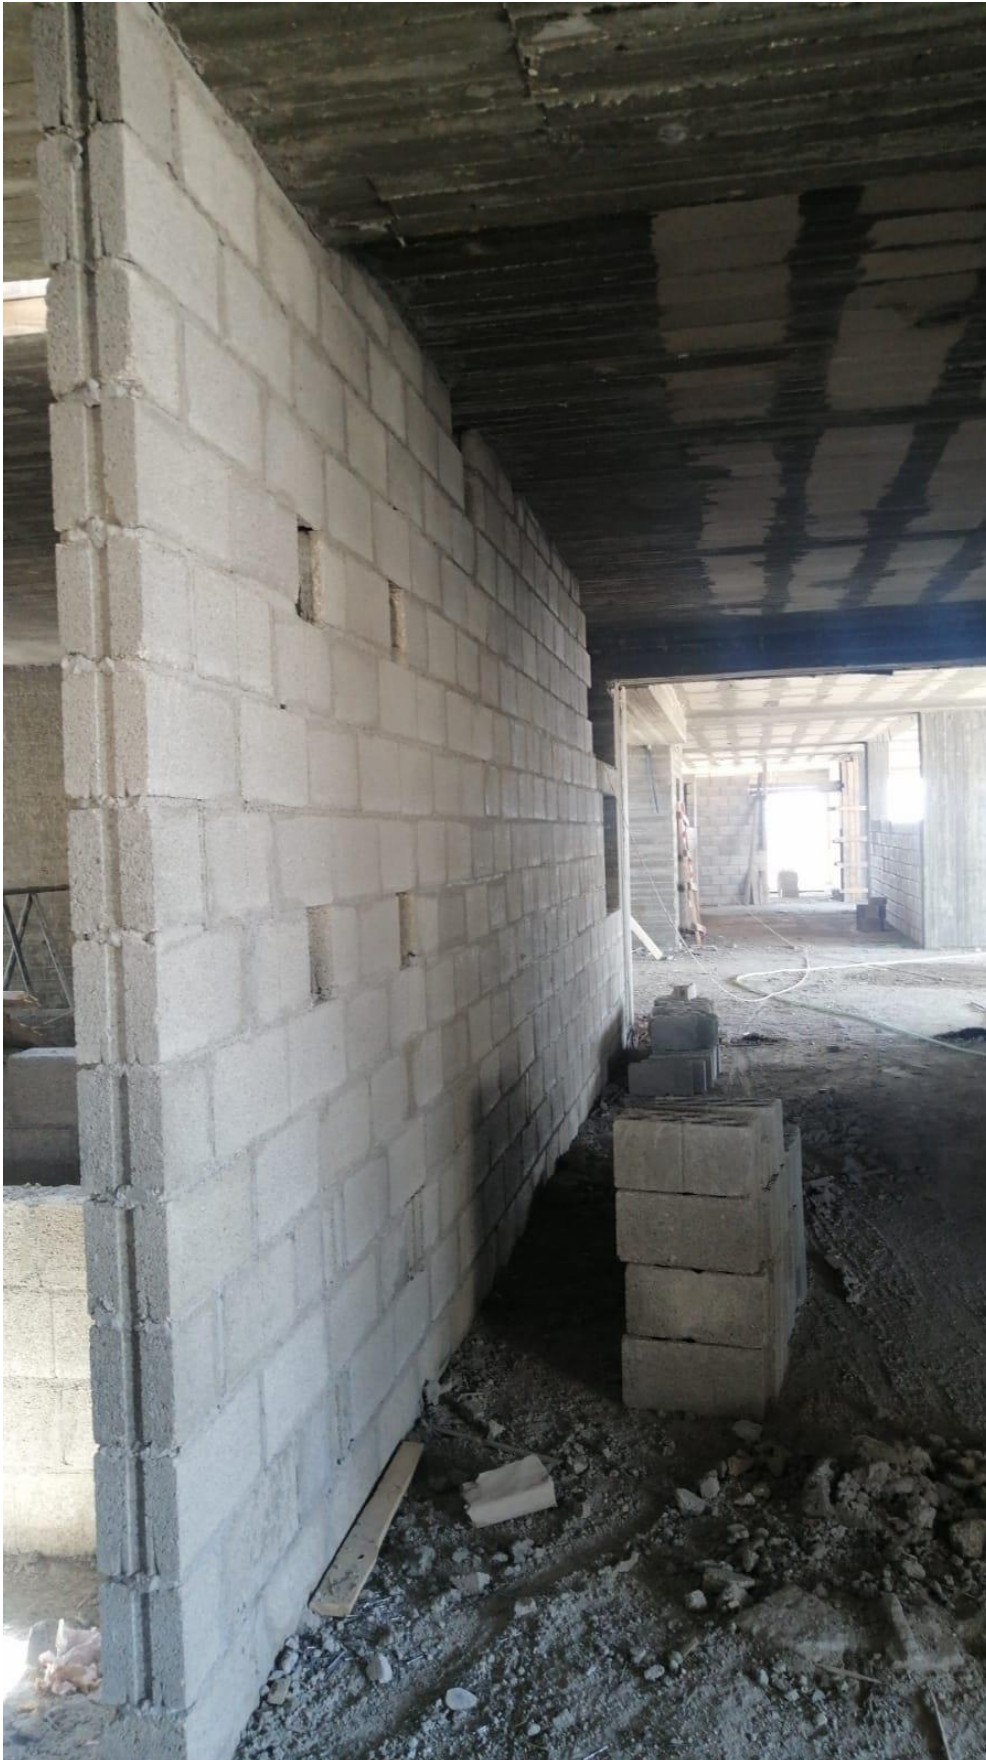
(Figure: 12)

It was observed that the Contractor followed the right procedure in rectifying the defects in casted concrete for walls using the approved repair materials

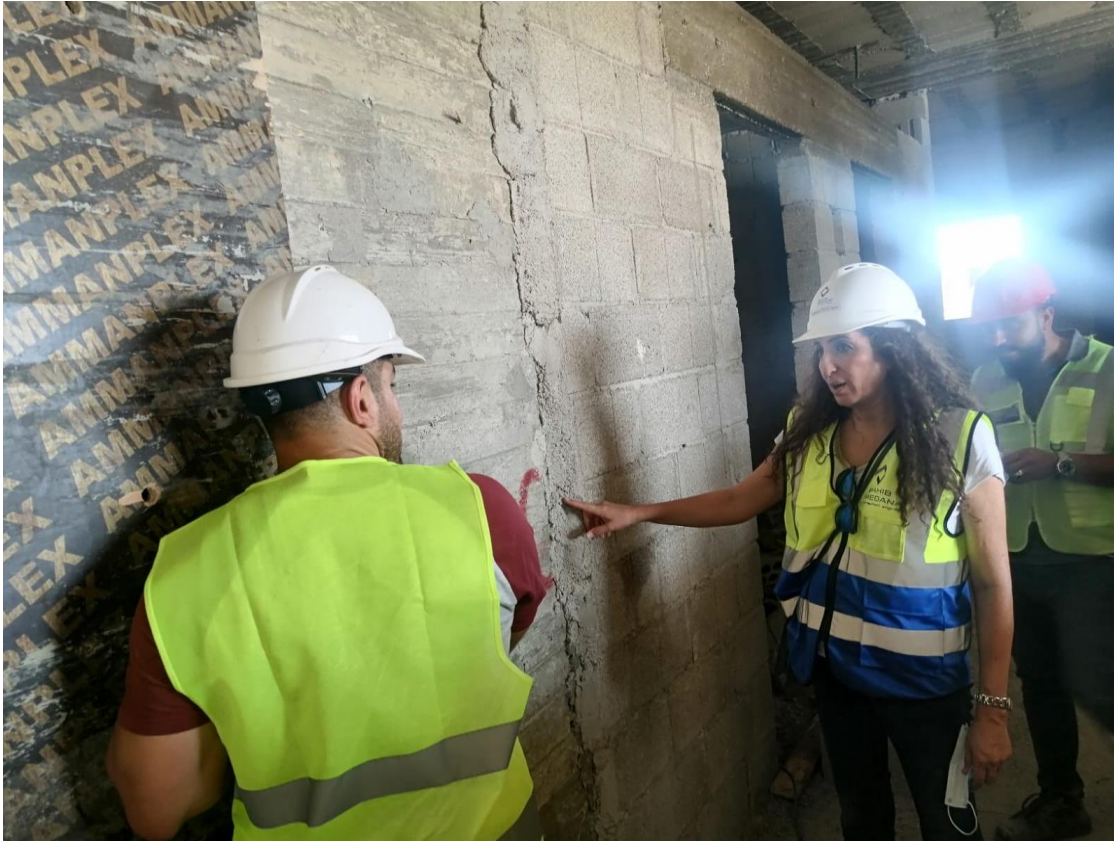
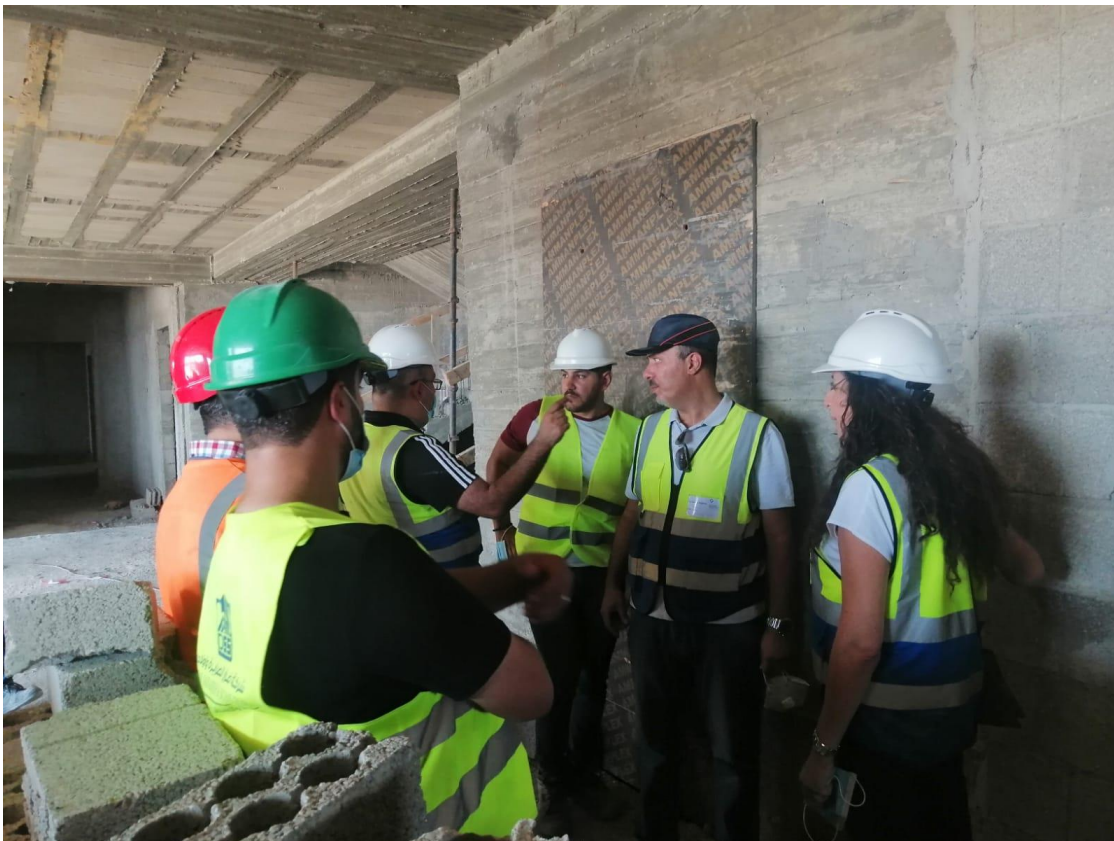
(Figure: 13)

It was observed that one block wall does not match with the concrete wall and the difference was found to be over 5cm. the Contractor was instructed to cast a concrete strip with the use of fixing accessories appropriate to the said case

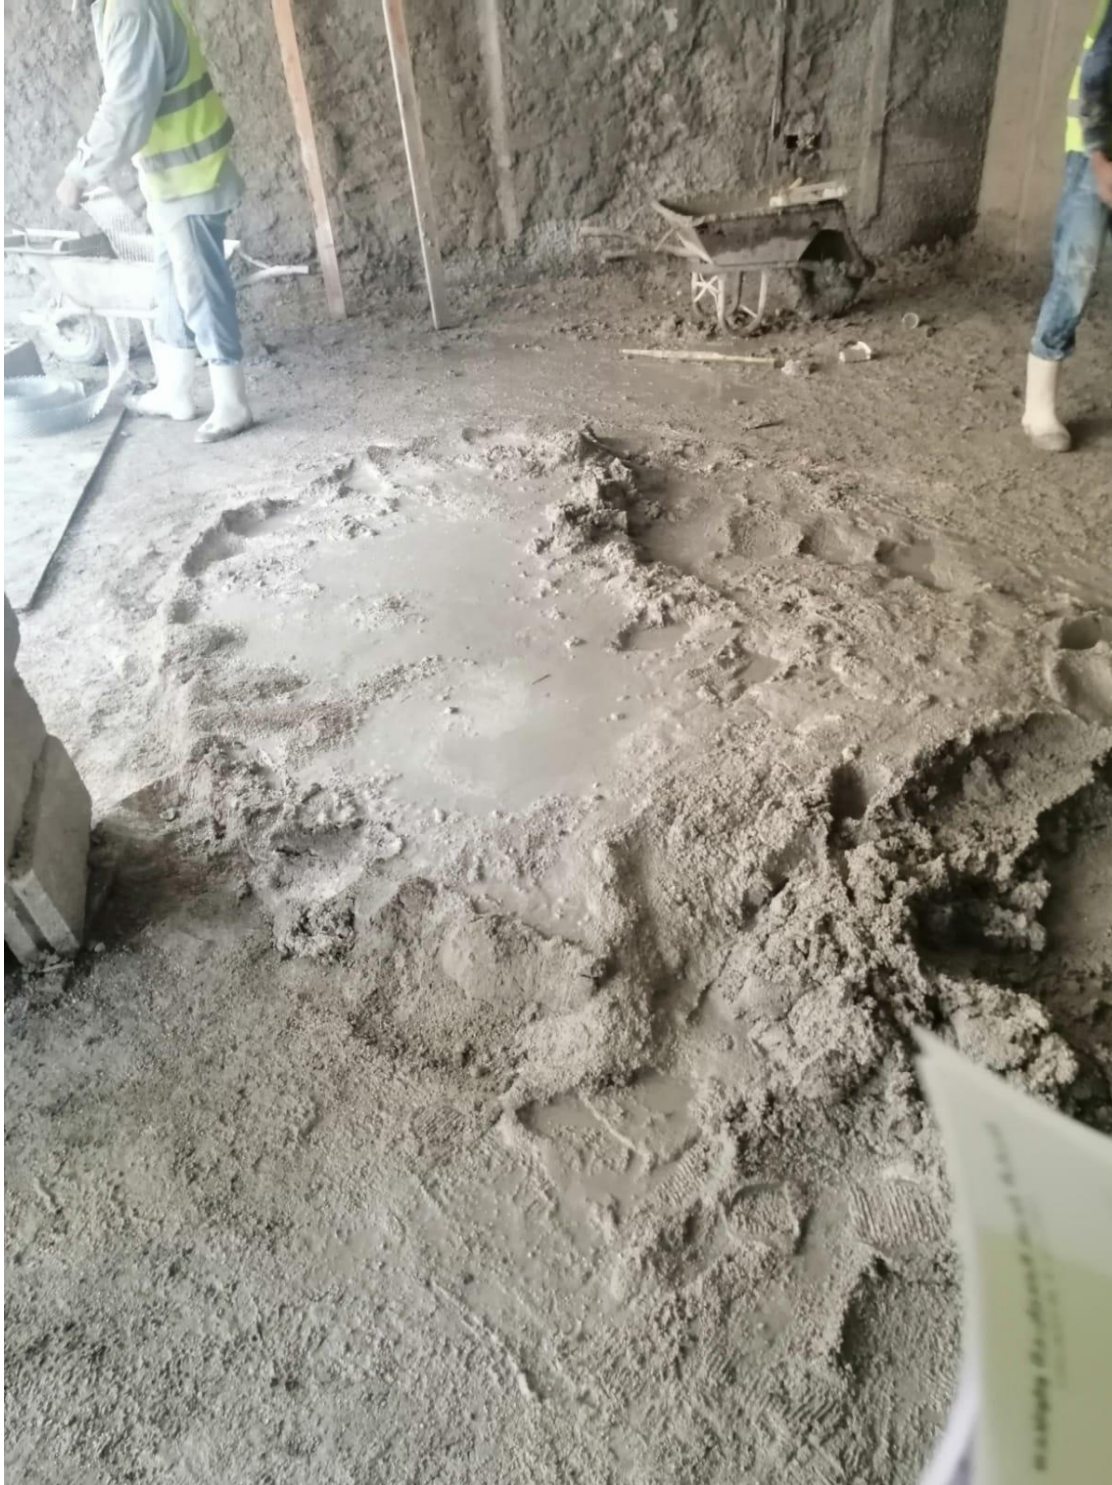
(Figure: 14)

Despite our written instructions the Contractor is not using a special container for mixing the mortar used for blockwork and plastering work

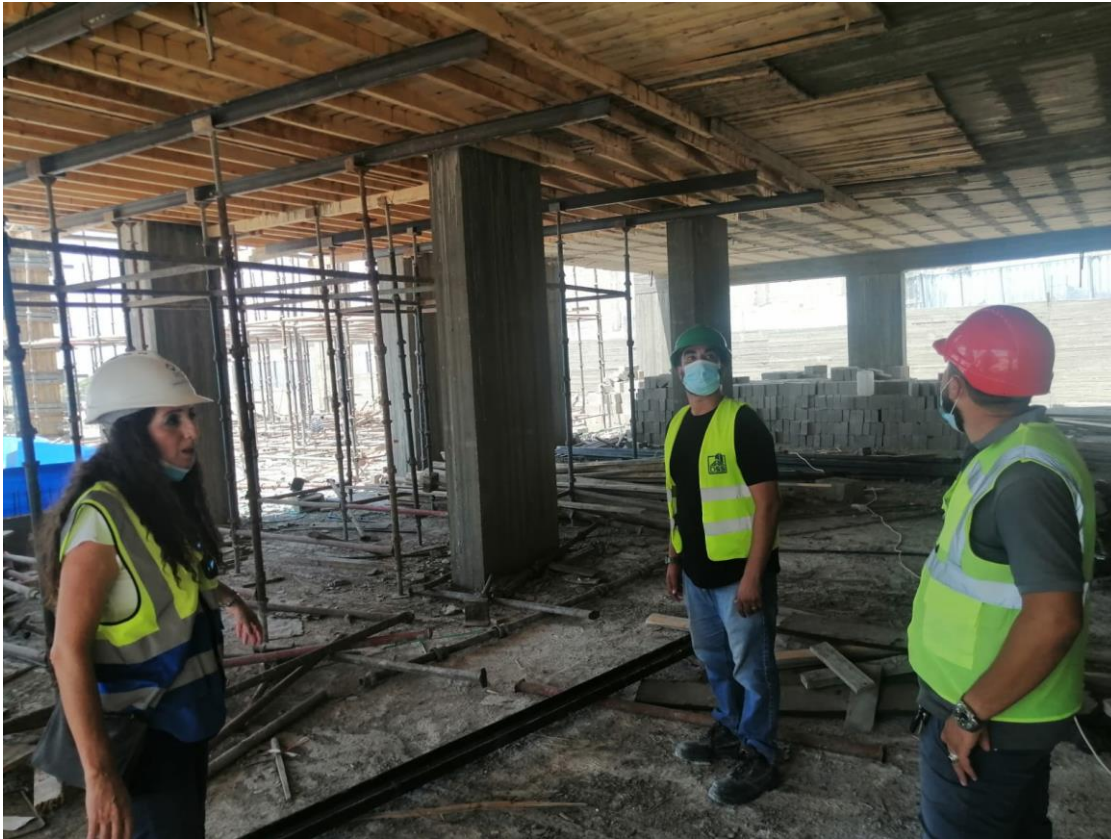
(Figure: 15)

The Contractor is requested to continue his work in the striking of the formwork for the completed roof slab of the theater at zone C

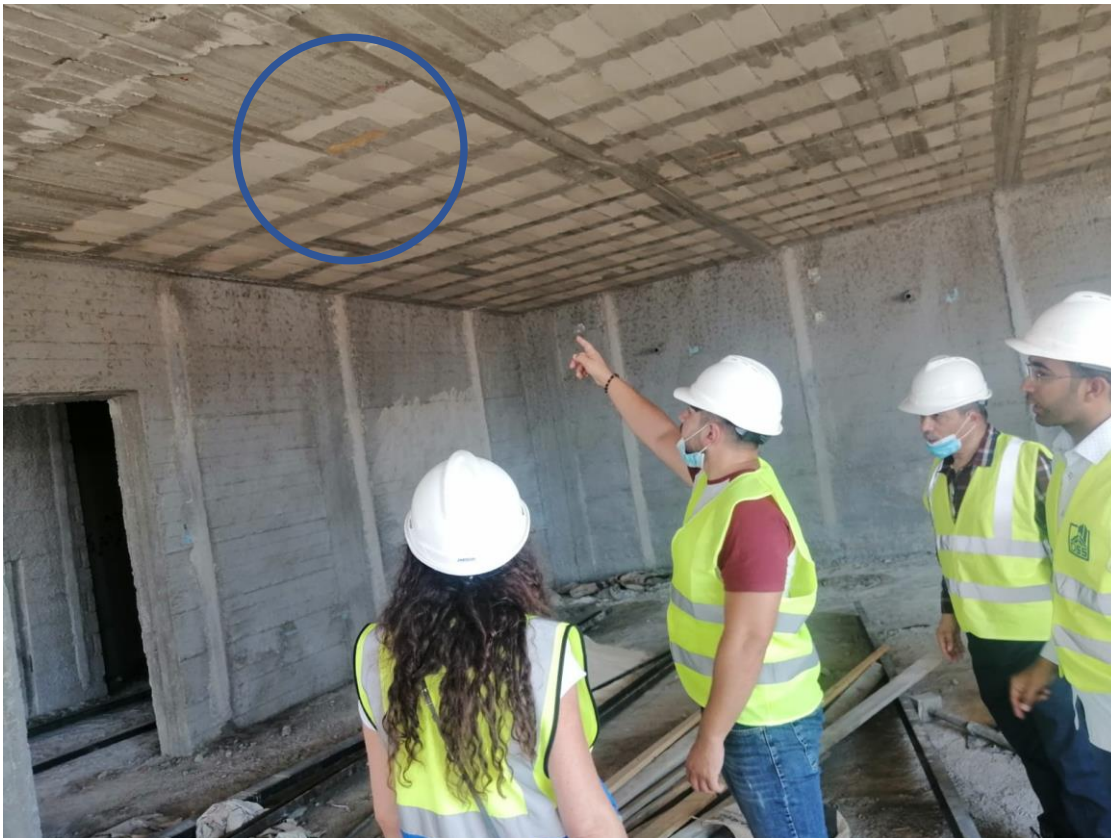
(Figure: 16)

the wooden pieces observed at the ceilings after formwork striking should be removed
