# SKEP III Home Office Support Site Visit Report

Consultant	Wahib Medanat Consultant Engineer	Rep No.	21-15112021
Contractor	Dijlah Establishment Constr. Contracting	Tender No.	(11/2019/USAID/SKEP/3/S) Schools for a Knowledge Economy Project (SKEP) - Phase (3) Package (1, 2)
Site Name	Hay Al Iskan Basic Mixed School- Jerash	Day/ Date	Mon. 15/11/2021
Duration of Project	450 Calendar Days	Total Project Budget	8,314,983.735 JD

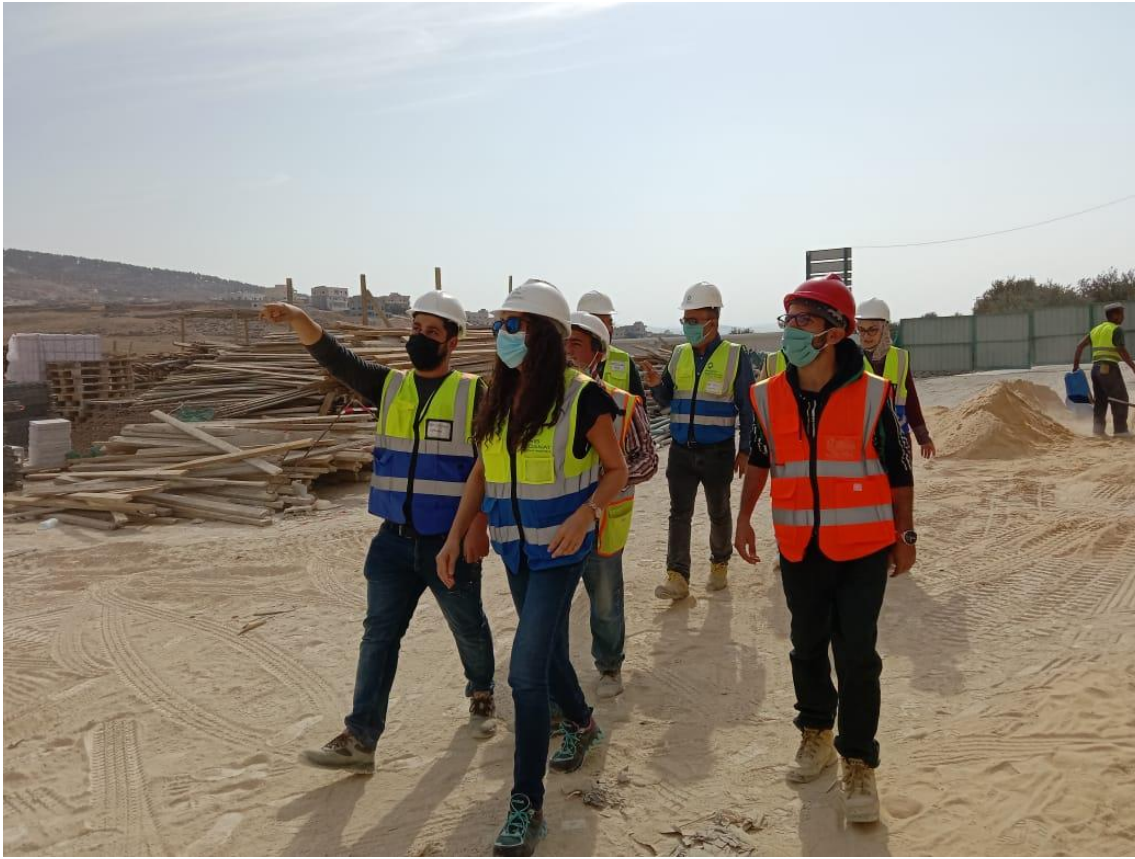
(Figure: 03)

A tour inside the site was conducted

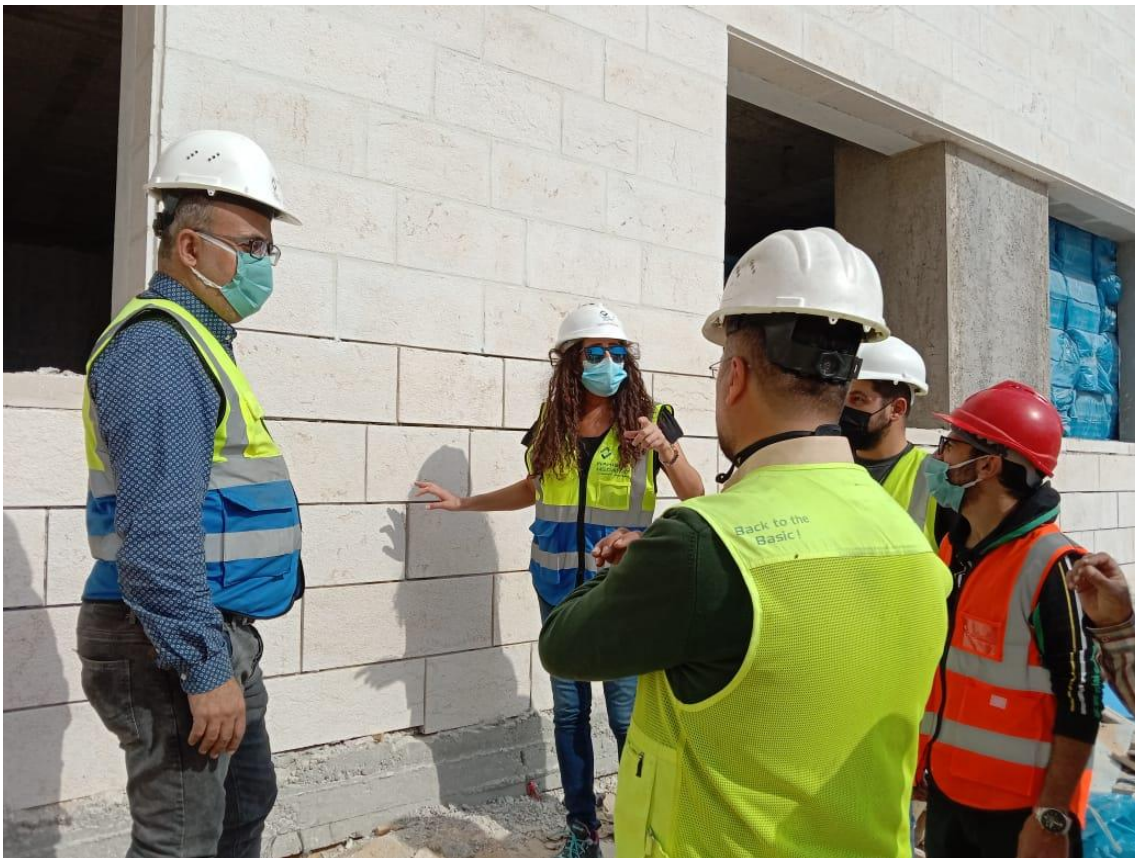
(Figure: 04)

The stone work at the facades was inspected and the Contractor was requested to replace the defected and broken stones

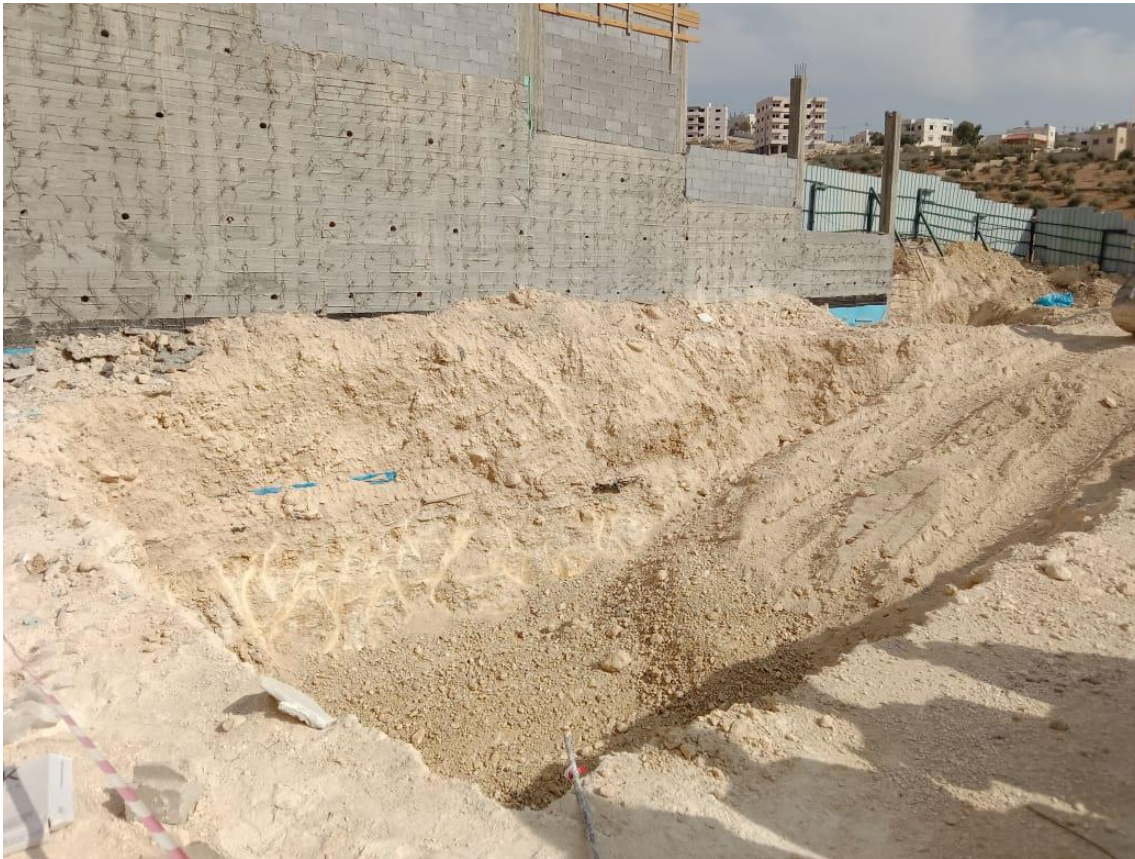
(Figure: 07)

It is noticed that the excavations for the water tank started without coordination with the Engineer and without taking the necessary protective precautions for the safety of persons and the preservation of the executed works. The Contractor was requested to call the geotechnical laboratory to inspect the excavation sides of the underground water tank and provide the technical advice

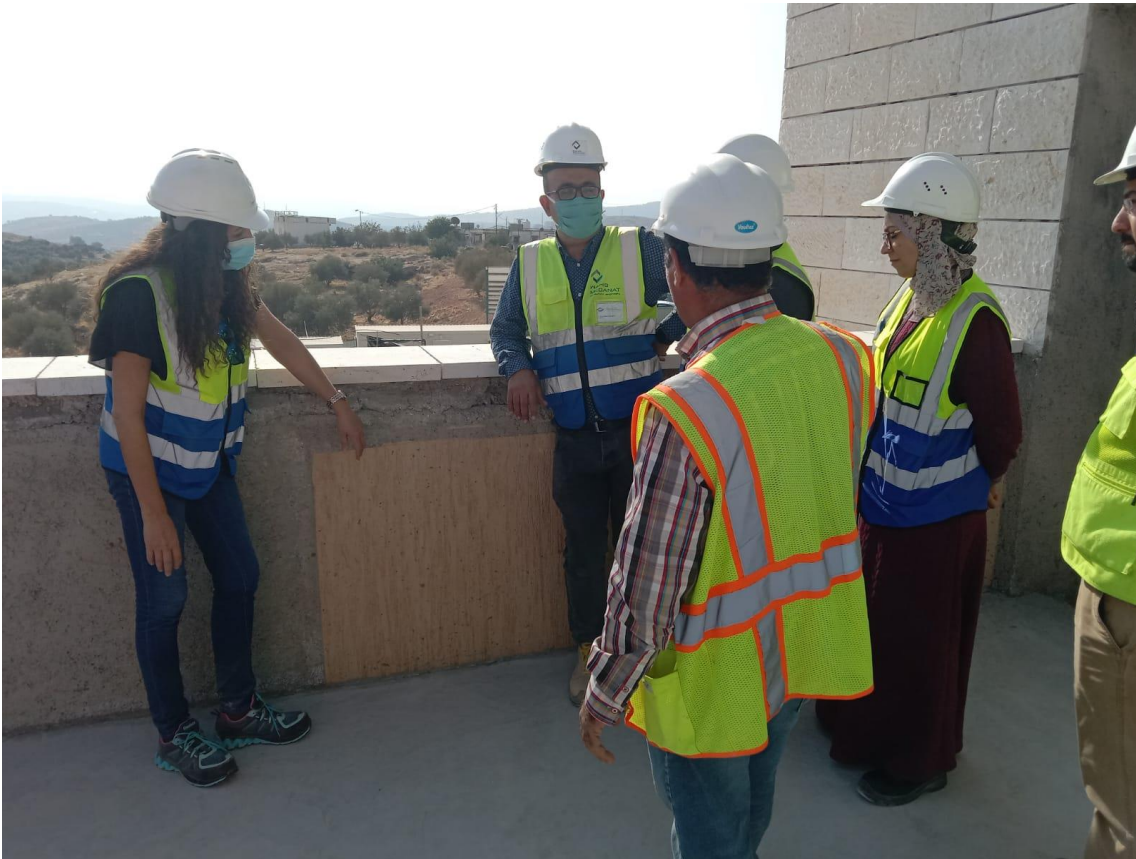
(Figure: 09)

The supervision conducted an inspection to the sample prepared by the Contractor for the colored plastering for parapets. The supervision approved the sample and the execution method was agreed upon with the Contractor

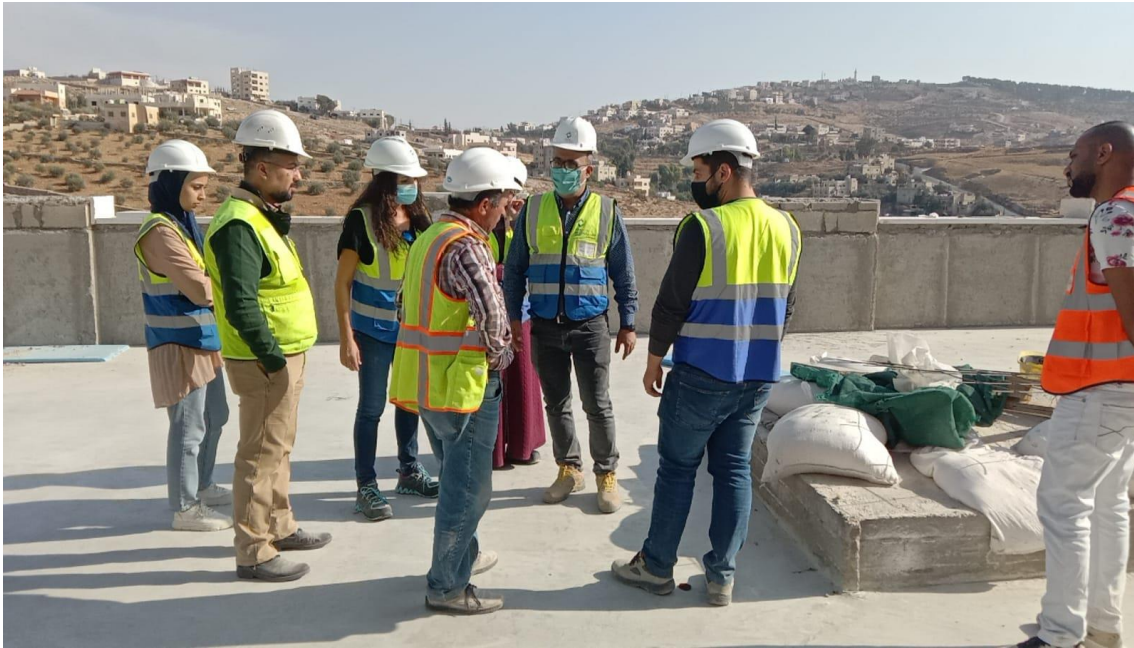
(Figure: 11)

It was observed that the Contractor has executed the sloped screed for the roof of the multi-purpose hall

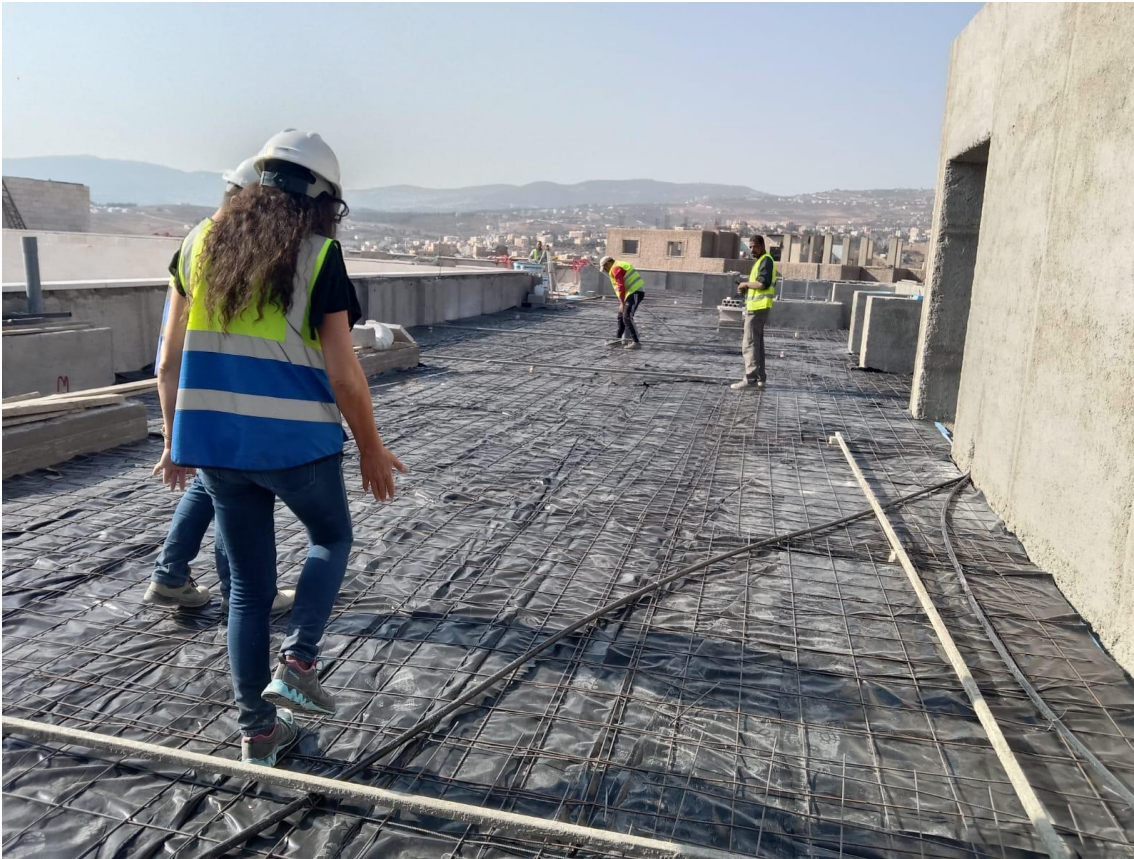
(Figure: 13)

It was observed that the Contractor started with insulation process for the roof of the building and upon that the supervision provided the Contractor with general remarks and advices

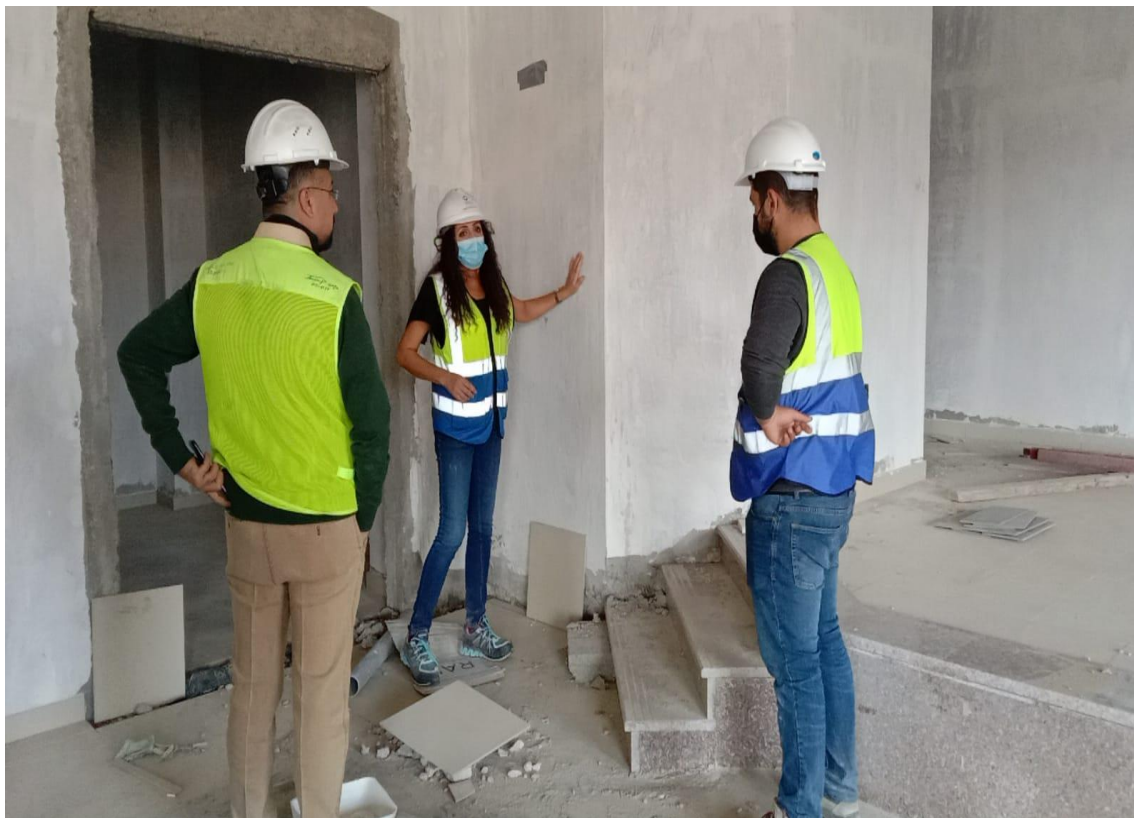
(Figure: 14)

It was observed that the Contractor has executed the stairs at the multi-purpose hall

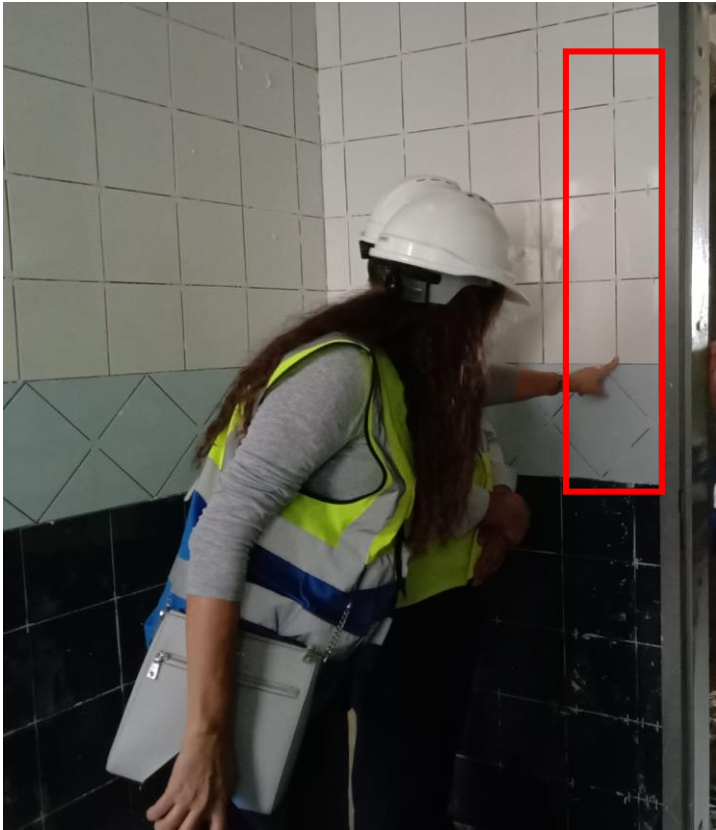
(Figure: 15)

Before

It was observed that the Contractor rectified one tiled elevations at one toilet due to incompatibility as per previous remarks by the supervision

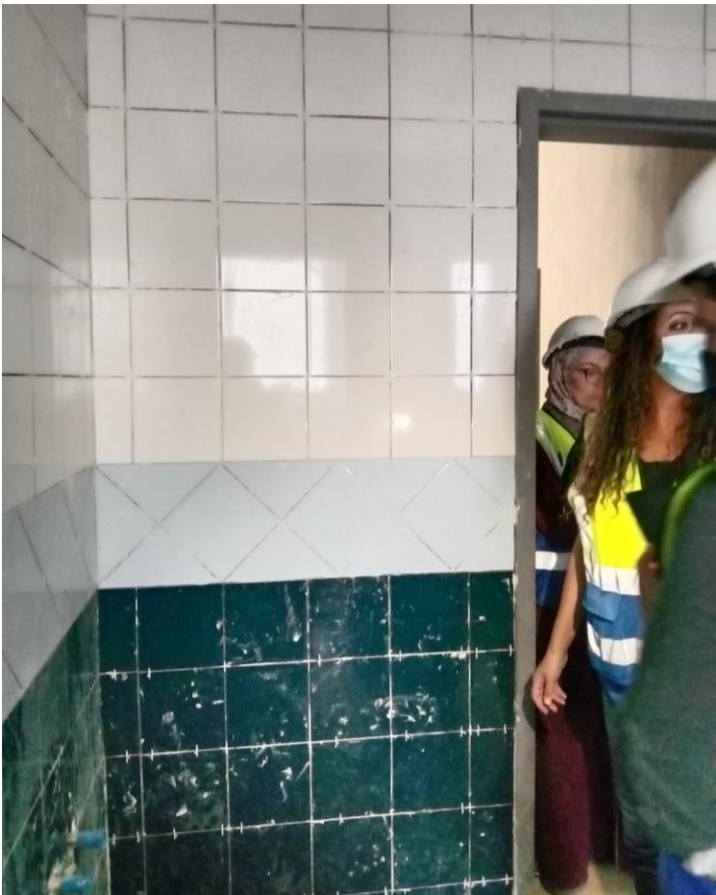
(Figure: 16)

After

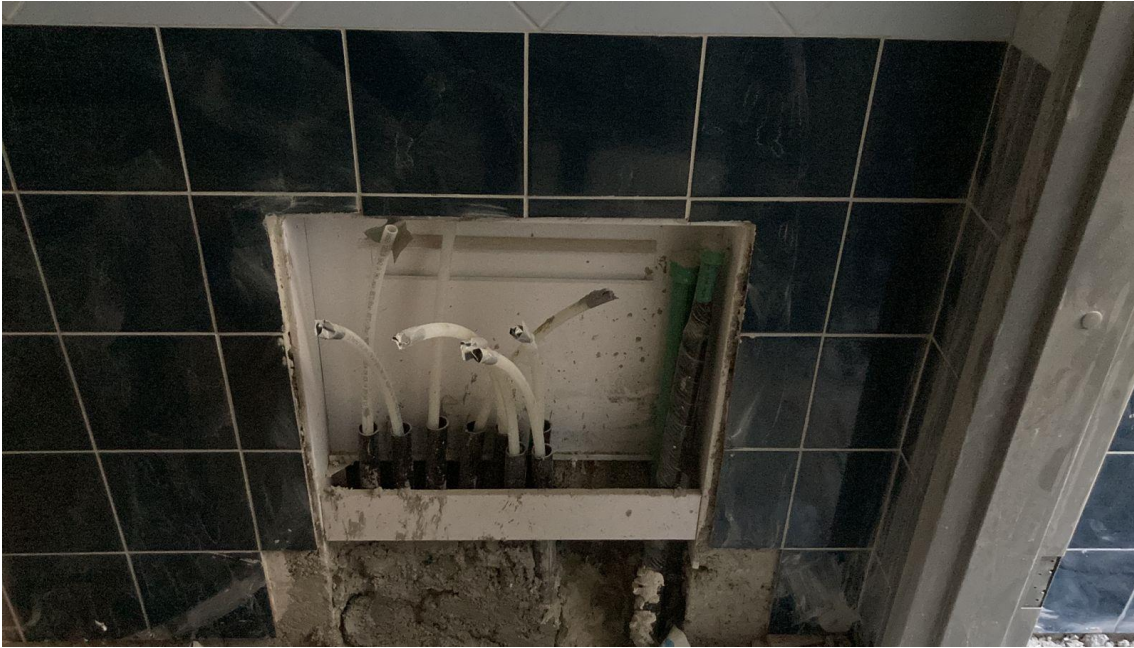
(Figure: 17)

It was observed that most of the water cabinets at the toilets still not shifted by the Contractor as per previous remarks by the supervision in order to be compatible with the tiling work cut-off pieces

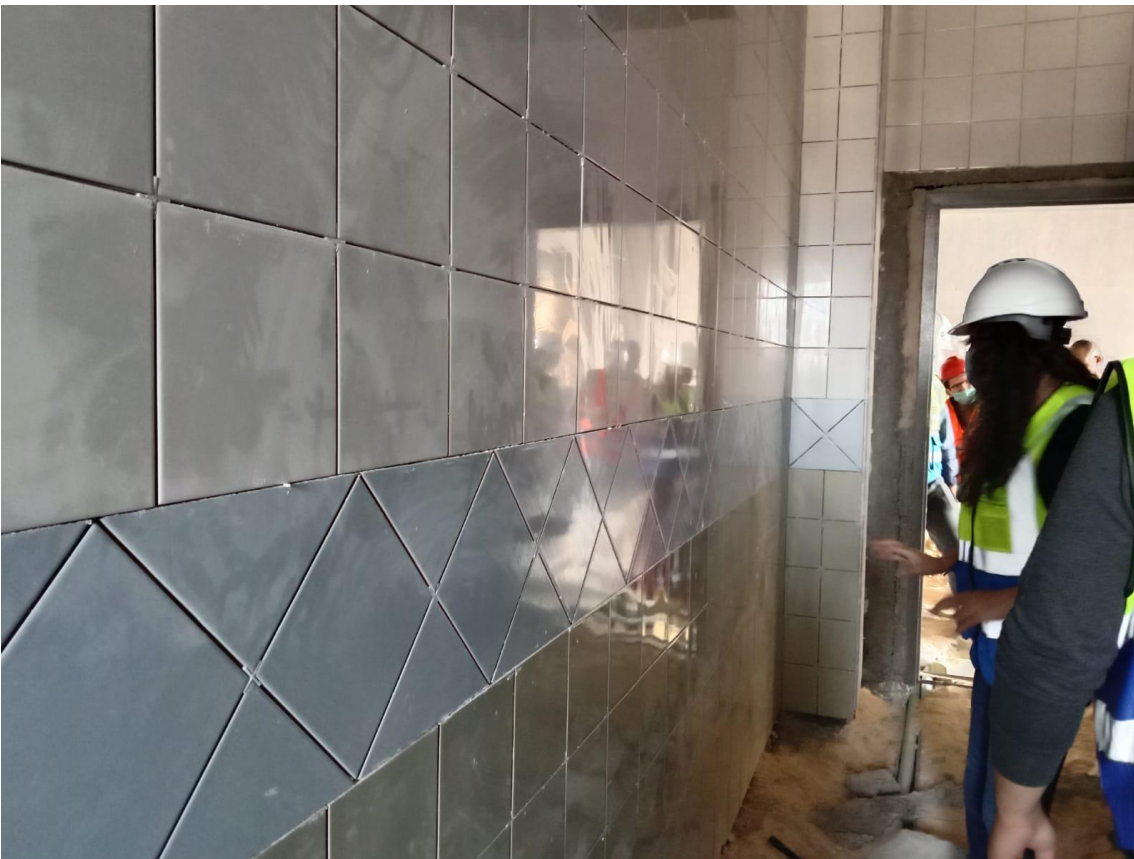
(Figure: 18)

Inspecting wall tiles work

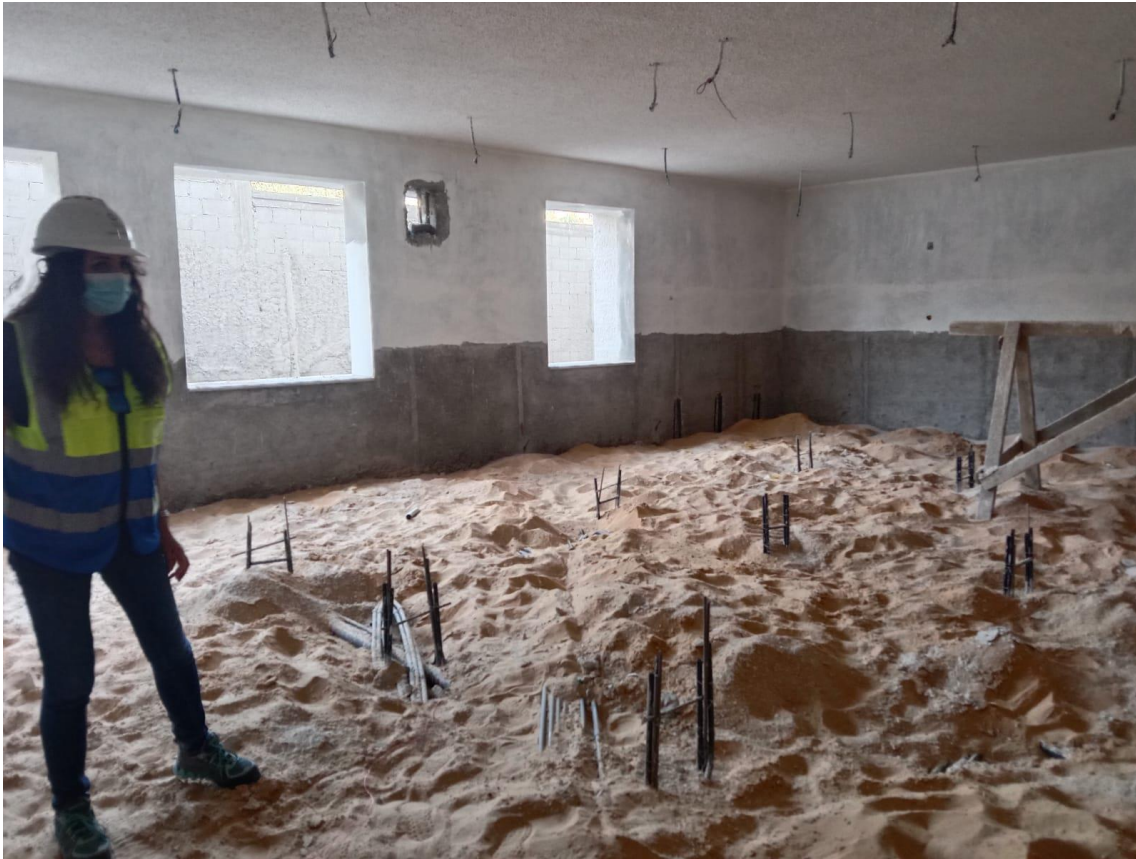
(Figure: 19)

It was observed that the Contractor has completed the electro-mechanical installation at the computer labs

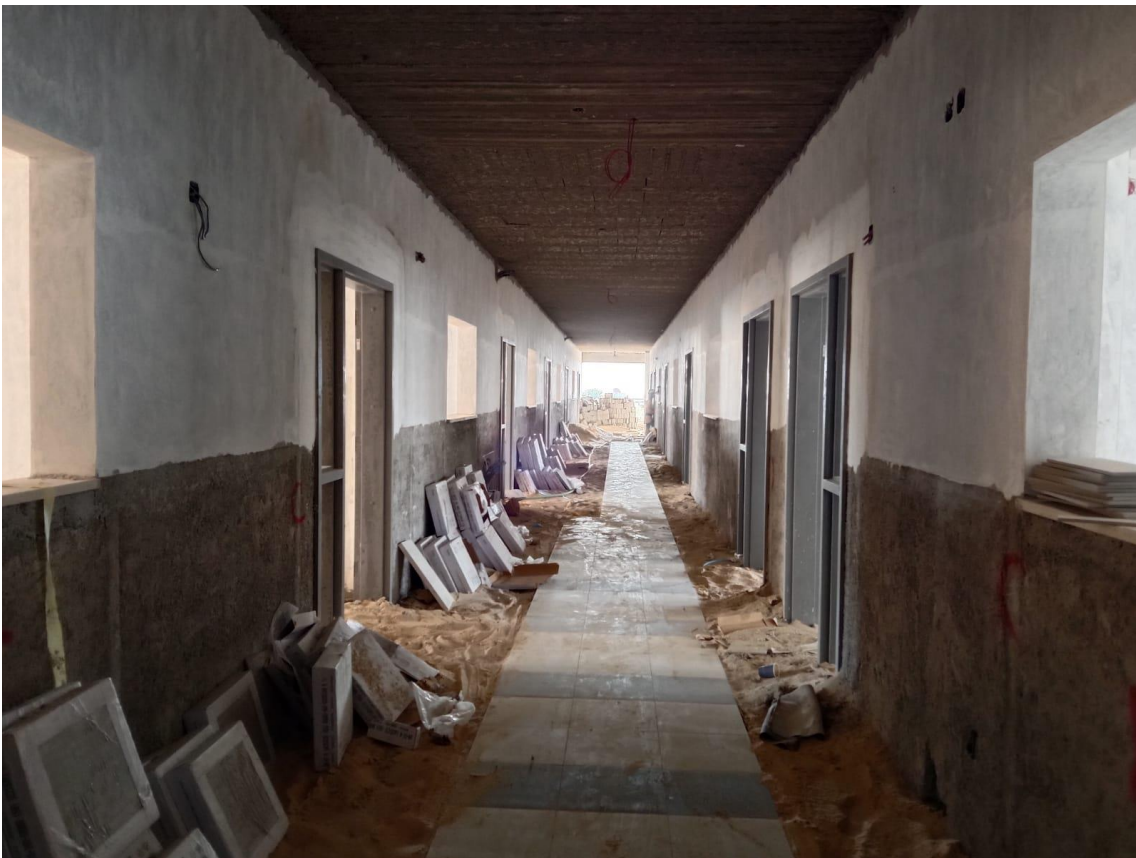
(Figure: 20)

General inspection to the first layers of painting and its relation with the porcelain cladding in the corridors has been conducted

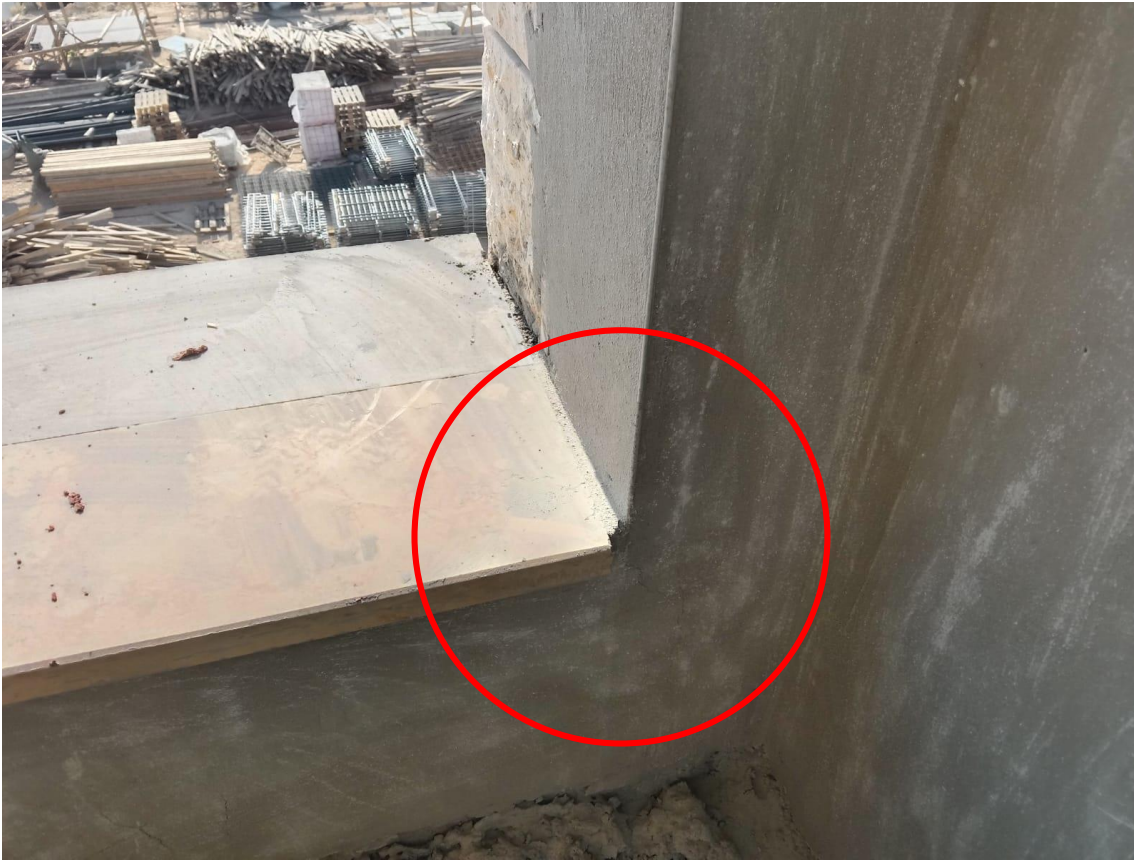
(Figure: 21)

It was observed that number of window sills do not comply with requirements in relation to the dimensions. The Contractor was requested to replace

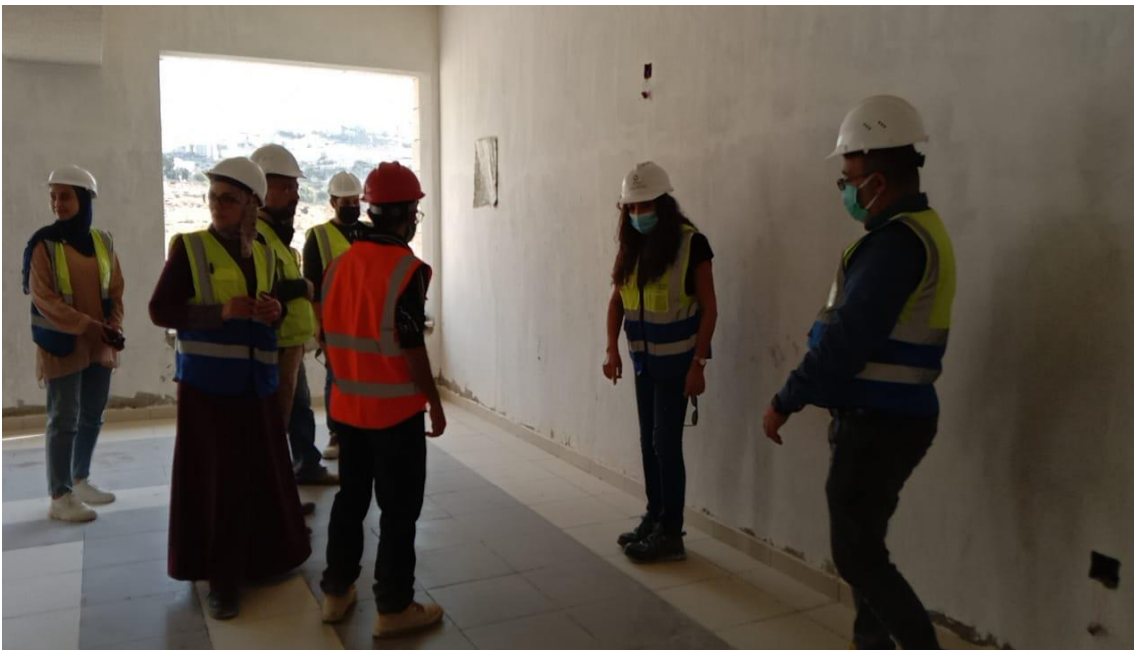
(Figure: 22)

The color of grout for tiles has been discussed with the Contractor for the areas which have more than one tile color

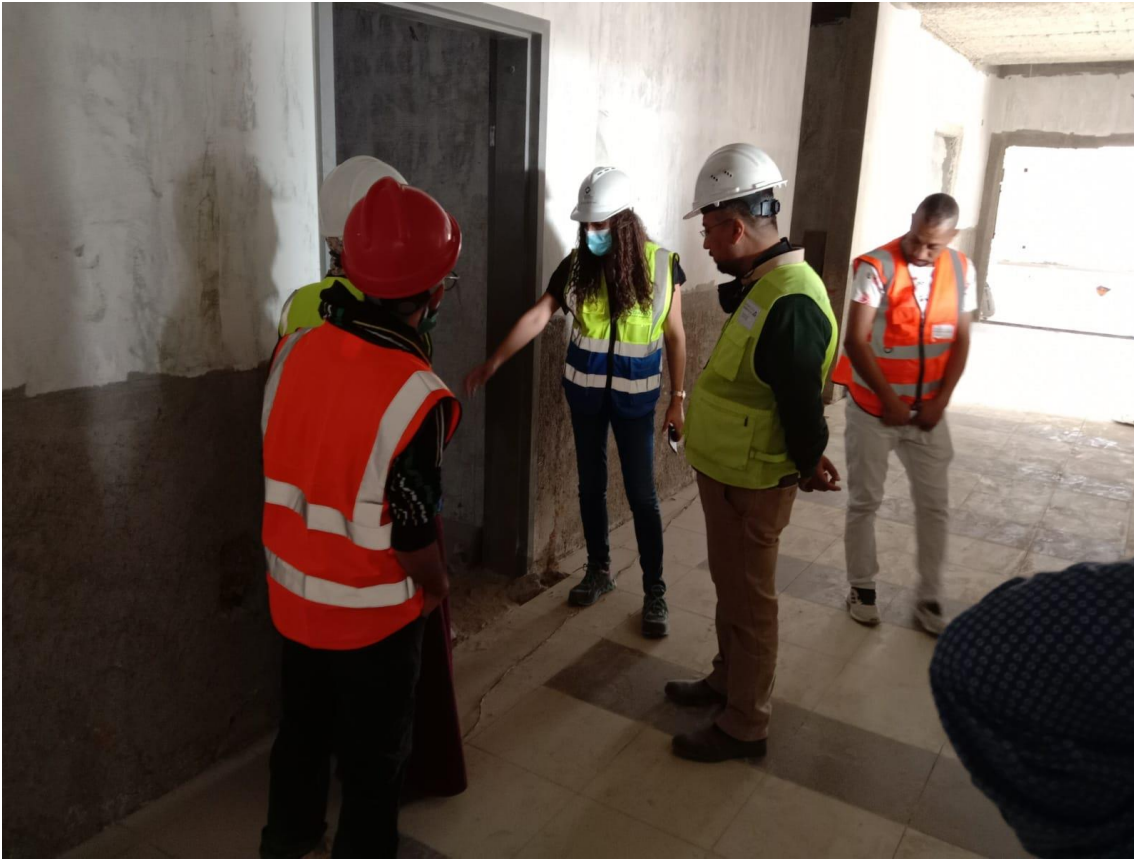
(Figure: 23)

The width of the thresholds at the doors between the rooms and corridors was discussed with the Contractor

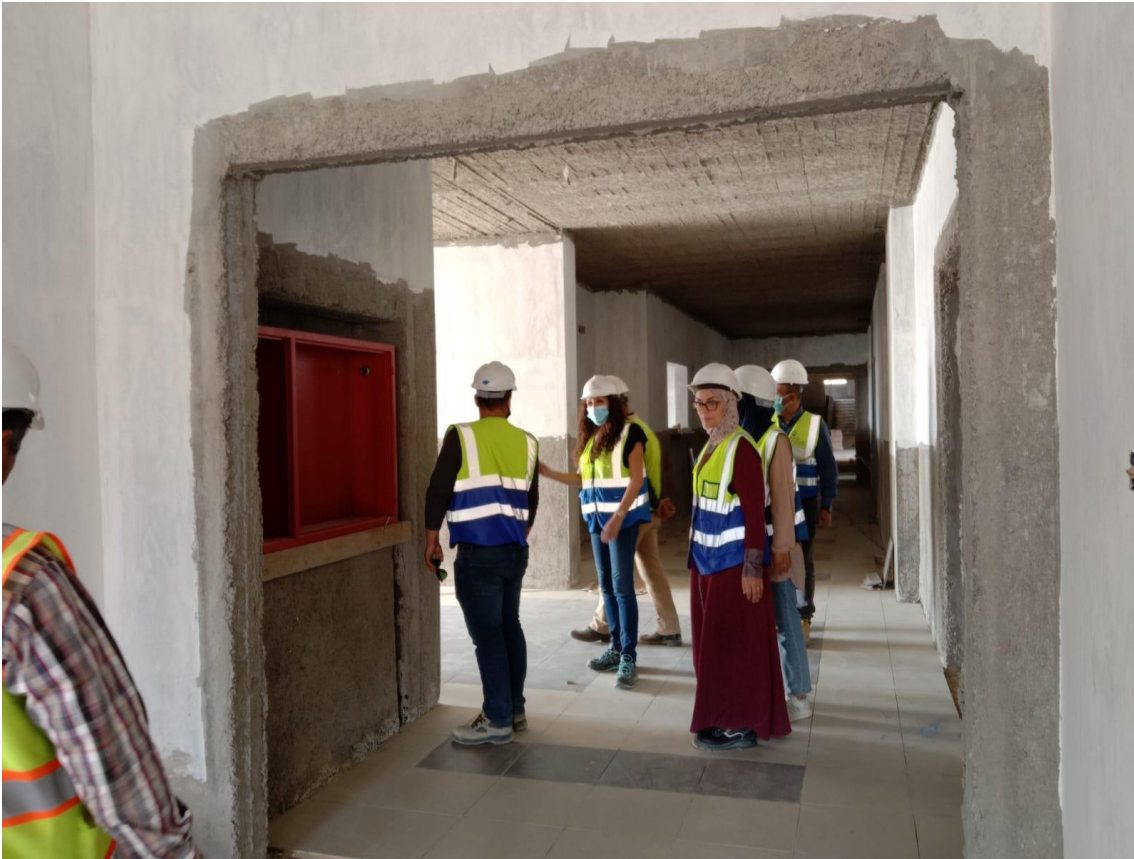
(Figure: 25)

It was observed that the Contractor has not finalized the installation of fire hose cabinets as per previous inspection of the supervision

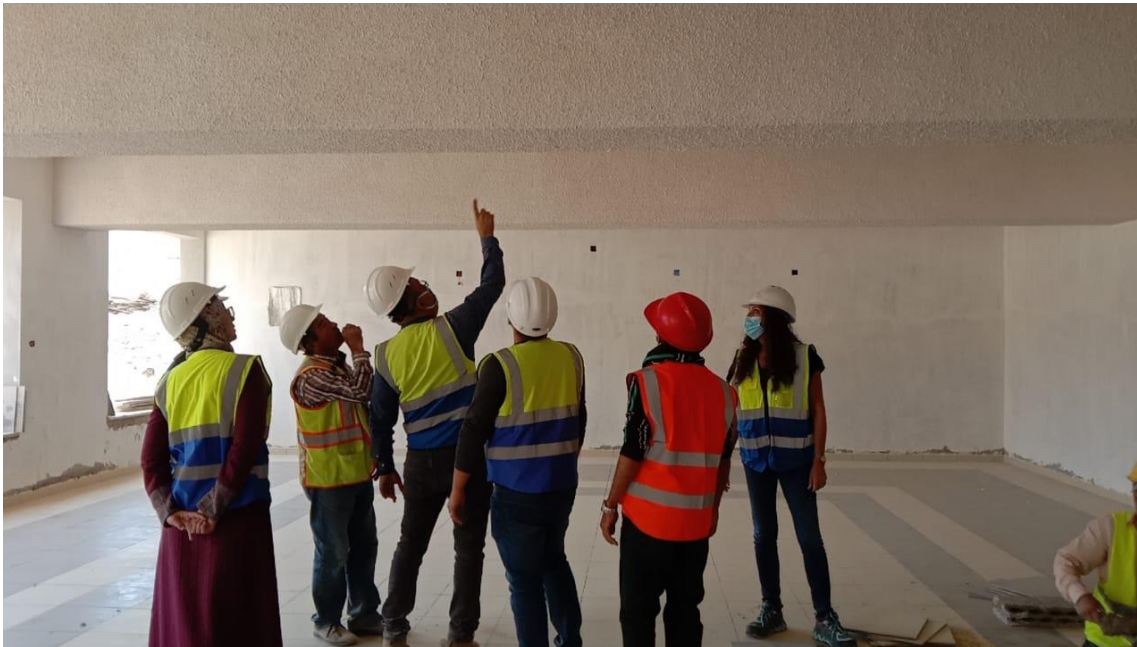
(Figure: 26)

The acoustical plastering was inspected by the supervision and no remarks were observed

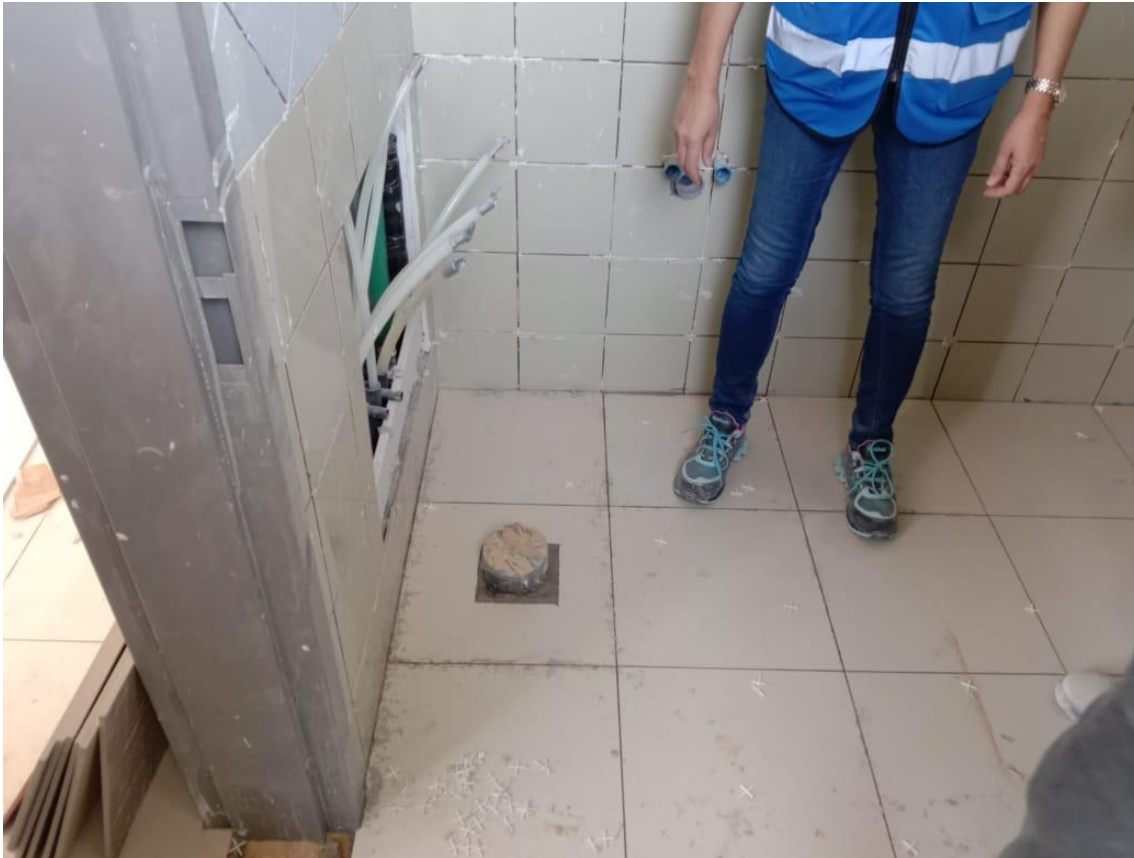
(Figure: 27)

Installing floor drain according to approved shop drawings

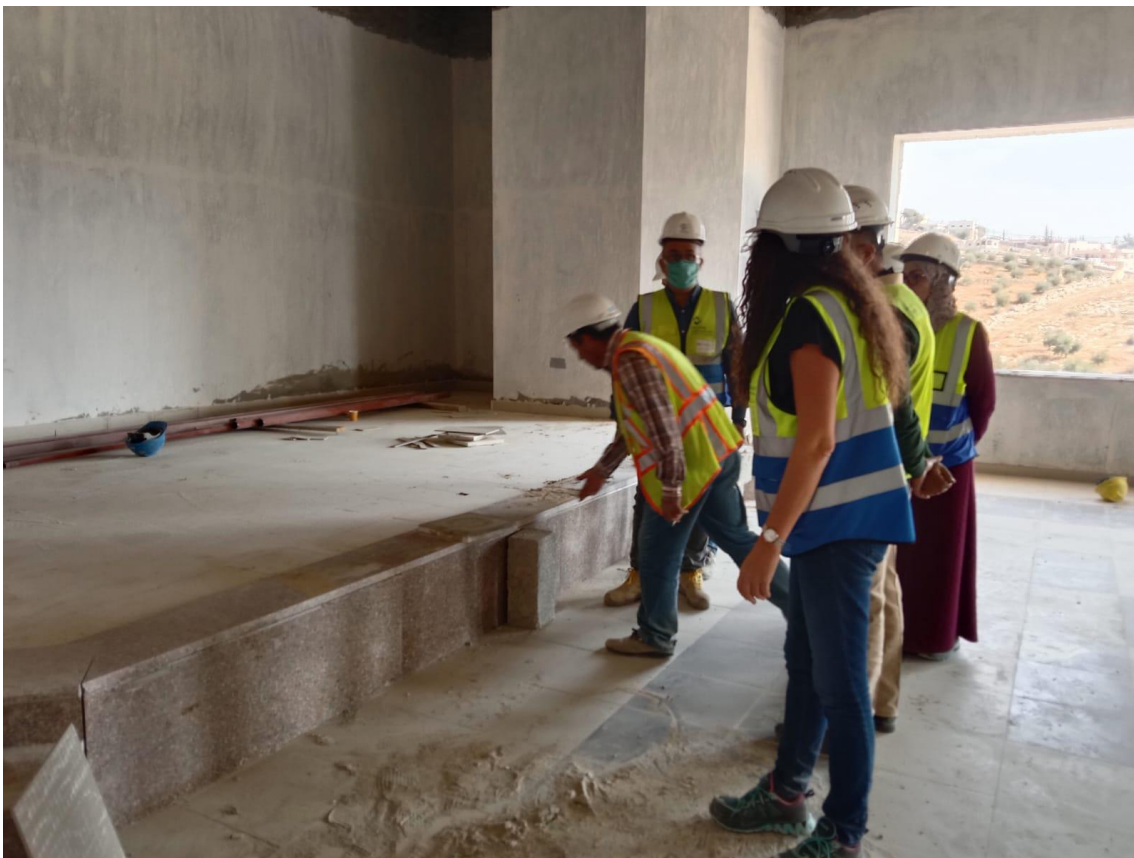
(Figure: 28)

Granite cladding installation for the platform at the multi-purpose hall was inspected

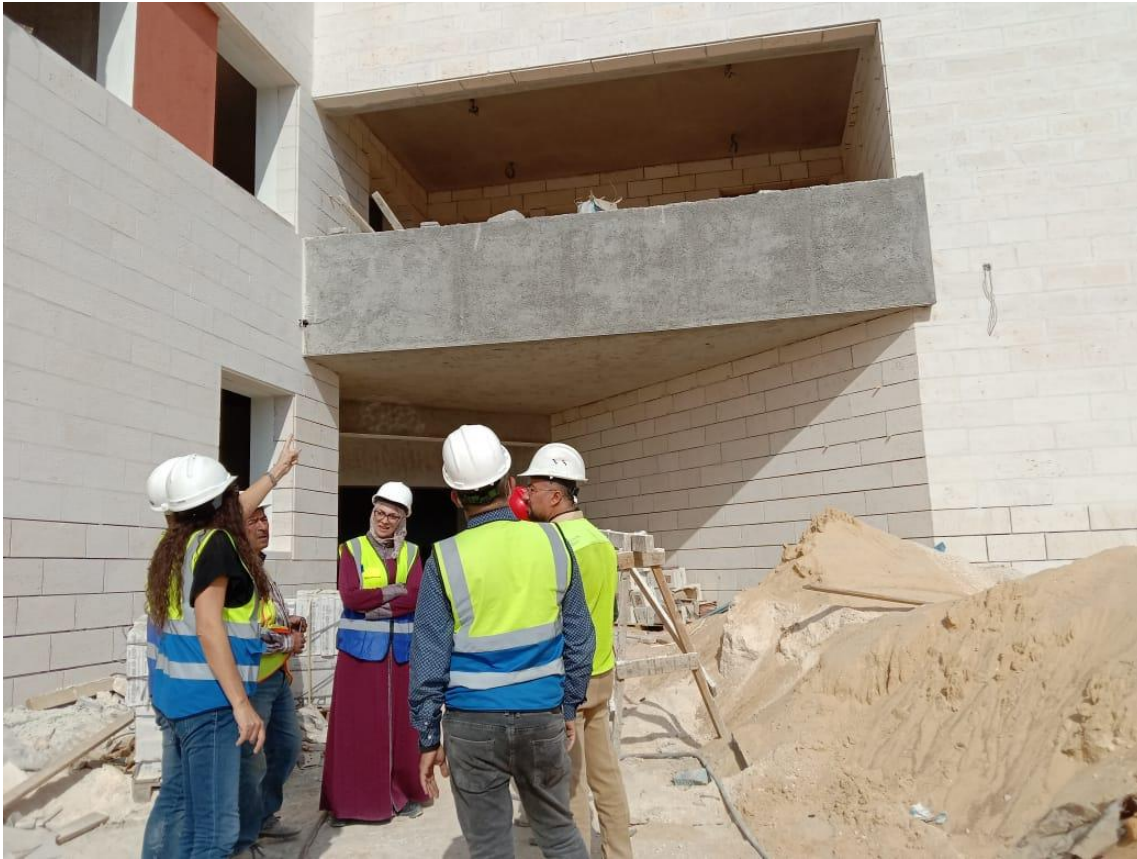
(Figure: 29)

Discussing the entrance canopy final finish
