SKEP III Home Office Support Site Visit Report

Consultant	Wahib Medanat Consultant Engineer	Rep No.	22-02012022
Contractor	Dijlah Establishment Constr. Contracting	Tender No.	(11/2019/USAID/SKEP/3/S) Schools for a Knowledge Economy Project (SKEP) - Phase (3) Package (1, 2)
Site Name	Thahr Al Sarow Basic School for Boys- Jerash	Day/ Date	Sun. 02/01/2022
Duration of Project	450 Calendar Days	Total Project Budget	8,314,983.735 JD

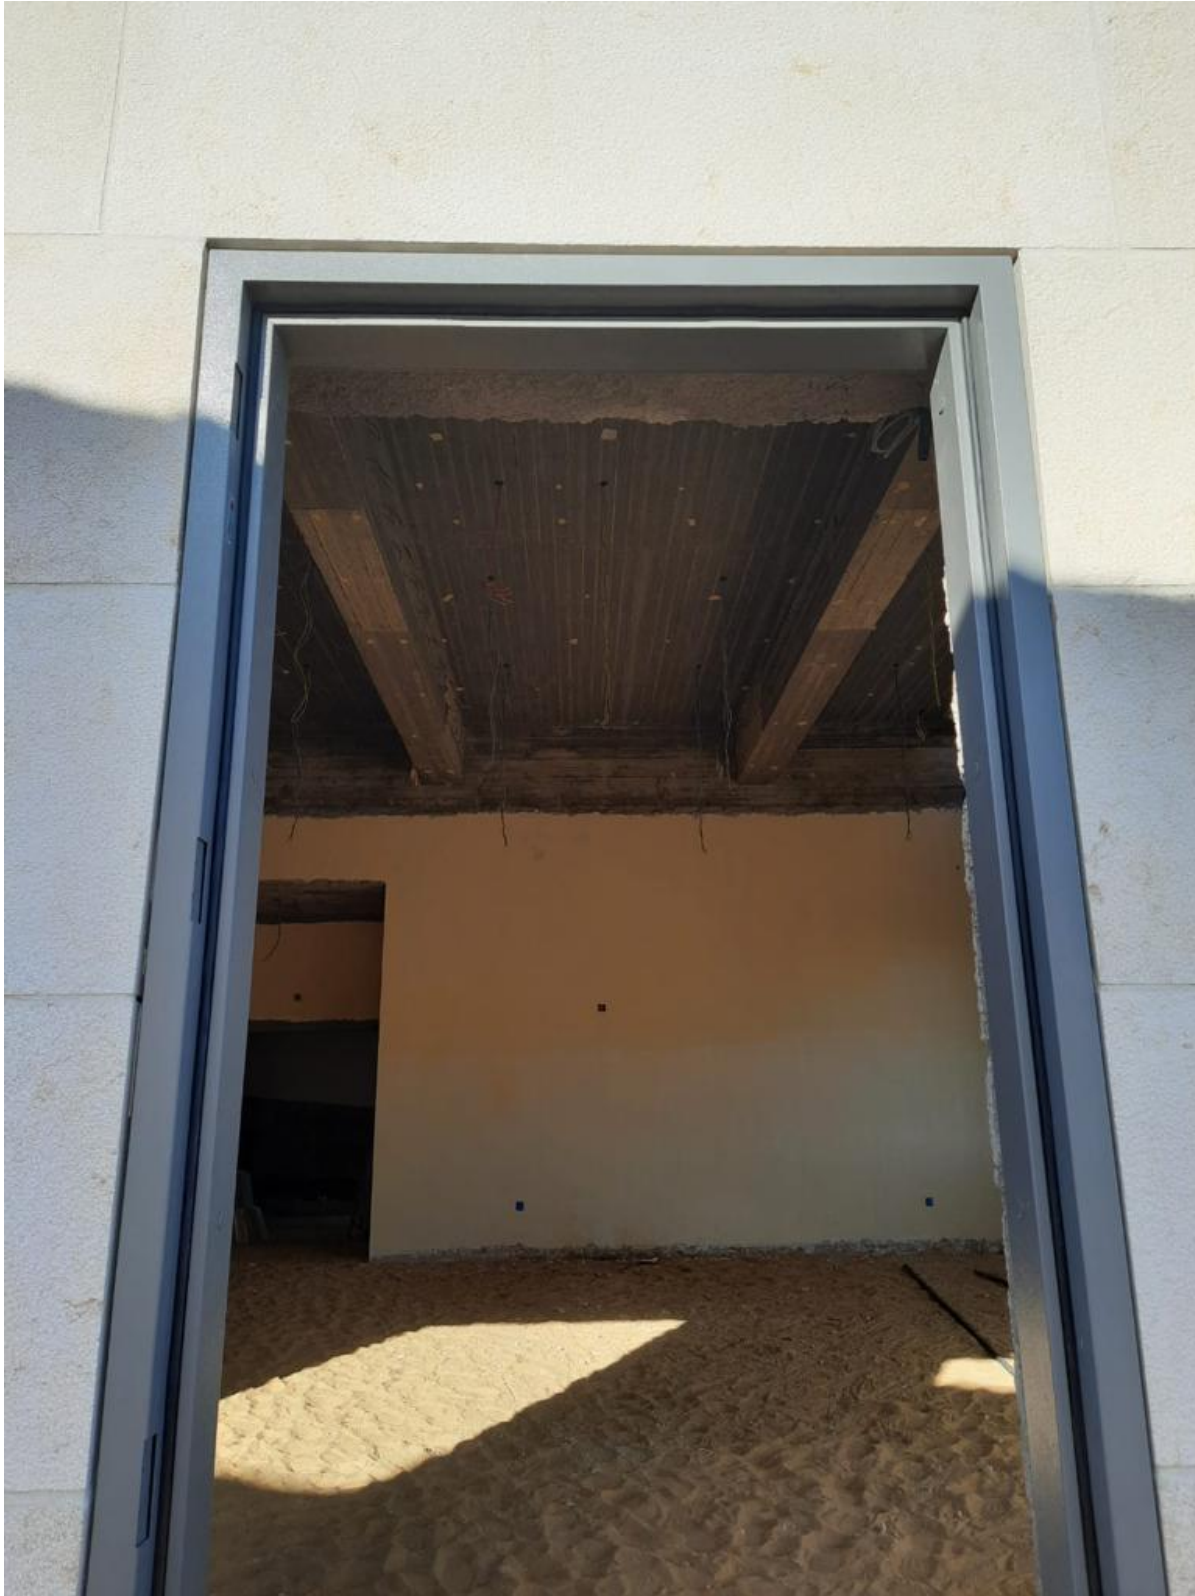
(Figure: 04)

The supervision team conducted the necessary inspection on the prepared sample by the Contractor for the installation of the steel door frames

After inspecting the sample in the presence of the Contractor's representative, it was agreed that the door frame shall protrude 1cm from the stone face to show appropriate view

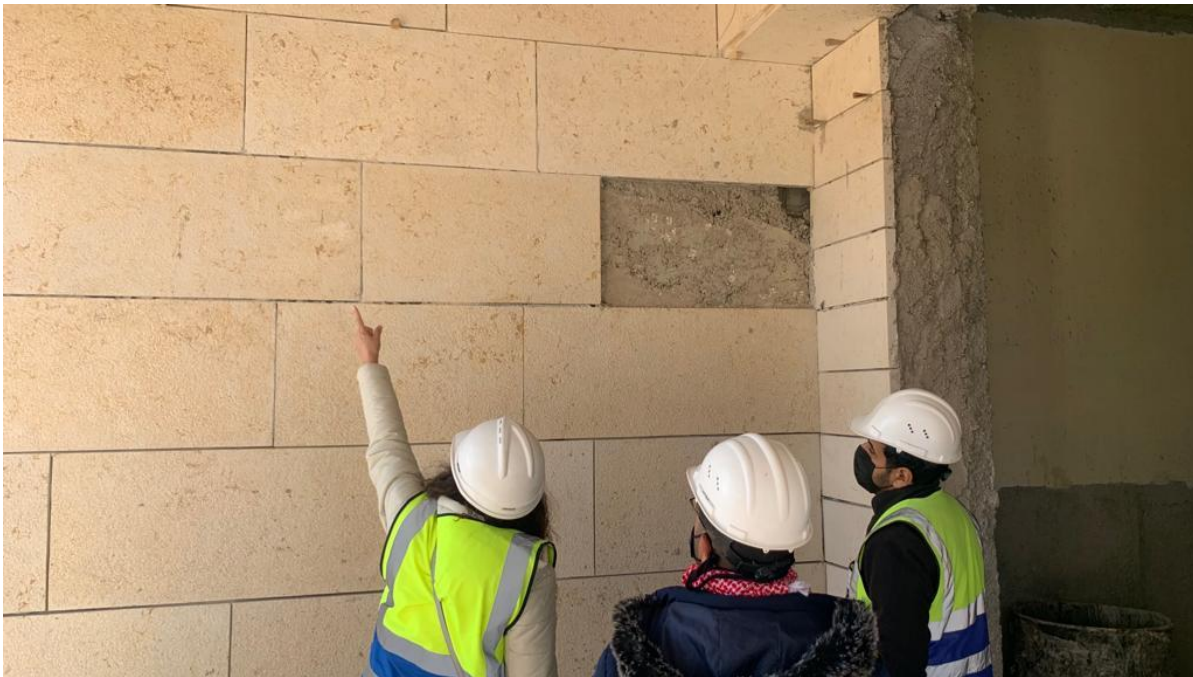
(Figure: 06)

The previously observed remarks still exist (defected stones)

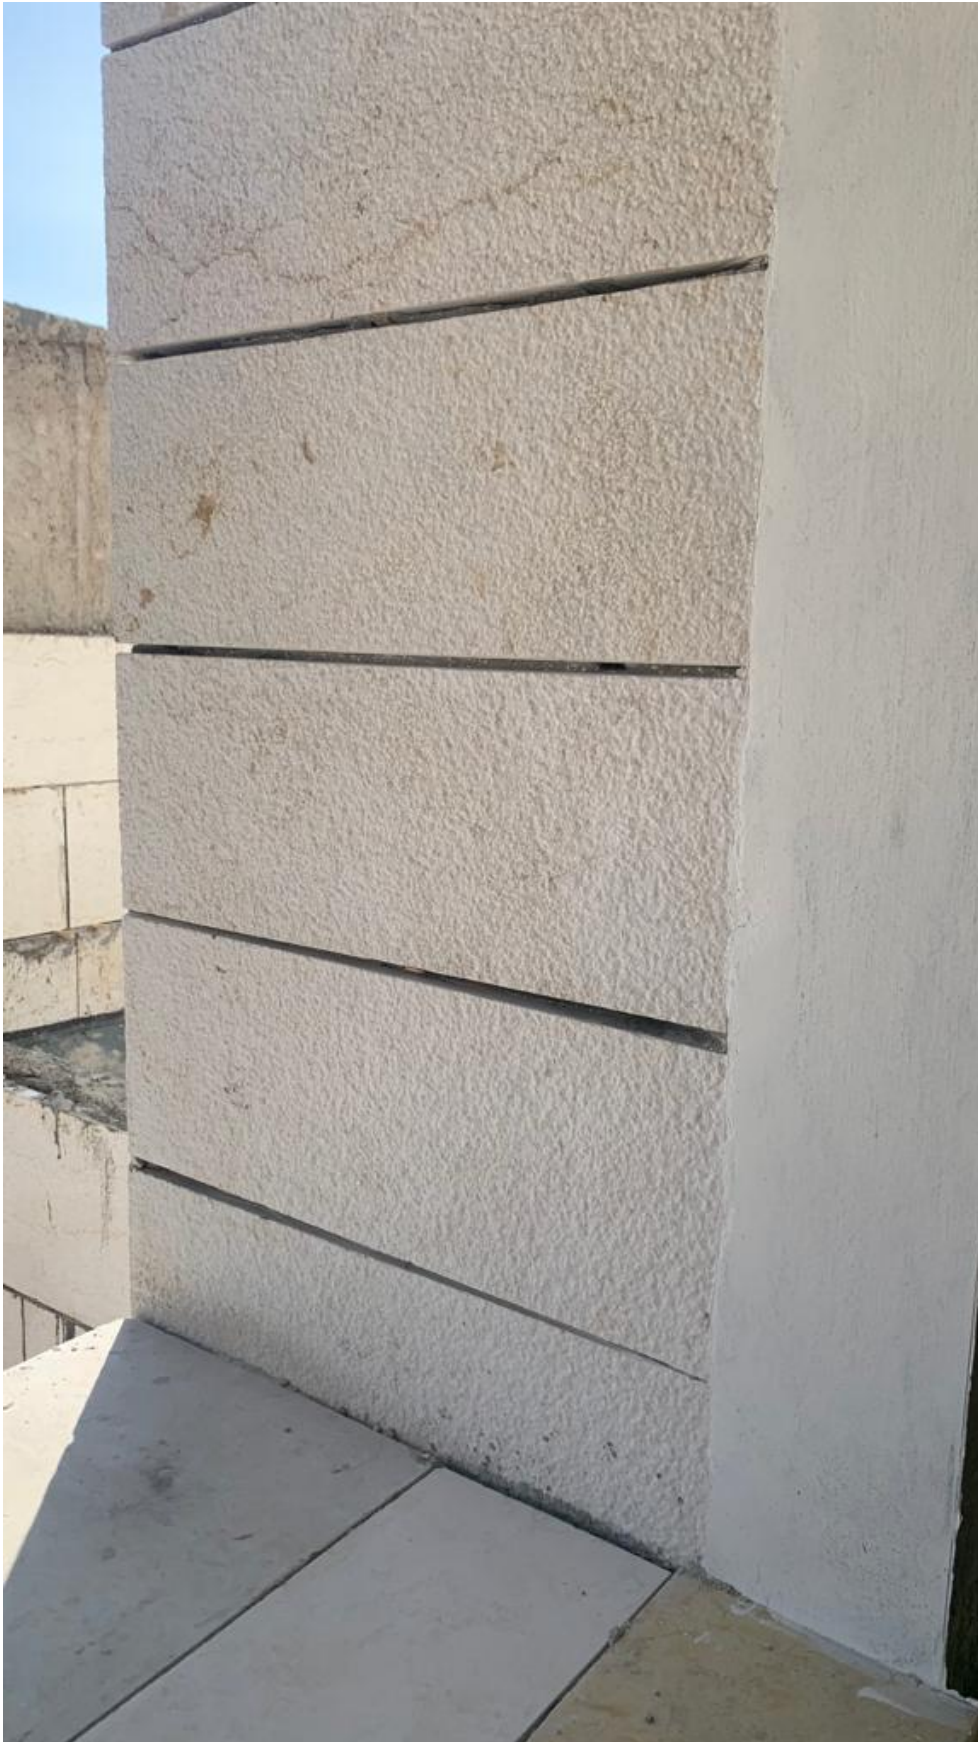
(Figure: 09)

Broken stones at the facades and the Contractor was requested to replace broken pieces

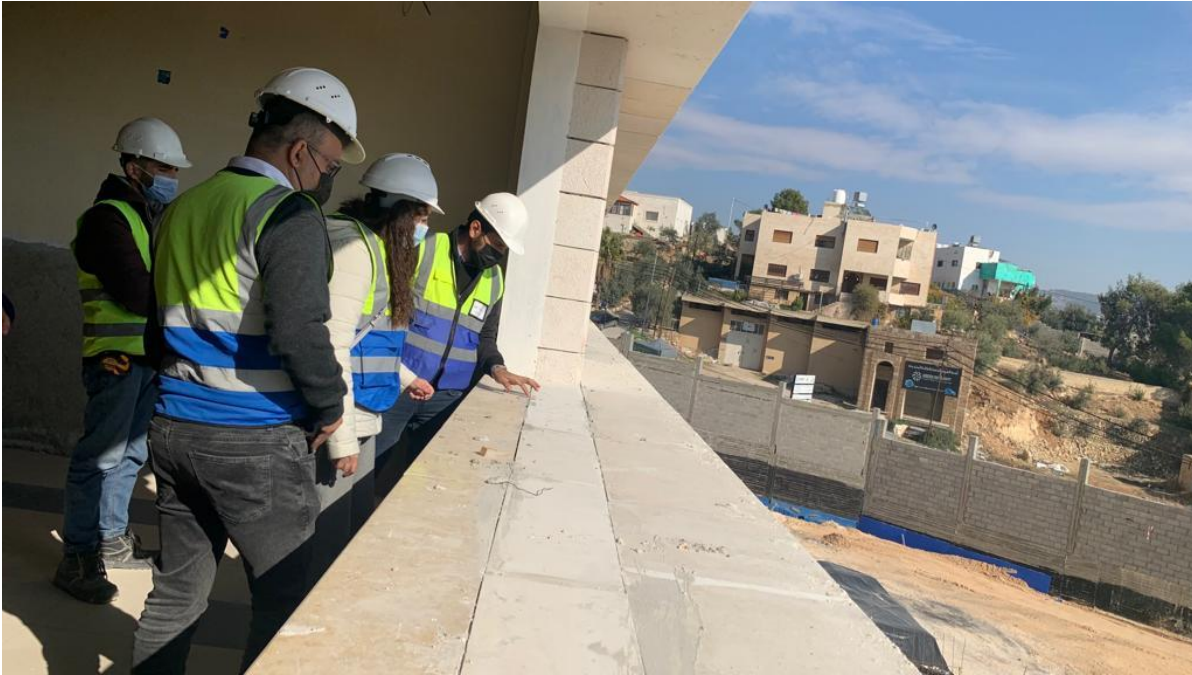
(Figure: 10)

Defects have been observed at the stone jambs such as irregular and wider than required joints

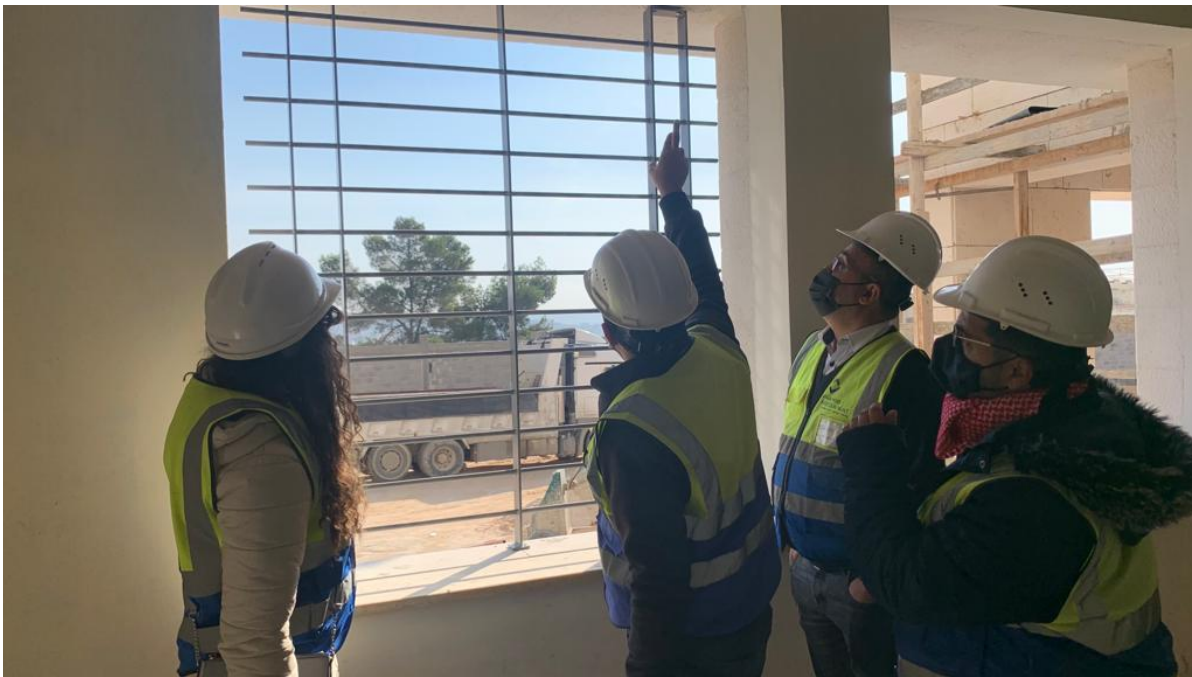
(Figure: 11)

The installation of window sills is not proper in several locations

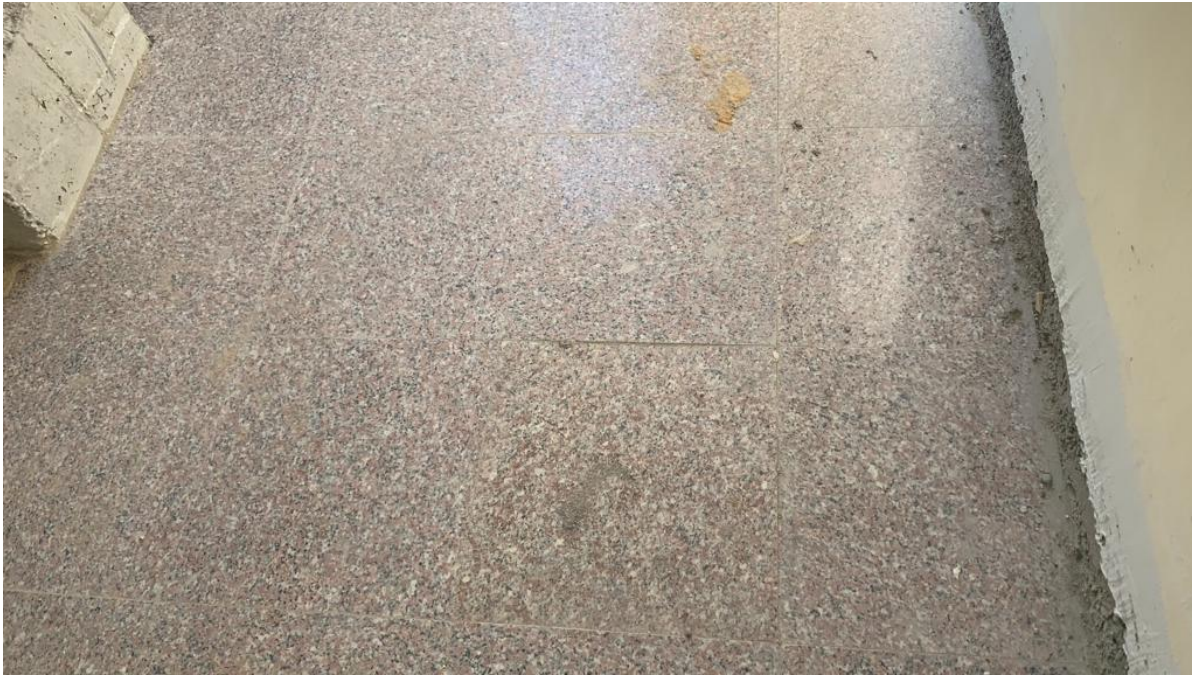
(Figure: 13)

The teething in the granite tiles for staircase landing is still existing and the Contractor was requested to rectify

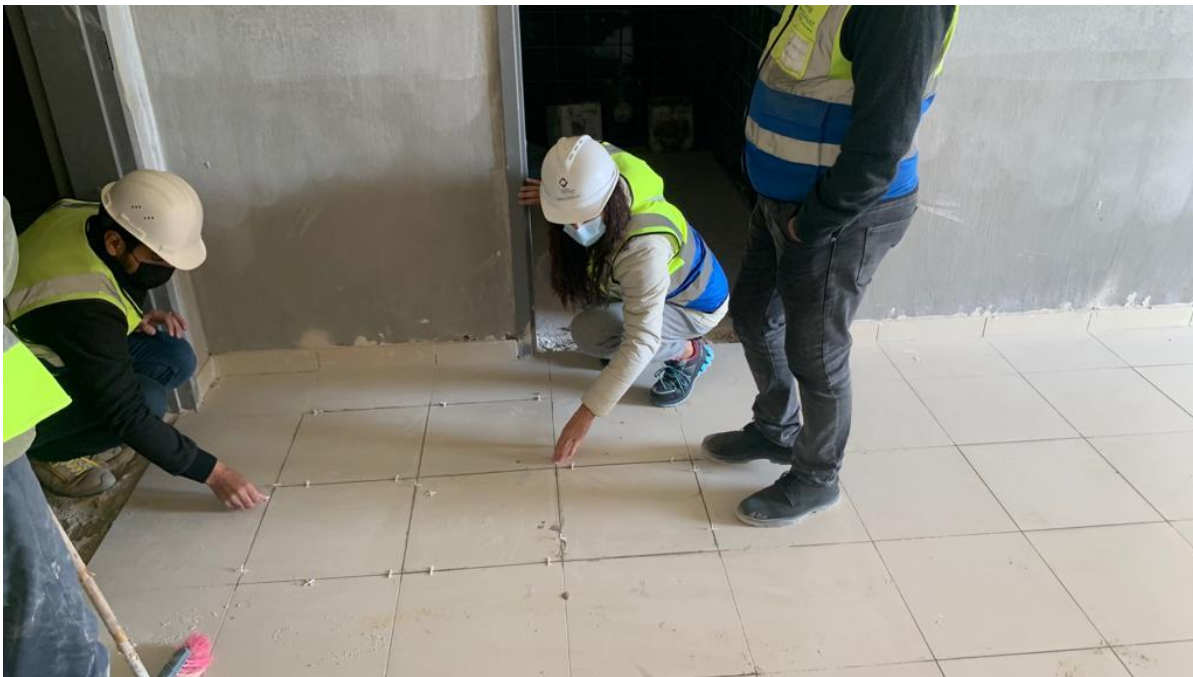
(Figure: 15)

The action of the Contractor to rectify the defective porcelain floor tiles was inspected. It was observed that the Contractor has not managed to rectify the defects and the previously observed defects still exist (uneven, Teething)

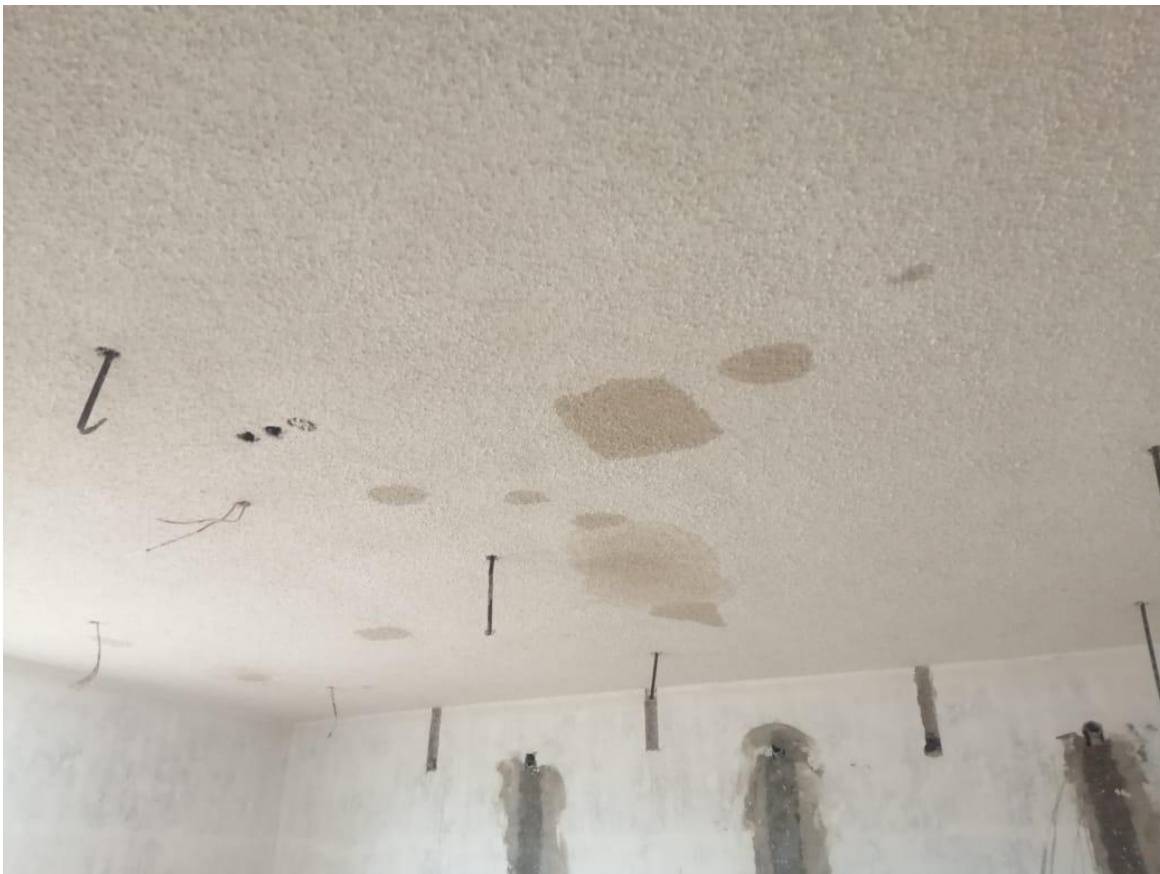
(Figure: 19)

It was observed that rain water penetrated the building due to defects in the roof waterproofing and, as a result, defects have been observed in the finishing work inside the building. The Contractor was requested to rectify
