# SKEP III Home Office Support Site Visit Report

Consultant	Wahib Medanat Consultant Engineer	Rep No.	22-21092021
Contractor	Dijlah Establishment Constr. Contracting	Tender No.	(11/2019/USAID/SKEP/3/S) Schools for a Knowledge Economy Project (SKEP) - Phase (3) Package (1, 2)
Site Name	Thahr Al Sarow Basic School for Boys- Jerash	Day/ Date	Tue. 21/09/2021
Duration of Project	450 Calendar Days	Total Project Budget	8,314,983.735 JD

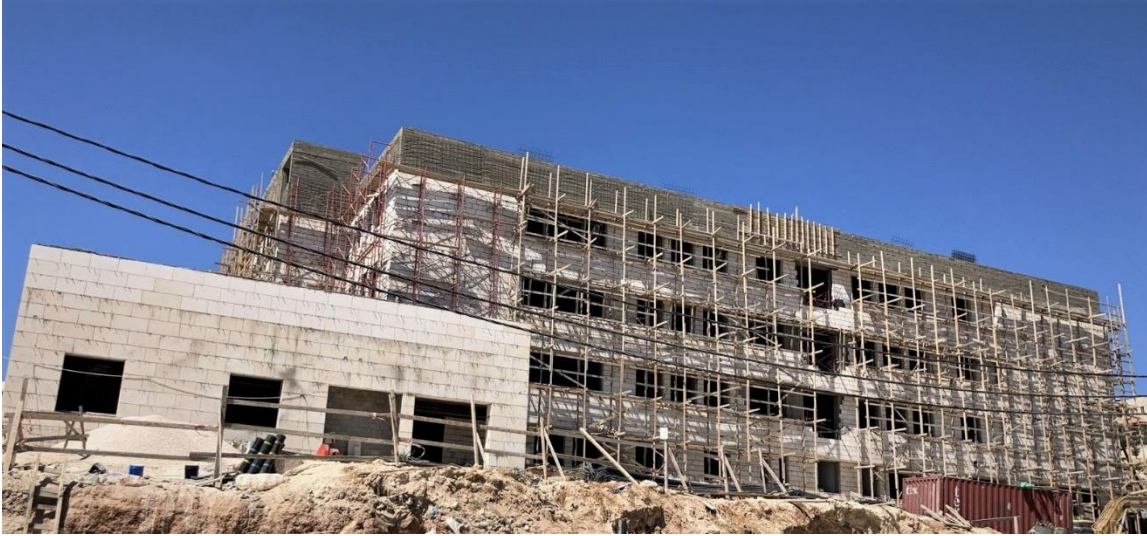
(Figure: 01)

General view of the completed third floor casting (the last slab)

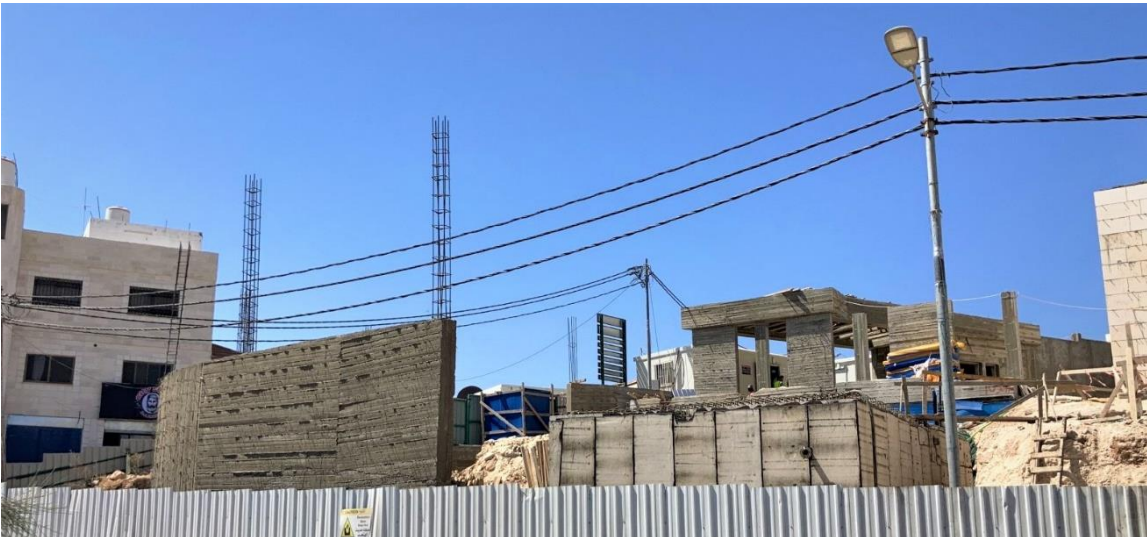
(Figure: 02)

Executed part of the external works at the side of the street down which was delayed due to the encroachment inside the school plot

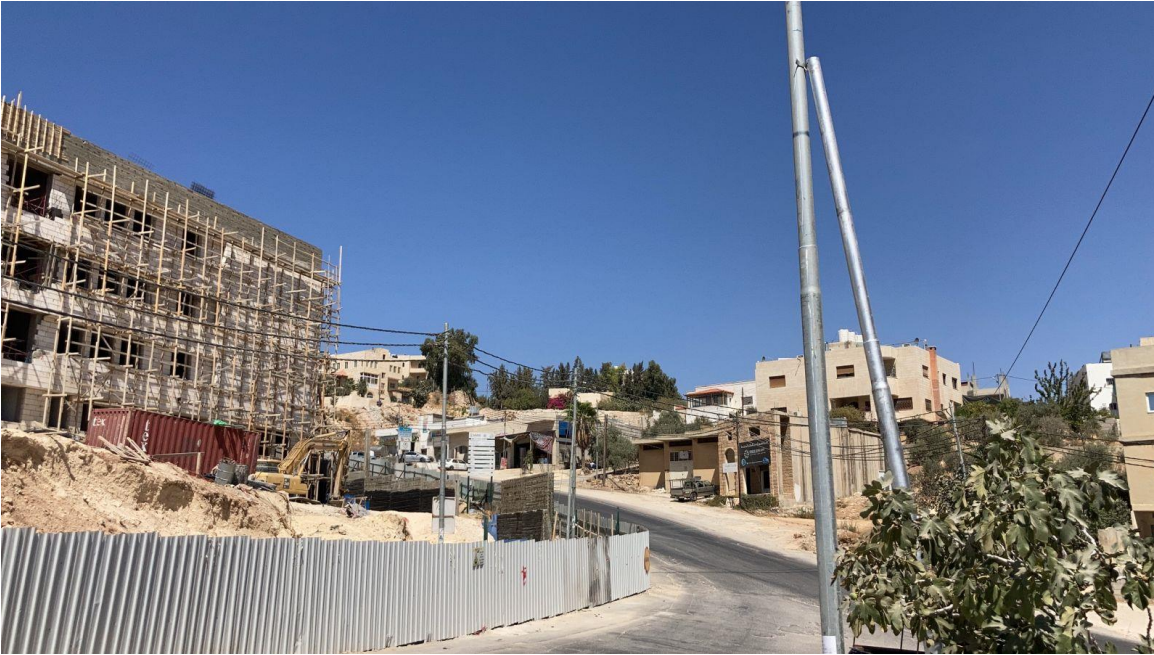
(Figure: 03)

Dismantling the electrical cables at the poles adjacent to the site and fixing those cables on the poles at the opposite side of the street including fixing an extra pole

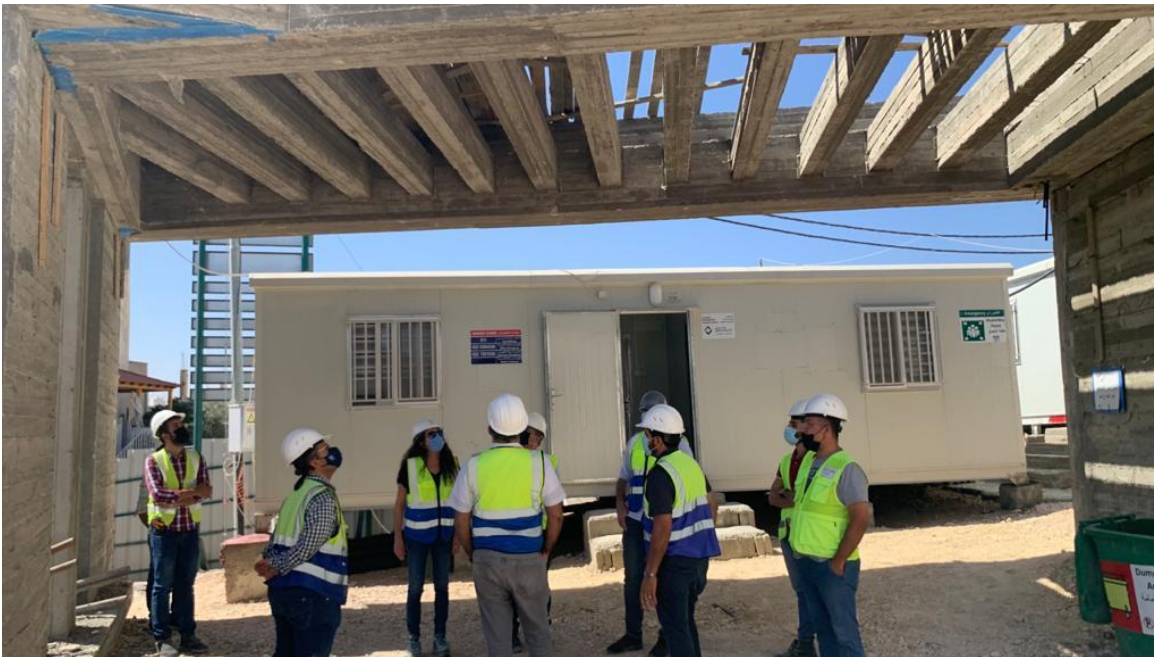
(Figure: 04)

Inspecting the concrete canopy at the school entrance

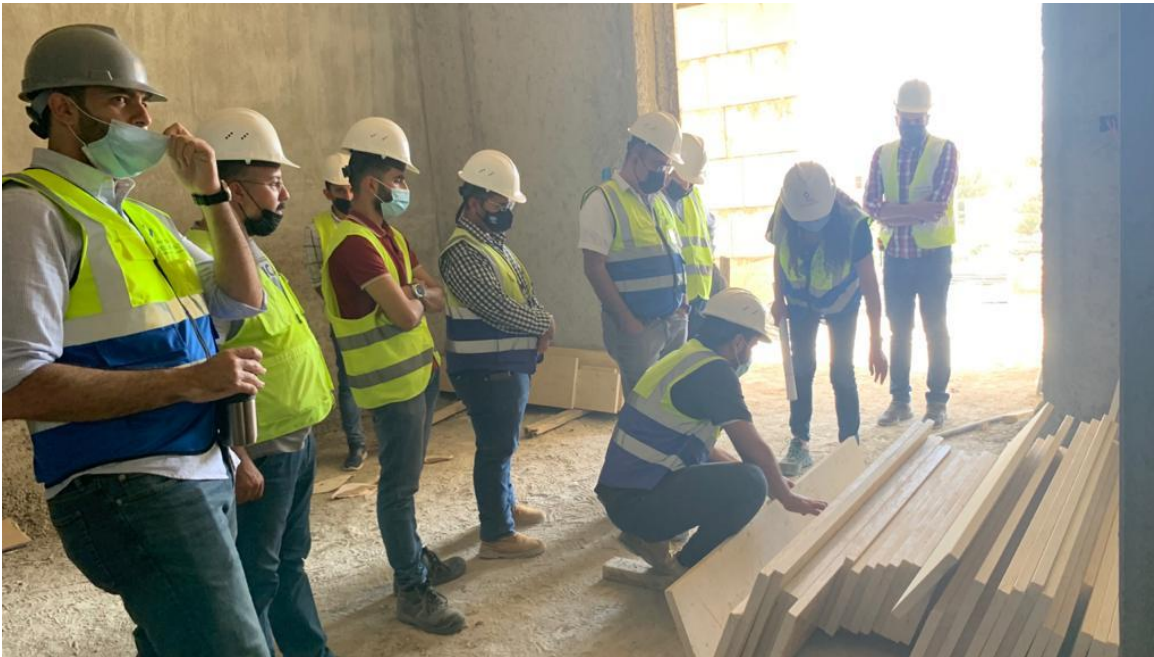
(Figure: 05)

Giving remarks to the Contractor about the acceptable status of delivered "Ajoun Marble" to the site and showing examples of acceptable and unacceptable sills

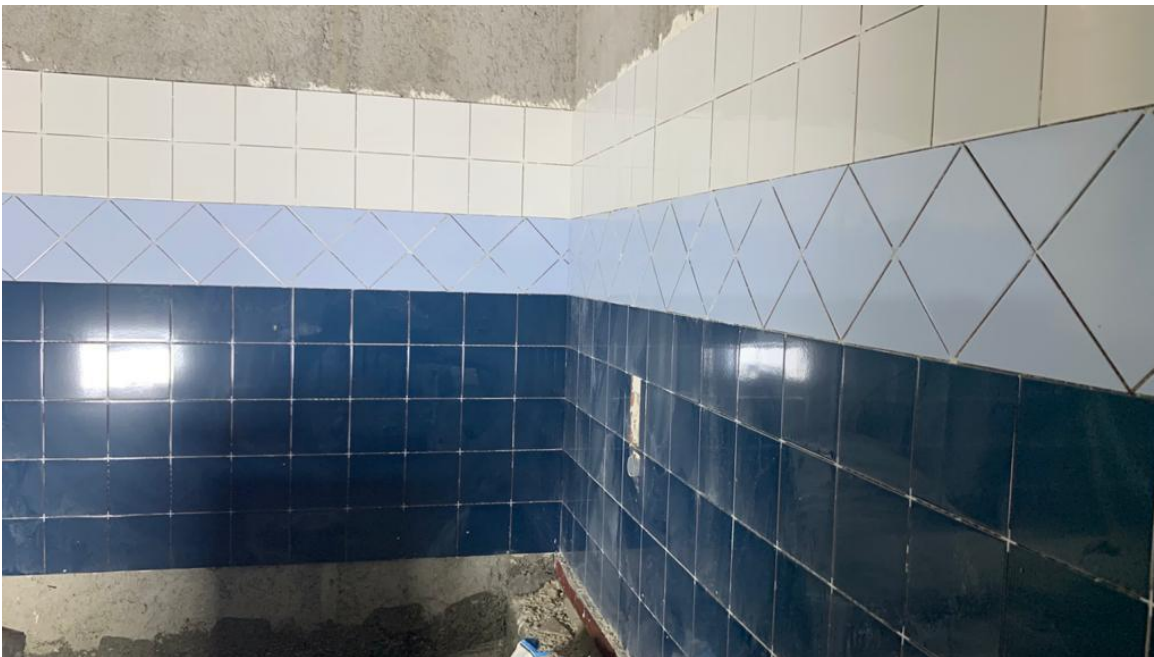
(Figure: 06)

It was observed that the Contractor started with tiling work in the sanitary units at the ground floor

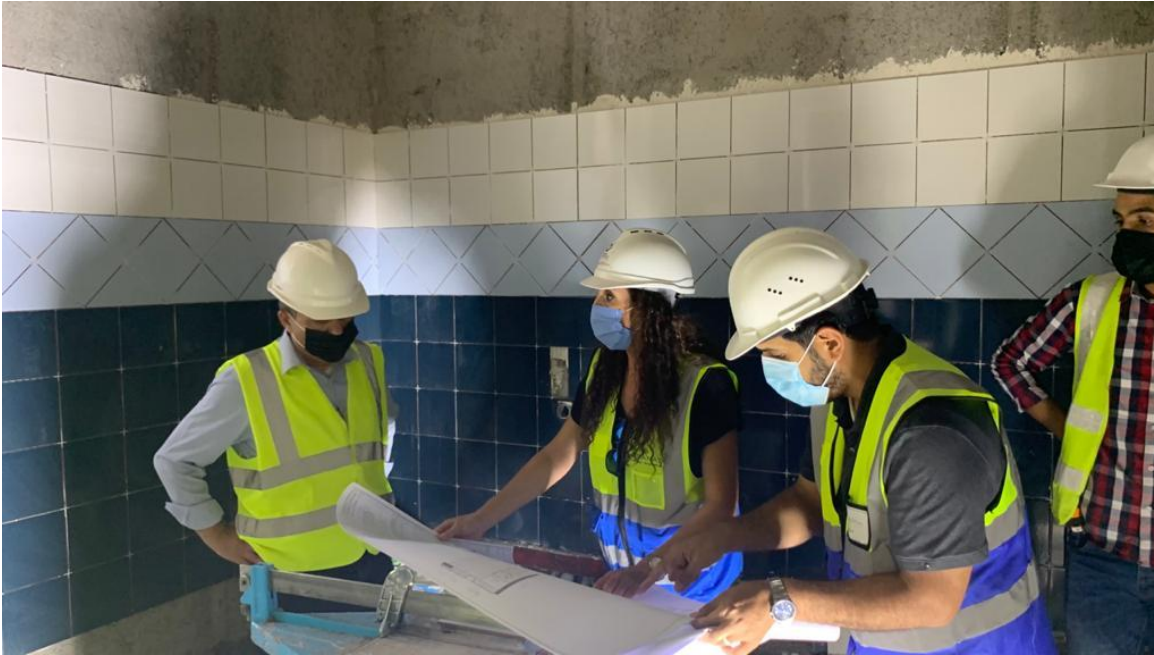
(Figure: 07)

making sure it complies with the approved workshop drawings

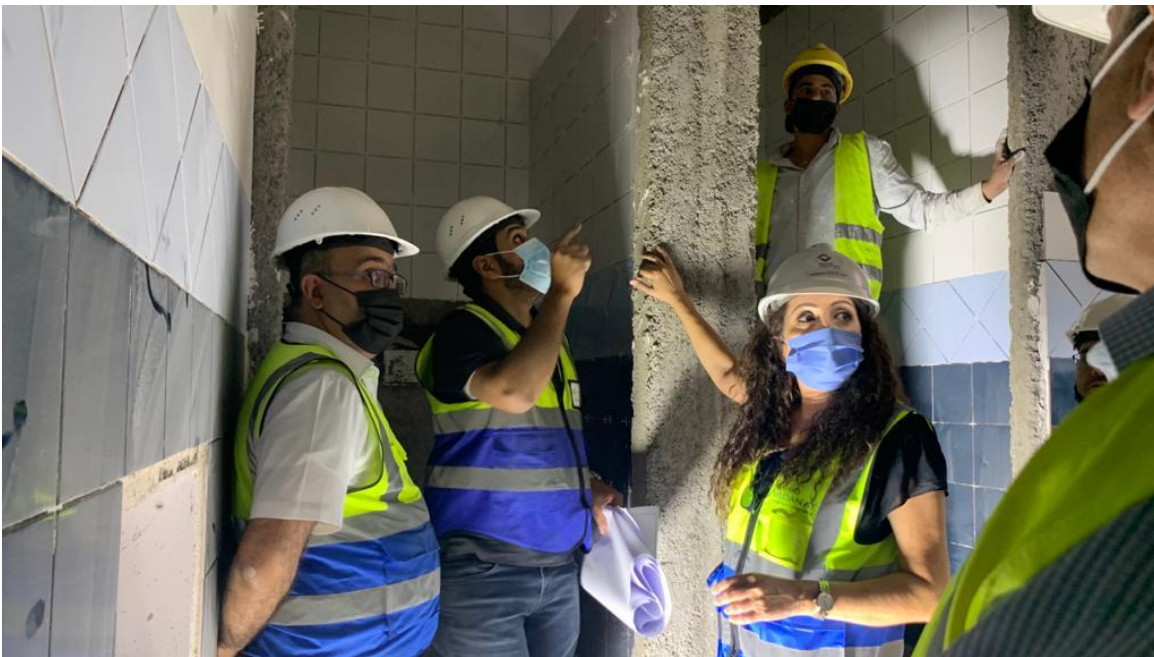
(Figure: 08)

The level of the false ceiling at the sanitary units was discussed with the Contractor. He was requested to submit shop drawings to the whole ceiling

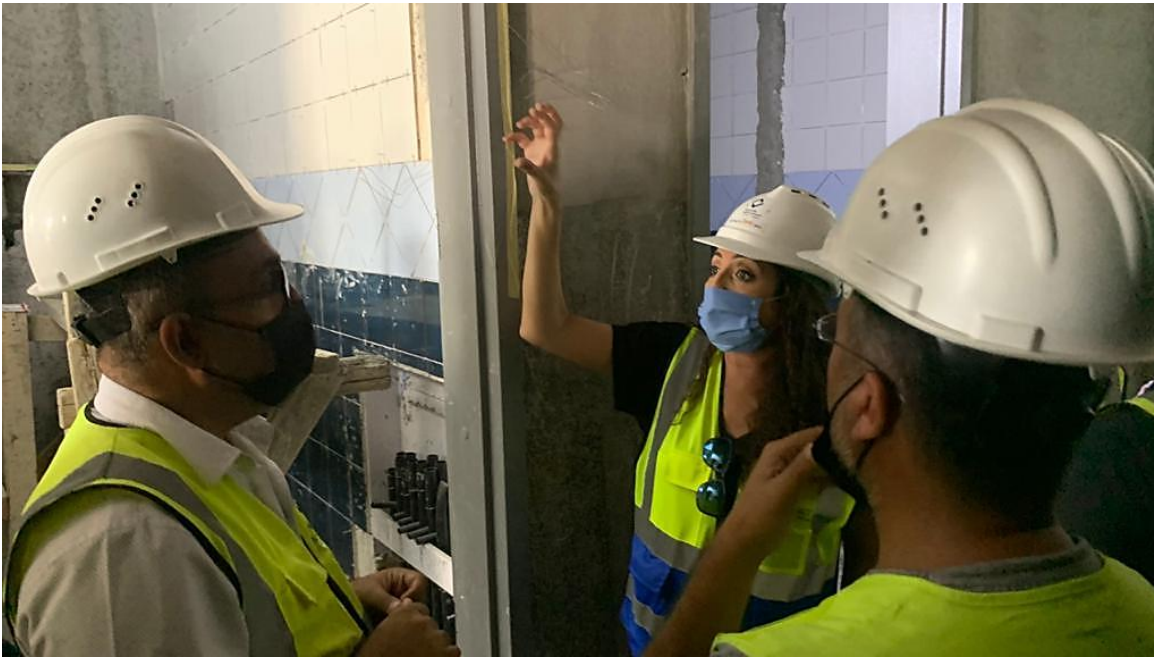
(Figure: 09)

The relationship between the door frames and the wall tiles of the sanitary units was discussed

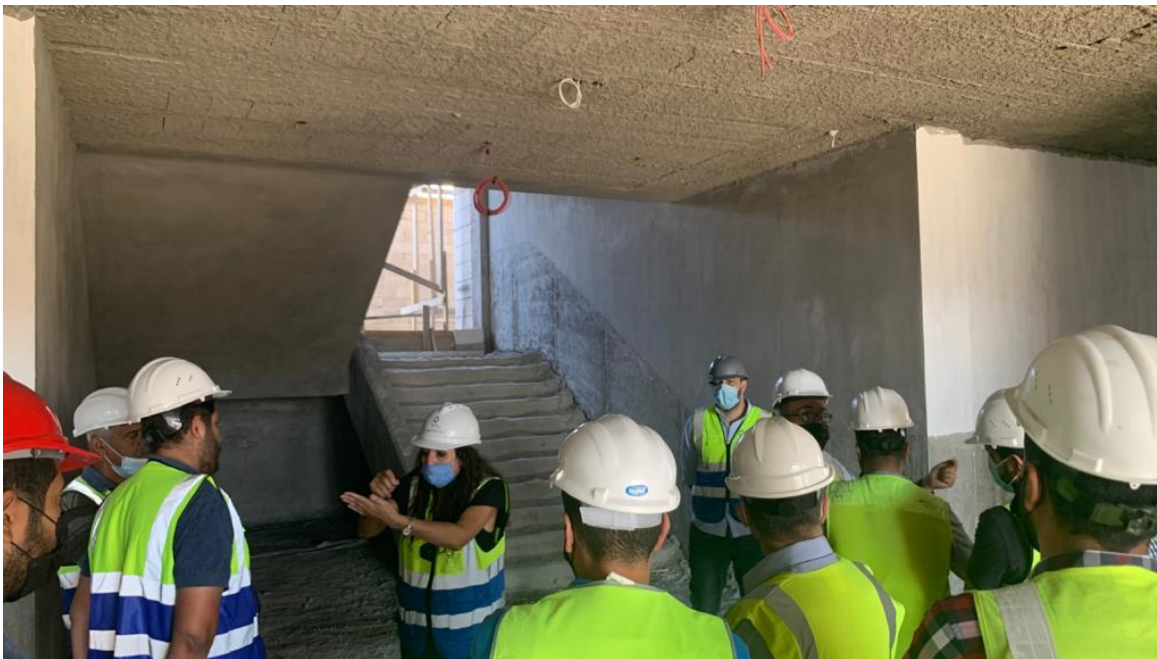
(Figure: 10)

The Contractor was requested to submit shop drawings for the false ceiling at corridors to specify the details of the false ceiling end at the staircase areas

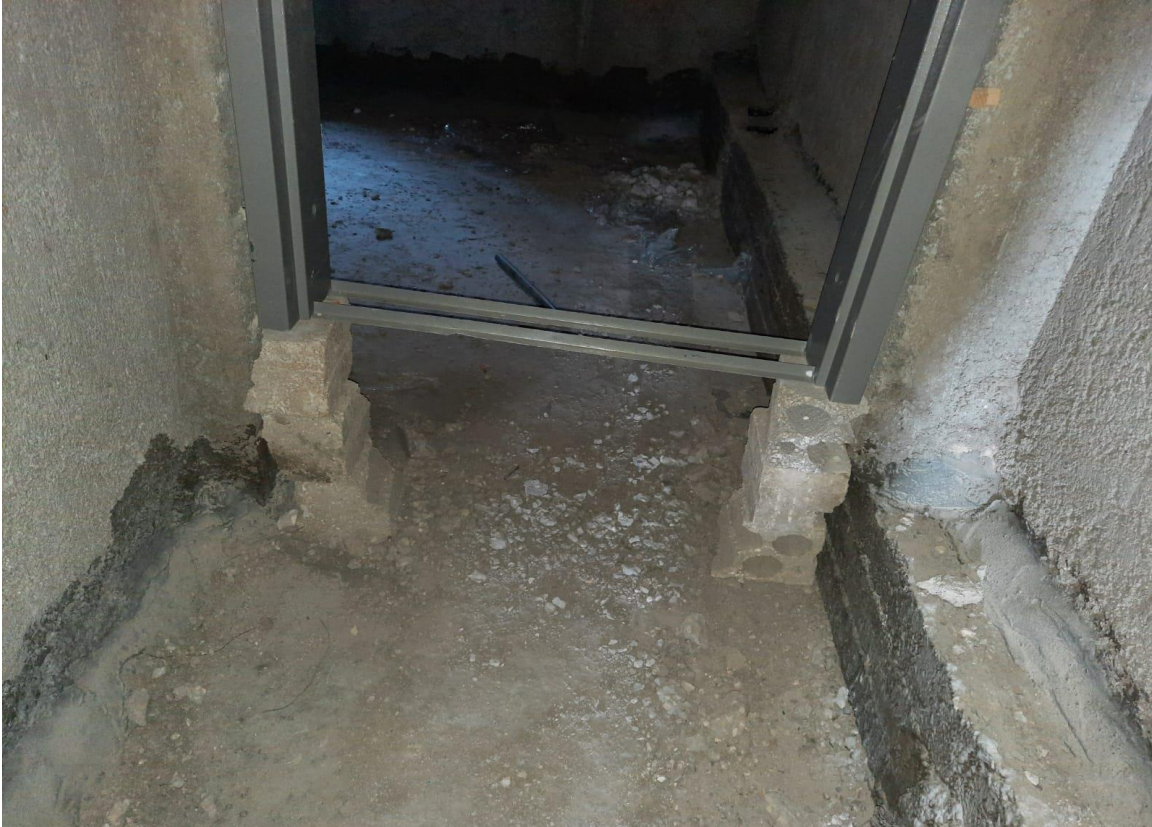
(Figure: 11)

15	The door frames of the sanitary units at the recess should be supported by mass concrete with convenient dimensions. Also dismantling of the bracing at the door frames before starting with floor tiling to avoid defects in the frame during the tiling work.

The door frames of the sanitary units at the recess should be supported by mass concrete with convenient dimensions. Also dismantling of the bracing at the door frames before starting with floor tiling to avoid defects in the frame during the tiling work

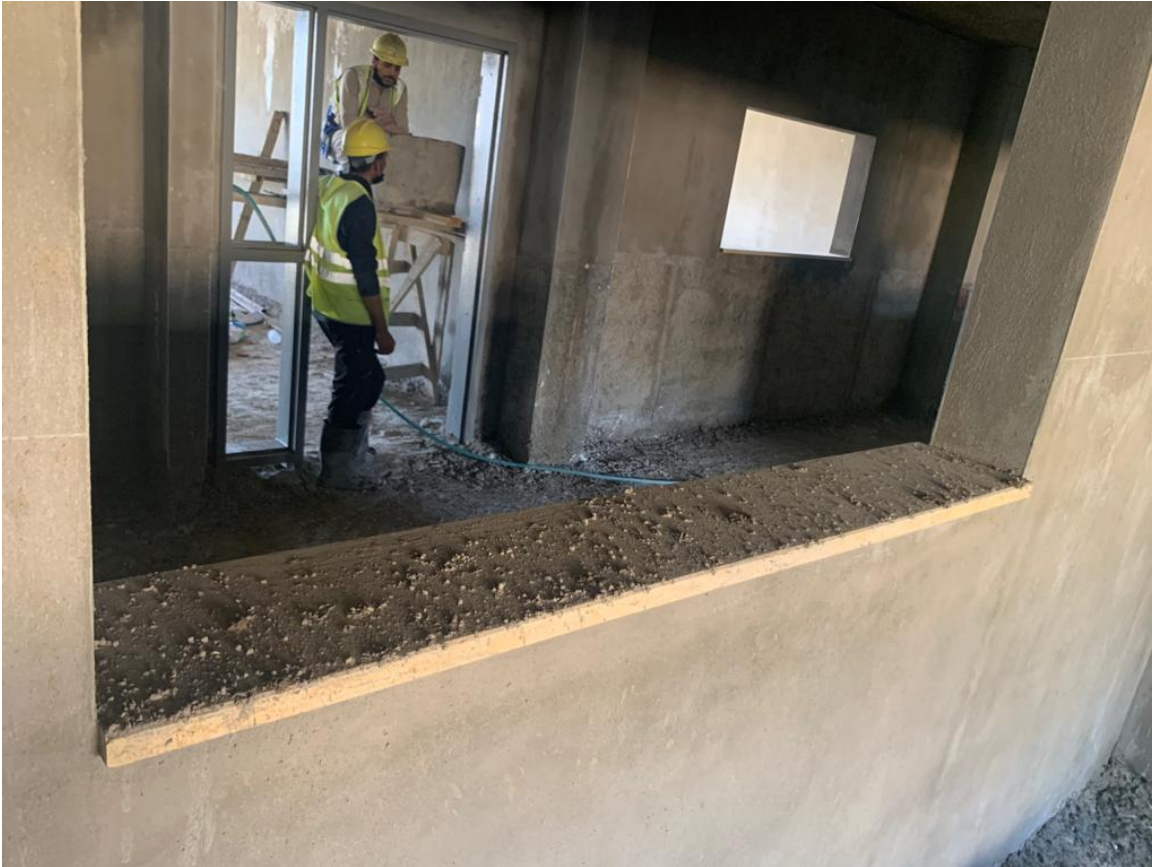
(Figure: 12)

Remains of mortar were observed stuck to the installed window sills. The Contractor was requested to avoid such status and keep clean and tidy sills

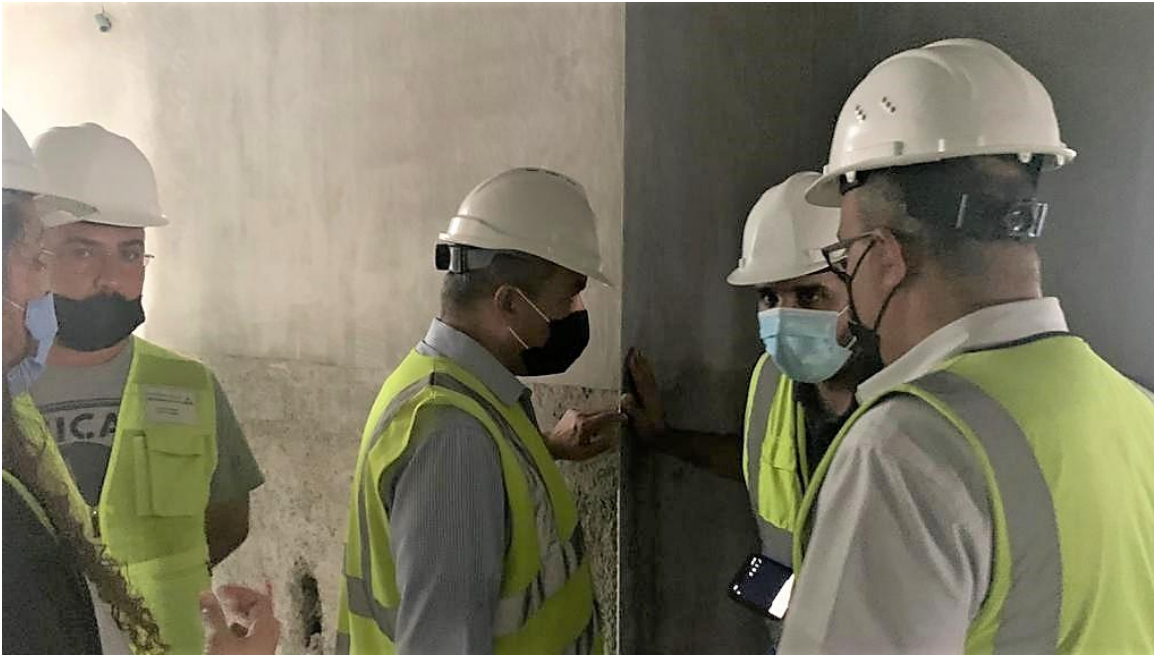
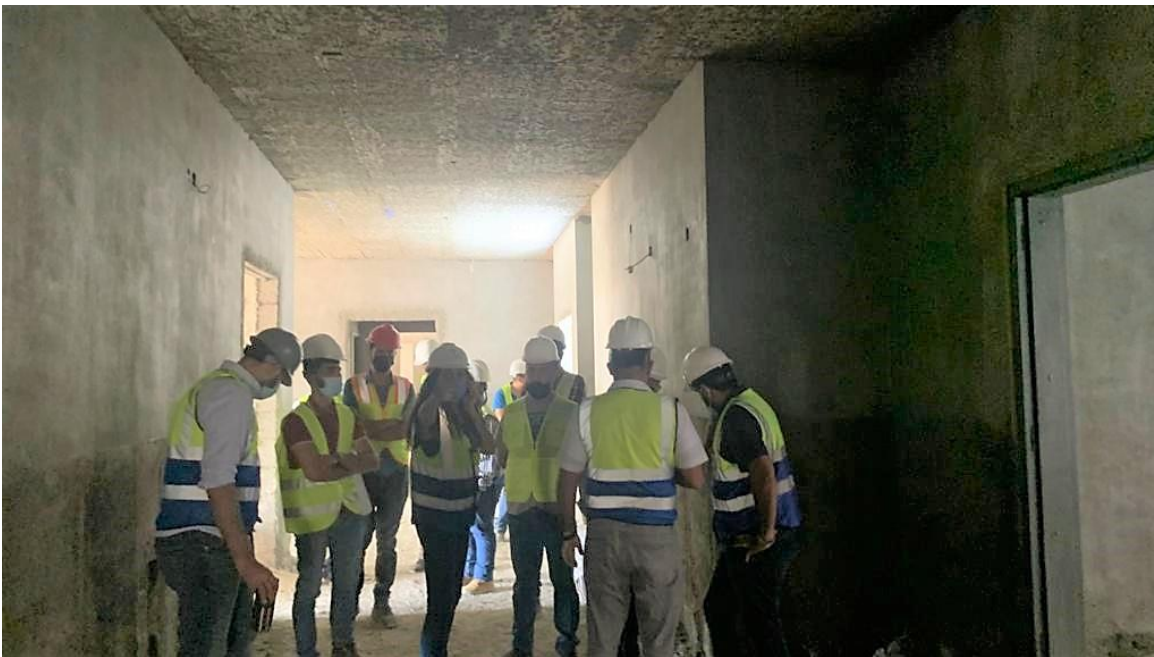
(Figure: 13 & 14)

The installed plastering beads were inspected and the Contractor was directed to take care at the external corners when executing the wall tiles at corridors

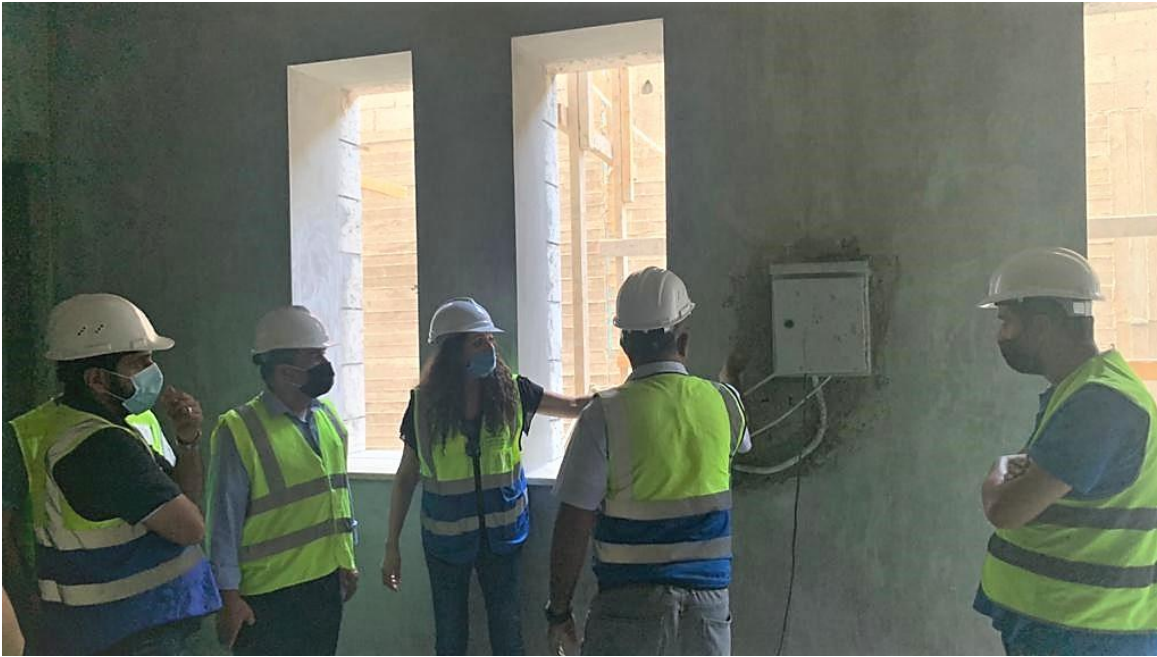
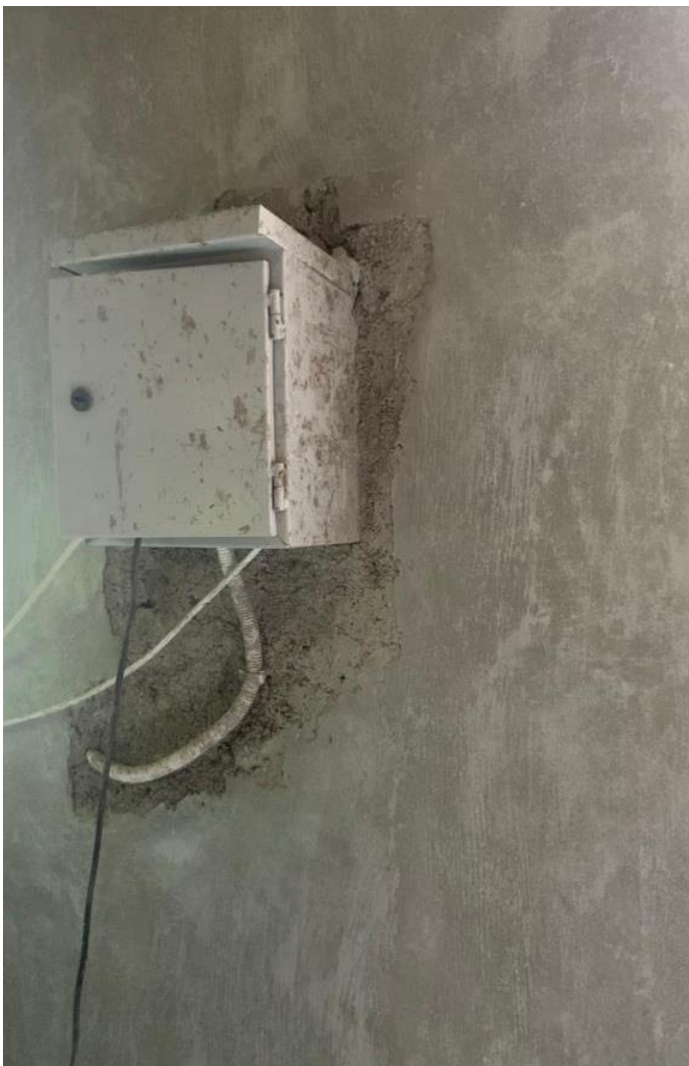
(Figure: 15 & 16)

Finishing of plastering and starting the painting work without taking clearance for the mechanical and electrical works

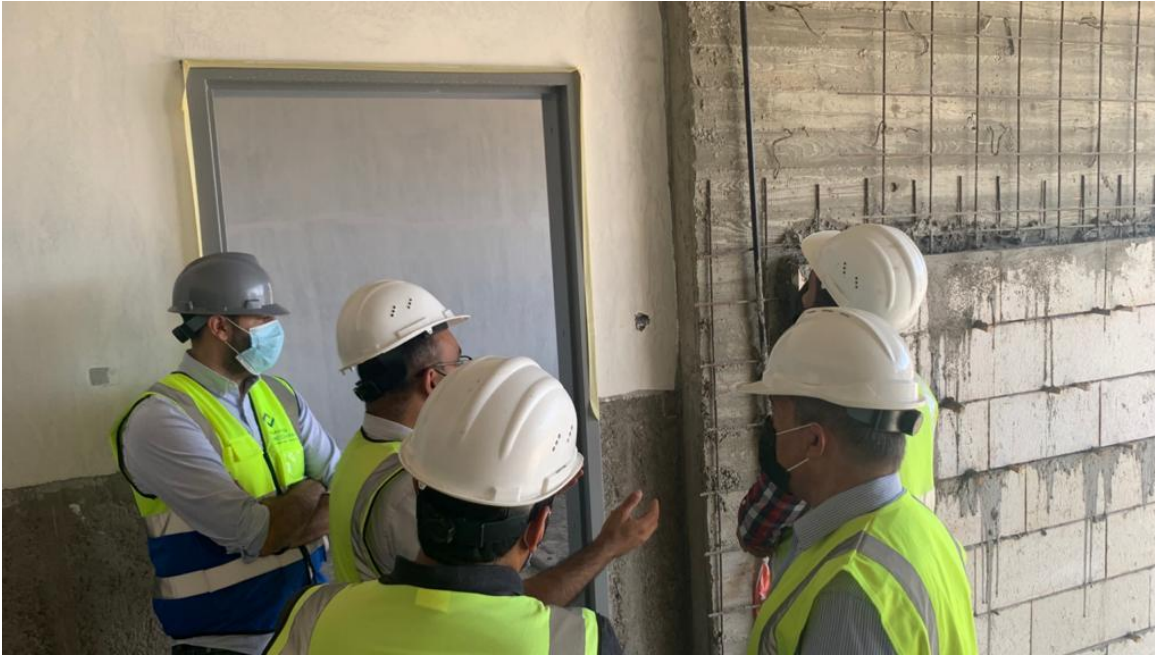
(Figure: 17)

The Contractor started with painting works without completing the surrounded stone and concrete work

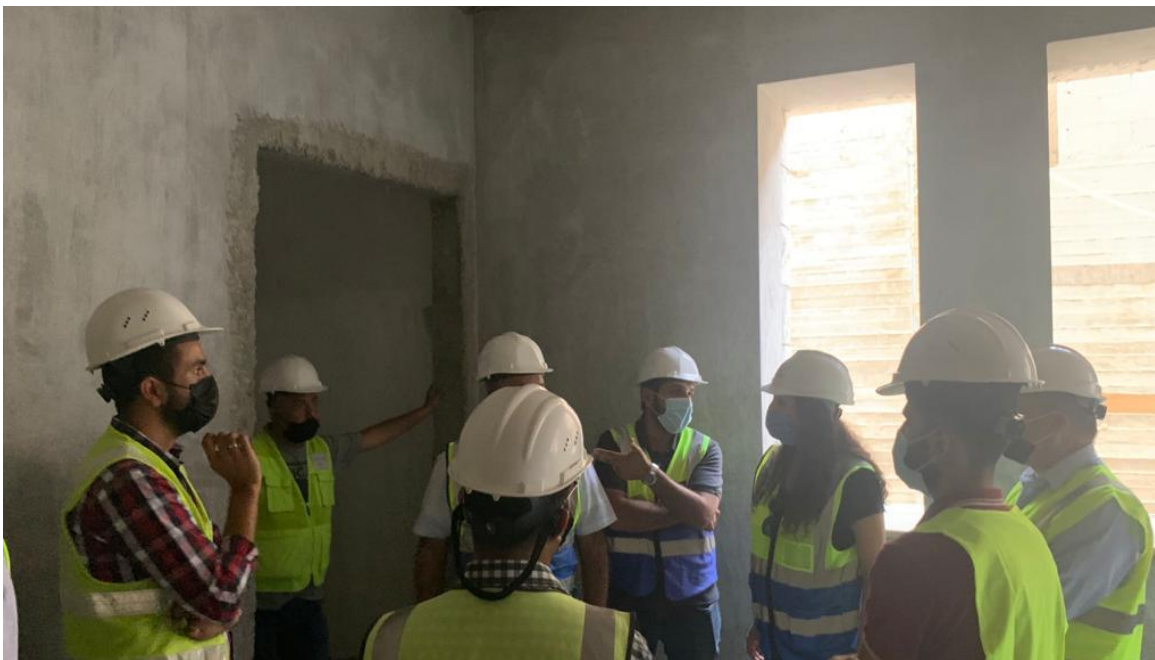
(Figure: 18)

It was observed that the Contractor postponed the fine finish of the plastering to allow for the installation of door frames

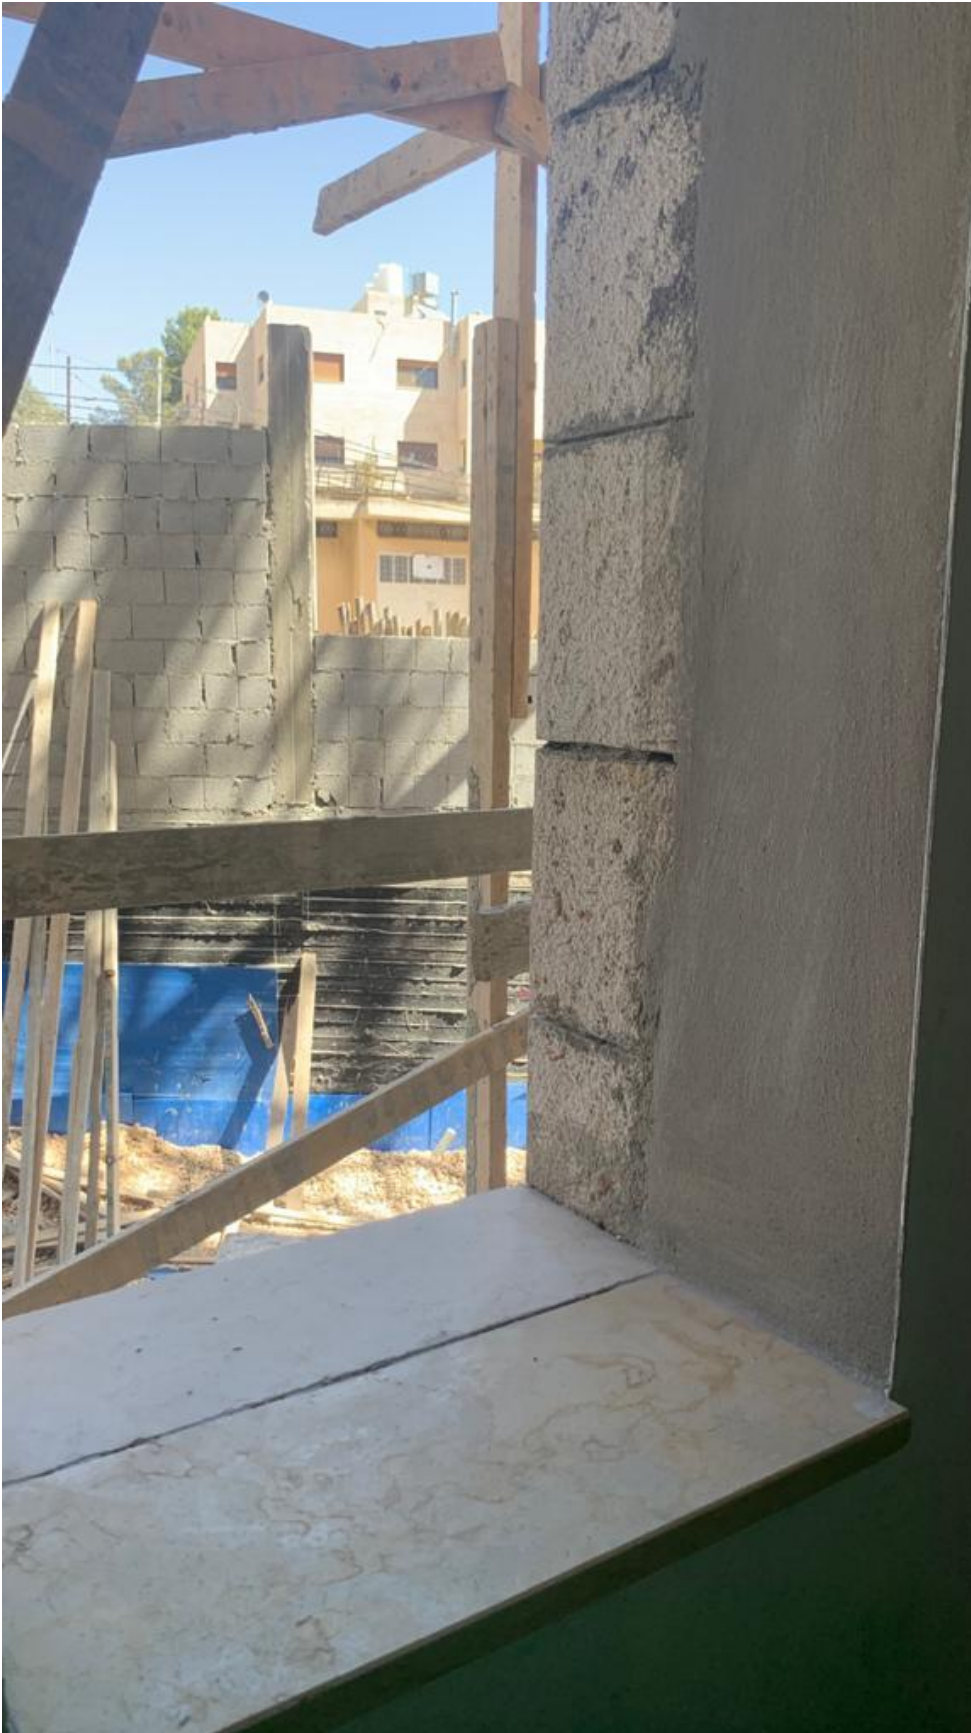
(Figure: 19)

Installing window  
sills and jambs  
finish as per  
requirement

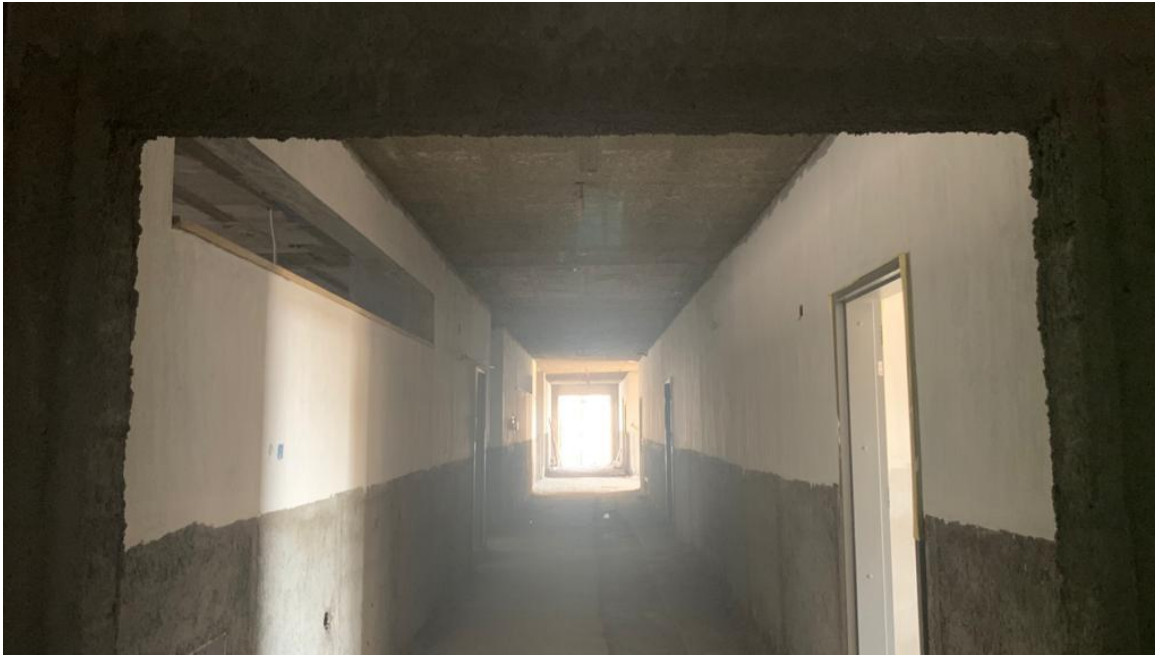
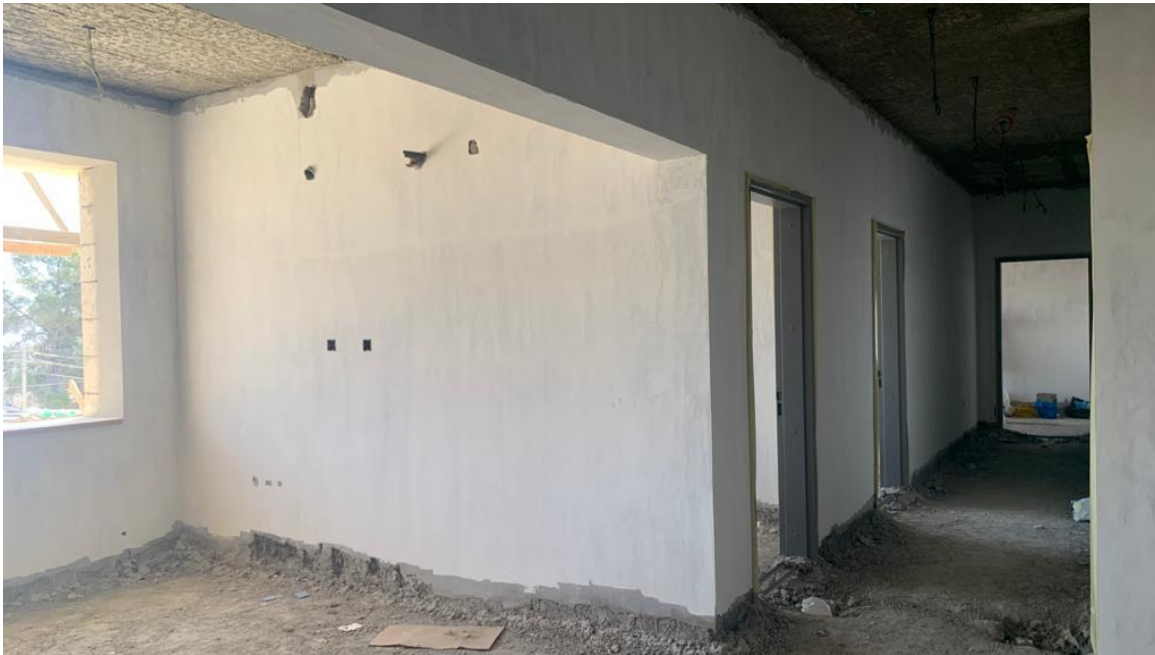
*(Figure: 20 & 21)*

General view showing the start of painting work
