| Consultant | Wahib Medanat Consultant Engineer | Rep No. | 11-04122021 |
| Contractor | Derar Saraireh & Sons for Engineering & Contracting | Tender No. | (11/2019/USAID/SKEP/3/S) Schools for a Knowledge Economy Project (SKEP) - Phase (3) Package (1, 2) |
| Site Name | Um Al Dananir Basic Mixed School- Al Balqa | Day/ Date | Sat. 04/12/2021 |

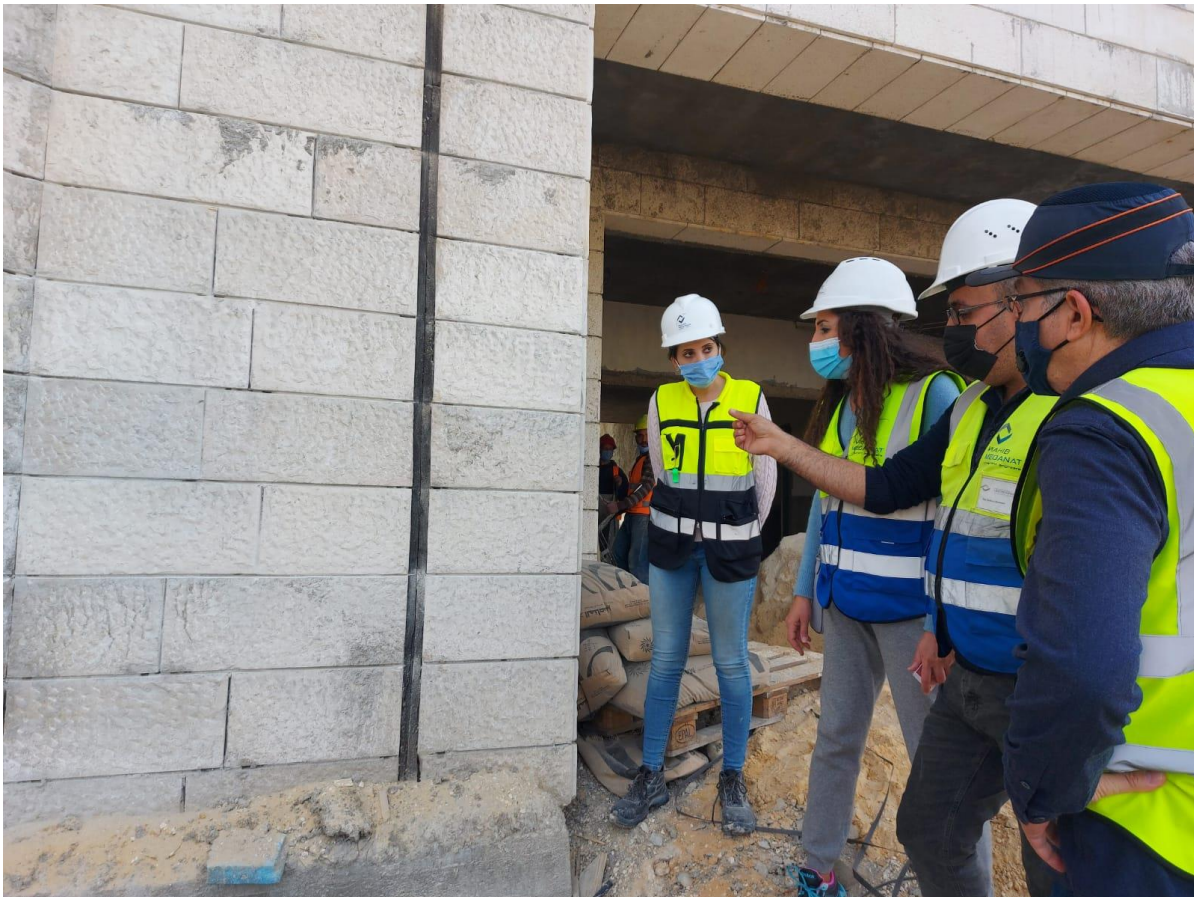
(figure:04)

| No. | Description |
|---|---|
| 1 | The executed expansion joint was under discussions regarding the external finishing of the expansion joint. The Engineer presented the Designer advice to keep the expansion joint as executed without fixing the aluminum cover. The details in the drawings should be taken into consideration. |

The Engineer presenting the Designer advice to keep the expansion joint as executed without fixing the aluminum cover. The details in the drawings should be taken into consideration

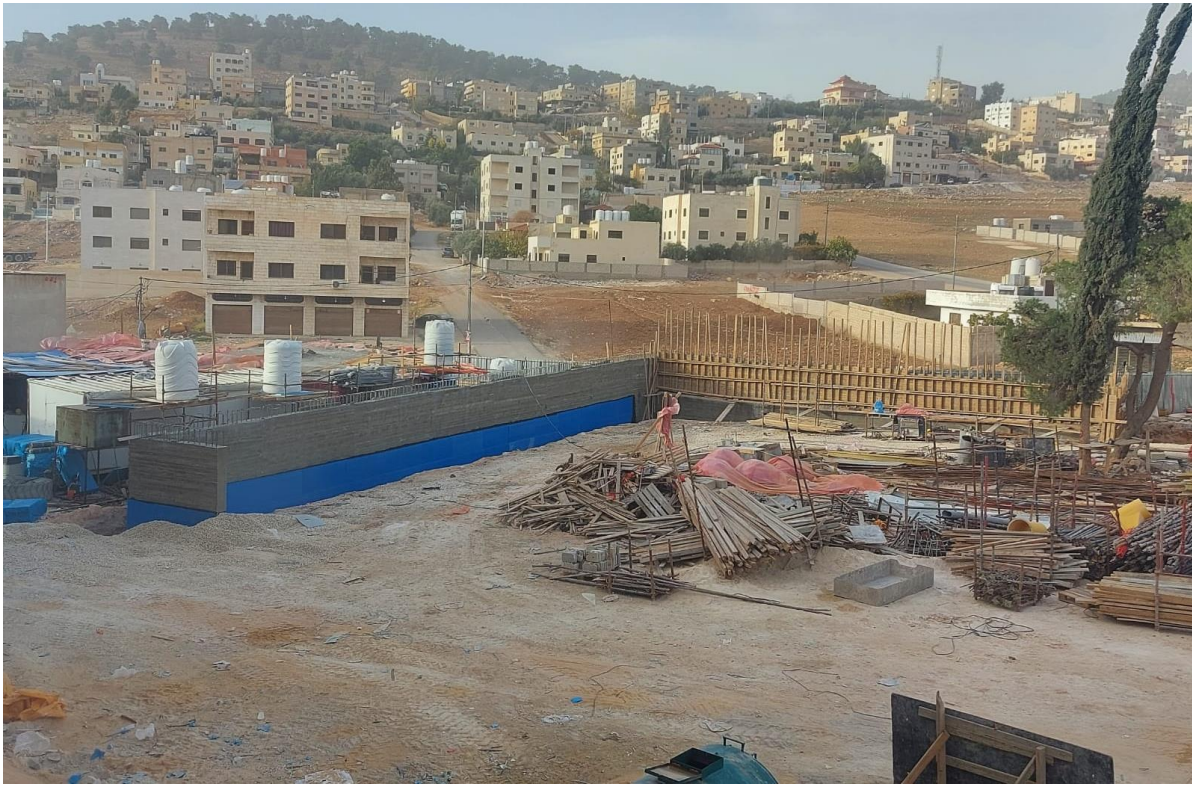
(figure:05)

| No. | Description |
|---|---|
| 2 | The execution of boundary walls was under discussion and the Engineer instructed the Contractor to accelerate the work there and take the necessary safety measures to support the excavation sides to ensure the safety of persons and equipment. |

The Engineer instructed the Contractor to accelerate works at the boundary wall and take the necessary safety measures to support the excavation sides to ensure the safety of persons and equipment

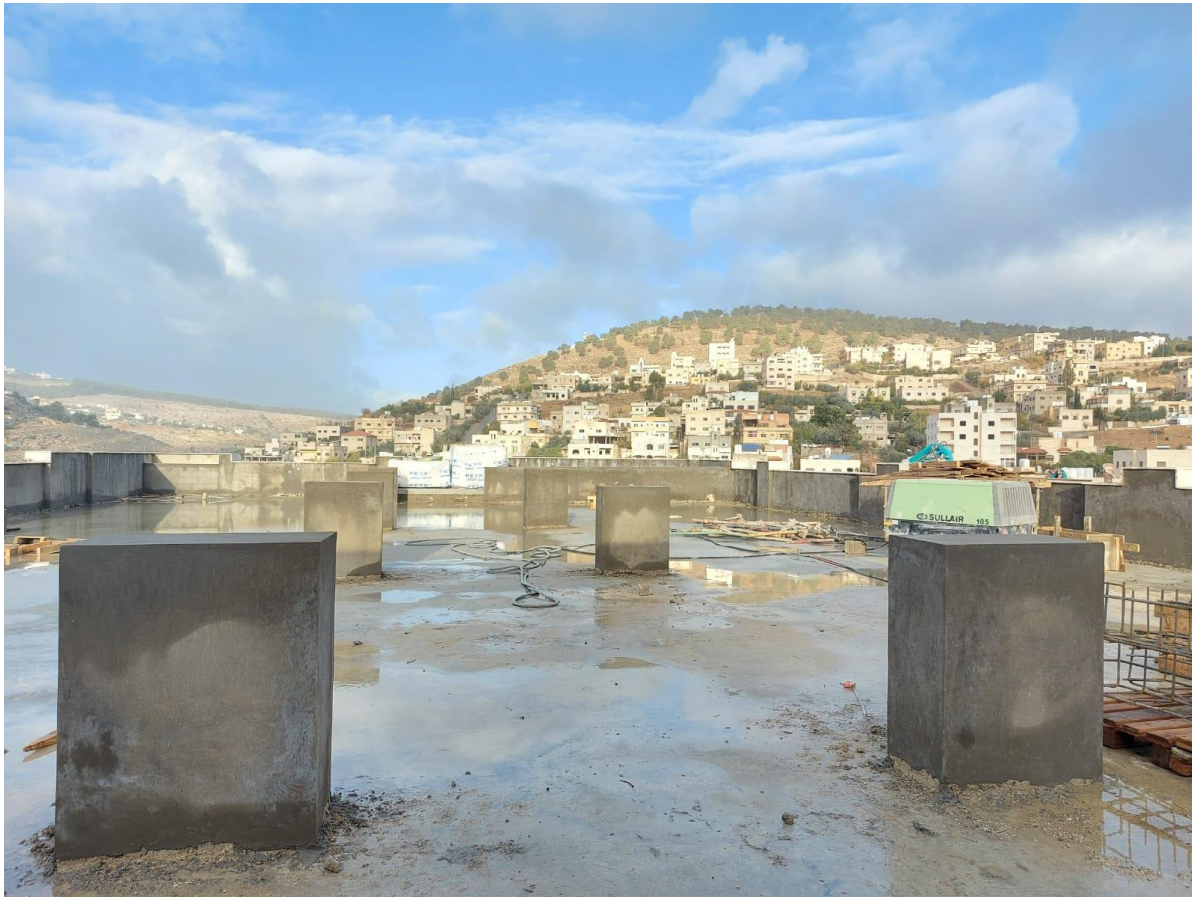
(figure:06)

| No. | Description |
|---|---|
| 3 | The Engineer stressed on the Contractor to accelerate the work related to the waterproofing of roofs. |

The Engineer stressed on the Contractor to accelerate the work related to the waterproofing of roofs

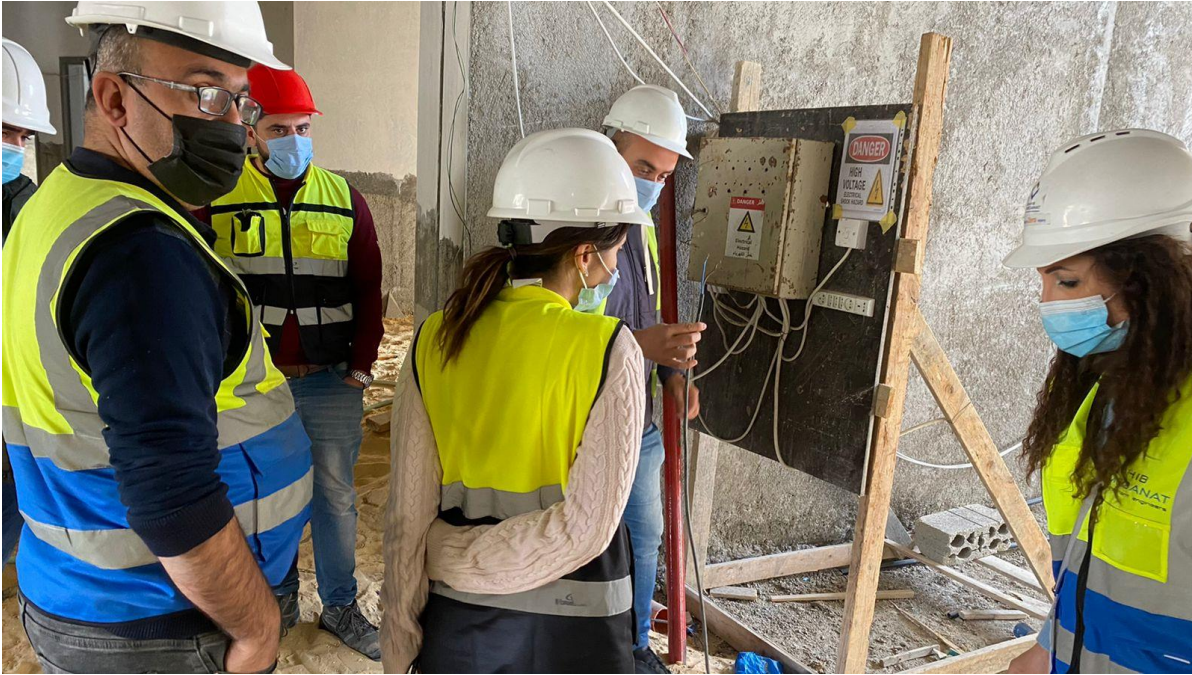
(figure:07)

Eng. Natheer commented on the correct way of installing temporary electrical wiring inside the building

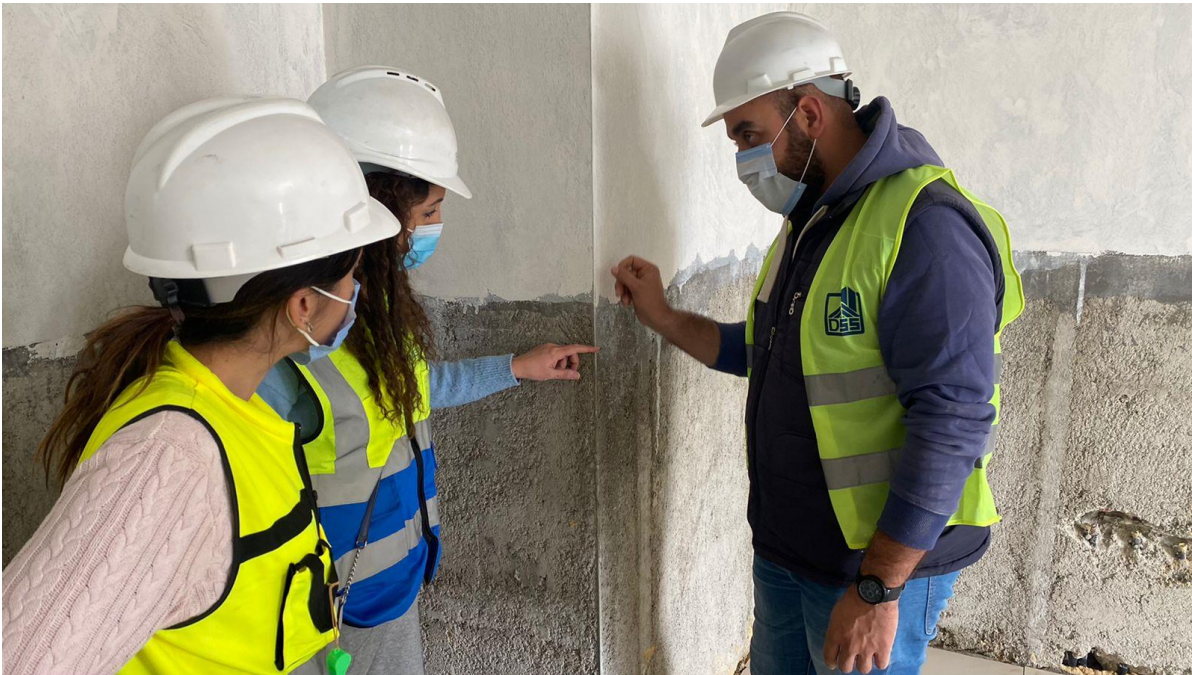
(figure:08)

| 5 | <p>The aluminum beads used as coping at the top of porcelain tiles at corridors (height of 1.20m) and number of facilities was discussed. Those beads are also used vertically for first aid, vocational workshop, art room and science labs.</p> |

Aluminum beads are also used vertically for first aid, vocational workshop, art room and science lab.

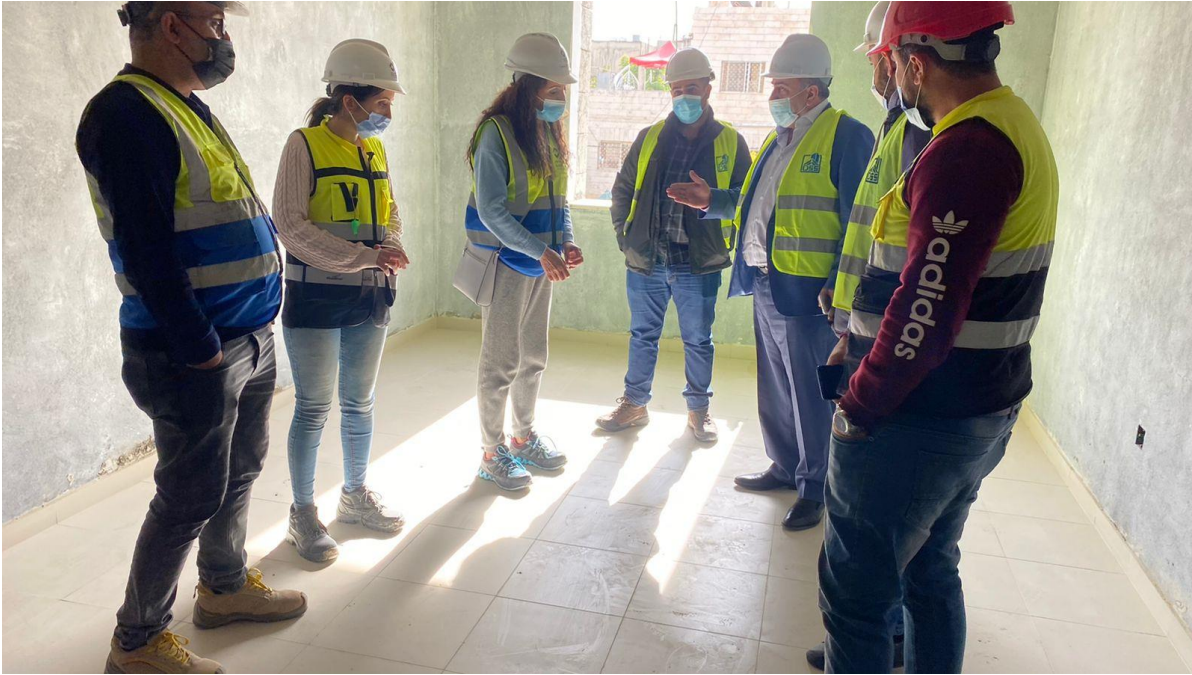
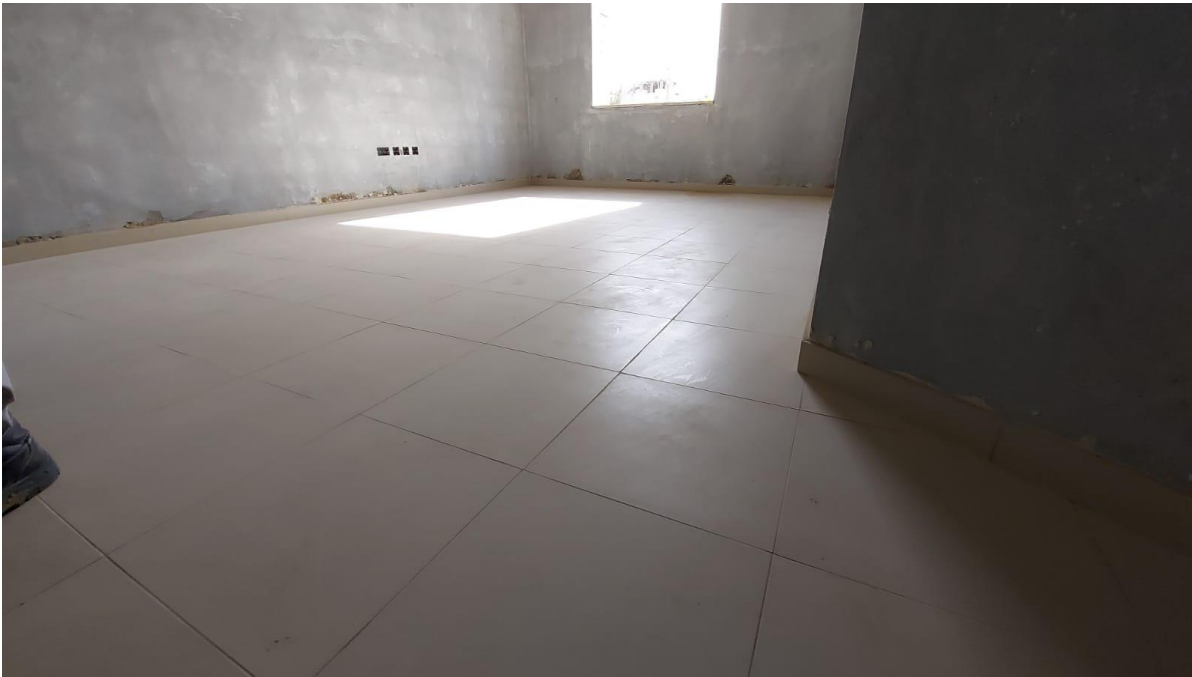
(figure:09 & 10)

| 4 | <p>The executed tiling work was intensively observed and the considerable defects in the tiles was under discussion with the Contractor. Tiles were found uneven and sever defects in teething were noticed, which might be due to defects in manufacturing and workmanship.</p> <p>The Engineer confirmed to the Contractor his rejection of most of the executed parts of floor tiling and stressed on him to start with the Engineer's instruction and started with rectification work by sorting out the delivered quantities and replacing the executed defected tiles.</p> |

The executed tiling work was intensively observed and the considerable defects in the tiles was under discussion with the Contractor. Tiles were found uneven and sever defects in teething were noticed, which might be due to defects in manufacturing and workmanship

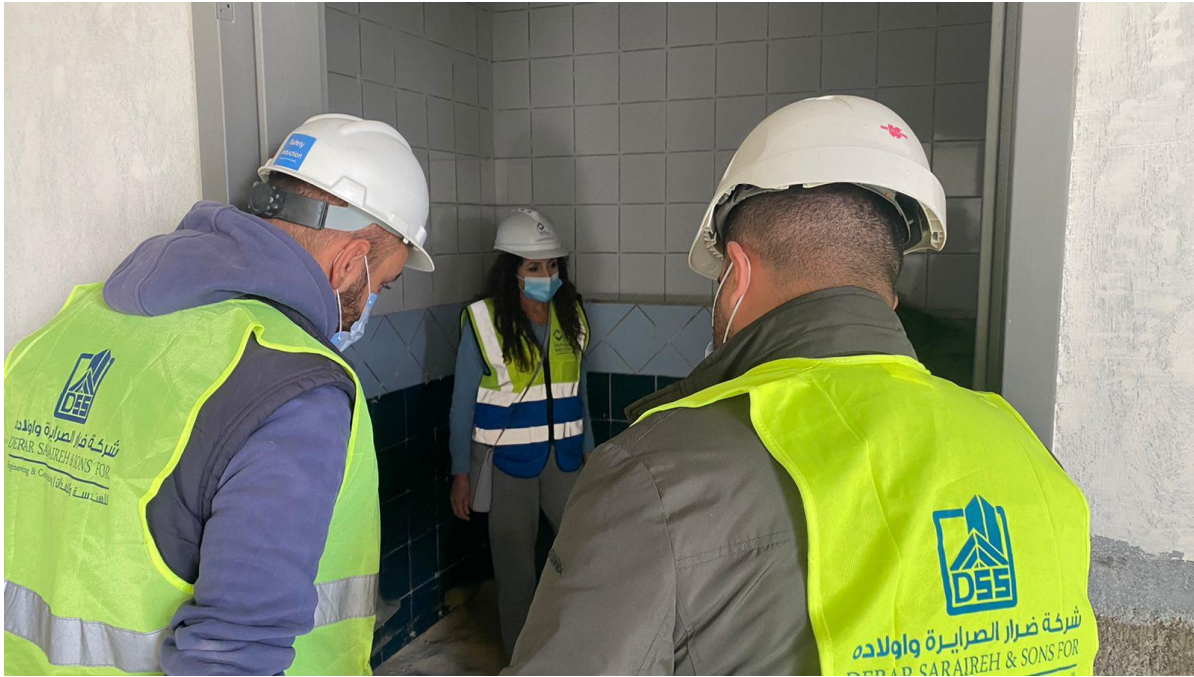
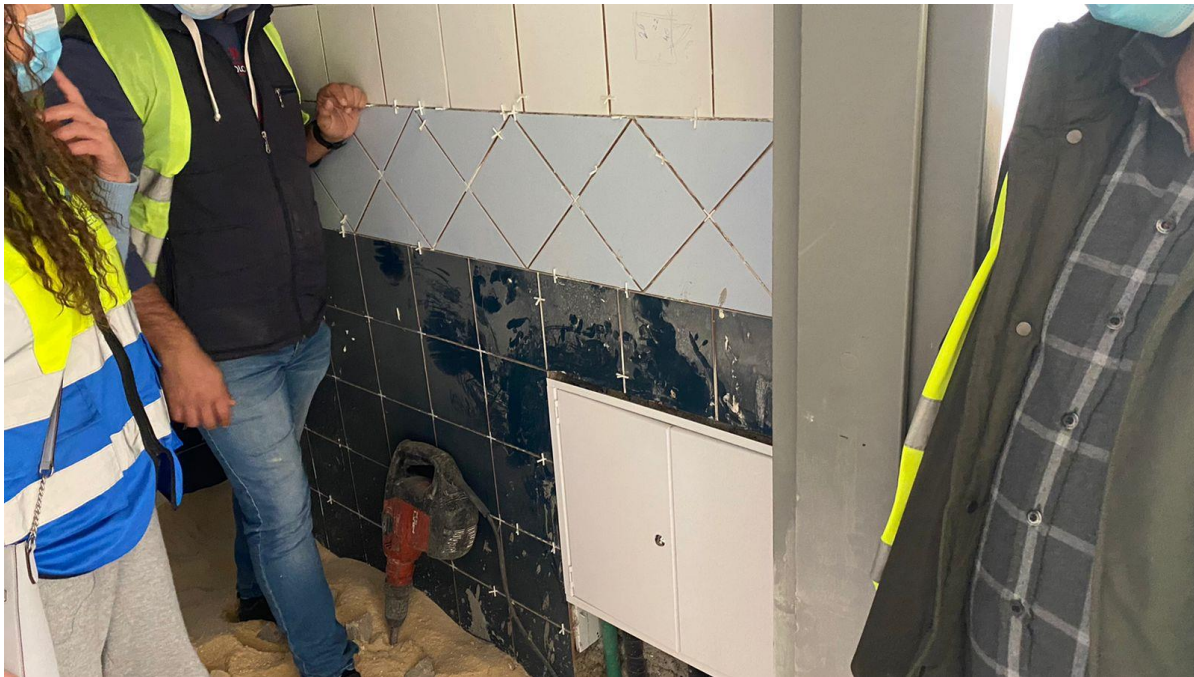
(figure:13 & 14)

| 6 | <p>Tiling work at wet areas was inspected and remarks regarding tiles cut-pieces were given to the Contractor.</p> |

Tiling work at wet areas was inspected and remarks

regarding tiles cut-pieces were given to the Contractor
