SKEP III Home Office Support Site Visit Report

Consultant	Wahib Medanat Consultant Engineer	Rep No.	23-22112021
Contractor	Dijlah Establishment Constr. Contracting	Tender No.	(11/2019/USAID/SKEP/3/S) Schools for a Knowledge Economy Project (SKEP) - Phase (3) Package (1, 2)
Site Name	Jumana Bint Abit Taleb Basic Mixed School - Jerash	Day/ Date	Mon. 22/11/2021
Duration of Project	450 Calendar Days	Total Project Budget	8,314,983.735 JD

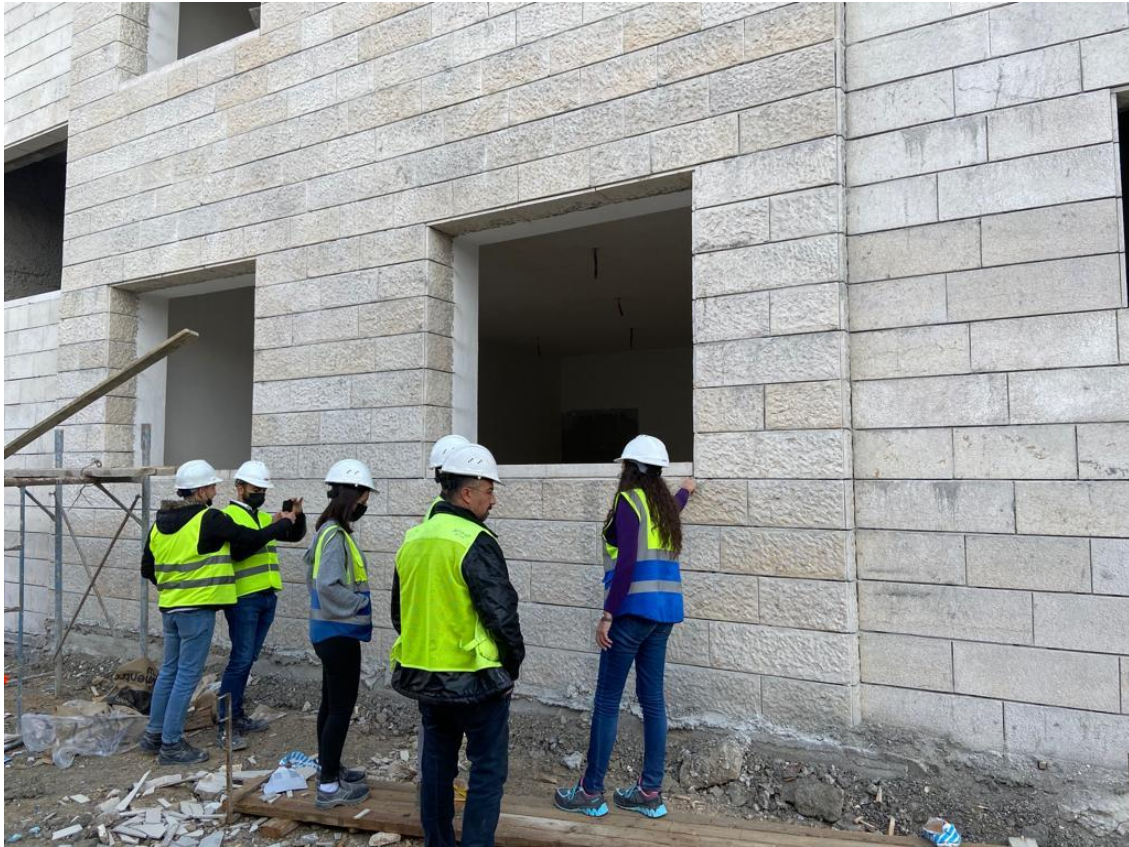
(Figure: 05)

General inspection has been conducted on the built stones at facades and general remarks were provided to the Contractor

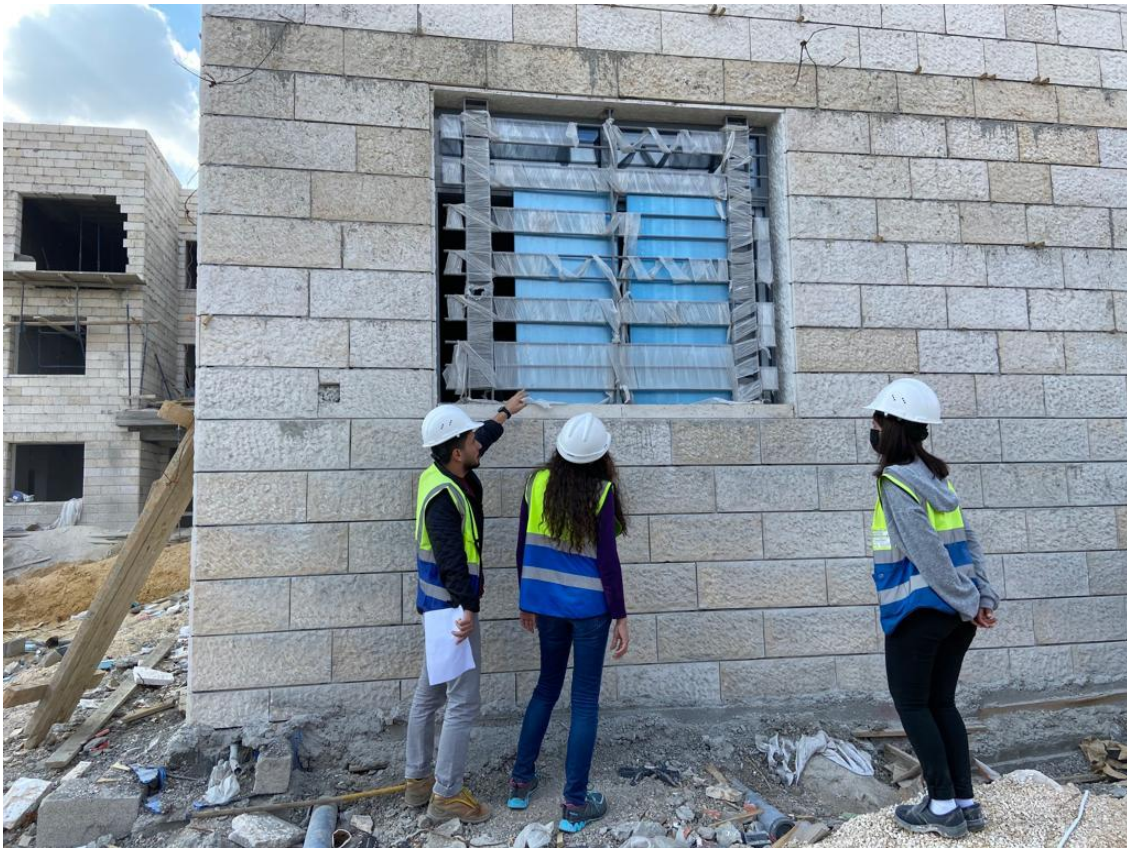
(Figure: 08)

The sample of window protection grill was inspected and approved

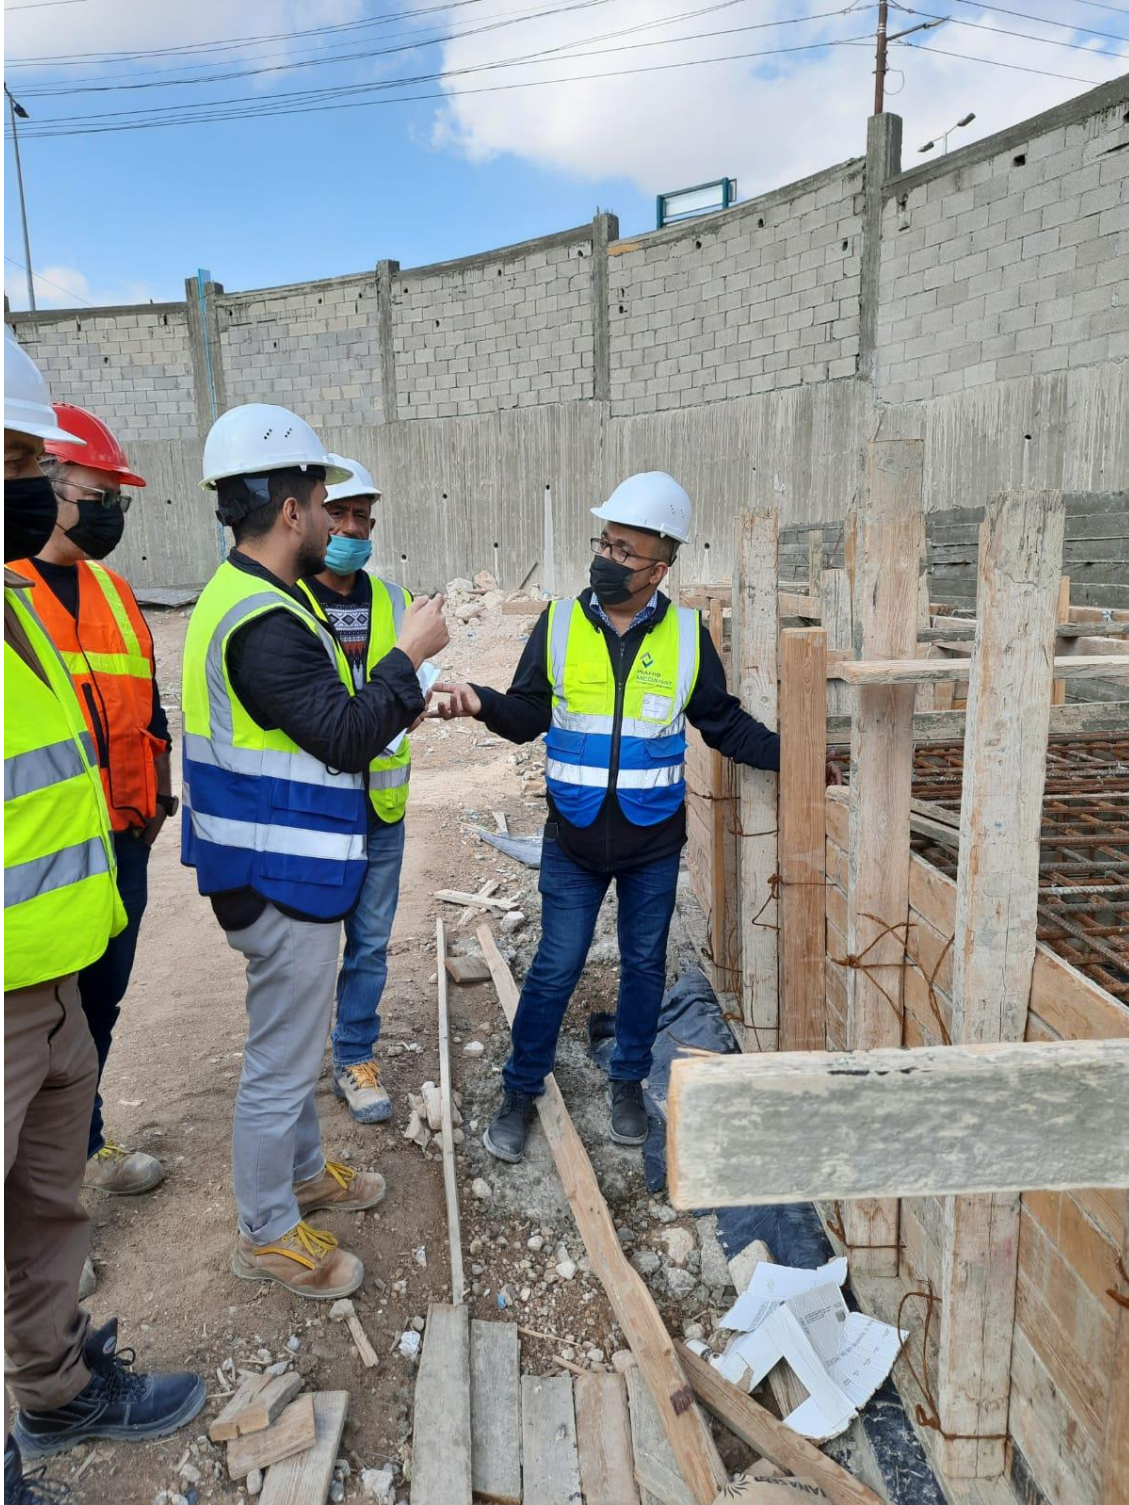
(Figure: 09)

According to the Contractor, there is a contradiction between the structural and architectural drawings regarding the external shading. The consultant instructed the Contractor to submit an RFI with the necessary details

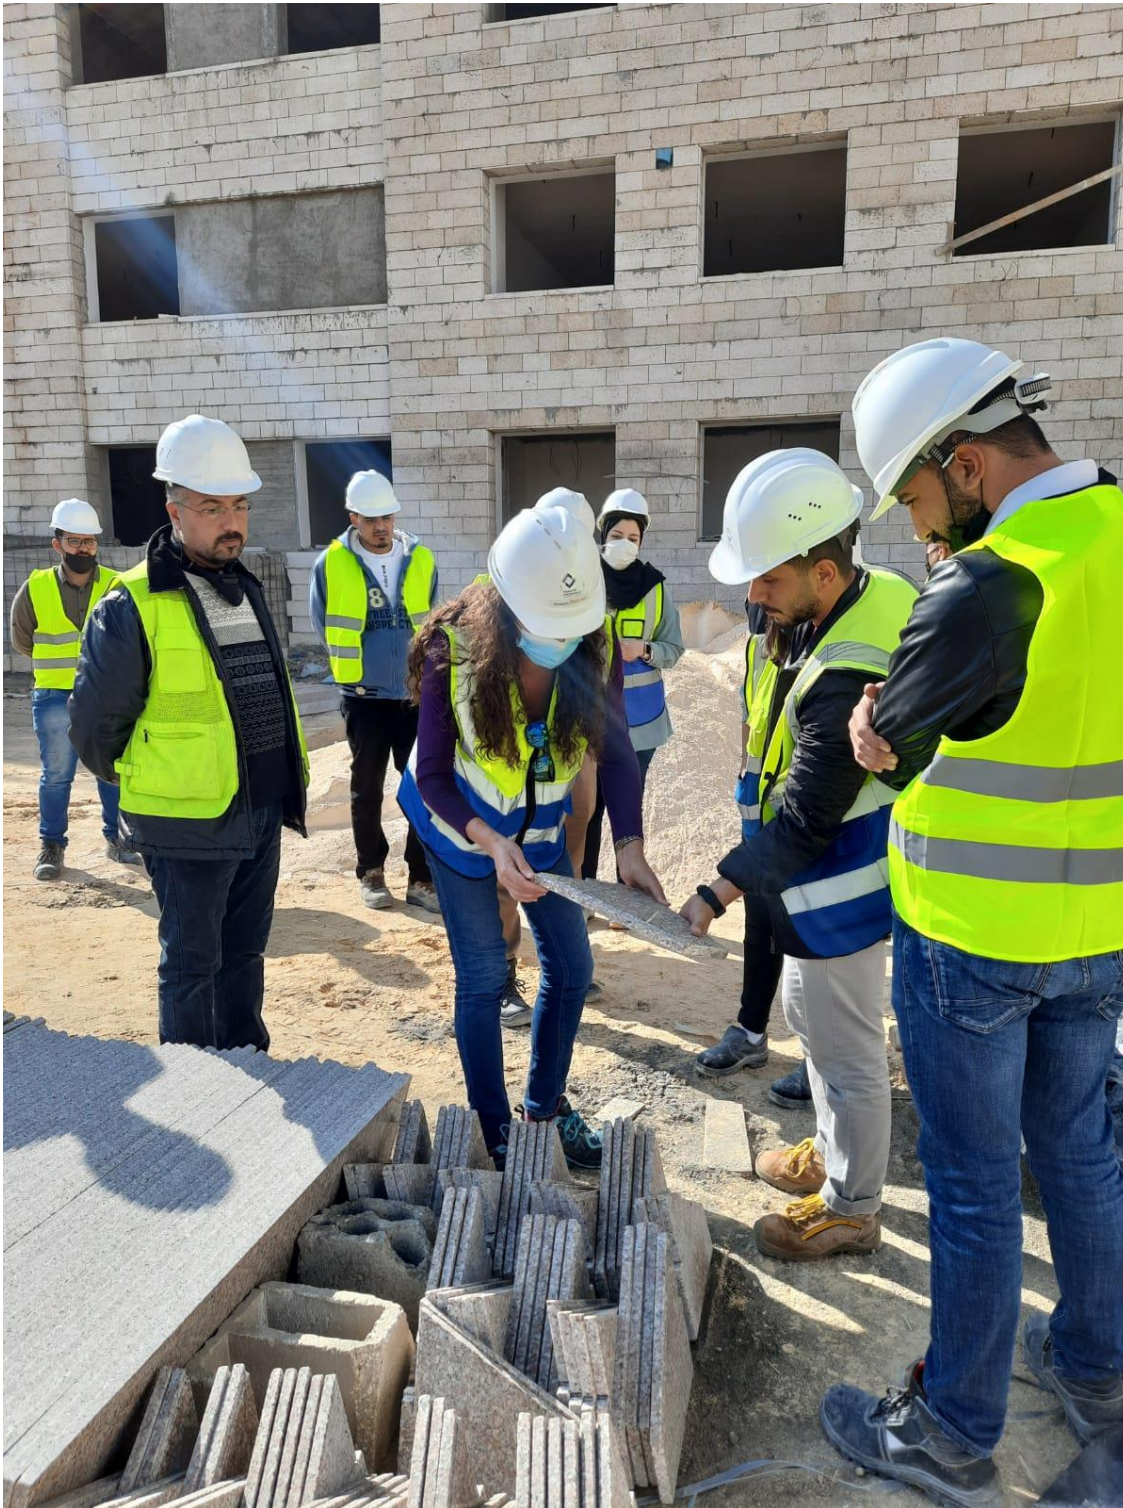
(Figure: 10)

The delivered quantities of granite for stairs were inspected including the special skirting for stairs and the required grooves

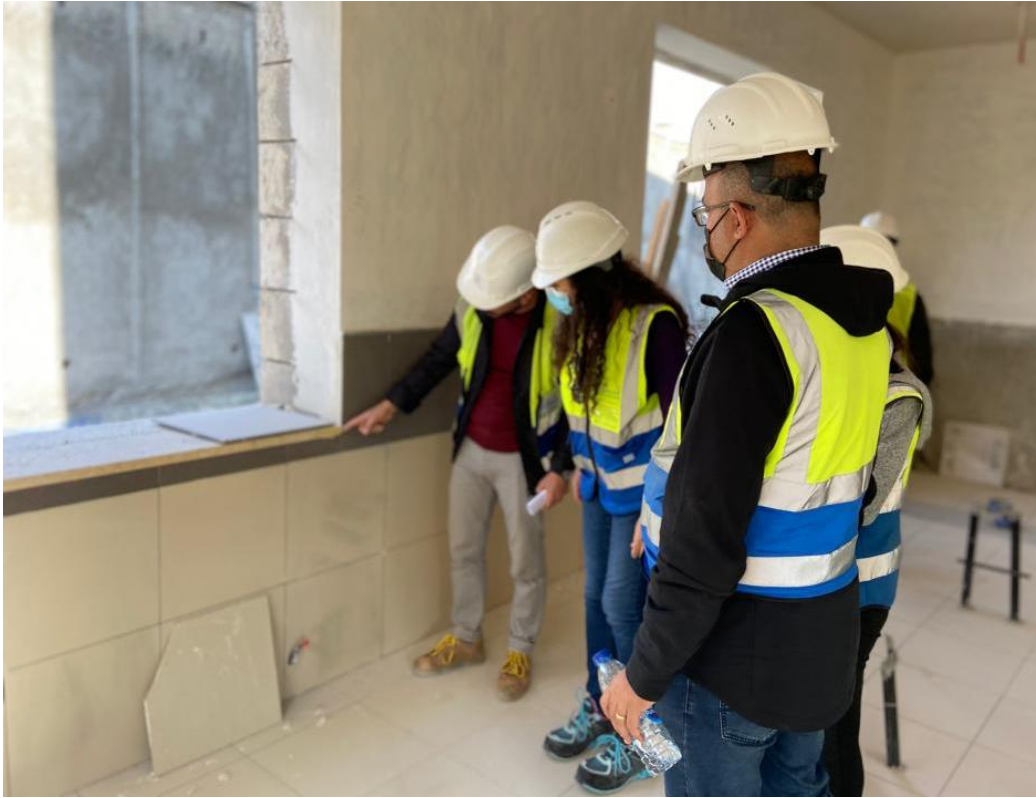
(Figure: 11)

The dimensions of installed window sills have been checked to ensure compliance as per requirements

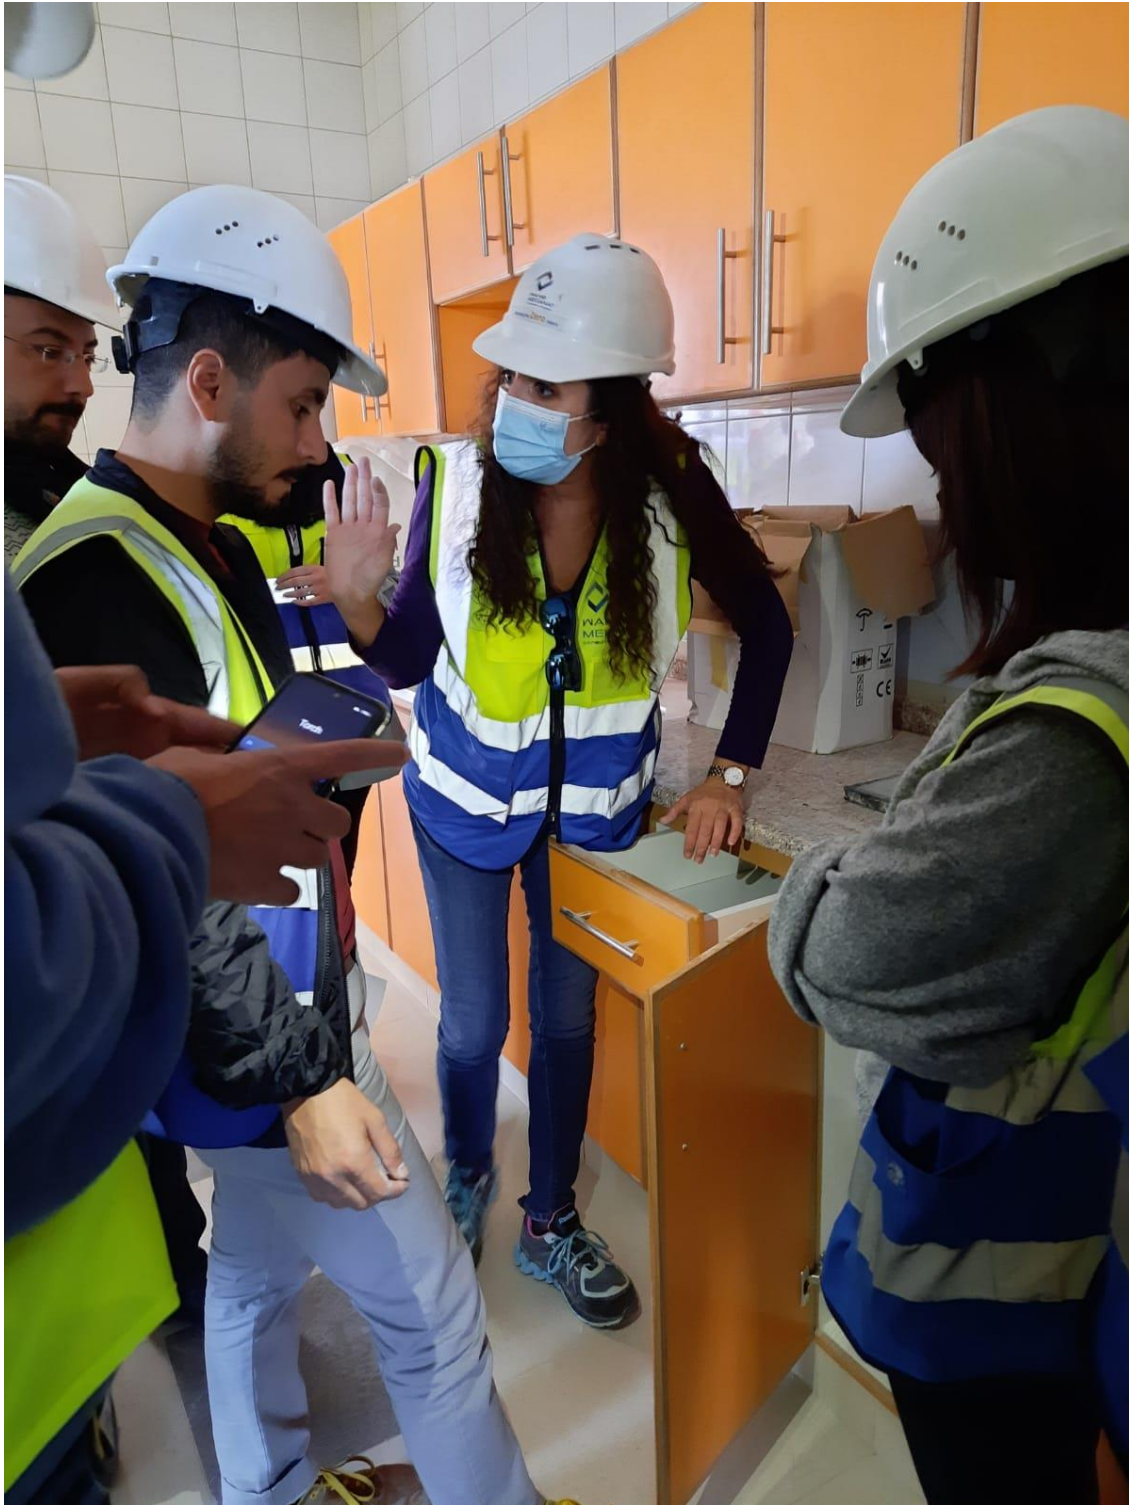
(Figure: 13)

Beach wood frame color for door leaf and kitchen cabinets at the mock-up room does not match the approved sample. The Contractor was requested to rectify

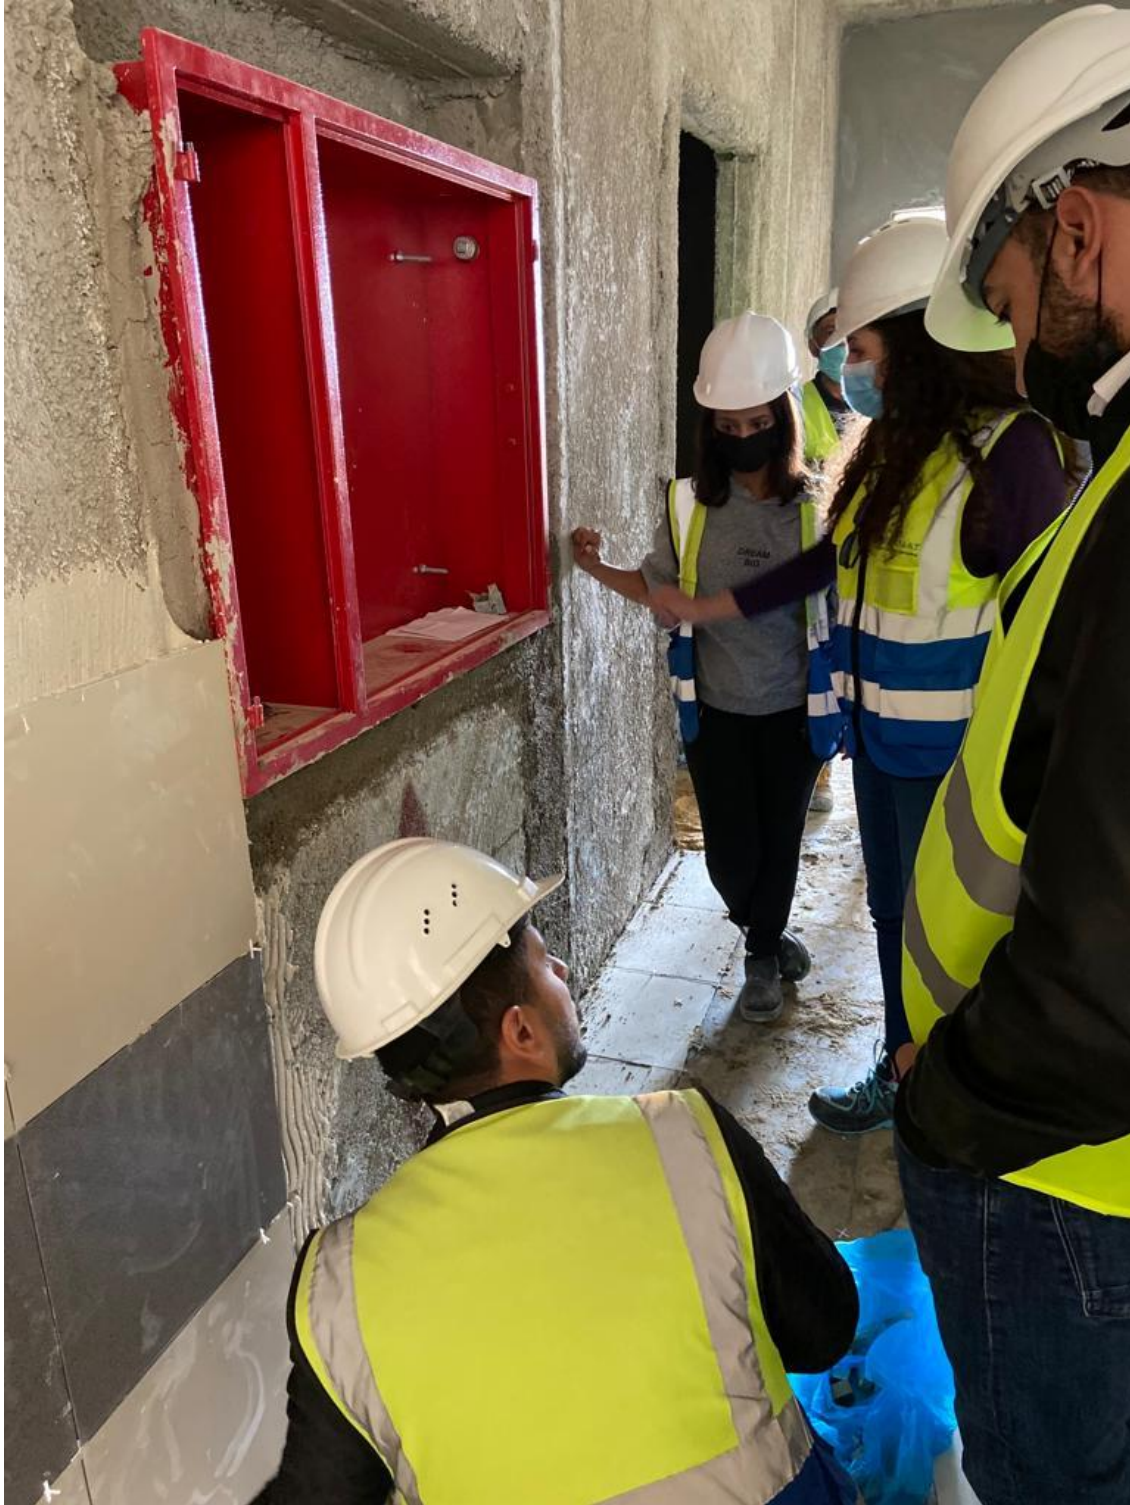
(Figure: 15)

The installed fire hose cabinet at the corridors and the tiles for the wall of the corridor was inspected and was found appropriate and approved

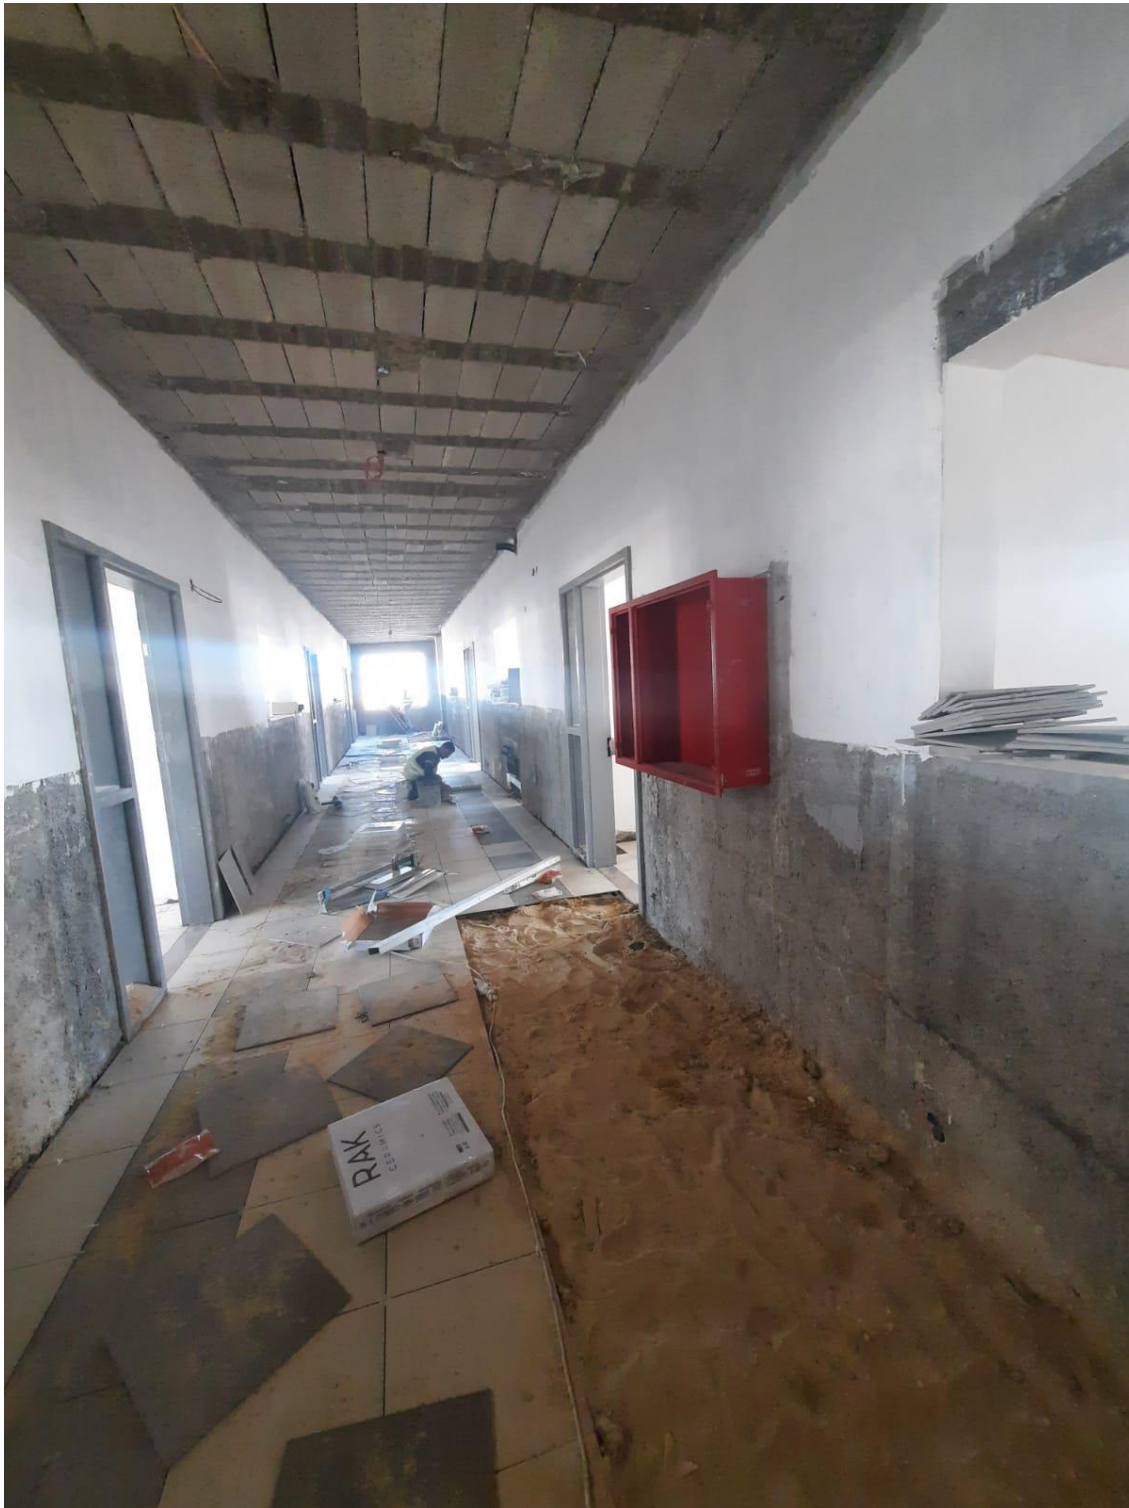
(Figure: 16)

The location of one fire hose cabinet at the corridor was discussed and the Contractor agreed on relocating the cabinet to be recessed in the storage room

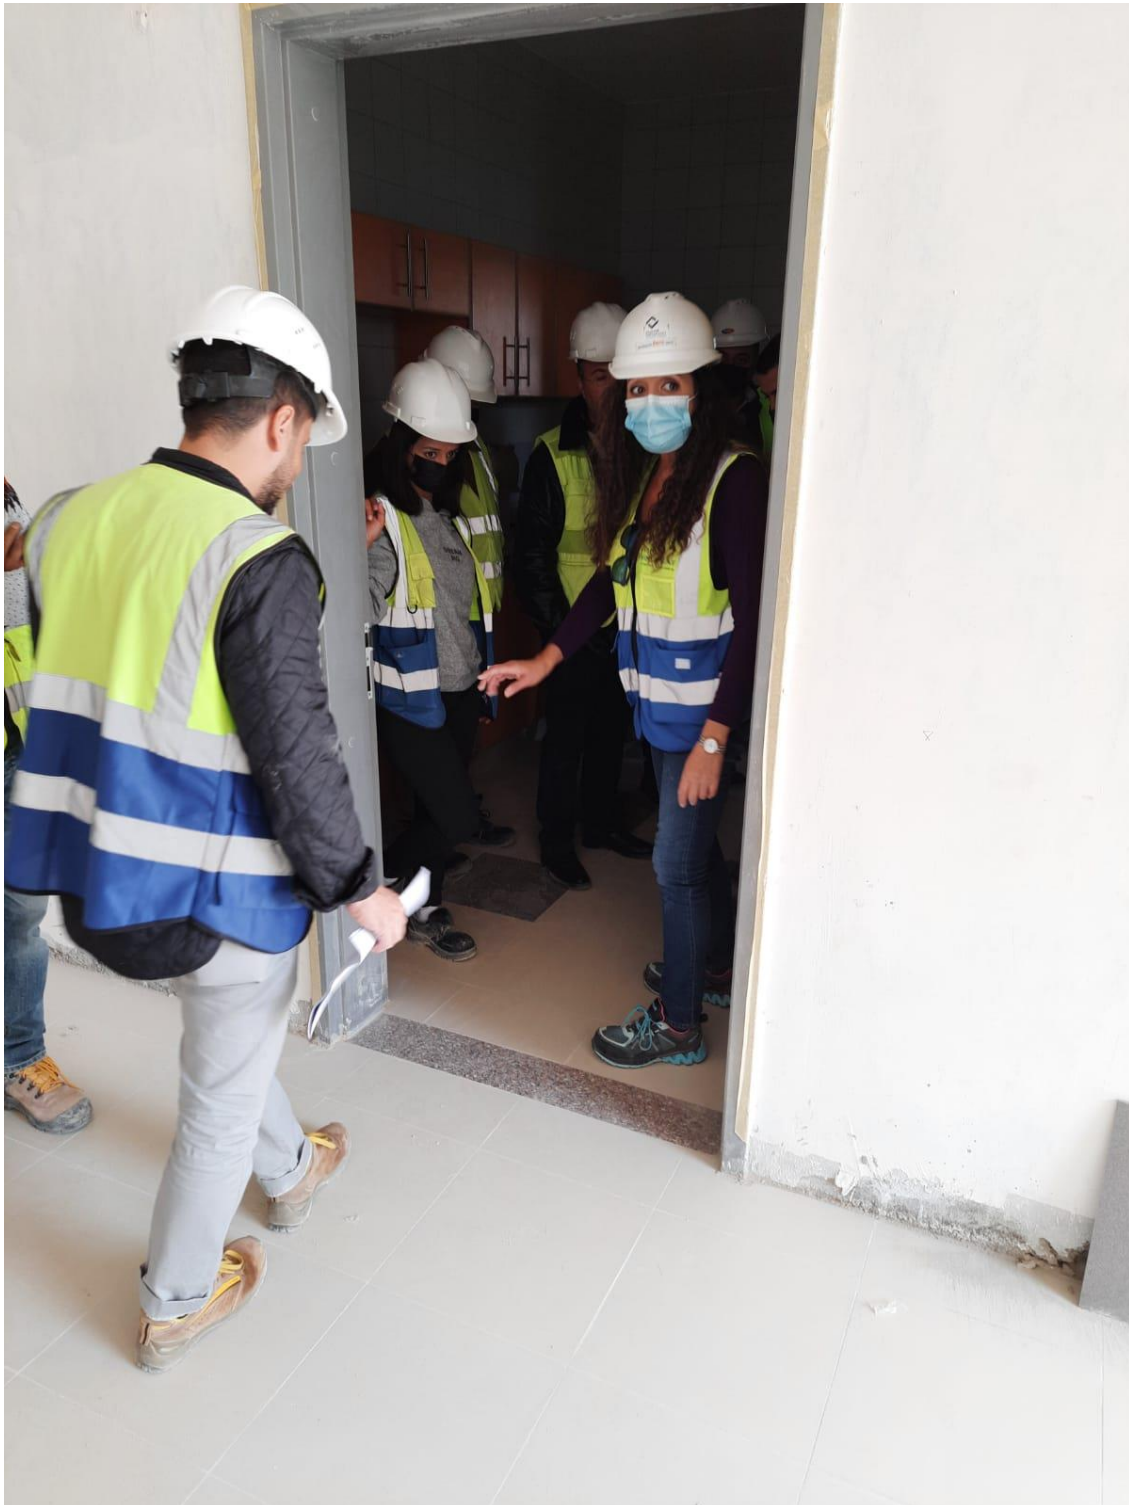
(Figure: 17)

The width of the thresholds at the doors between the rooms and corridors was discussed with the Contractor. Certain thresholds' length was found less than the required. The Contractor was instructed to replace them

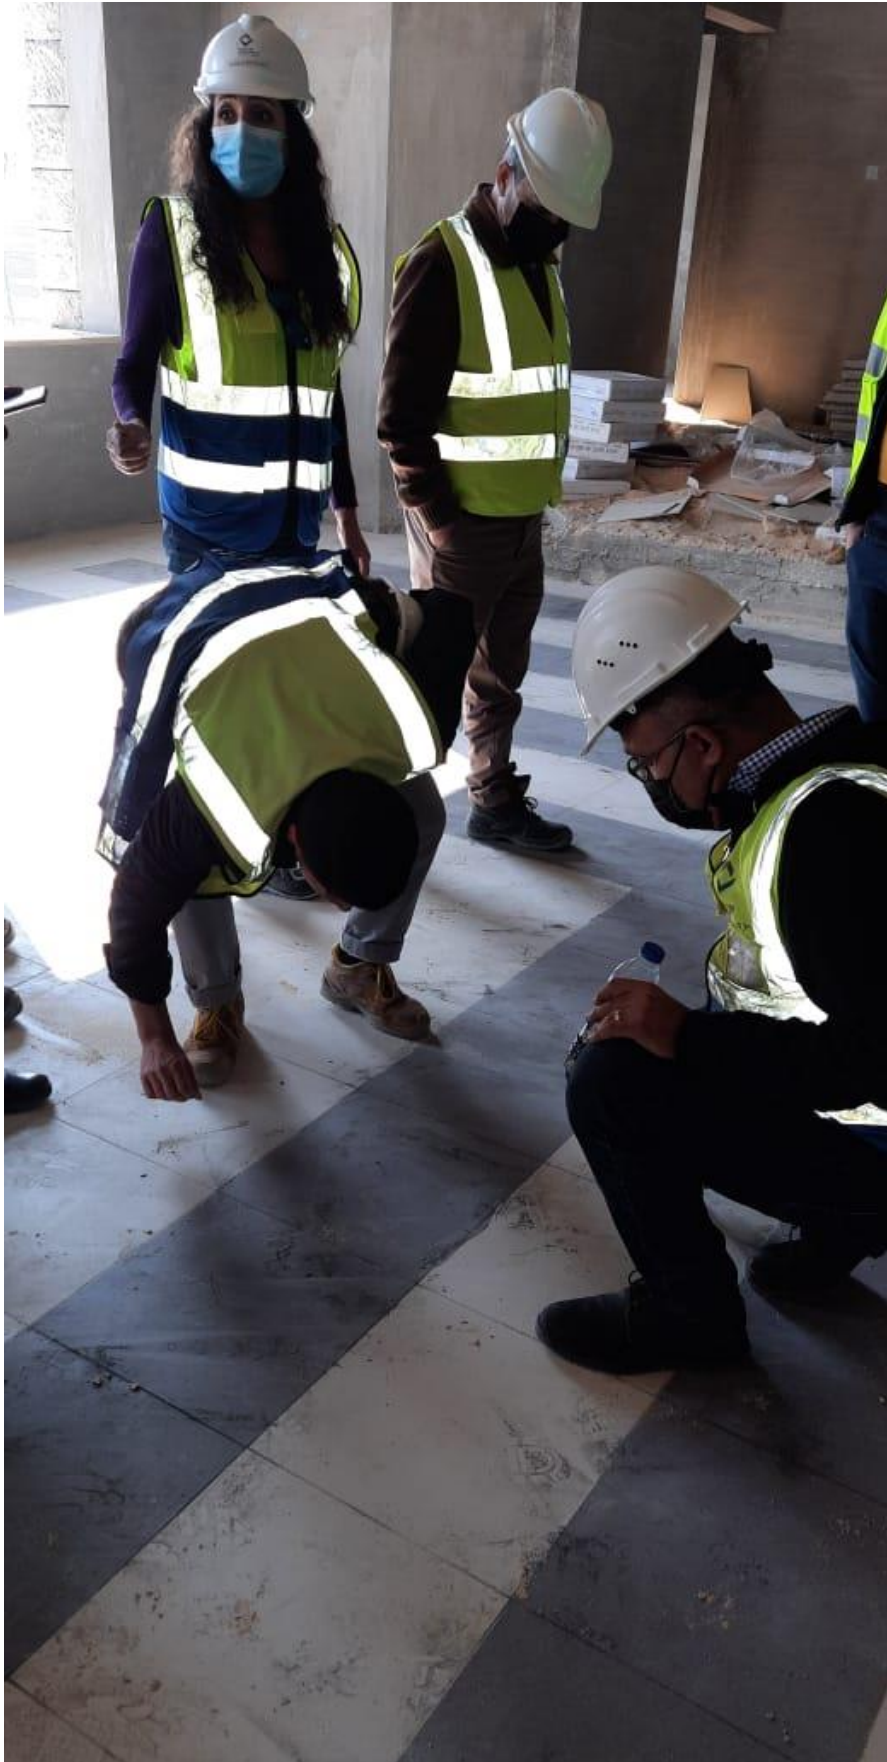
(Figure: 19)

The color of tile grout was discussed for floor tiles. Colors of grout for tile color combination was agreed upon

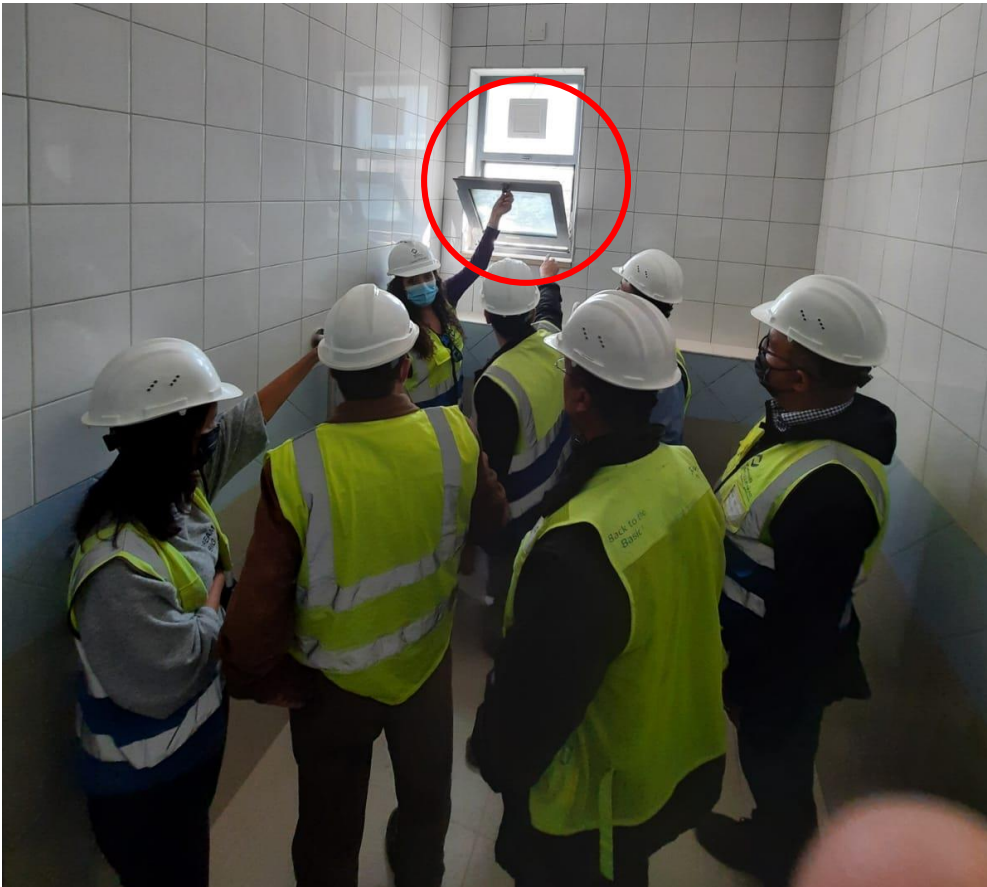
(Figure: 24)

The opening of the window panel for toilets was discussed and instruction by the Engineer to the opening angle not to exceed 30° for safety purposes.
