SKEP III Home Office Support Site Visit Report

| Consultant | Wahib Medanat Consultant Engineer | Rep No. | 21-17072021 |
| Site Name | Hay Al Iskan Basic Mixed School- Jerash | Day/ Date | Sat. 17/07/2021 |

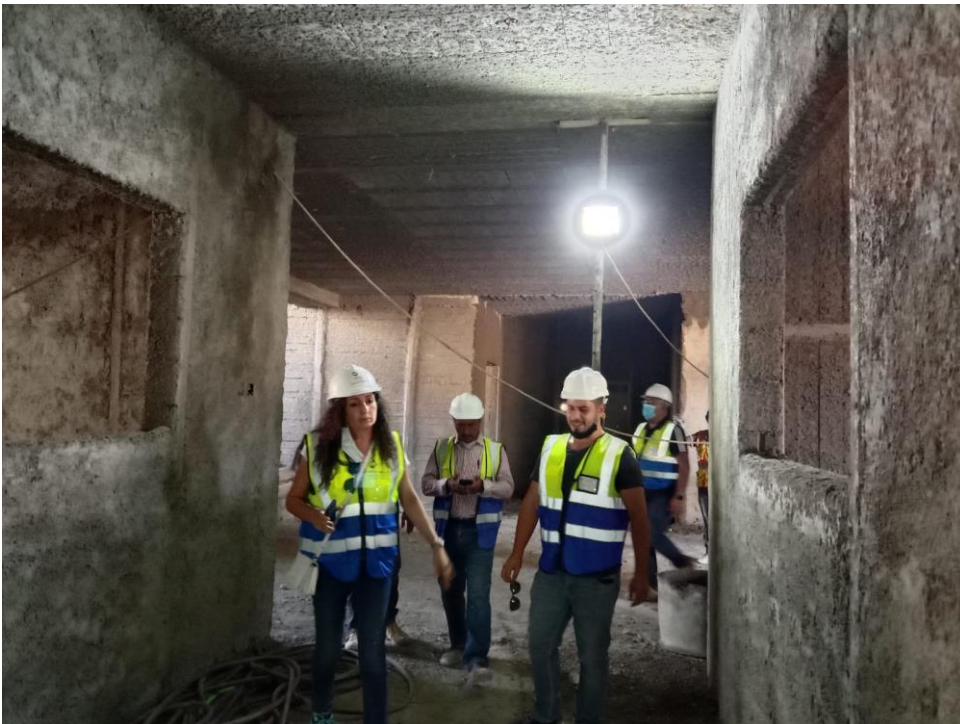
Acceptable process and quality for plastering work

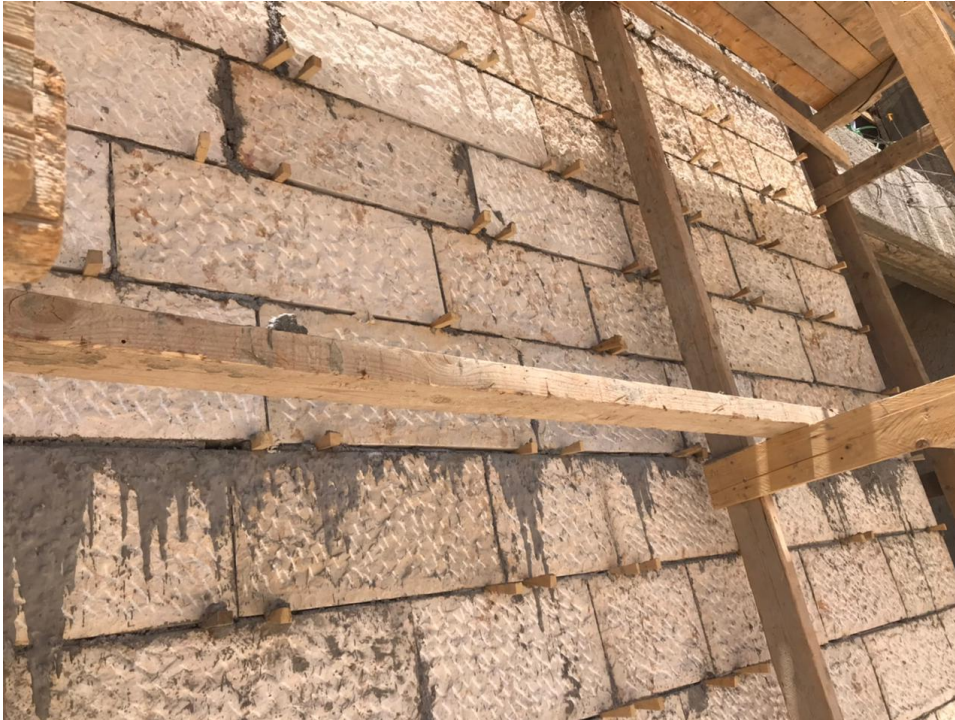
-Stone: The same chiseling pattern should be done in accordance to the approved pattern by the Engineer. Stones having different pattern should be removed. It is preferable to clean the mortar at the stone face at once and further taking care to avoid such status.

| No. | Description |
|---|---|
| 4 | <ul style="list-style-type: none">- Stone: The same chiseling pattern should be done in accordance to the approved pattern by the Engineer. Stones having different pattern should be removed. It is preferable to clean the mortar at the stone face at once and further taking care to avoid such status.- Broken stones should be replaced and gaps between stone layers should be regular. |

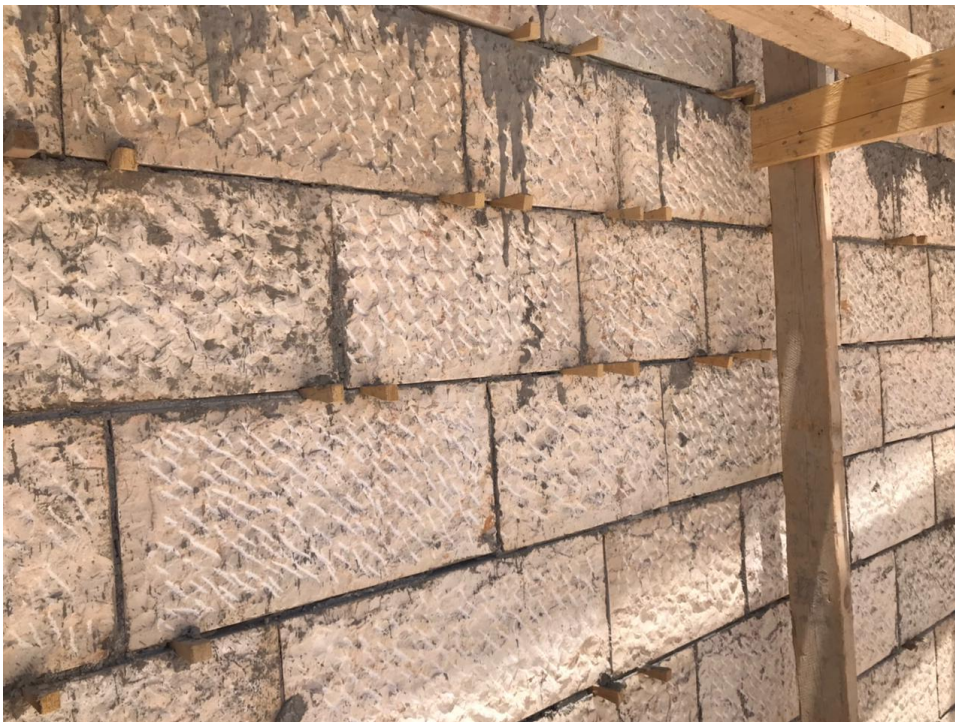
-Broken stones should be replaced and gaps between stone layers should be regular

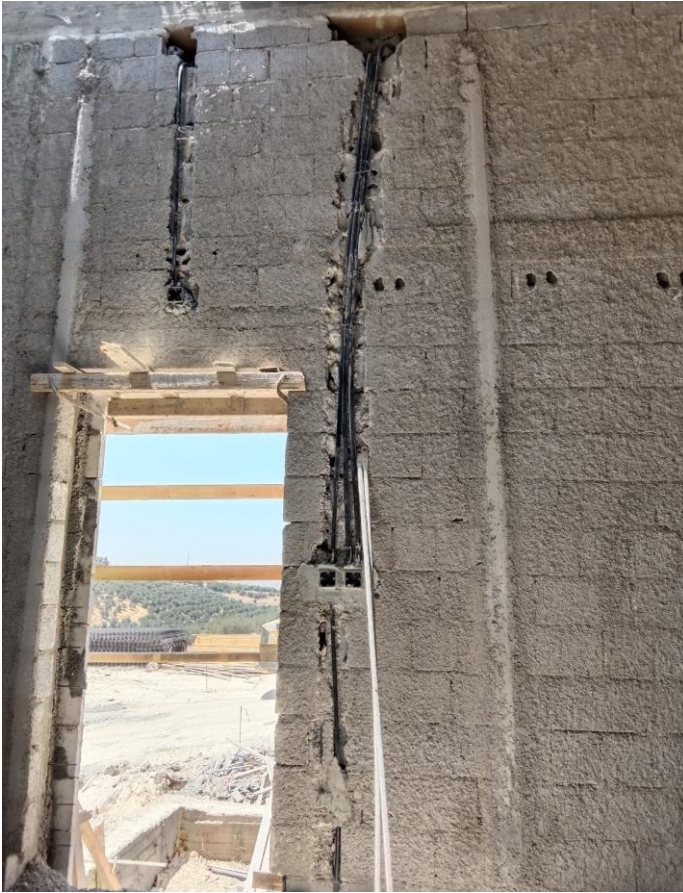
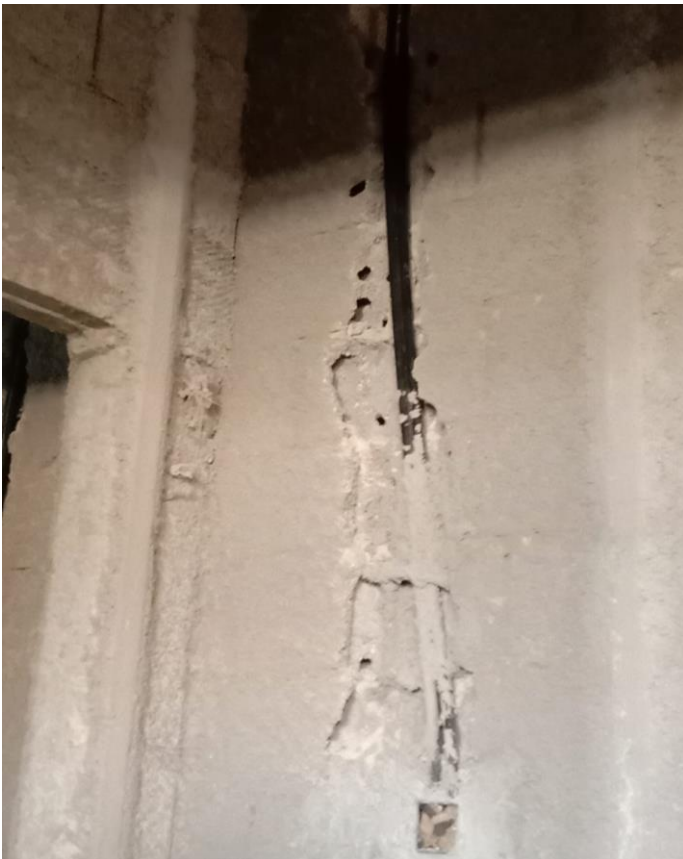
MEP first fix installation:
Chipping in block walls to be obtained saw-cut and the Contractor has to submit a method of statement for the Engineer's review

| No. | Description |
|---|--|
| 3 | - MEP first fix installation: Chipping in block walls to be obtained saw-cut and the Contractor has to submit a method of statement for the Engineer's review. |

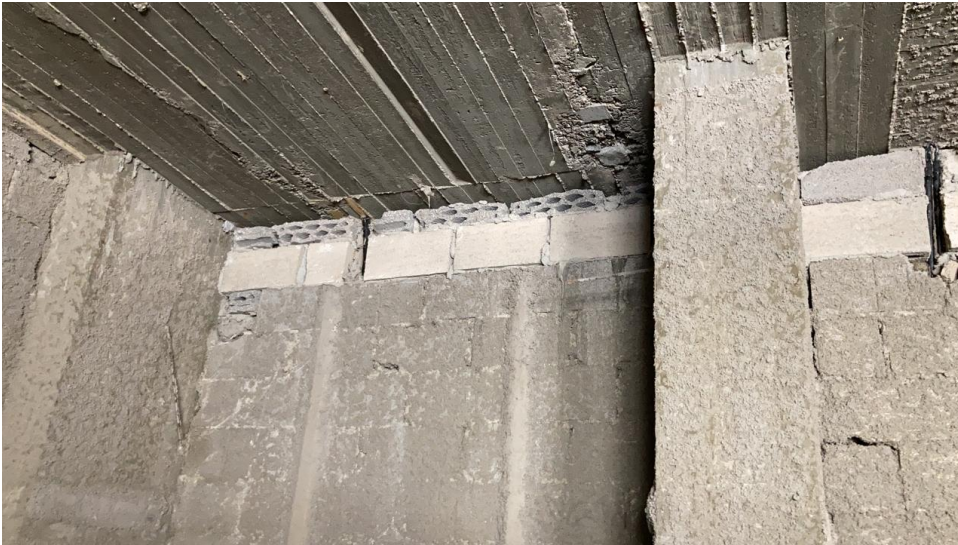
Blockwork:
Top layers at same places are built incorrectly-need to be removed and re-built correctly and evenly

| No. | Description |
|---|--|
| 2 | - Blockwork: Top layers at same places are built incorrectly- need to be removed and re-built correctly and evenly. |

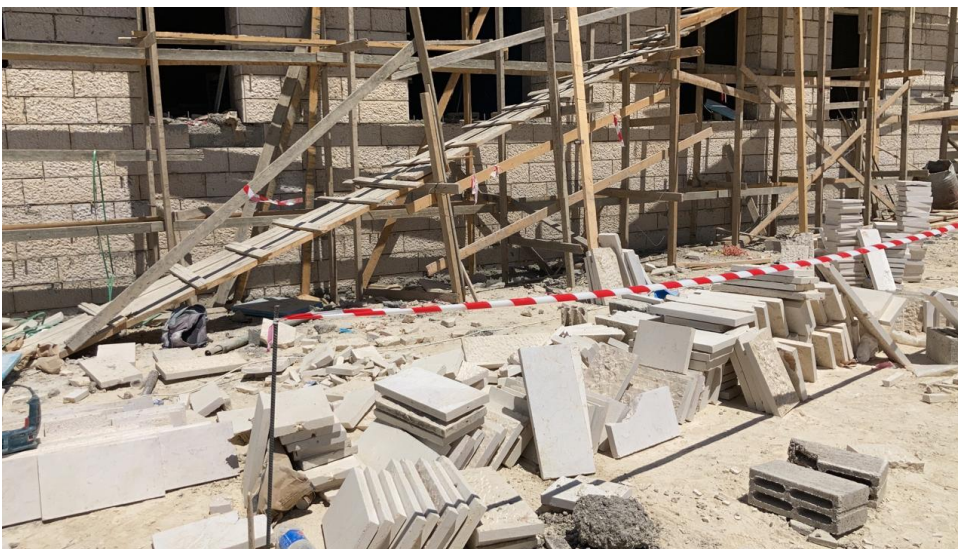
Poor housekeeping

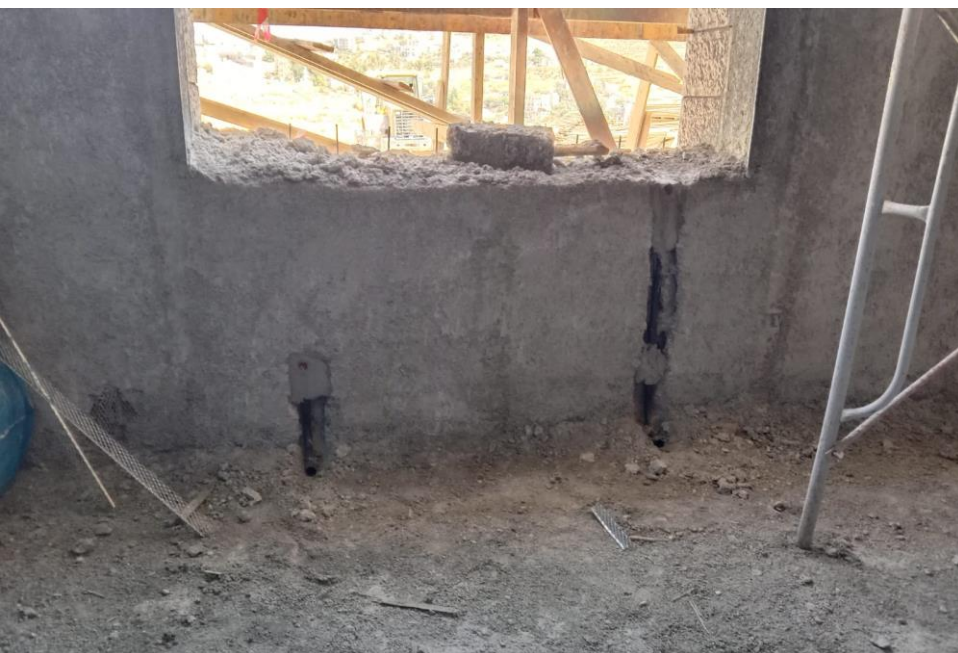
Radiators:
Execution of first fix (Bottom-Top) without approval

| No. | Description |
|---|--|
| 1 | - Radiators: Execution of first fix (Bottom-Top) without approval. |
