# SKEP III Home Office Support Site Visit Report

Consultant	Wahib Medanat Consultant Engineer	Rep No.	12-27072022
Contractor	Derar Saraireh & Sons for Engineering & Contracting	Tender No.	(11/2019/USAID/SKEP/3/S) Schools for a Knowledge Economy Project (SKEP) - Phase (3) Package (1, 2)
Site Name	Al Khansa' Basic Mixed School- Al Balqa	Day/ Date	Wed. 27/07/2022
Duration of Project	450 Calendar Days	Total Project Budget	9,789,417.840 JD

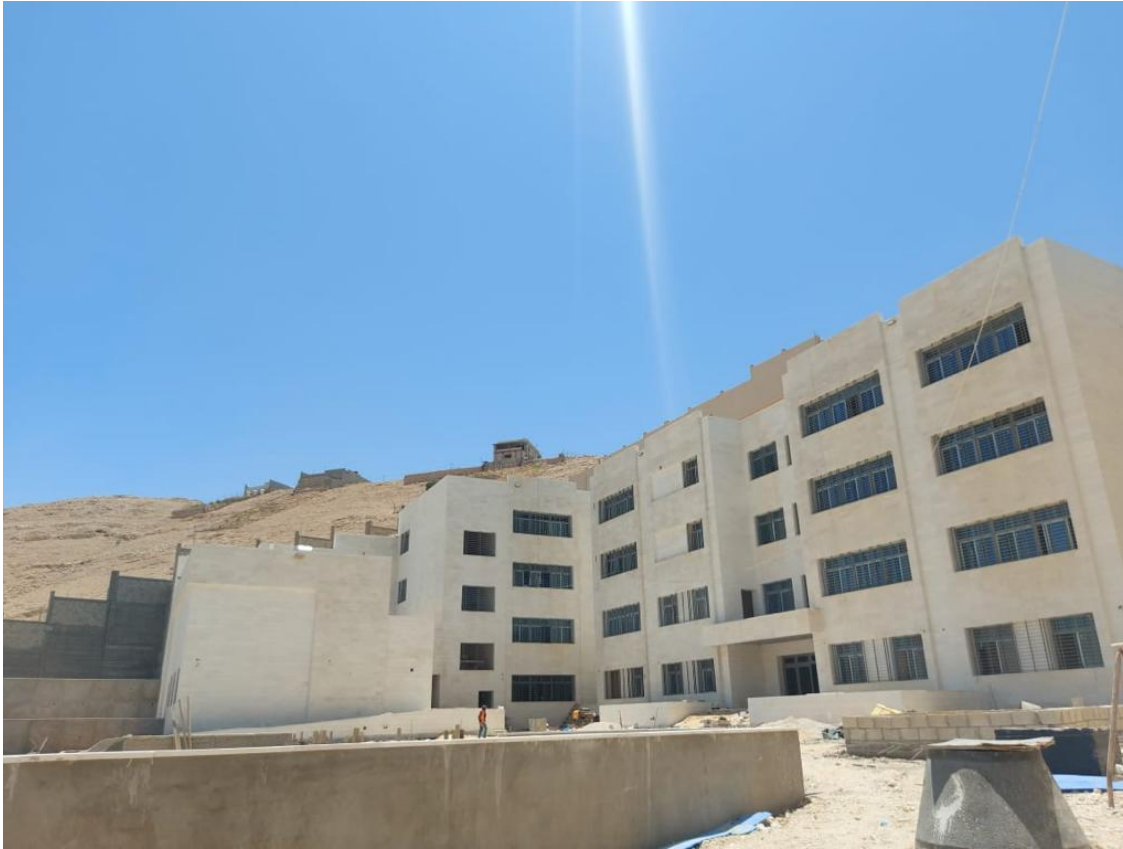
(Figure: 01)

General view of the project site

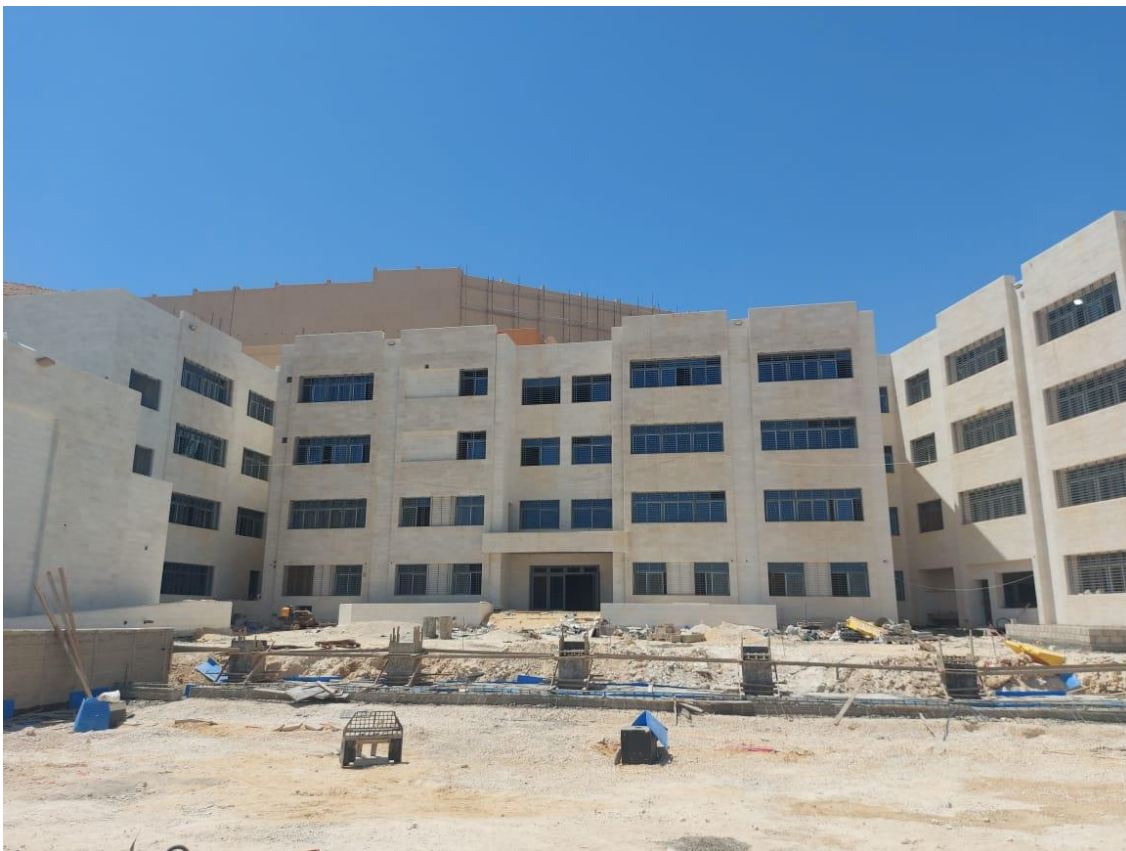
(Figure: 06)

The Supervision team inspected the executed works at the playing yard and the external walls

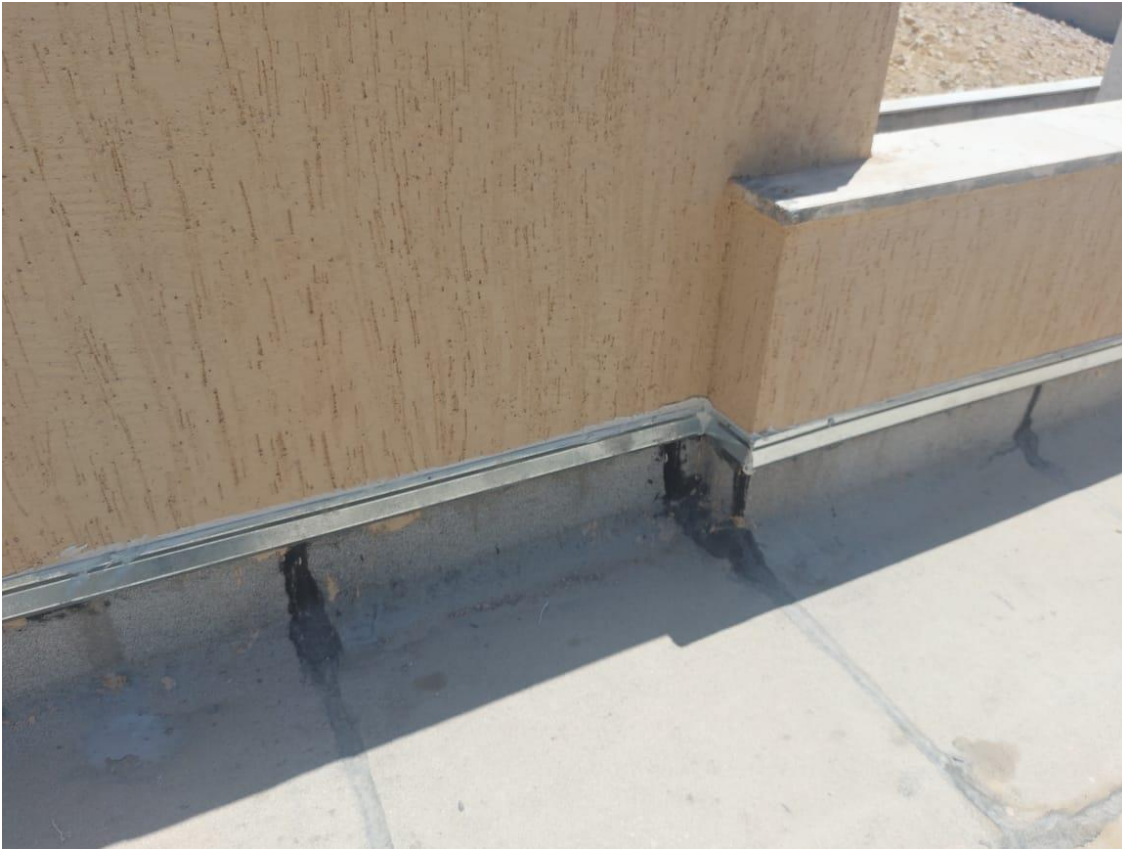
(Figure: 07)

The team reminded the Contractor that the relation between the Plastering limit and flashing requires refinement

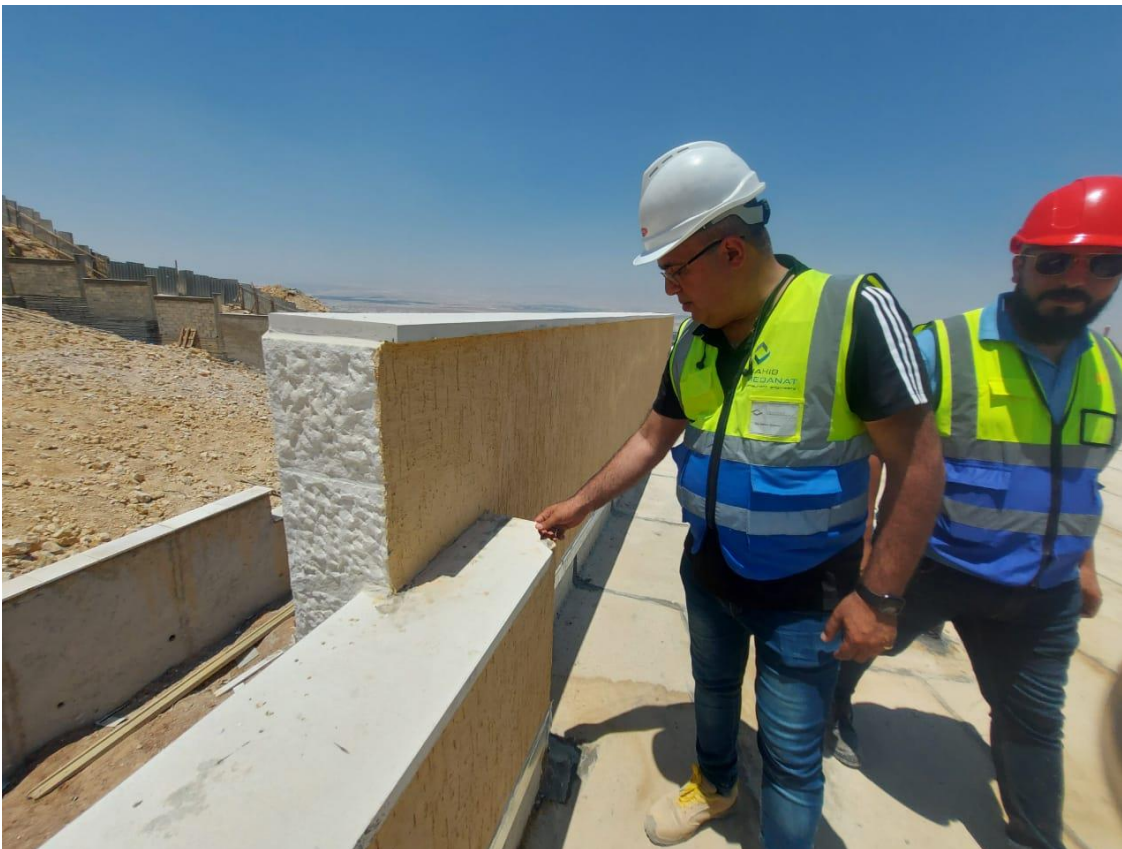
(Figure: 08)

The team inspected the parapet at the roof and observed that the broken stone coping is not yet replaced as instructed in the previous visit

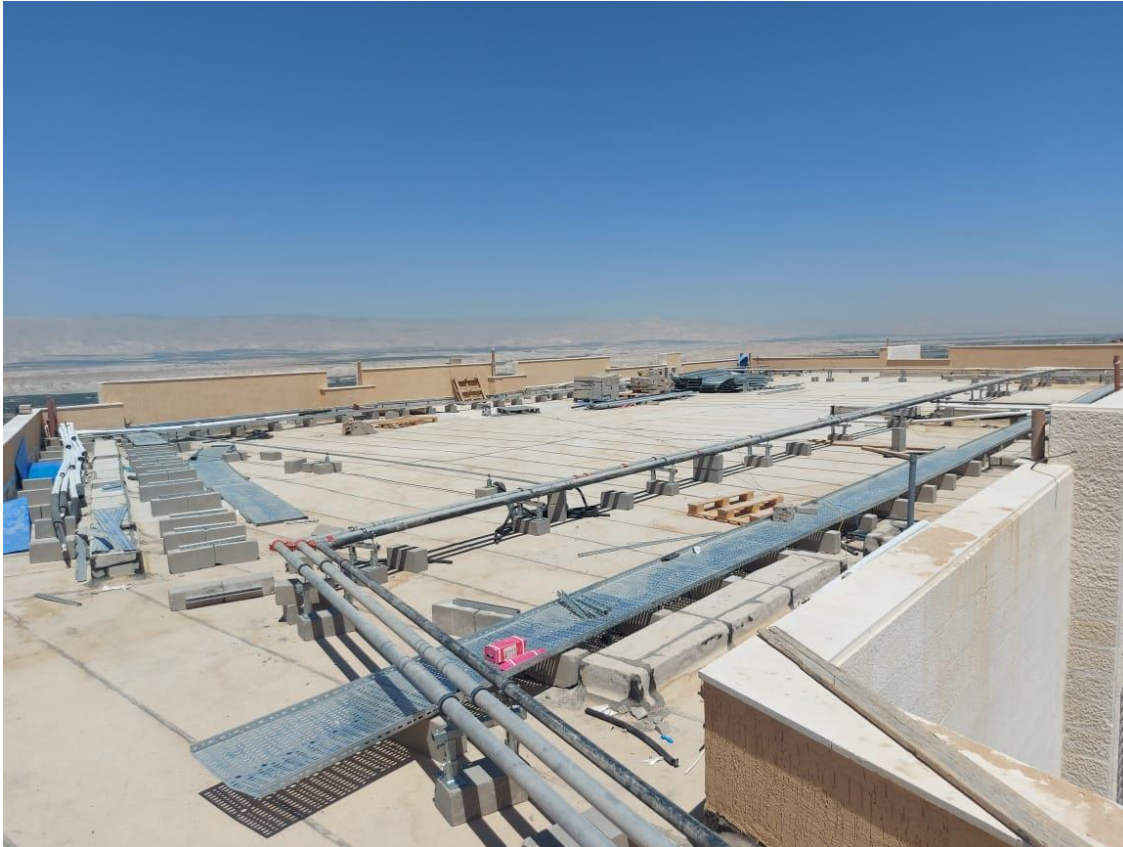
(Figure: 09)

The team inspected the electrical and mechanical executed works at the roof

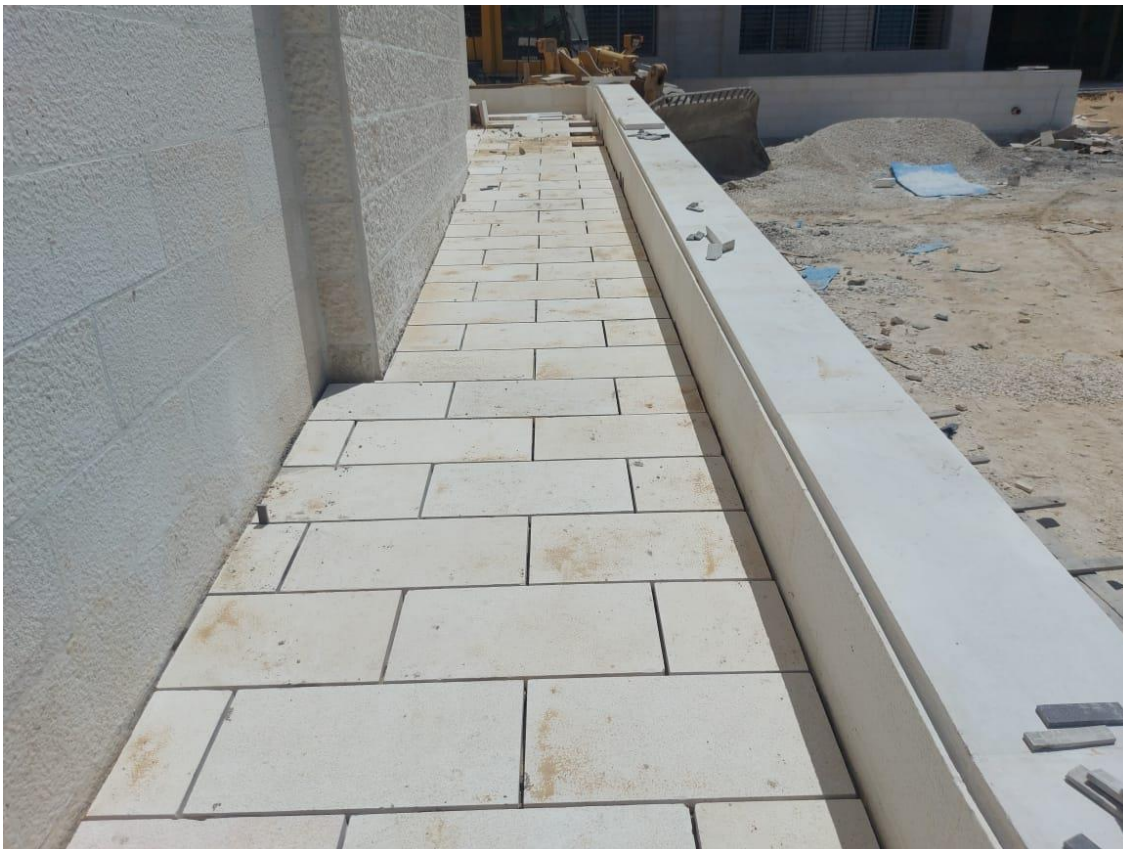
(Figure: 10)

The team has confirmed that the stone tiling done for the ramp and the entrance at zone C is executed in accordance to the approved shop drawings

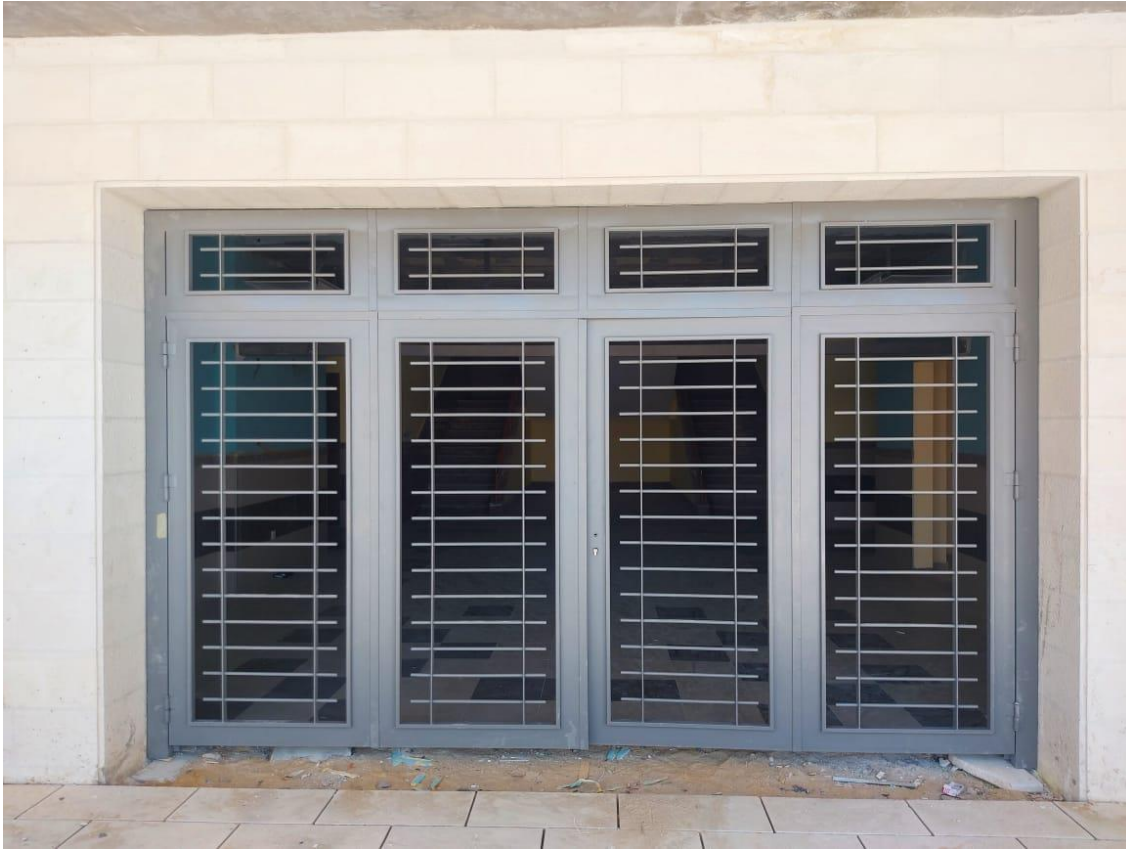
(Figure: 11)

The team inspected the installation of the steel doors at the entrance of the main building and noticed defects in the fixation of the screws

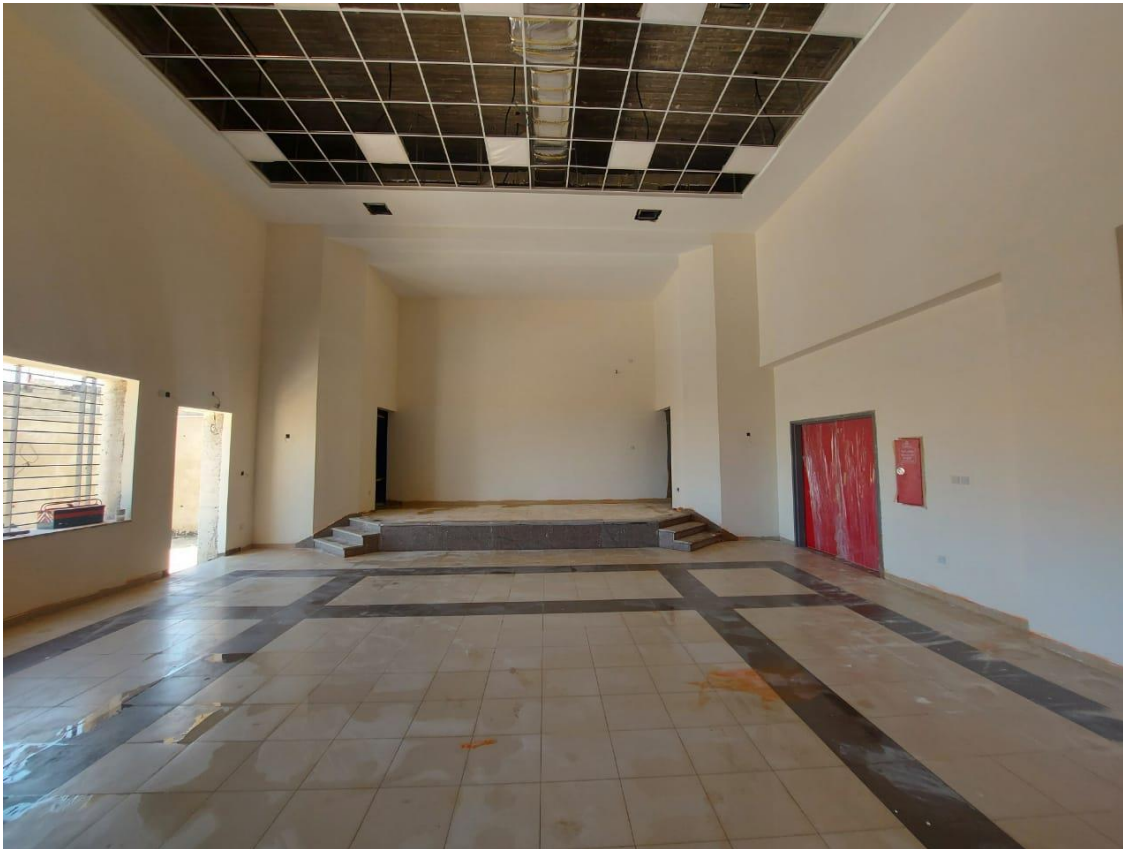
(Figure: 13)

The team inspected the progress of work at the multi-purpose hall

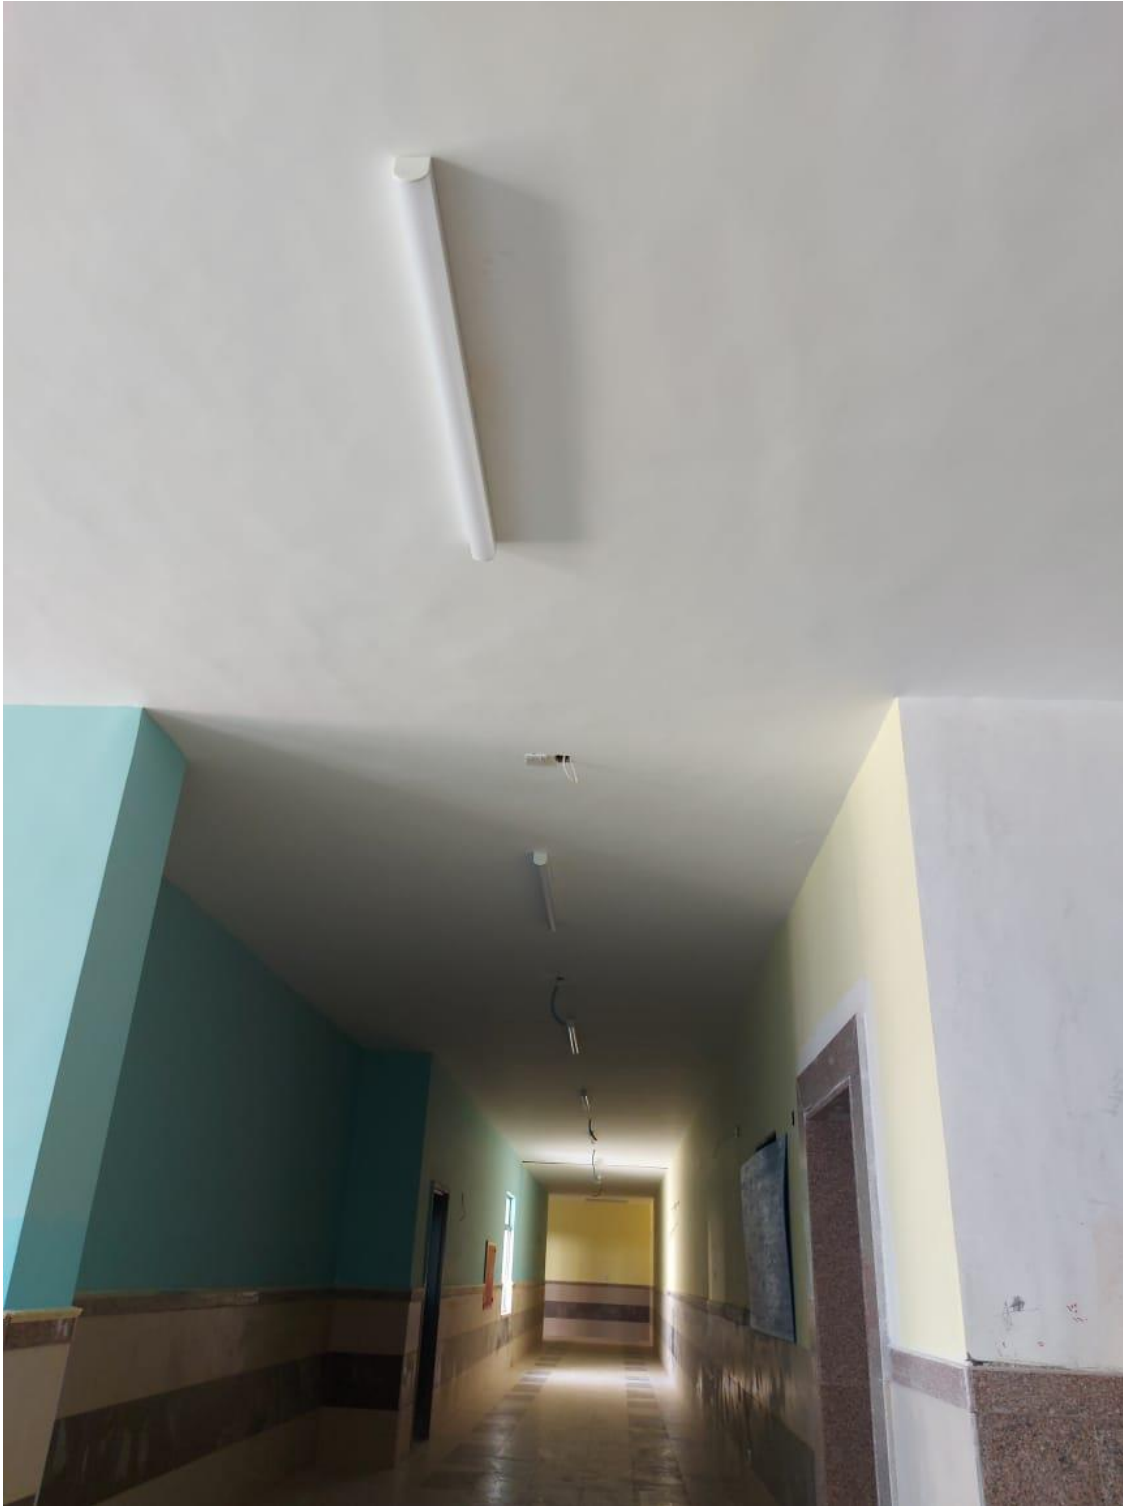
(Figure: 15)

The team observed that the Contractor has not yet rectified the waving in the plastering and painting at the corridors and ceilings

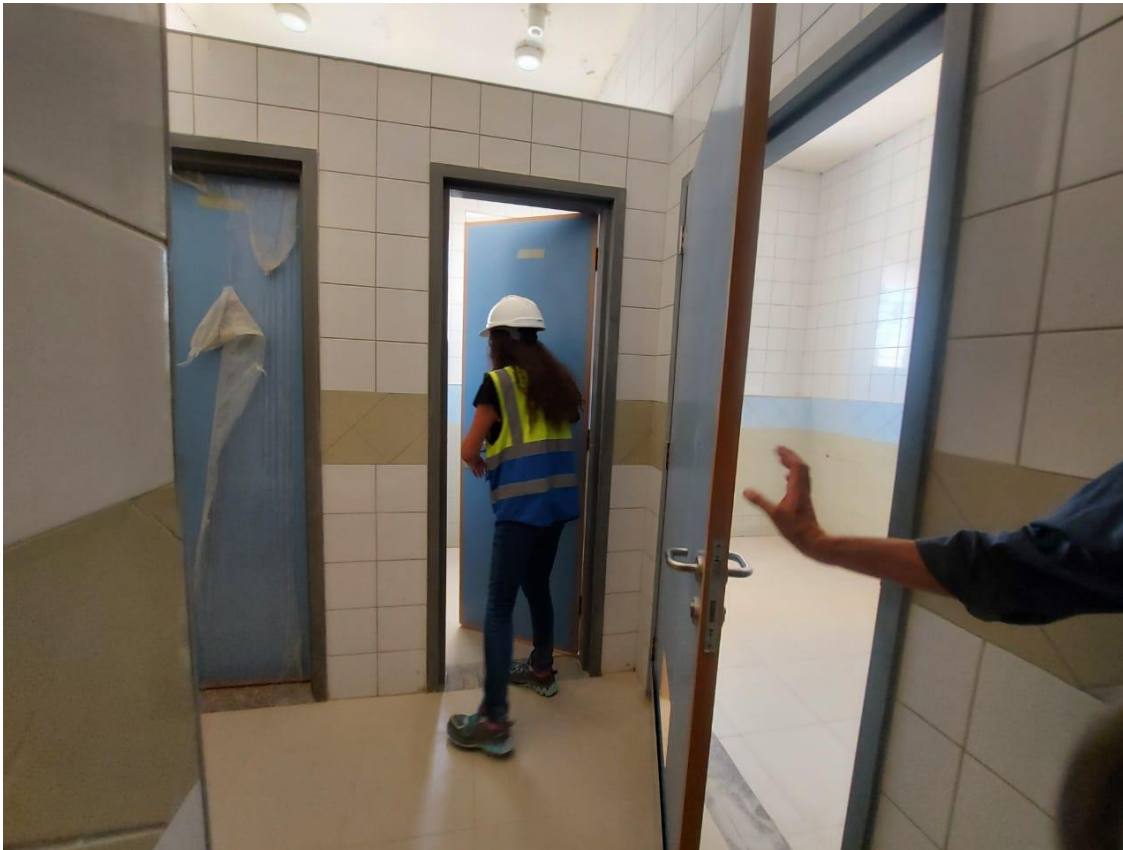
(Figure: 16)

The team inspected the wet areas' in the building to check the status of all executed items

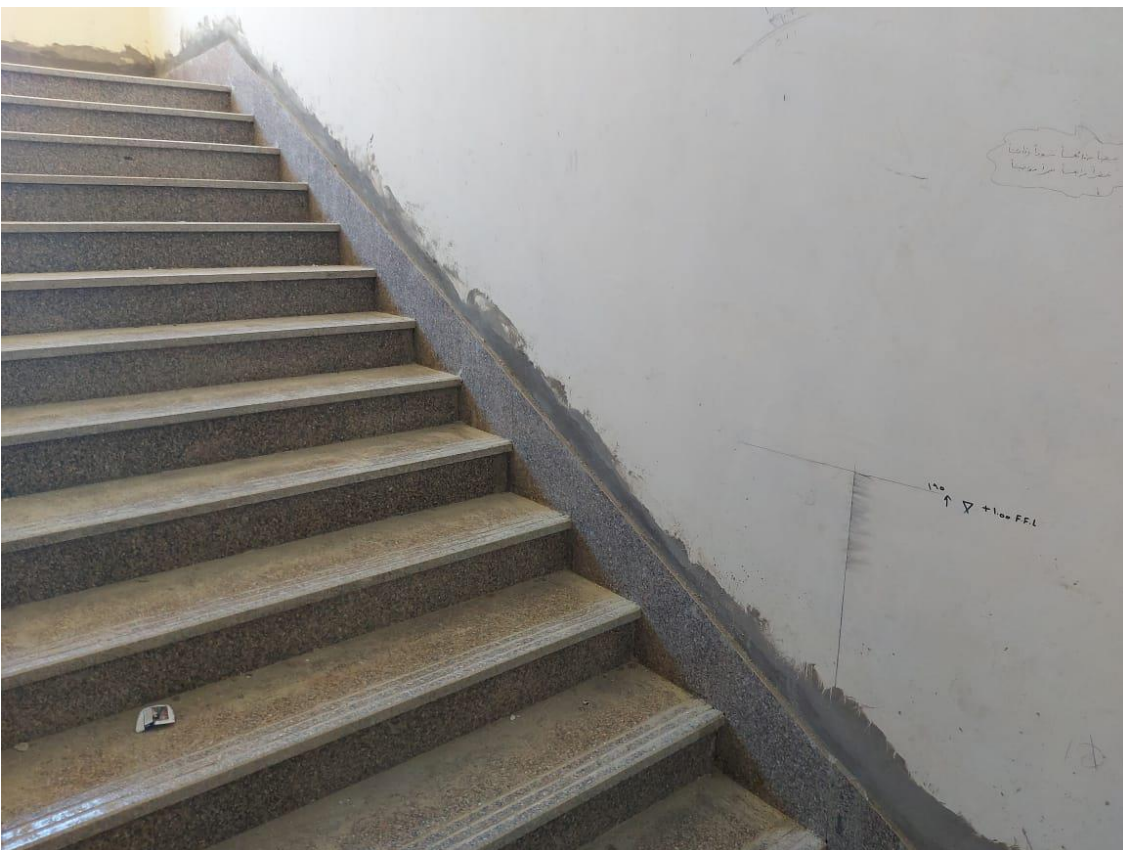
(Figure: 17)

The team inspected granite cladding and coping work at the staircase

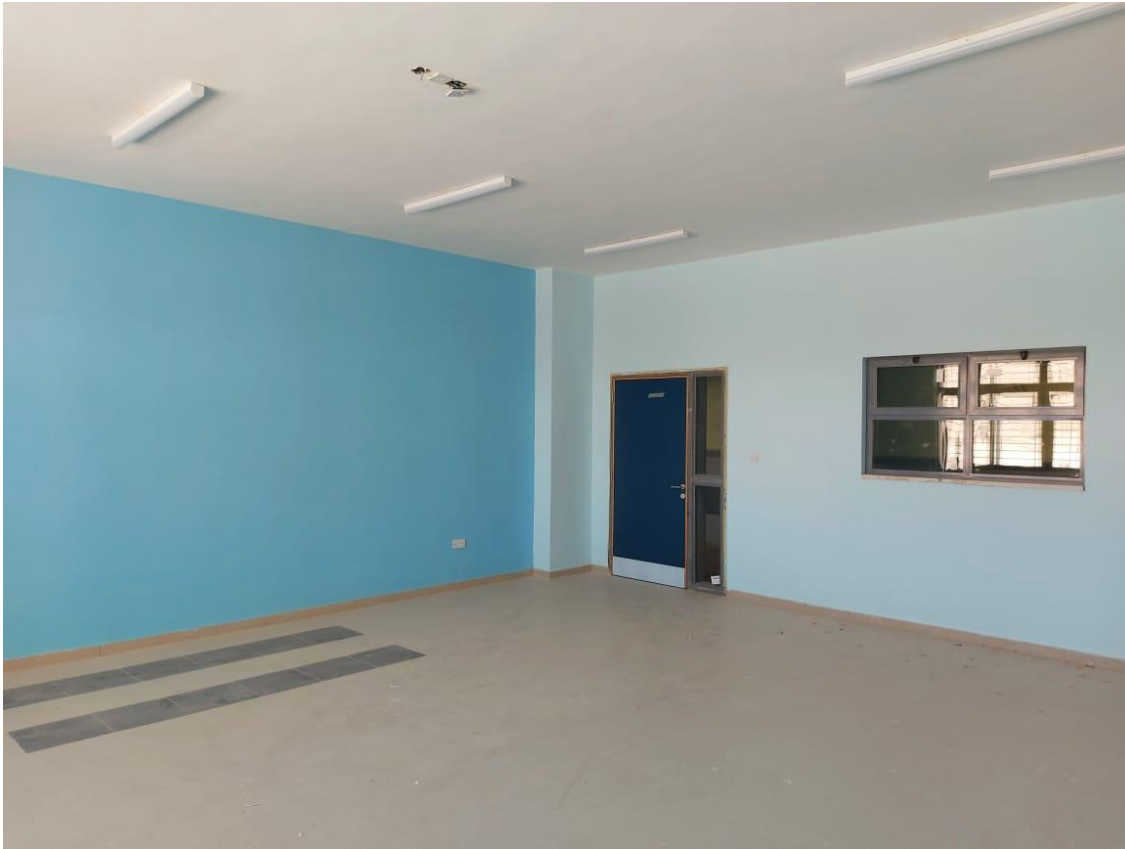
(Figure: 18)

The team inspected the installation of lighting fixtures, painting work, tiling and wooden doors installation
