SKEP III Home Office Support Site Visit Report

Consultant	Wahib Medanat Consultant Engineer	Rep No.	21-17072022
Contractor	Dijlah Establishment Constr. Contracting	Tender No.	(11/2019/USAID/SKEP/3/S) Schools for a Knowledge Economy Project (SKEP) - Phase (3) Package (1, 2)
Site Name	Hay Al Iskan Basic Mixed School- Jerash	Day/ Date	Wed. 17/07/2022
Duration of Project	450 Calendar Days	Total Project Budget	8,314,983.735 JD

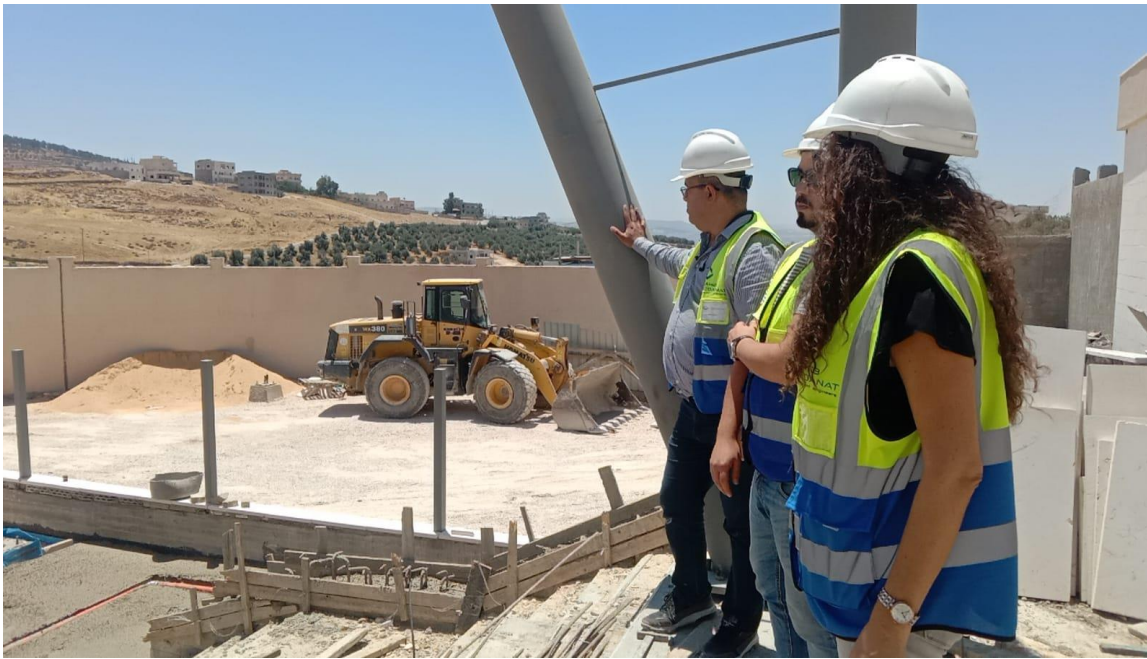
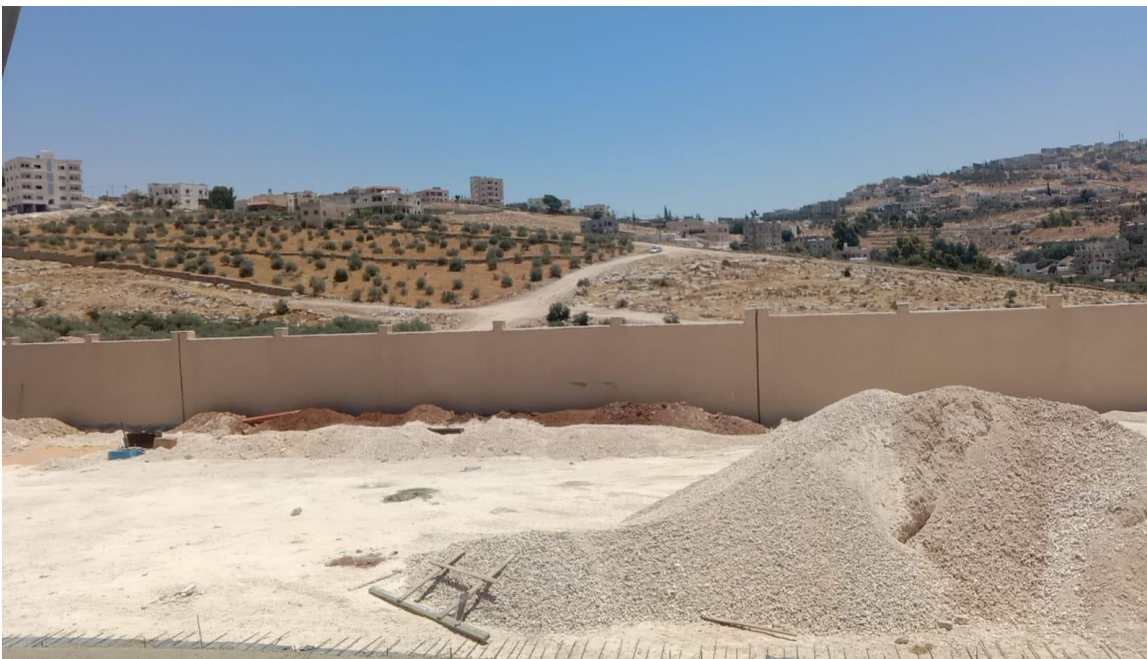
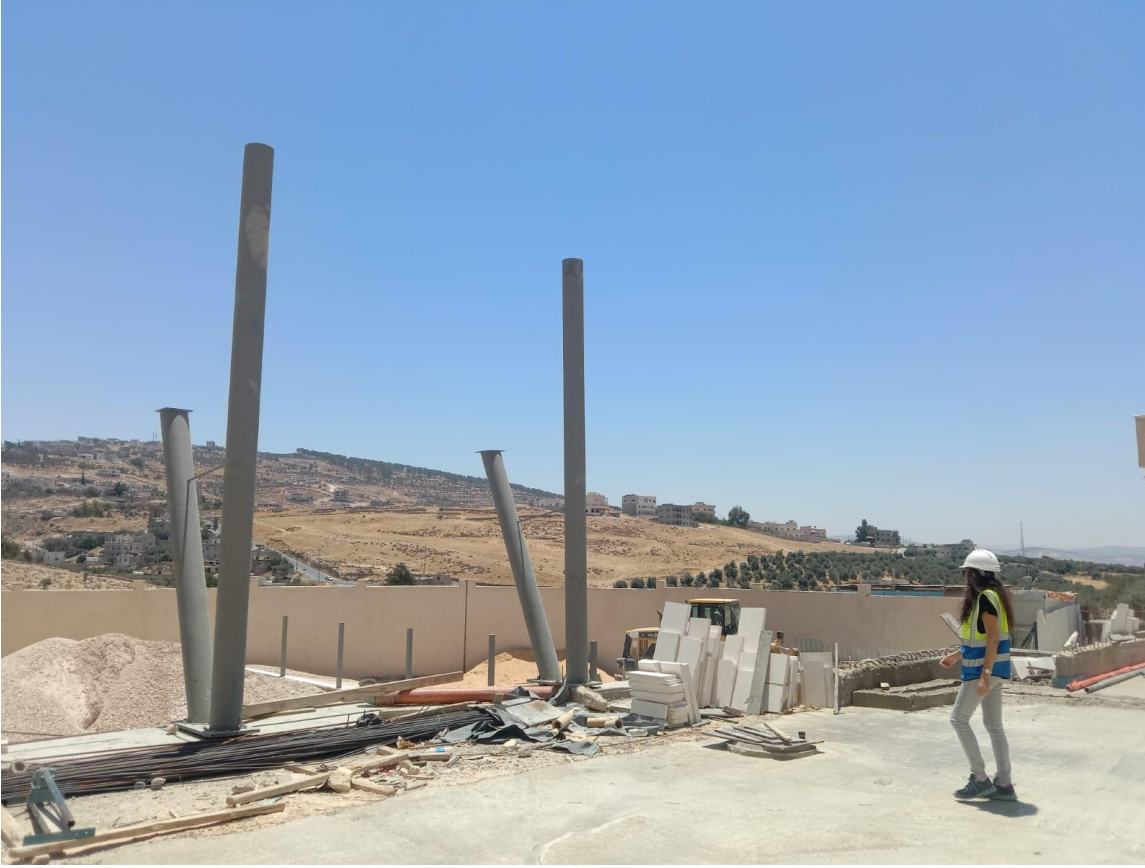
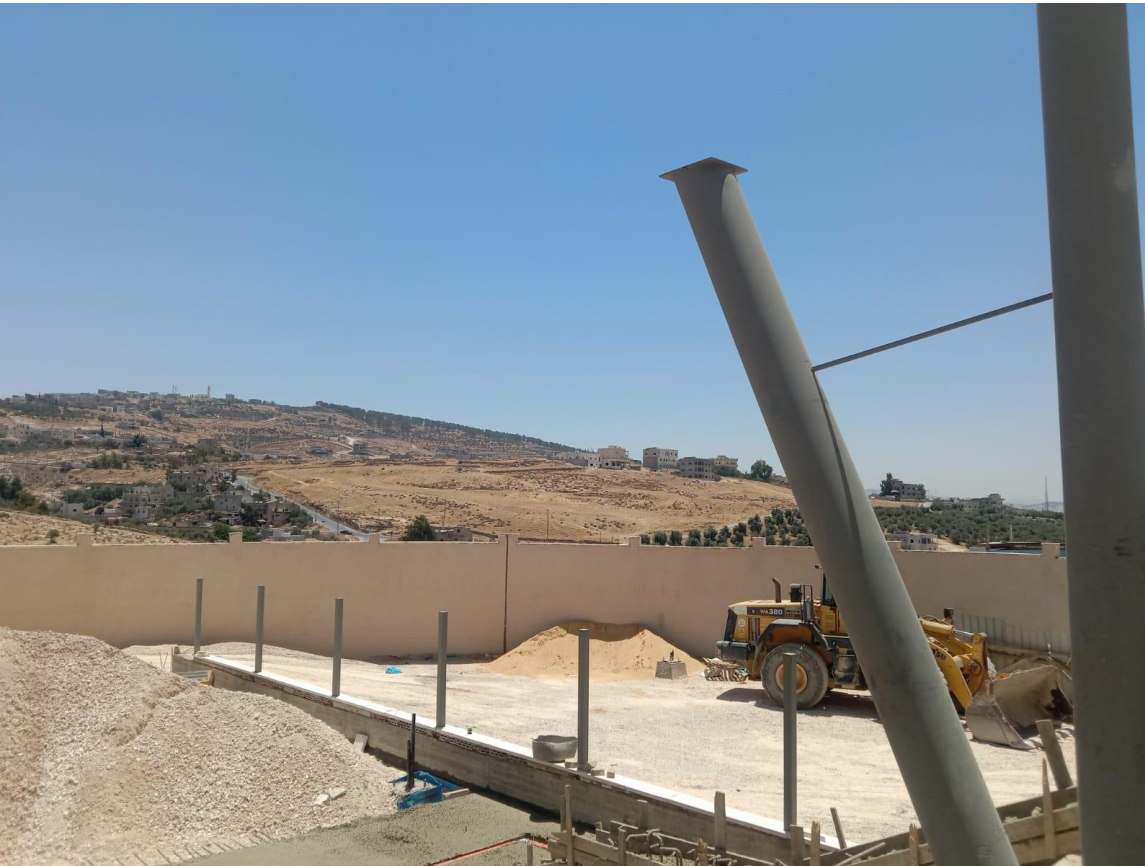
(Figure: 05, 06, 07 & 08)

The supervision team observed that the number of skilled and unskilled labors is severely insufficient despite that the work is open in all parts of the site. The team expressed his resentment to this and stressed on the Contractor to provide sufficient number of labors. Also the team observed that the Contractor is not performing any activity related to the external work

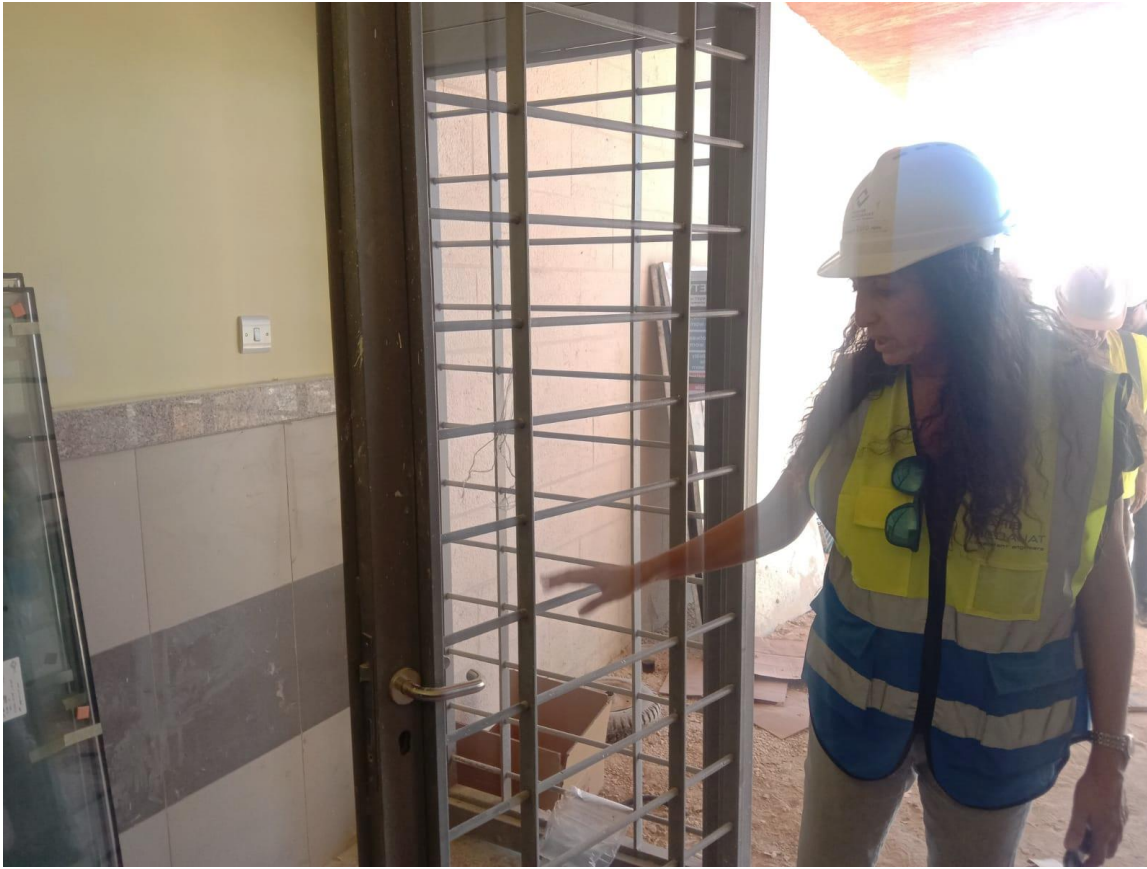
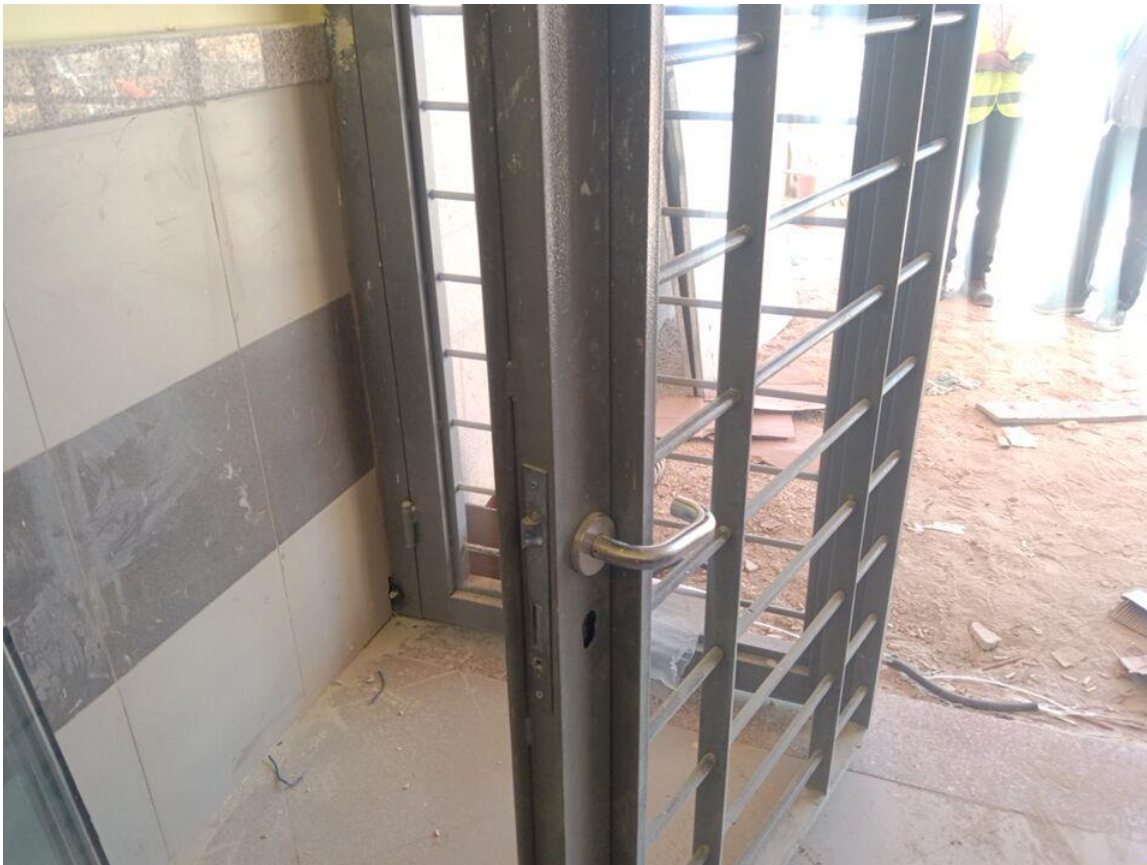
(Figure: 09 & 10)

The team requested the Contractor to rectify the installation of the external doors similar to the approved sample at Jumana Bint Abi Taleb school of the same package

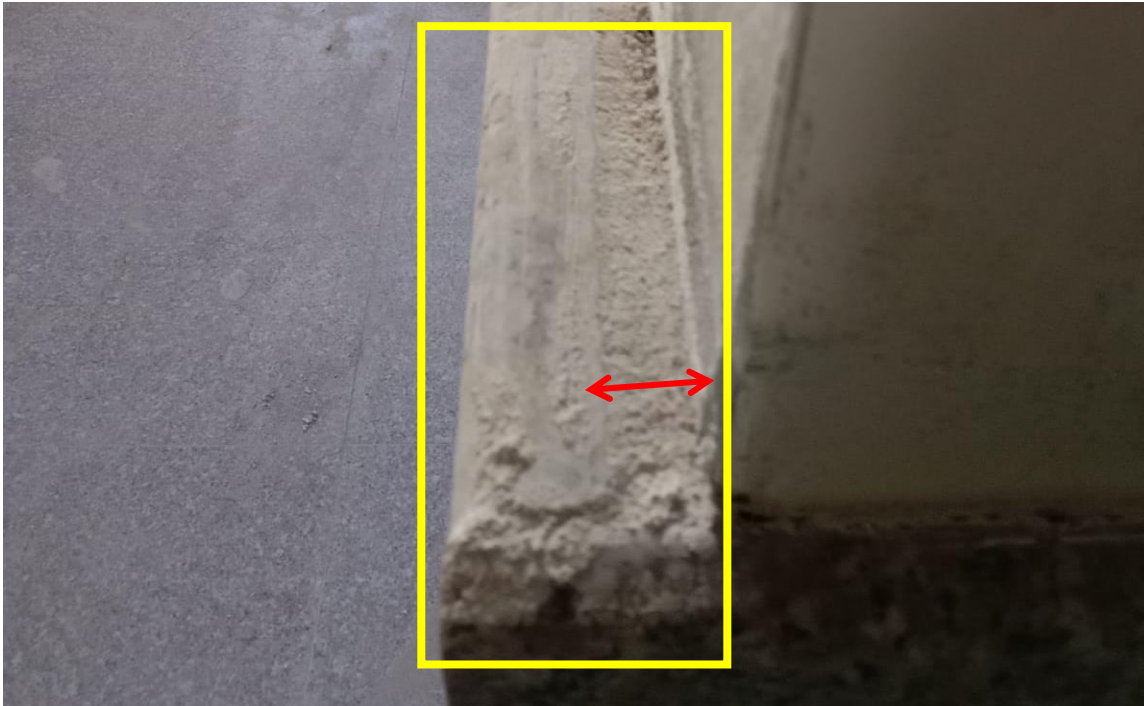
(Figure: 11)

The team Previously discussed with the Contractor the suggestions to resolve the defects in granite coping at the corridors and staircases

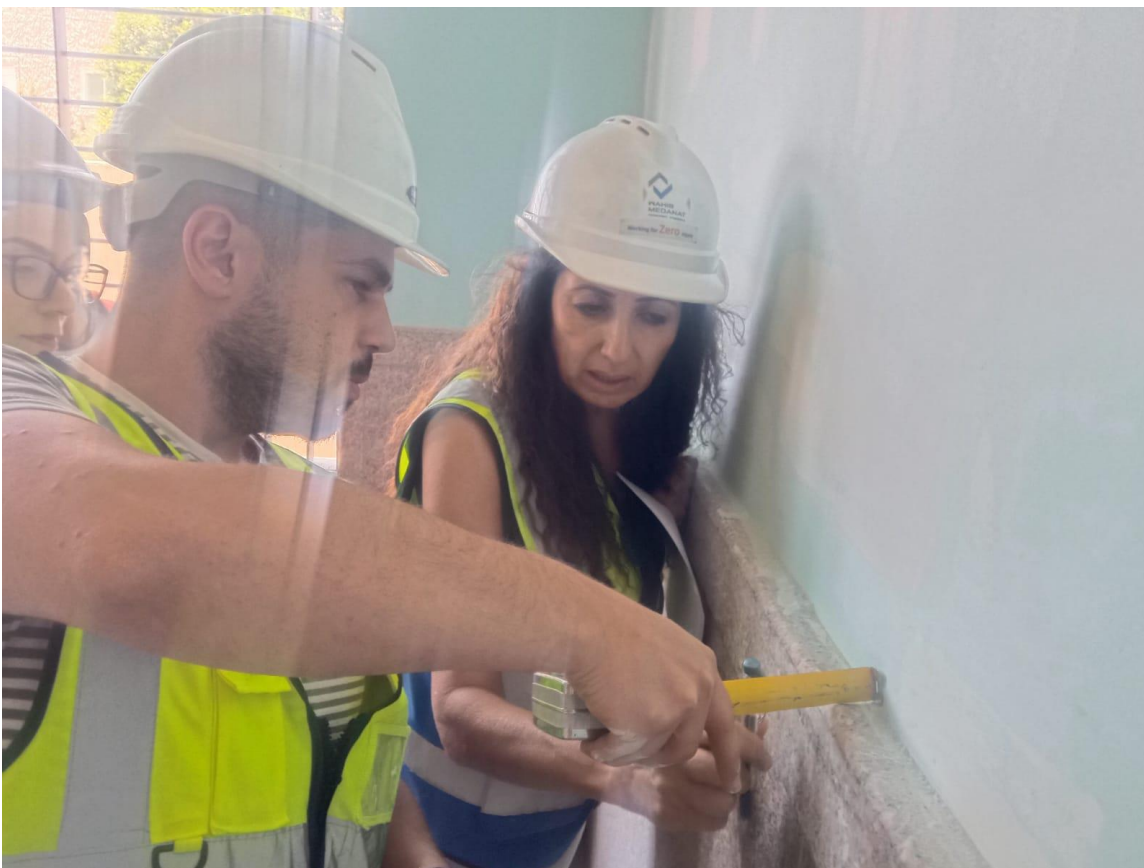
(Figure: 12)

The team observed that the Contractor performed rectification to the granite coping at the staircase

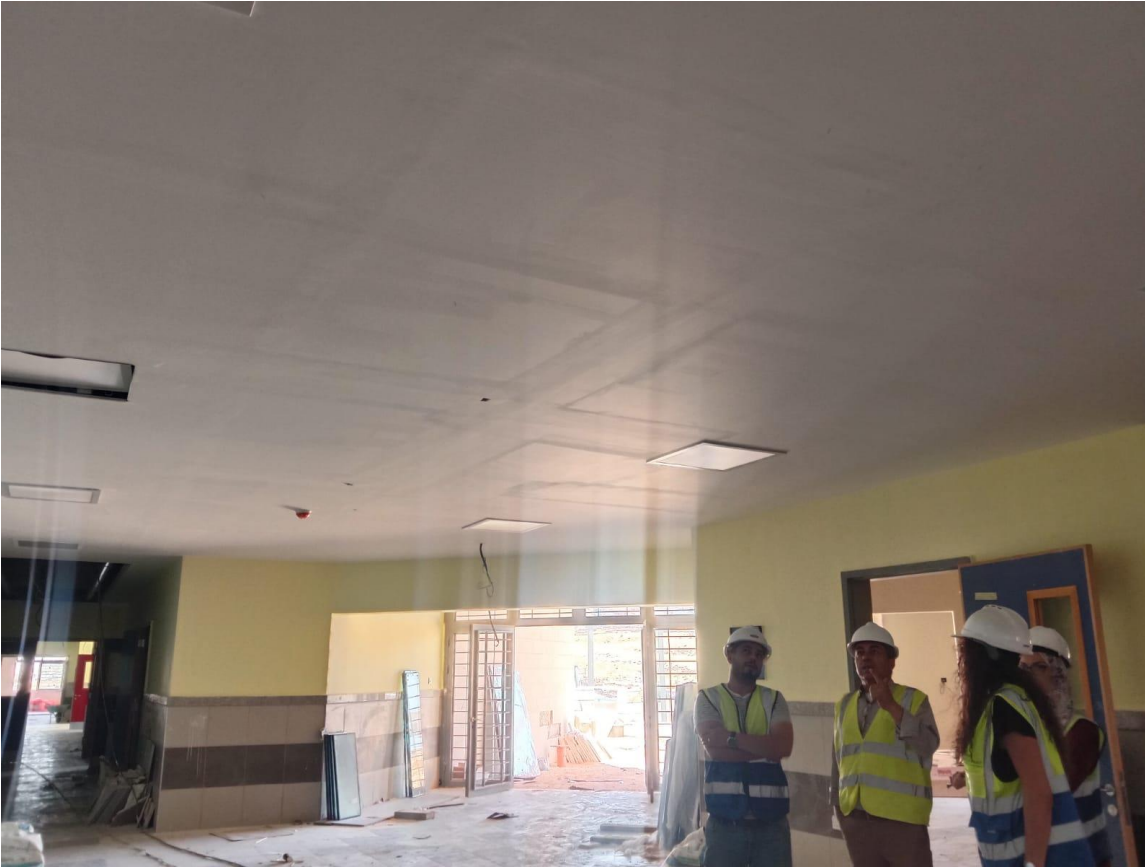
(Figure: 13)

The team observed clear waving in the painting work under progress for the suspended ceilings

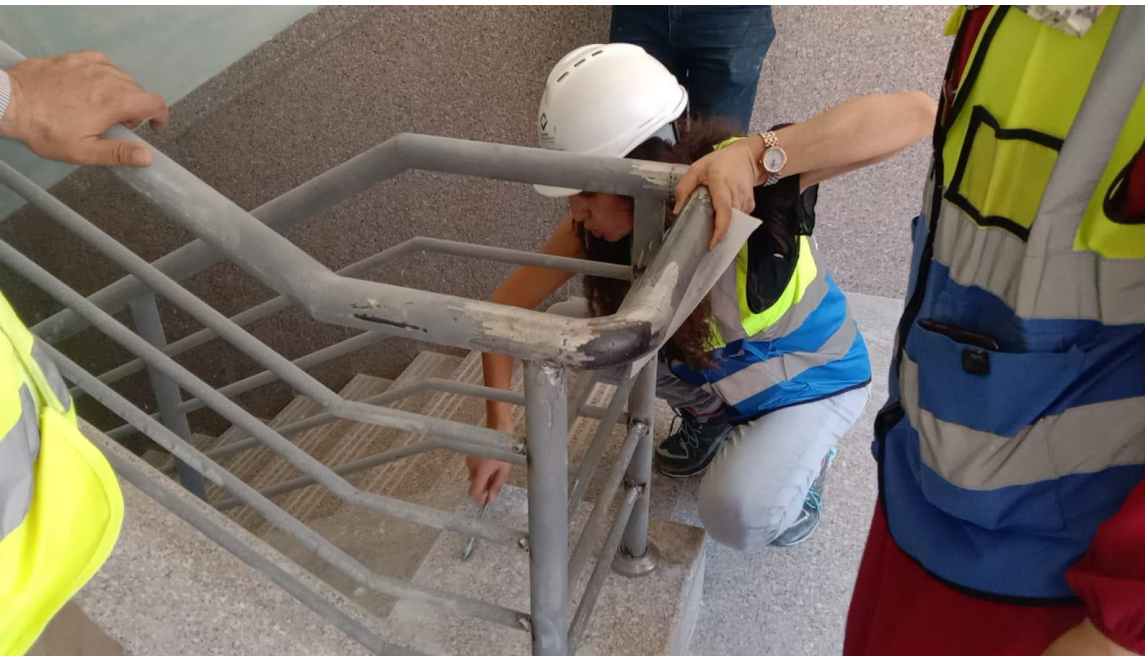
(Figure: 14)

The team discussed with the Contractor the rectification of the dissimilarity regarding the ends of the parapets at the two sides of the main staircase at the same landing

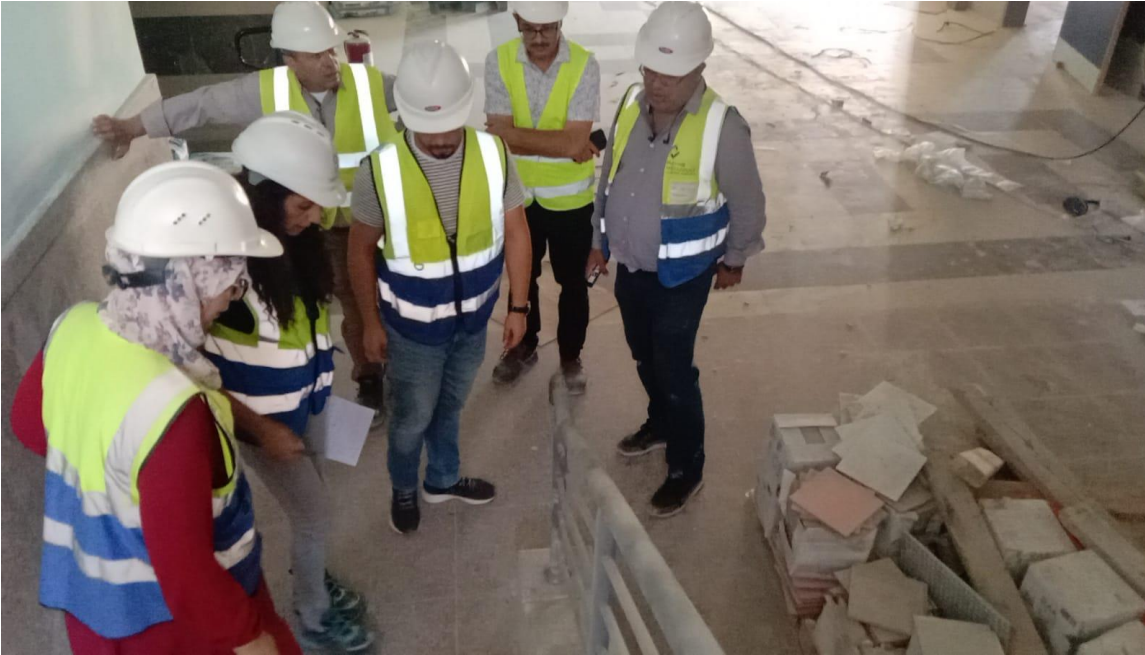
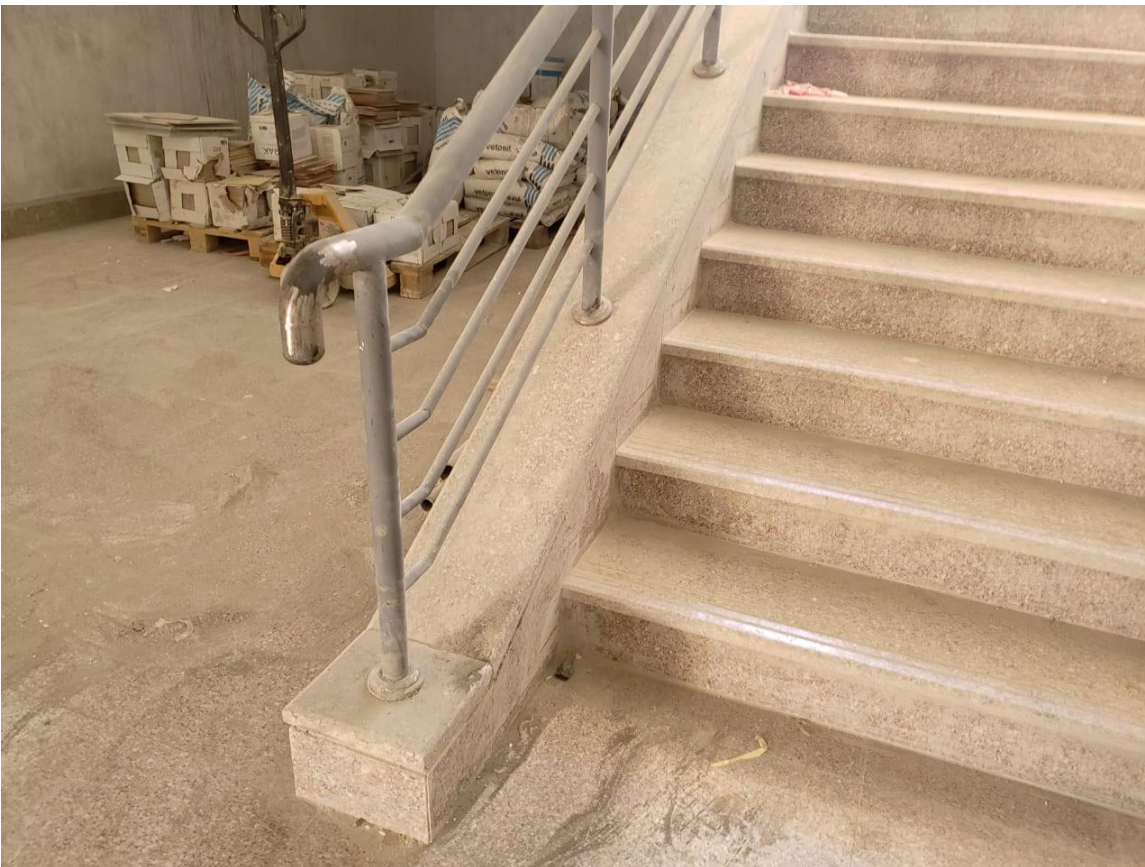
(Figure: 15 & 16)

The team inspected the installed handrails for the staircase and observed that the fixation is not sufficient

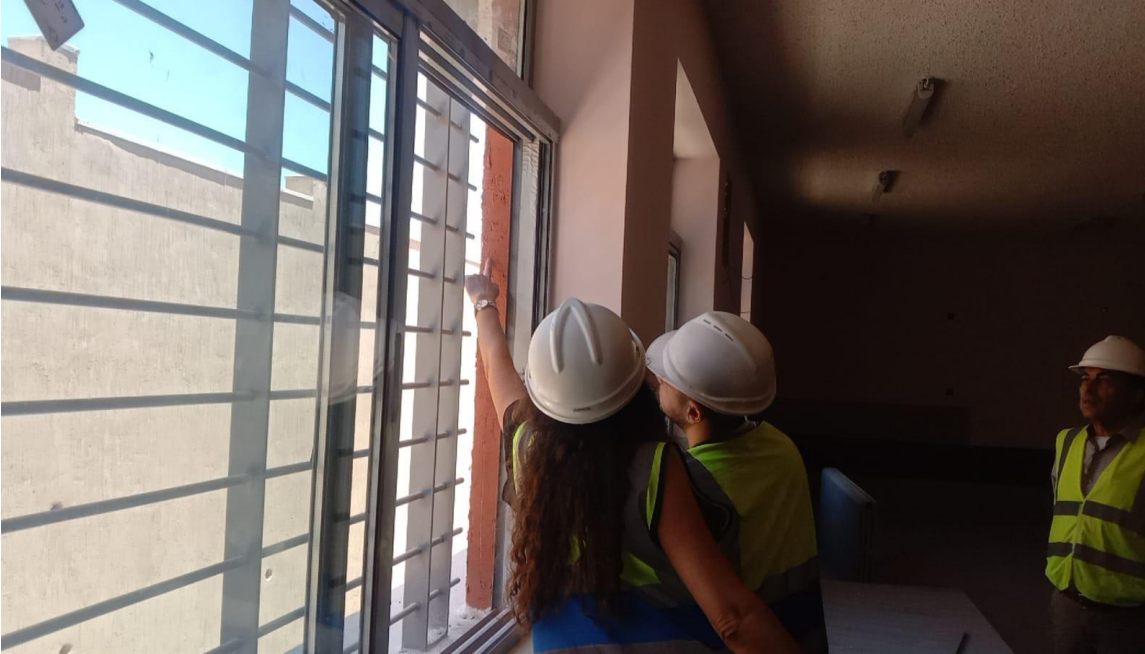
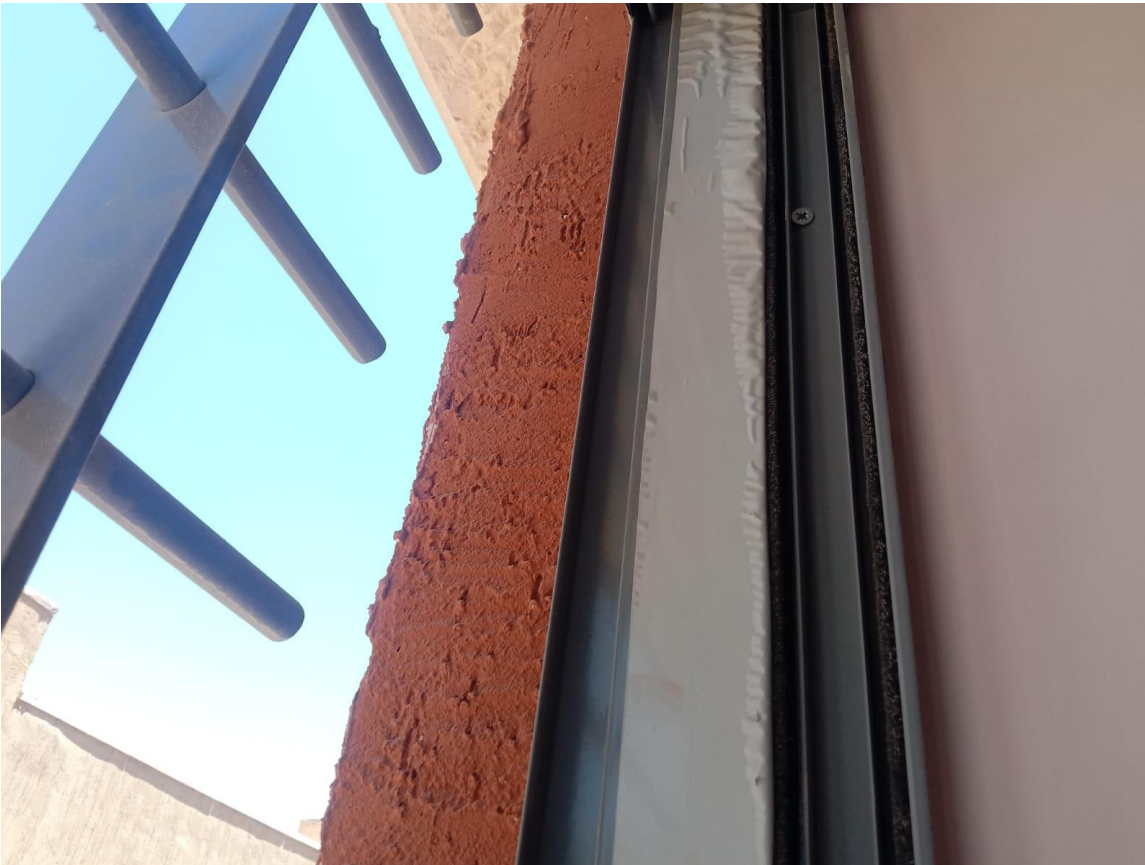
(Figure: 17 & 18)

The team observed clear defects in a number of window jambs. The Contractor was requested to rectify the plastering and the painting accordingly

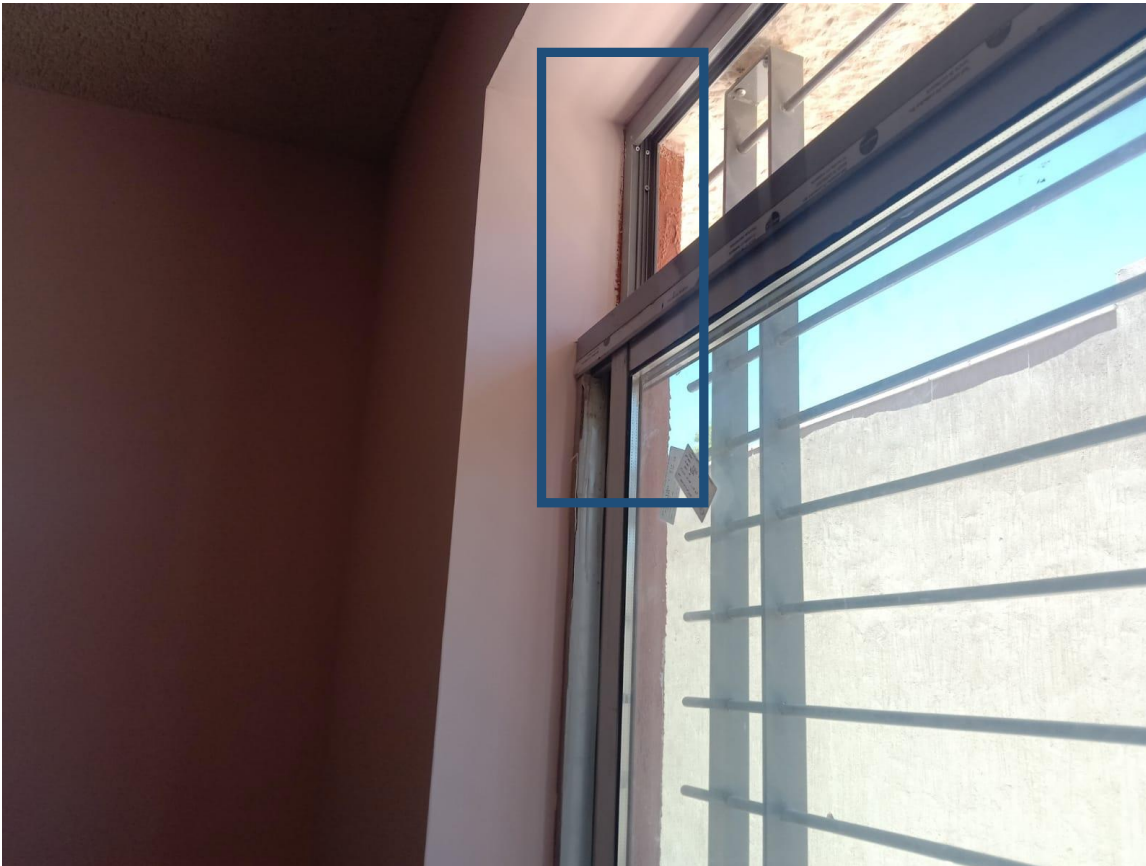
(Figure: 19)

The team observed variation in the installation of the aluminum section, the external plastering appears inside the window

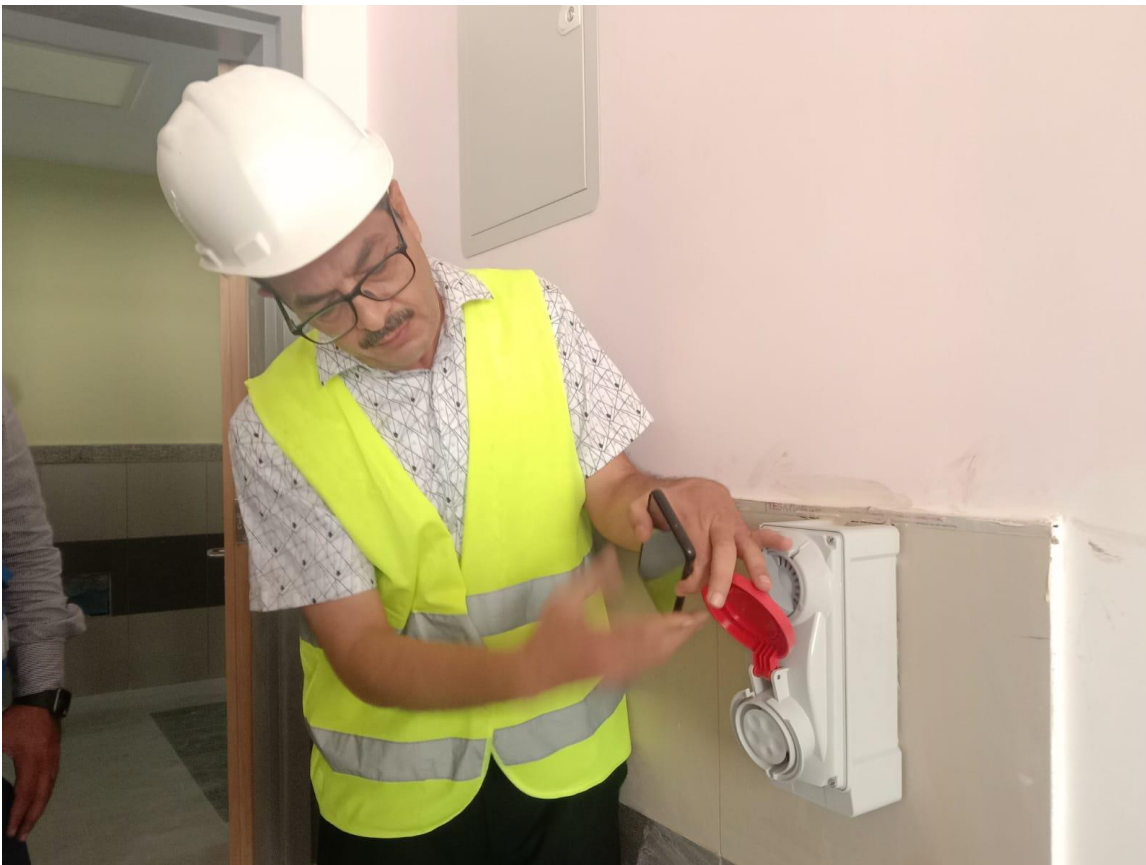
(Figure: 20)

The team observed that a number of electrical outlets in the laboratories are fixed incorrectly. The team requested the Contractor to rectify

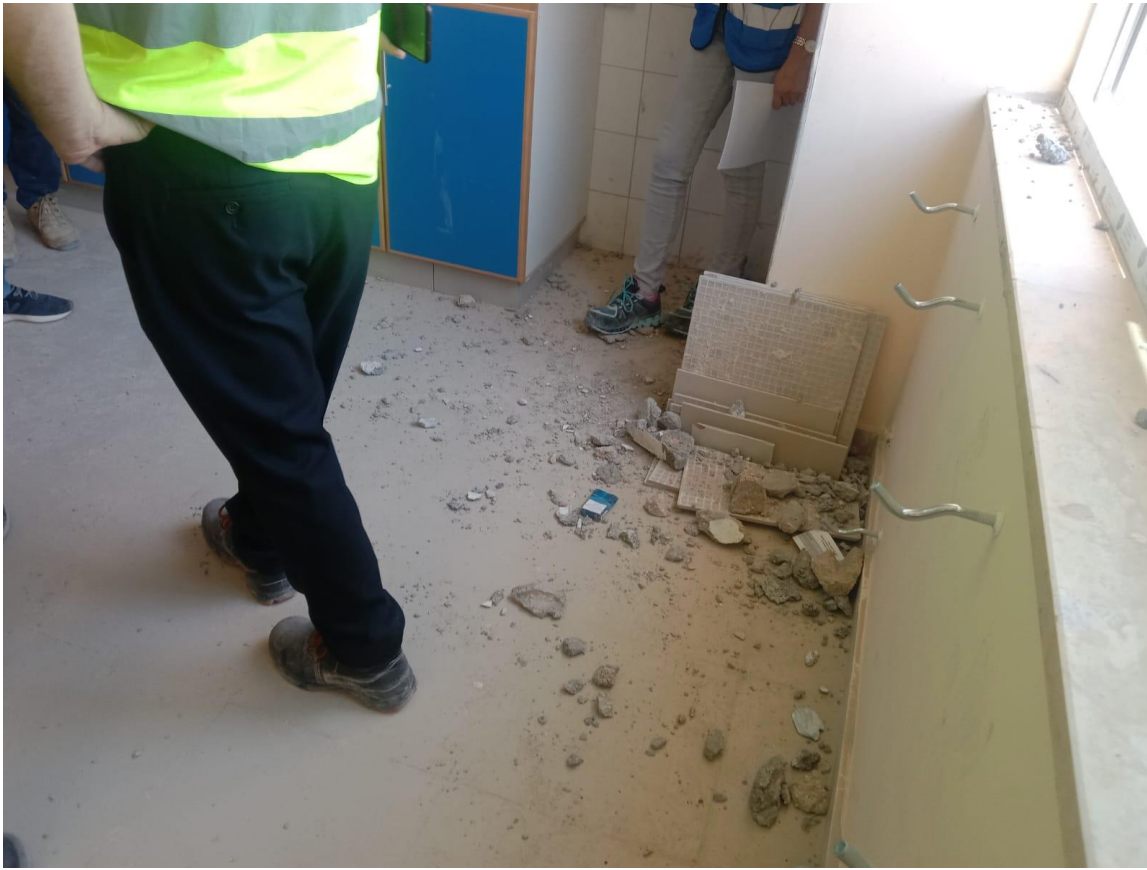
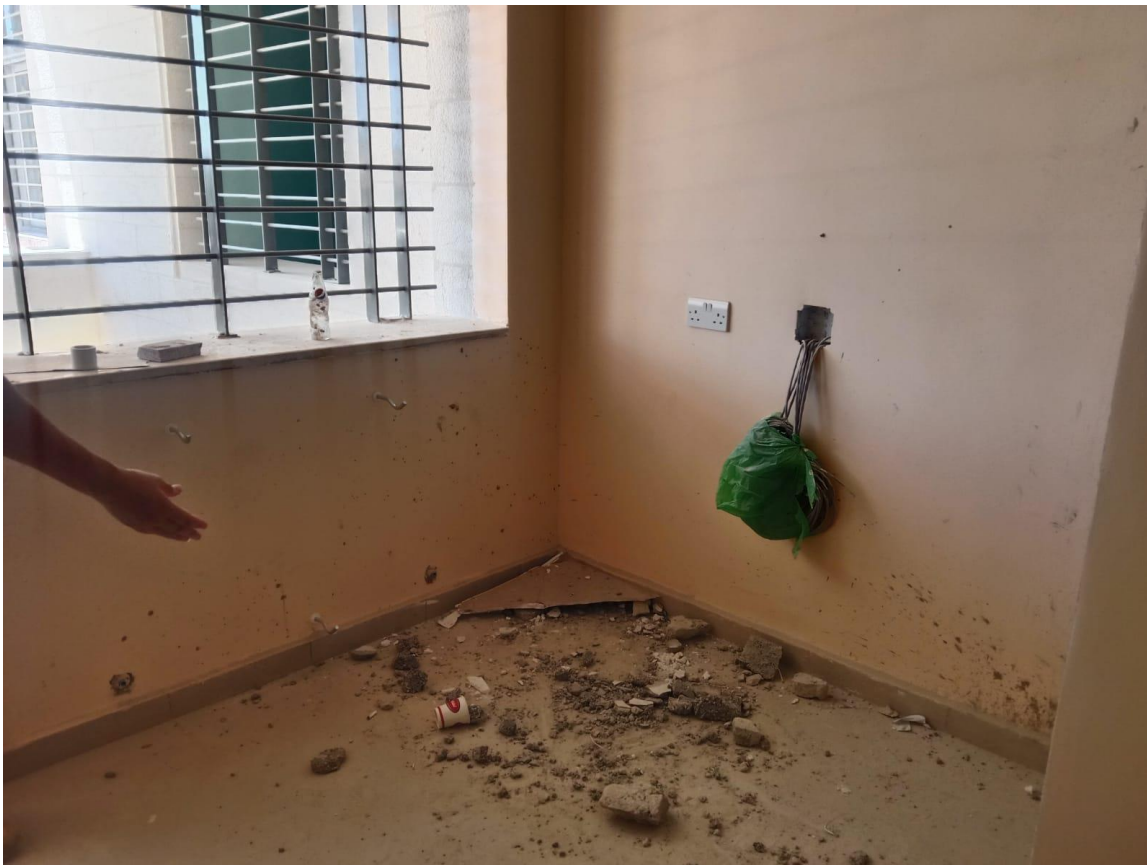
(Figure: 21 & 22)

The team observed accumulation of debris inside the building and requested the Contractor to remove outside and to check any defects in the tiles as a result of that

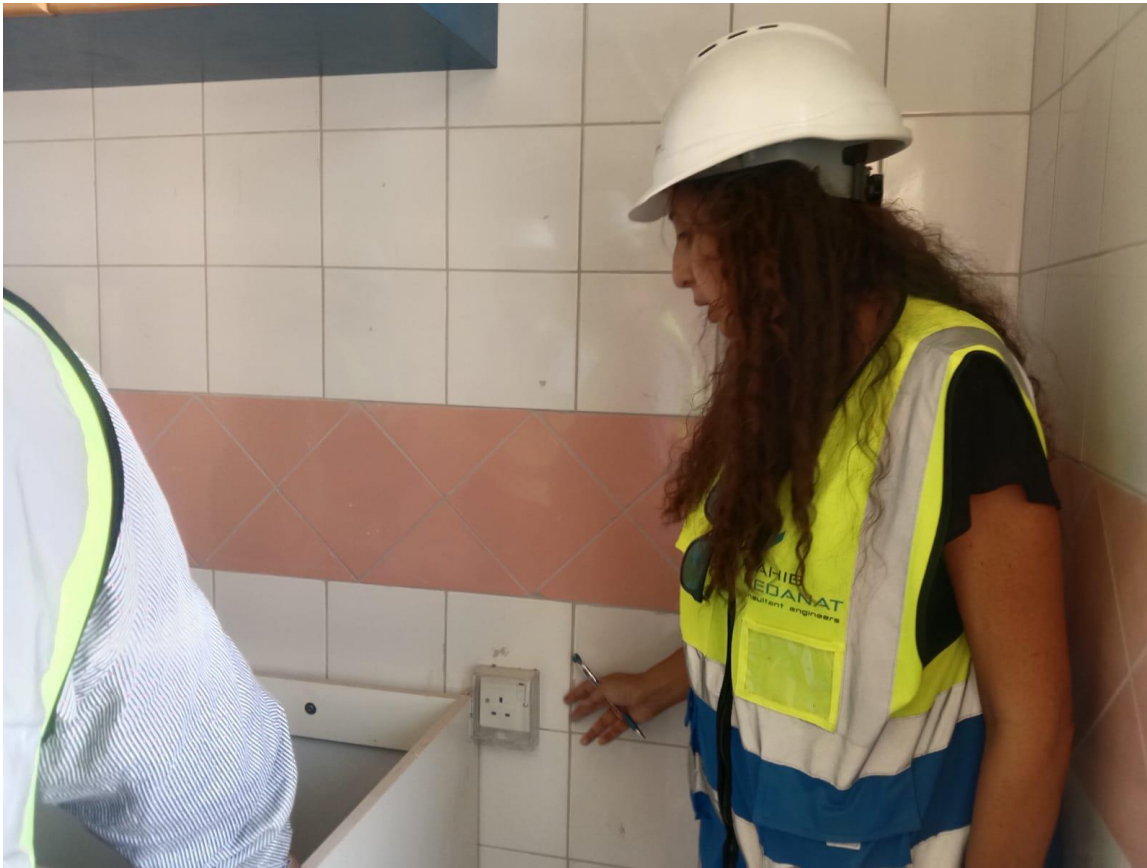
(Figure: 23)

The team observed contradiction in the installation of the electrical outlets in the kitchen with the granite counter top for the cabinets. The team requested the Contractor to shift one outlet and the same for similar case

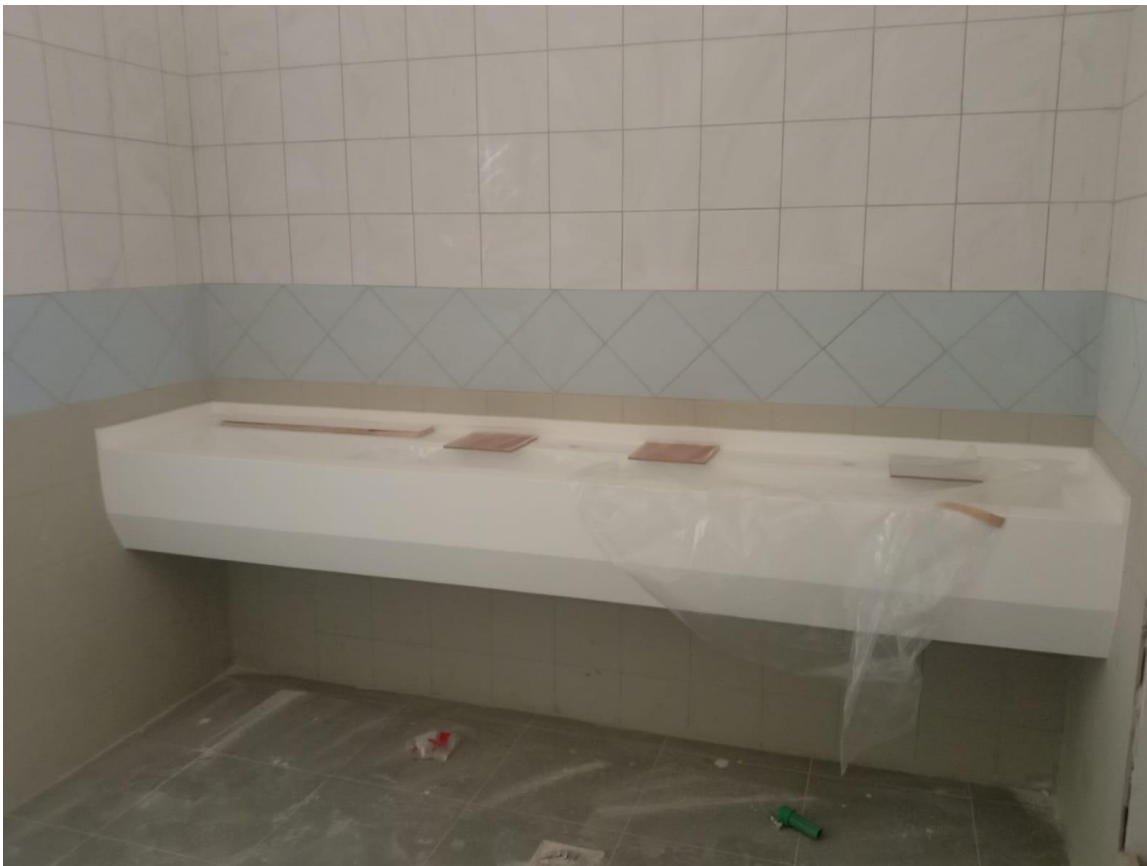
(Figure: 24)

The team observed that the Contractor has delivered and installed the acrylic wash trough in the sanitary unit

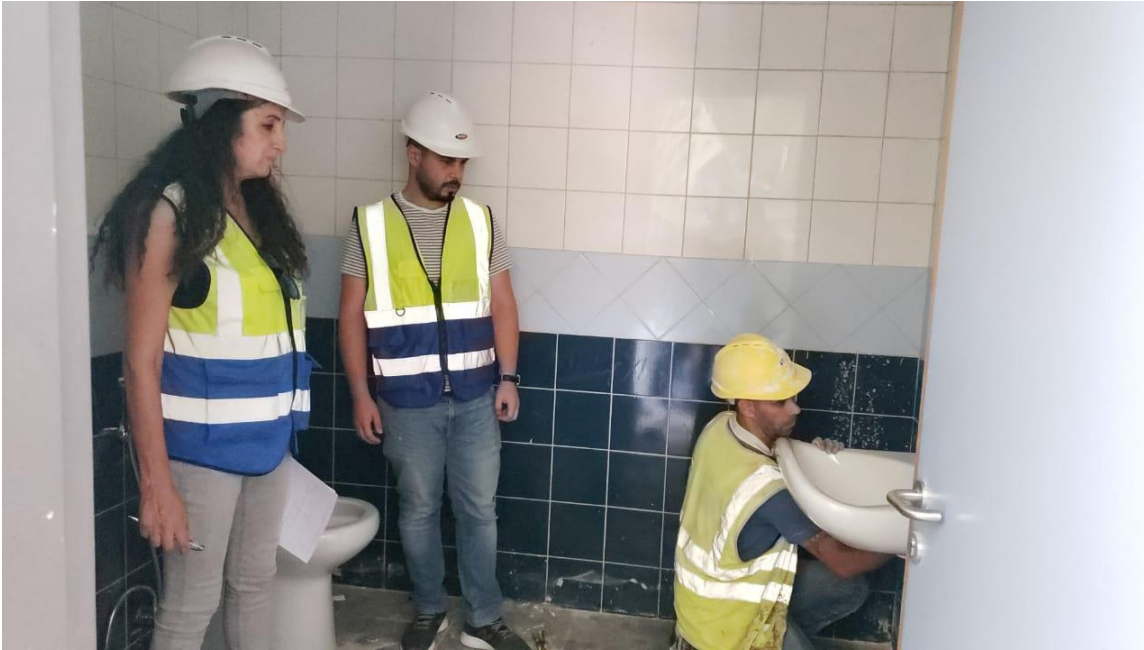
(Figure: 25)

The team observed that the Contractor is installing the sanitary fixtures at the sanitary units without using protection means for the floor tiles

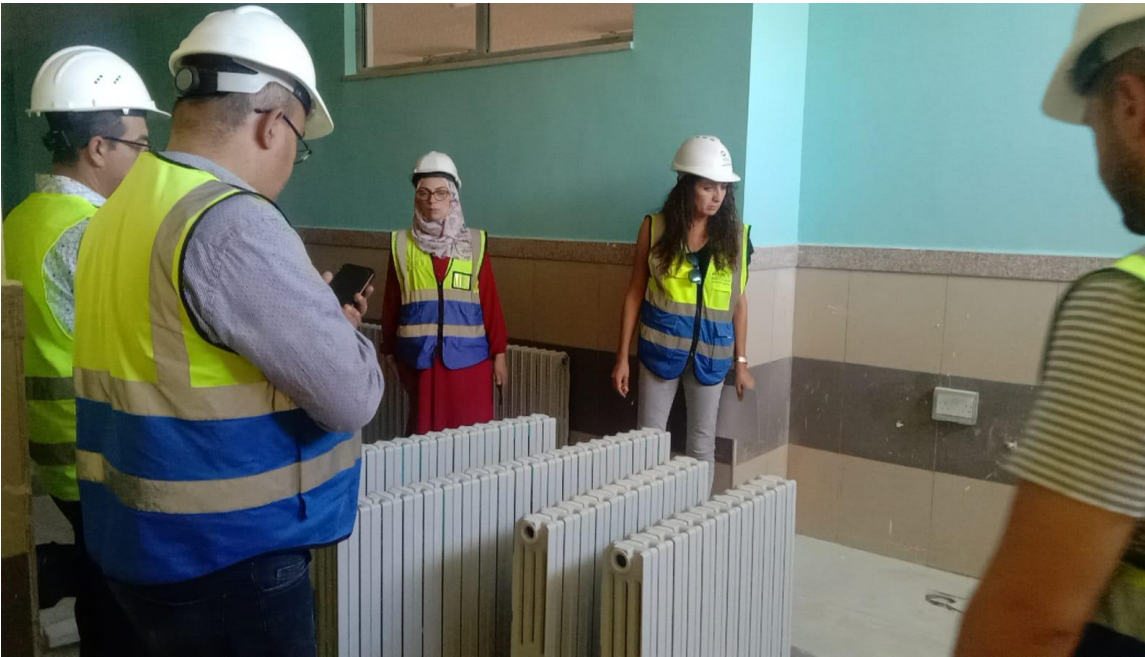
(Figure: 27)

The team requested the Contractor to continue the installation of heating radiators
