## School for Knowledge Economy Project (SKEP) Phase III – Package 2

Defects Liability Period/ General Observations

Periodic Site Visits/ February 21, 2023

Hay Al Iskan Basic Mixed School

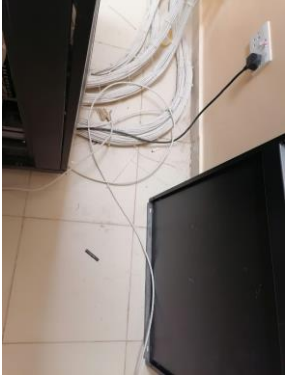
No.	Floor	Function	Defect	Comments	Action Taken		Status	Photo <input type="checkbox"/>
					√	x		
1	Ground Floor	Corridor	One water cabinet needs treatment	<b>Leakage and corrosion observed</b>	√		Completed	
2	Ground Floor	Server Room	Cleaning is required	—		x	No Action Taken

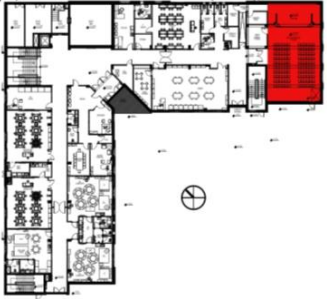
4	Ground Floor	Multi-purpose hall

Thermostat for the package unit is not installed	—		X	No Action Taken

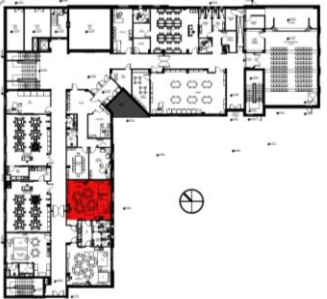
5	Ground Floor	KG Classroom

Broken tiles shall be replaced	—	√		Completed	
6	All Floors/External Yards	Sidewalks, the administrative department and in the guard house	Defects in painting works were observed	—		X	No Action Taken

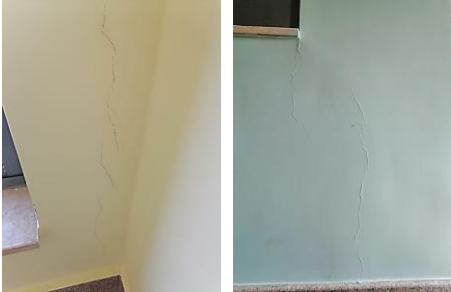
7	General	multi-purpose hall and one classroom at the second floor	Cracks appear in the walls	—	√	Completed

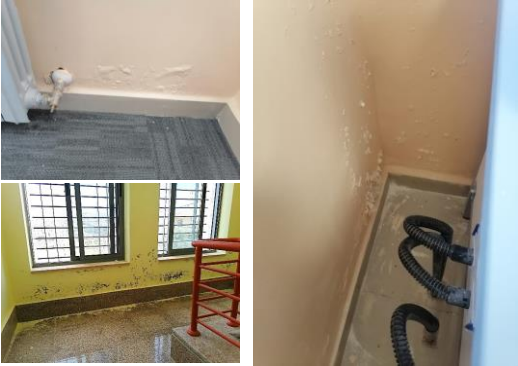
8	General	KG classroom, library, school administration department, some classrooms, the teachers' room at the second floor and next to the staircase at second floor	Damp batches and paint bubbles were observed at the bottom of the walls	—	X	No Action Taken

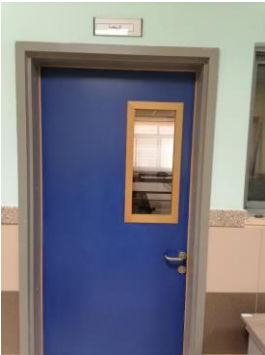
9	General	Sports room (ground floor) and the meeting room (Second floor)	Doors do not open with the master key	—	X	No Action Taken

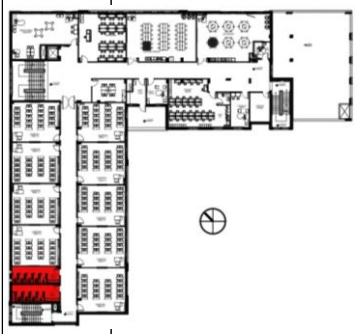
14	General	General	Some doors need adjustment	<b>They don't close or open easily</b>	√		Completed	
15	First Floor	Toilet	Corrosion can be observed on the floor drain cover	—		X	No Action Taken

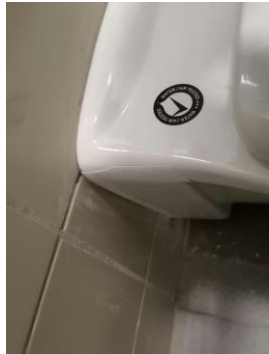
16	First Floor	Toilet	One toilet seat is broken and needs to be replaced	—		X	No Action Taken

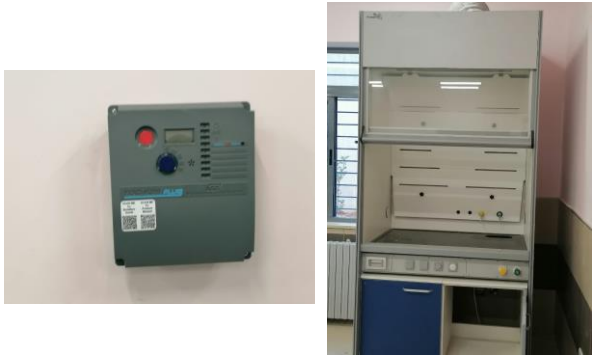
18	Ground Floor	Laboratory	Fume hood system shall be completely connected	<b>Not activated</b>		X	No Action Taken

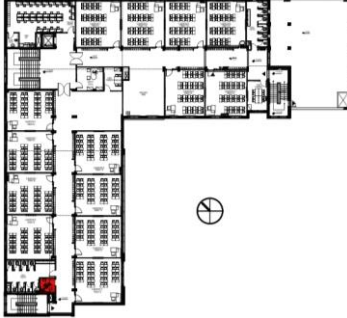
19	Second Floor	Handicapped Toilet

Mixer taps should be replaced with the approved type	—	X	No Action Taken

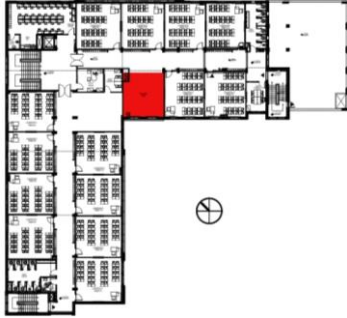
20	Second Floor	Resources Room

Lighting fixtures do not work	—	√	Completed	
21	Roof Floor	Top Roof	Water pools were observed and they resulted from wrinkles in the bitumen sheets	—	X	No Action Taken

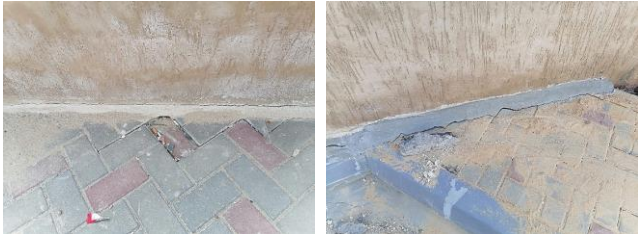
23	External Works/Site	Parking Area	Lightning poles bolts need to be covered with protection caps	—	√		Completed	
24	External Works/Site	External yards	Cracks and interlock tiles subsidence can be observed	—		X	No Action Taken

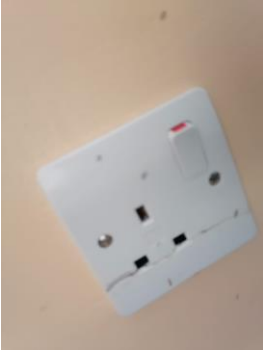
25	Guard House	Guard House	A broken electrical socket should be replaced	—		X	No Action Taken
