School for
Knowledge Economy Project (SKEP)
Phase III – Package 1

Defects Liability Period/ General Observations

Periodic Site Visits/ February 14, 2023

Khadija Bint Khwailed Basic Mixed School

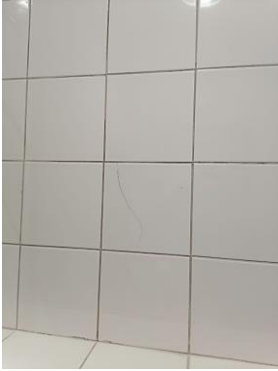
8	General	Toilets	There are broken and inflated tiles at the floors and walls

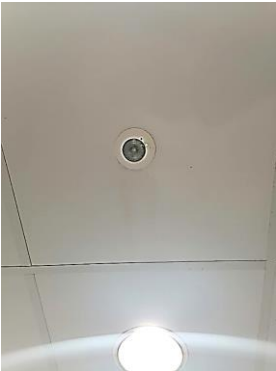
10	Ground Floor	Toilets	Yellow spots can be observed at the ceiling	 		X	No Action Taken

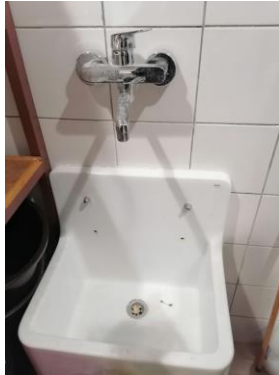
12	Ground Floor	Janitor Room	It was observed that the sieve of the janitor sink is missing	 		X	No Action Taken

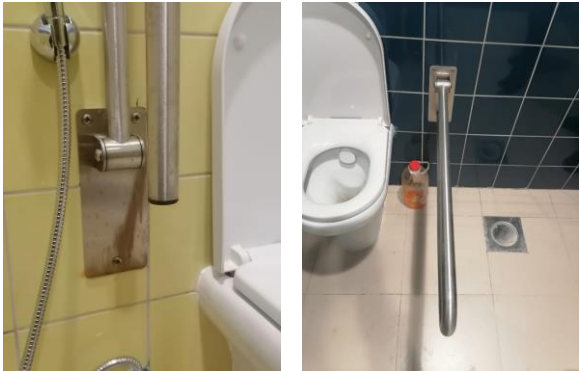
15	General	Handicapped toilets	Grab bars and other accessories are suffering corrosion and are not fixed properly	They need treatment		X	No Action Taken

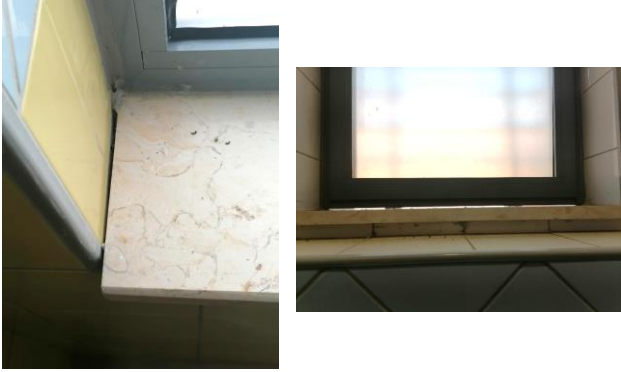
18	General	Toilet	Gap between window sill and jamb	Window sill shall be properly fit		X	No Action Taken

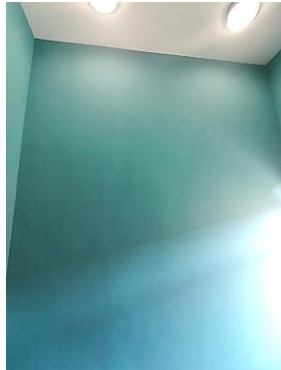
33	General	General	Plastering works should be completed at the staircase	—		X	No Action Taken

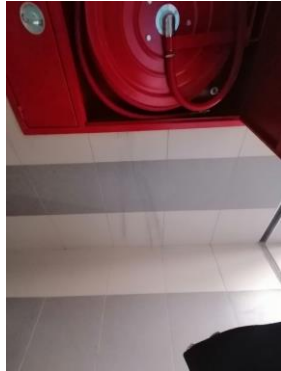
34	Second Floor	Corridor Next to the Teacher Center	Water leakage was observed in one of the fire hose cabinets	—		X	No Action Taken

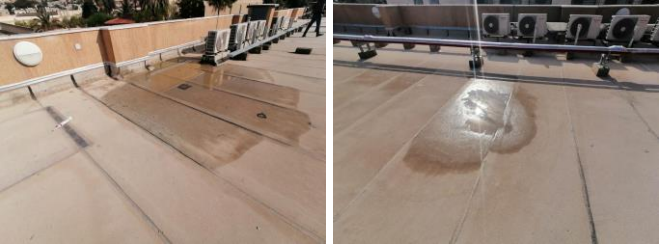
35	Roof Floor	Top Roof	Water pools were observed on the top of roof resulted from wrinkles in the bitumen sheets	—		X	No Action Taken

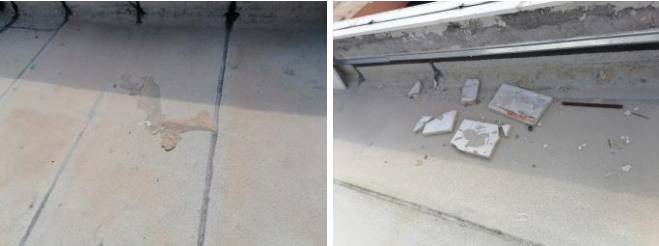
36	Roof Floor	Top Roof	Roof must be cleaned from waste and debris	—		X	No Action Taken

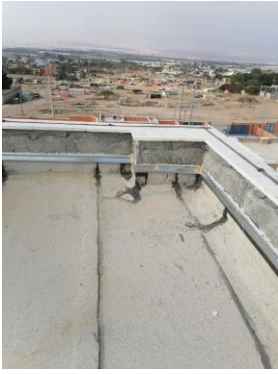
38	Roof Floor	Top Roof	Colored plastering works are not completed	—		X	No Action Taken
