SKEP III Home Office Support Site Visit Report

Consultant	Wahib Medanat Consultant Engineer	Rep No.	23-27032022
Contractor	Dijlah Establishment Constr. Contracting	Tender No.	(11/2019/USAID/SKEP/3/S) Schools for a Knowledge Economy Project (SKEP) - Phase (3) Package (1, 2)
Site Name	Jumana Bint Abit Taleb Basic Mixed School - Jerash	Day/ Date	Sun. 27/03/2022
Duration of Project	450 Calendar Days	Total Project Budget	8,314,983.735 JD

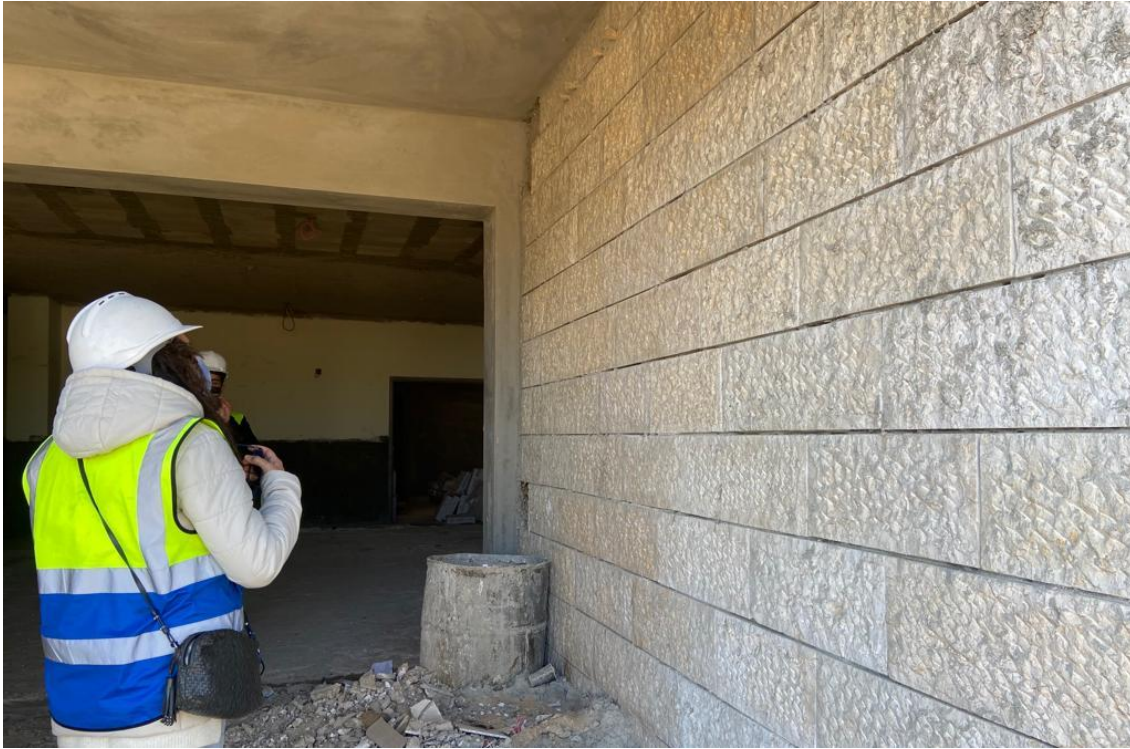
(Figure: 05)

No.	Description
1	The team observed that the built stones at the entrance still not rectified by Contractor as required.
2	The team inspected the installation of the aluminum flashing for the roof insulation and stressed on the Contractor to fill the mastic under the flashing correctly.
3	The team observed the unacceptable status of granite cladding for the staircases and stressed on the Contractor to rectify all defected parts due to wrong cutting of granite pieces.

The team observed that the built stones at the entrance still not rectified by Contractor as required

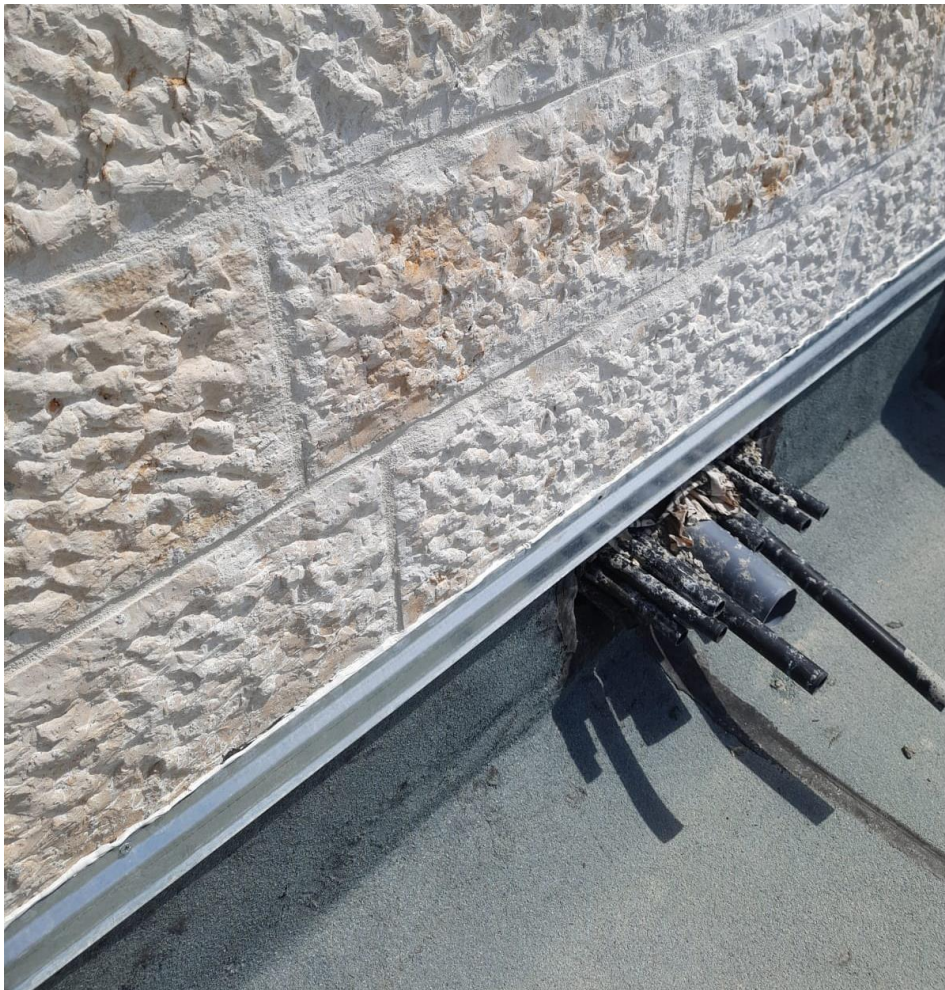
(Figure: 06)

The team inspected the installation of the aluminum flashing for the roof insulation and stressed on the Contractor to fill the mastic under the flashing correctly

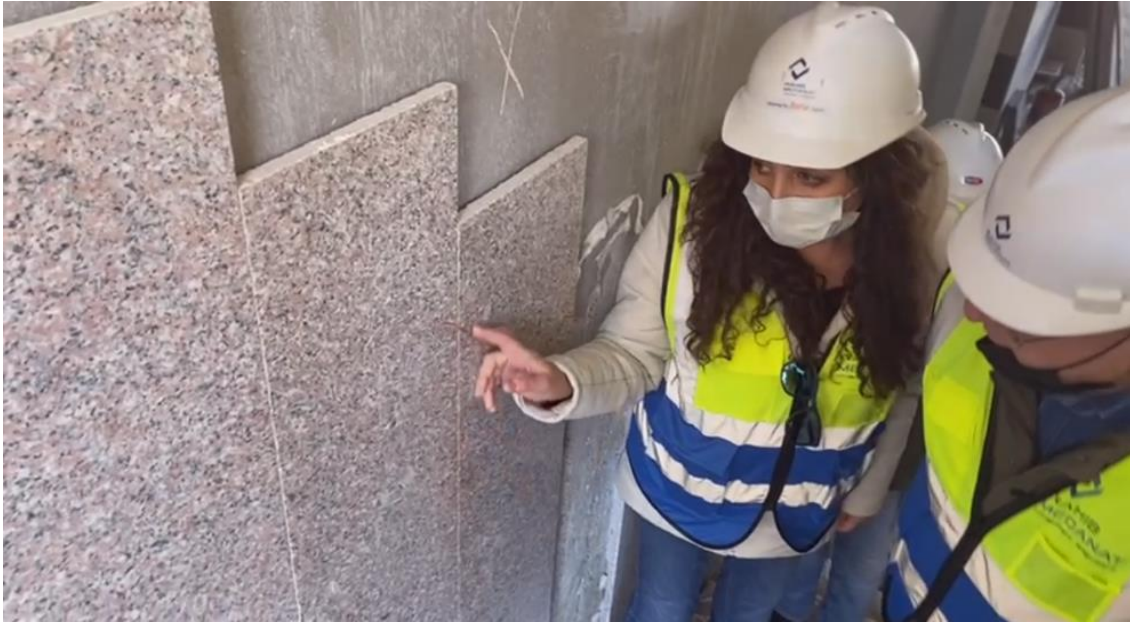
(Figure: 08)

The team observed wrong cutting of granite pieces at the staircases and stressed on the Contractor to rectify all defects

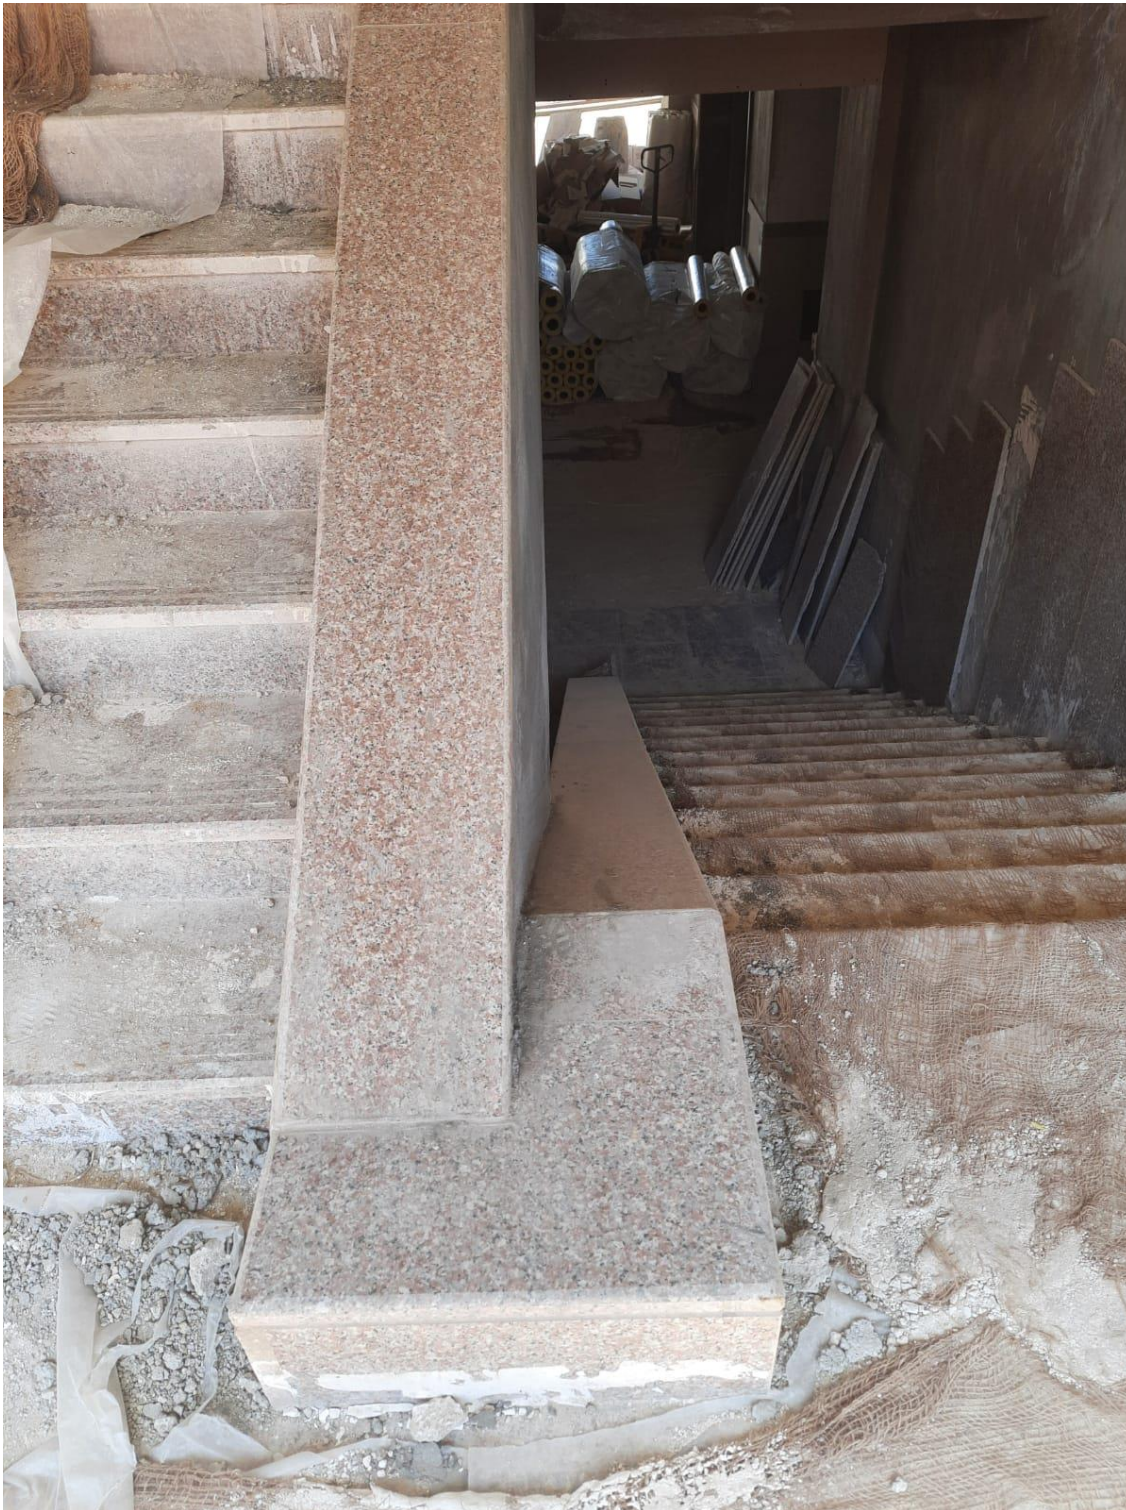
(Figure: 10)

The team inspected the executed granite for staircase parapets

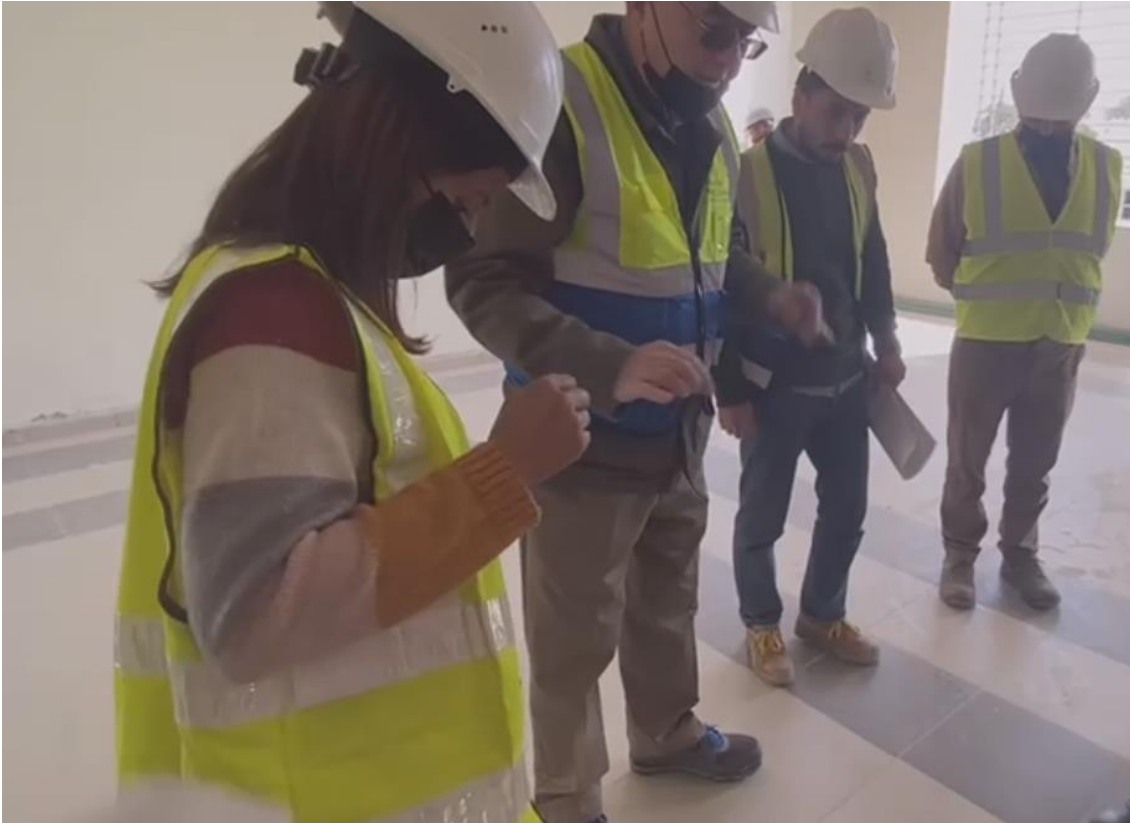
(Figure: 11)

The team inspected the executed porcelain floor tiles and stressed on the Contractor to replace any teething cases

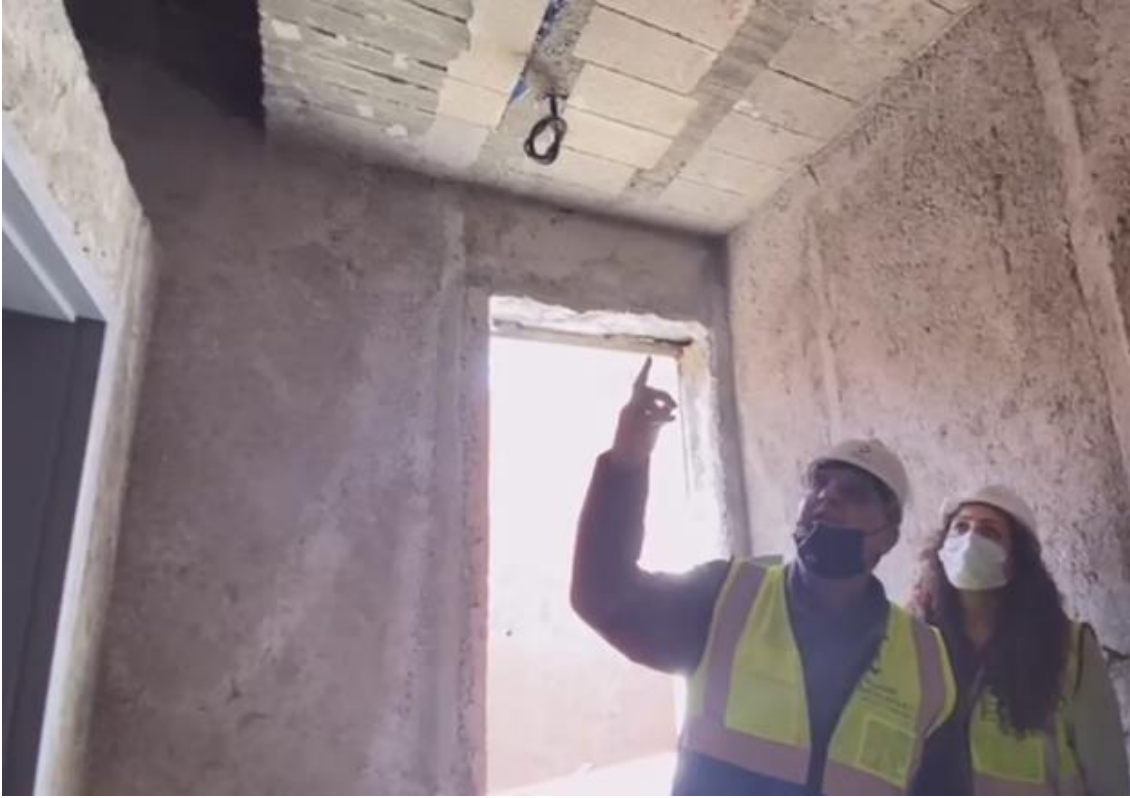
(Figure: 13)

The team inspected the built block above false ceiling at the wet area in the multi-purpose hall and stressed on the Contractor to fill all gaps between blocks before installing the suspended ceiling

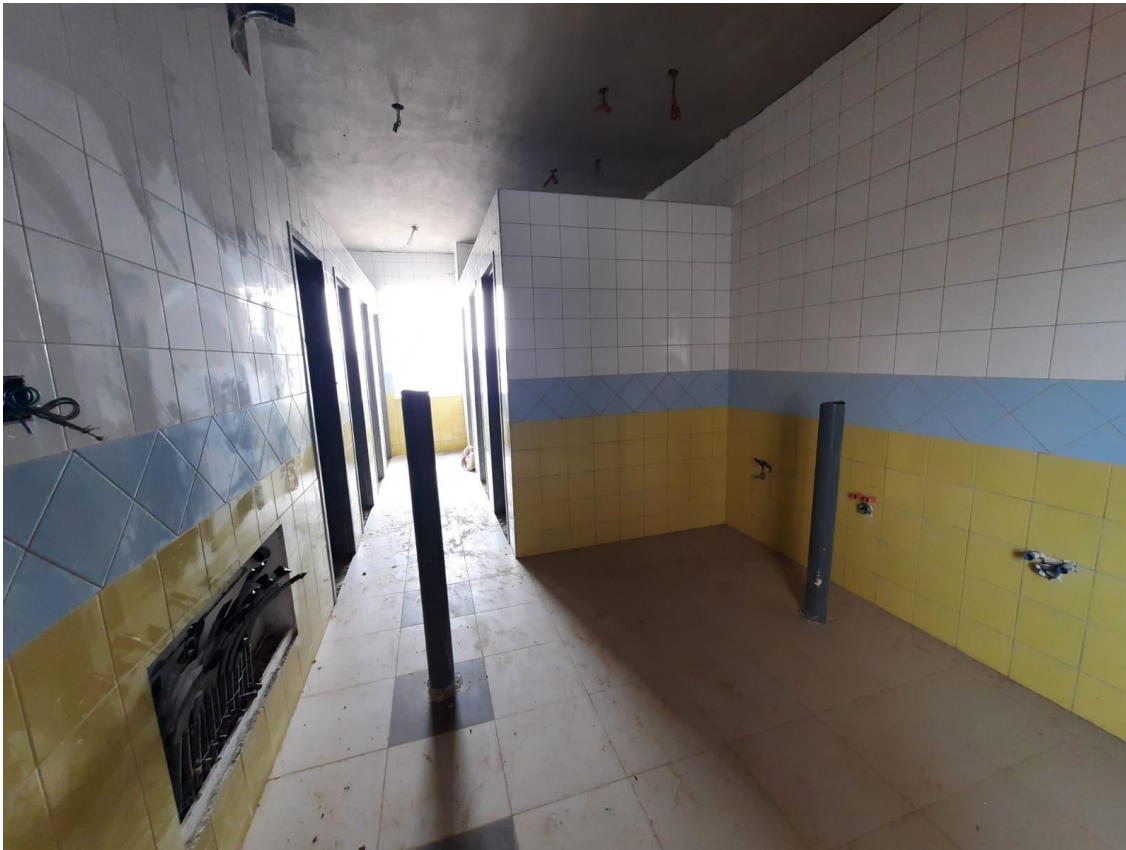
(Figure: 15)

The team inspected the ceramic tiling work for the walls at the wet area

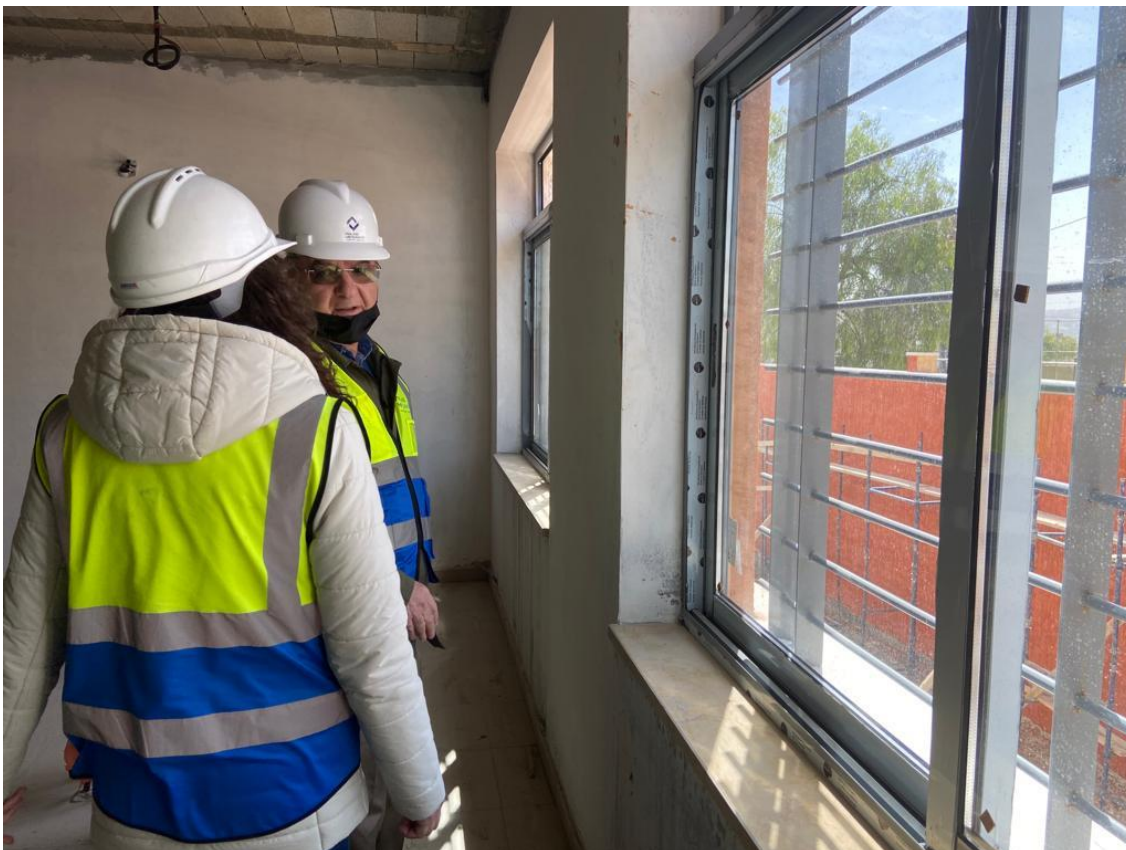
(Figure: 16)

No.	Description
4	The supervision team observed that in number of windows, the aluminum sections do not match the actual dimensions of the opening. Therefore, those sections should be replaced.
5	The team inspected the executed porcelain floor tiles and stressed on the Contractor to replace any teething cases.
6	The team inspected the built block above false ceiling at the wet area in the multi-purpose hall and stressed on the Contractor to fill all gaps between blocks before installing the suspended ceiling.
7	The team inspected the electro-mechanical installation work under the ceilings.
8	The team inspected the ceramic tiling work for the walls at the wet area.
9	The team Inspected the executed granite for staircase parapets.

The supervision team observed that in number of windows, the aluminum sections do not match the actual dimensions of the opening. Therefore, those sections should be replaced

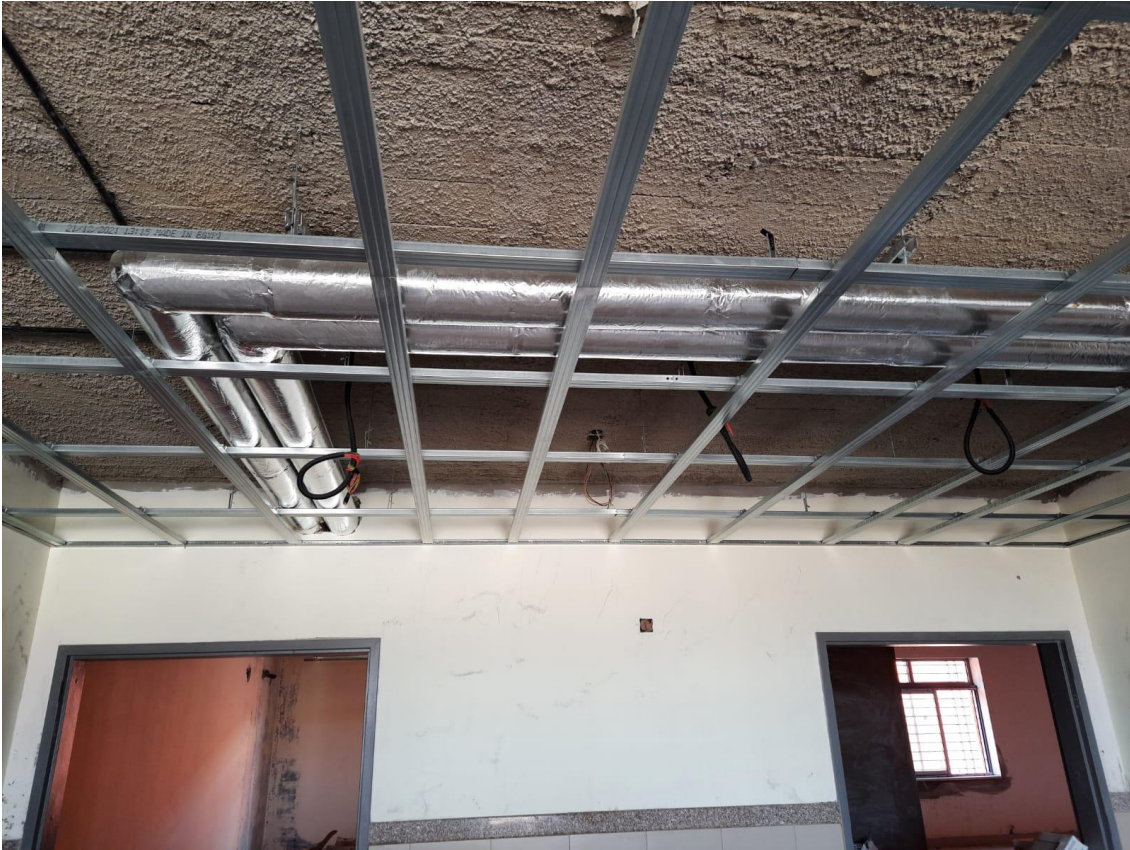
(Figure: 17)

The team inspected the electro-mechanical installation work under the ceilings
