SKEP III Home Office Support Site Visit Report

Consultant	Wahib Medanat Consultant Engineer	Rep No.	22-17072022
Contractor	Dijlah Establishment Constr. Contracting	Tender No.	(11/2019/USAID/SKEP/3/S) Schools for a Knowledge Economy Project (SKEP) - Phase (3) Package (1, 2)
Site Name	Thahr Al Sarow Basic School for Boys- Jerash	Day/ Date	Wed. 17/07/2022
Duration of Project	450 Calendar Days	Total Project Budget	8,314,983.735 JD

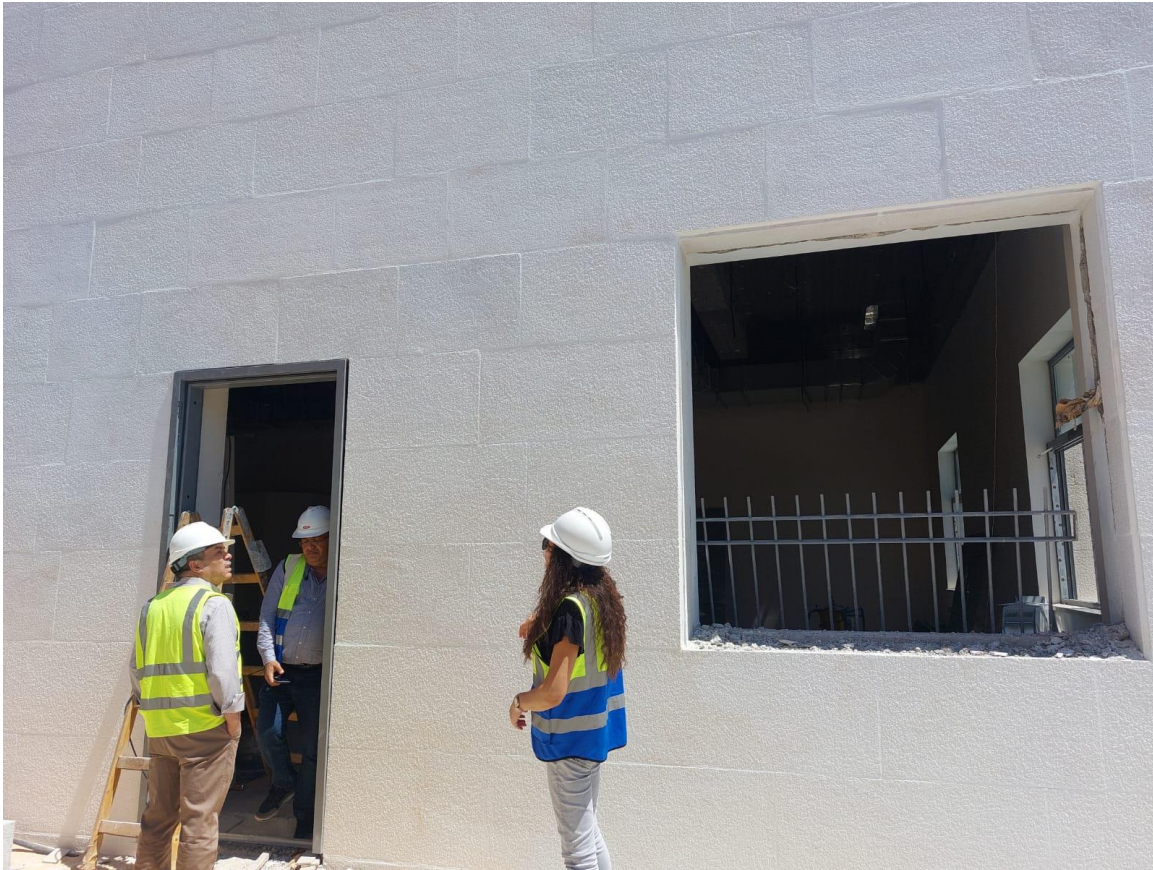
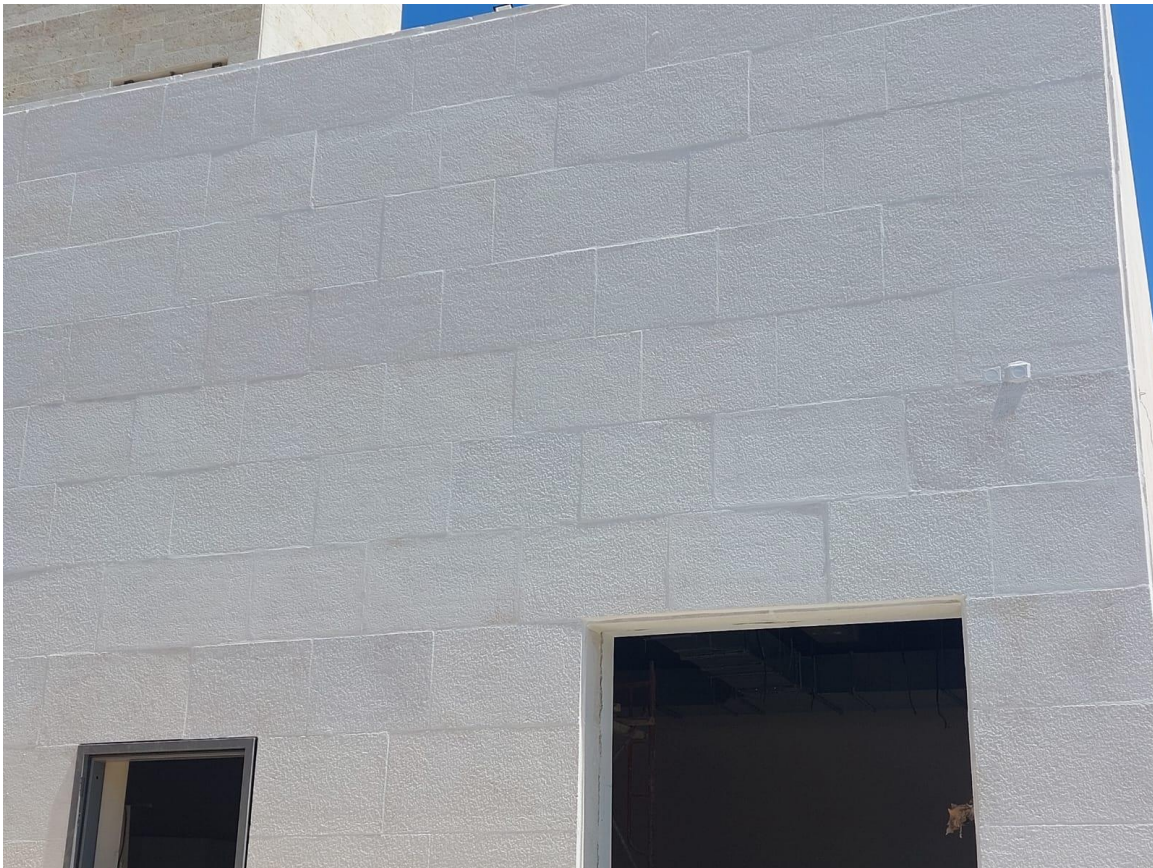
(Figure: 05 & 06)

The team observed clear and unaccepted teething in the newly re-built stone façade at the front elevation

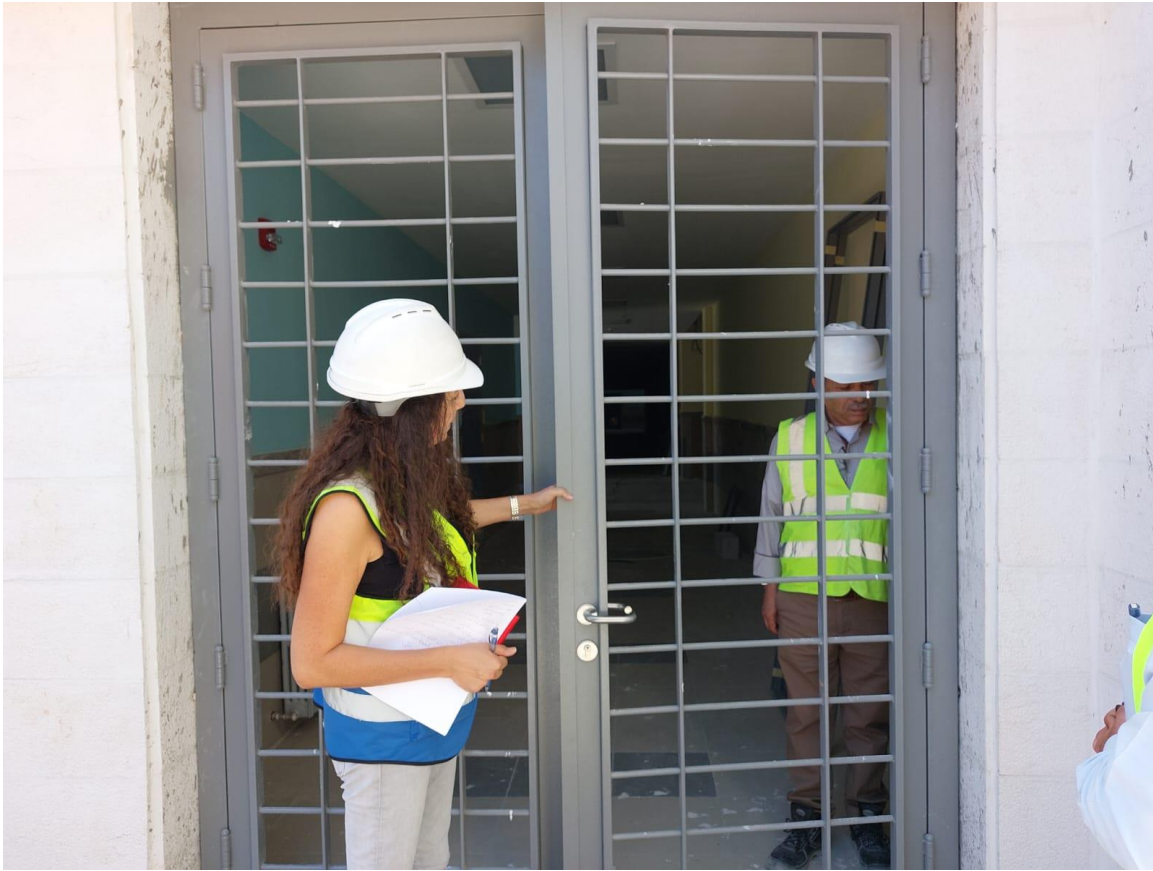
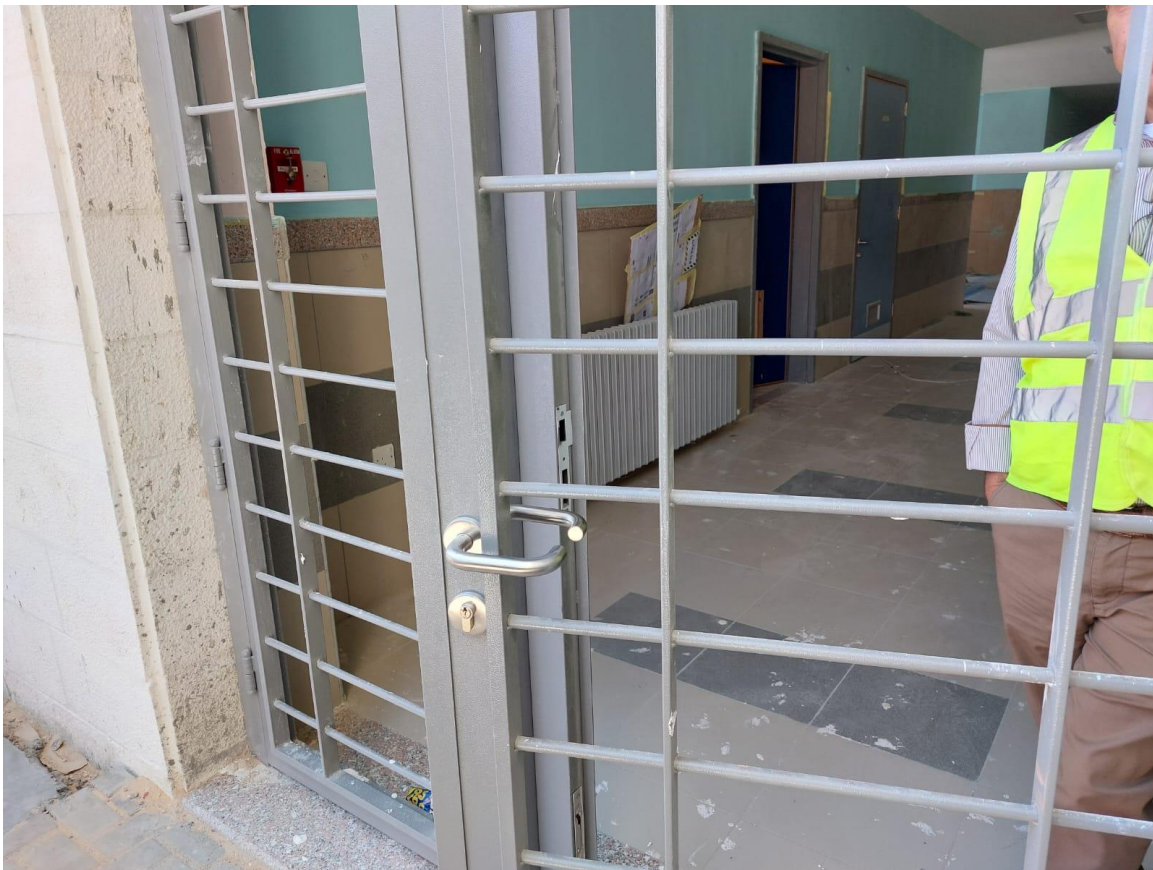
(Figure: 07 & 08)

The team requested the Contractor to rectify the installation of the external doors similar to the approved sample at Jumana Bint Abi Taleb school of the same package

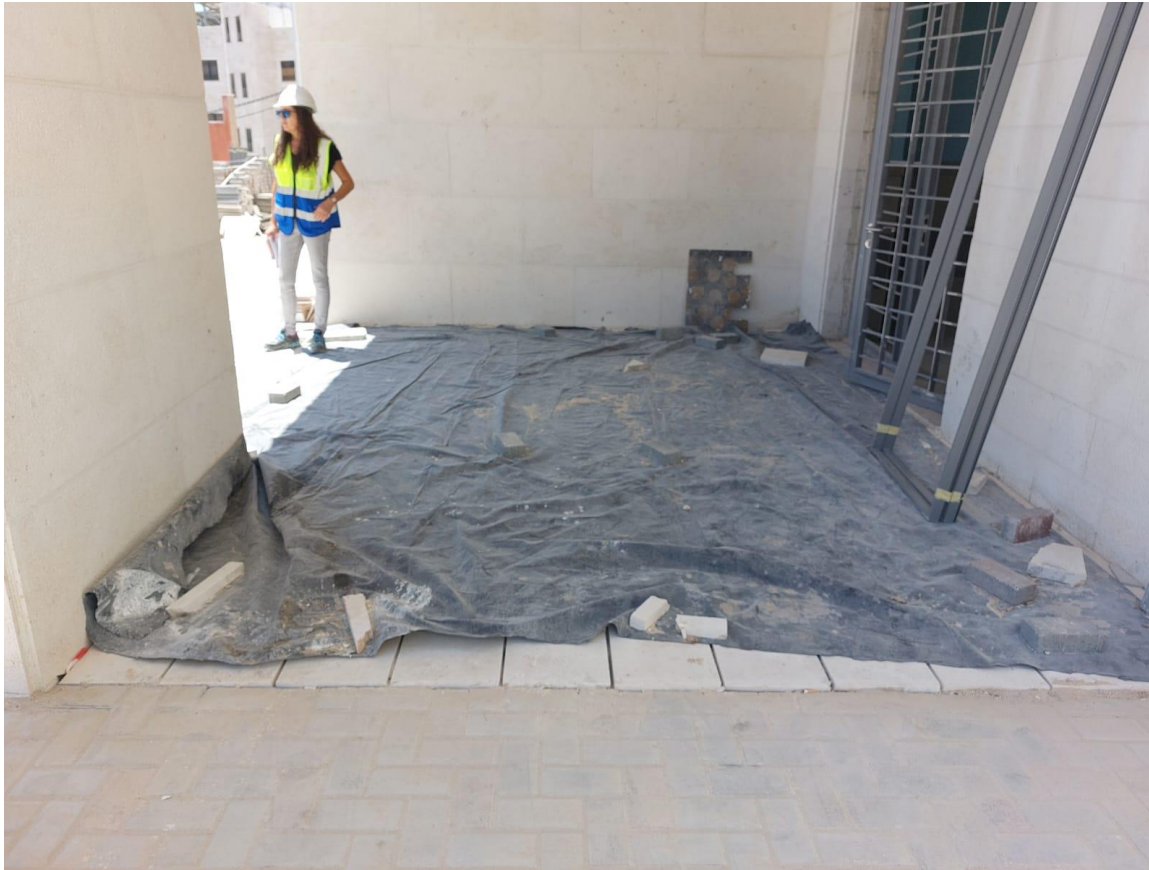
(Figure: 09)

The tiled stones at the entrance should be re-executed with slope towards outside to avoid the accumulation of rain water at the entrance

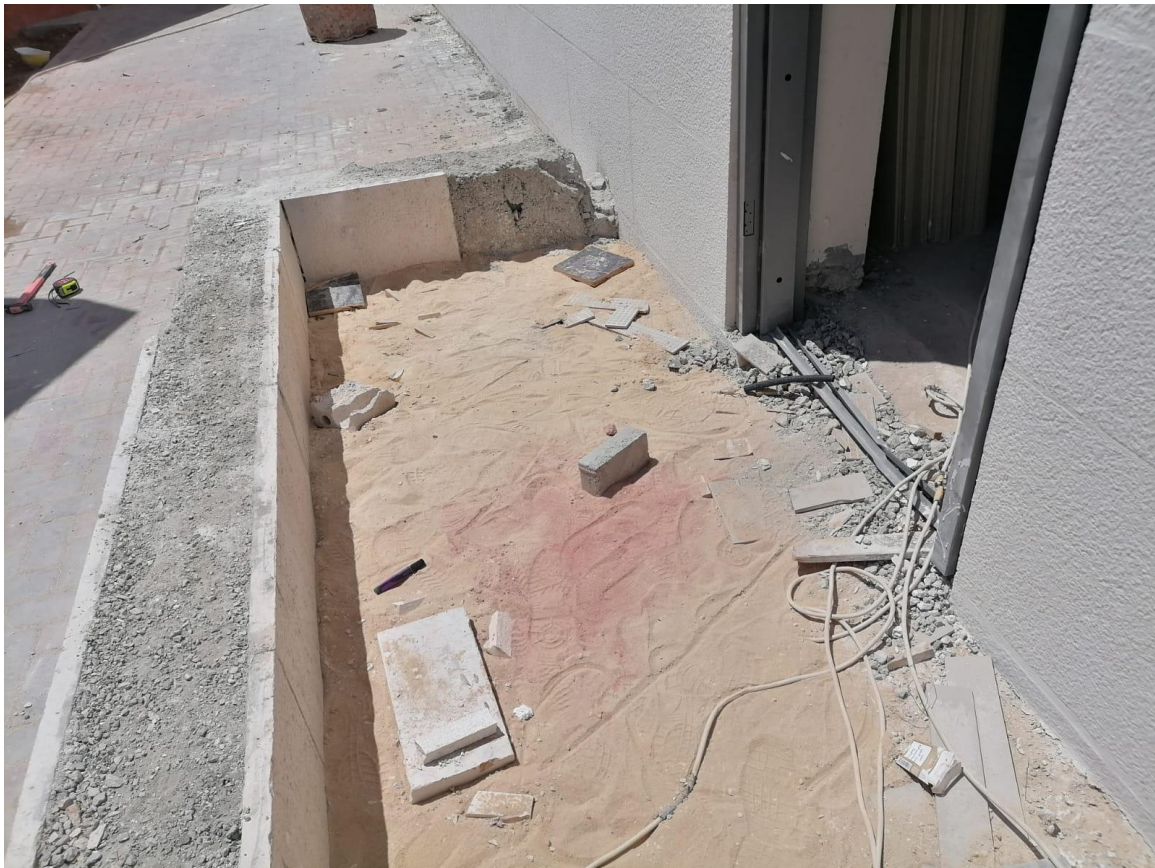
(Figure: 12)

The team discussed with the Contractor the execution of ramp for the disabled at the multi-purpose hall emergency exit

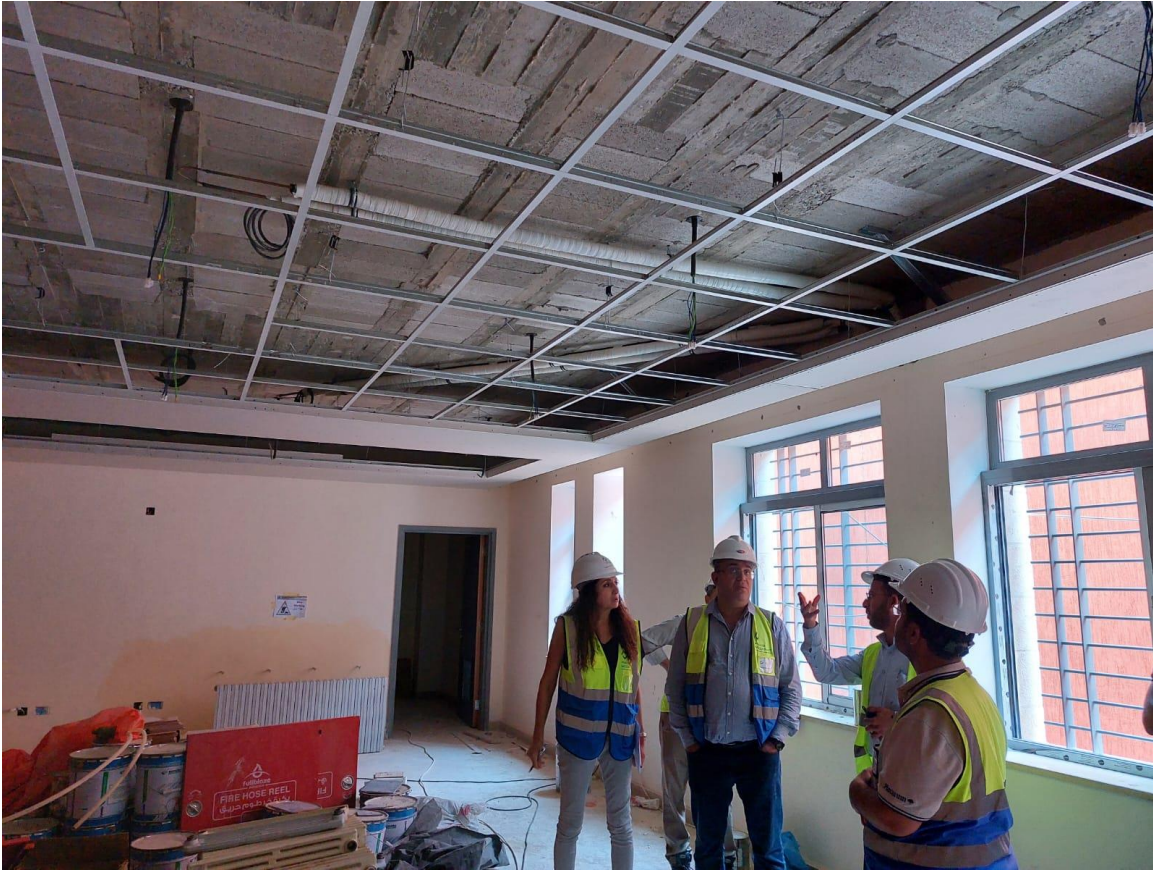
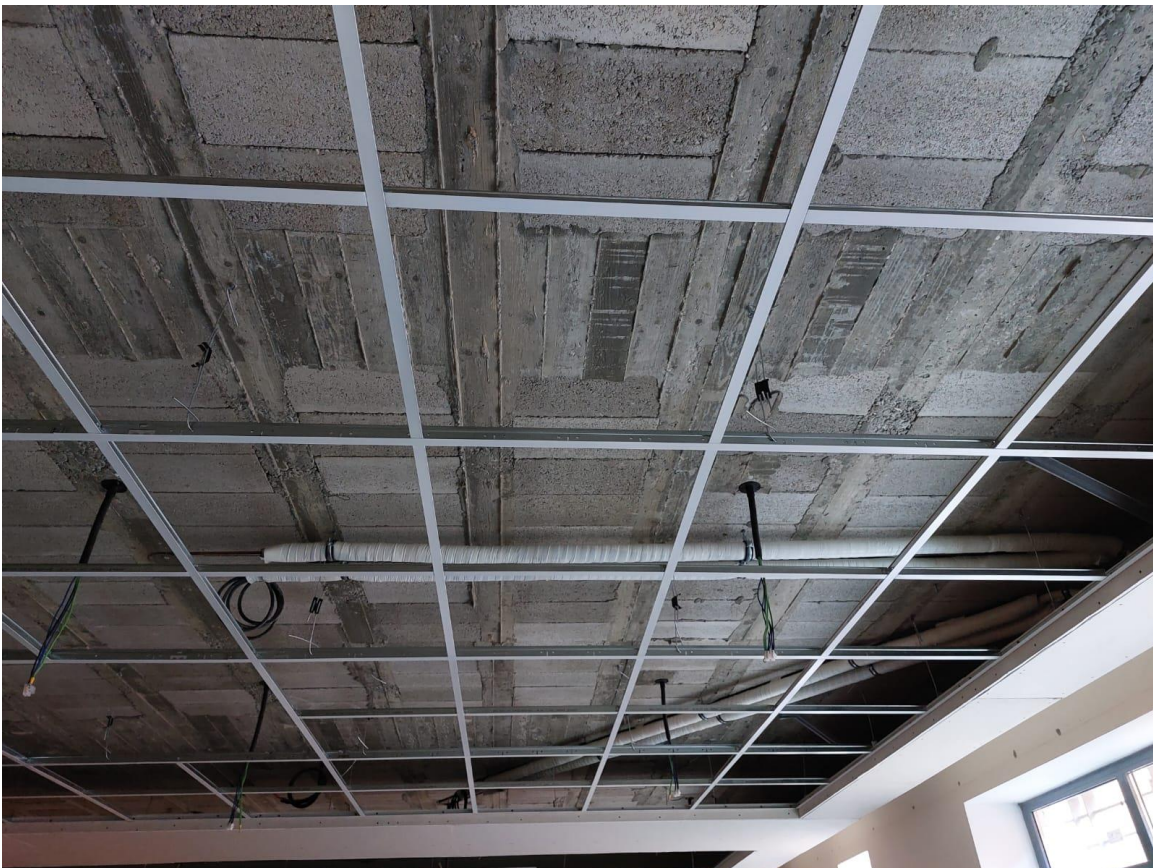
(Figure: 13 & 14)

The team discussed with the Contractor the process of installing hangers for the suspended ceiling frame at the library

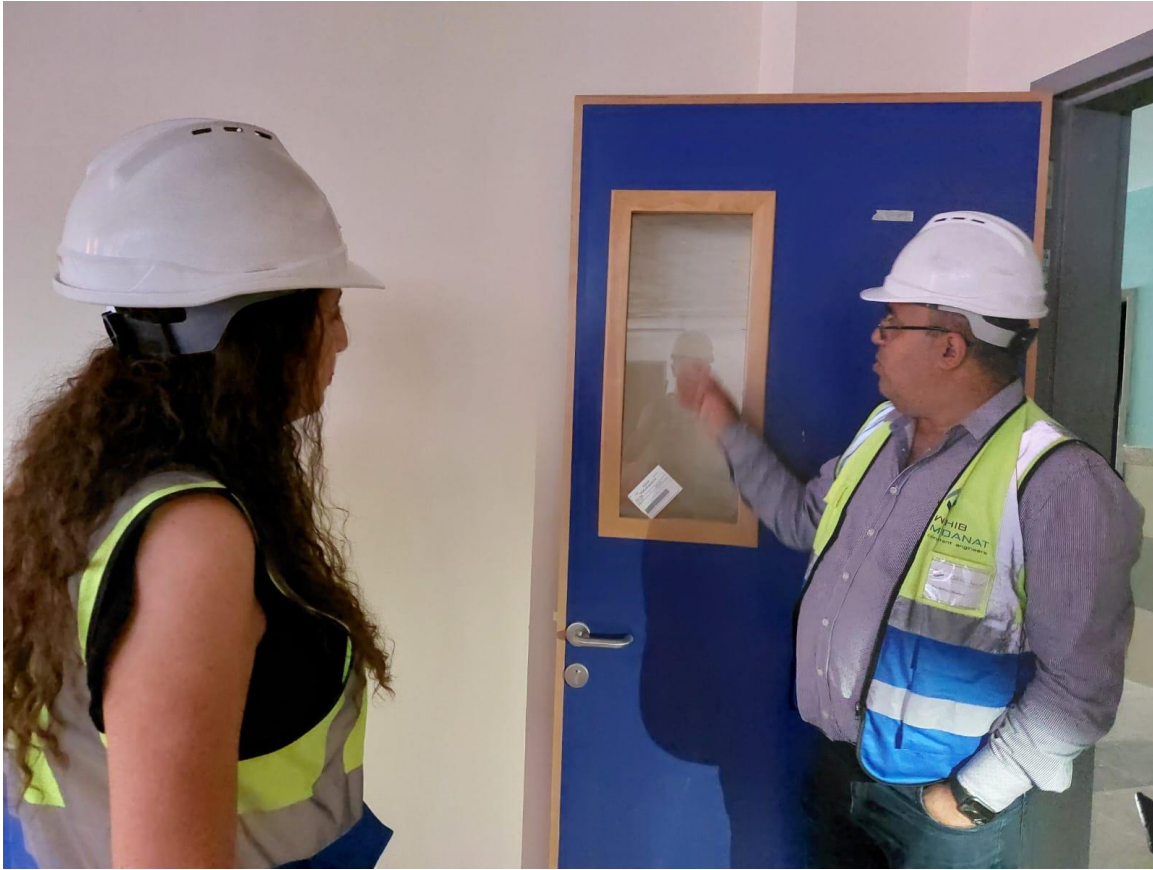
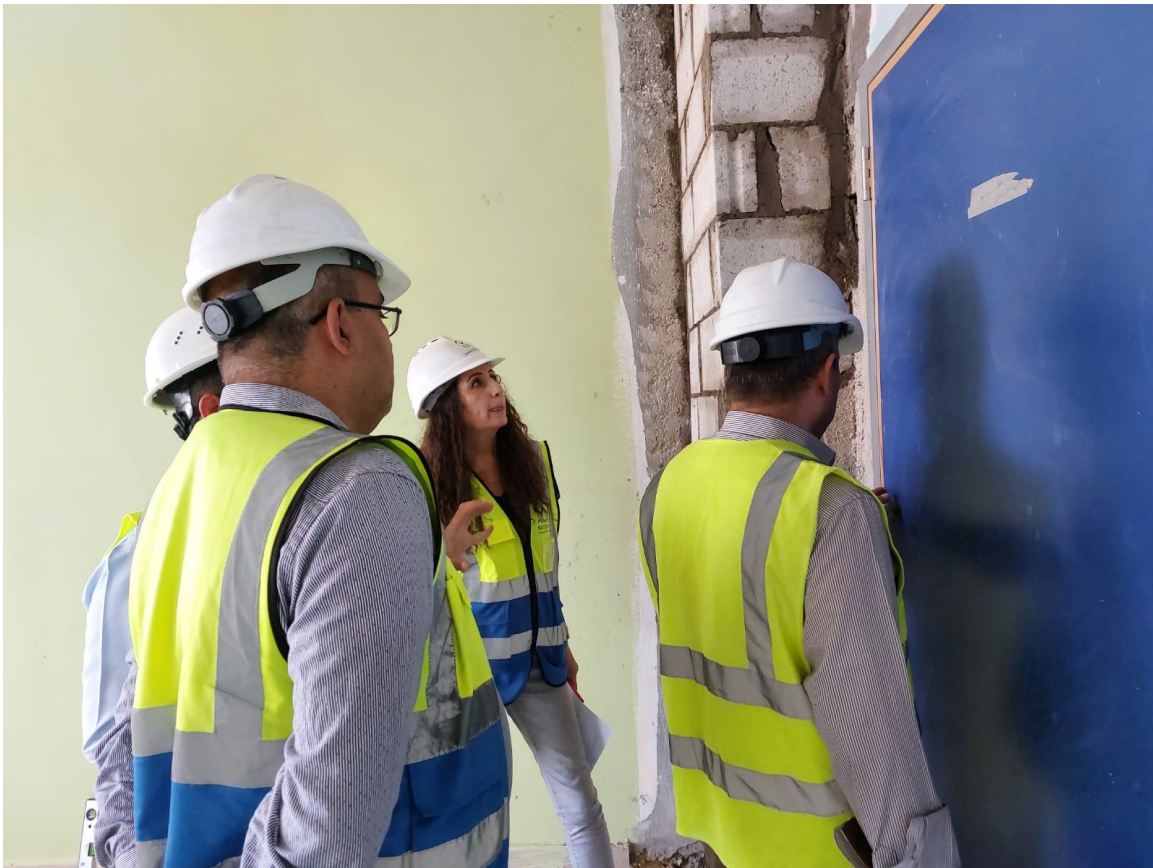
(Figure: 15 & 16)

The team conducted a check on the vision panel of the wooden doors and observed that the dimension of the panel is less than what is required in the drawings. Furthermore, defects in the laminated sheet cutting were observed (not sharp)

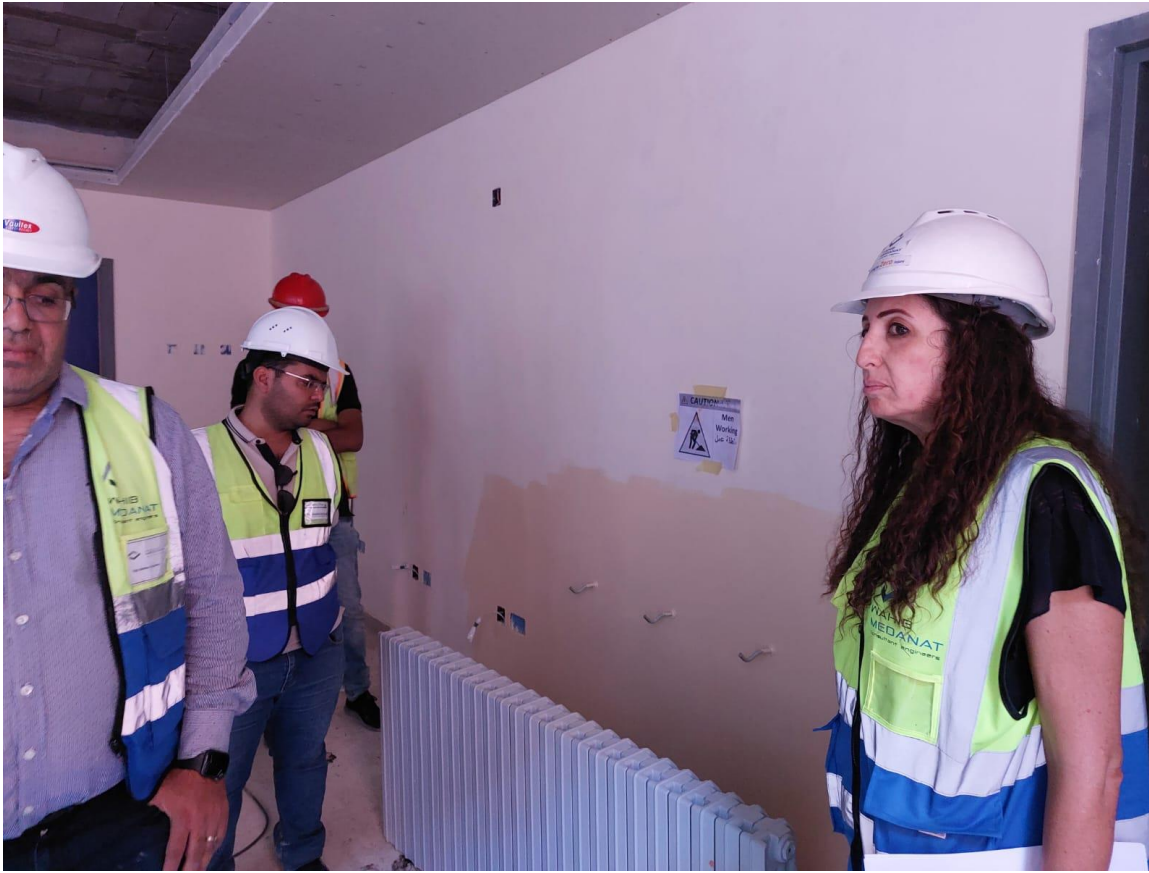
(Figure: 17)

The team requested the Contractor to continue the installation of heating radiators

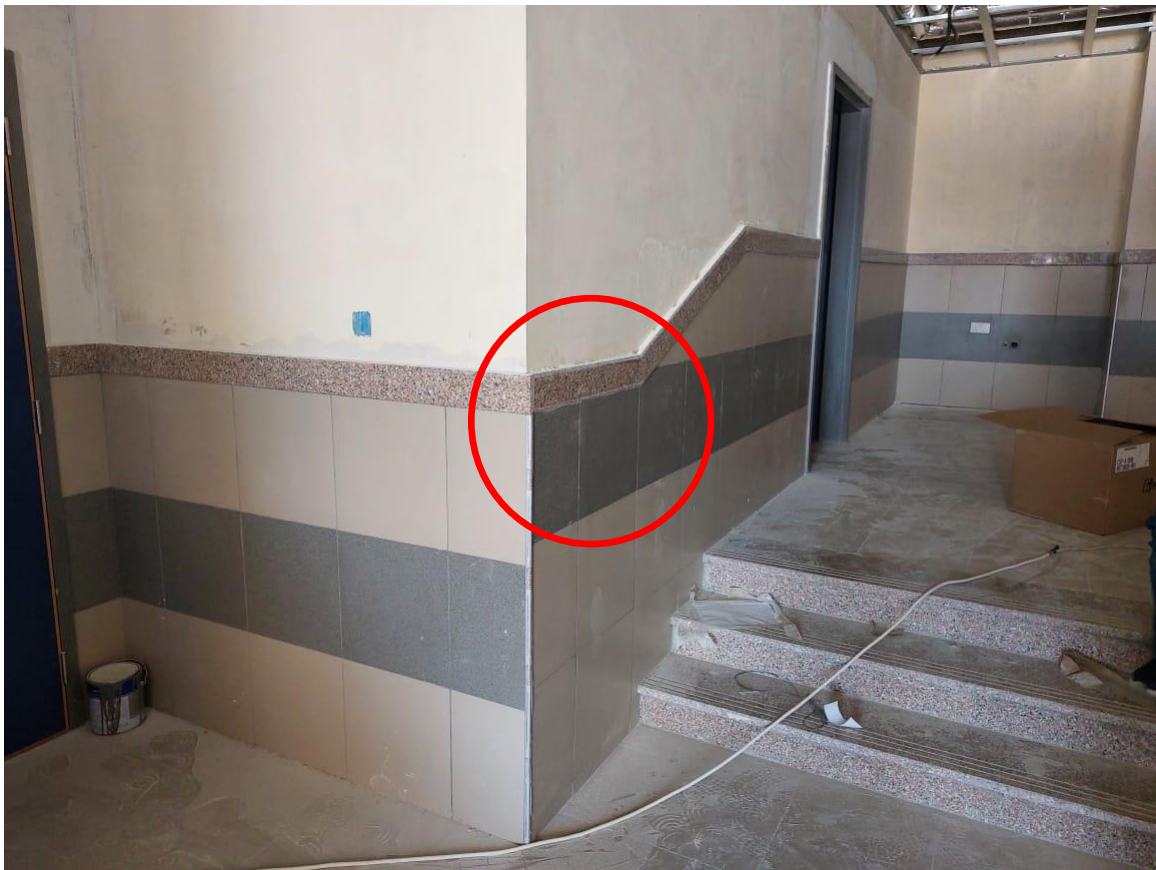
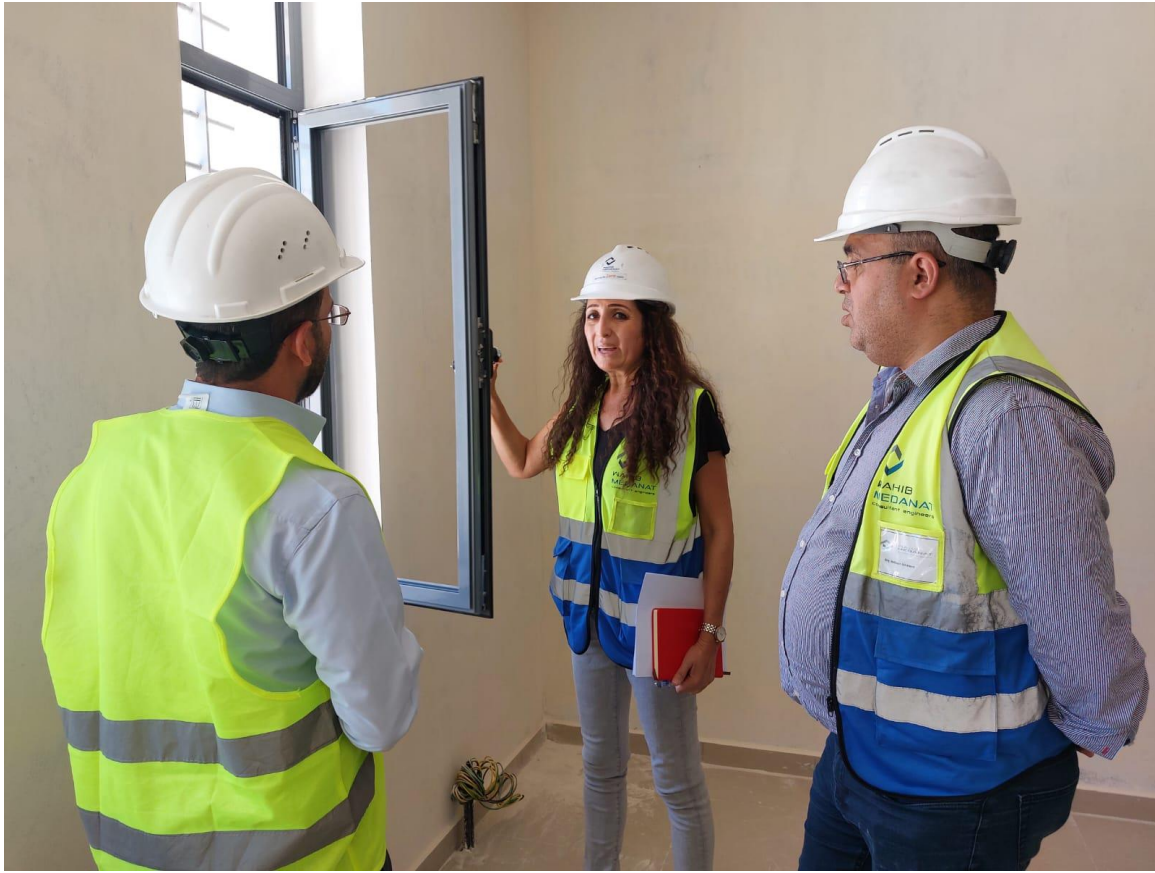
(Figure: 24 & 25)

The team observed that the Contractor haven't abide by the previously given instructions regarding the executed porcelain wall tiles at the building entrance- ramp area. The Contractor was requested to remove the dark colored strip to be replaced with the light colored tiles at the wall adjacent to the staircase

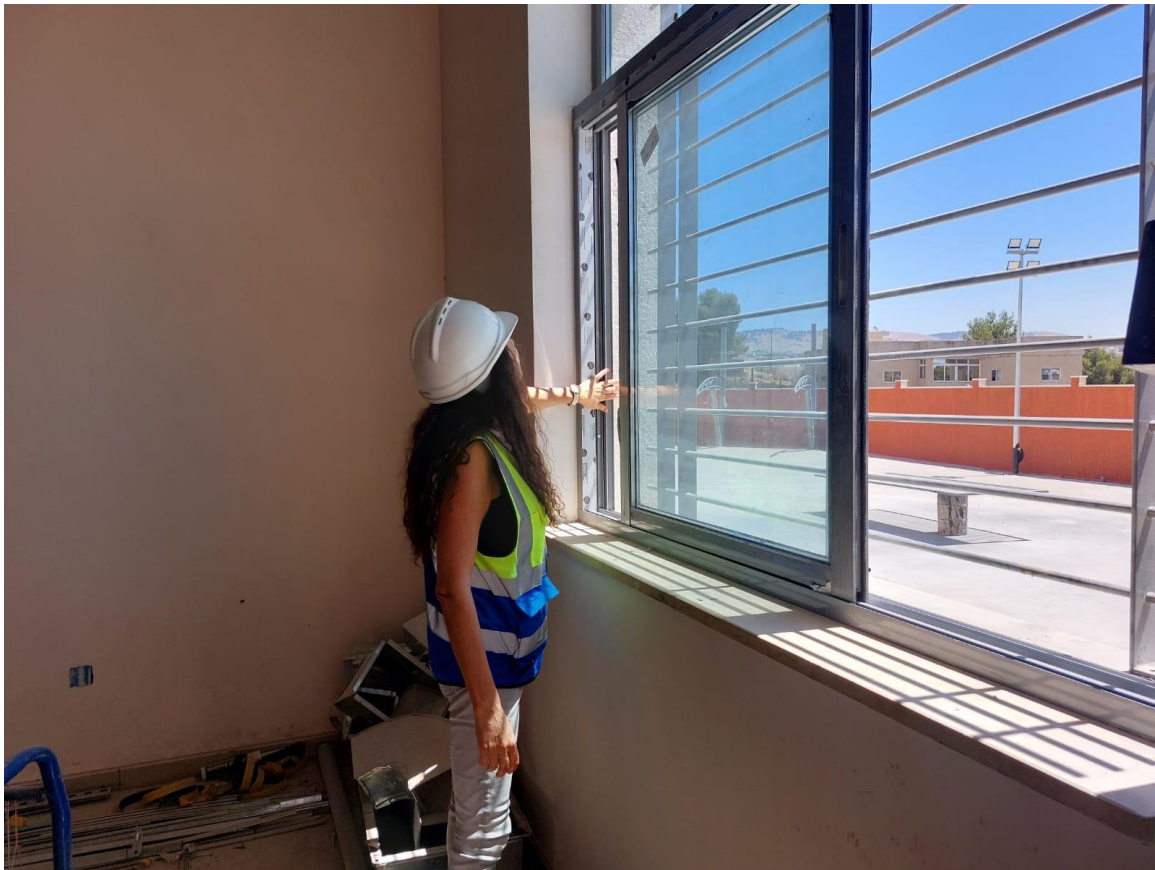
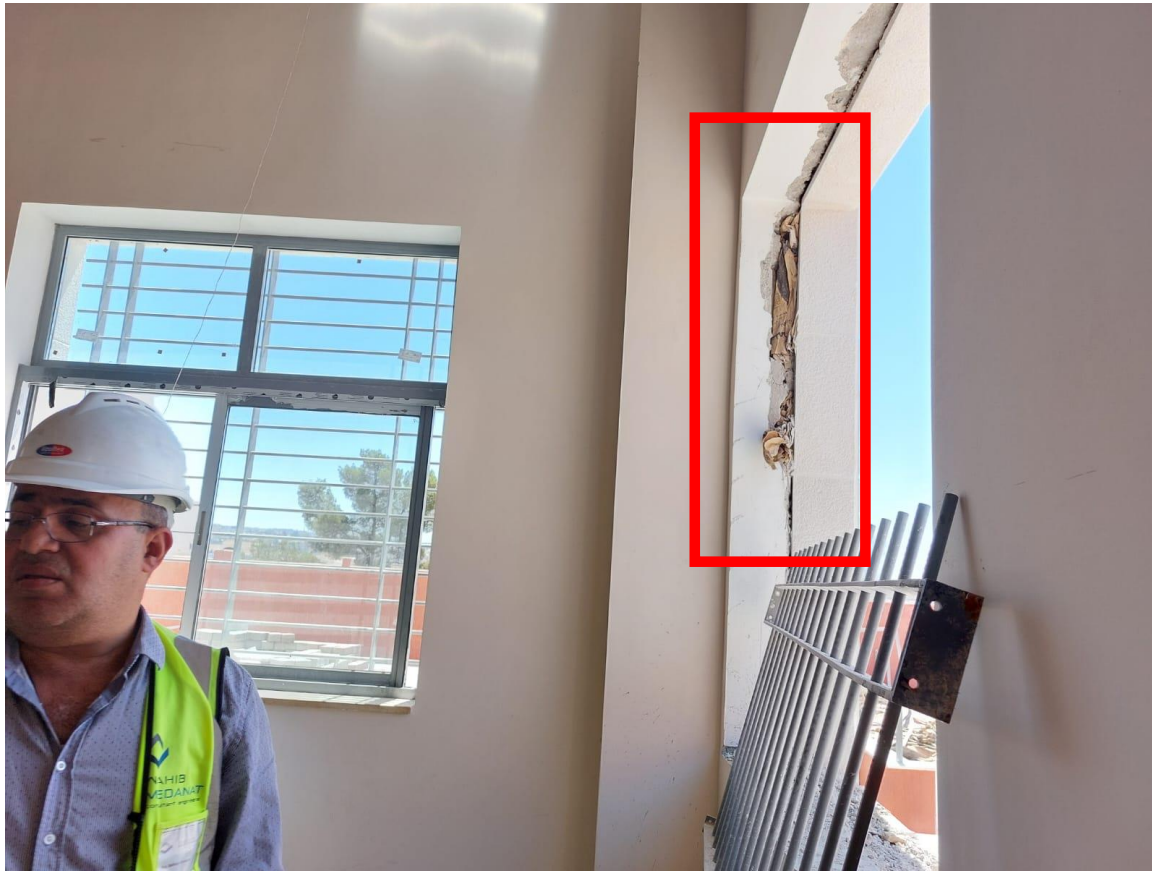
(Figure: 26 & 27)

Inspecting
the installed
aluminum
windows

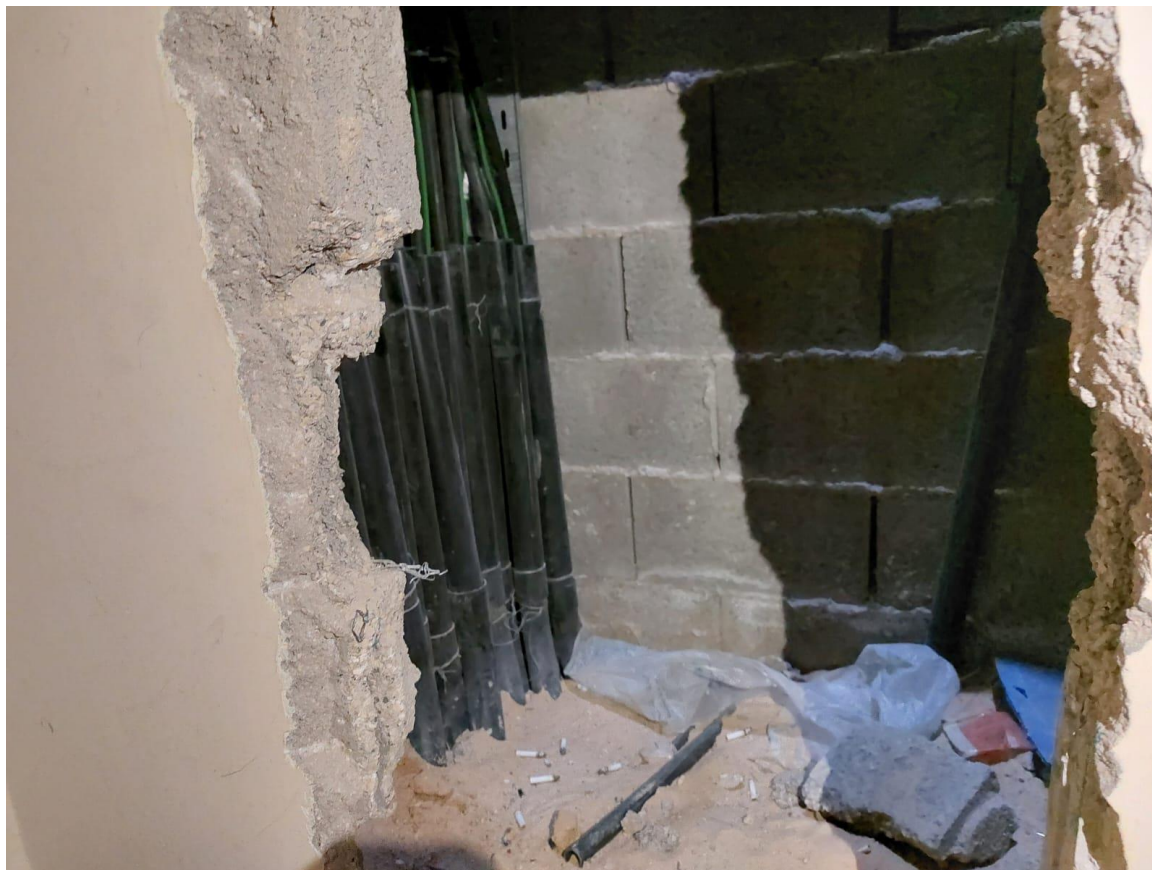
(Figure: 28)

No.	Description
5	The team observed that in one window jamb of the multi-purpose hall the Contractor used the material which the cement bags are made of. The team requested to conduct the necessary corrective action at that window jamb.
6	The team requested the Contractor to continue the installation of heating radiators.
7	The team discussed with the Contractor the process of installing hangers for the suspended ceiling frame at the library.
8	The team conducted a check on the vision panel of the wooden doors and observed that the dimension of the panel is less than what is required in the drawings. Furthermore, defects in the laminated sheet cutting were observed (not sharp).
9	The team observed that the Contractor to this date has not executed the blockwork partition between the Data cables and the Electrical cables at the shaft despite the team request during the previous site visit.
10	The team requested the Contractor to rectify the installation of the external doors similar to the approved sample at Jumana Bint Abi Taleb school of the same package.

The team observed that in one window jamb of the multi-purpose hall the Contractor used the material which the cement bags are made of. The team requested to conduct the necessary corrective action at that window jamb
