School for  
Knowledge Economy Project (SKEP)  
Phase III – Package 1

Defects Liability Period/ General Observations

Periodic Site Visits/ February 14, 2023

Al Khansa' Basic Mixed School

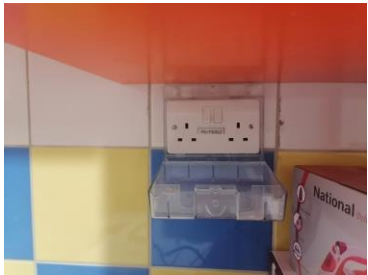
No.	Floor	Function	Defect	Comments	Action Taken		Status	Photo <input type="checkbox"/>
					√	x		
1	Ground Floor	Kitchen	Some electrical wall sockets at the kitchen are not working	—		X	No Action Taken

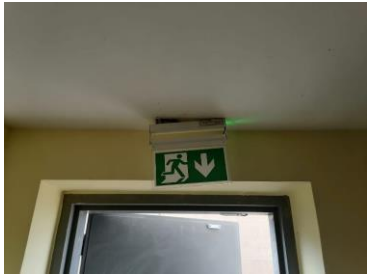
2	Ground Floor	Entrance Door	Emergency exit light needs fixation	—		X	No Action Taken

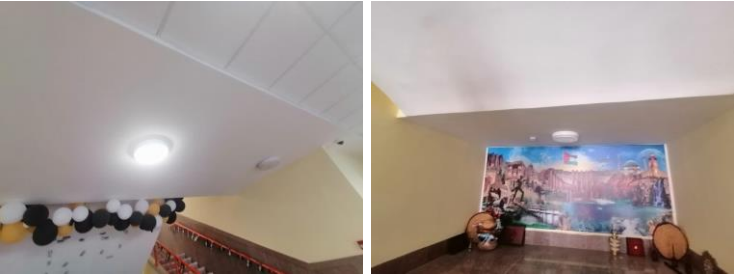
3	Ground Floor	School entrance	Staircase lighting fixtures are not working	<b>They need maintenance</b>		X	No Action Taken

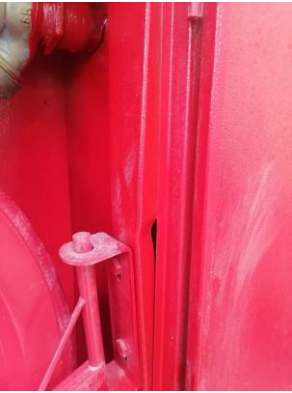
5	Ground Floor	<p>Next to the multi-purpose hall</p>

<p>Defects in the fire hose cabinet can be observed</p>	—		X	No Action Taken

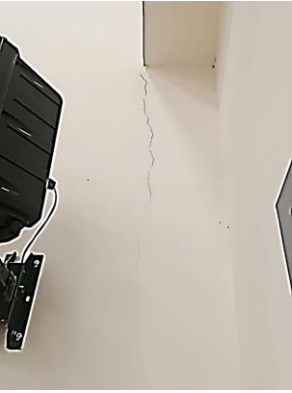
6	Ground Floor	<p>Multi-purpose hall</p>

<p>Slight cracks can be observed</p>	—		X	No Action Taken

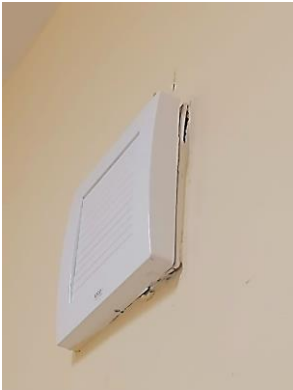
7	Ground Floor	Multi-purpose hall

The area around the ventilation fan in the service room needs treatment, and the ventilation fan itself is not working	—		X	No Action Taken

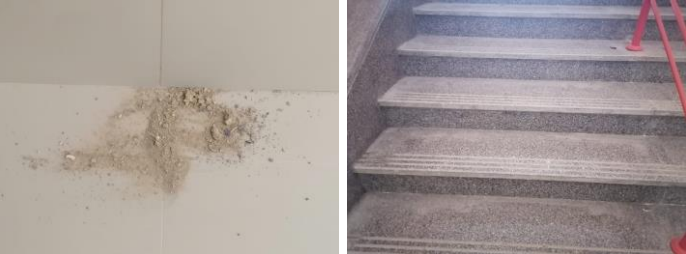
8	All Floors	General	Overall cleaning is required	—		X	No Action Taken

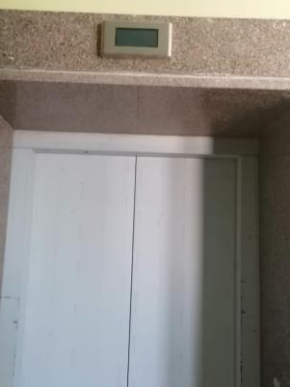
9	All Floors	General	The Elevator is out of service	—		X	No Action Taken

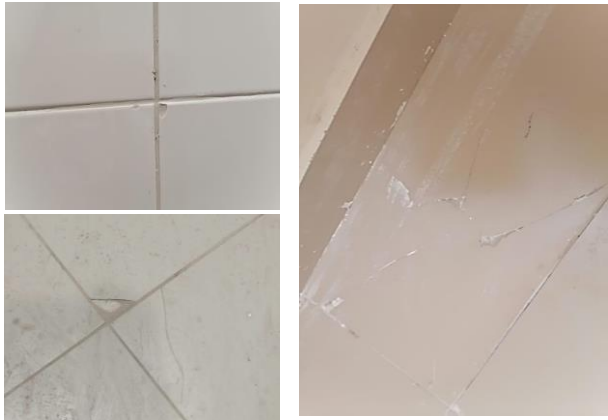
22	General	General	There are some broken tiles at the toilets and some other rooms	—		X	No Action Taken

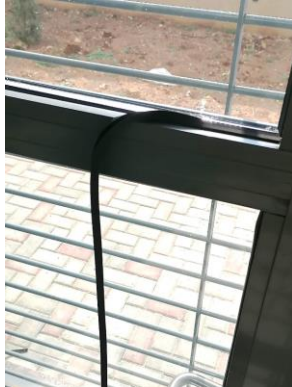
24	First Floor	Corridors	Defects in one steel door at the back of the school	—		X	No Action Taken

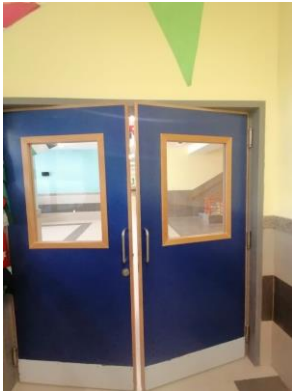
25	Second Floor	Corridor	The Swinging door needs adjustment	—		X	No Action Taken

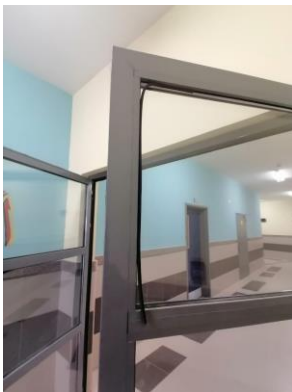
26	Second Floor	Corridor	Defects in one aluminum door	—		X	No Action Taken

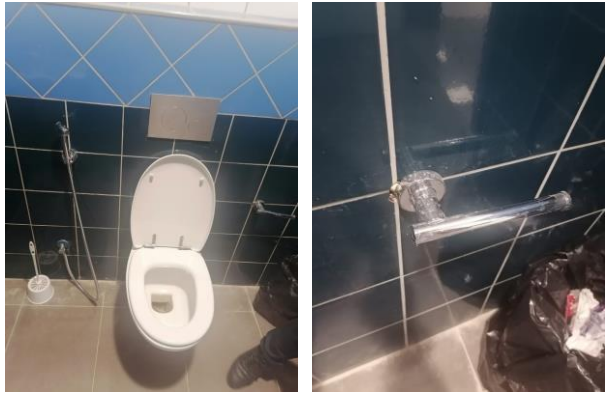
28	Third Floor	Teacher's room toilet	Water leakage from the flush button and the same toilet accessories need to be fixed properly	—	X	No Action Taken

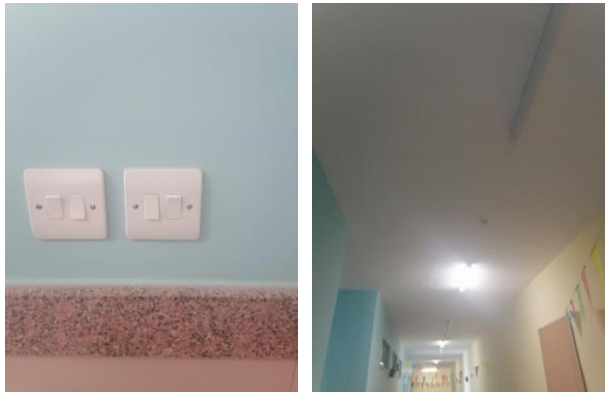
29	Third Floor	Corridor	Lighting fixtures need maintenance	—	X	No Action Taken

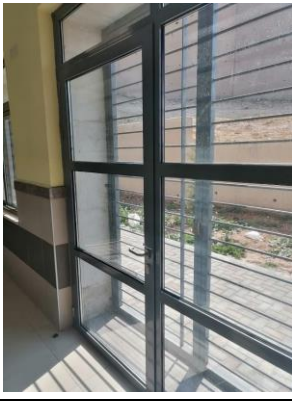
30	Third Floor	External door	External door needs adjustment	—	X	No Action Taken

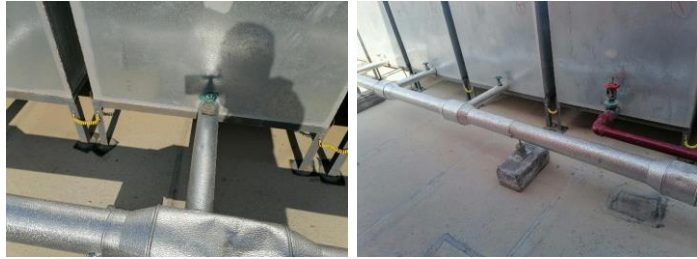
31	Roof Floor	Roof	Water tanks steel bases at the roof are not painted	—		X	No Action Taken

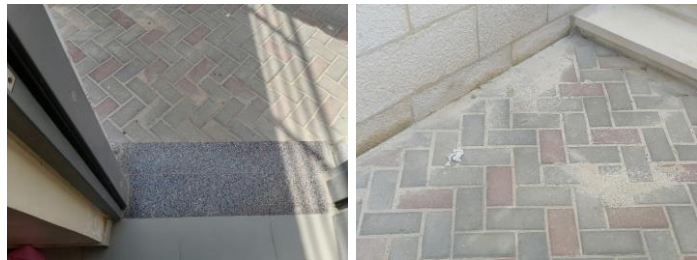
32	External Works-Site	Guard house entrance and multi-purpose hall external entrance	Water pools were observed	—		X	No Action Taken

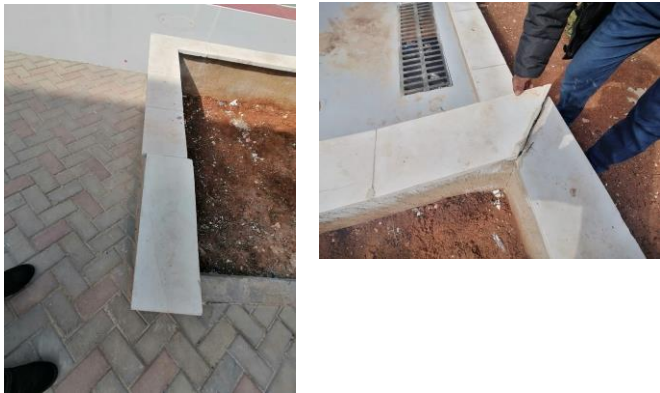
35	External Works-Site	Planters	Marble sills are not well installed (can be easily be removed by hand)	<b>Need to be installed Properly</b>		X	No Action Taken

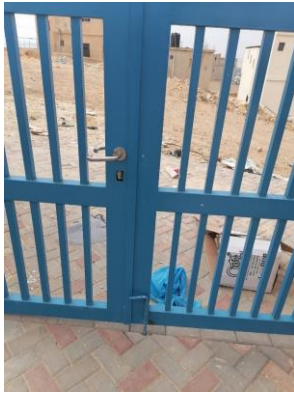
37	External Works-Site	Western Side	One of the school's main gates needs fixation	—		X	No Action Taken
