SKEP III Home Office Support Site Visit Report

Consultant	Wahib Medanat Consultant Engineer	Rep No.	11-21052022
Contractor	Derar Saraireh & Sons for Engineering & Contracting	Tender No.	(11/2019/USAID/SKEP/3/S) Schools for a Knowledge Economy Project (SKEP) - Phase (3) Package (1, 2)
Site Name	Um Al Dananir Basic Mixed School- Al Balqa	Day/ Date	Sat. 21/05/2022
Duration of Project	450 Calendar Days	Total Project Budget	9,789,417.840 JD

Visit Notes

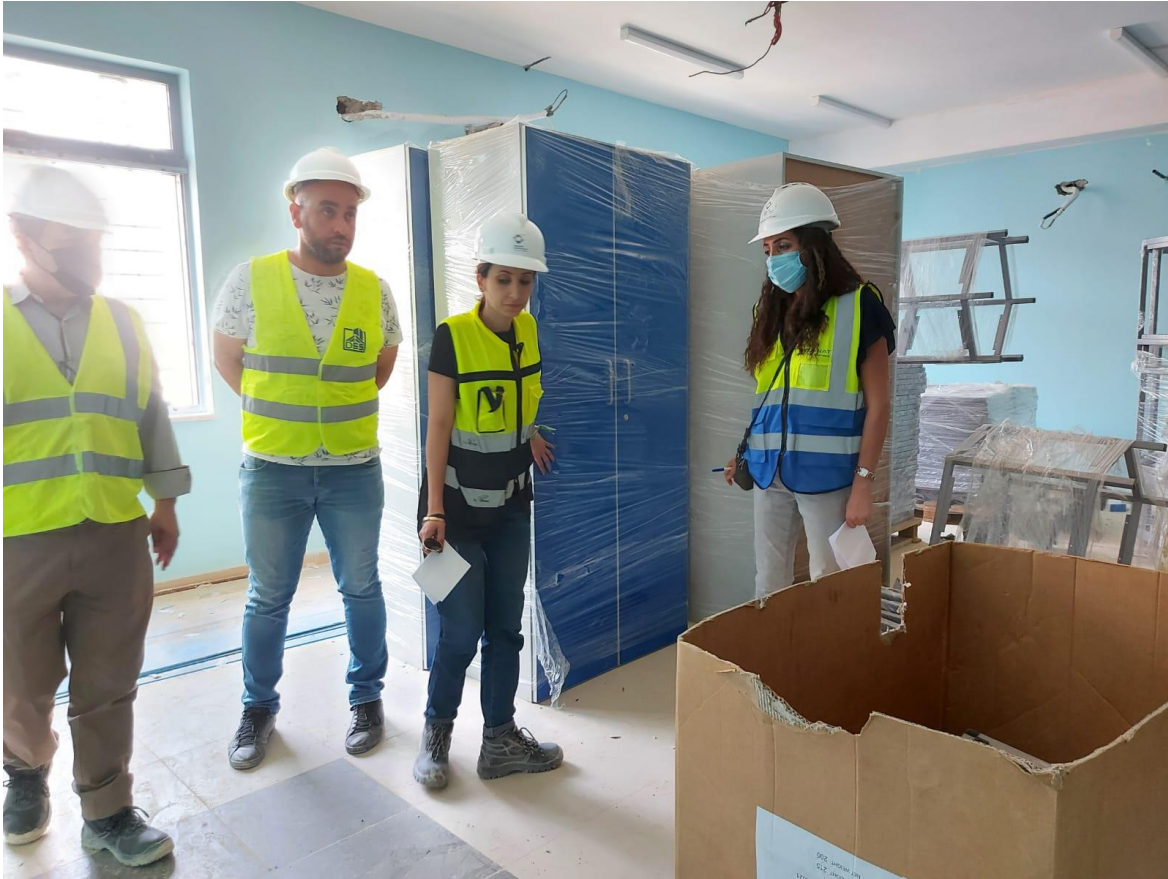
(figure:07)

The supervision team observed that the Contractor delivered the laboratory furniture to the site. The delivered furniture was inspected by the supervision team

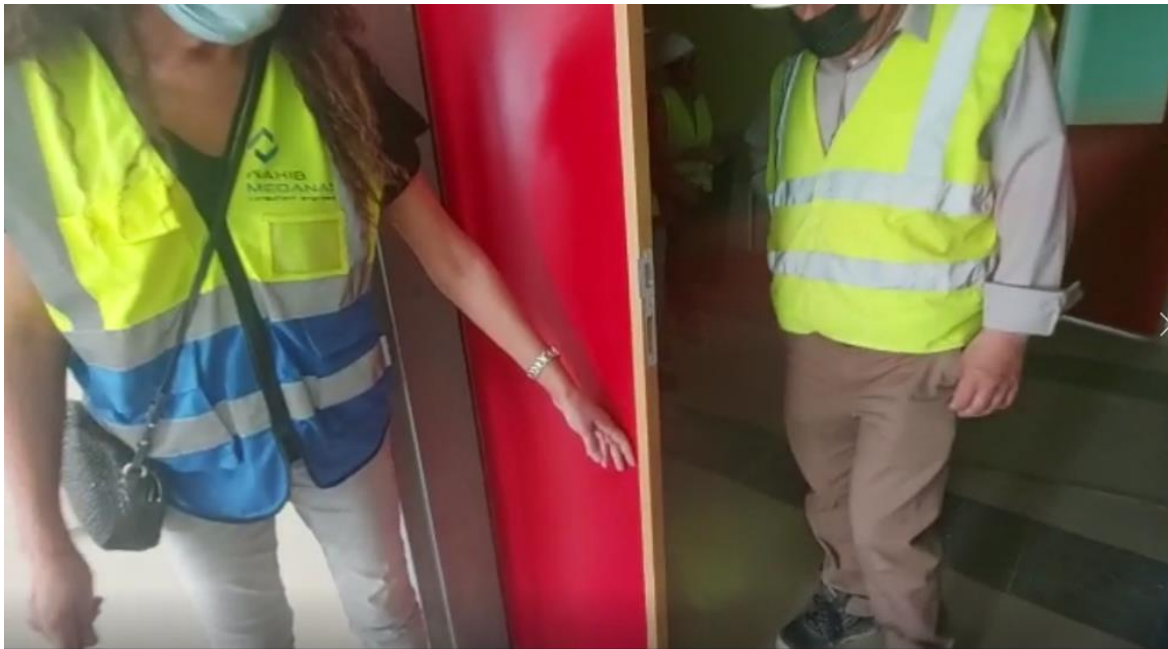
(figure:08)

The team observed some defects in the wooden doors related to the fixing of the accessories at the doors and requested the Contractor to rectify

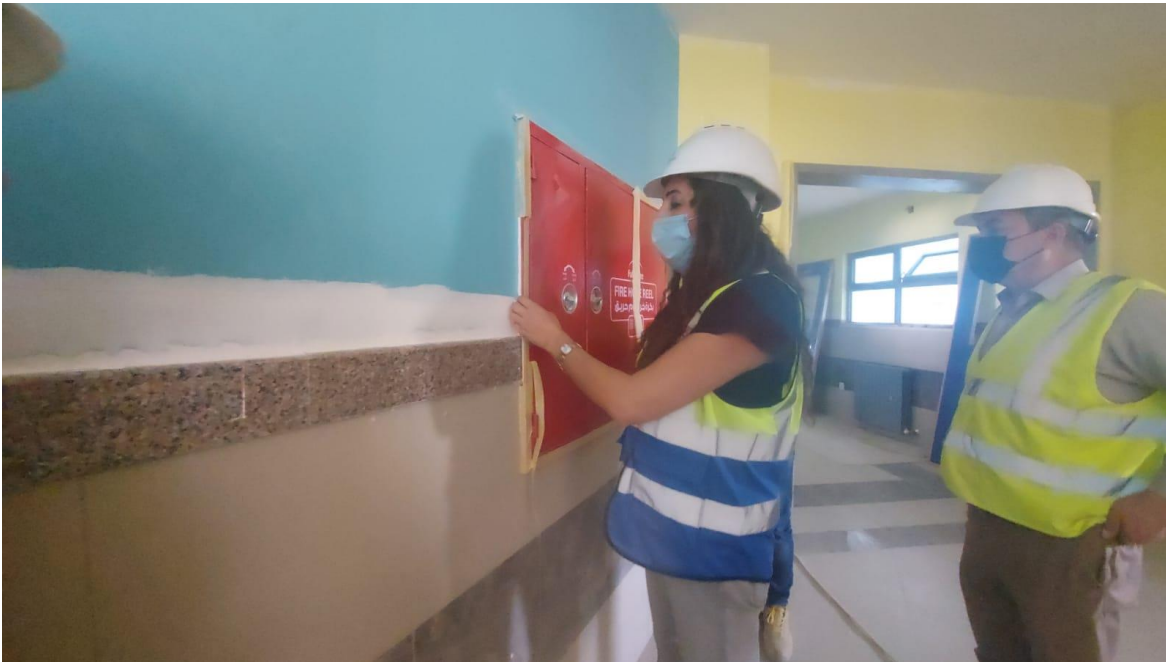
(figure:09)

The team observed that the gaps around the fire hose cabinets are still not covered with the appropriate steel section as agreed upon previously

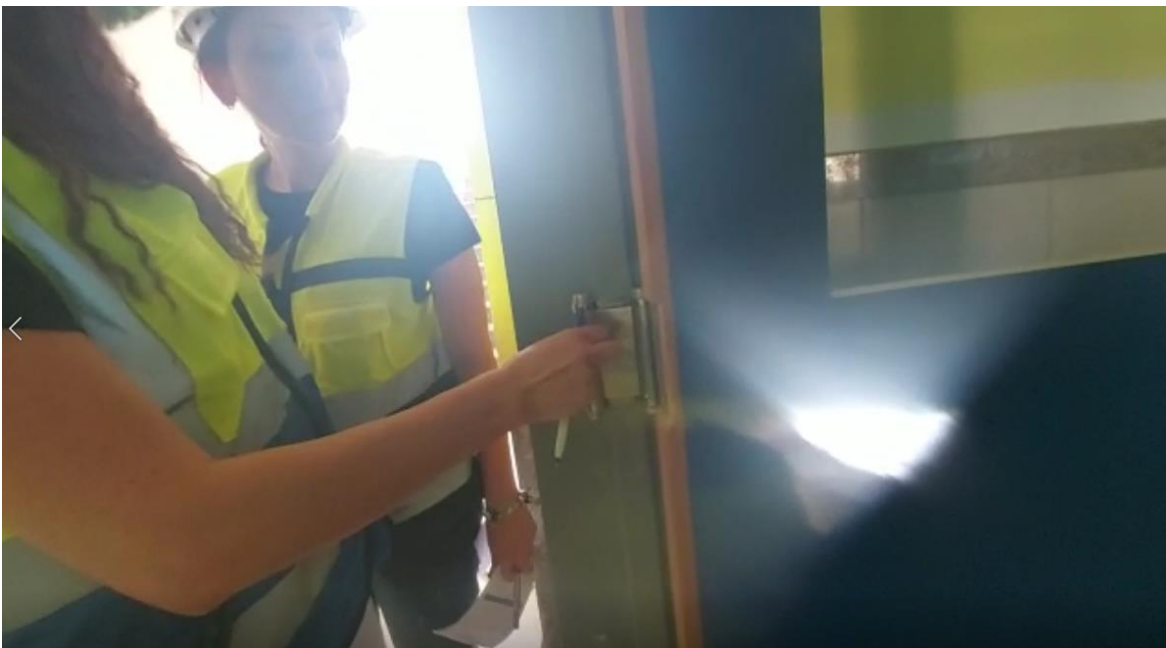
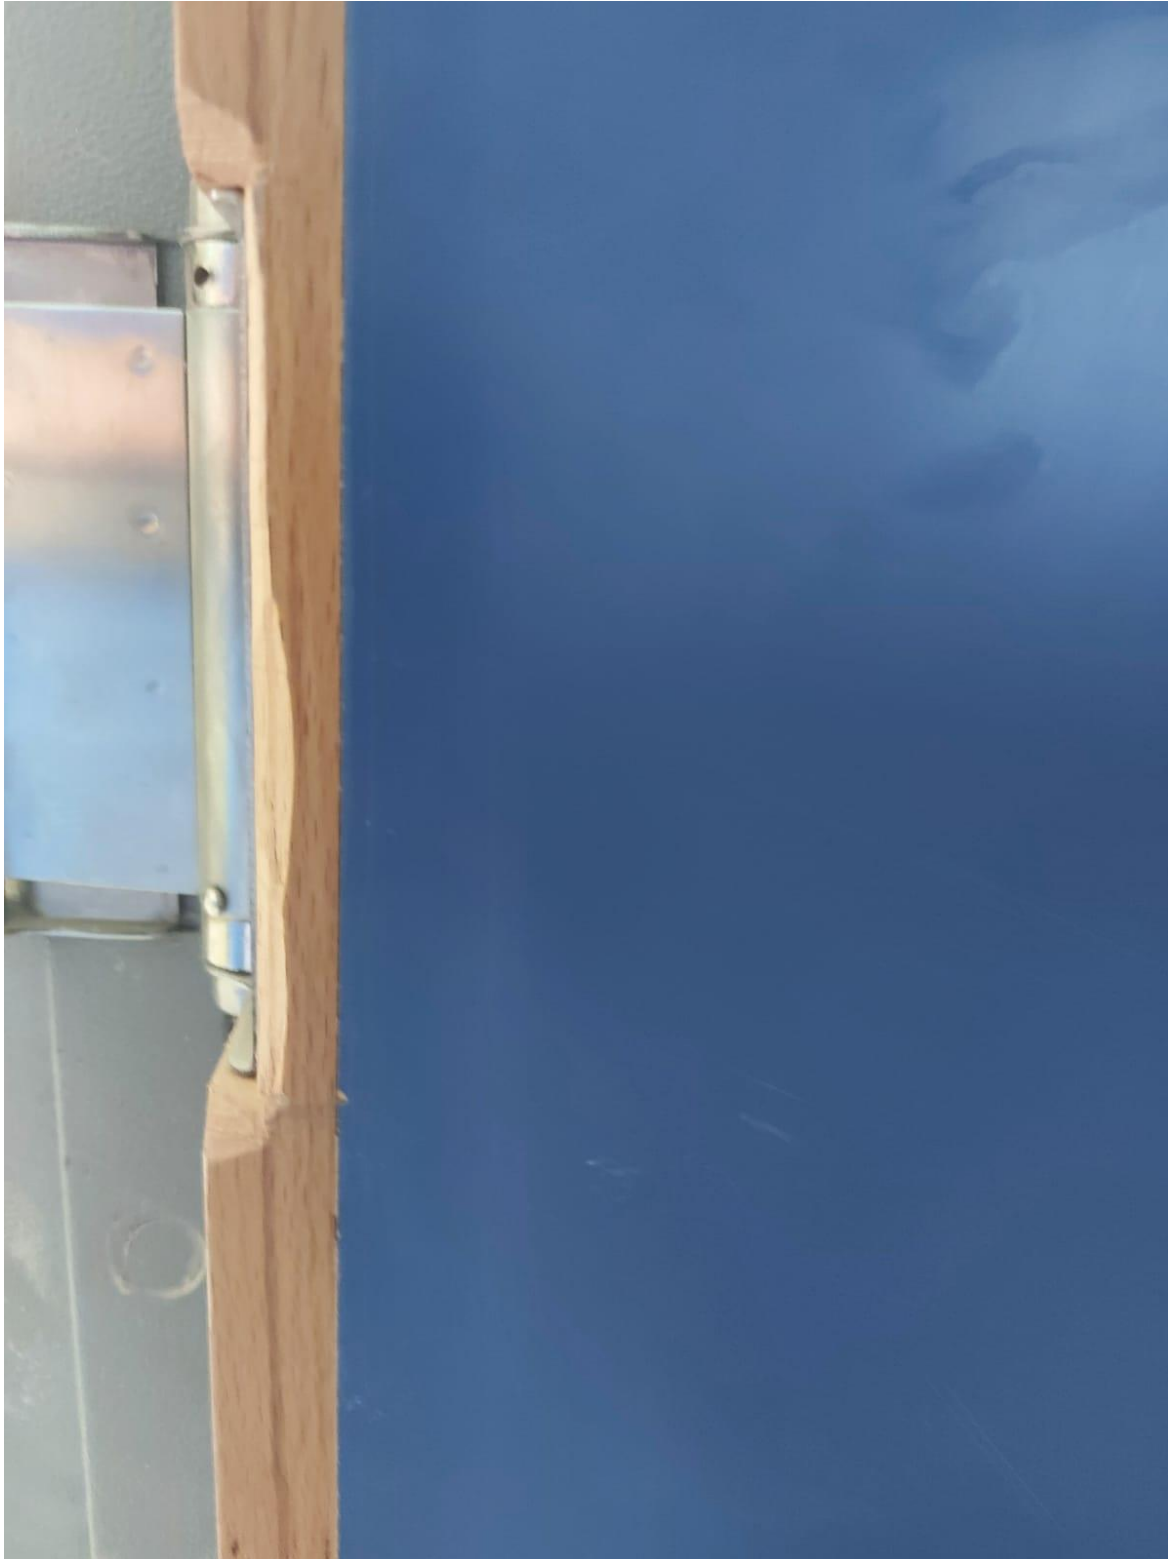
The team inspected the installed swing doors at the corridors

and requested the Contractor to conduct the necessary finishing around the doors' accessories and informed the Contractor that the installed hinges are not acceptable

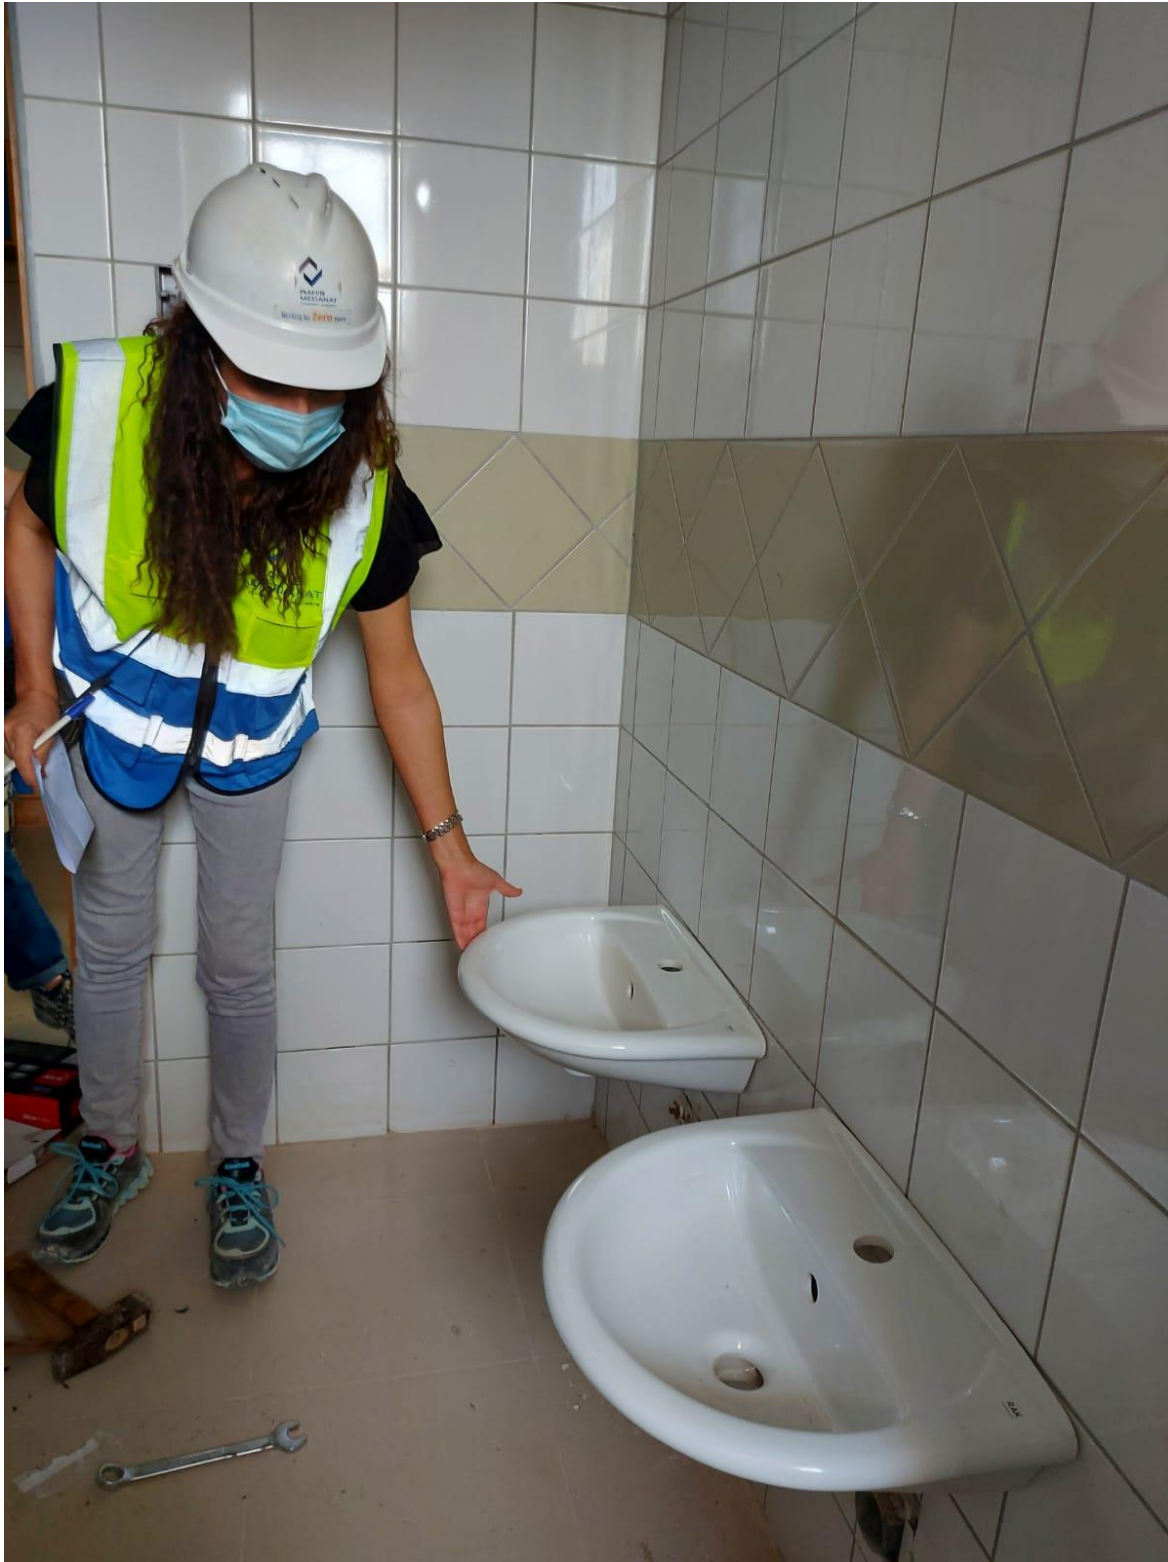
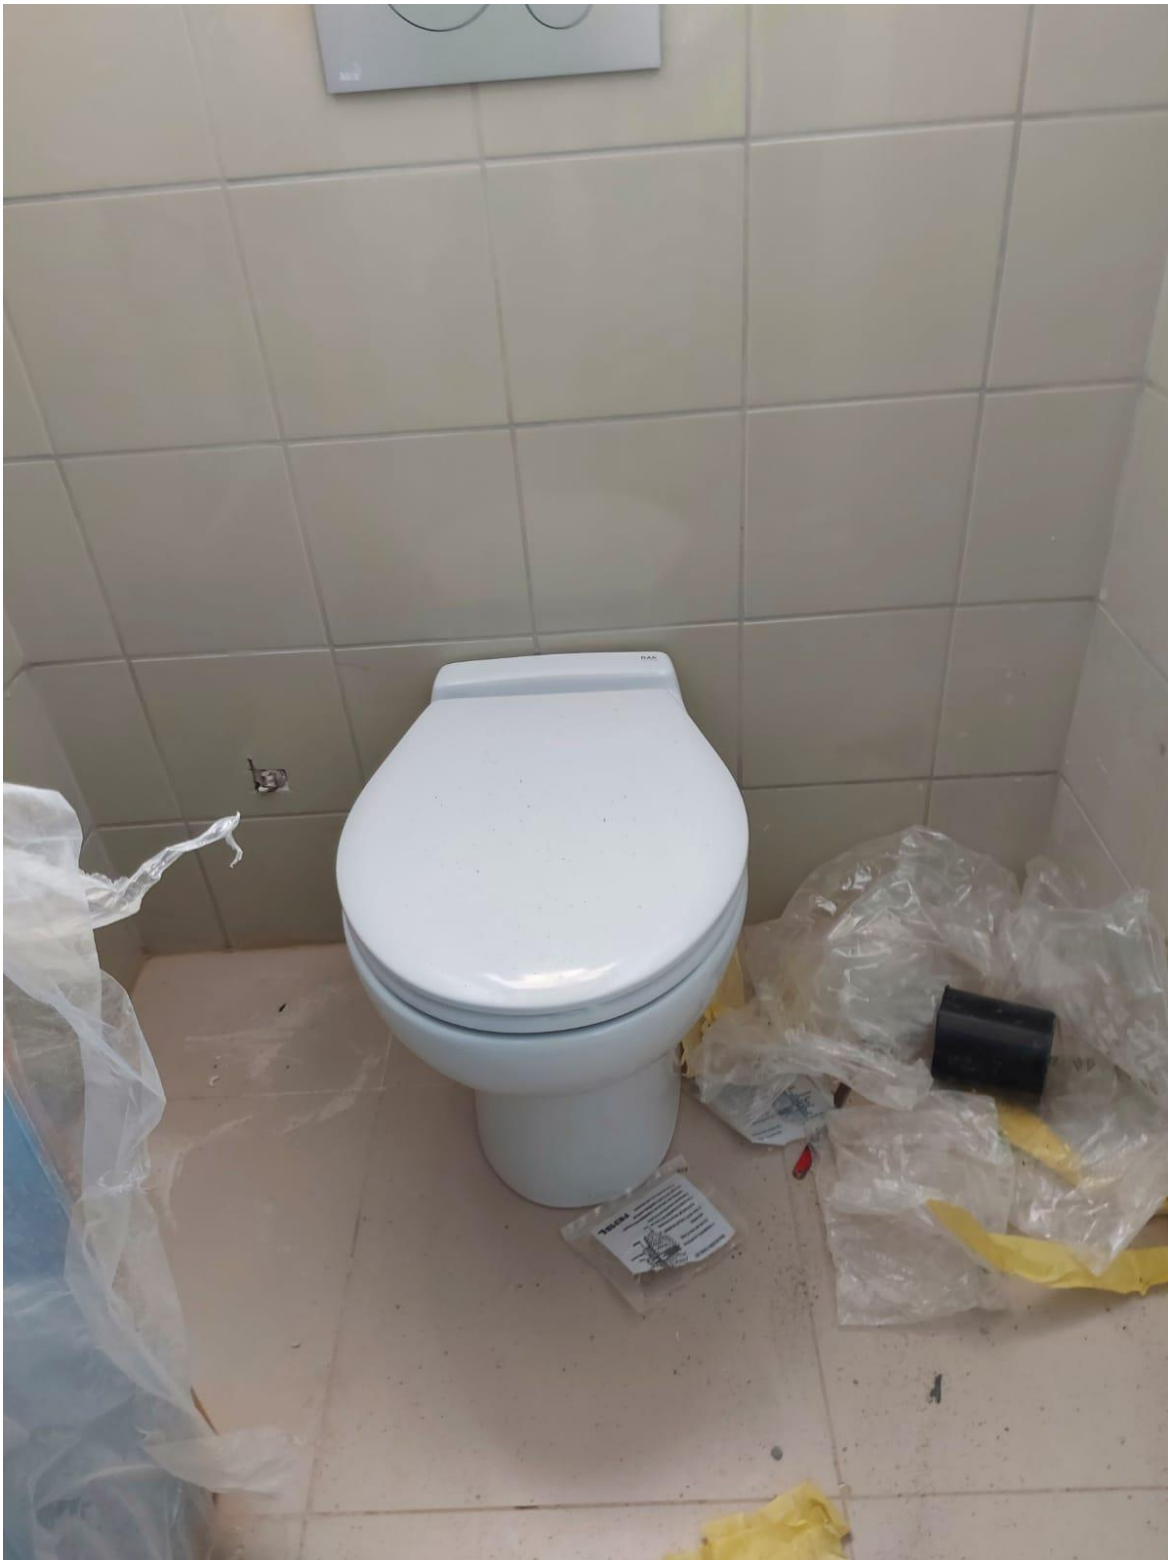
The team observed and inspected the start of installing the sanitary fixtures

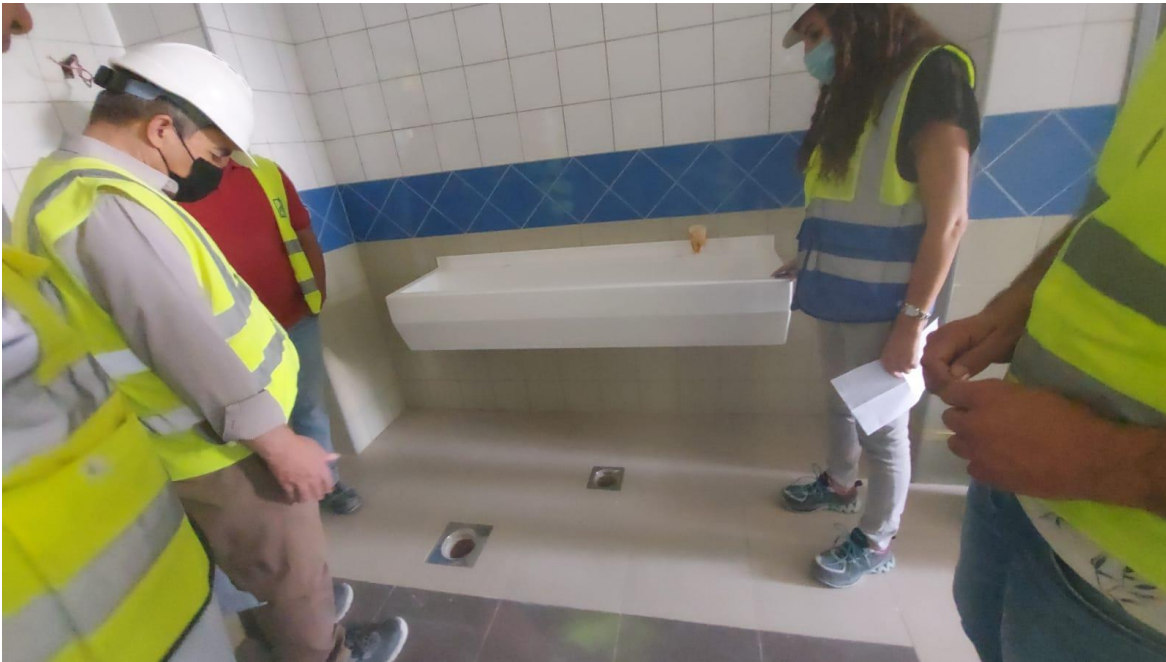
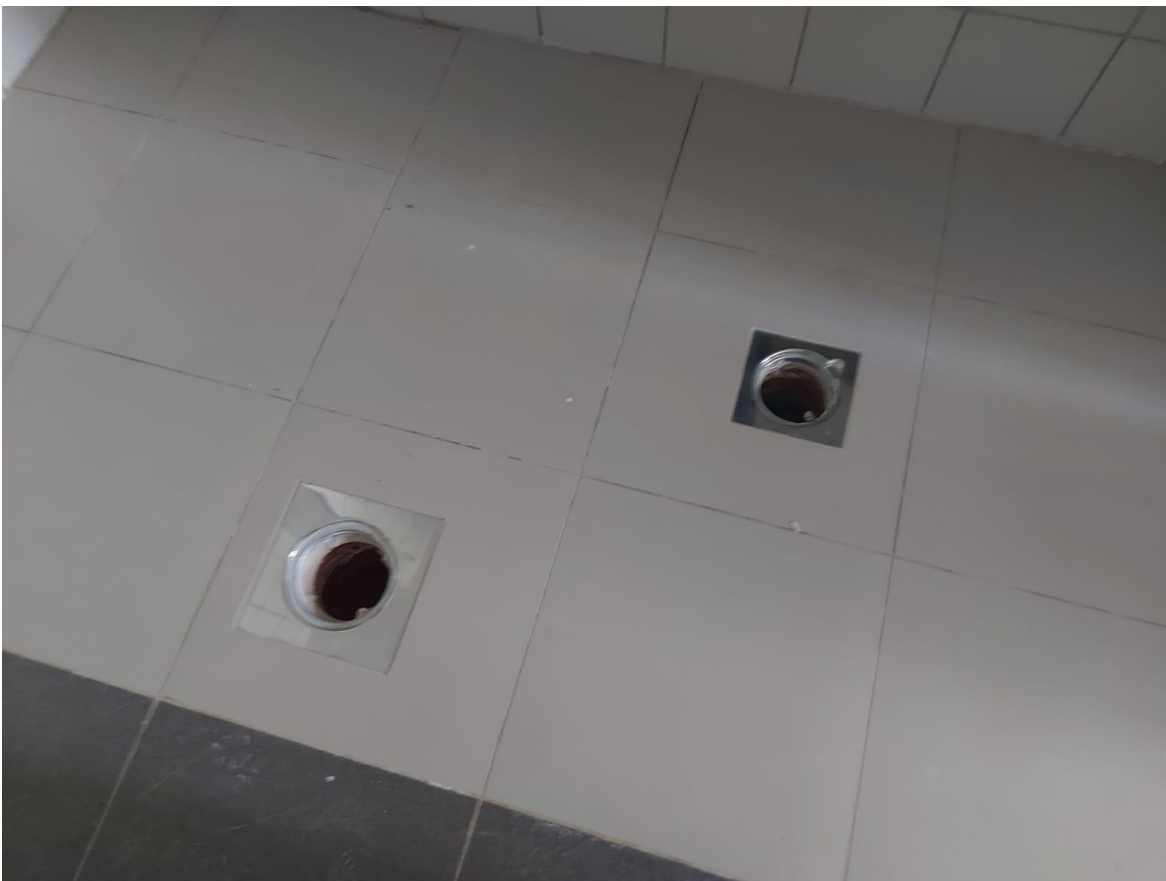
The team inspected and checked the dimensions of the sanitary fixtures at the wet area and requested the Contractor to close the opened clean outs and drains and keep clean and tidy fixtures

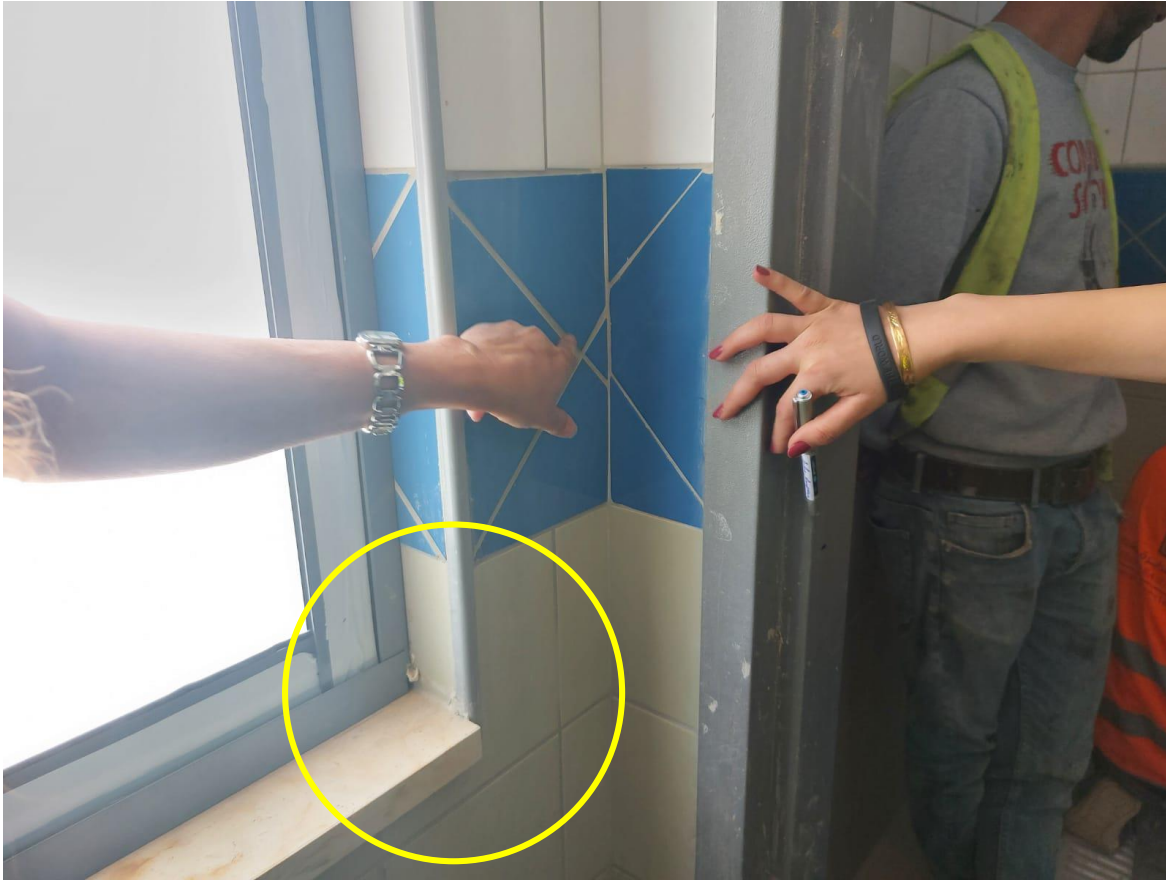
(figure:16)

In the wet area, the team observed that the gaps between tiles at one corner are wider than required and requested the Contractor to rectify. Moreover, some windows have smaller aluminum sections than required

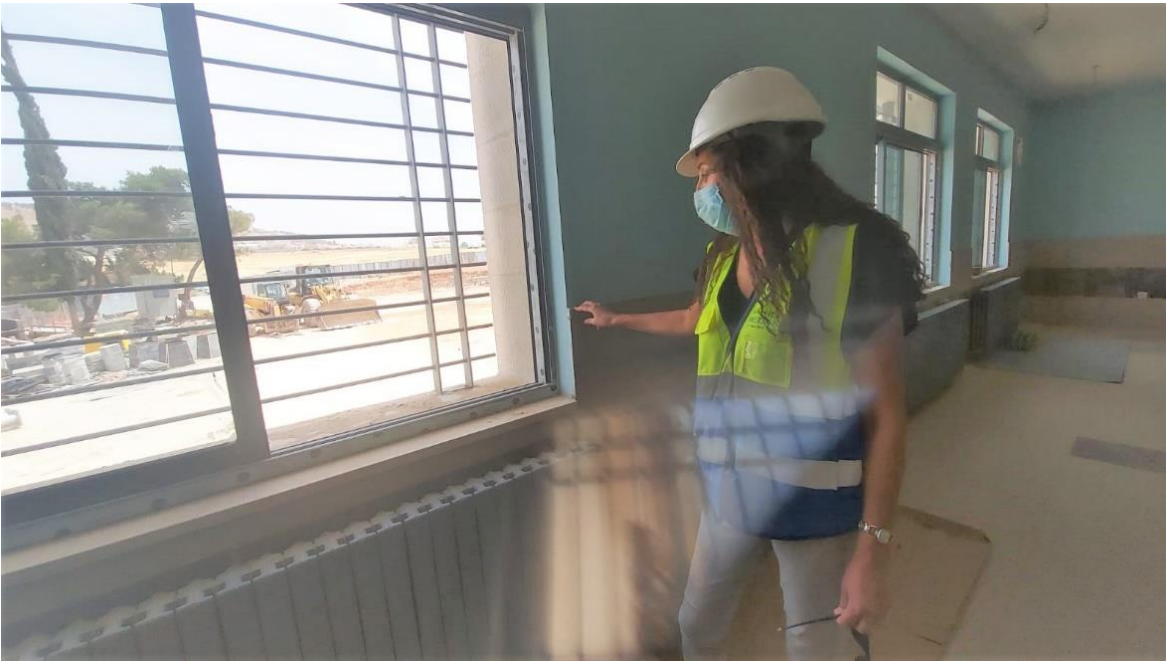
(figure:17)

Inspecting the installed aluminum windows

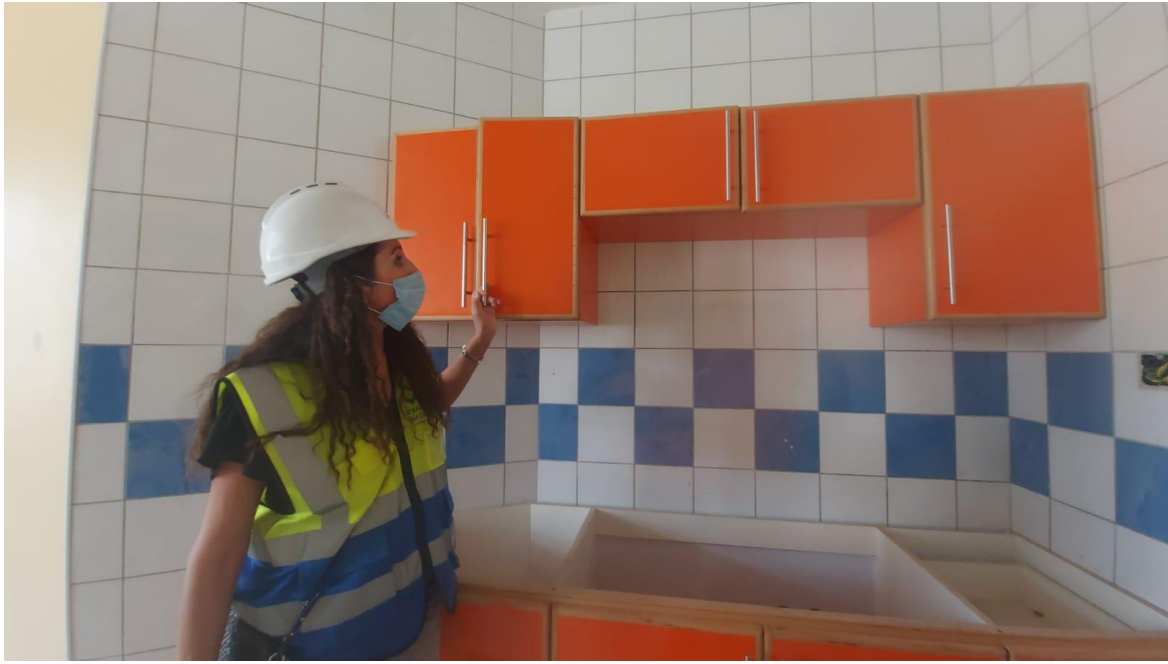
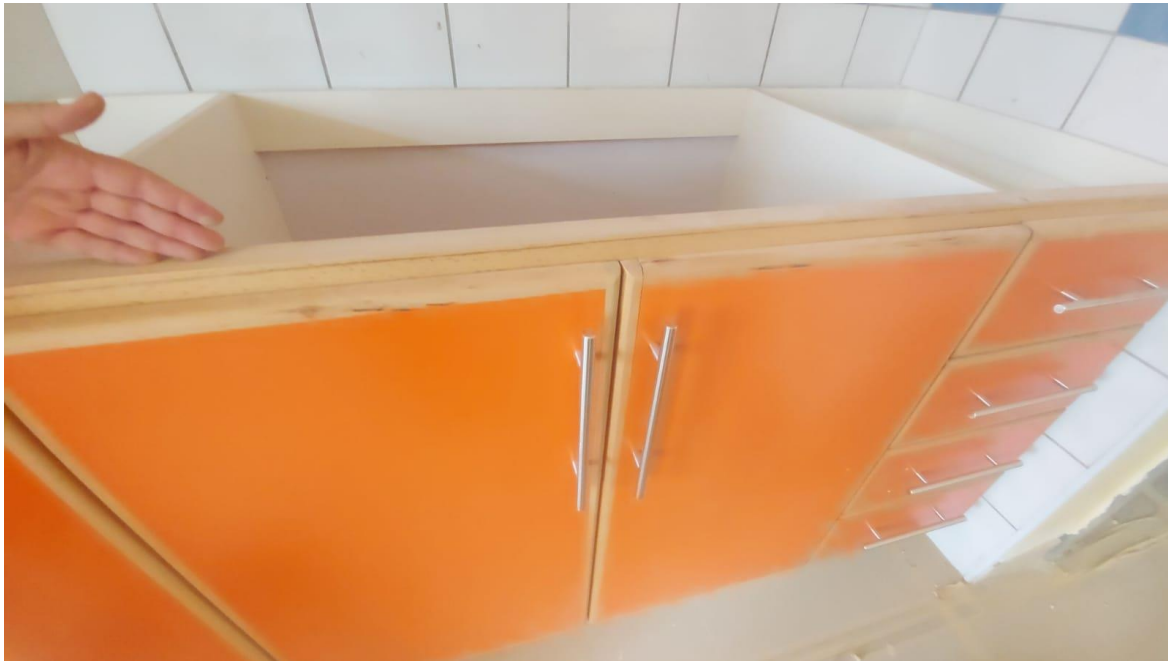
9	The team inspected the wooden cabinets at the teachers' center and observed defected beech wood frames and requested the Contractor to replace those cabinets and stressed on avoiding this repeated defect in the next cabinets to be delivered.
10	The team observed that the gaps around the fire hose cabinets are still not covered with the appropriate steel section as agreed upon previously.
11	The team inspected and checked the dimensions of the sanitary fixtures at the wet area and requested the Contractor to close the opened clean outs and drains and keep clean and tidy fixtures.
12	In the wet area, the team observed that the gaps between tiles at one corner are wider than required and requested the Contractor to rectify.
13	The team observed that some windows have smaller aluminum sections than required to match with the structural opening. The Contractor was requested to replace those smaller sections.

The team inspected the wooden cabinets at the teachers' center and observed defected beech wood frames and requested the Contractor to replace those cabinets and stressed on avoiding this repeated defect in the next cabinets to be delivered

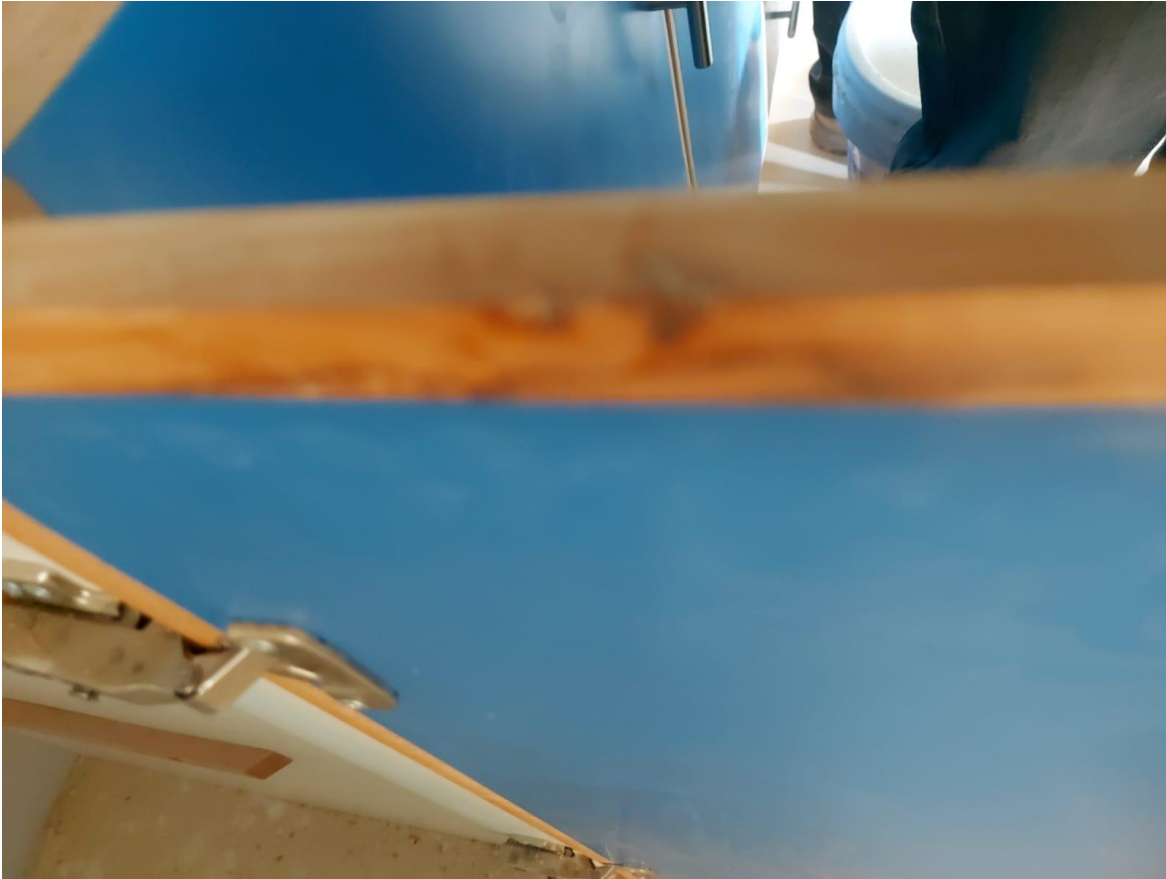
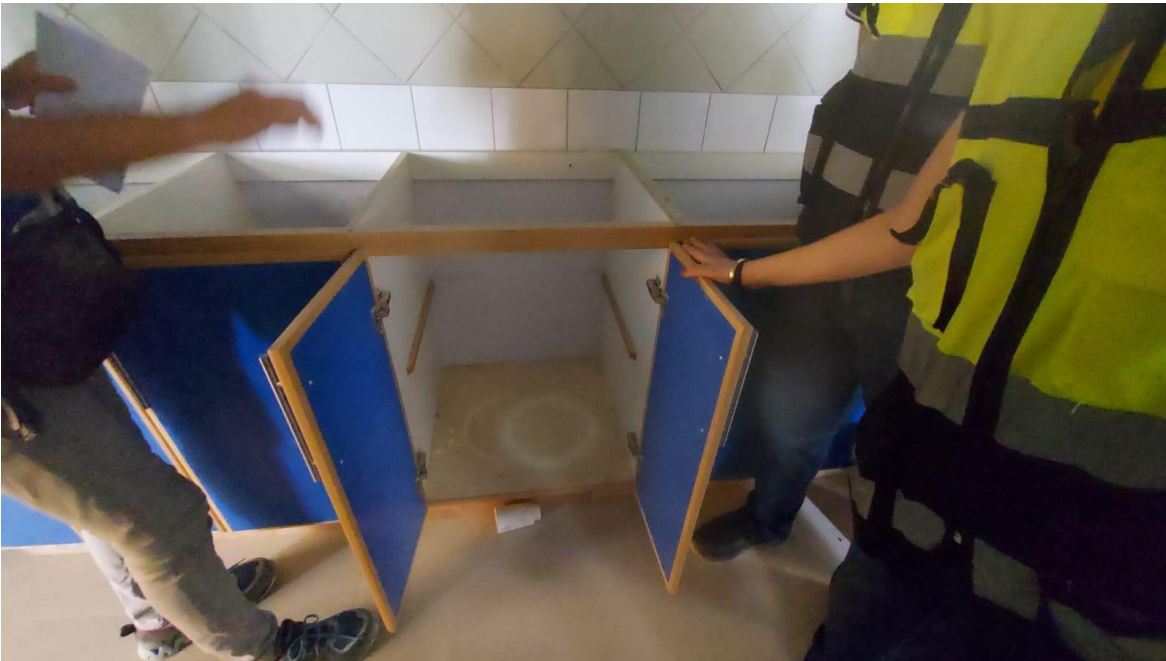
The team inspected the wooden cabinets at the kitchen and observed that a number of cabinets does not comply with the drawings in relation to the dimensions. The team requested the Contractor to replace those cabinets

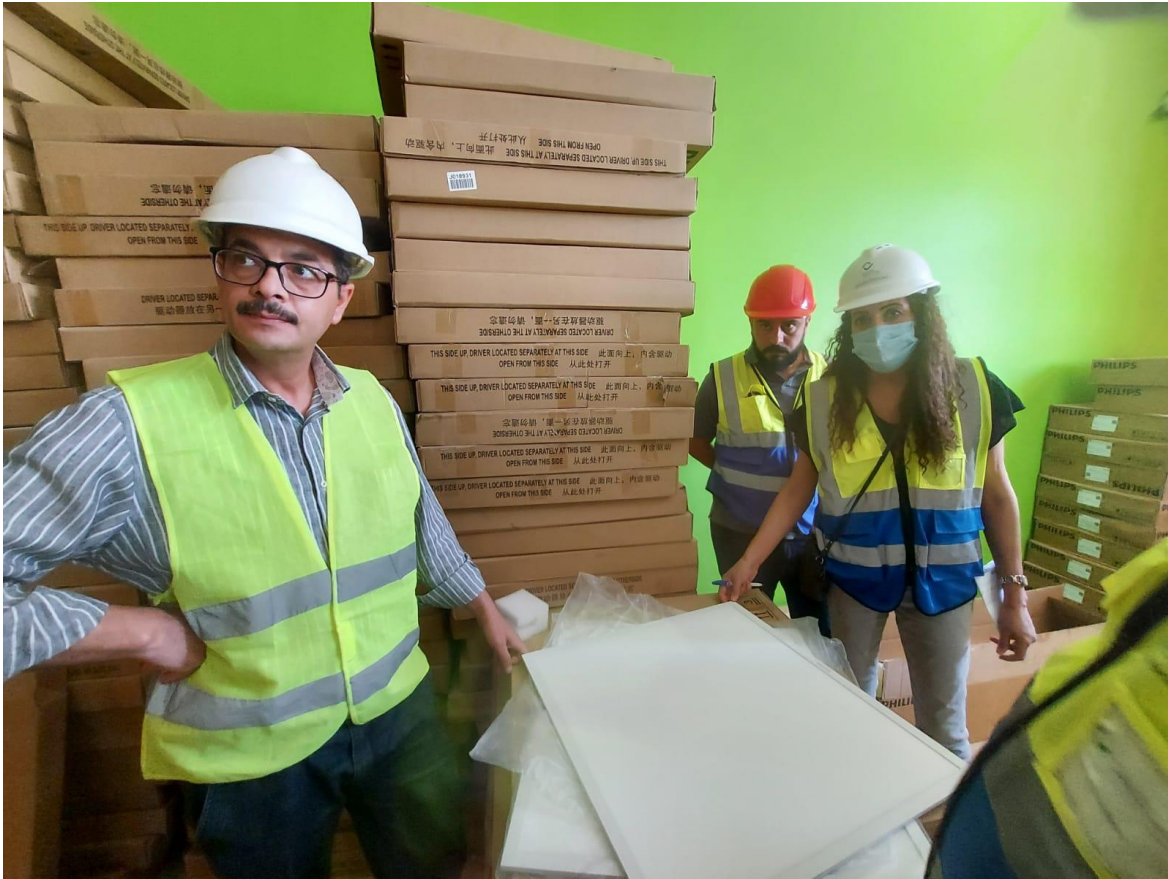
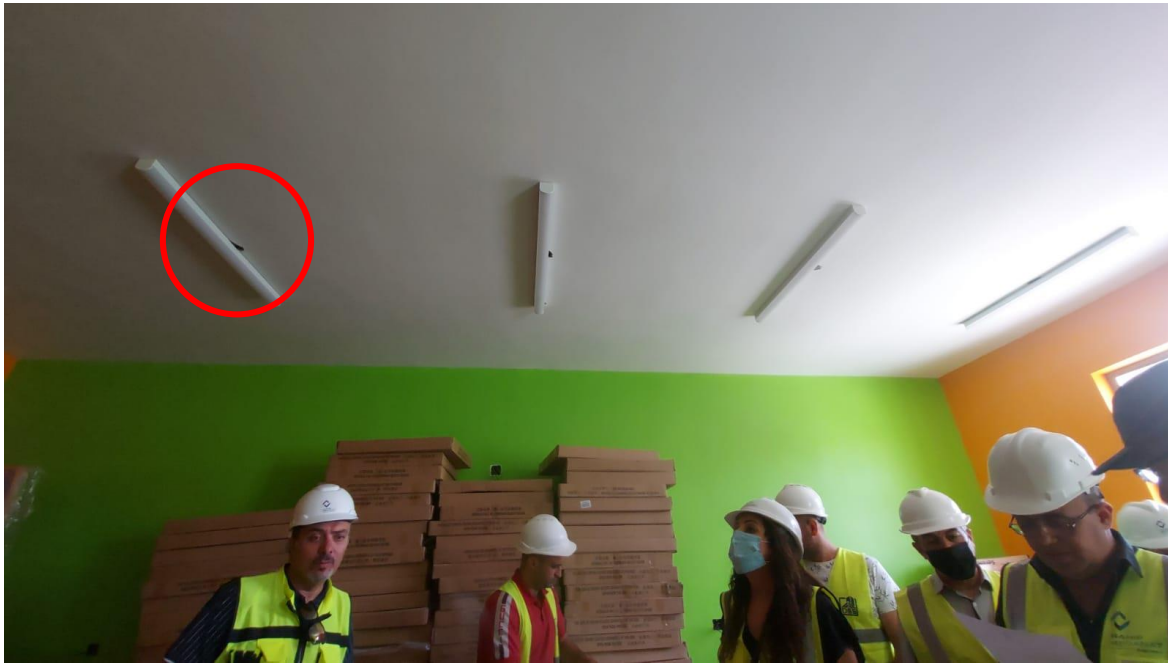
4	The team inspected the delivered lighting fixtures and the installed fixtures and requested the Contractor to close all the gaps around the points of the lighting fixtures. Also, the Contractor was requested to repair some finishes around the sockets.
5	The team discussed the Contractor's suggestion to substitute the local marble counter top as specified by granite. The supervision team showed no objection.
6	The team inspected the installed sample of granite for the staircase landing with grout and observed defects in the tiling such as broken tiles edges, and accordingly the Contractor was requested to replace all broken pieces and conduct sorting out of the tiles to dismiss broken pieces.
7	The team inspected the installed granite coping at the corridors and observed some gaps in the grouting behind and requested the Contractor to re-check and rectify accordingly.
8	The team inspected the installed swing doors at the corridors and requested the Contractor to conduct the necessary finishing around the doors' accessories and informed the Contractor that the installed hinges are not acceptable.

The team inspected the delivered lighting fixtures and the installed fixtures and requested the Contractor to close all the gaps around the points of the lighting fixtures. Also, the Contractor was requested to repair some finishes around the sockets

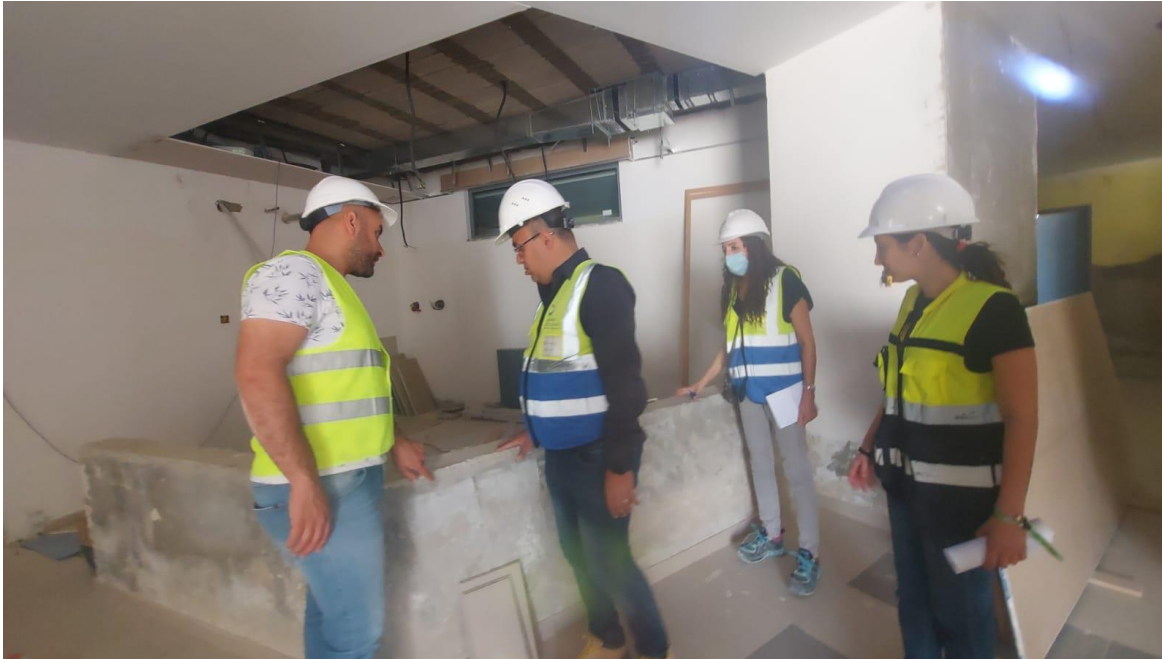
(figure:24)

The team discussed the Contractor's suggestion to substitute the local marble counter top as specified by granite. The supervision team showed no objection

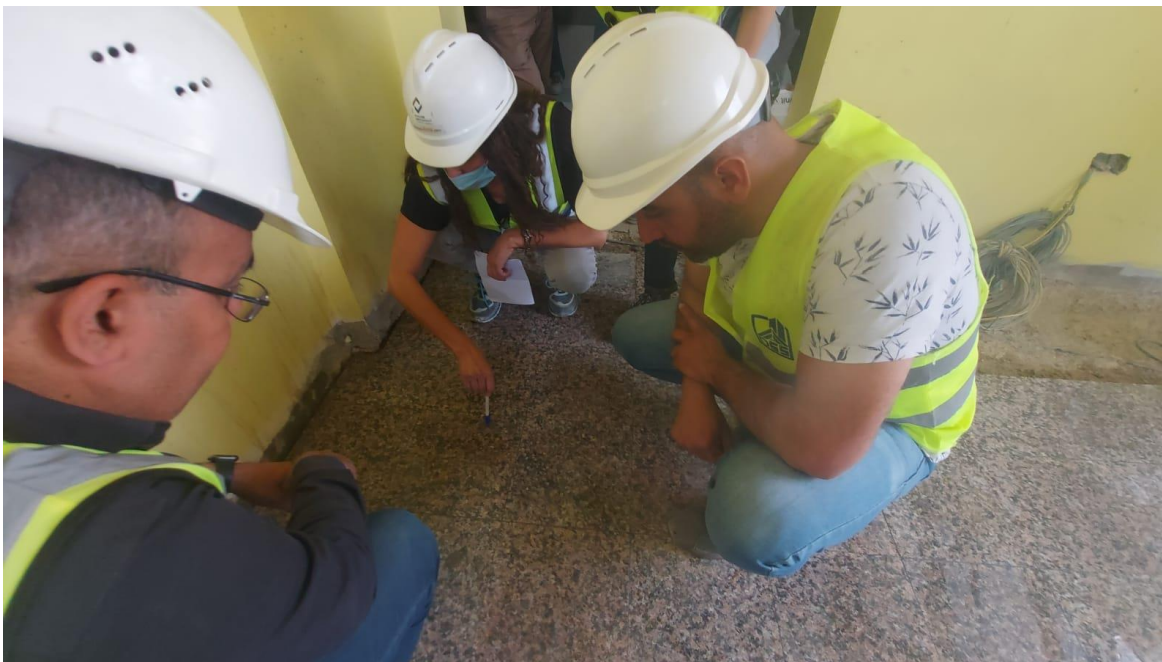
(figure:25)

The team inspected the installed sample of granite for the staircase landing with grout and observed defects in tiling such as broken tiles edges. The Contractor was requested to rectify

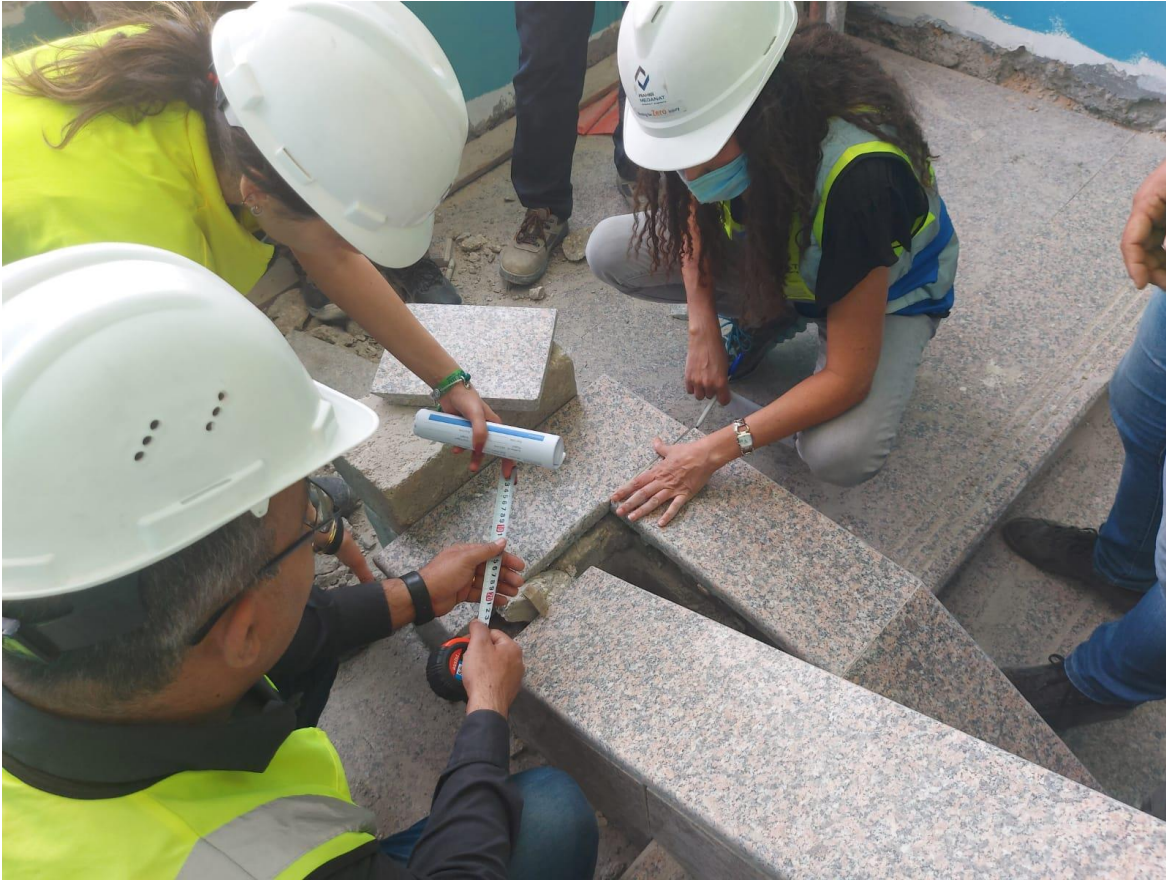
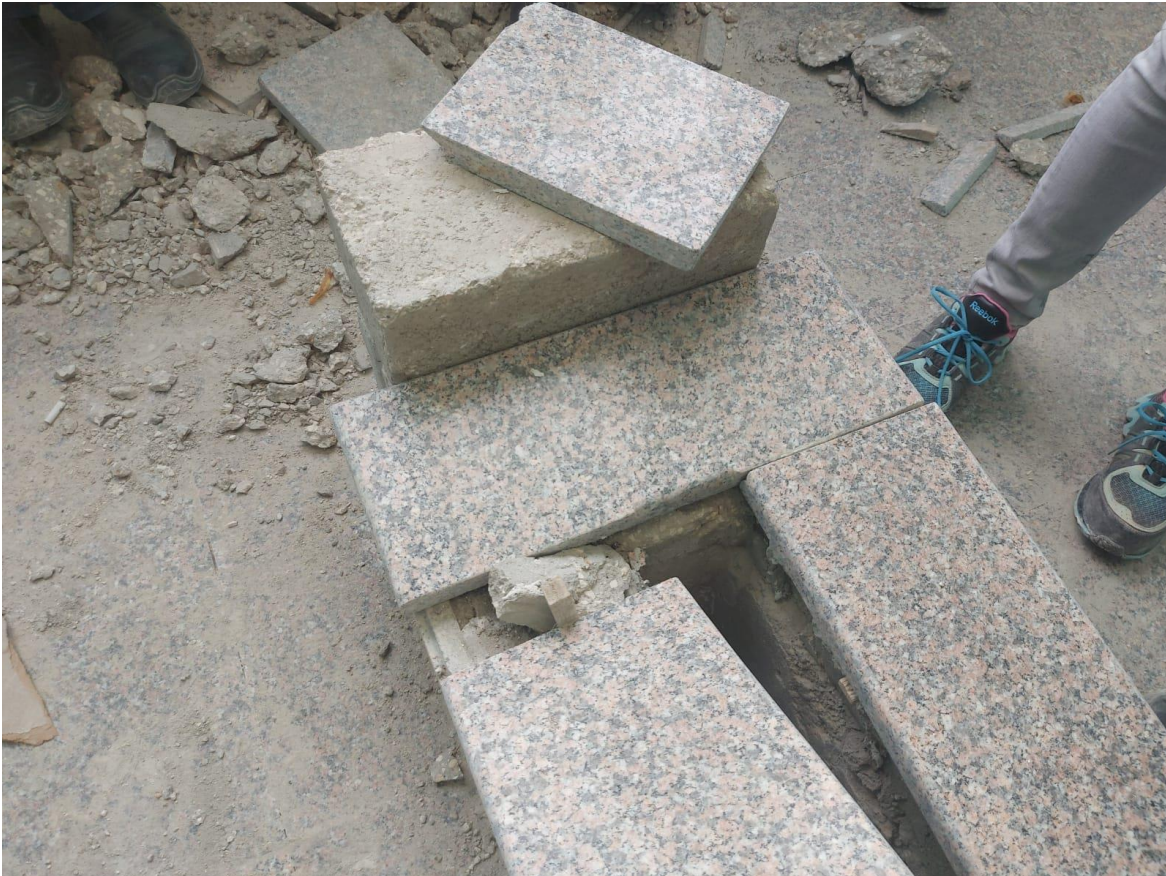
The team discussed with the Contractor the granite finish for the staircase upstands at the level of the landing in order to ensure acceptable shape and landing width

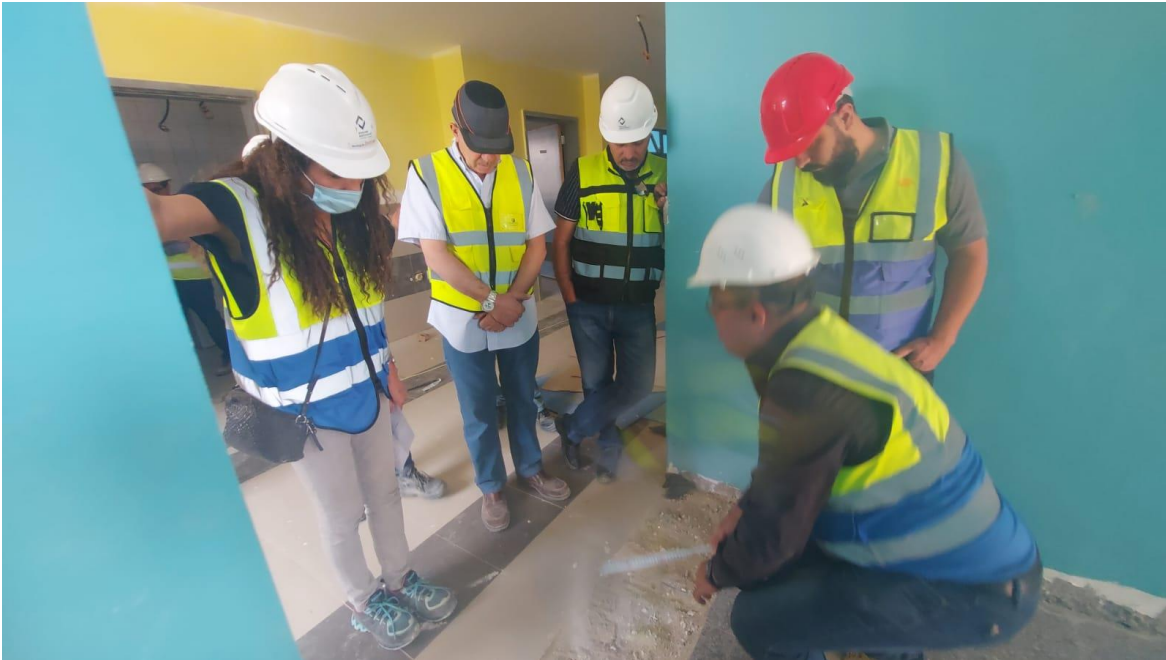
(figure:28)

The team discussed with the Contractor the width of door granite thresholds between the staircases and the corridors
