SKEP III Home Office Support Site Visit Report

Consultant	Wahib Medanat Consultant Engineer	Rep No.	11-21052022
Contractor	Derar Saraireh & Sons for Engineering & Contracting	Tender No.	(11/2019/USAID/SKEP/3/S) Schools for a Knowledge Economy Project (SKEP) - Phase (3) Package (1, 2)
Site Name	Um Al Dananir Basic Mixed School- Al Balqa	Day/ Date	Sat. 21/05/2022
Duration of Project	450 Calendar Days	Total Project Budget	9,789,417.840 JD

Visit Notes

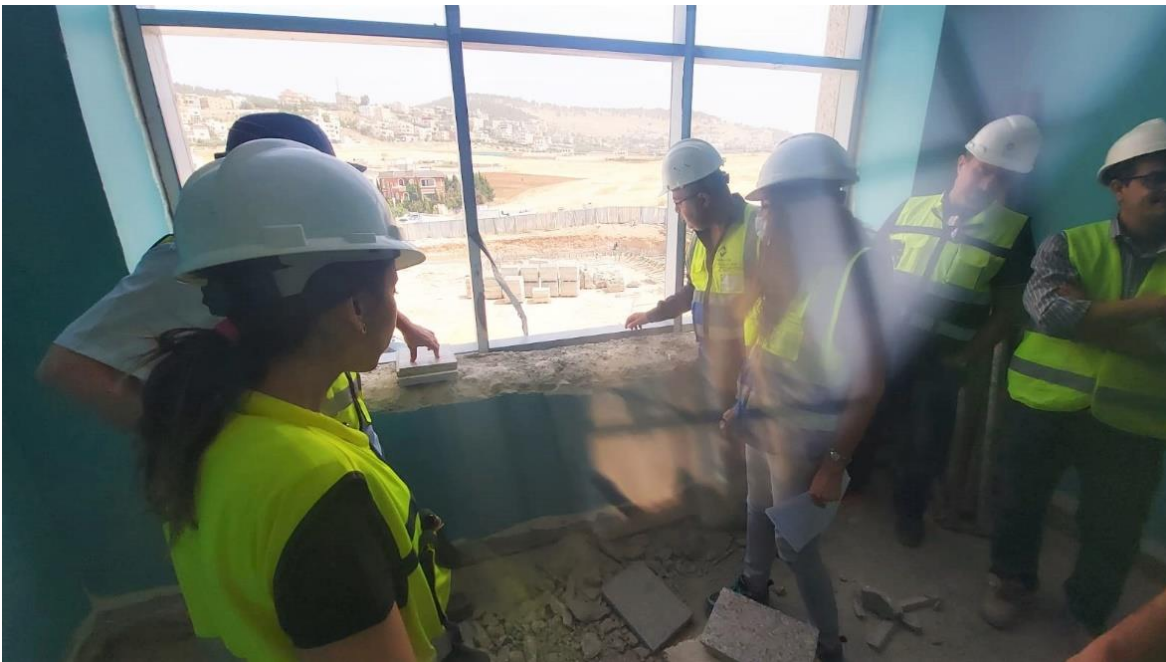
(figure:29)

Discussing details related to the installation of curtain walls. The Contractor was requested to conduct enough chipping at the window sills to ensure correct level of the aluminum windows

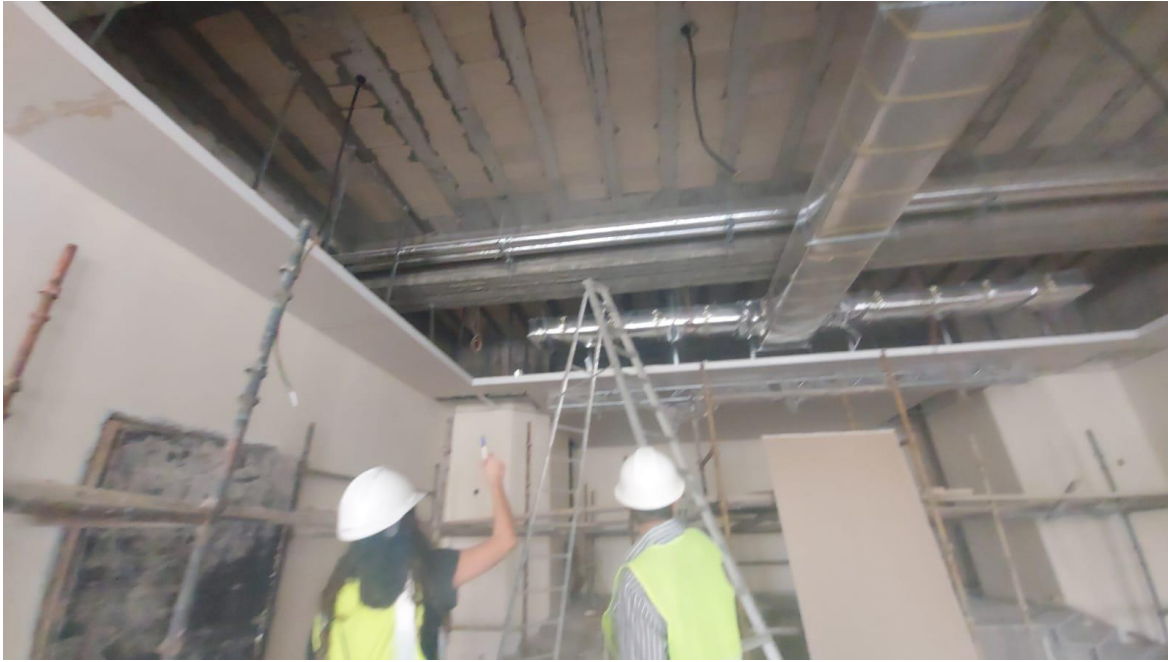
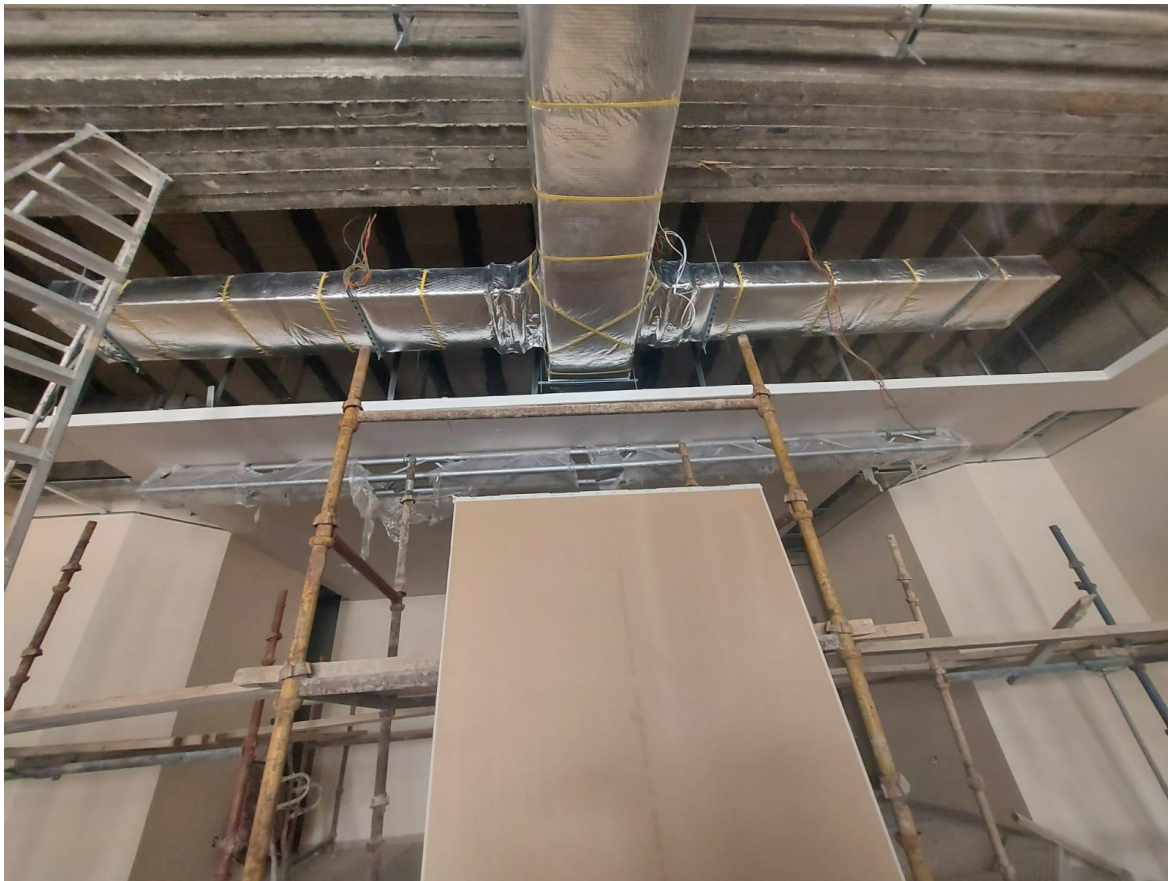
The team inspected the electrical works at the multi-purpose hall and discussed increasing the maintenance access opening in the suspended ceiling for electrical installations. It was observed that the Contractor erected the truss at the ceiling to hold the lighting fixtures at the stage without getting the necessary approval of the Engineer. The Contractor was requested to get the approval of the Engineer on the truss and also the method statement for installation

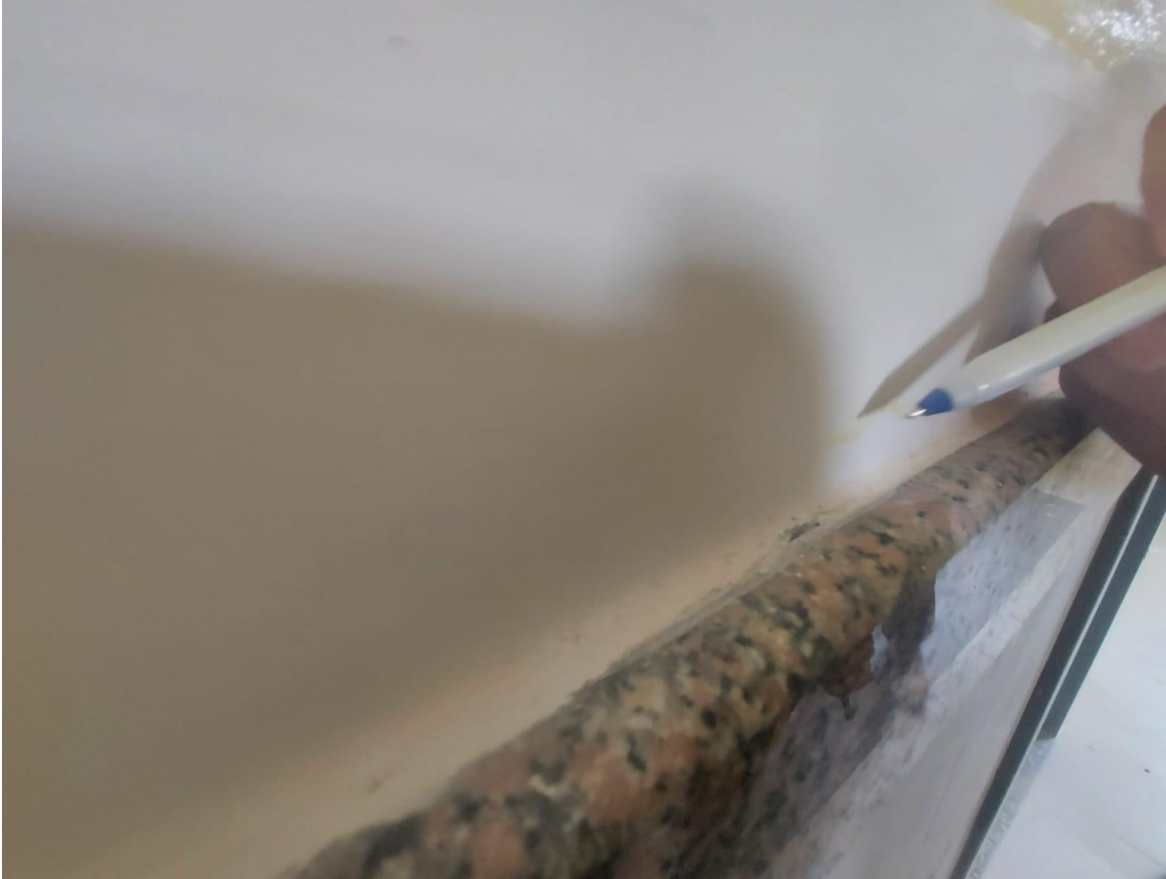
(figure:32)

The team inspected the installed granite coping at the corridors and observed some gaps in the grouting behind and requested the Contractor to re-check and rectify accordingly
