Consultant	Wahib Medanat Consultant Engineer	Rep No.	12-16022022
Contractor	Derar Saraireh & Sons for Engineering & Contracting	Tender No.	(11/2019/USAID/SKEP/3/S) Schools for a Knowledge Economy Project (SKEP) - Phase (3) Package (1, 2)
Site Name	Al Khansa' Basic Mixed School- Al Balqa	Day/ Date	Wed. 16/02/2022
Duration of Project	450 Calendar Days	Total Project Budget	9,789,417.840 JD

### Visit Notes

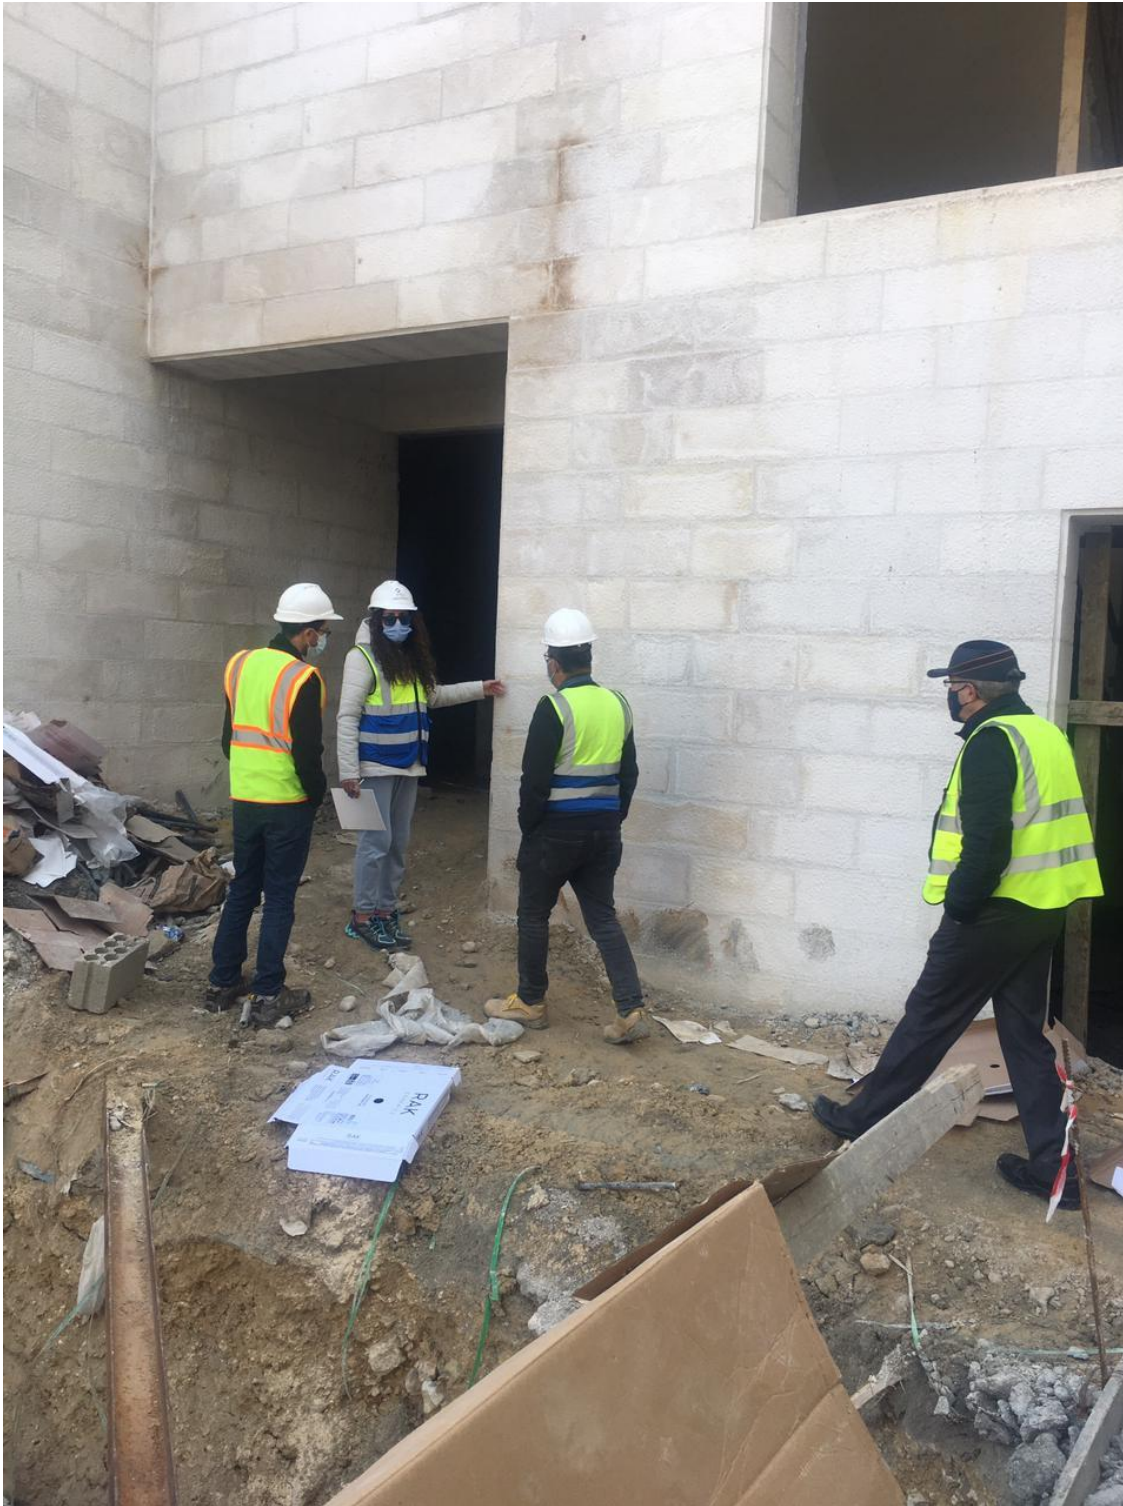
(Figure: 05)

The team inspected the stone of the facades and observed that a number of defective stones were still not rectified

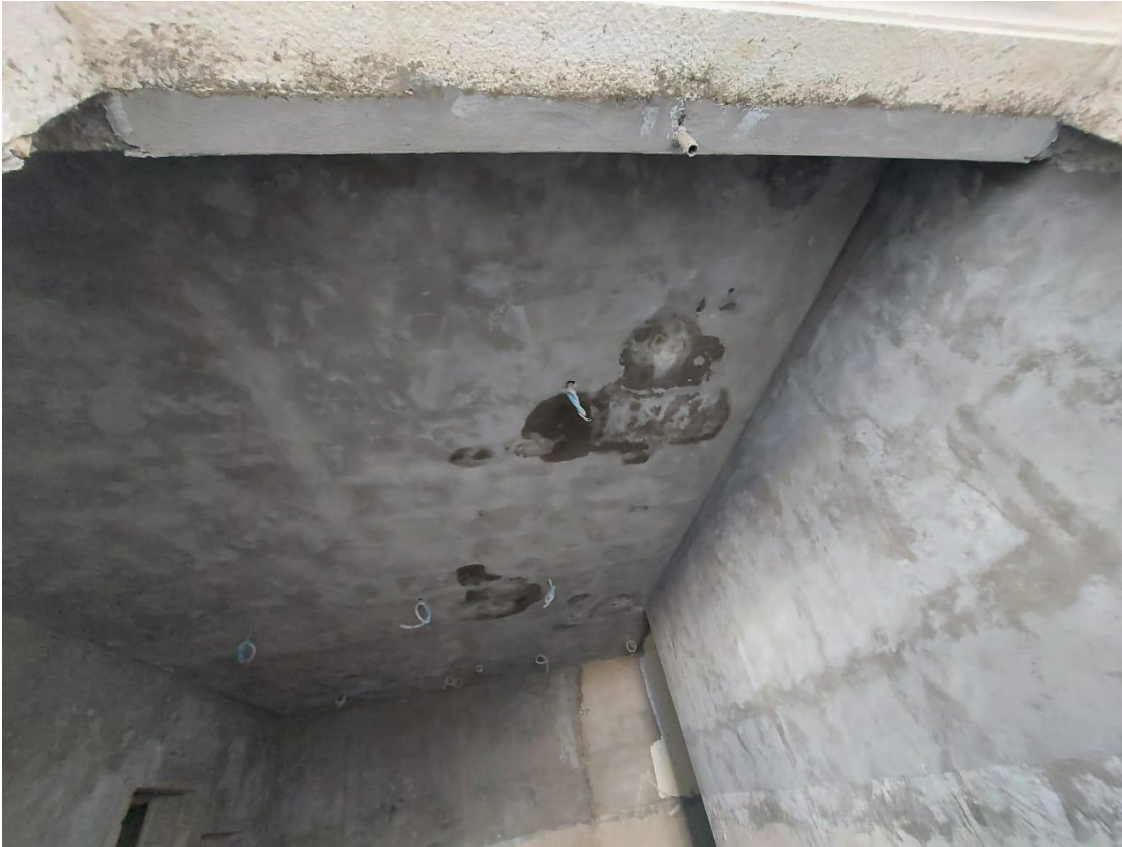
(Figure: 07)

The team observed water leakage at the ceiling of the multi-purpose hall and was informed that the waterproofing layers at the roof are still not completed

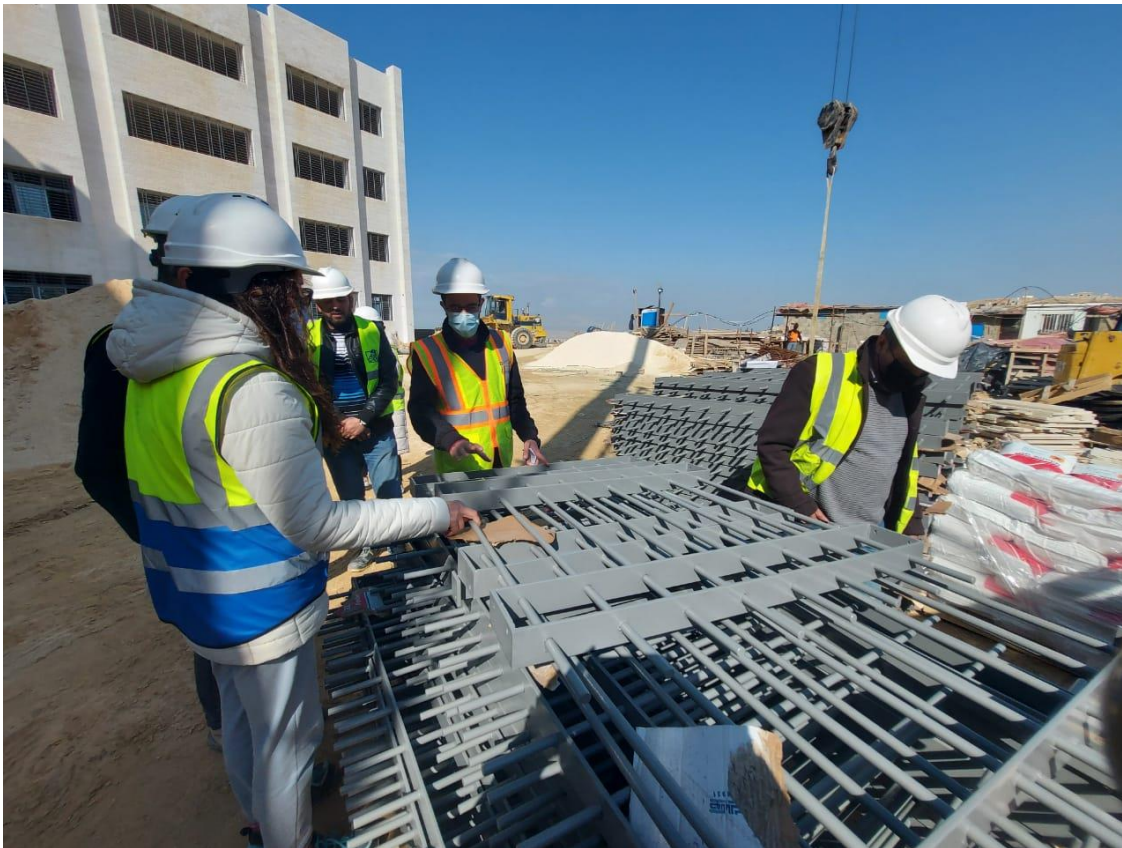
(Figure: 08)

The supervision team inspected the delivered steel protection screen

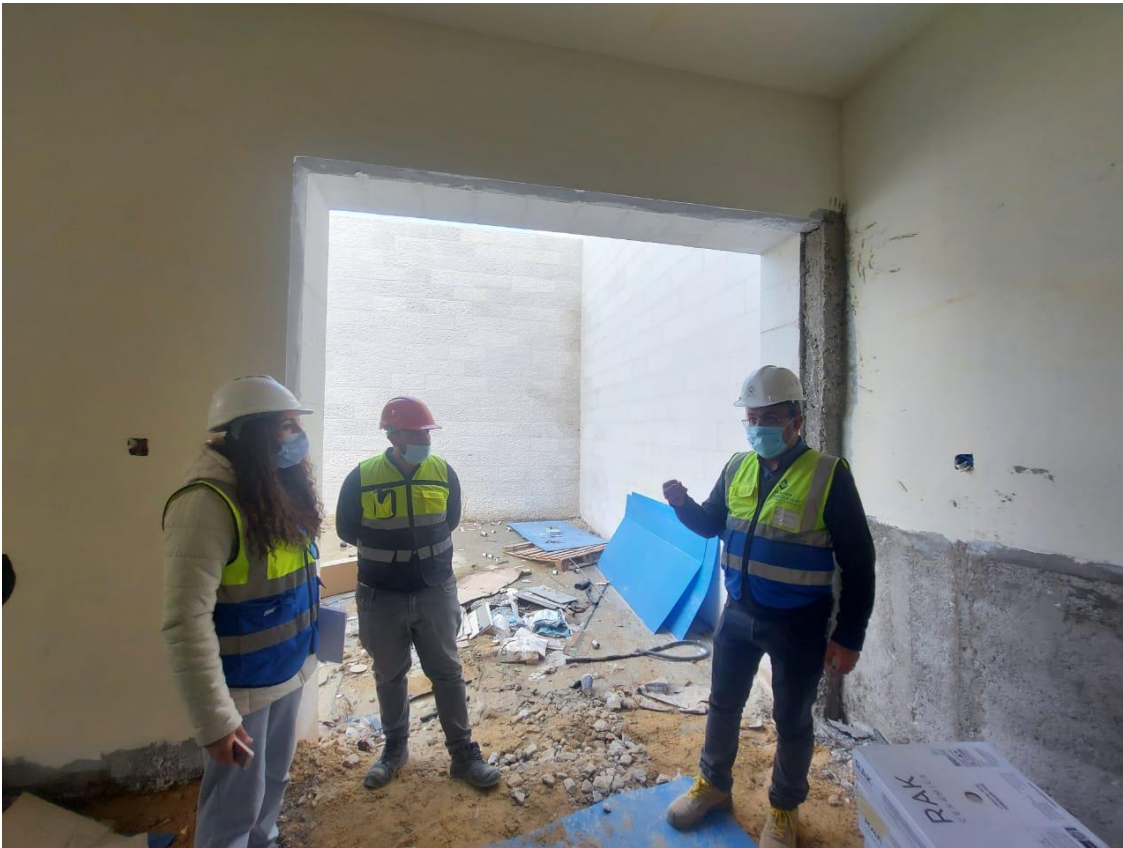
(Figure: 09)

A discussion regarding the clear height of door opening leading to the roof of the multi-purpose hall was conducted with the Contractor

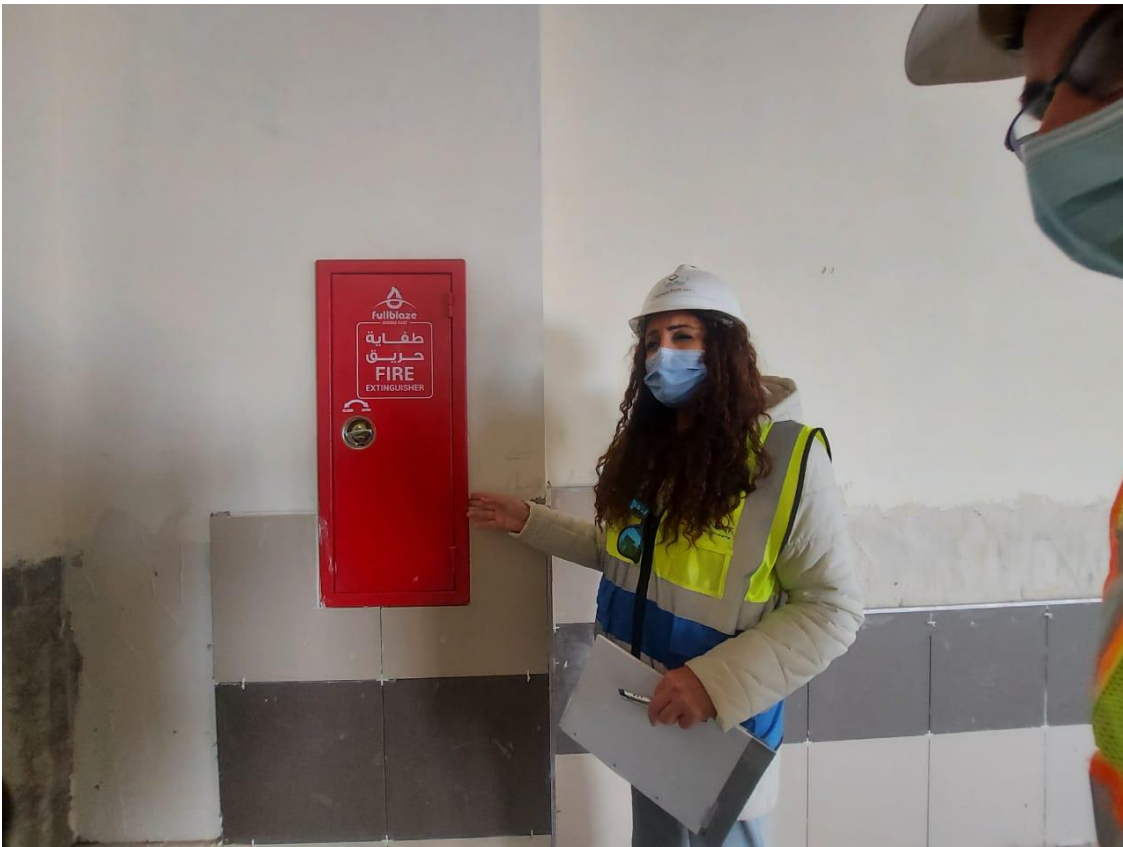
(Figure:10)

Discussing the fixing of mechanical cabinets such as fire extinguishers. The Contractor was requested to prepare two examples showing the installation of mechanical cabinets

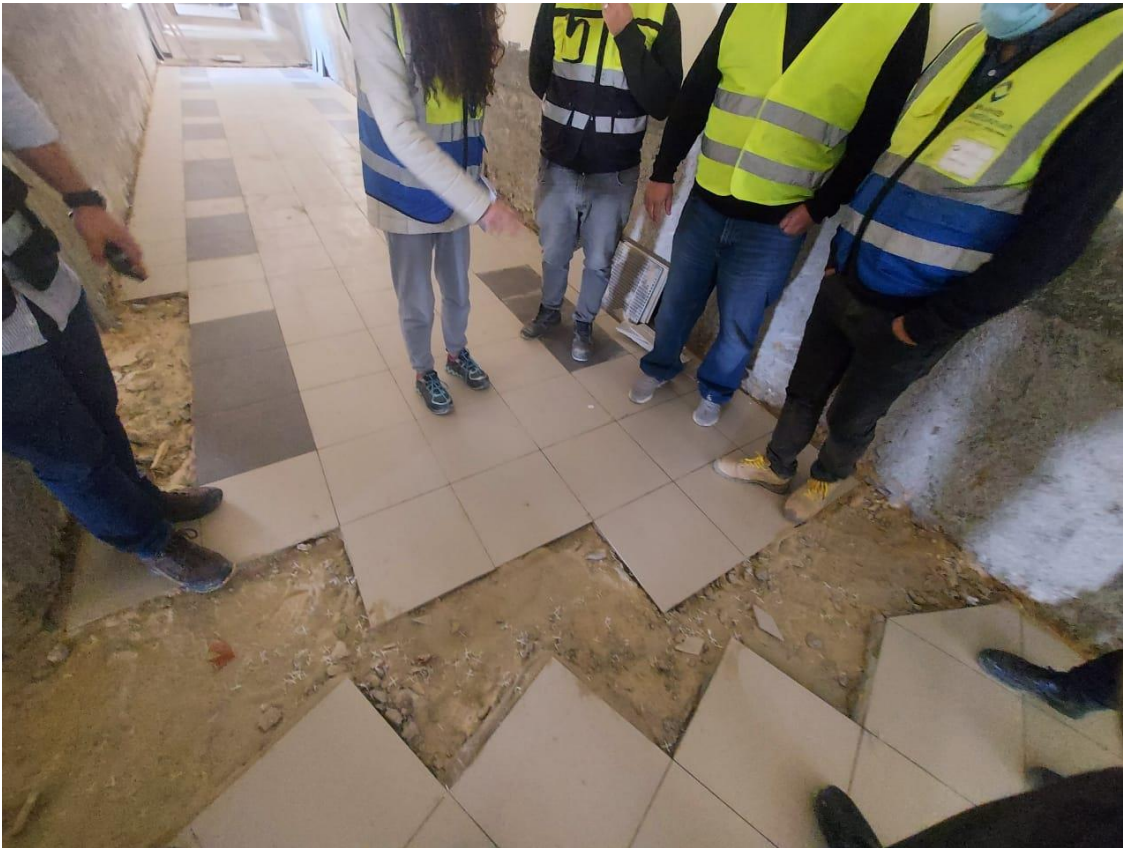
(Figure: 11)

The team discussed with the Contractor the connection of floor porcelain tiles of two corridors

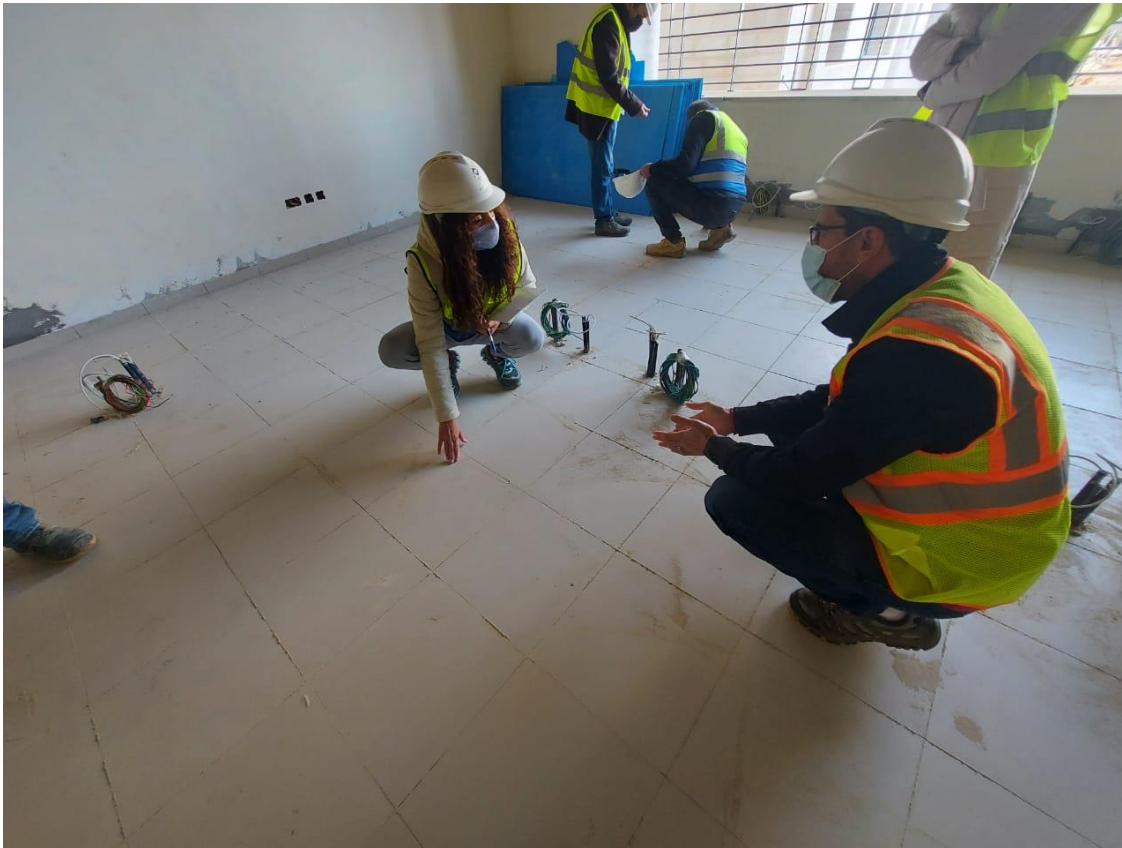
(Figure: 13)

the team observed defects in parts of the executed floor tiles due to the teething. The supervision requested the Contractor to replace the teethed tiles and avoid the teething to occur again by not allowing the workers to walk on the newly tiled areas before drying

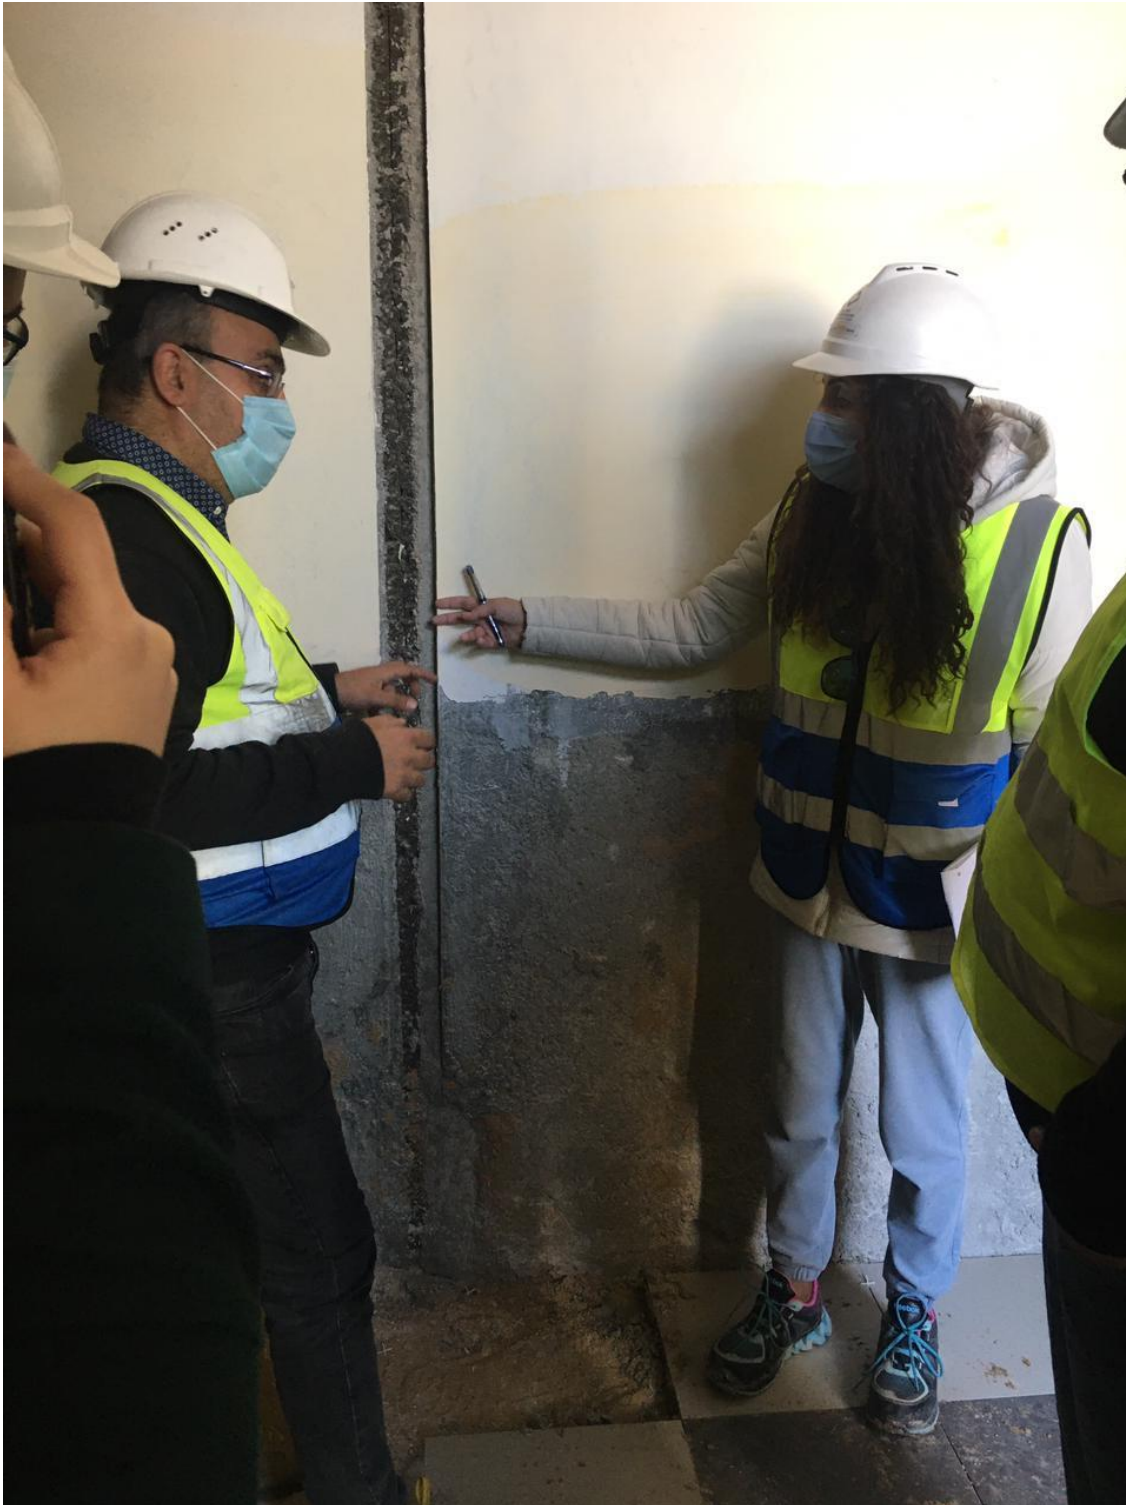
(Figure: 15)

The team discussed with the Contractor the finishing of the porcelain wall cladding at the expansion joints in the corridors

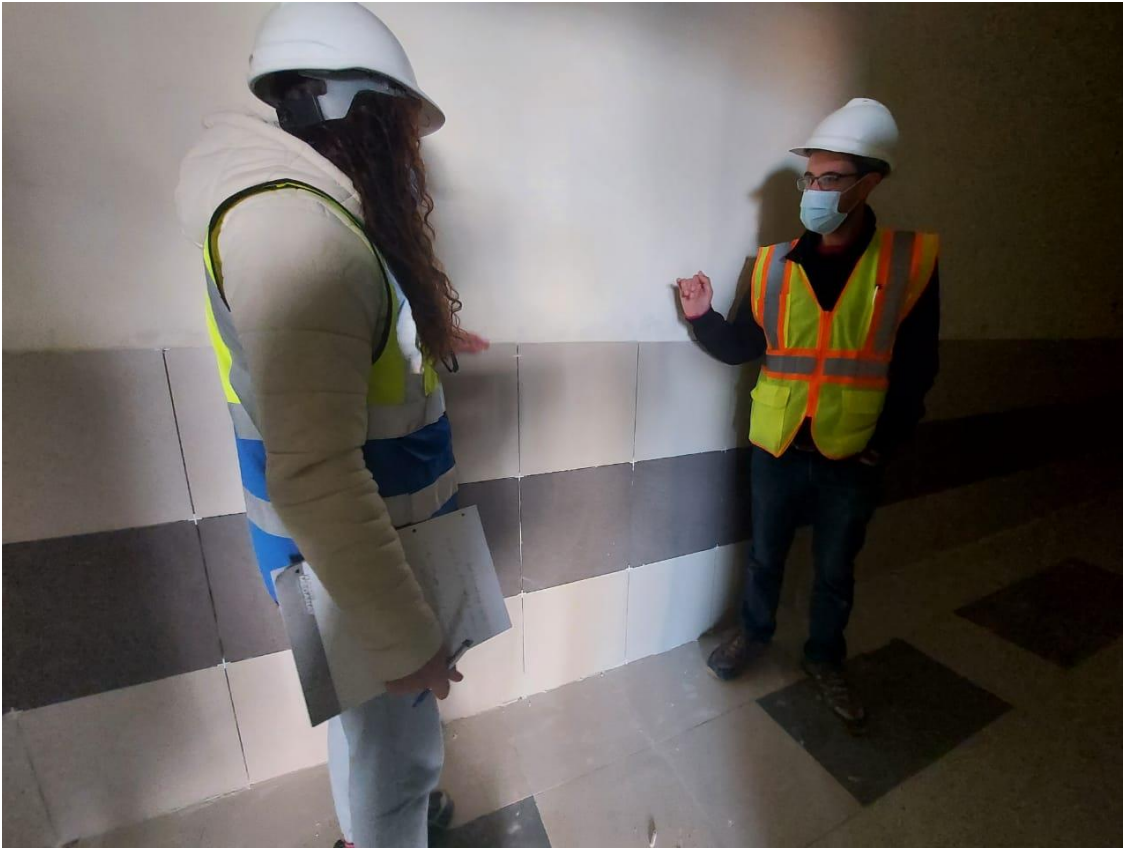
(Figure: 16)

Inspecting the execution of wall tiling for the corridors

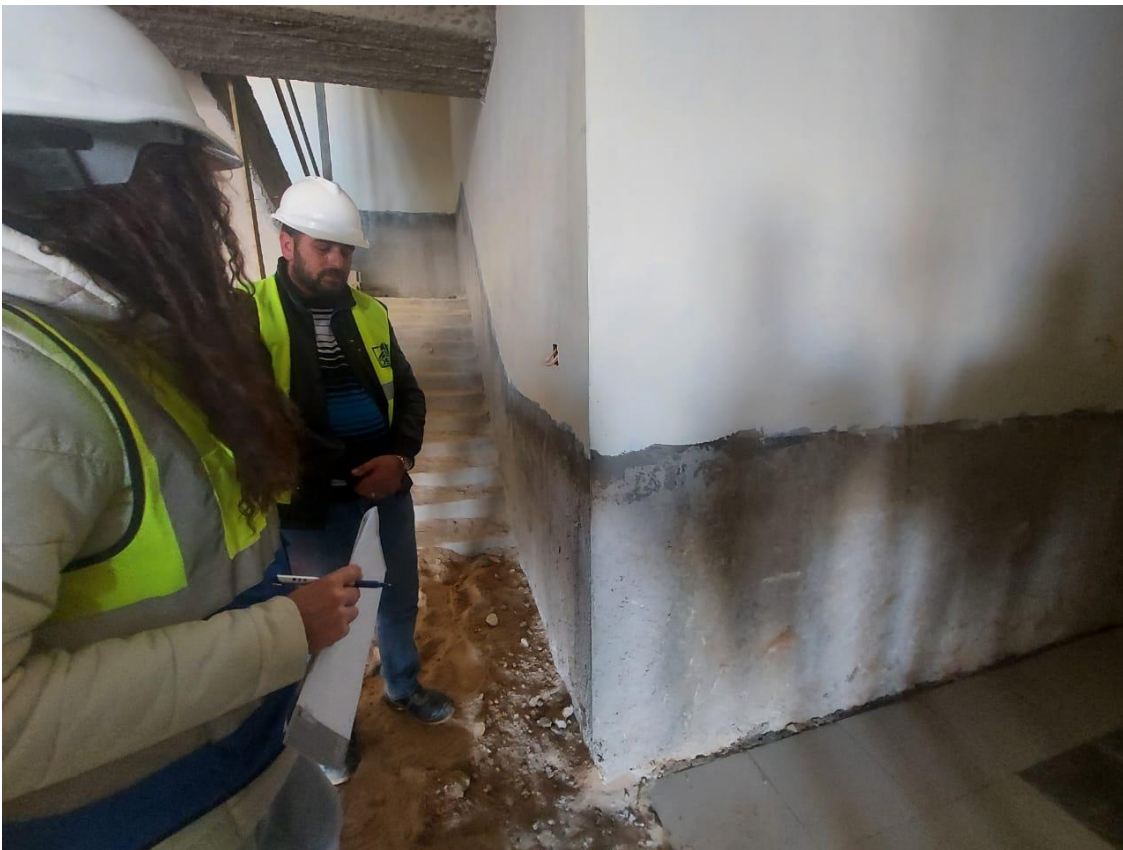
(Figure: 17)

The team discussed with the Contractor the connection between porcelain wall cladding at the corridors with the granite cladding at staircases

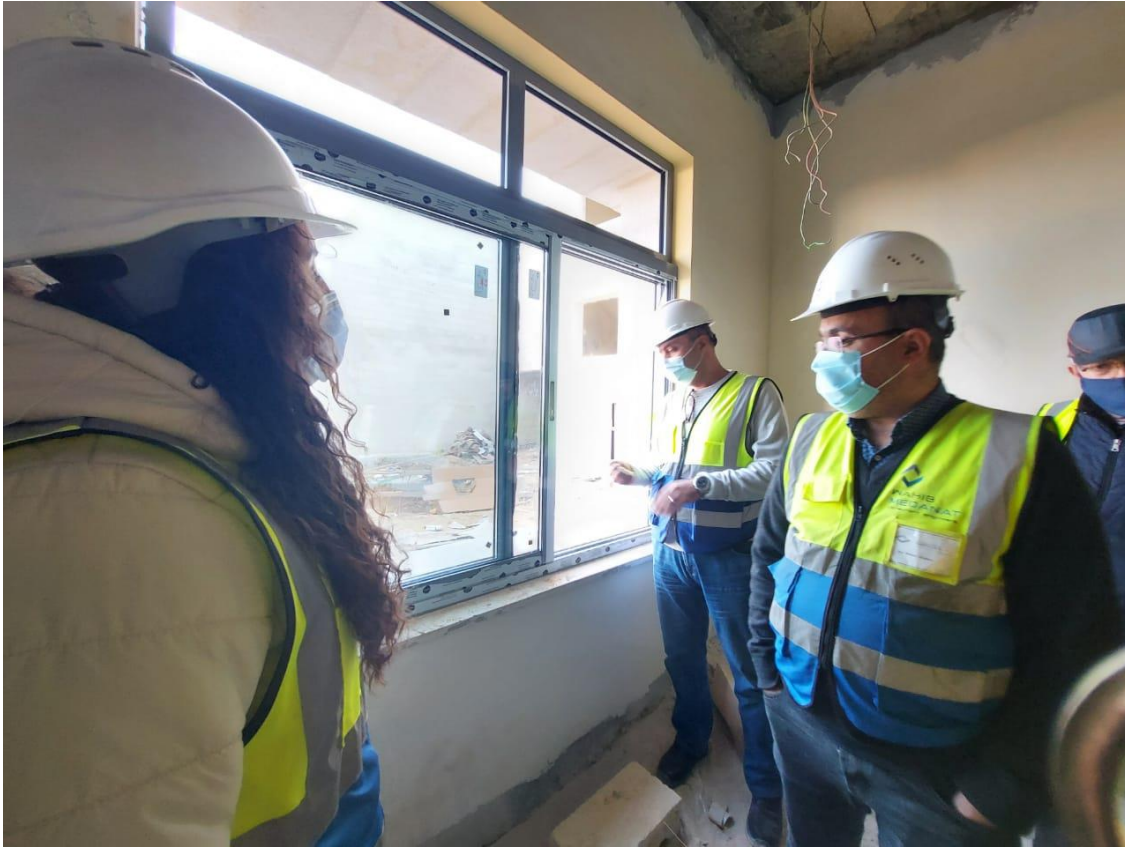
(Figure: 18)

The team inspected the aluminum windows under installation and stressed that the window jambs should be well finished and inspected by the supervision site team before installation of aluminum frames

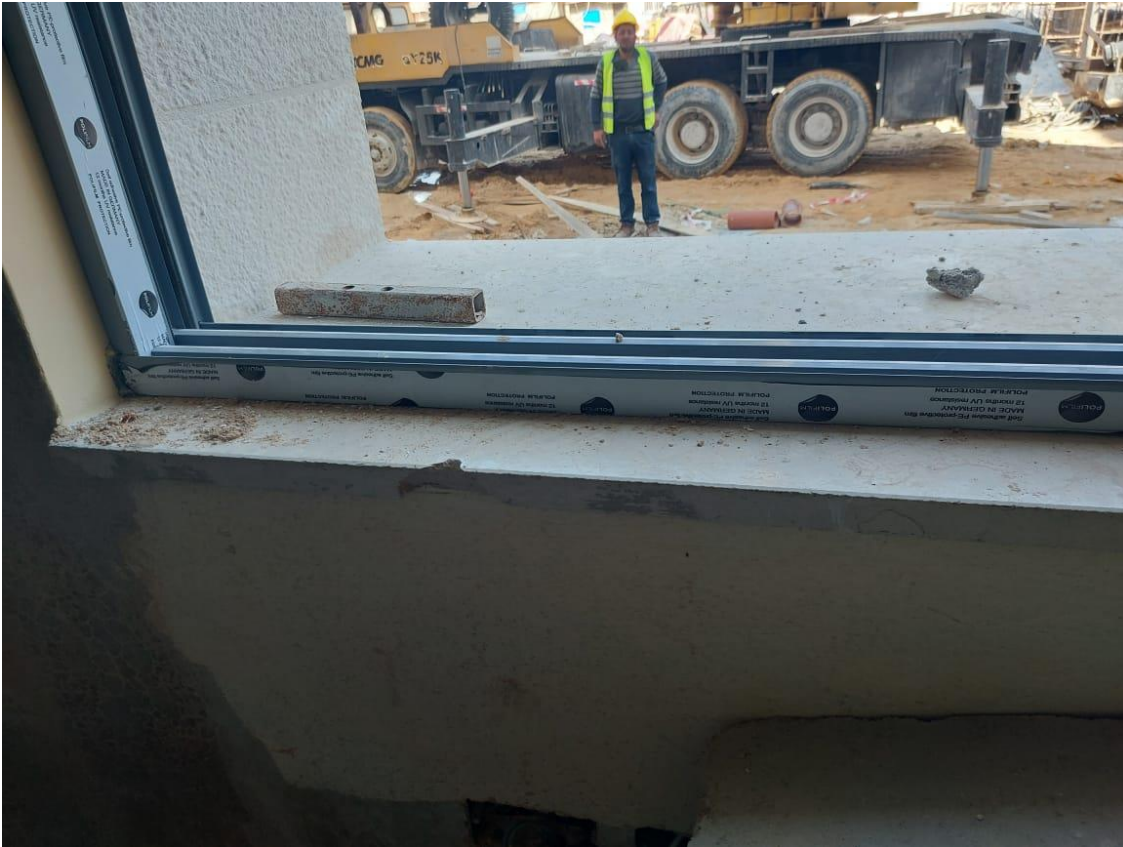
(Figure: 20)

The team requested the Contractor to replace the broken window sills

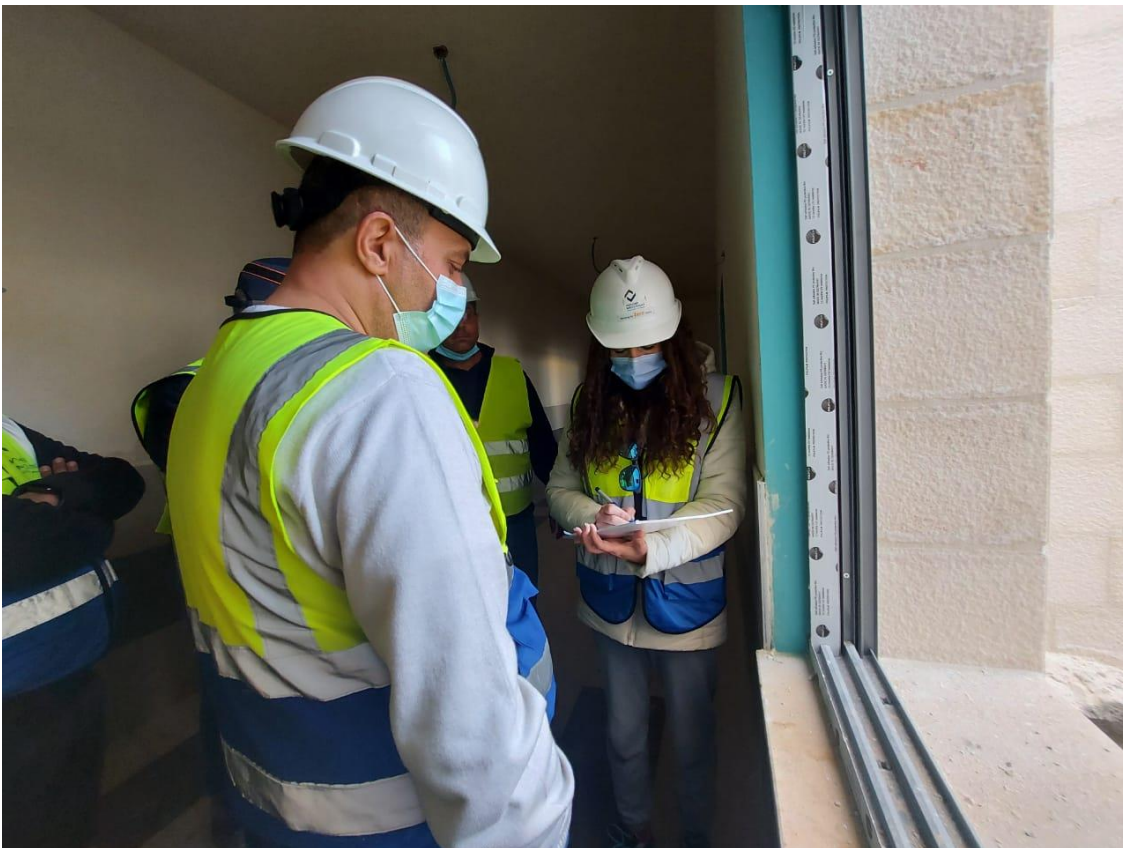
(Figure: 21)

Discussing the continuation of granite coping at the window jambs.

The team requested the Contractor to prepare samples showing the coping connection between the granite coping and window sills

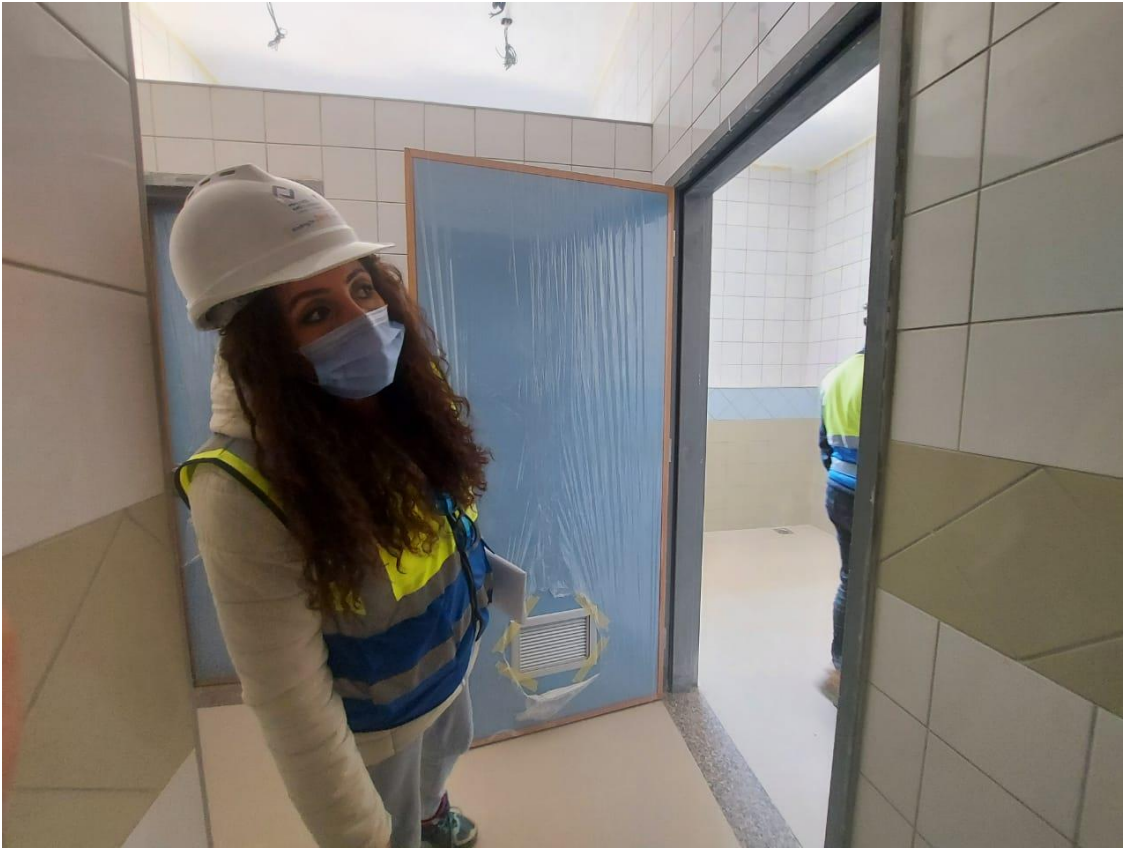
(Figure: 22)

The team inspected the prepared wooden door sample and requested the Contractor to modify the location of the door lock and handle not to merge into the beech wood door frame
