SKEP III Home Office Support Site Visit Report

Consultant	Wahib Medanat Consultant Engineer	Rep No.	21-19042022
Contractor	Dijlah Establishment Constr. Contracting	Tender No.	(11/2019/USAID/SKEP/3/S) Schools for a Knowledge Economy Project (SKEP) - Phase (3) Package (1, 2)
Site Name	Hay Al Iskan Basic Mixed School- Jerash	Day/ Date	Tue. 19/04/2022
Duration of Project	450 Calendar Days	Total Project Budget	8,314,983.735 JD

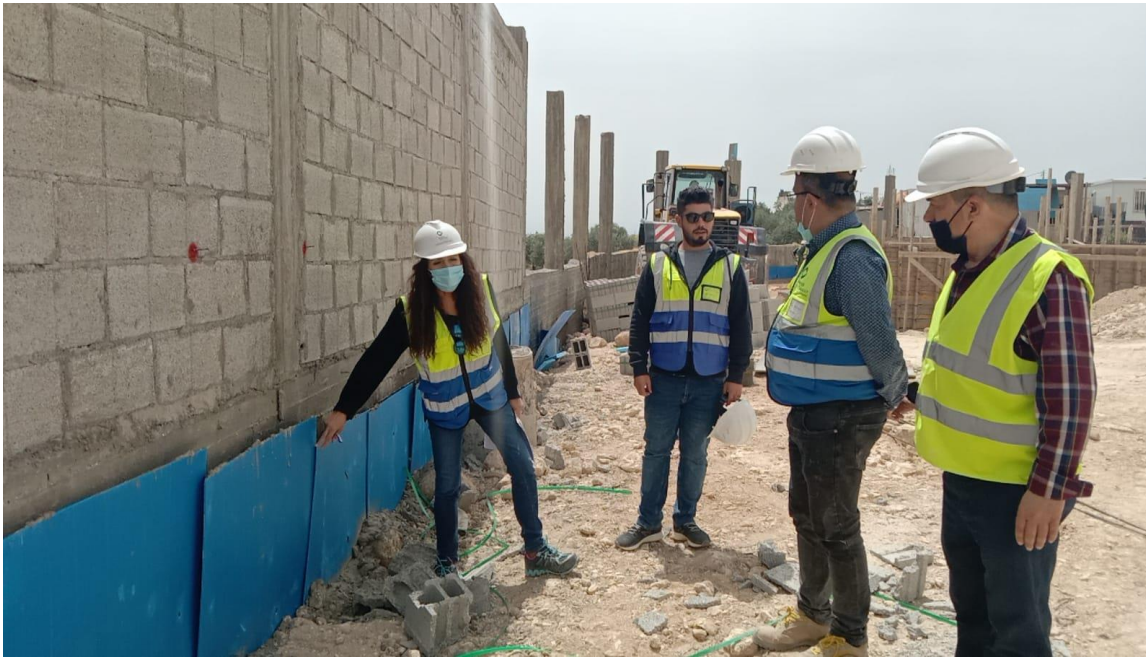
(Figure: 05)

The team inspected the work at external walls and stressed on the following:

- Cartonal sheets should be fixed before backfilling
- Overlap between sheets should be ensured

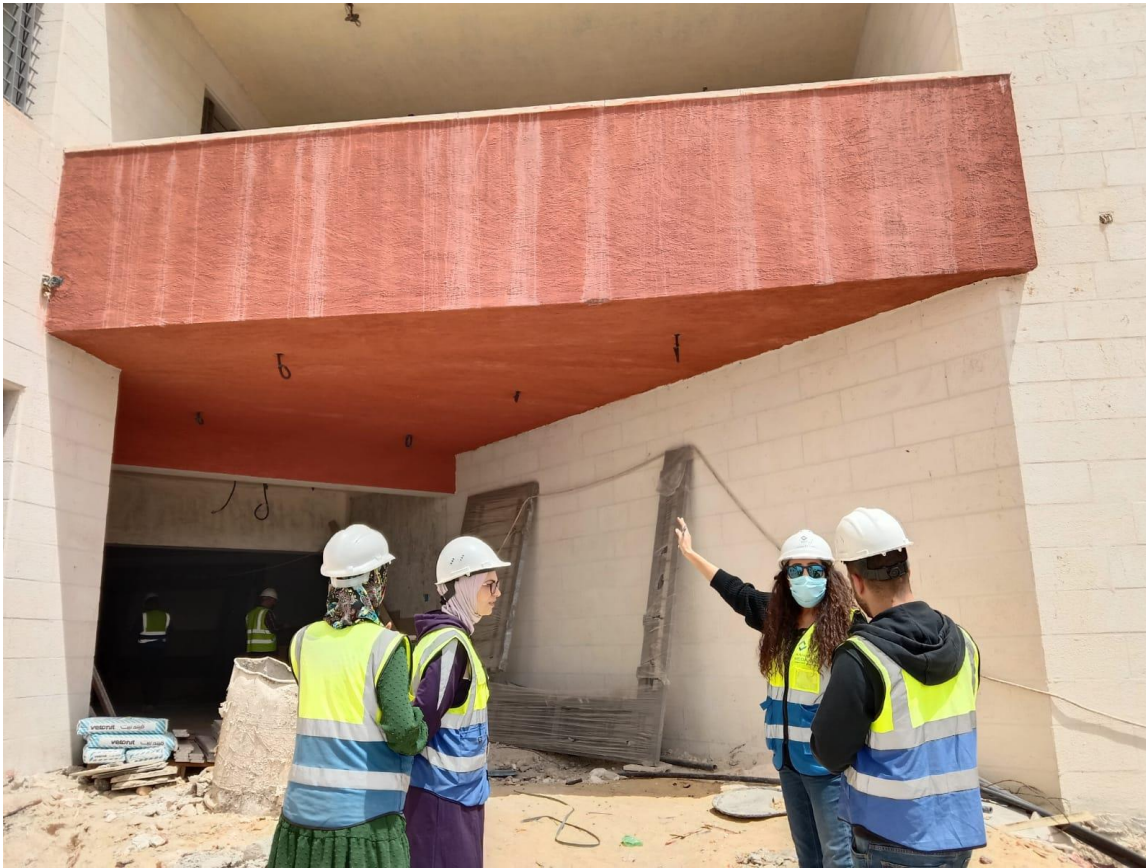
(Figure: 07)

Inspecting external colored plastering at the building and the boundaries. the Contractor was reminded with one of the requirements of the specifications, which is to apply protective coating at the top of plastering

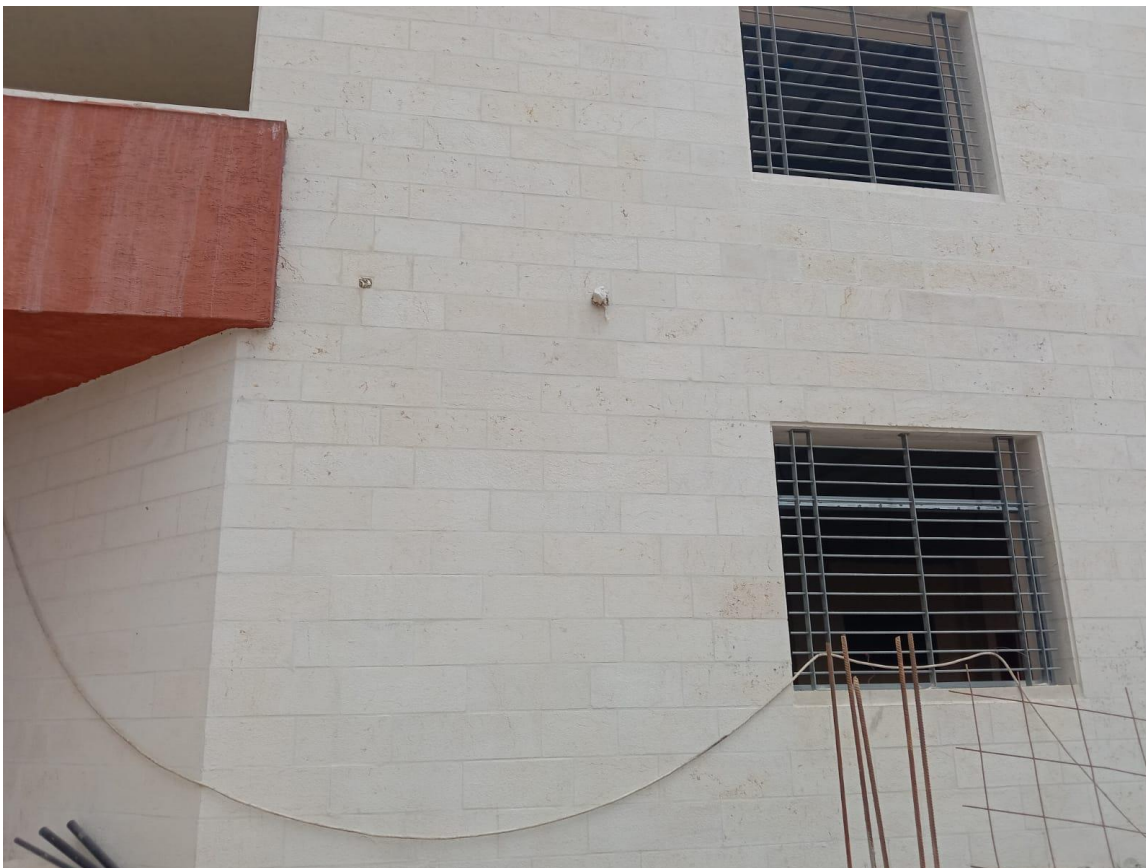
(Figure: 08)

The supervision team observed defects in the stones built at the front elevation. The Contractor was requested to replace

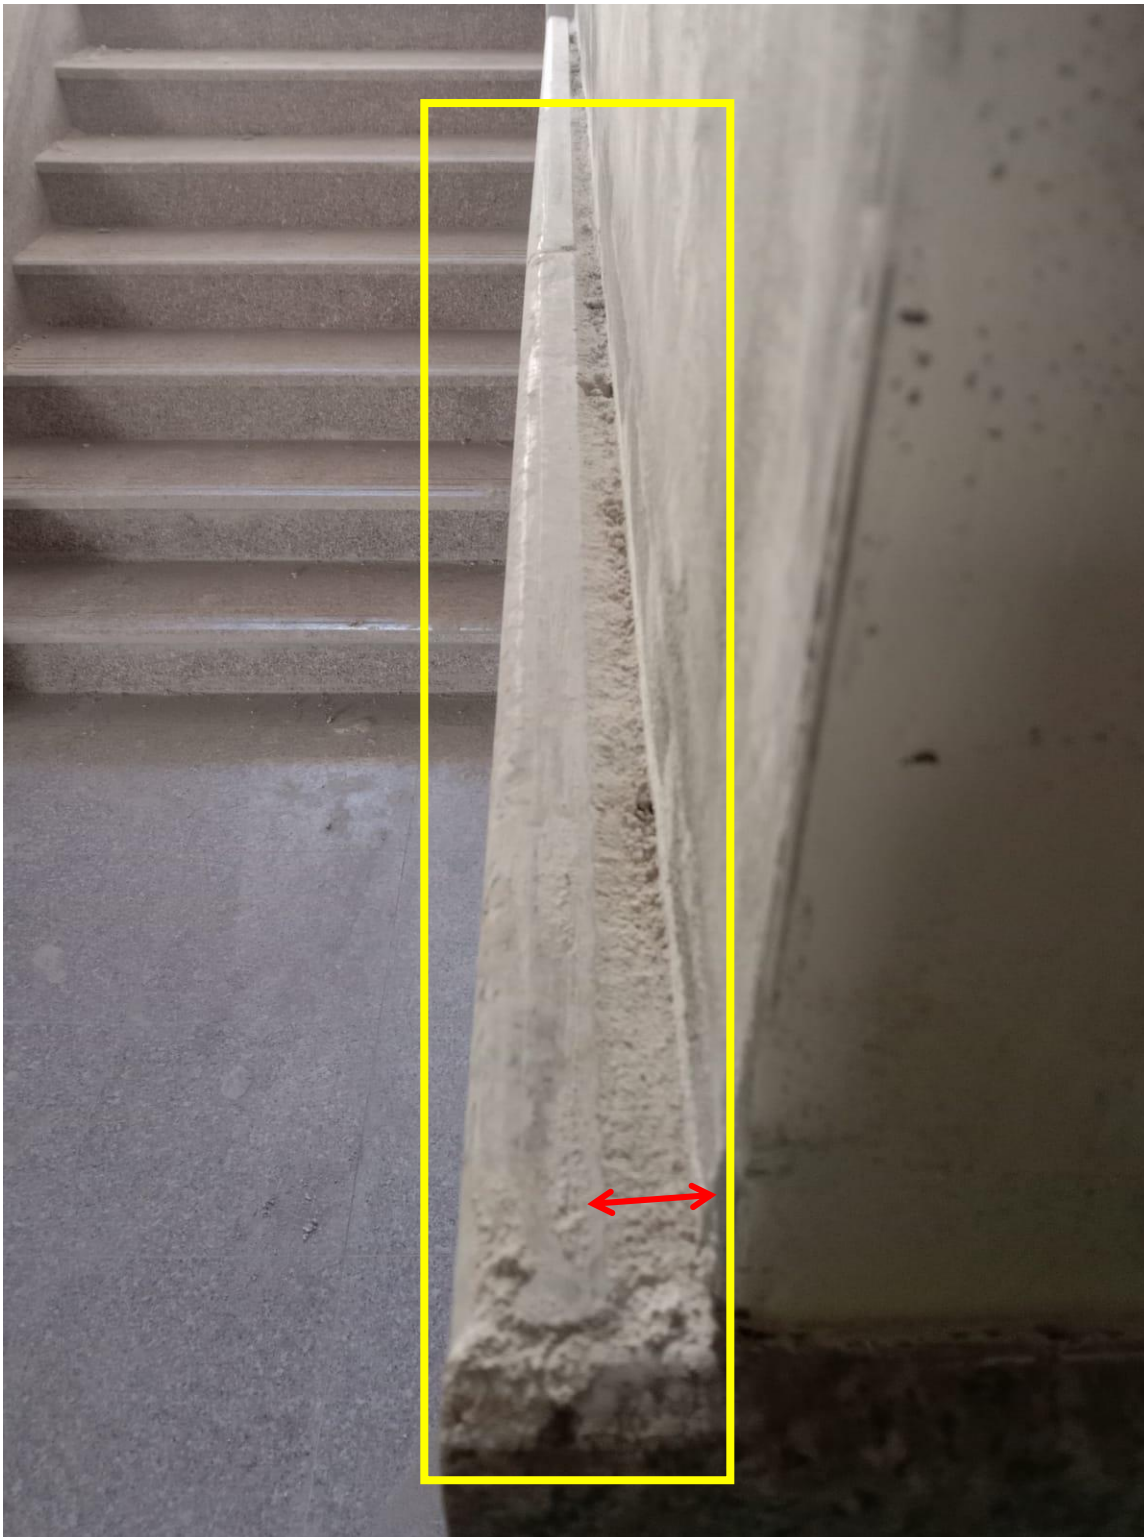
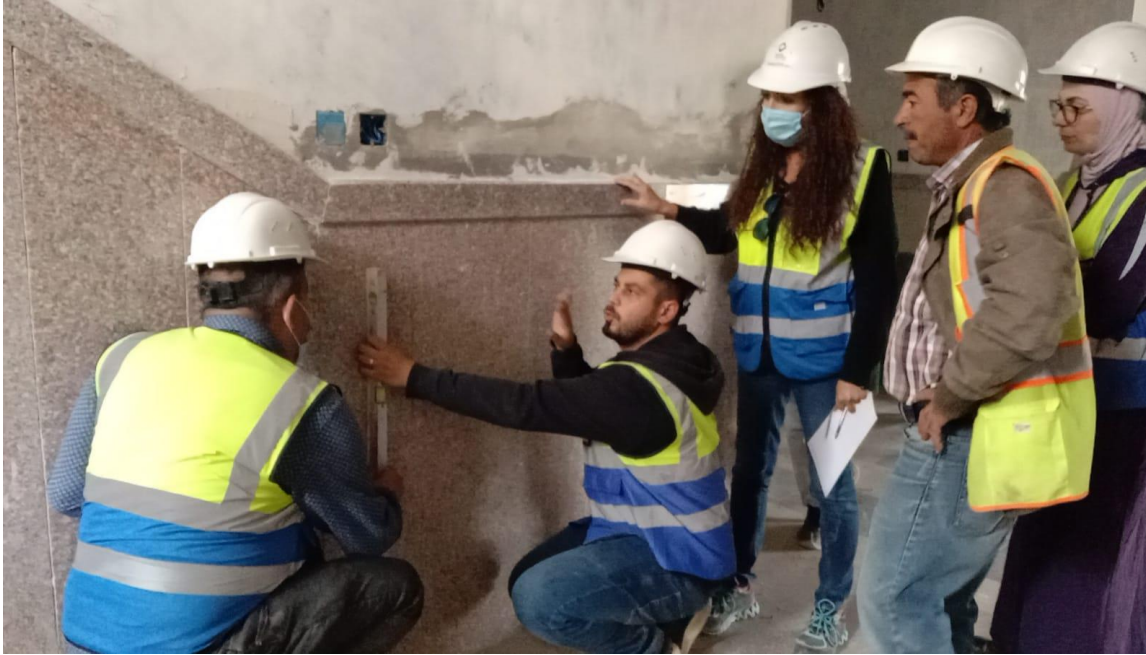
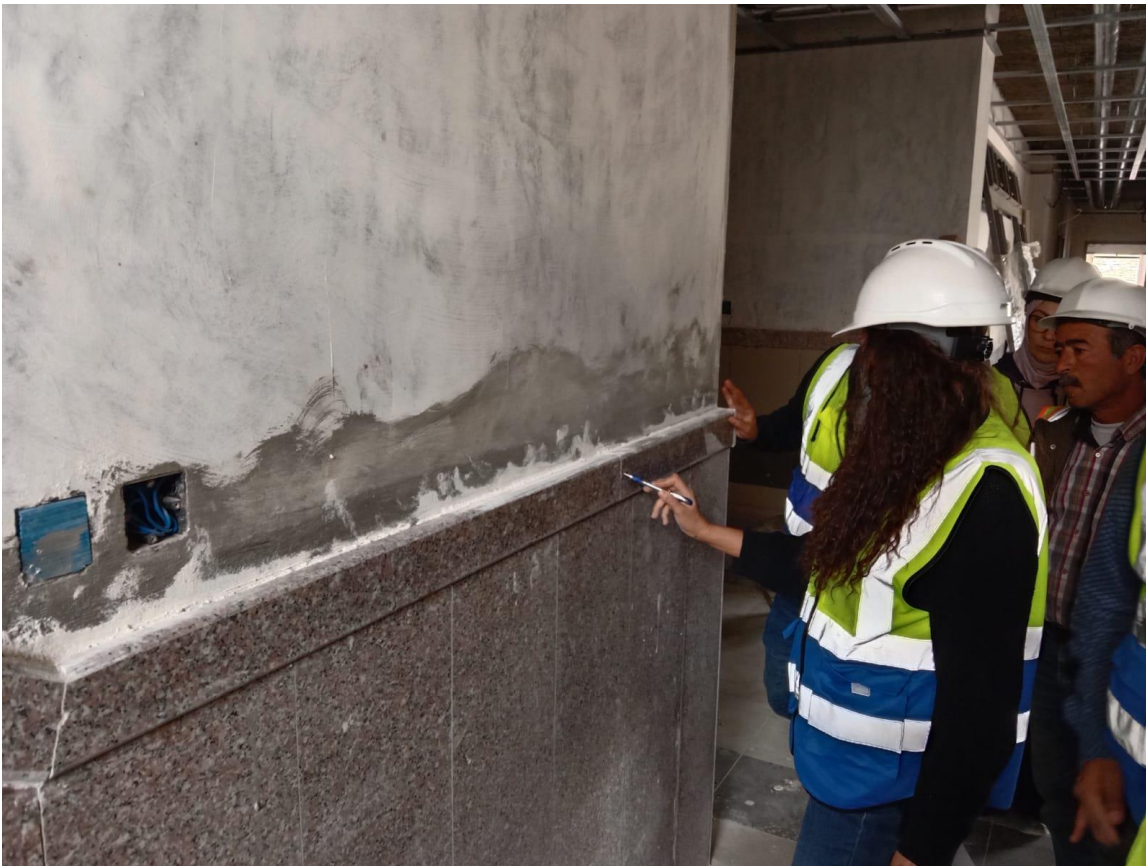
(Figure: 09, 10 & 11)

The team inspected cladding and the installation of granite coping at the staircases and observed defects in the verticality of cladding and coping which made a large gap between coping and the plastered wall. The team found that the installed granite does not comply with the drawing details since the granite coping should be installed within the plastering layer not over it. The Contractor was requested to rectify accordingly

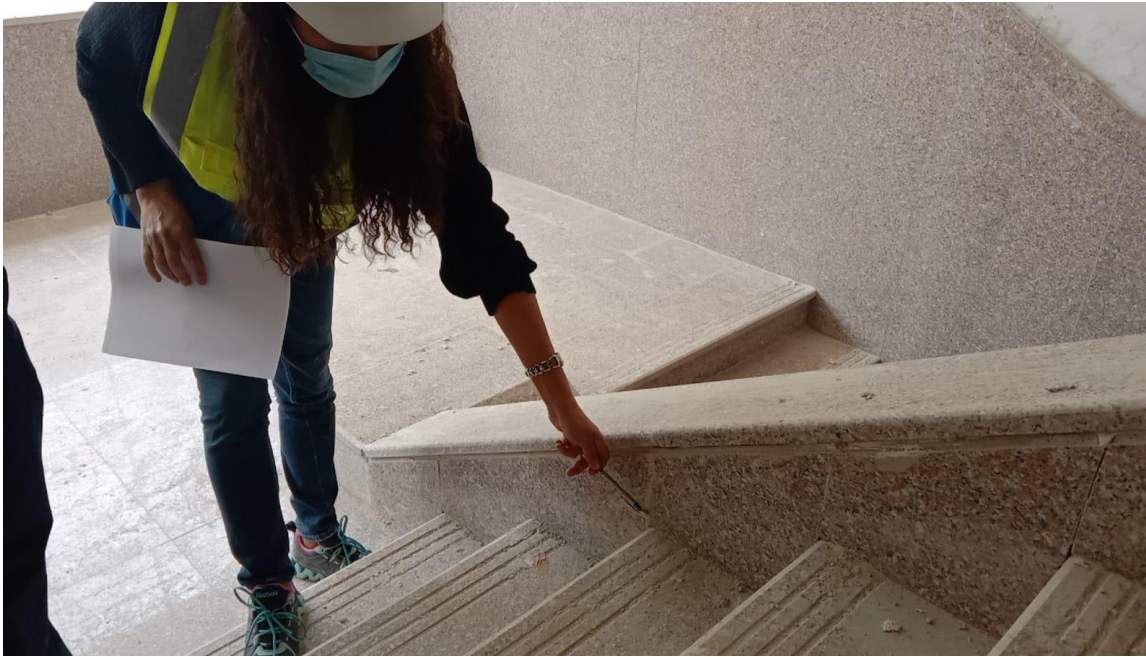
(Figure: 12)

The team observed defects at the connection points between inclined skirting and the stairs. Those defects are gaps and inaccurate cutting

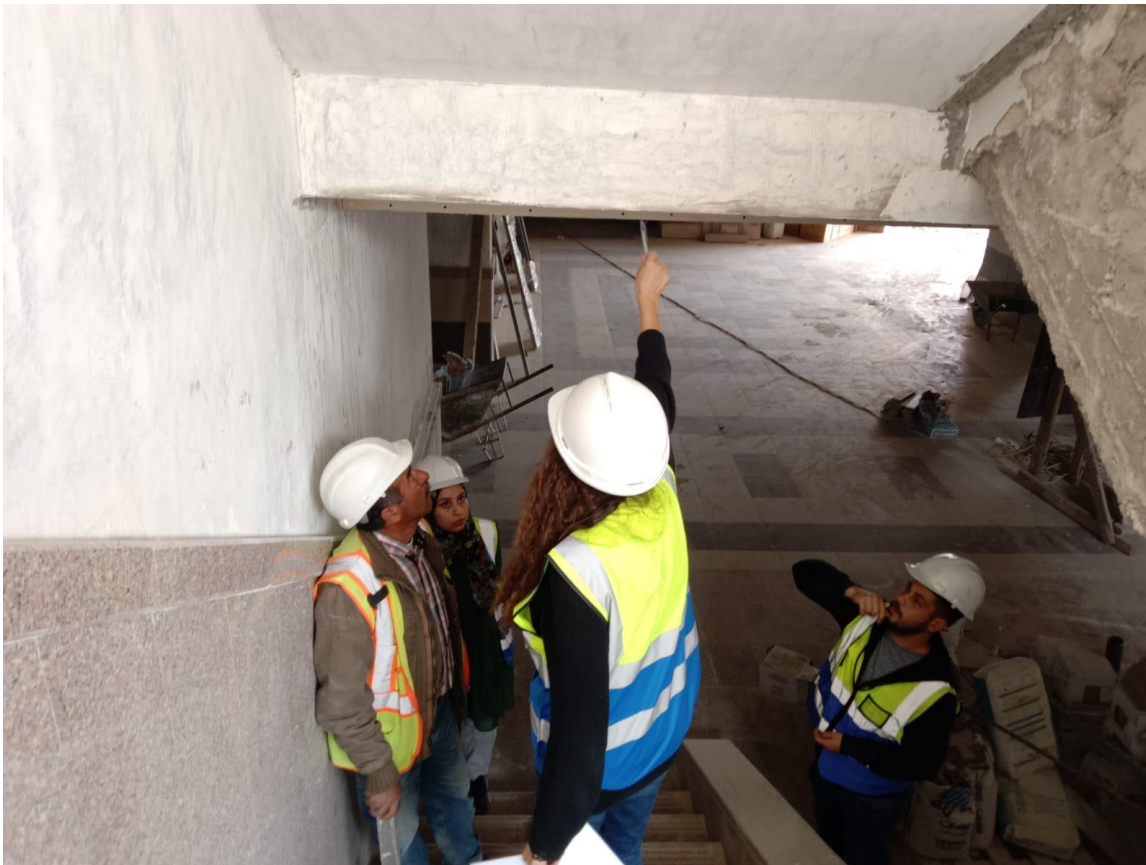
(Figure: 13)

The team discussed with the Contractor the limit of the suspended ceiling at the staircase area and instructed the Contractor to extend the suspended ceiling to the start of the first step of the staircase

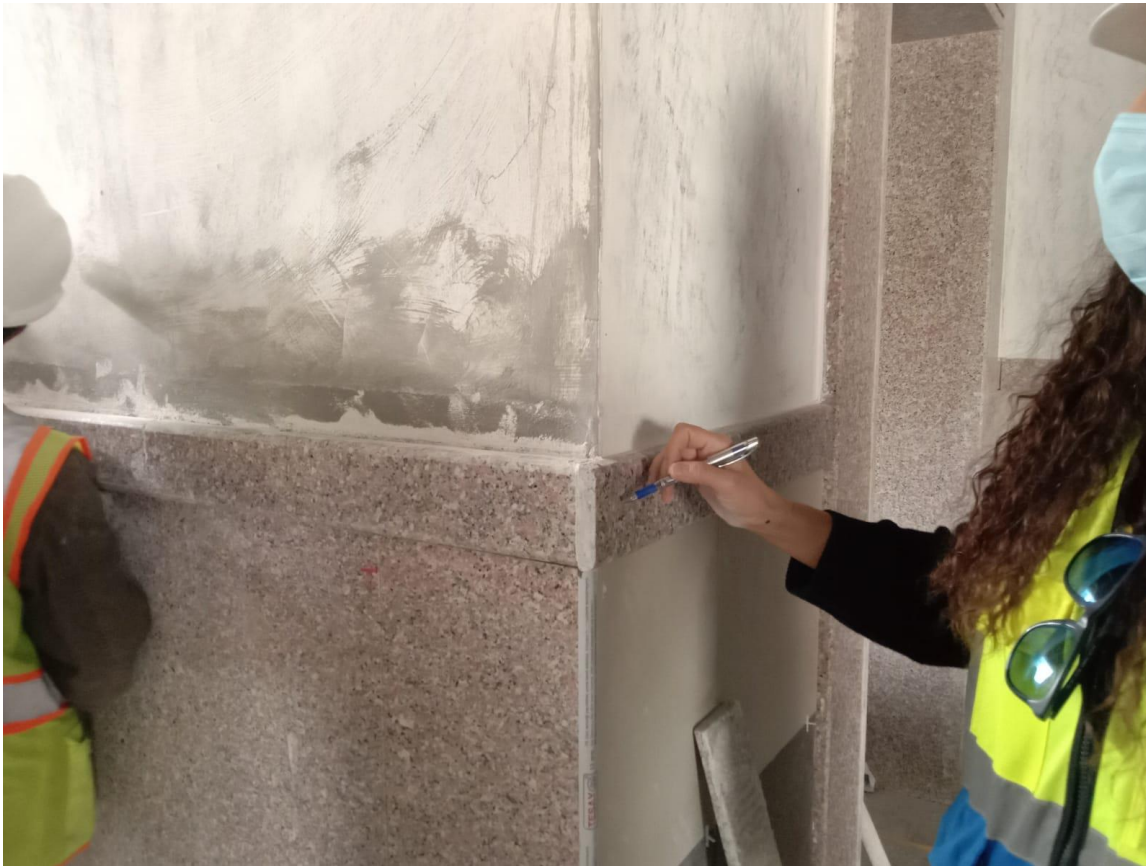
(Figure: 14)

The team inspected the granite coping at the corridors in general and informed the Contractor to ensure the grinding of edges

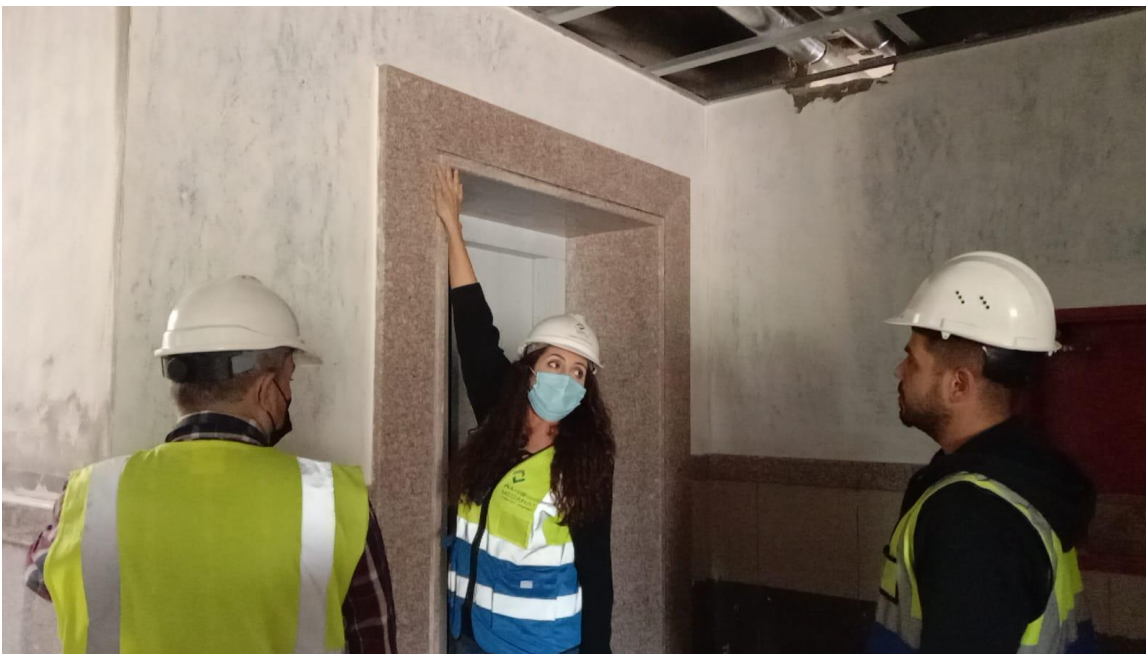
(Figure: 15)

The team inspected the granite frame around the elevators doors and the Contractor was requested to repair the corners

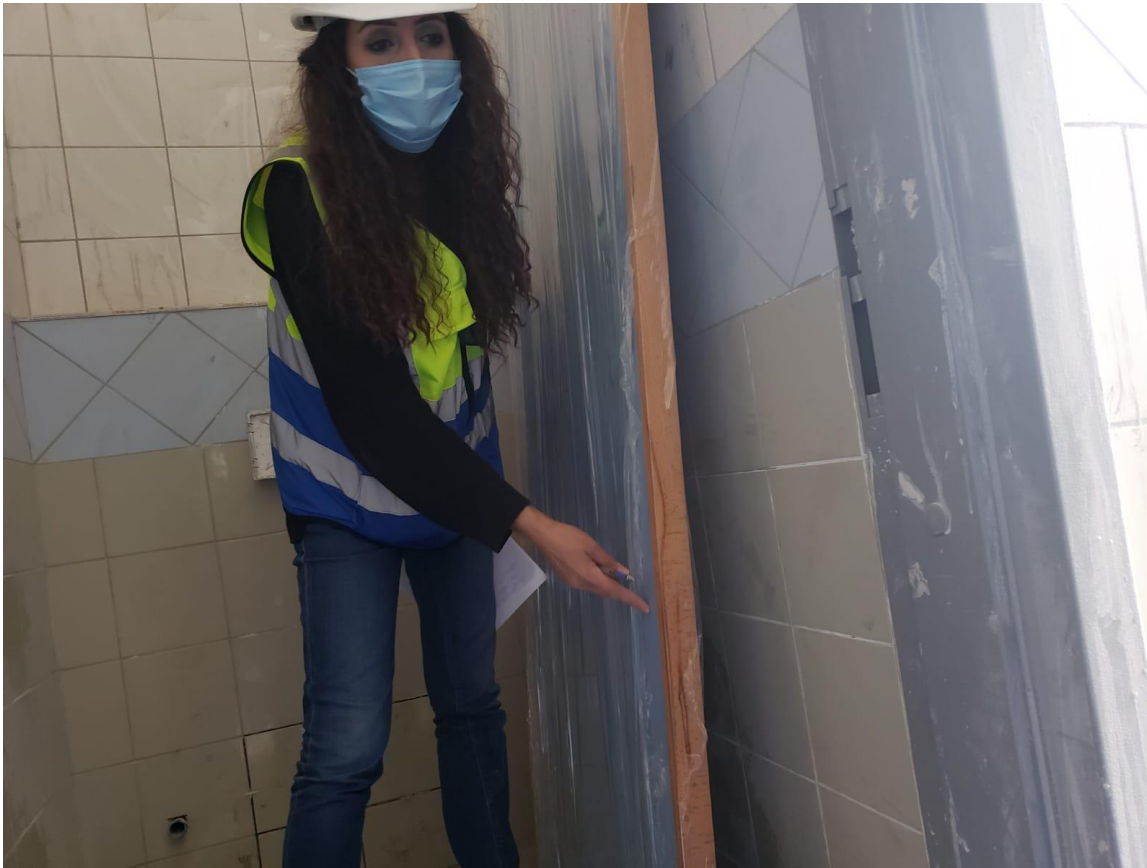
(Figure: 16)

The team observed defects in the beech wood frame for a number of wooden doors at wet areas. The Contractor was requested to remove the defective doors out of the site

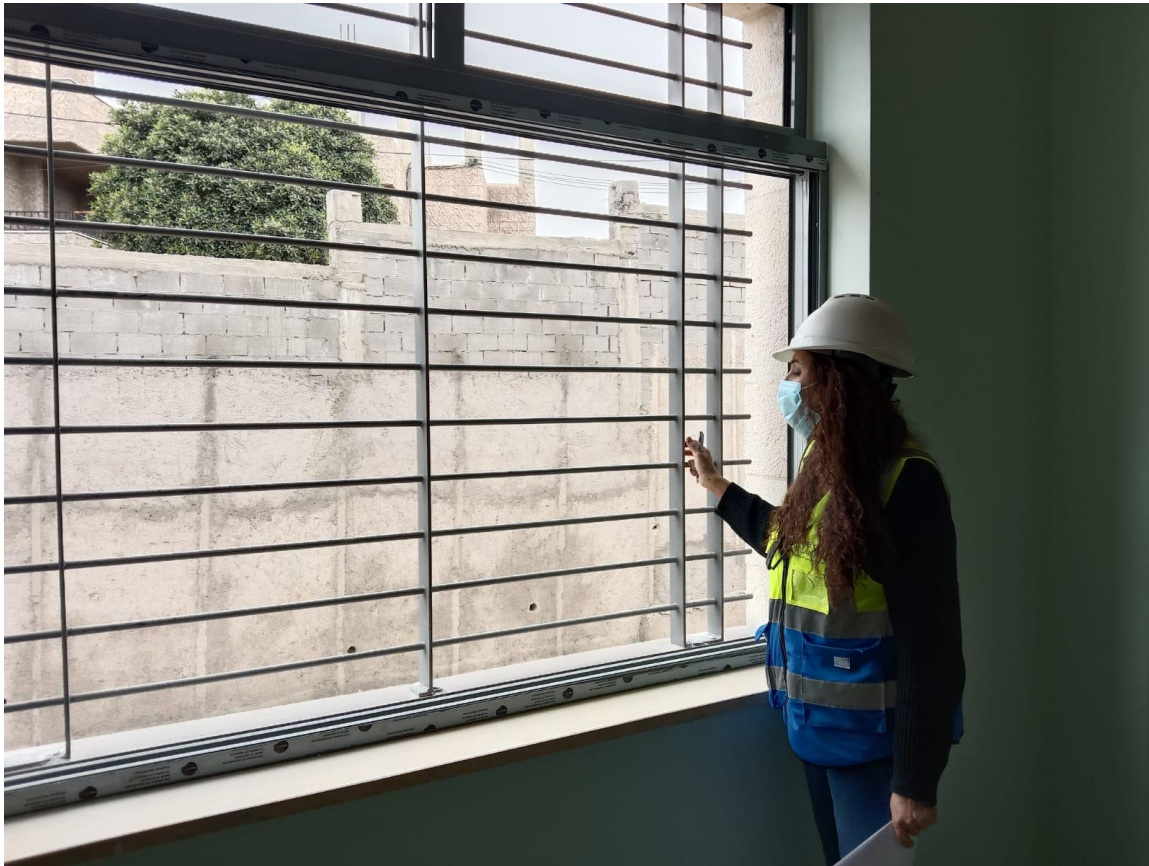
(Figure: 18)

The team inspected the installed steel protection screens and provided the Contractor with a number of remarks

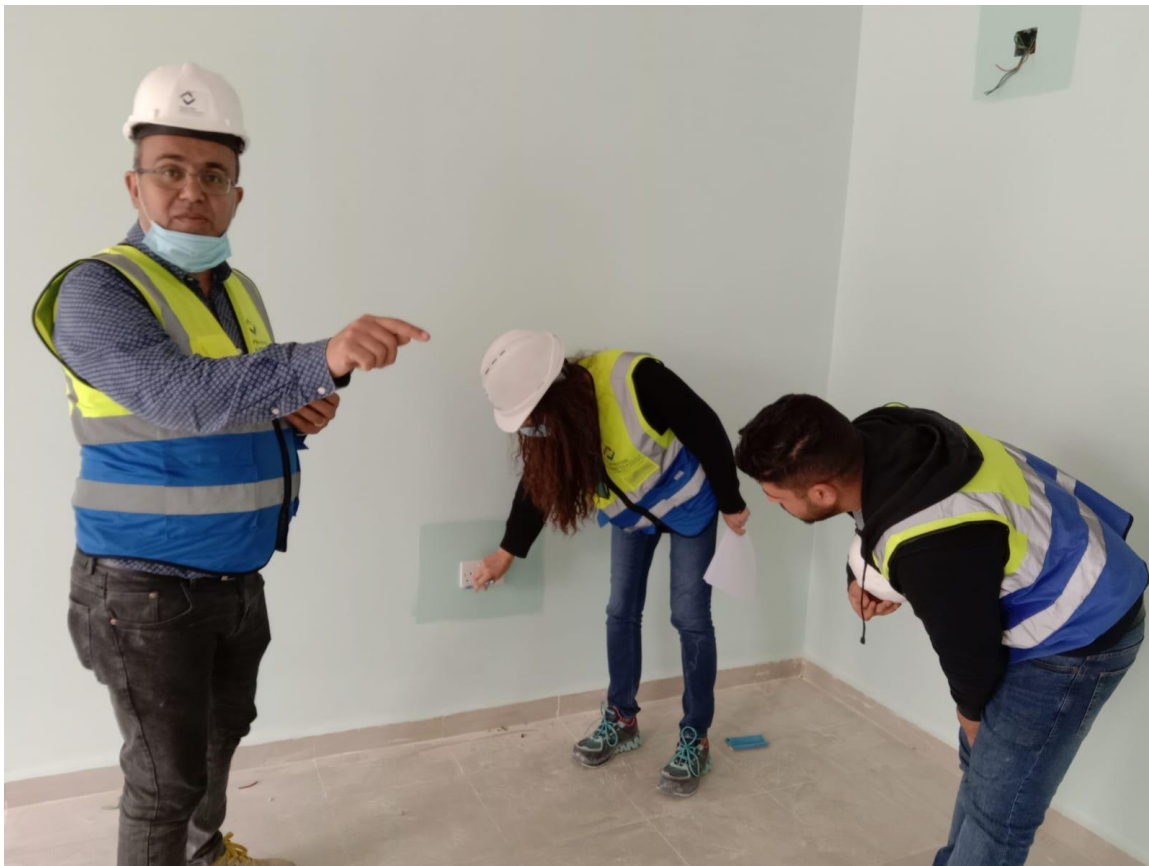
(Figure: 19)

The Contractor was requested not to fix the cover of sockets before completing the painting work for internal walls. It was observed that the color around the sockets is not neat due to installing before completing painting work

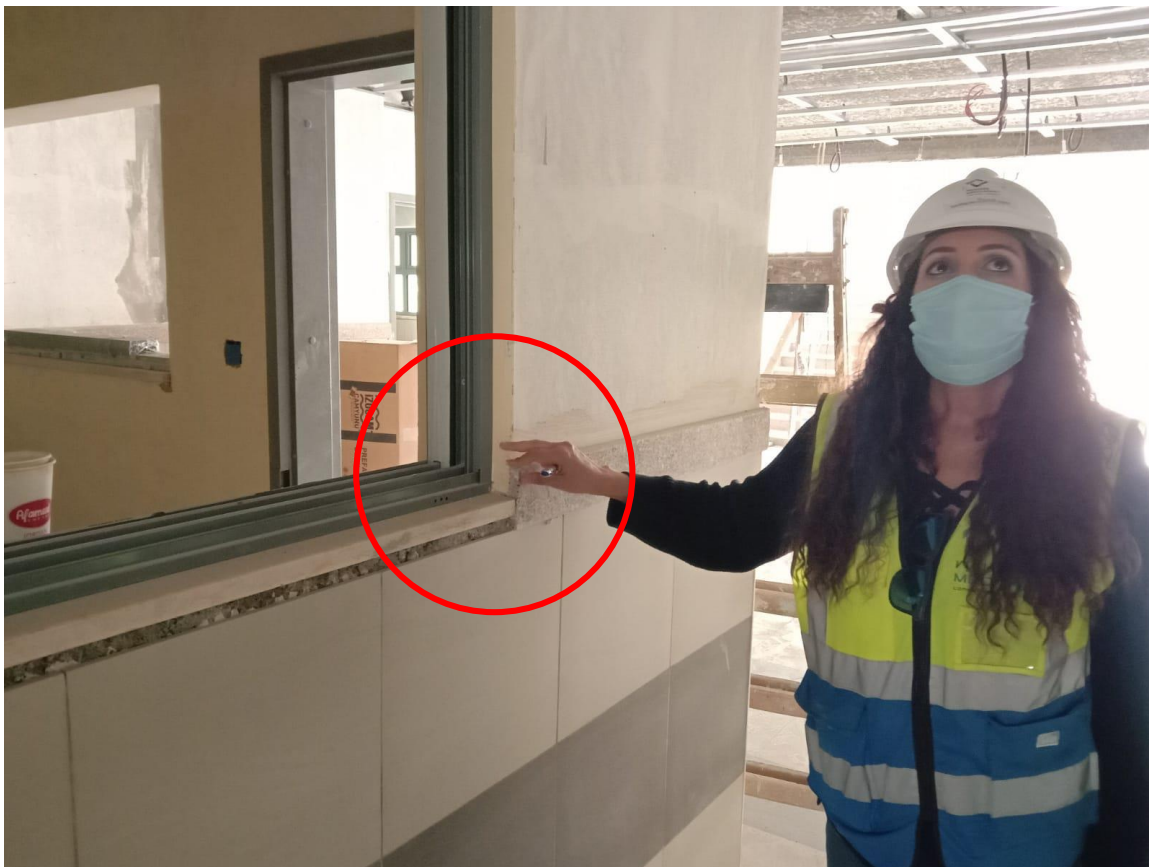
(Figure: 21)

The team instructed the Contractor to extend the granite coping over the porcelain at corridors to be also at the window jambs using small pieces

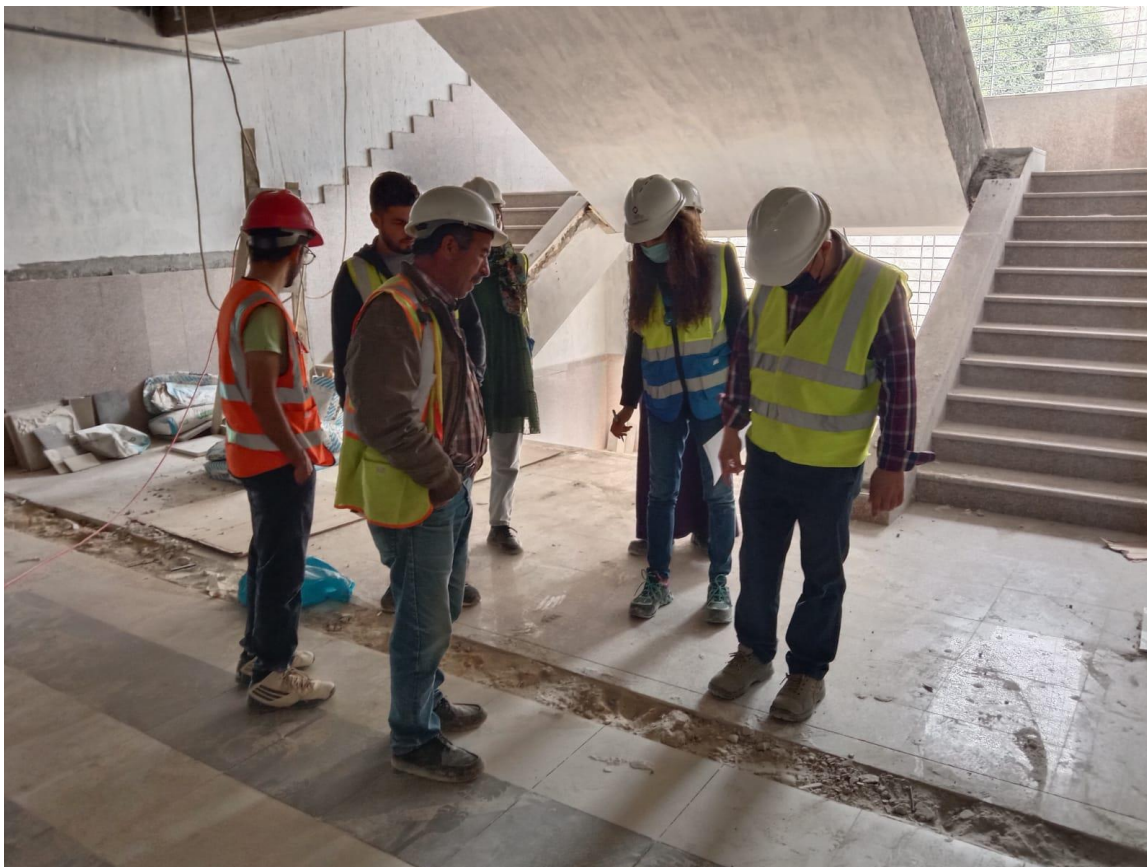
(Figure: 23)

The end of porcelain tiles and corridors at the staircase area should be coordinated with the granite tiling and the dimensions and cutting should be arranged correctly
