School for Knowledge

Economy Project (SKEP) Phase III – Package 2

Defects Liability Period/ General Observations

Hay Al Iskan Basic Mixed School

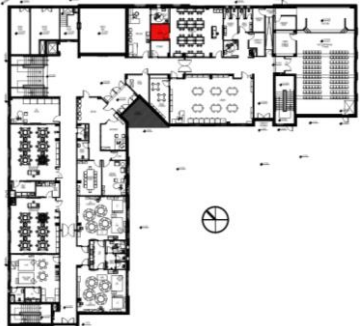
Ground Floor	Server Room	Cleaning is required

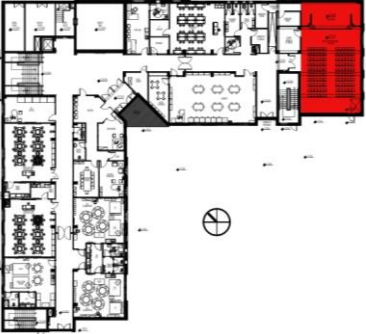
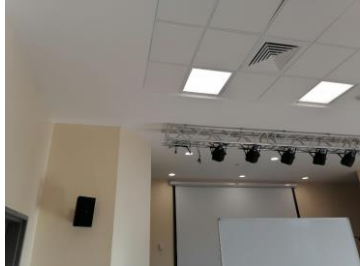
3	Ground Floor Multi-purpose hall

One lighting unit (stage) is missing

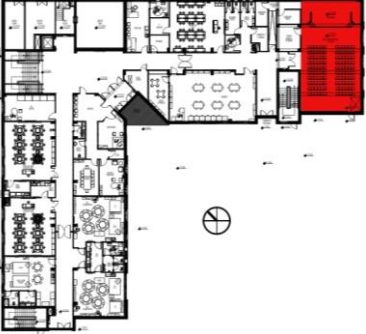
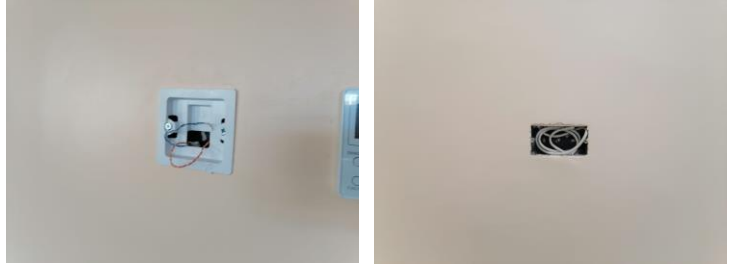
4	Ground Floor Multi-purpose hall

Thermostat for the package unit is not installed

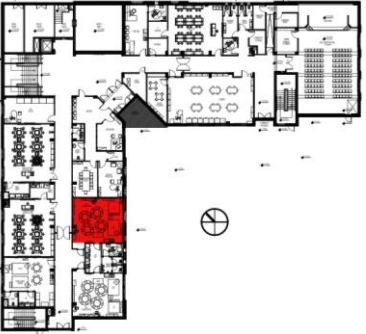
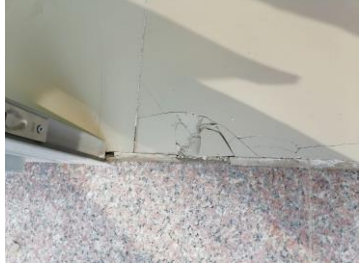
5	Ground Floor KG Classroom

Broken tiles shall be replaced

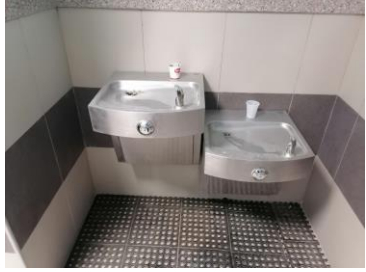
9	General	General	Some water coolers need maintenance

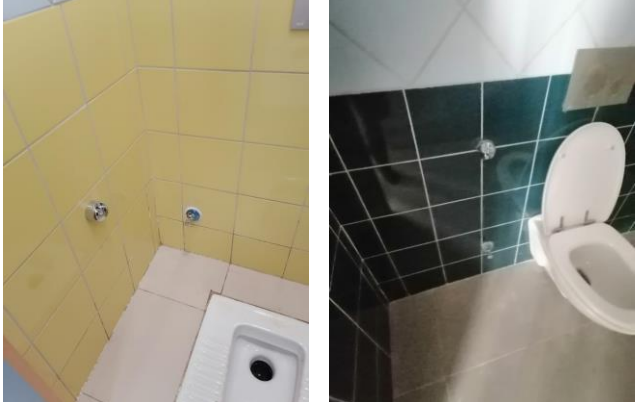
10	General	General	Plastic cases and tapes that are still covering equipment should be removed			
11	First Floor Second Floor	Computer room, toilet at the first floor and the toilet at the second floor	Hose bibs (bidets) shall be installed

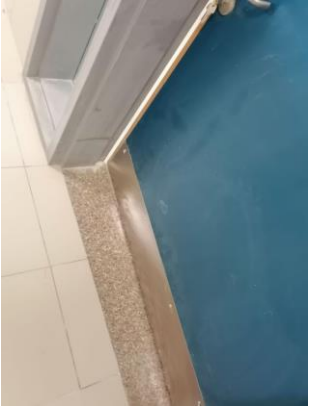
12	General	General	Some doors need adjustment	They don't close or open easily

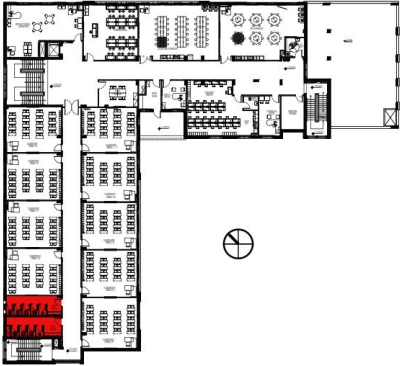
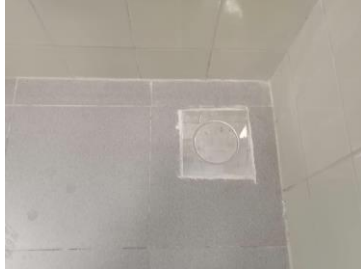
<p>13 First Floor Toilet</p>

<p>Corrosion can be observed on the floor drain cover</p>

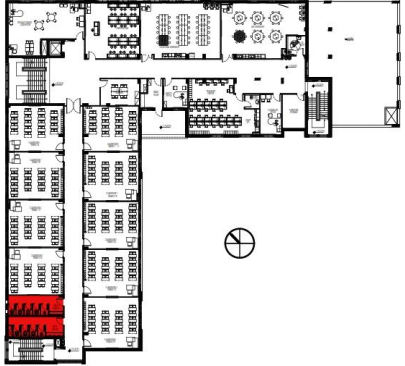
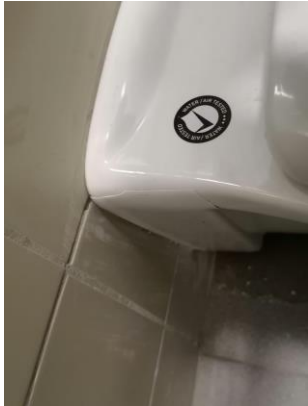
<p>14 First Floor Toilet</p>

<p>One toilet seat is broken and needs to be replaced</p>

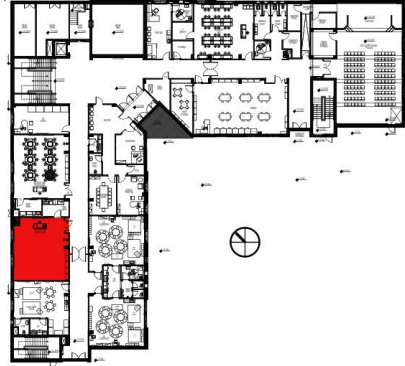
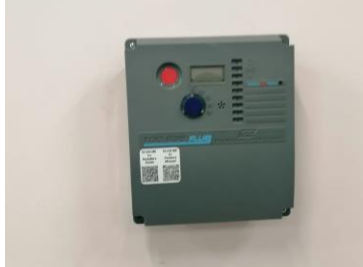
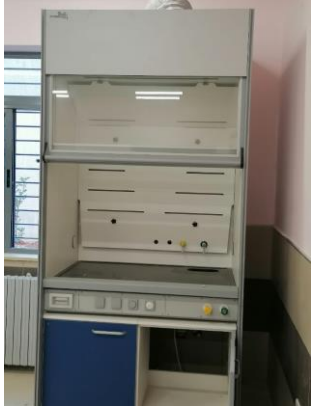
<p>15 Ground Floor Laboratory</p>

<p>Fume hood system shall be completely connected</p>	<p>Not activated</p>

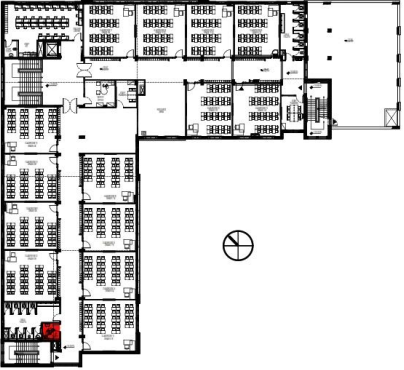
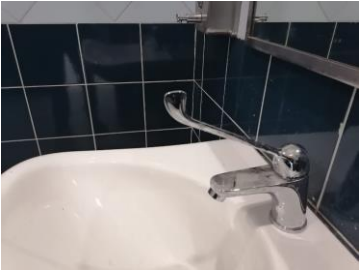
16	Second Floor	Handicapped Toilet

Mixer taps should be replaced with the approved type

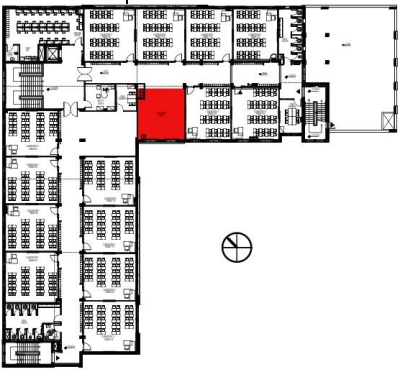
17	Second Floor	Resources Room

Lighting fixtures do not work			
18	Roof Floor	Top Roof	Water pools were observed and they resulted from wrinkles in the bitumen sheets

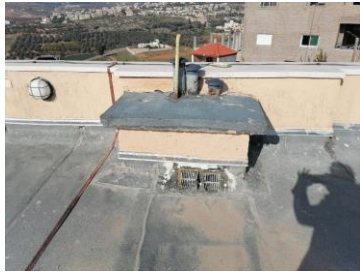
19	Roof Floor	Top Roof	One rain drain cover should be replaced

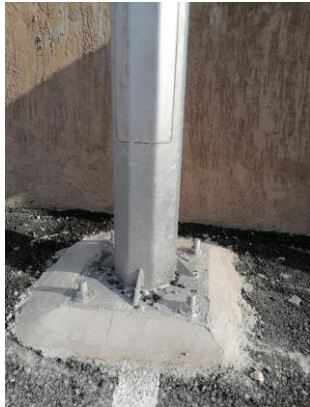
20	External Work	Parking Area	Lightning poles bolts need to be covered with protection caps

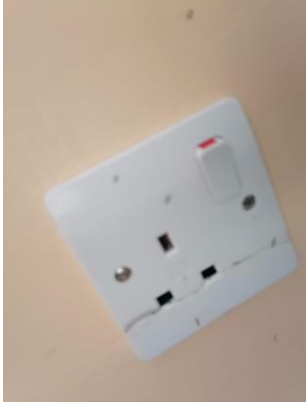
21	Guard House	Guard House	A broken electrical socket should be replaced
