SKEP III Home Office Support Site Visit Report

Consultant	Wahib Medanat Consultant Engineer	Rep No.	13-20032022
Contractor	Derar Saraireh & Sons for Engineering & Contracting	Tender No.	(11/2019/USAID/SKEP/3/S) Schools for a Knowledge Economy Project (SKEP) - Phase (3) Package (1, 2)
Site Name	Khadija Bint Khwailed Basic Mixed School- Shouna Janoubia	Day/ Date	Sun. 20/03/2022
Duration of Project	450 Calendar Days	Total Project Budget	9,789,417.840 JD

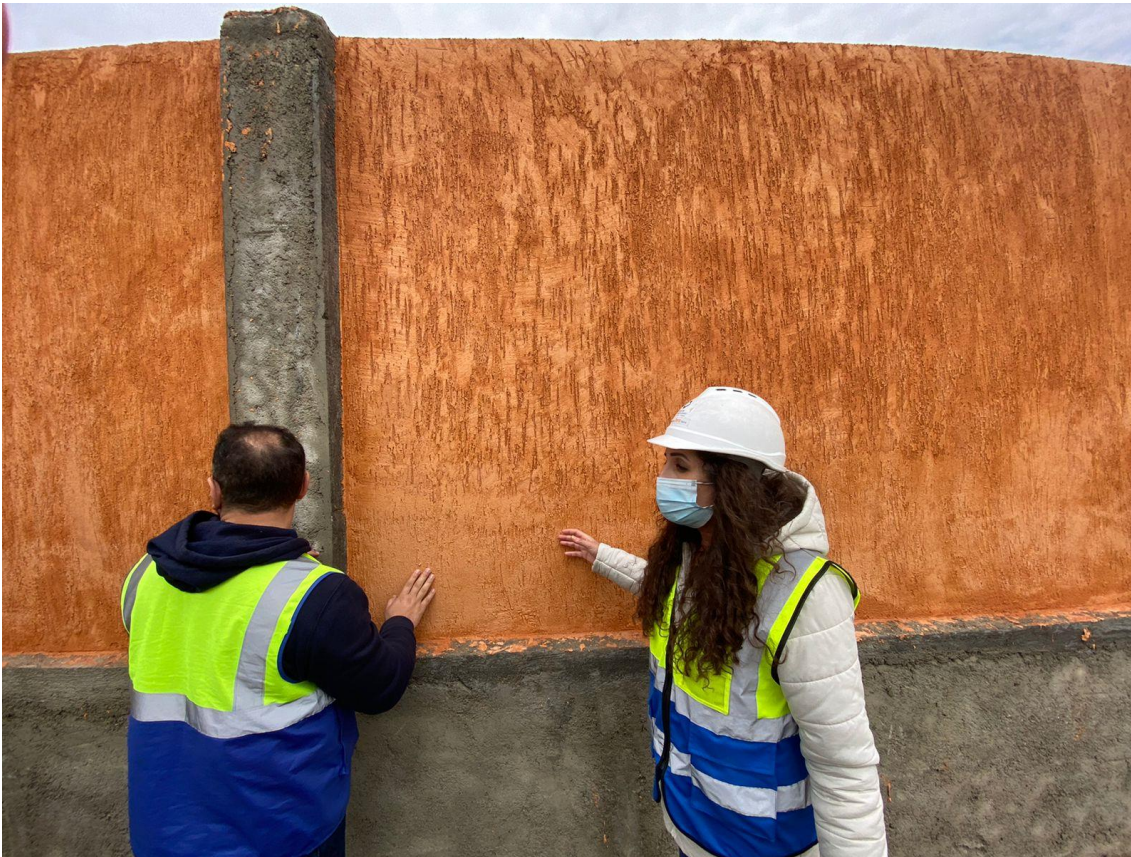
(Figure: 04)

The supervision team inspected the external plastering-final finish executed for some parts of boundary walls. The Contractor was requested to remove and comply with the approved sample

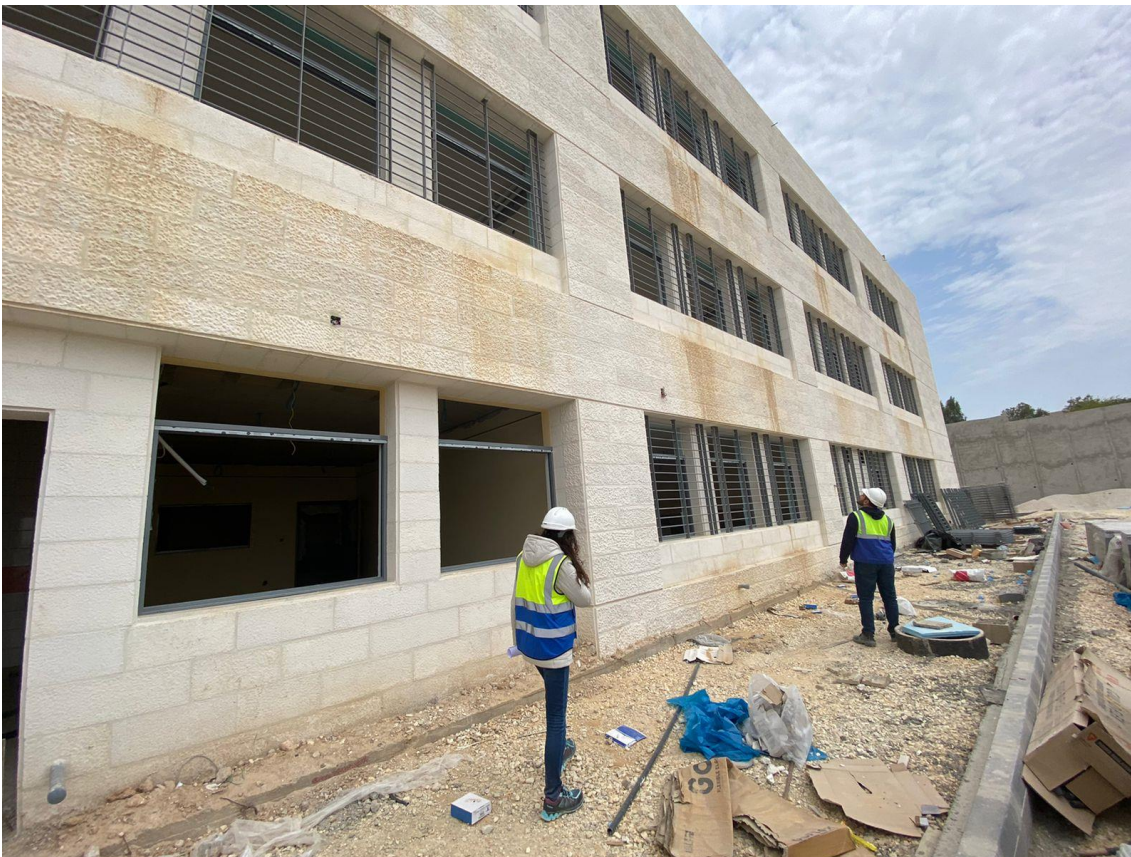
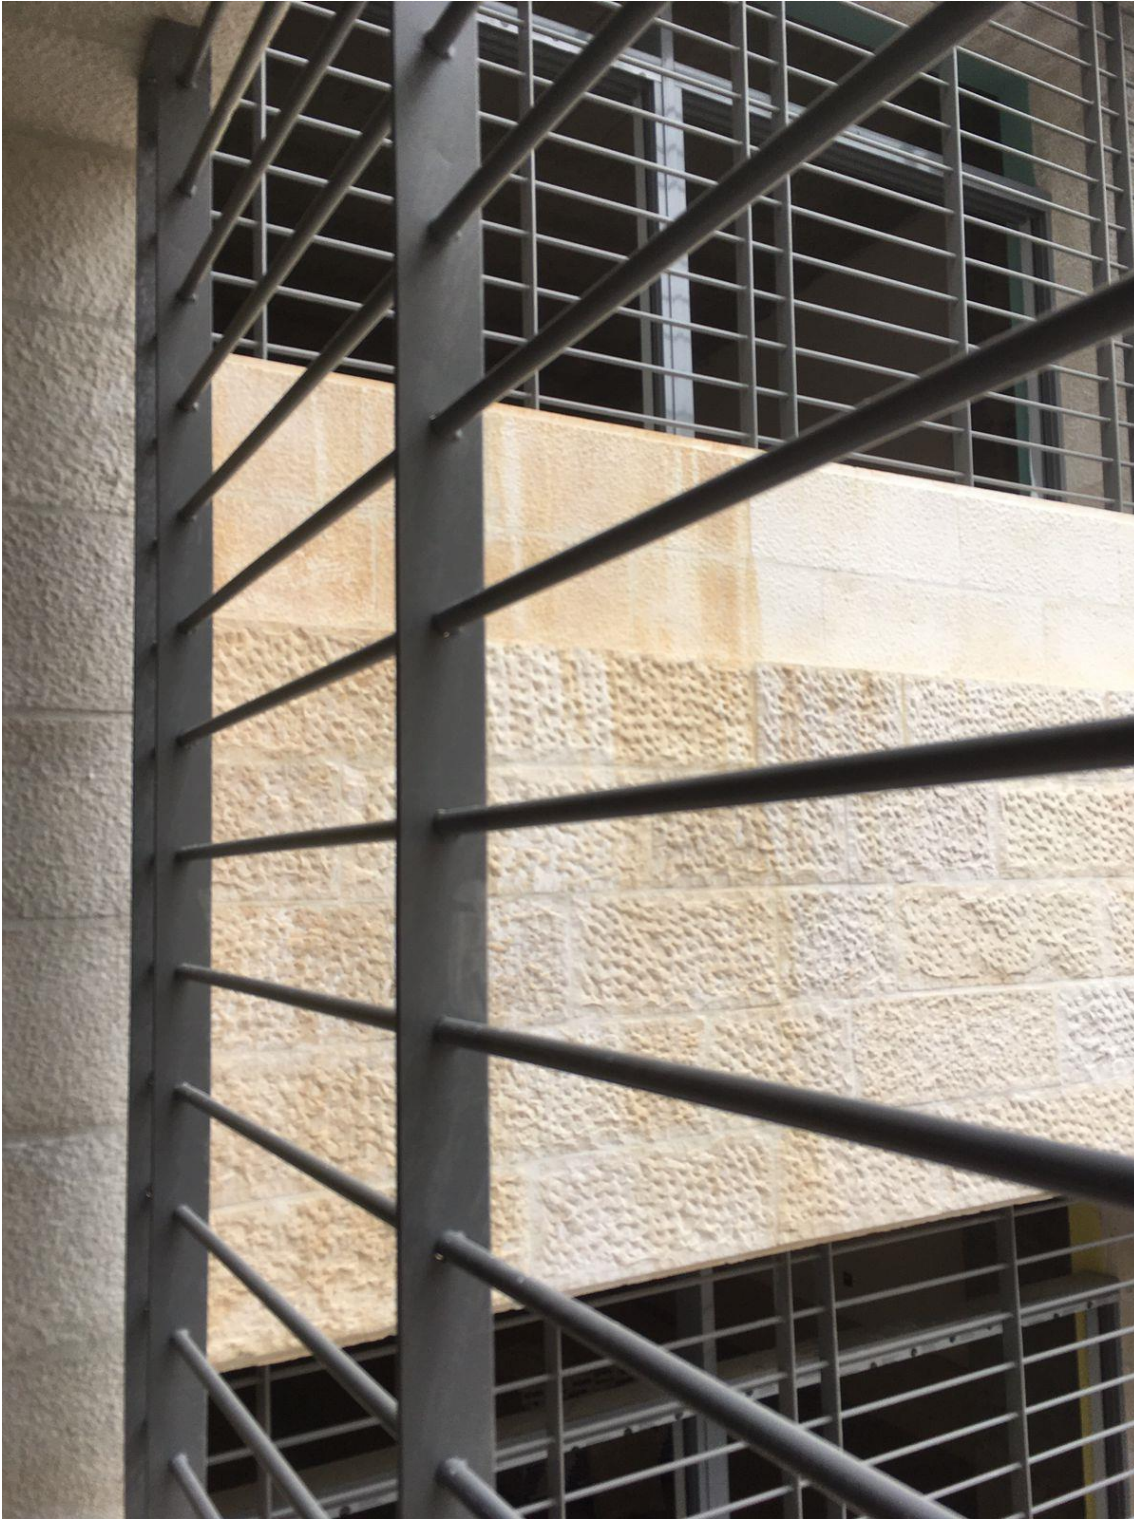
(Figure: 05 & 06)

The team observed that due to other activities the stone facades require cleaning

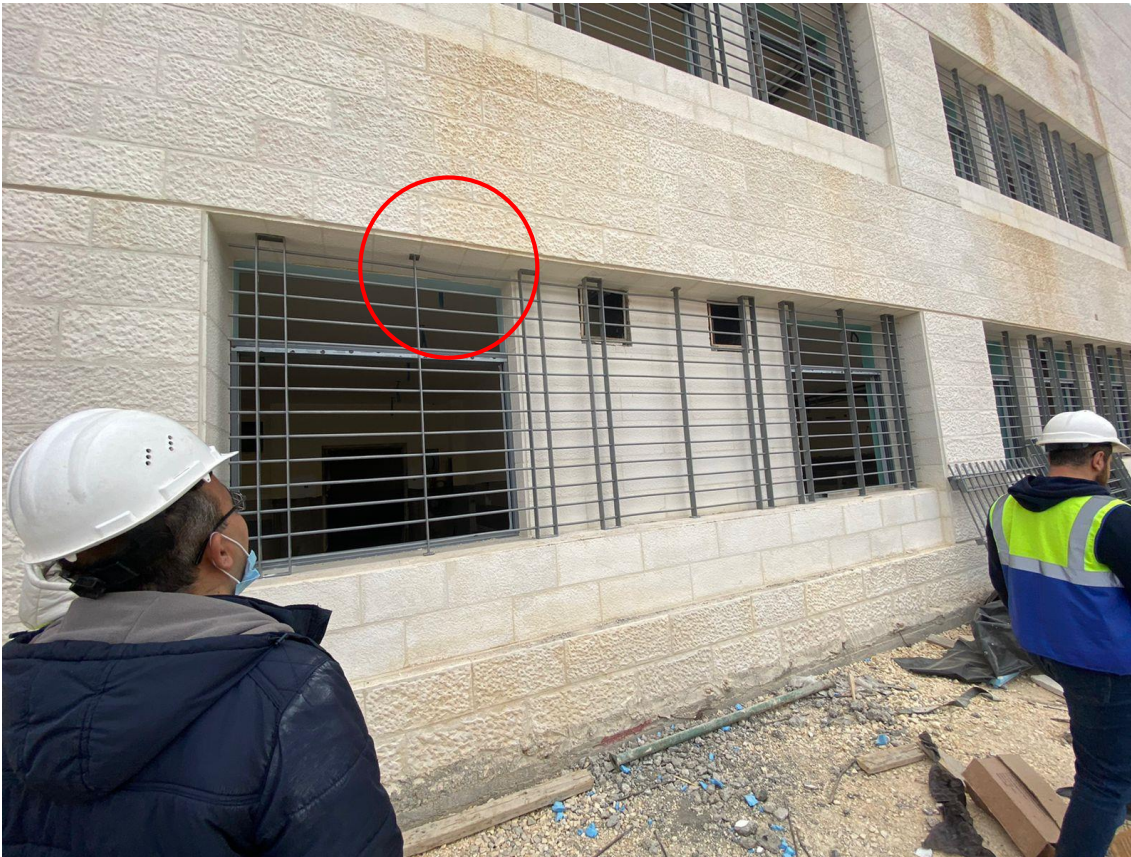
(Figure: 07)

The team observed that parts of the steel protection screens are defective in regards to the paint and to the straightness of bars which constitute the screens. The team stressed on the Contractor to replace those screens

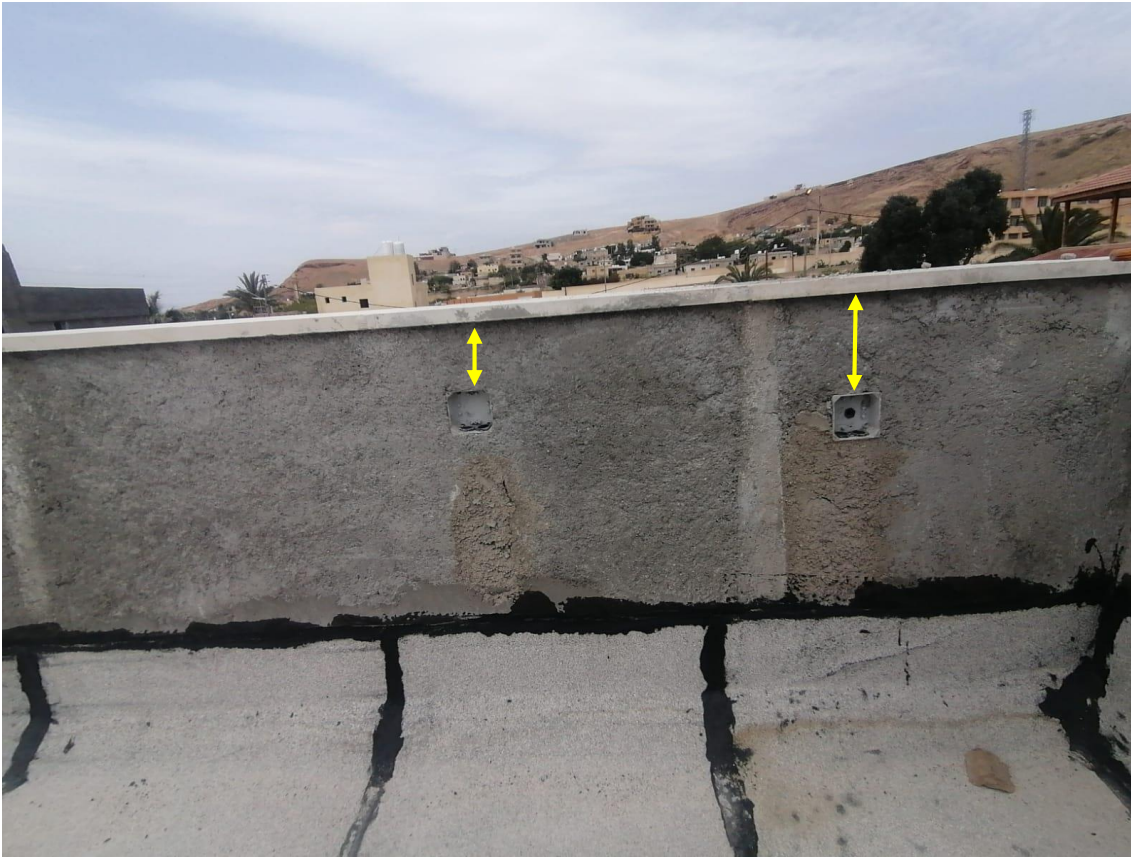
(Figure: 09)

The team observed that the electrical outlets at the parapet are not in line

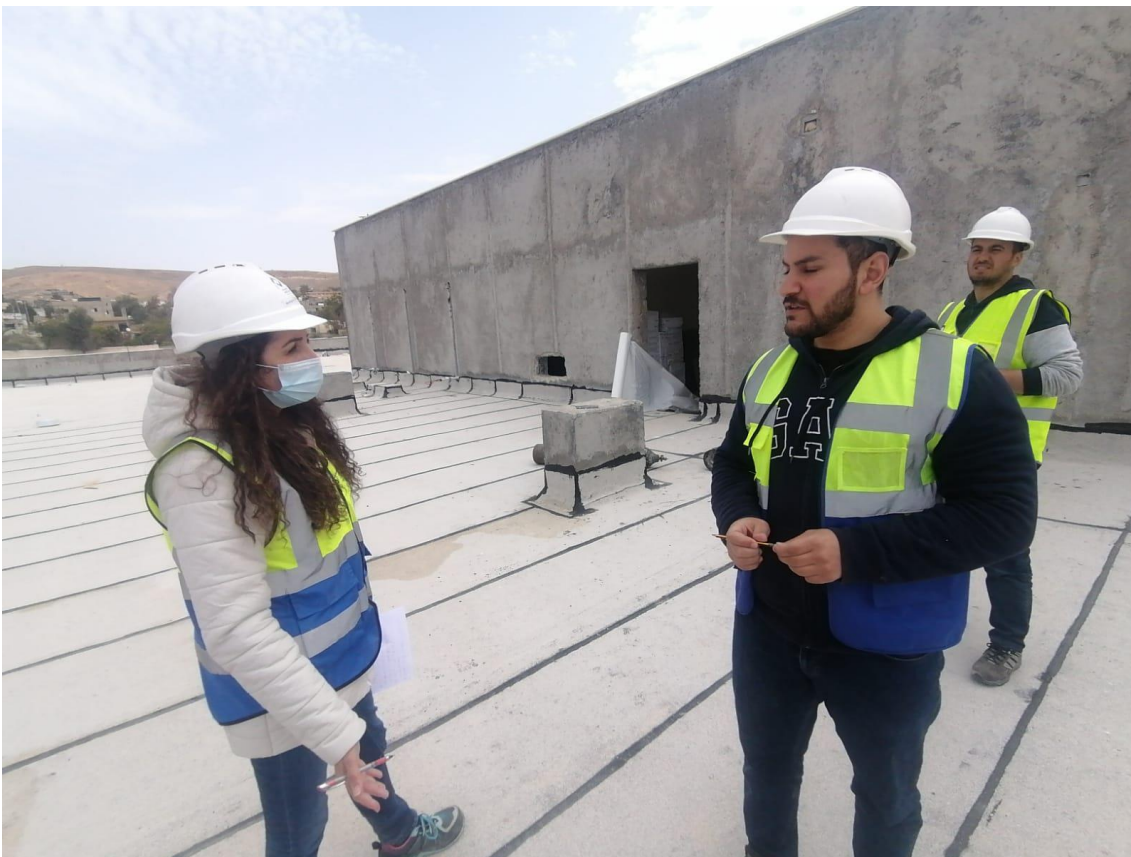
(Figure: 10)

The team inspected the sheet waterproofing executed at the roof and observed defects related to air voids under the sheets which is considered as poor execution that should be rectified

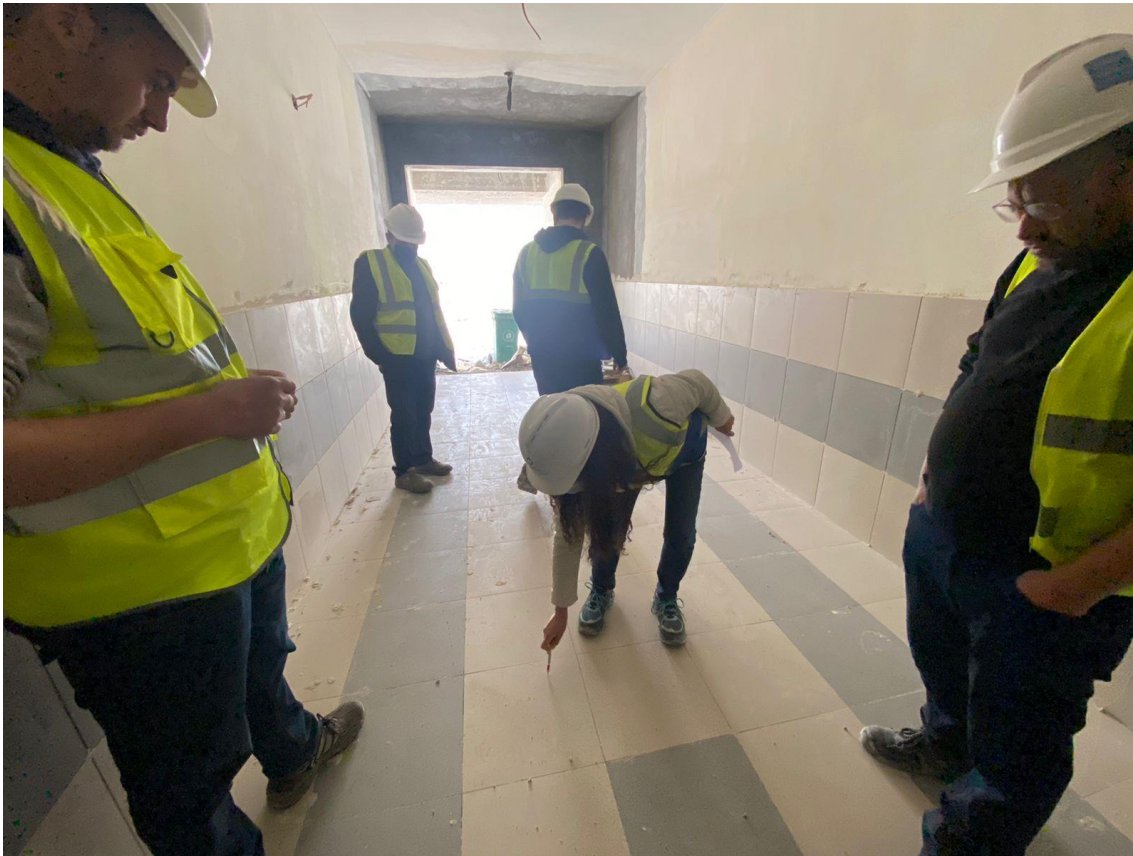
(Figure: 11)

The team observed teething of executed porcelain floor tiles in some parts and requested the Contractor to rectify

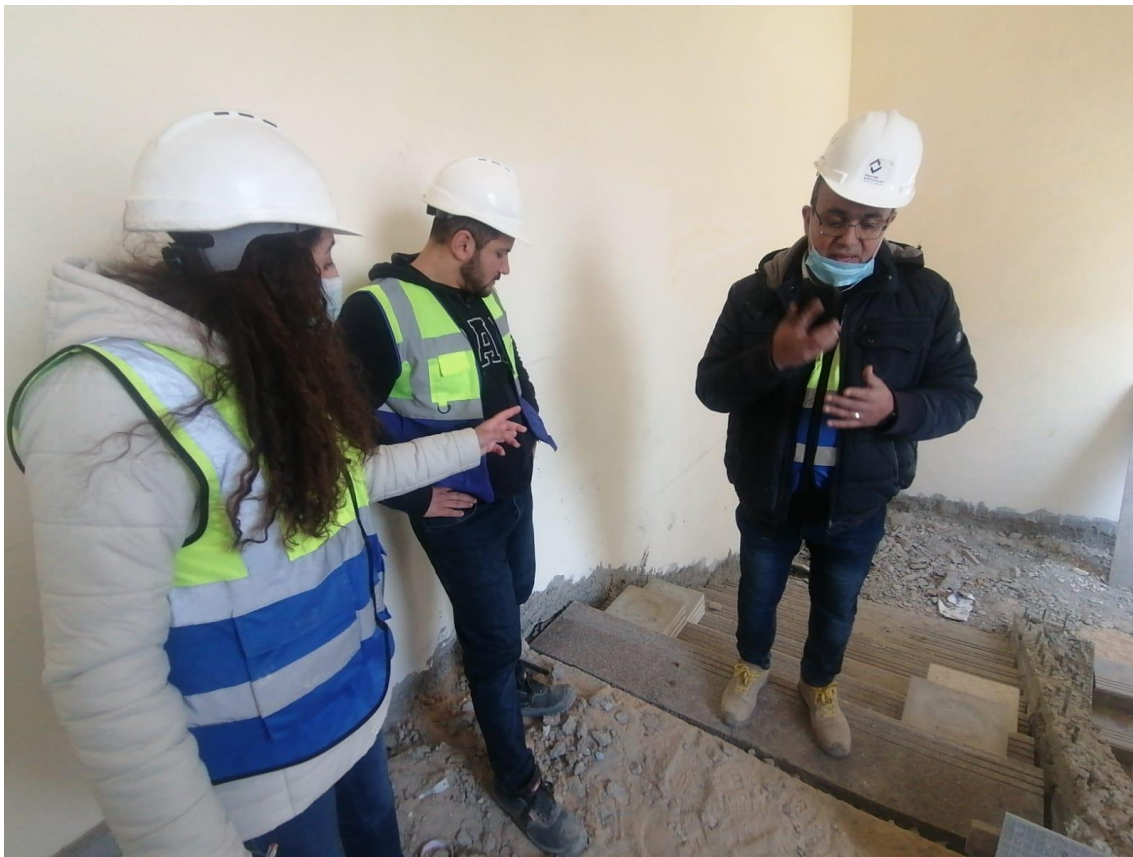
(Figure: 12)

The team requested the Contractor to re-check the levels of staircases, number of stairs in connection with the levels and similar requirements in the drawings

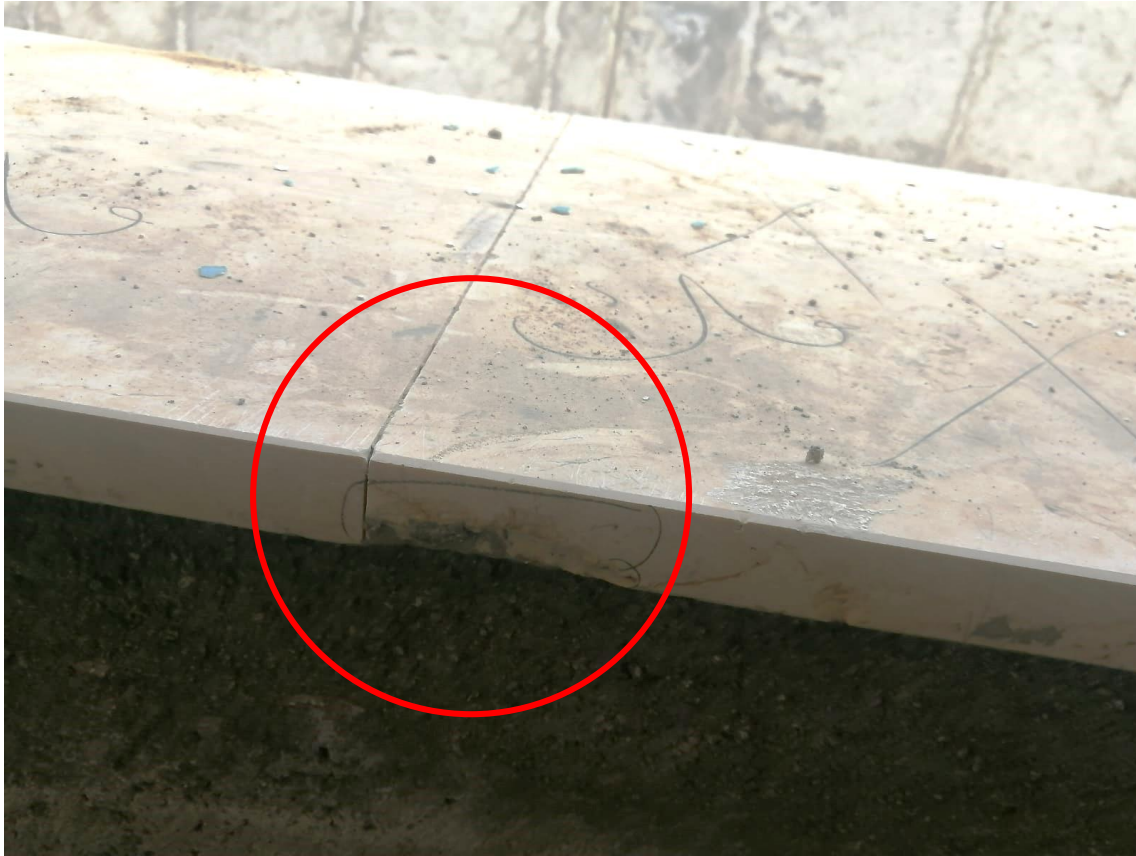
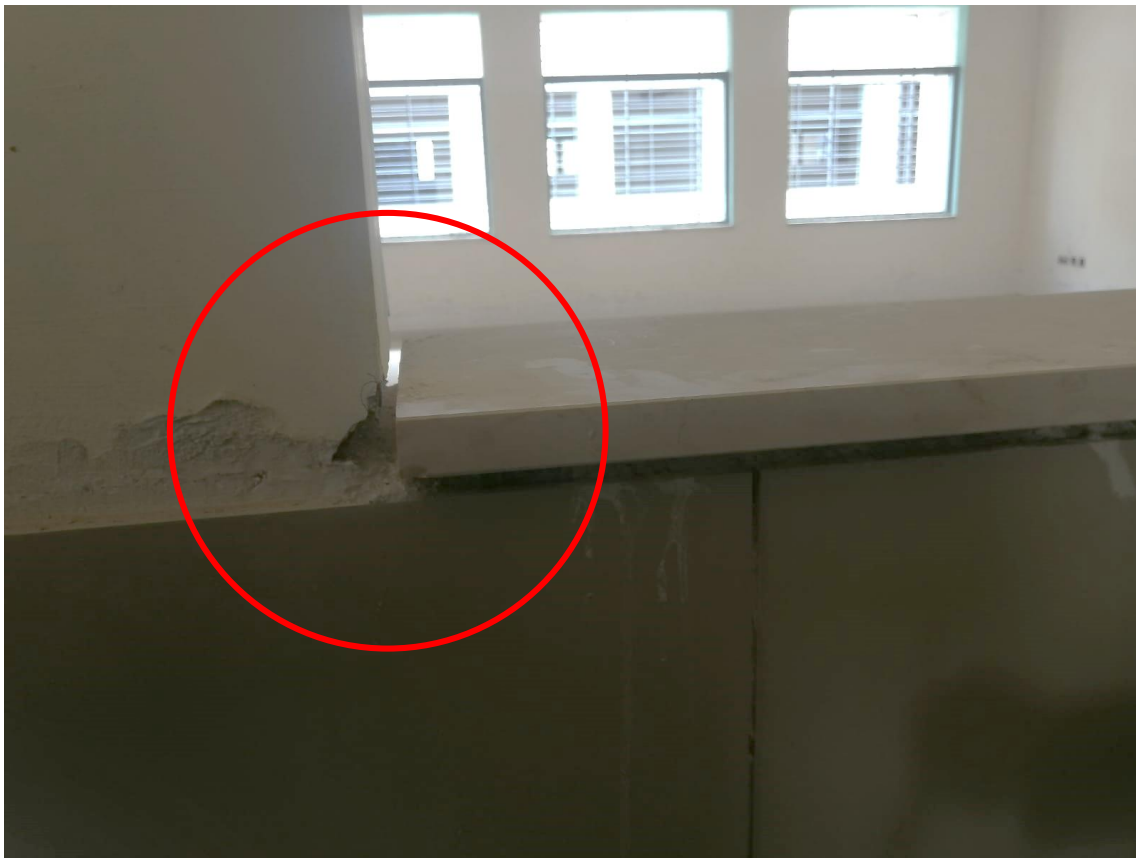
(Figure: 13 & 14)

The team observed a number of broken window sills and shortage in length. The Contractor was requested to replace

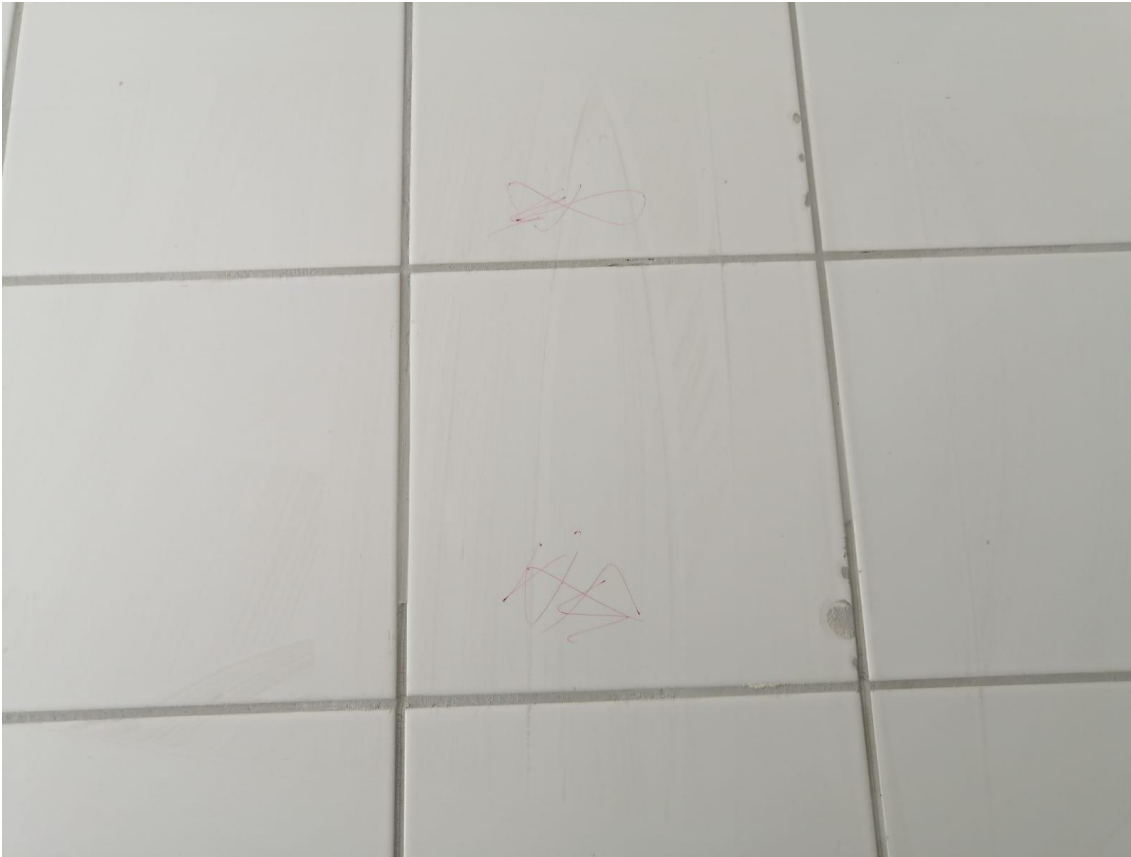
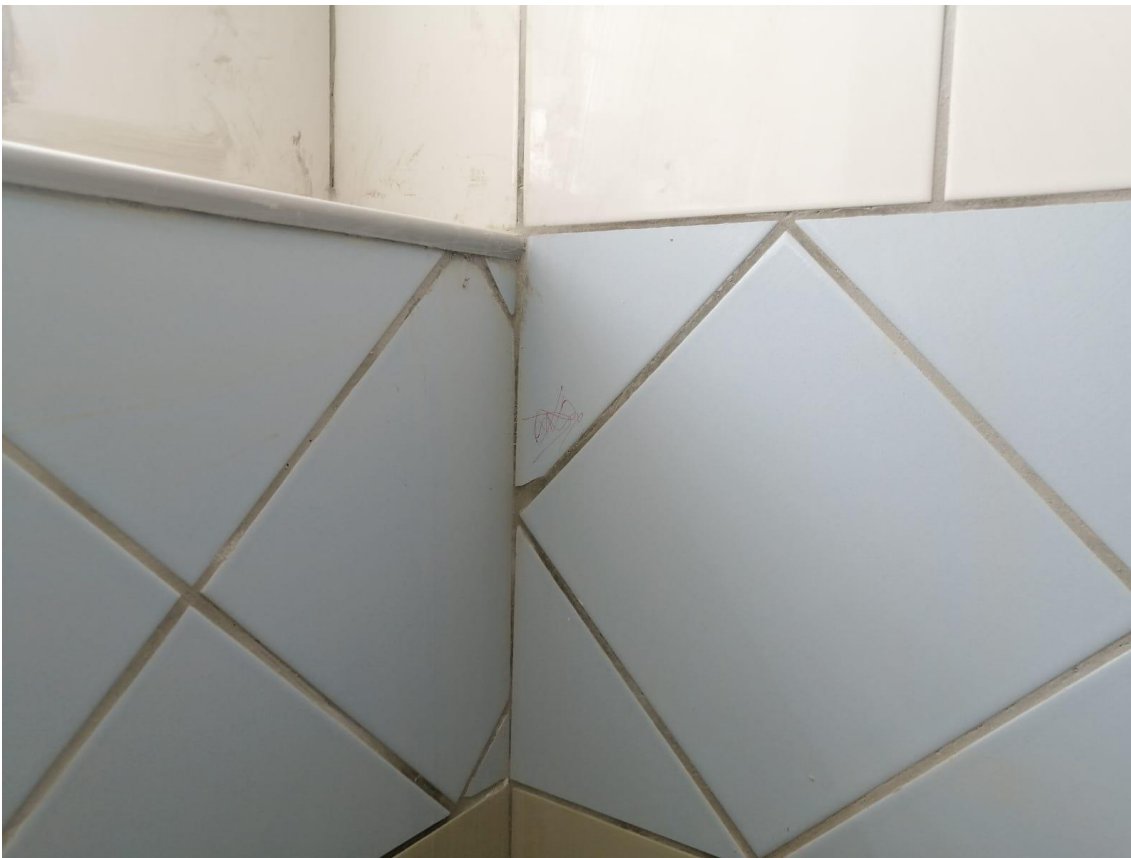
(Figure: 15 & 16)

The team inspected the tile work at the wet areas and observed the following remarks:

- Broken tiles
- Repairs in the grouting are needed

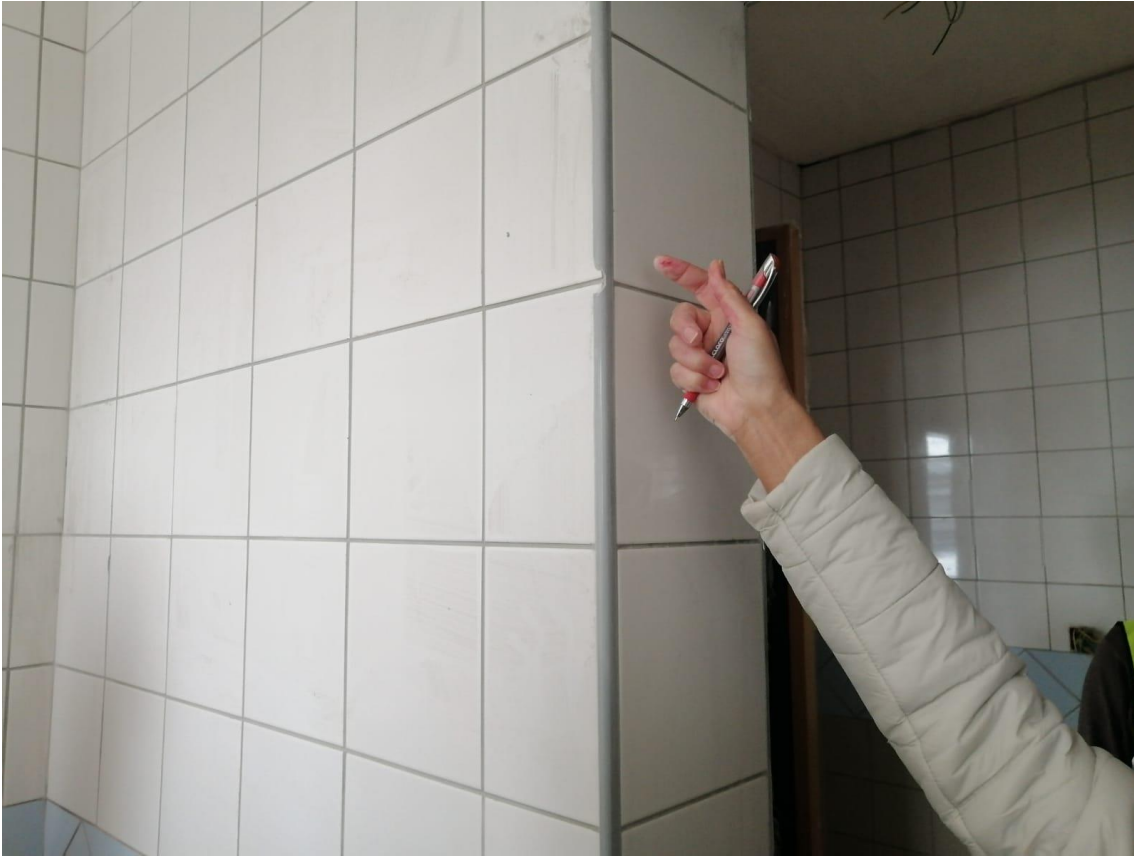
(Figure: 17)

- Broken beads

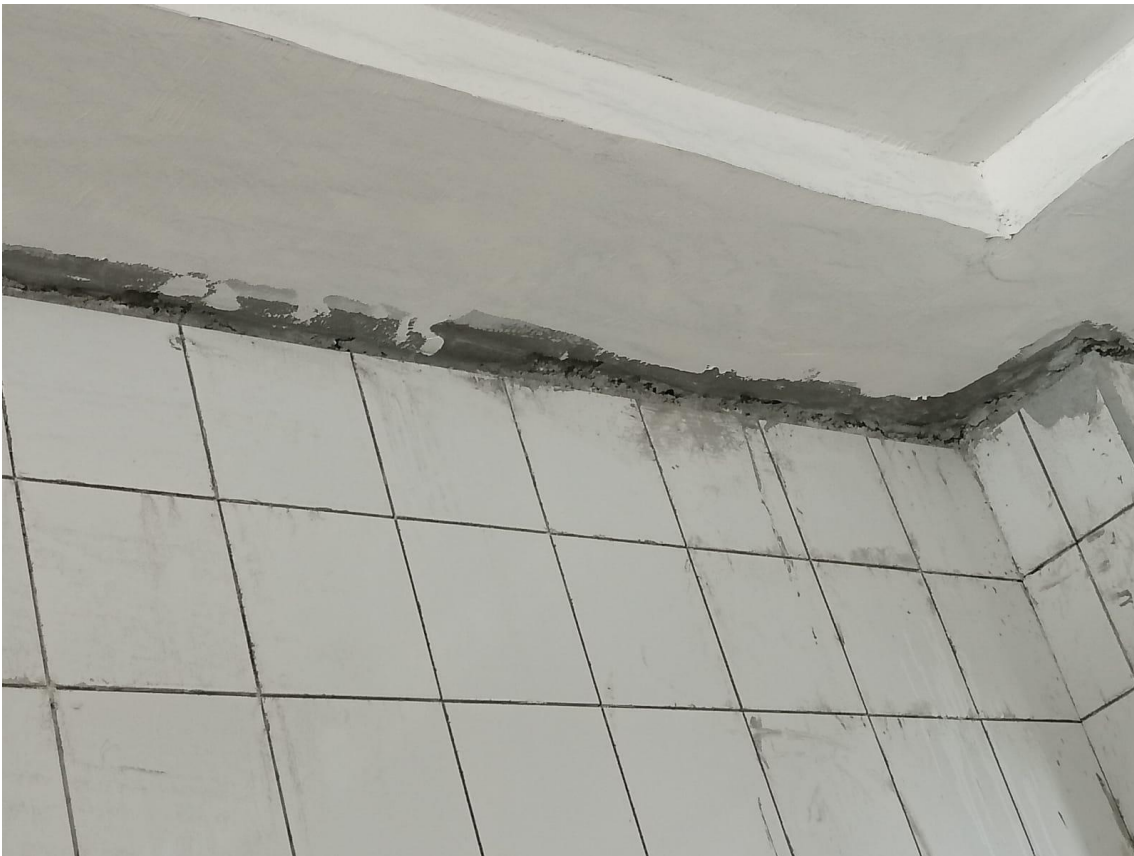
(Figure: 18)

- The plastering for ceiling to be checked to ensure compatibility with the top layer of wall tiles. Gypsum board might be used to remove the defect

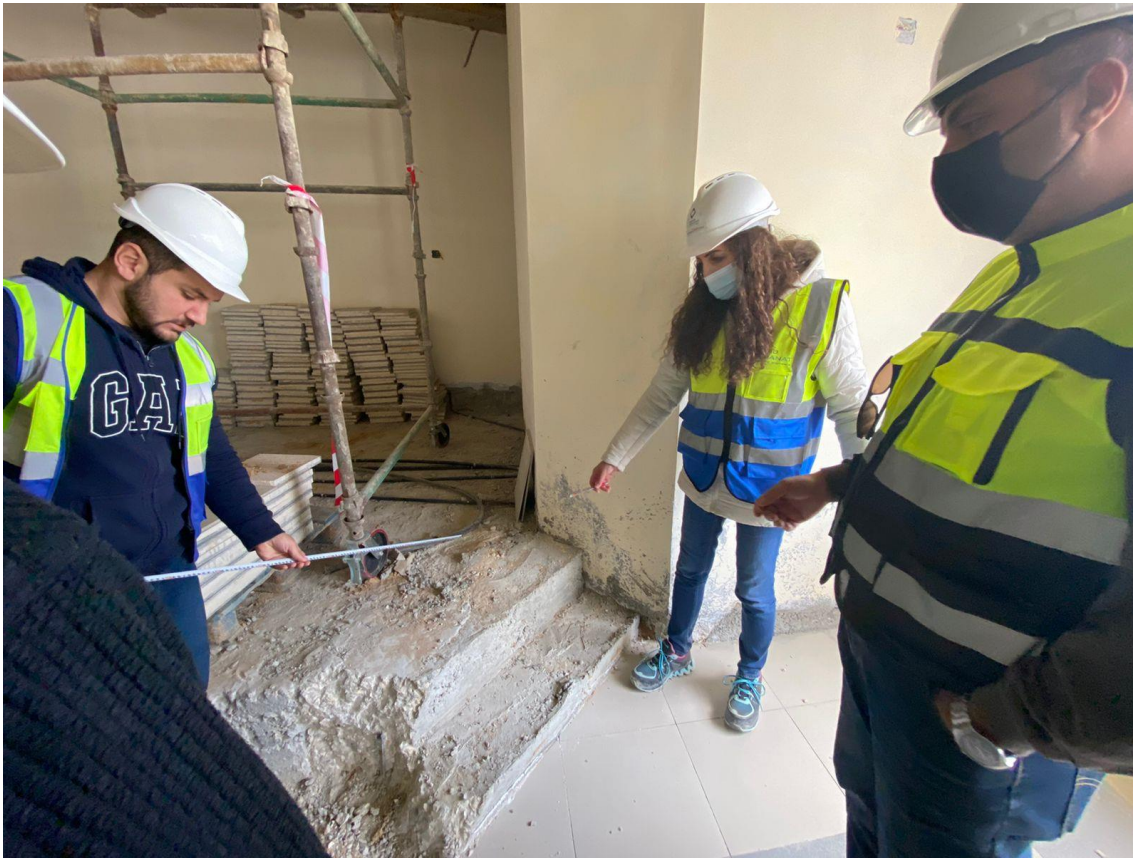
(Figure: 19)

The team observed that the Contractor conducted the necessary repairs regarding the concrete work of the stage and stairs at the multi-purpose hall to comply with the drawings

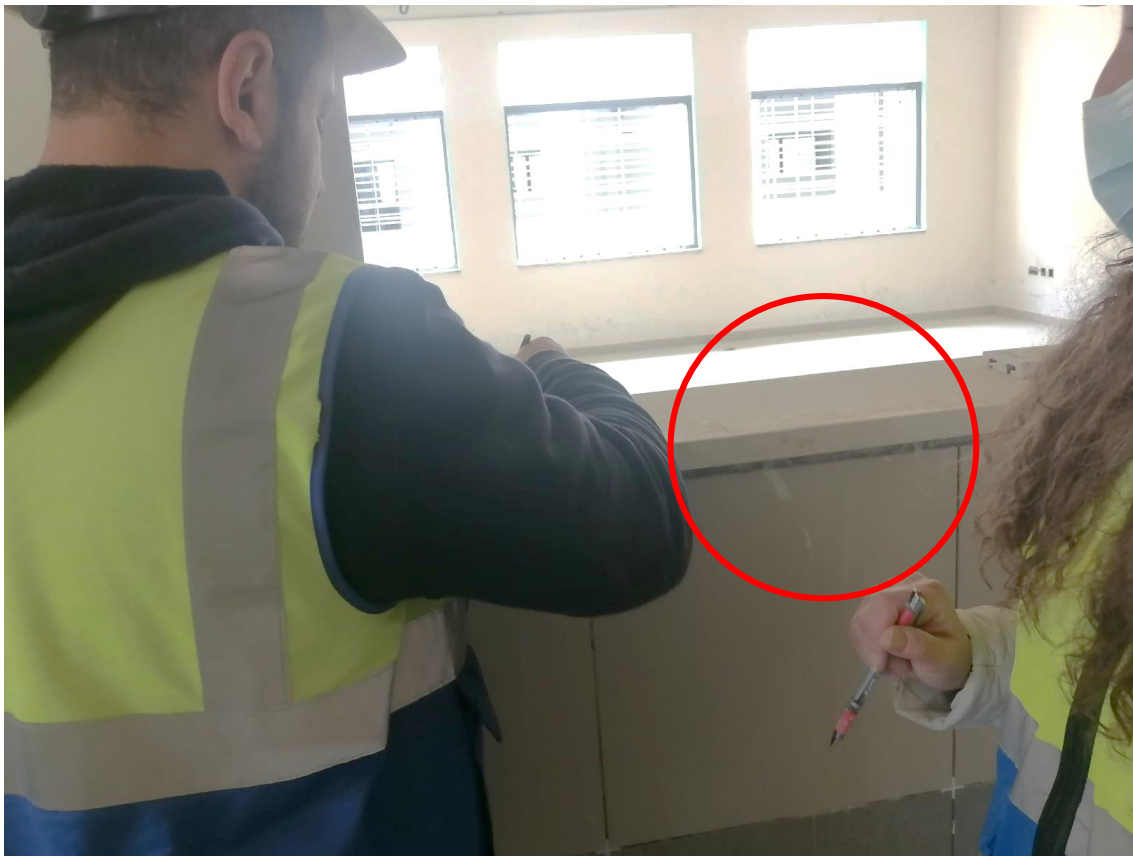
(Figure: 20)

The team observed that the levels of window sills in the corridor are not compatible and need to be checked and rectified

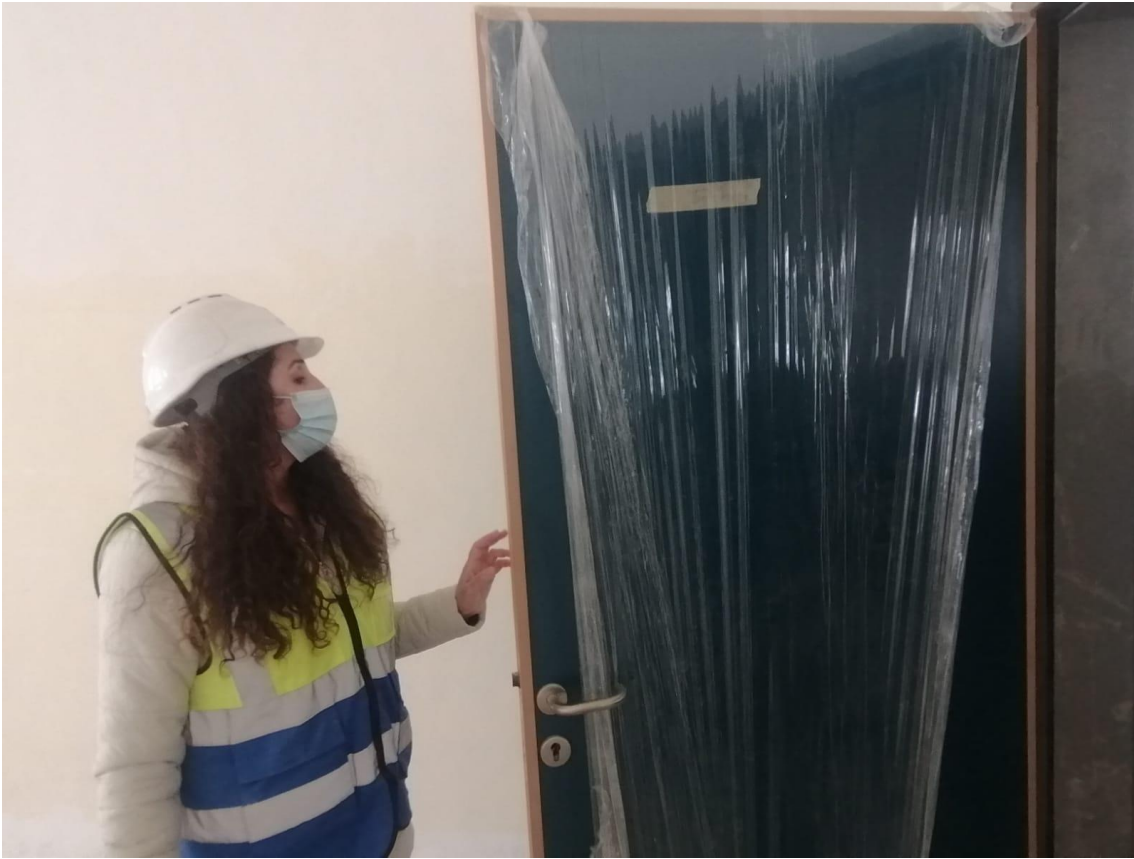
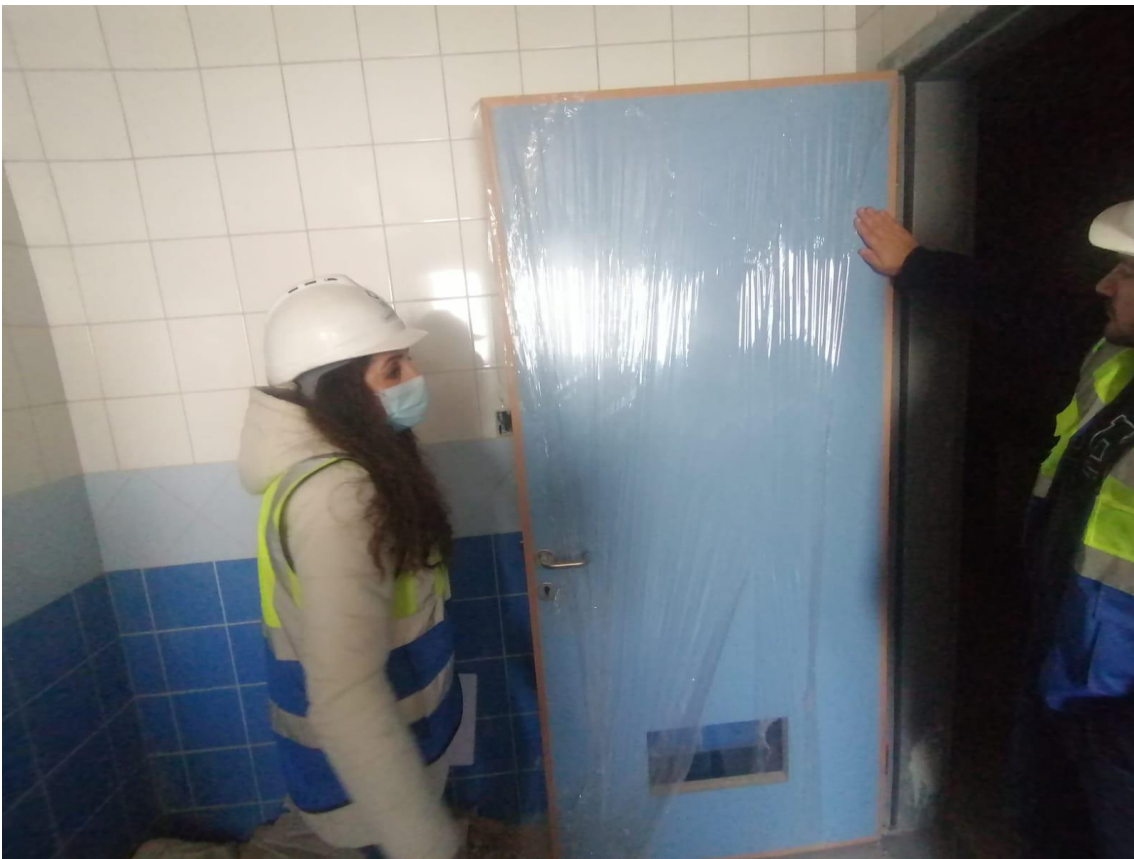
(Figure: 21 & 22)

The team inspected the delivered wooden doors and pointed out to the Contractor to ensure that any door that has certain defects in the beech frame or similar defects should not be installed
