SKEP III Home Office Support Site Visit Report

Consultant	Wahib Medanat Consultant Engineer	Rep No.	21-15062022
Contractor	Dijlah Establishment Constr. Contracting	Tender No.	(11/2019/USAID/SKEP/3/S) Schools for a Knowledge Economy Project (SKEP) - Phase (3) Package (1, 2)
Site Name	Hay Al Iskan Basic Mixed School- Jerash	Day/ Date	Wed. 15/06/2022
Duration of Project	450 Calendar Days	Total Project Budget	8,314,983.735 JD

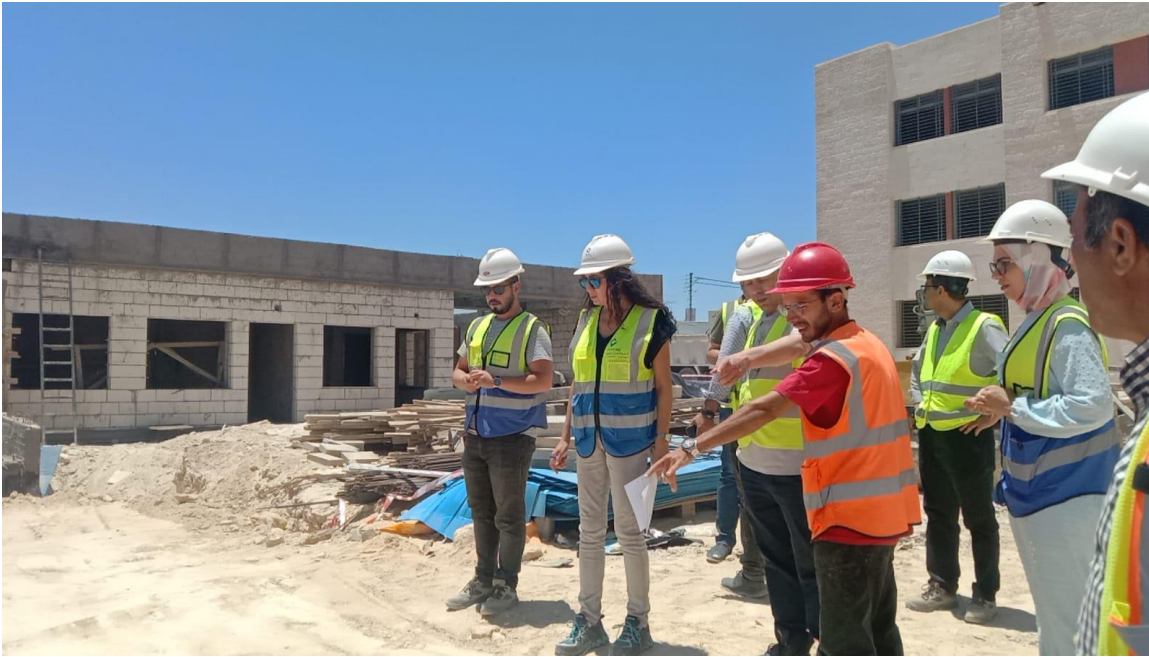
(Figure: 05)

The team inspected the works at the playing yards, theater and the shading

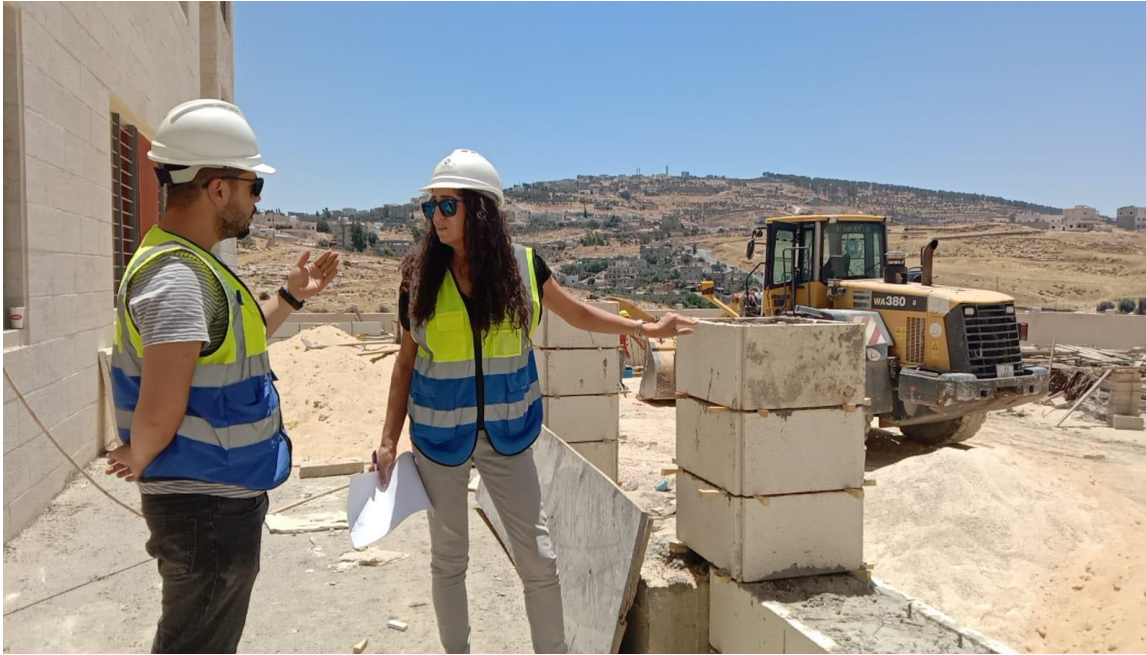
(Figure: 07)

The supervision team inspected the built stone for the planters and the external facades

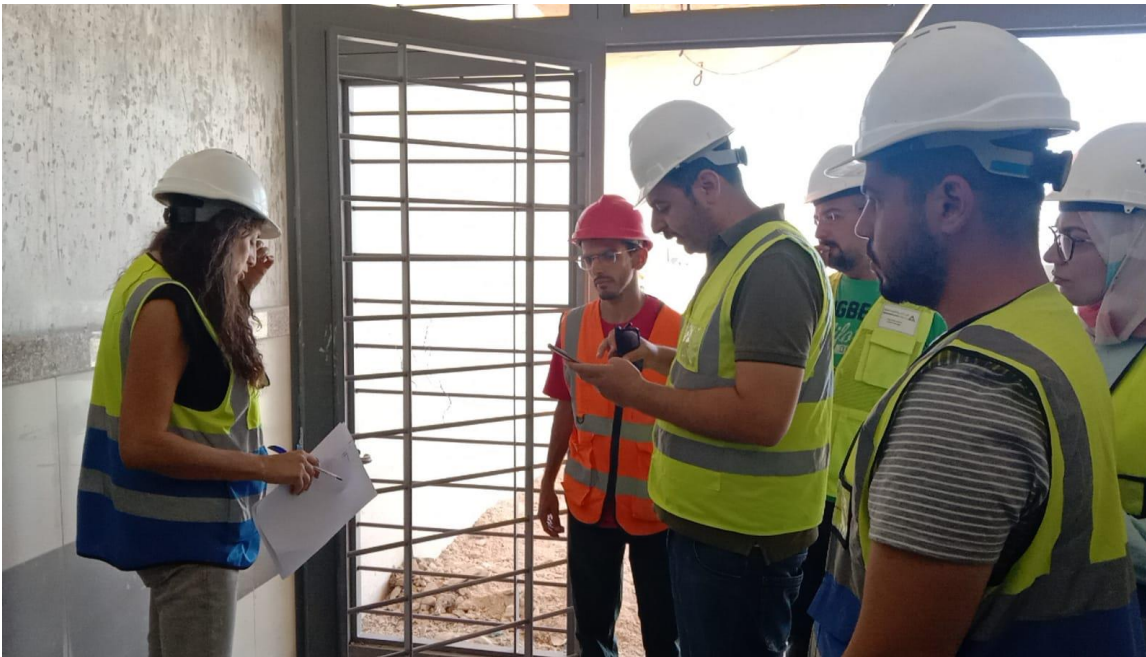
(Figure: 10)

The team inspected the steel doors at the school entrances and observed that the installed doors don't comply with the architectural details in relation to the dimensions of steel sections

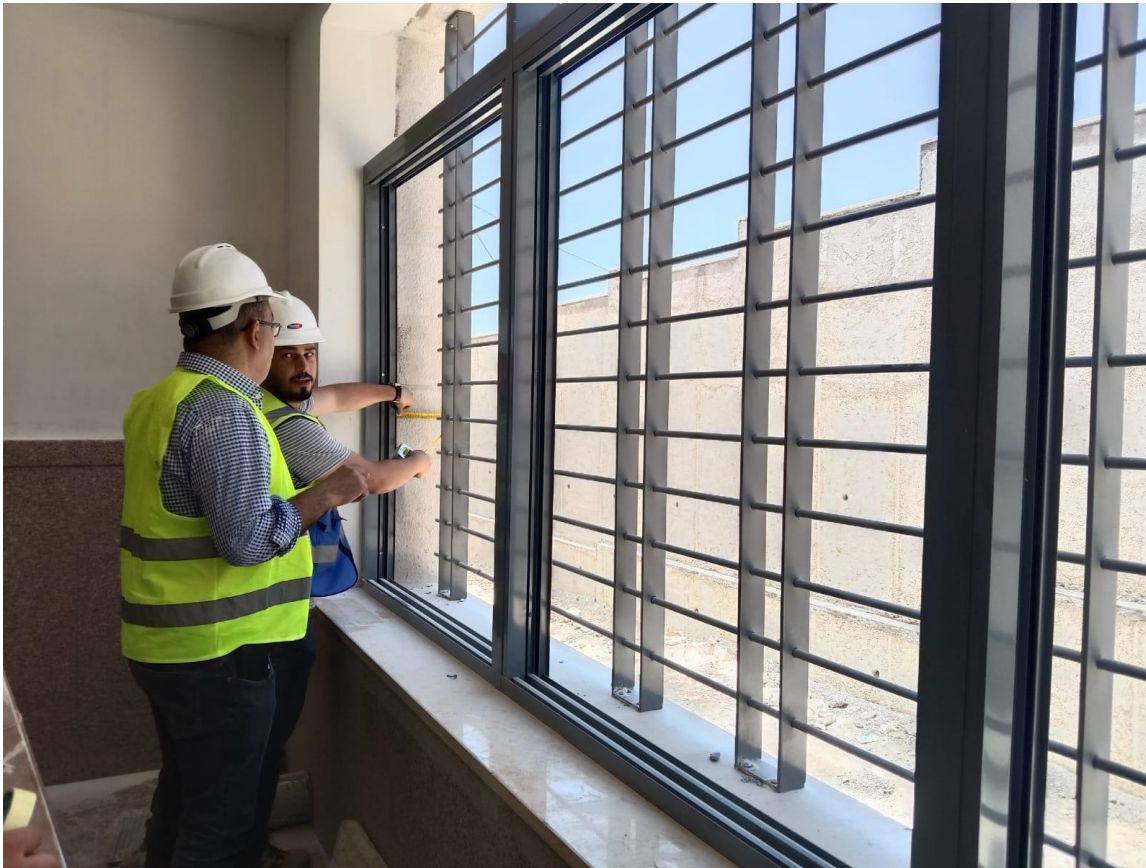
(Figure: 11)

The team inspected the executed aluminum windows at the staircase façade and observed variations regarding the fixation points, relation with the built stones at the window jambs and the window sills as well

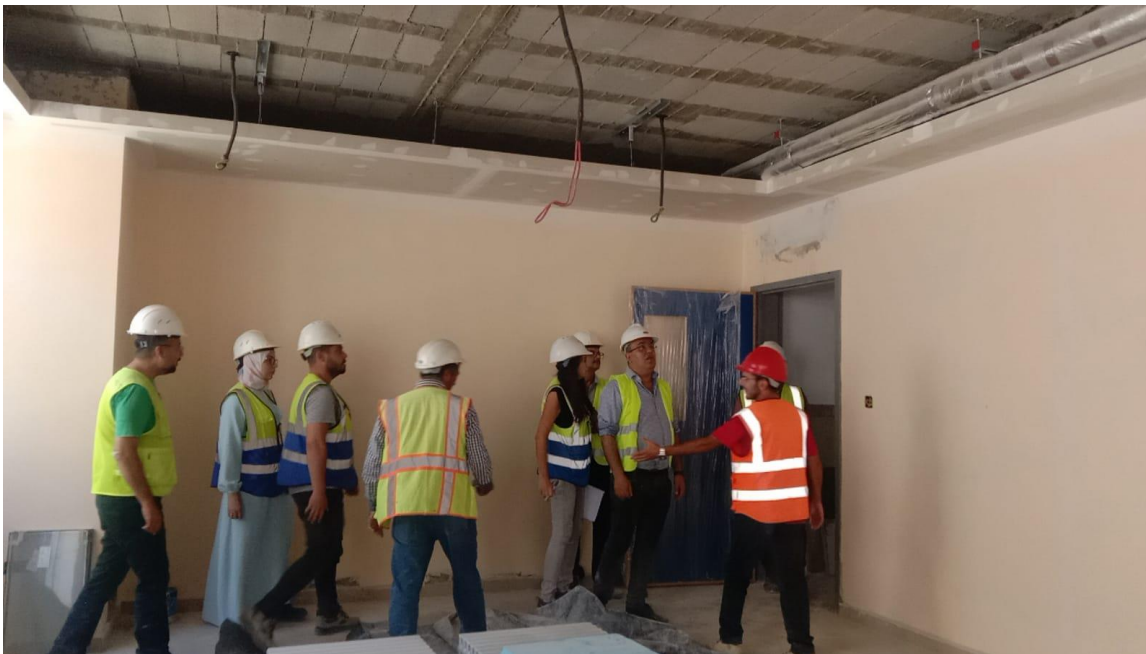
(Figure: 12)

The team inspected the works at the ceiling of the specialty needs room and gave general notes to the Contractor

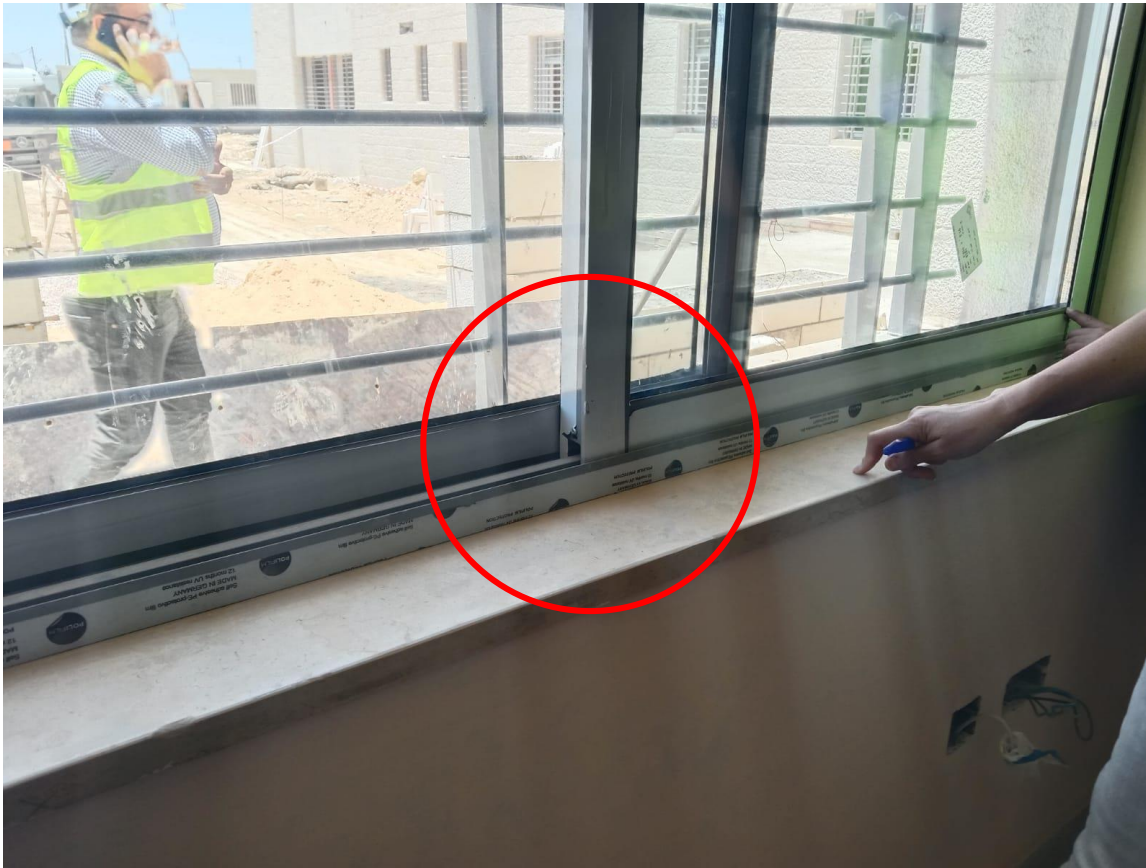
(Figure: 13)

The team observed that the rubber fixed for aluminum windows should continue all over around the glass panel

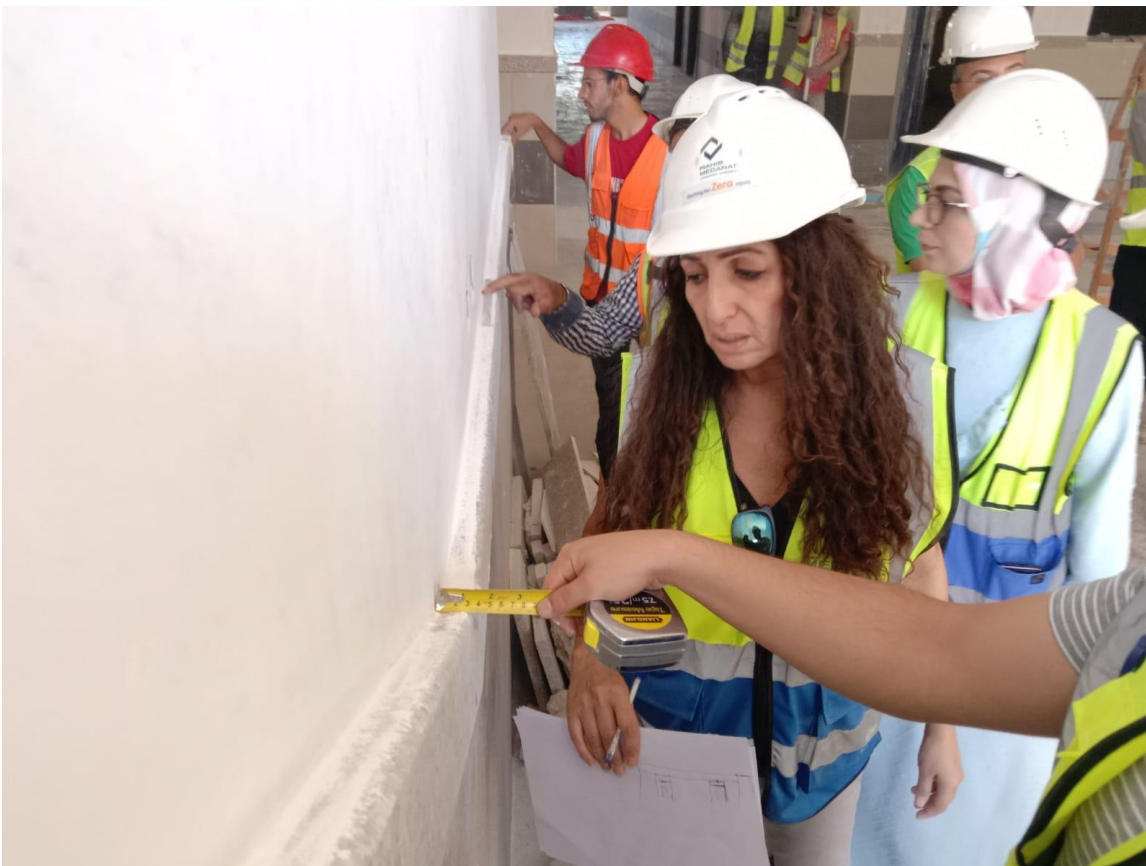
(Figure: 14)

The team observed that the Contractor rectified the granite coping at the staircase walls for several locations and found it acceptable

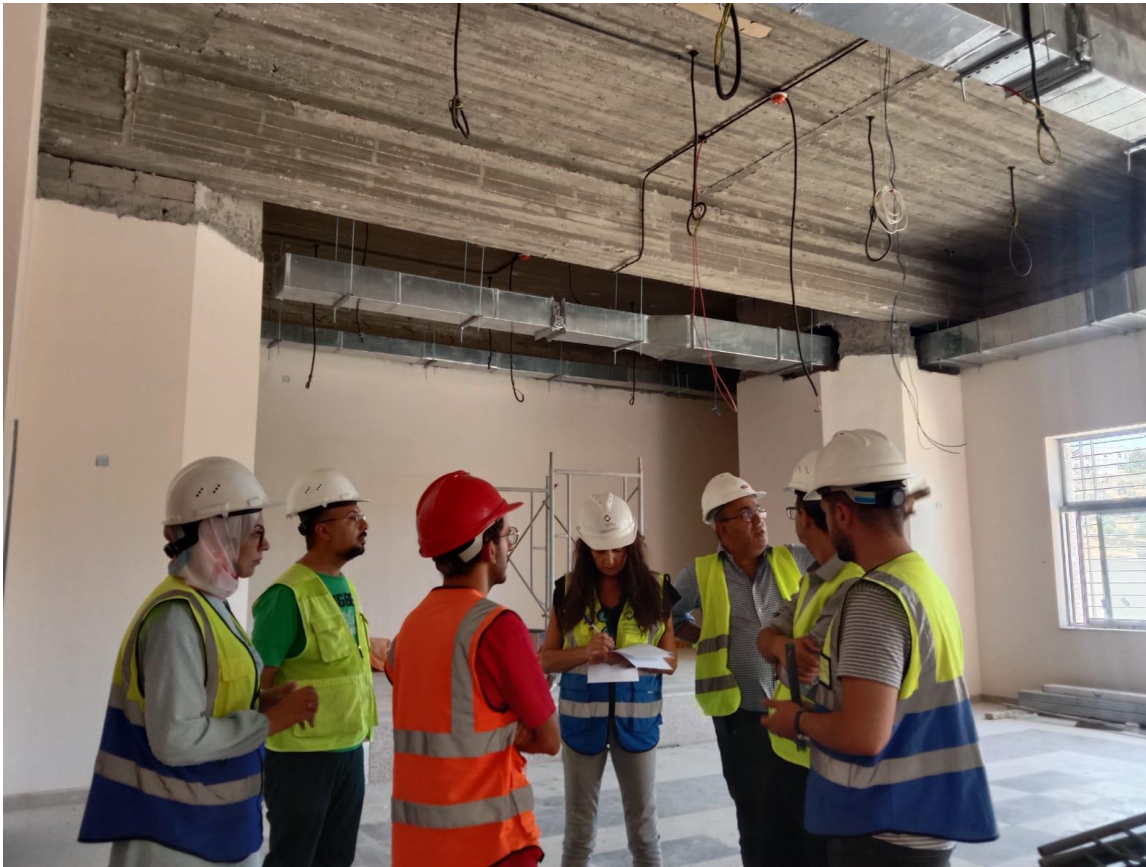
(Figure: 15)

The team observed that the electro-mechanical works at the multi-purpose hall are still not completed. The items which are not yet executed are the truss used to hold electrical lighting fixtures and the support of the truss, the projector support and the smoke detectors

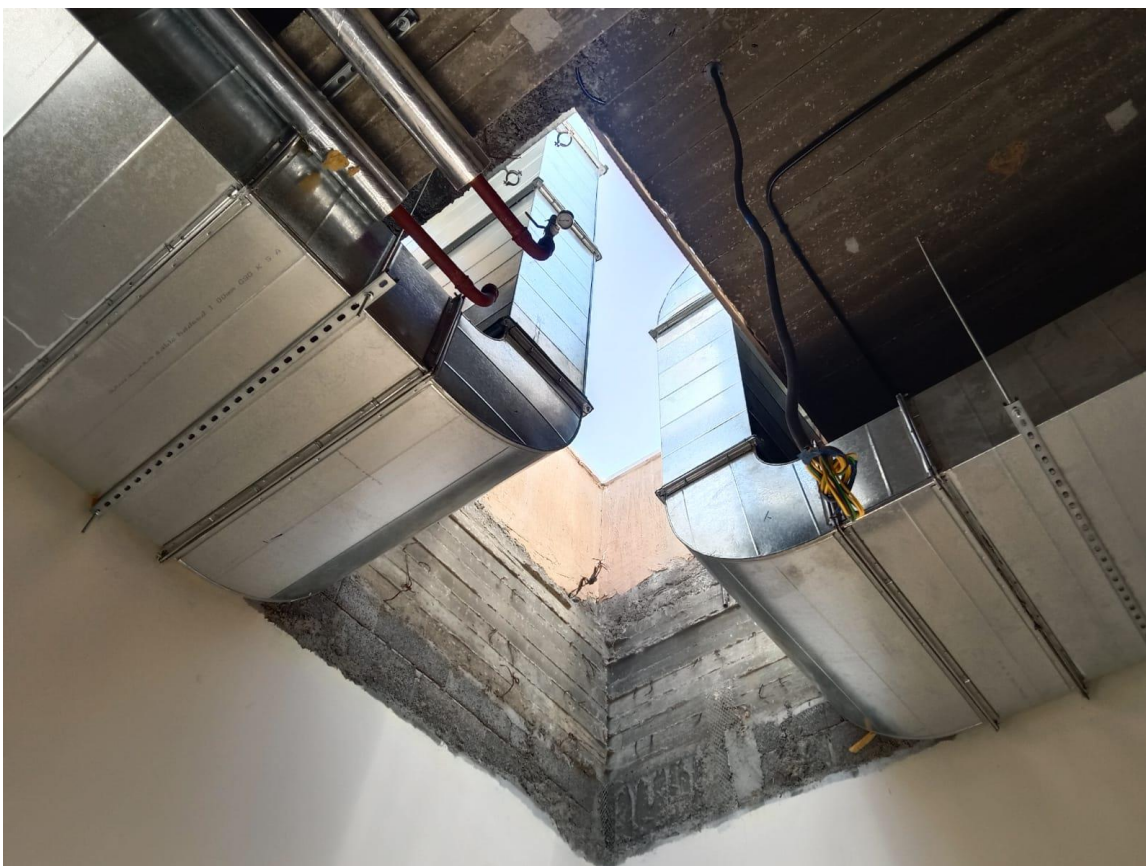
(Figure: 16)

The team requested the Contractor to submit a proposal to close the opening in the shaft at the multi-purpose hall ceiling. Precast concrete might be one of the proposals

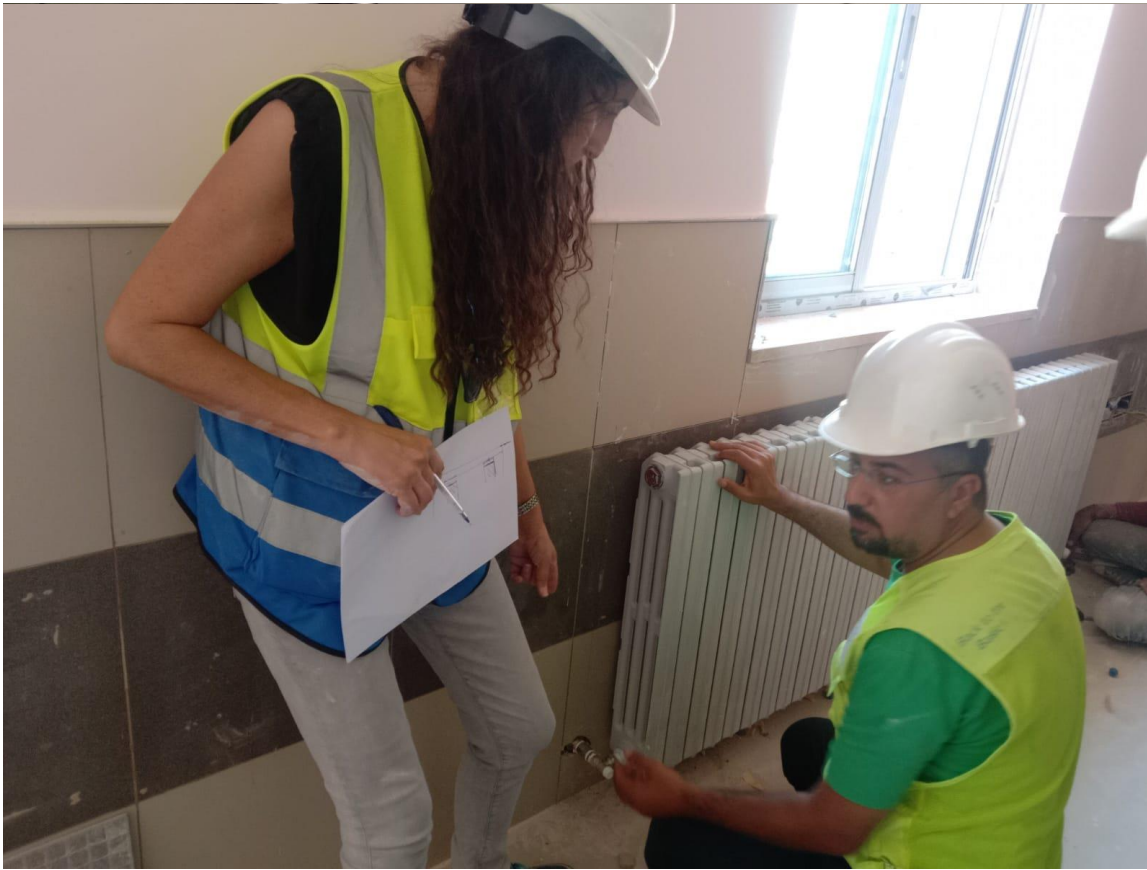
(Figure: 17)

The team observed broken tiles around the connection points of the heating radiators. The broken areas have to be covered with accessories, otherwise the broken tiles have to be replaced

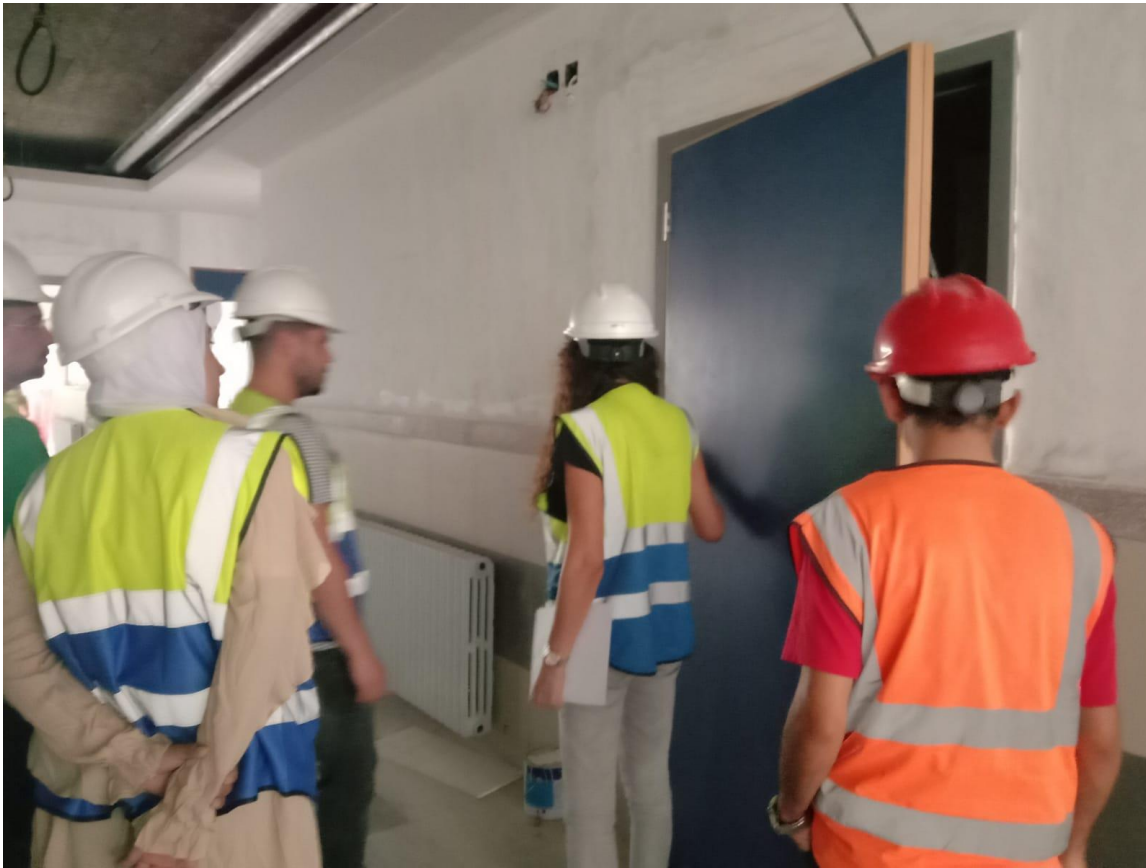
(Figure: 19)

The team inspected the installed fire rated doors

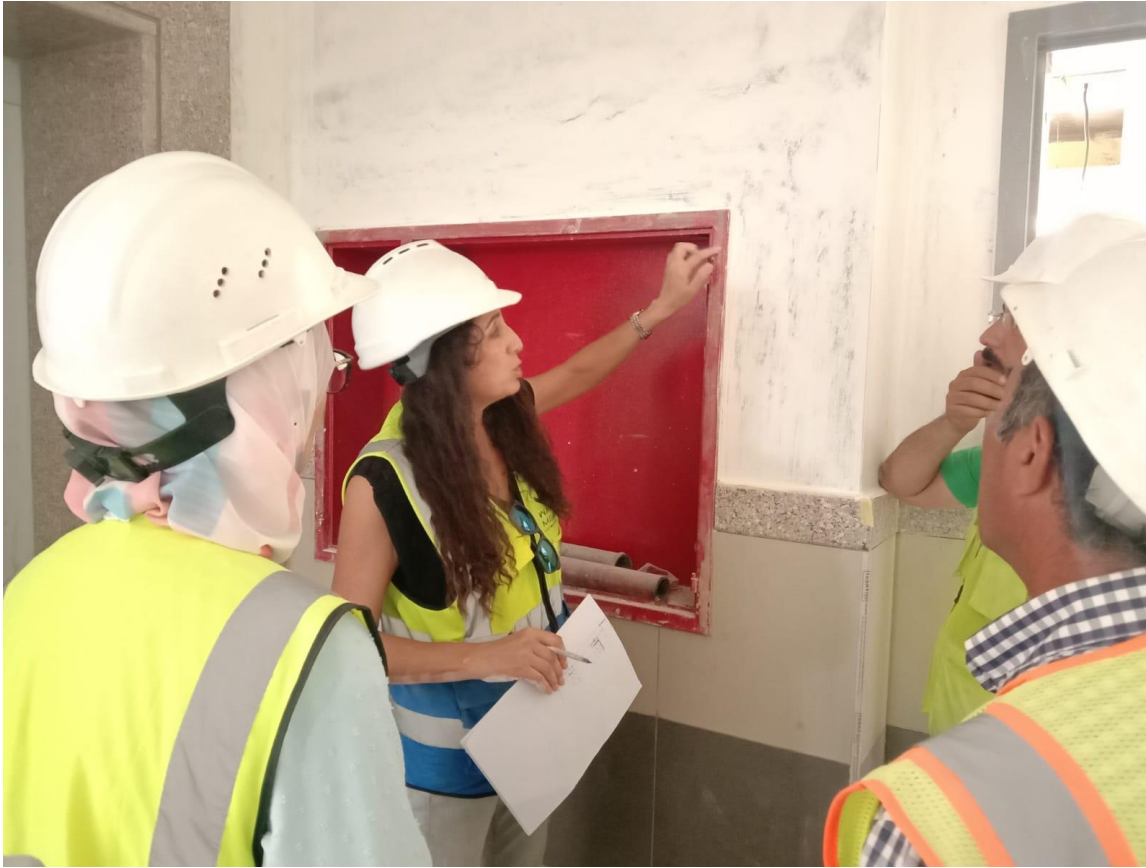
(Figure: 21)

The team inspected the works in the mechanical cabinets at the corridors

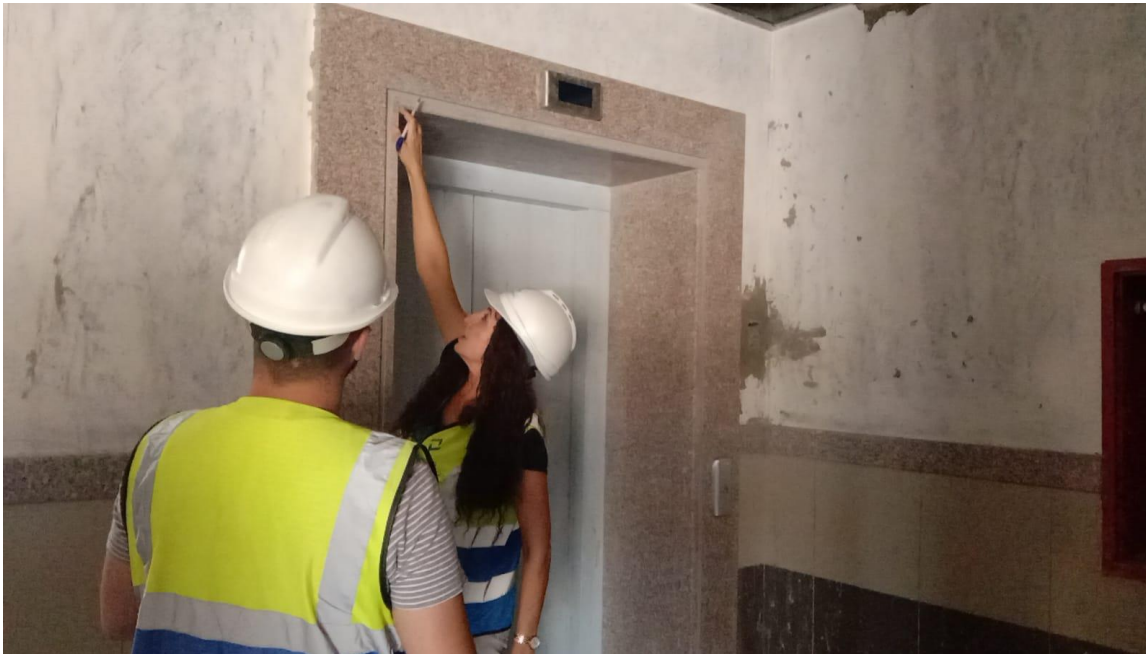
(Figure: 22)

The team inspected granite tiling at the elevator's frames and found it acceptable
