SKEP III Home Office Support Site Visit Report

Consultant	Wahib Medanat Consultant Engineer	Rep No.	21-22022022
Contractor	Dijlah Establishment Constr. Contracting	Tender No.	(11/2019/USAID/SKEP/3/S) Schools for a Knowledge Economy Project (SKEP) - Phase (3) Package (1, 2)
Site Name	Hay Al Iskan Basic Mixed School- Jerash	Day/ Date	Tue. 22/02/2022
Duration of Project	450 Calendar Days	Total Project Budget	8,314,983.735 JD

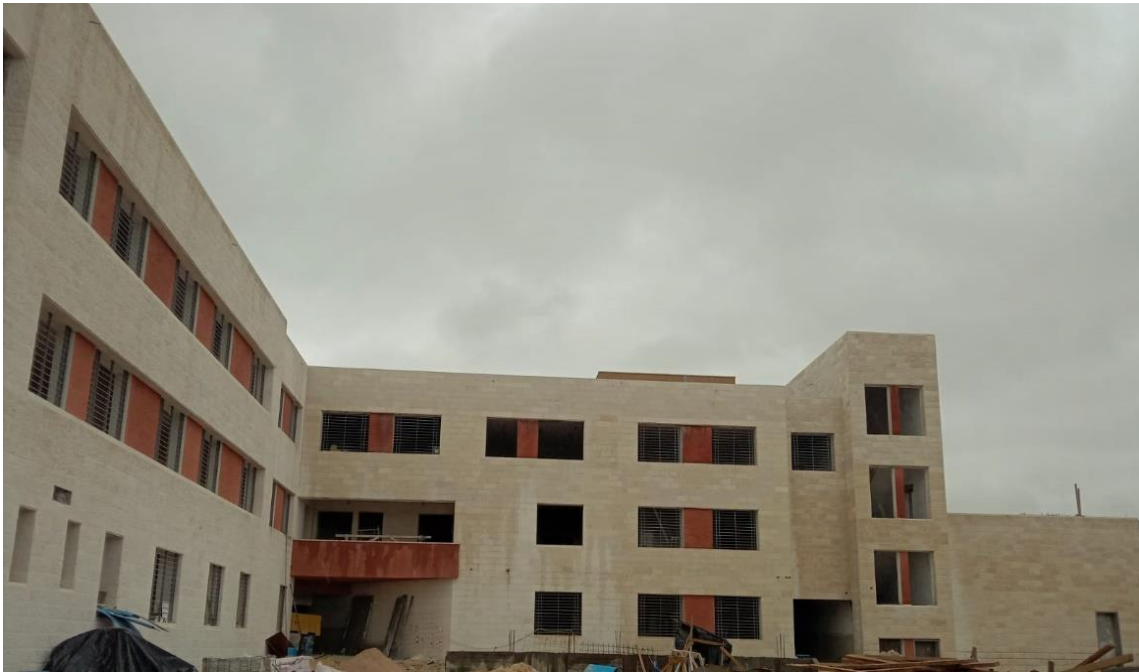
(Figure: 01)

General view of the project site
(Figure: 01, 02 & 03)

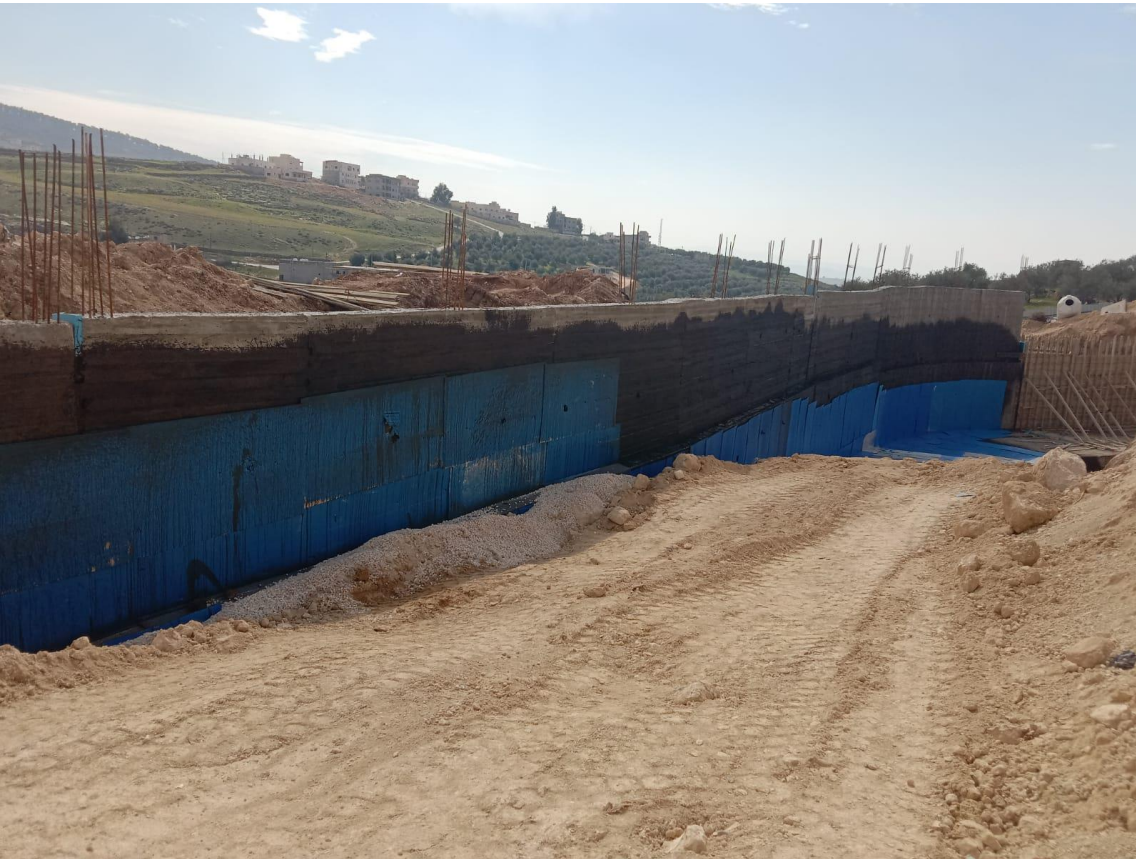
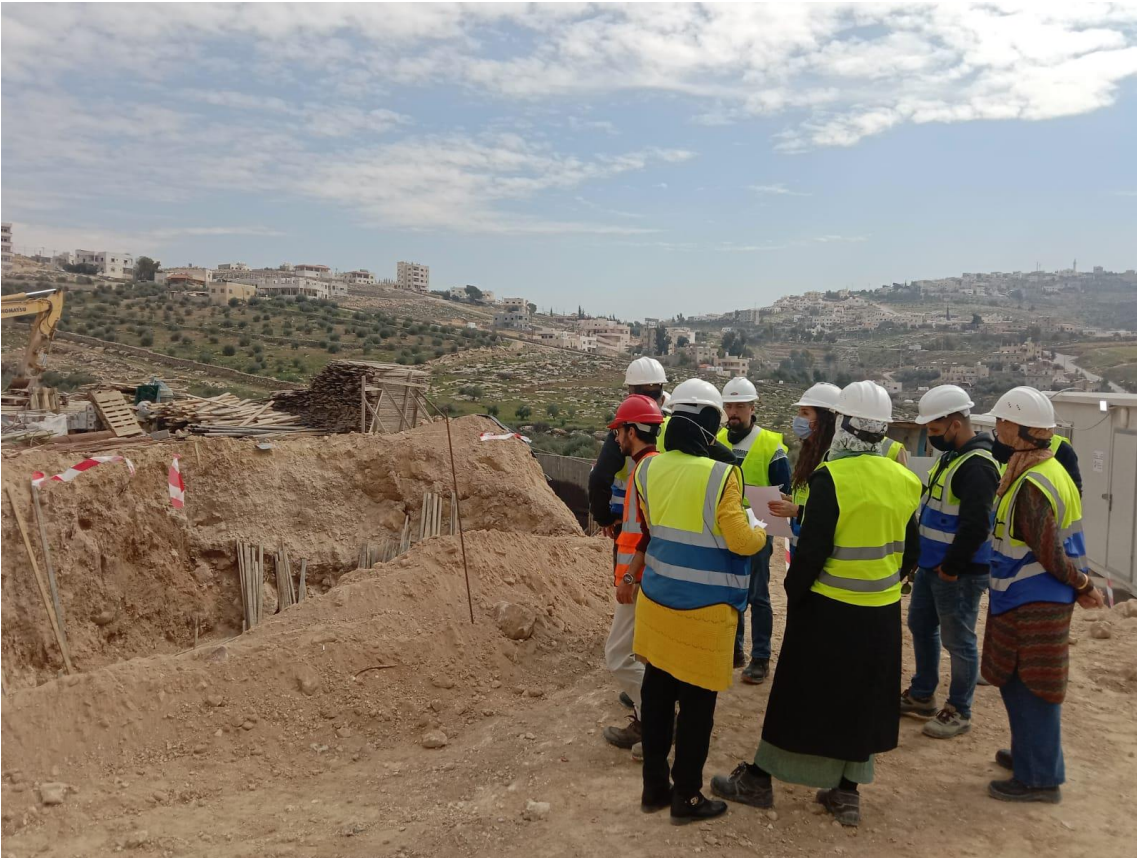
(Figure: 05 & 06)

The team inspected the ongoing work in the external walls and requested the Contractor to accelerate the work there in order to start with the backfilling and the rest of the external works

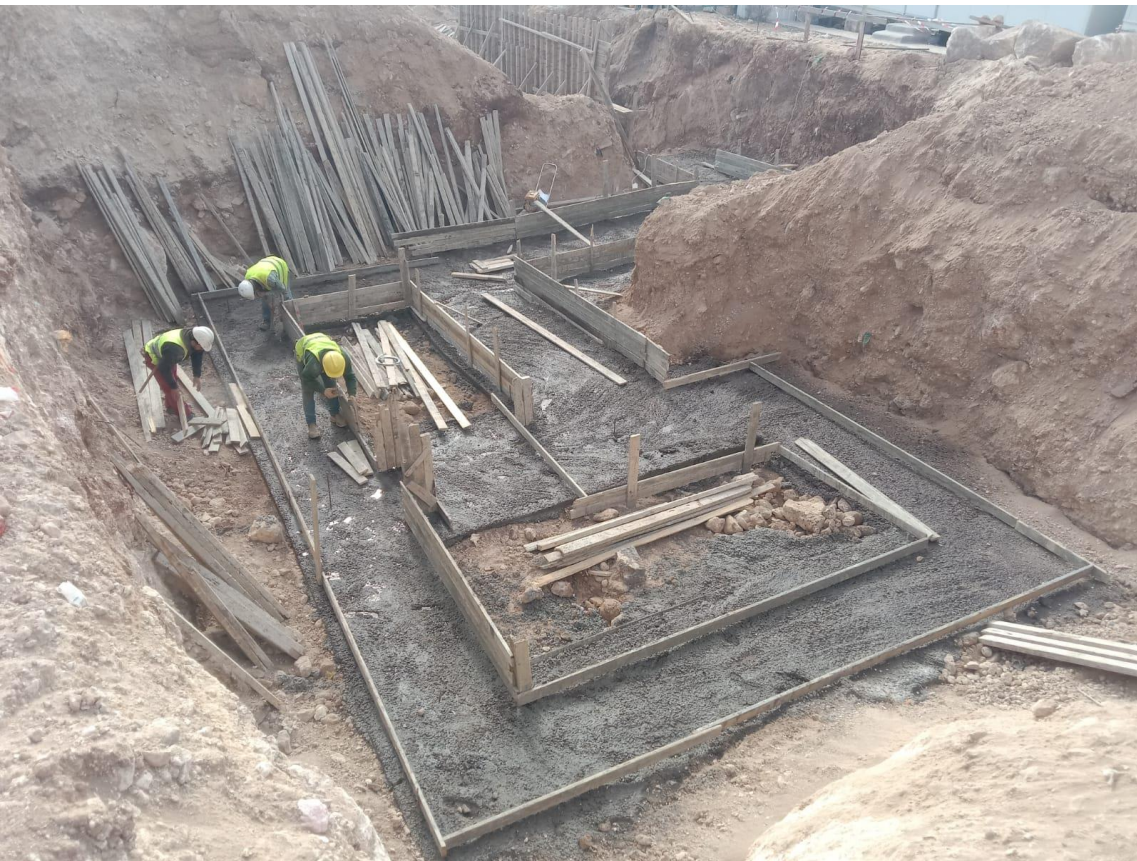
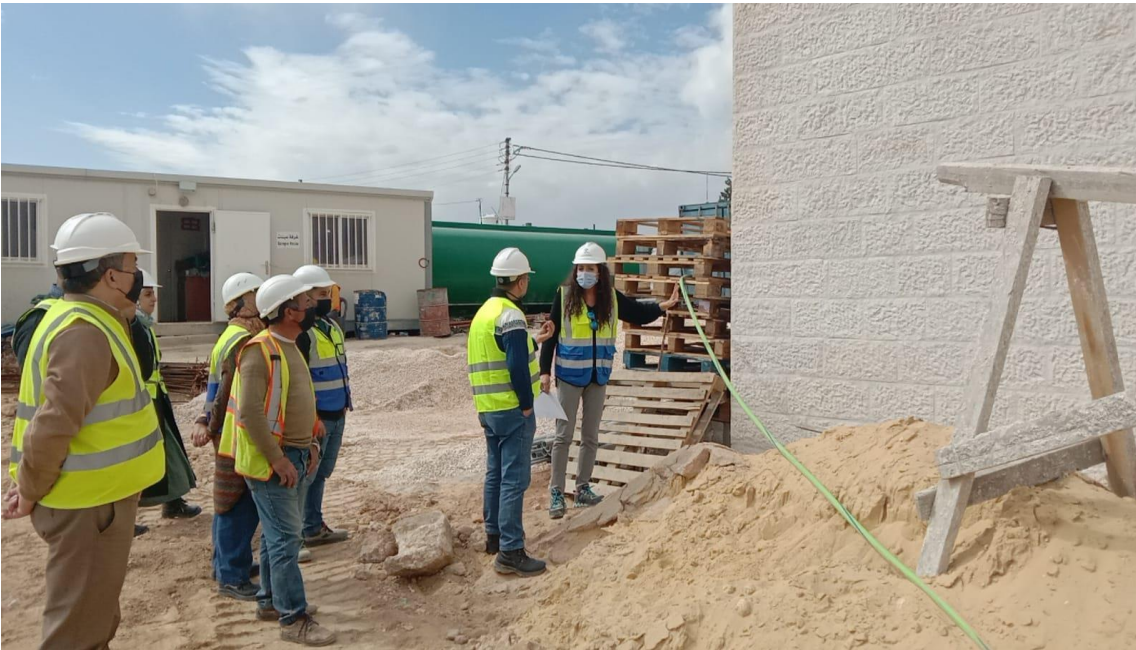
(Figure: 07 & 08)

The supervision team inspected the ongoing work in the foundation of the guard room and discussed with the Contractor the process of foundation casting and requested the Contractor to implement safety protection to the excavated area and around since the current protection is very weak

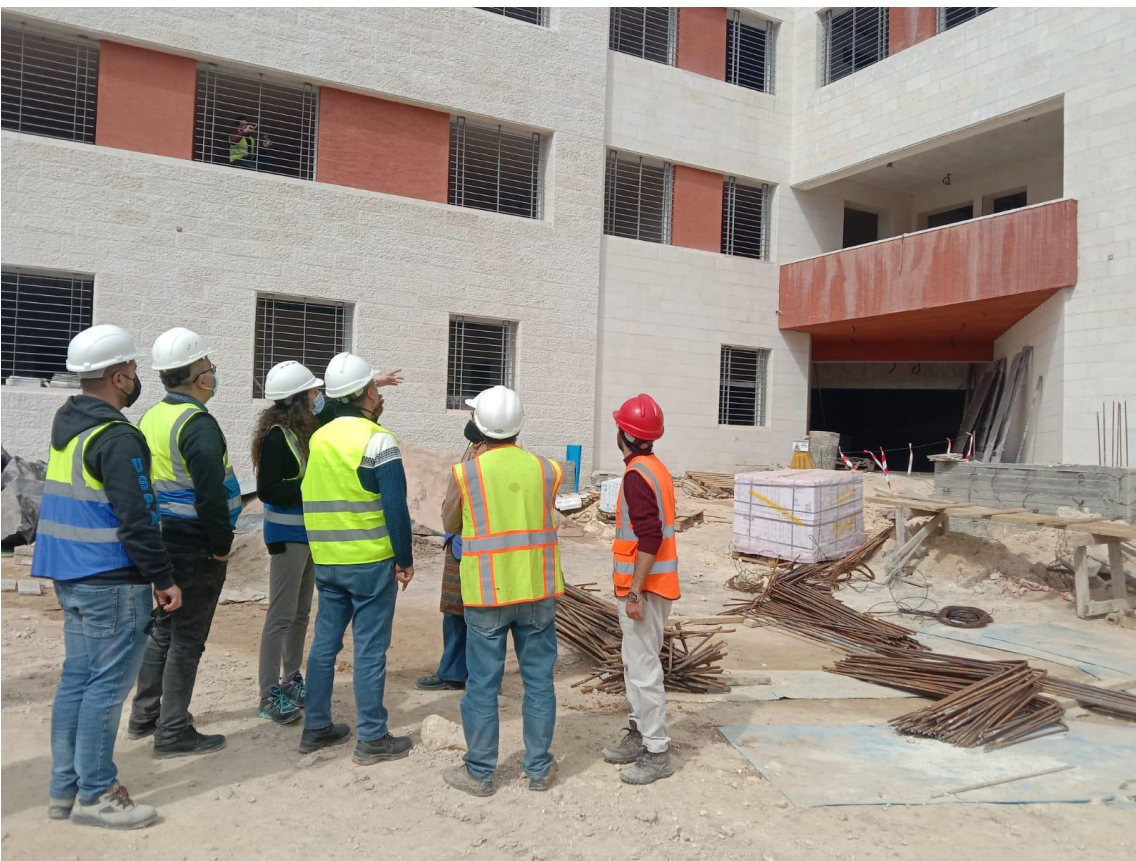
(Figure: 09)

The team inspected the stone facades of the building

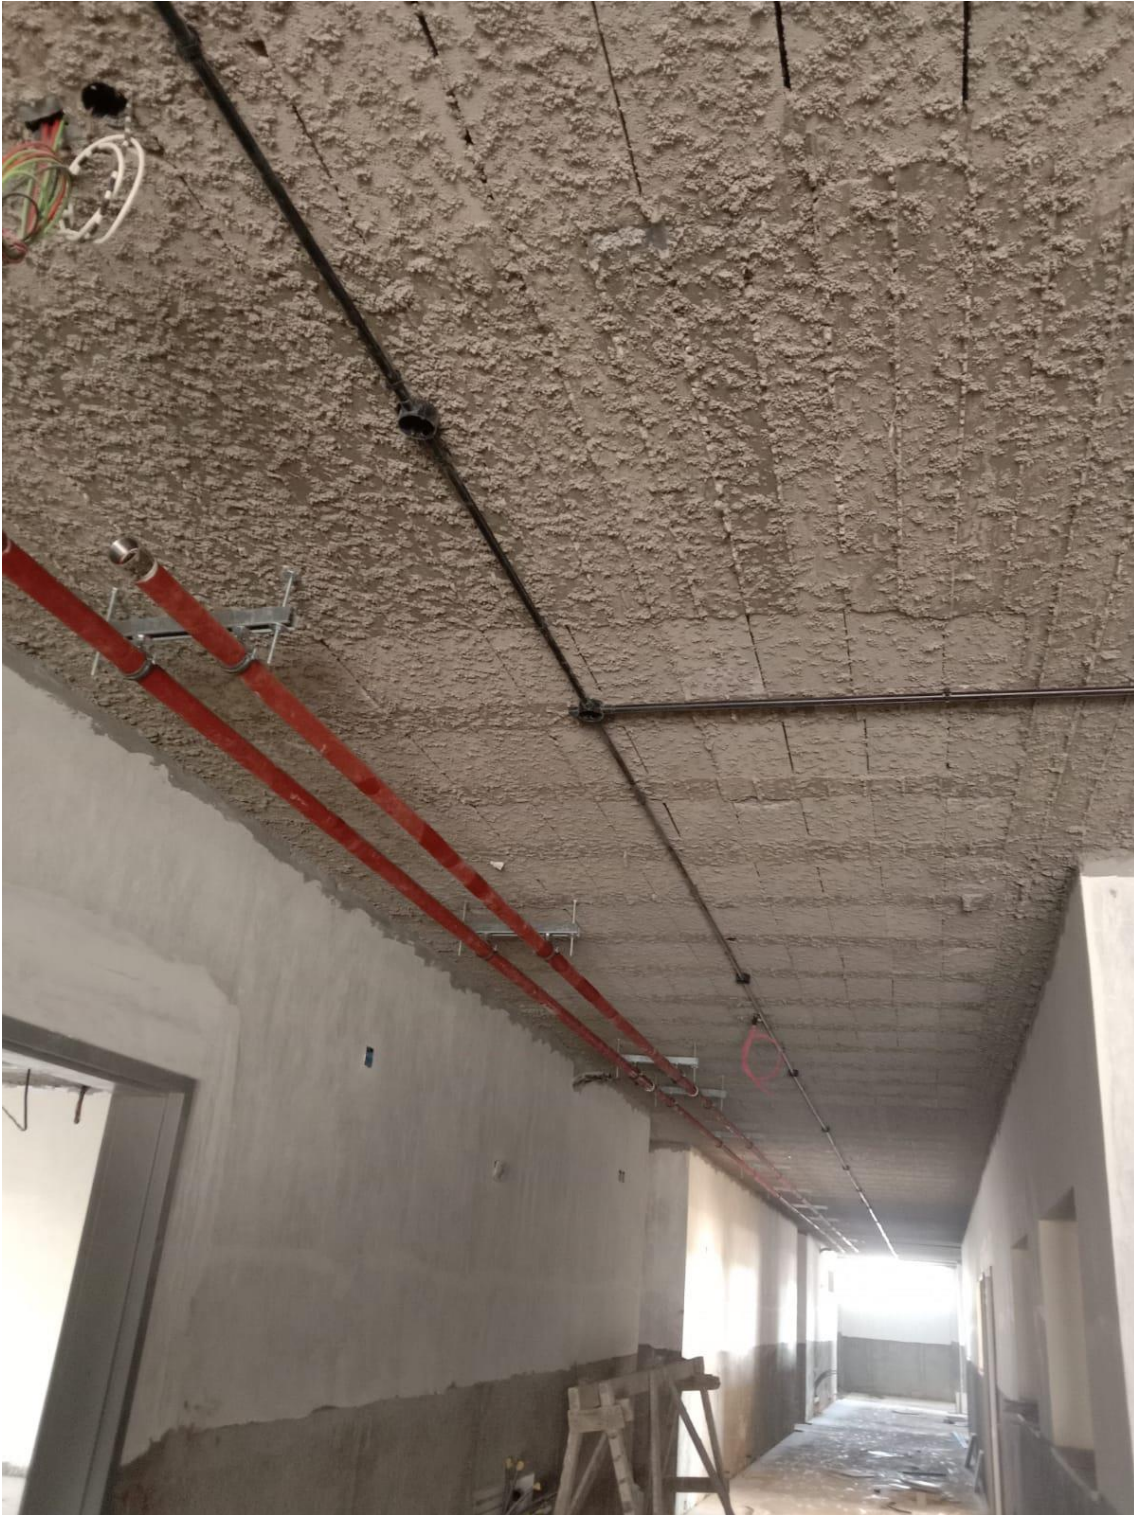
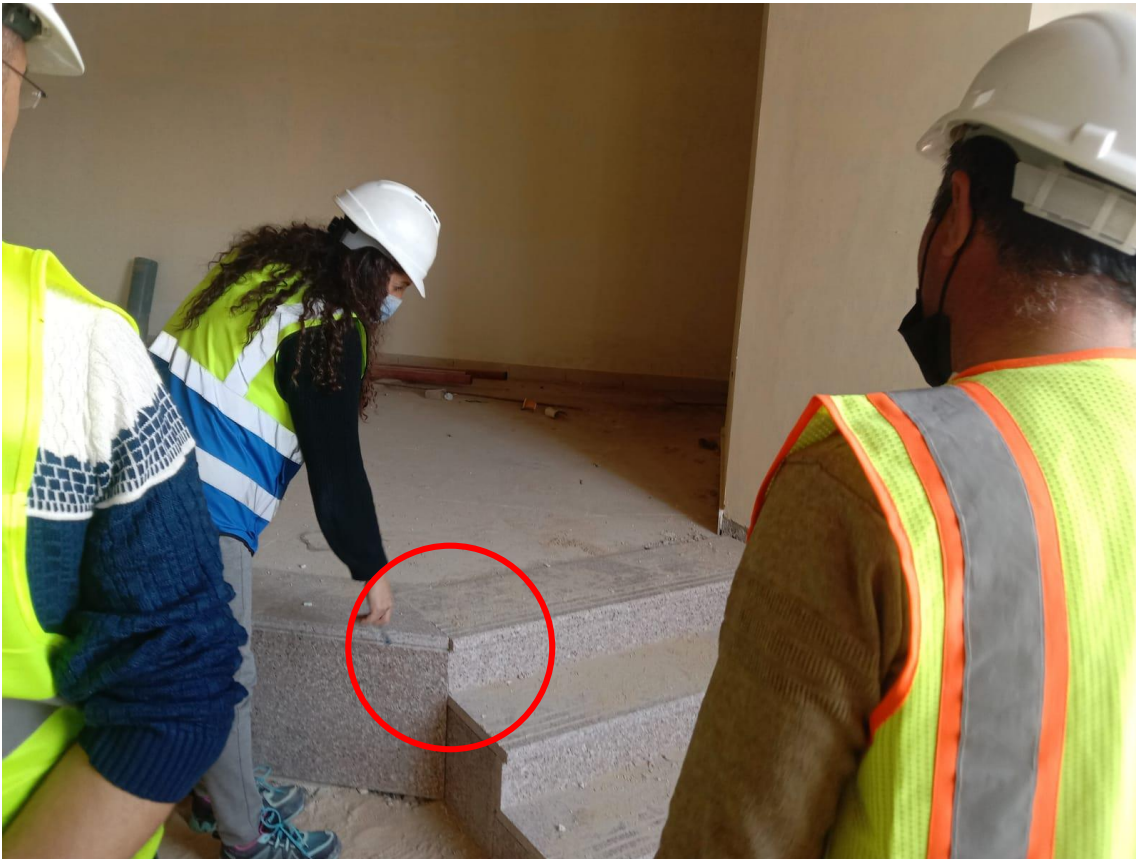
(Figure: 12 & 13)

The team inspected the electro-mechanical installations at the ceilings

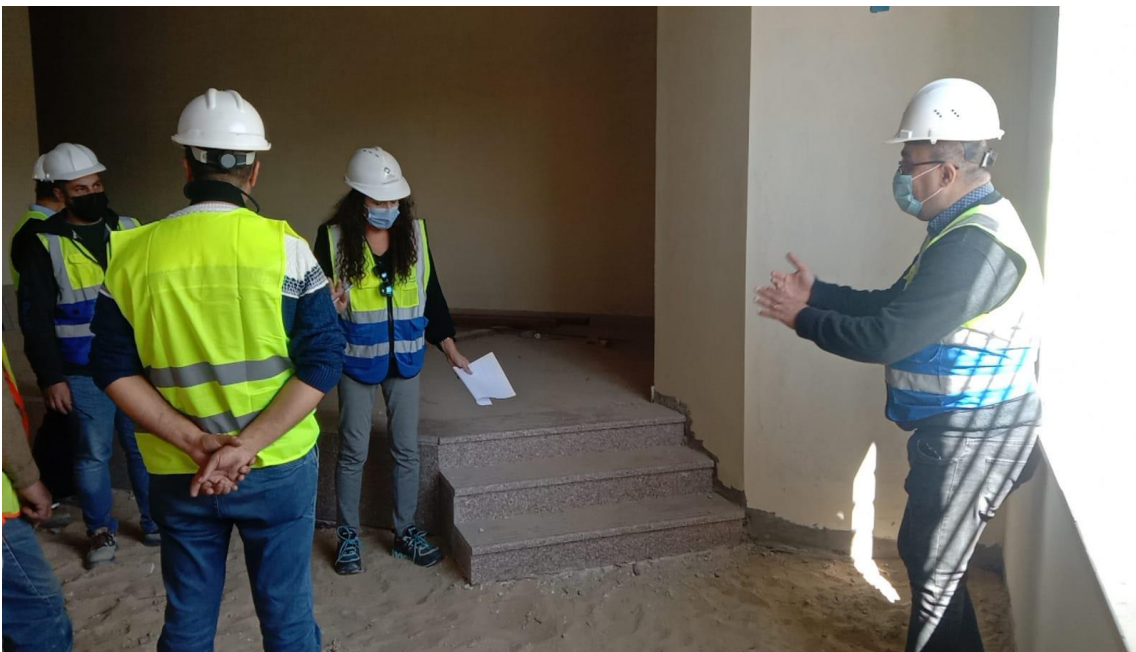
(Figure: 14)

The team observed prominence of the top thread during inspecting the stairs at the multi-purpose hall. The Contractor was requested to remove the prominence at the end of the thread

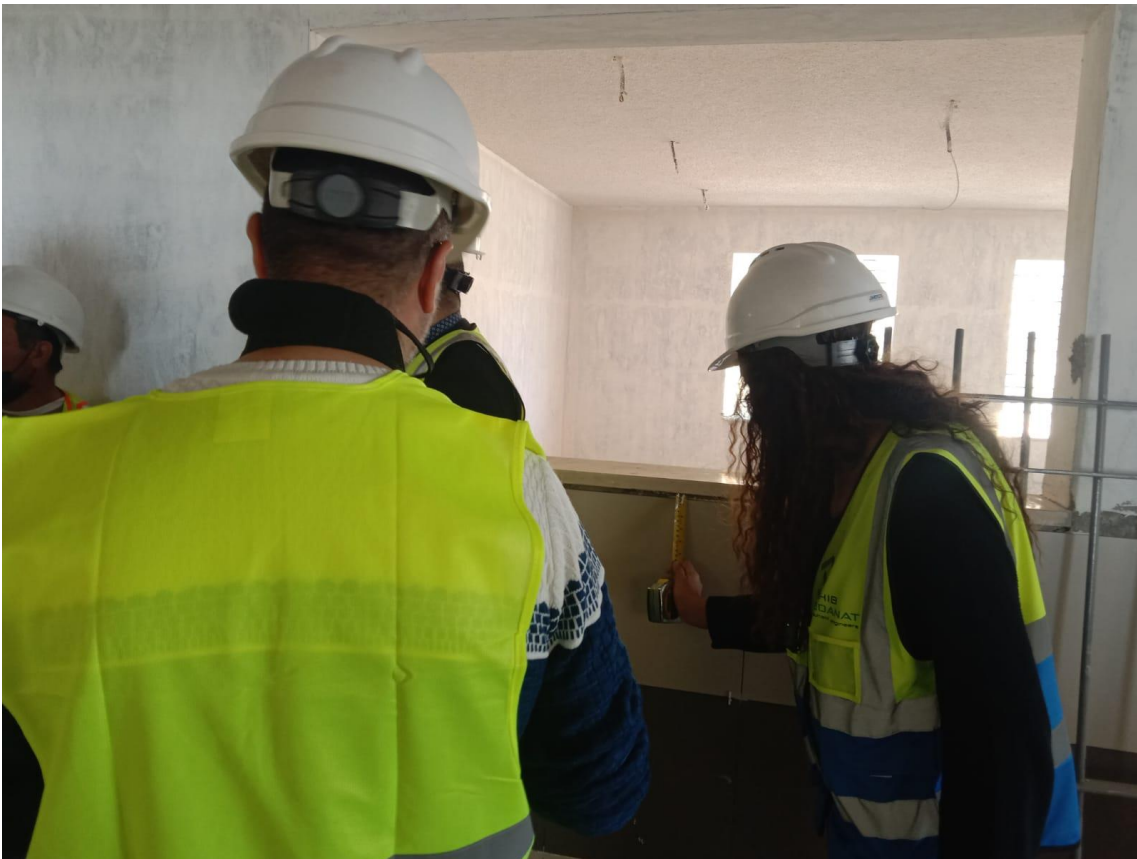
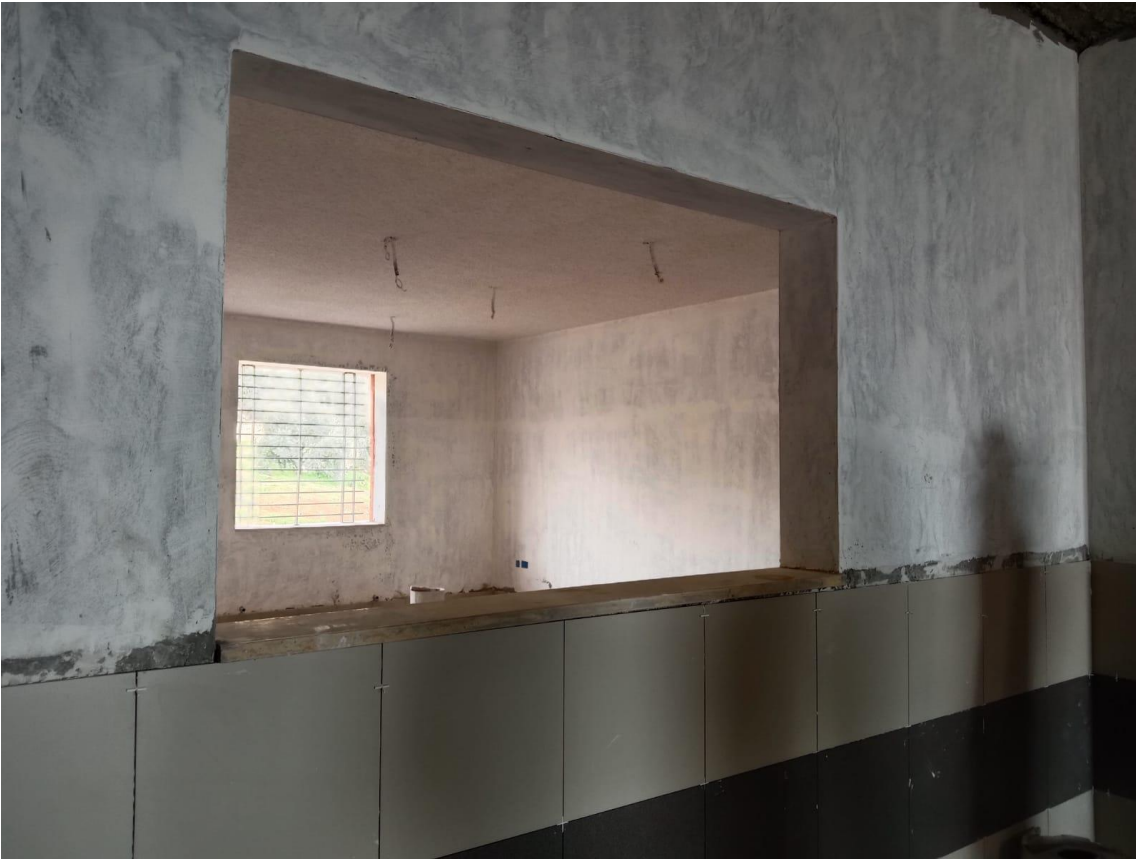
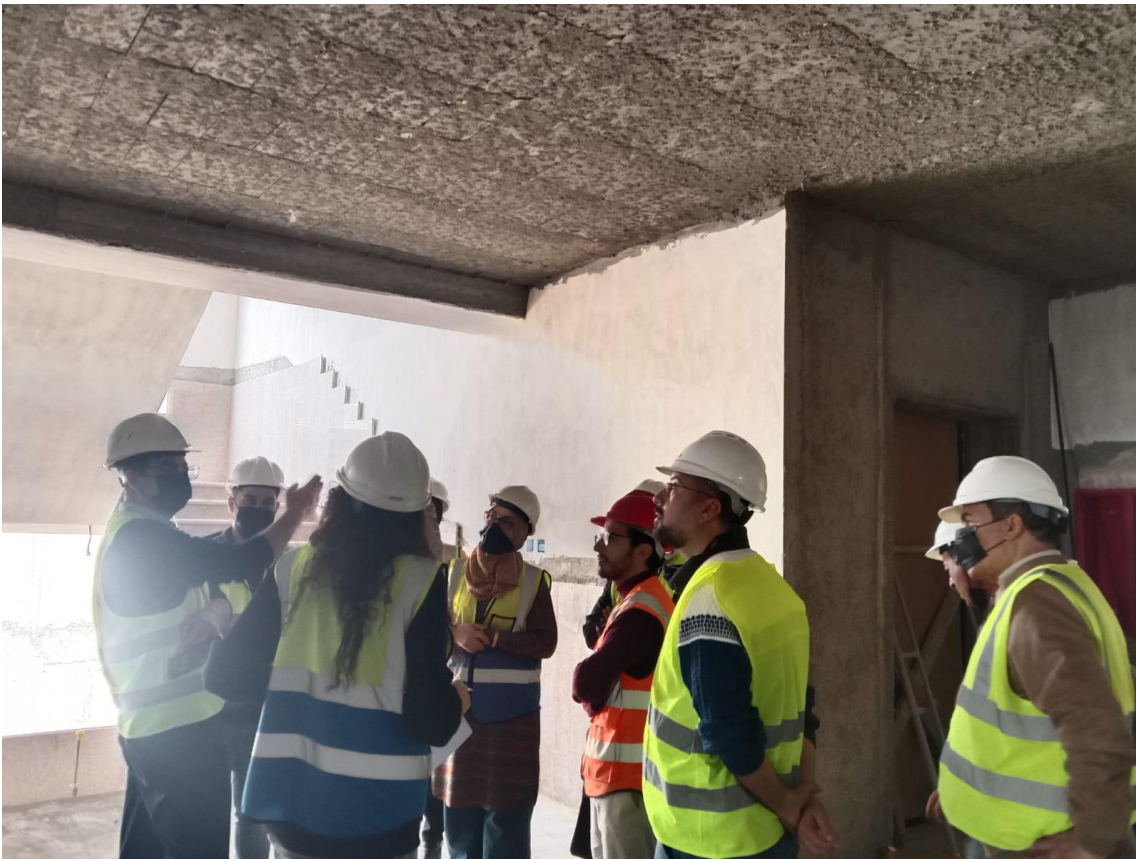
(Figure: 18, 19 & 20)

The team observed defects in the execution of the sills for the internal windows at the corridors. Clear mistakes in the levelling of those sills. The team requested the Contractor to ensure the correct level for all windows and ensure the correct opening of the windows

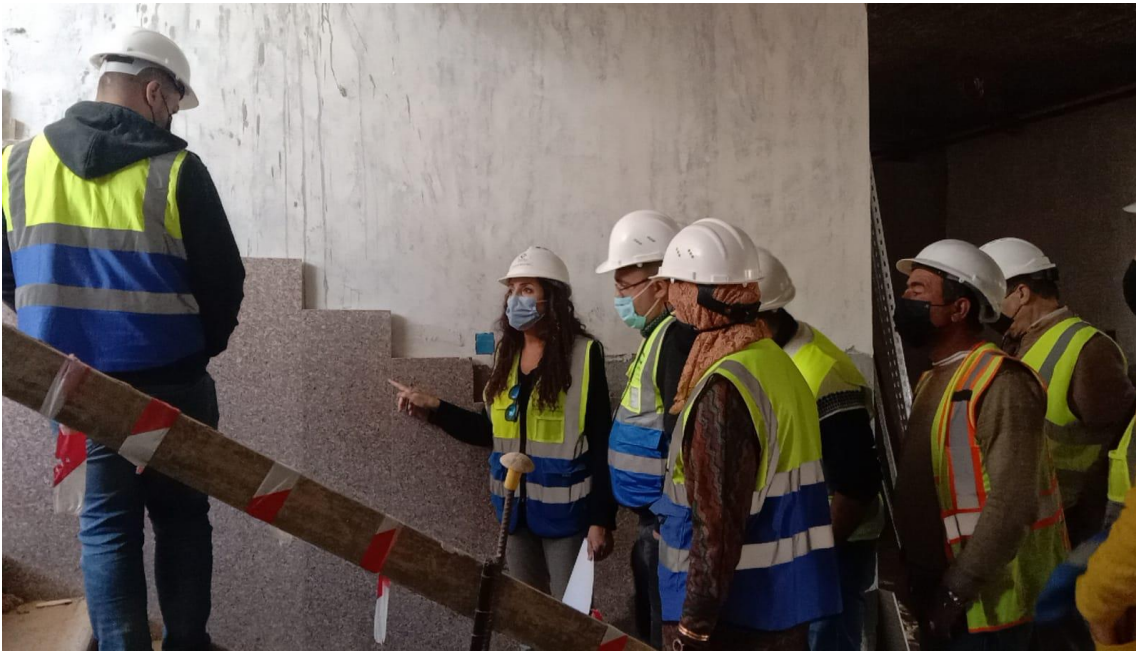
(Figure: 21)

The team discussed with the Contractor the limits of the false ceiling and requested the Contractor to extend the false ceiling to reach the drop beam

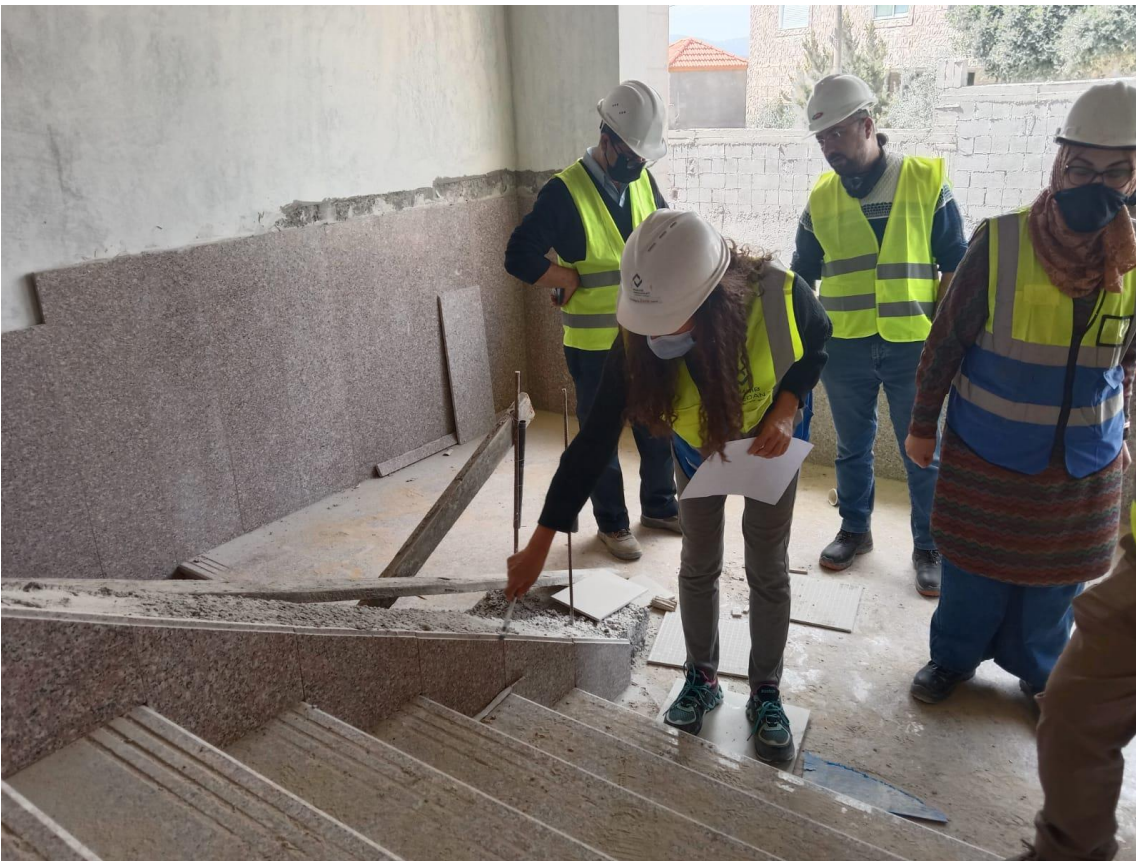
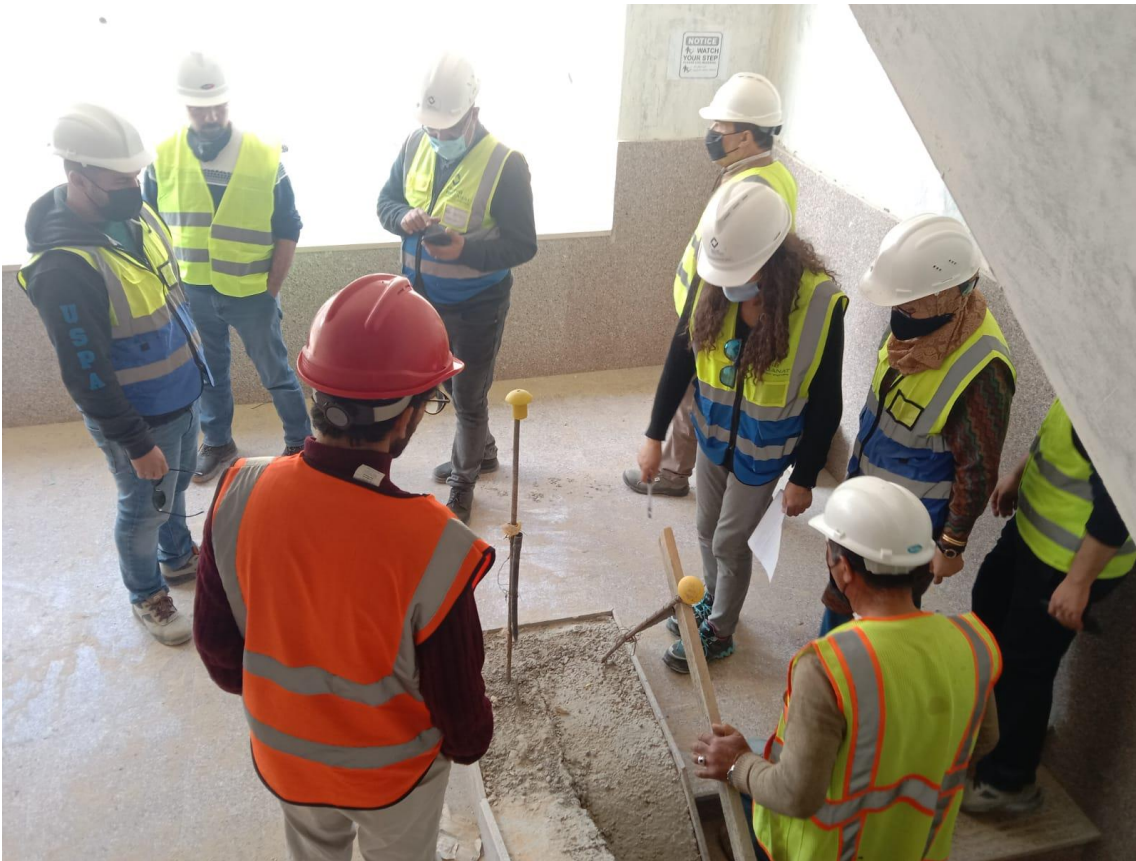
(Figure: 22 & 23)

The team observed that the Contractor has not rectified the granite cladding and panel for staircases and the status not changed regarding the cutting of the pieces, beside that the joint should be zero

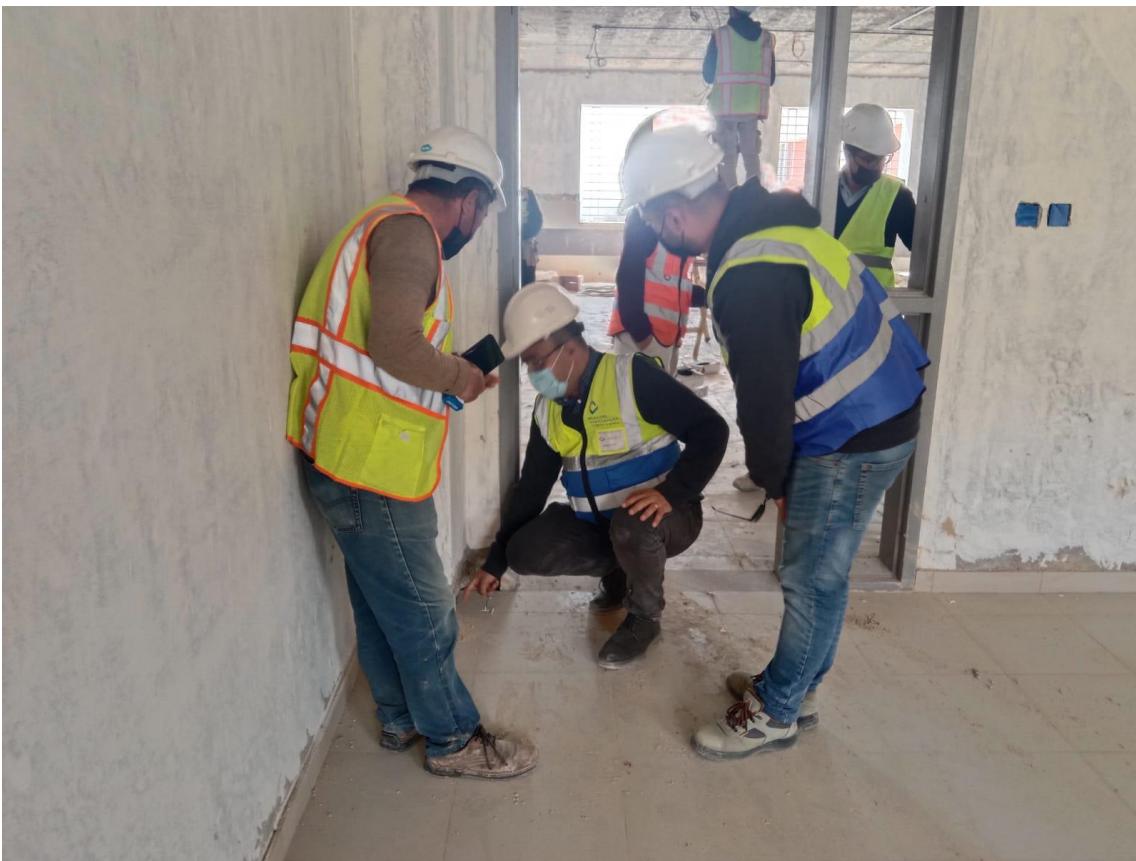
(Figure: 24)

The team discussed with the Contractor the staircase parapet all along and instructed the Contractor to conduct a minor change to the parapet at the landing

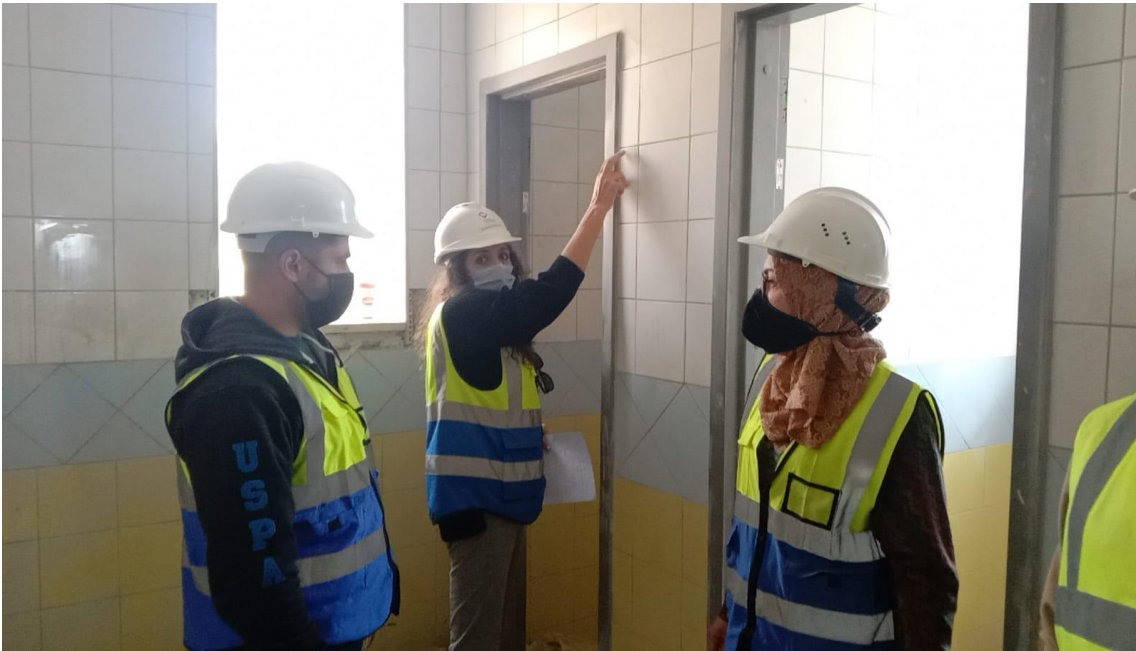
(Figure: 25)

The team instructed the Contractor not to use small pieces of skirting tiles at the narrow areas and use pieces with complete dimension to cover the whole distance

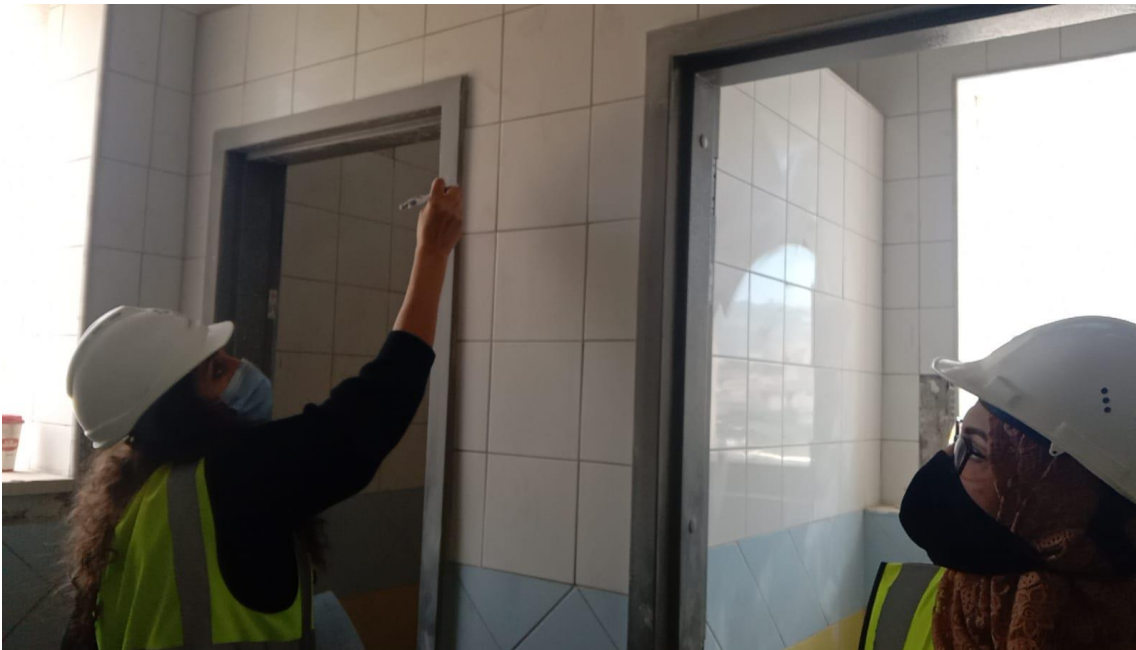
(Figure: 26 & 27)

The team observed variations in the cutting of wall ceramic tiles adjoining the door frame. The team requested the Contractor to rectify
