# SKEP III Home Office Support Site Visit Report

Consultant	Wahib Medanat Consultant Engineer	Rep No.	12-11042022
Contractor	Derar Saraireh & Sons for Engineering & Contracting	Tender No.	(11/2019/USAID/SKEP/3/S) Schools for a Knowledge Economy Project (SKEP) - Phase (3) Package (1, 2)
Site Name	Al Khansa' Basic Mixed School- Al Balqa	Day/ Date	Mon. 11/04/2022
Duration of Project	450 Calendar Days	Total Project Budget	9,789,417.840 JD

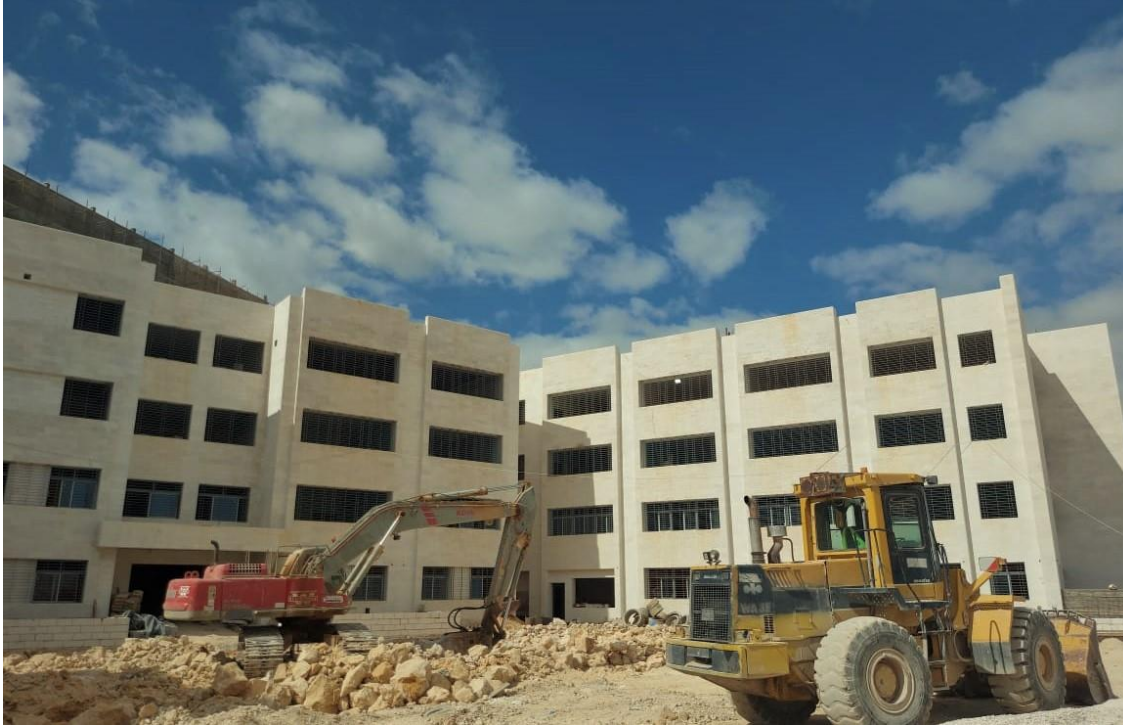
(Figure: 01)

General view of the project site

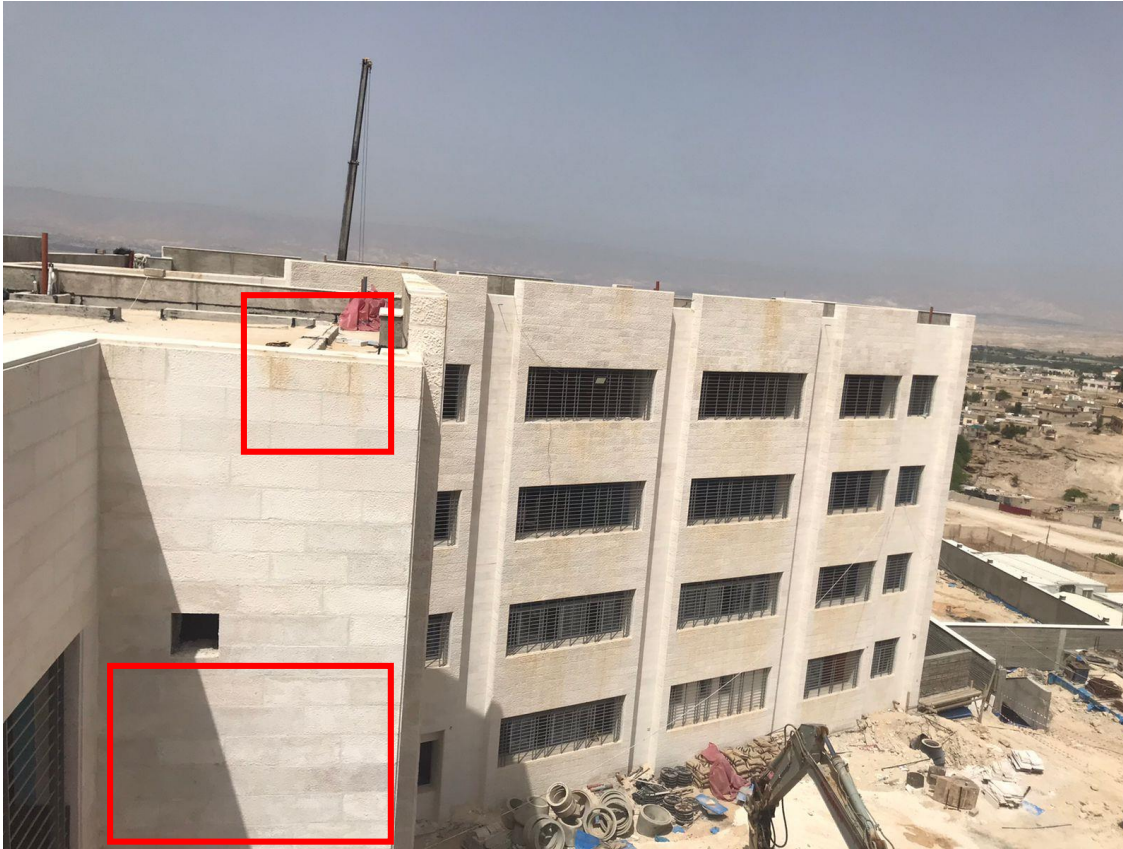
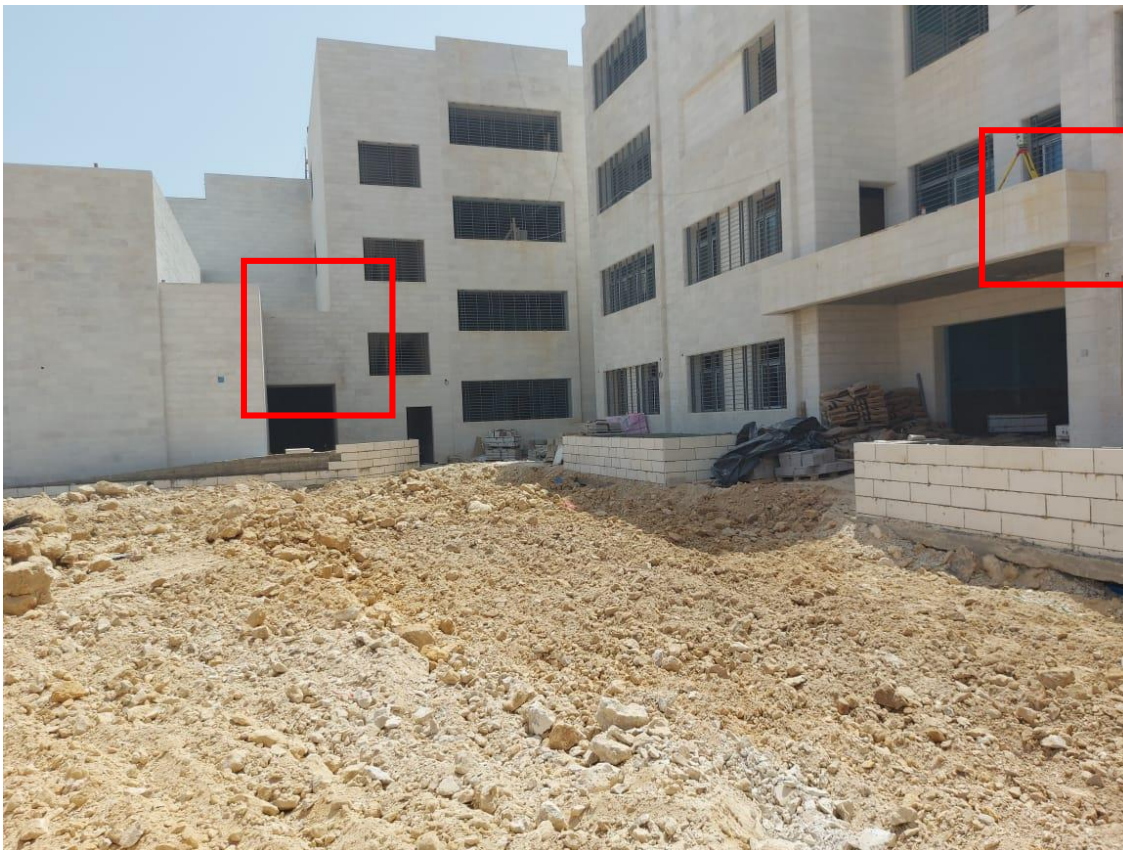
(Figure: 05 & 06)

The team observed that parts of the stone facades have dirt on and need to be cleaned

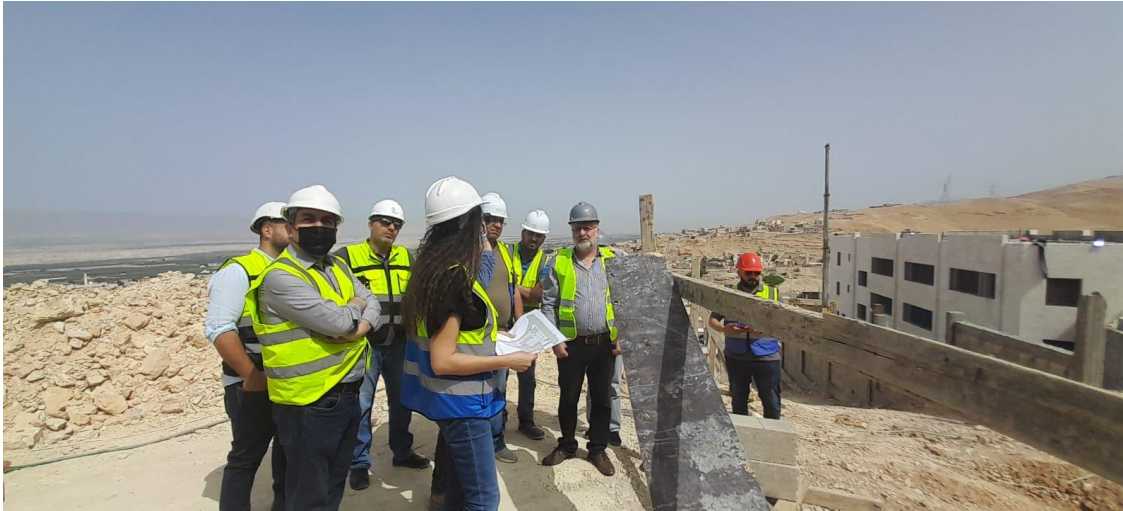
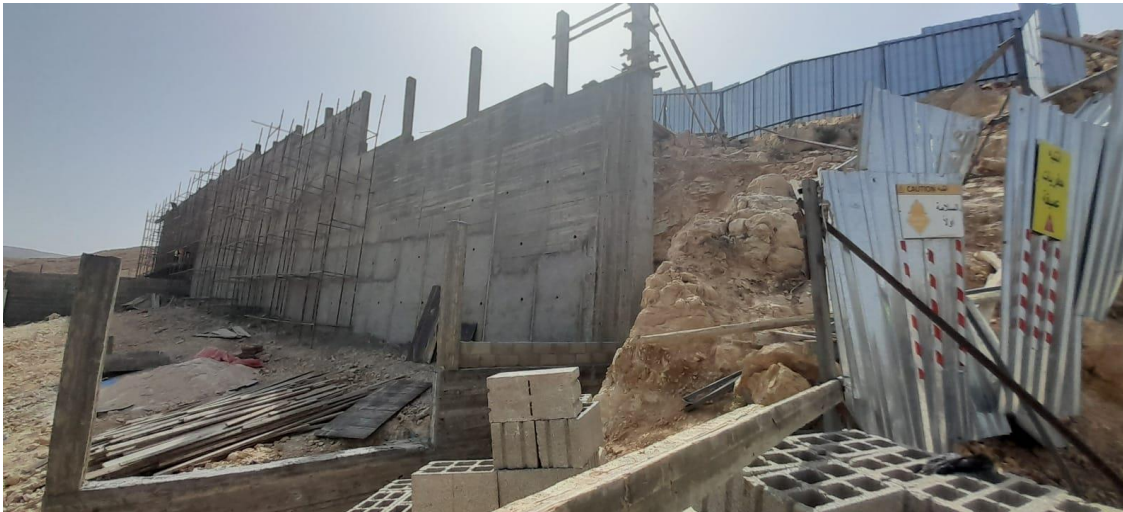
(Figure: 07 & 08)

the supervision team met with the Designer's representatives visiting the site upon prior arrangement to discuss general issues focusing on the finishing work of the area at the southern end of the site

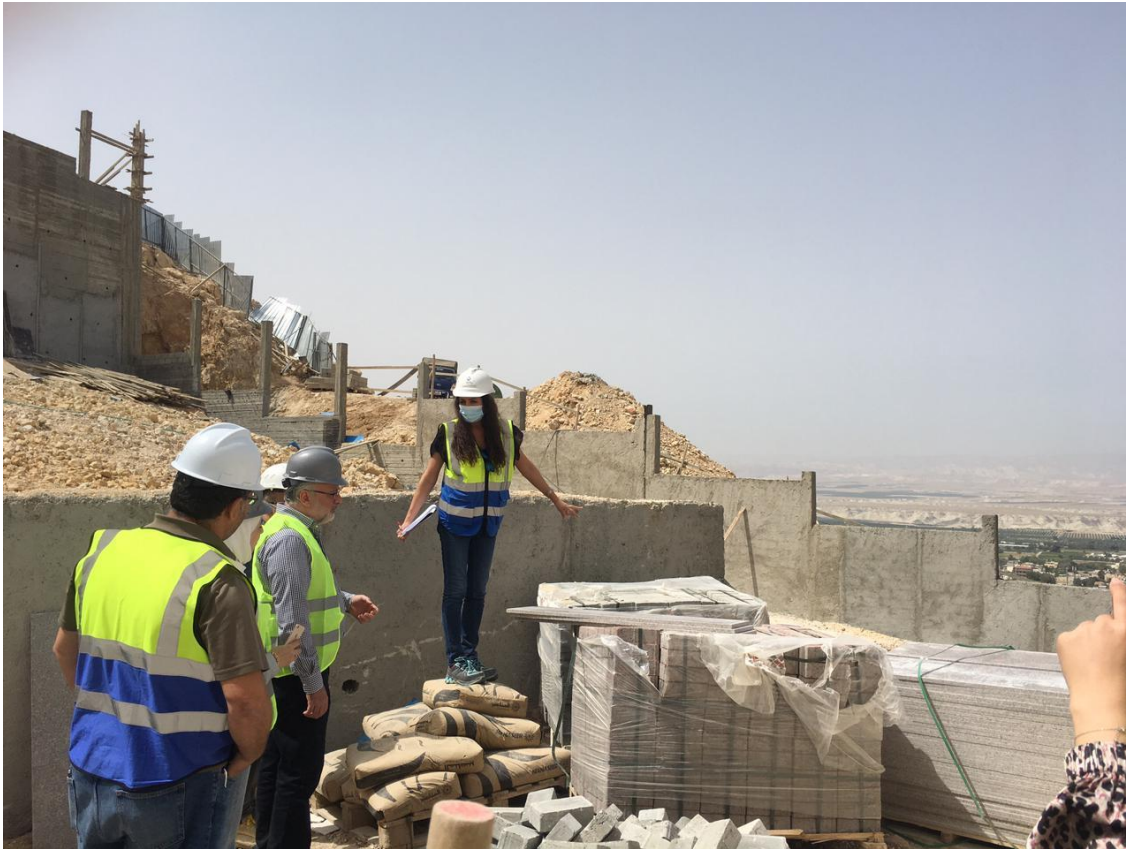
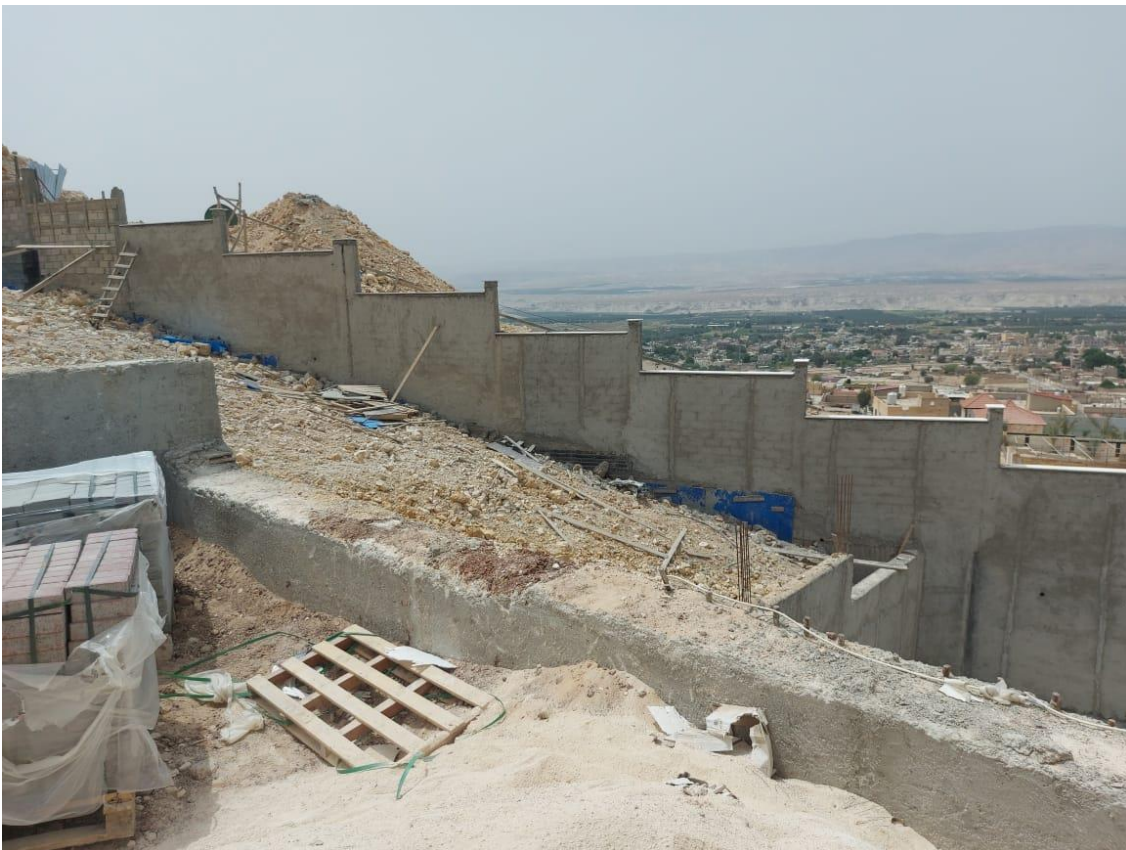
(Figure: 09 & 10)

The team discussed with the “Designer” the height of parapets at the steep areas and the Designer requested to execute the parapet to be not less than (1.10m) height as per the previous feedback by the Designer to be 0.90m reminding that it was (0.20m) in the design drawings

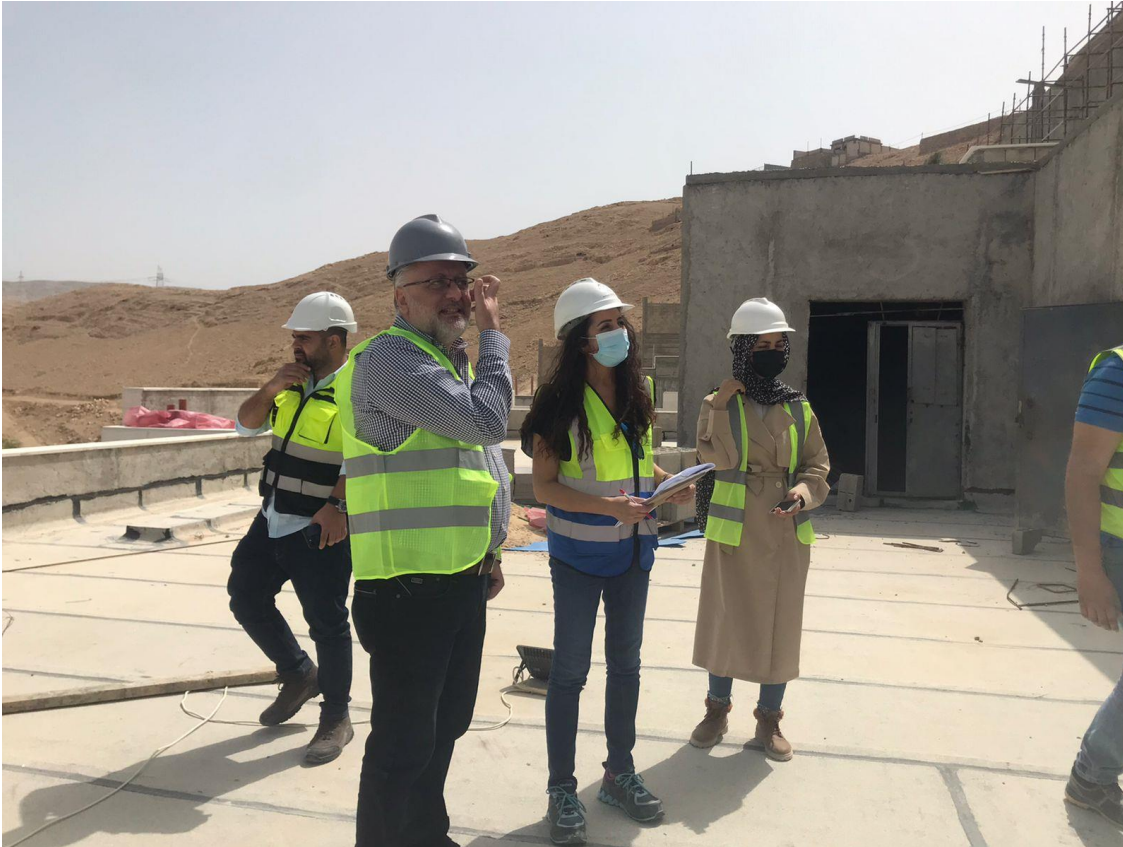
(Figure: 11)

The team stressed on that the Contractor should take action to conduct the water penetration test to the roof of the building

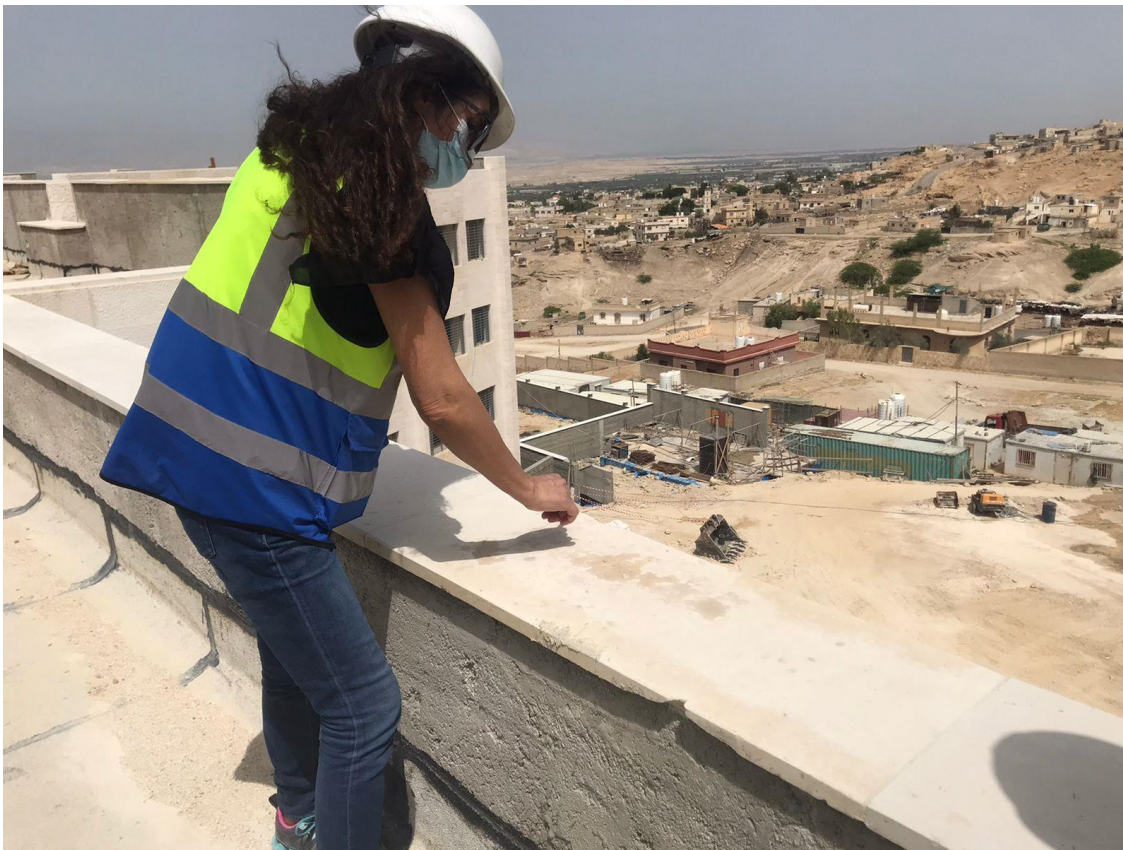
(Figure: 12)

The team observed that number of stone coping are broken and need to be replaced

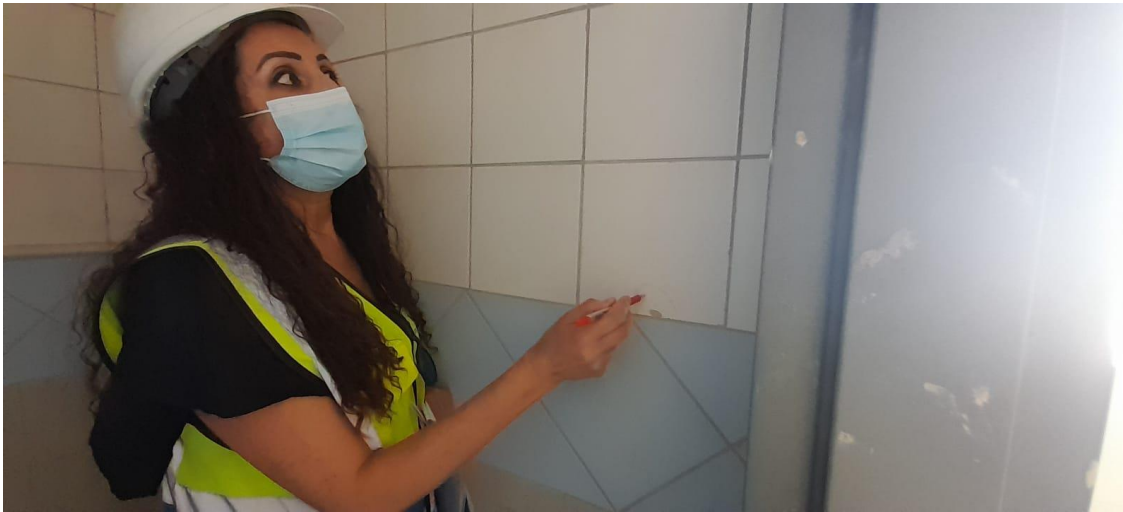
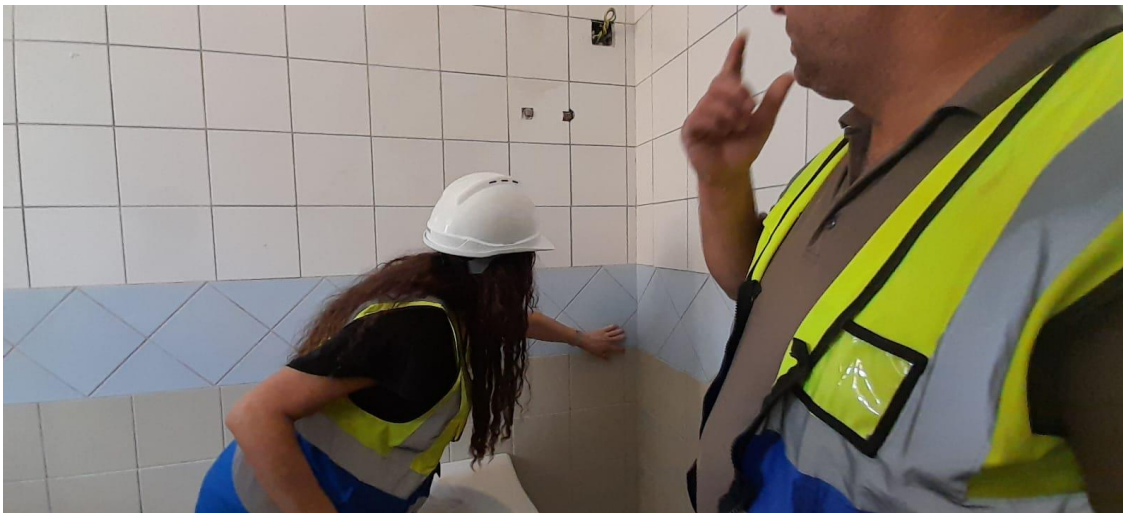
(Figure: 13 & 14)

The team inspected the ceramic wall tiles installed at the wet areas and stressed that the small cut-off pieces and the broken tiles wherever found should be replaced

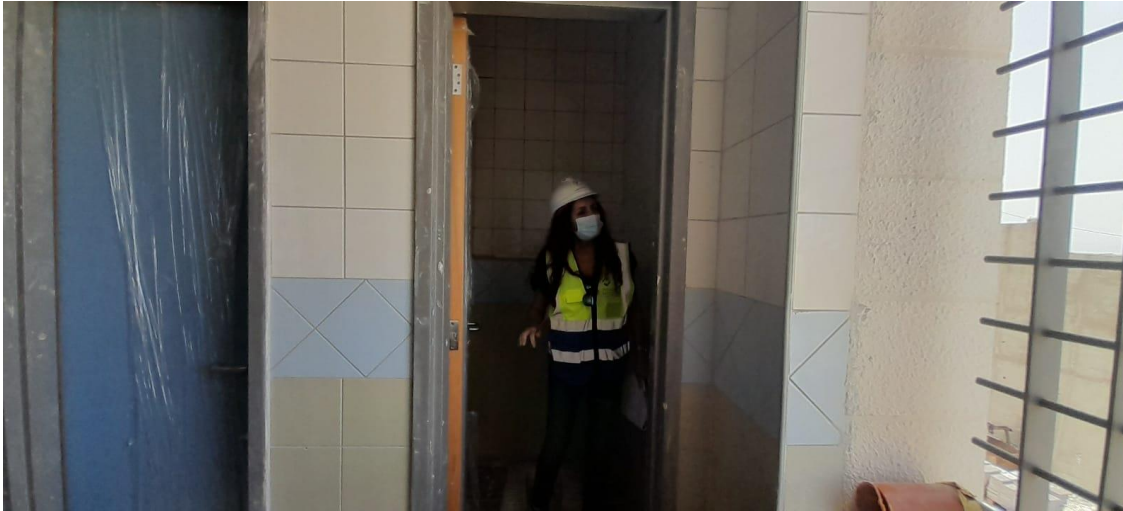
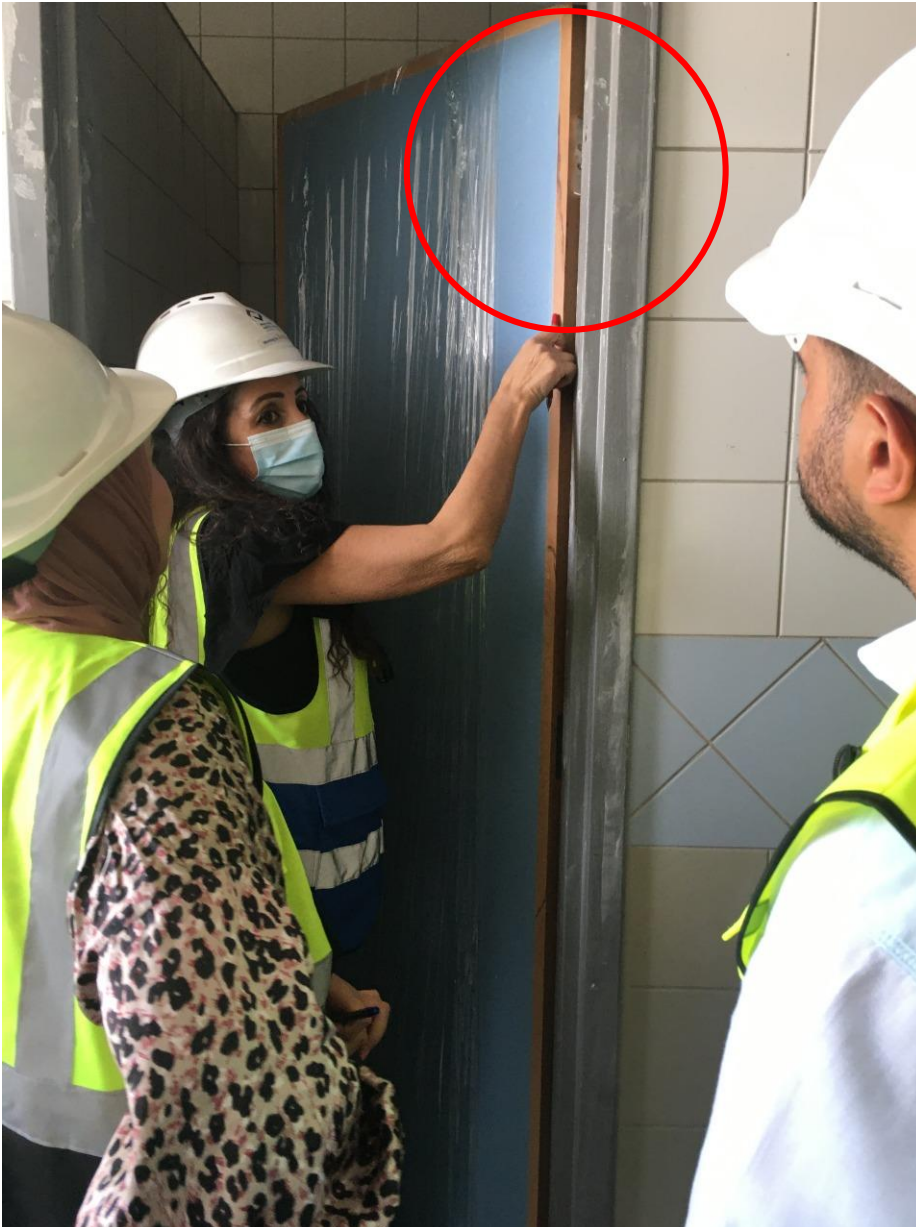
(Figure: 15 & 16)

The supervision team inspected the installed wooden doors and requested the Contractor to replace the leafs having defected beech wood frame

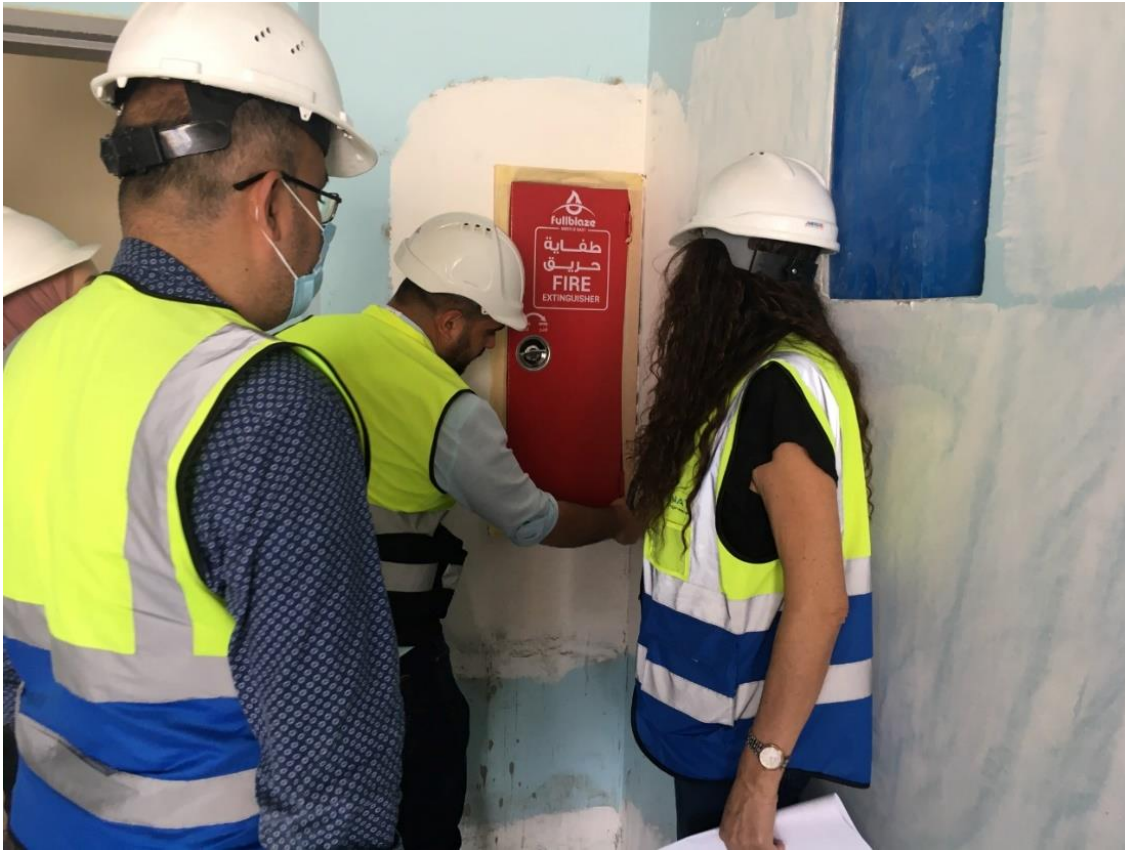
(Figure: 17)

The team observed the gap between the edge of extinguisher cabinets and the plastering wall and discussed with the Contractor some suggestions of the appropriate solutions

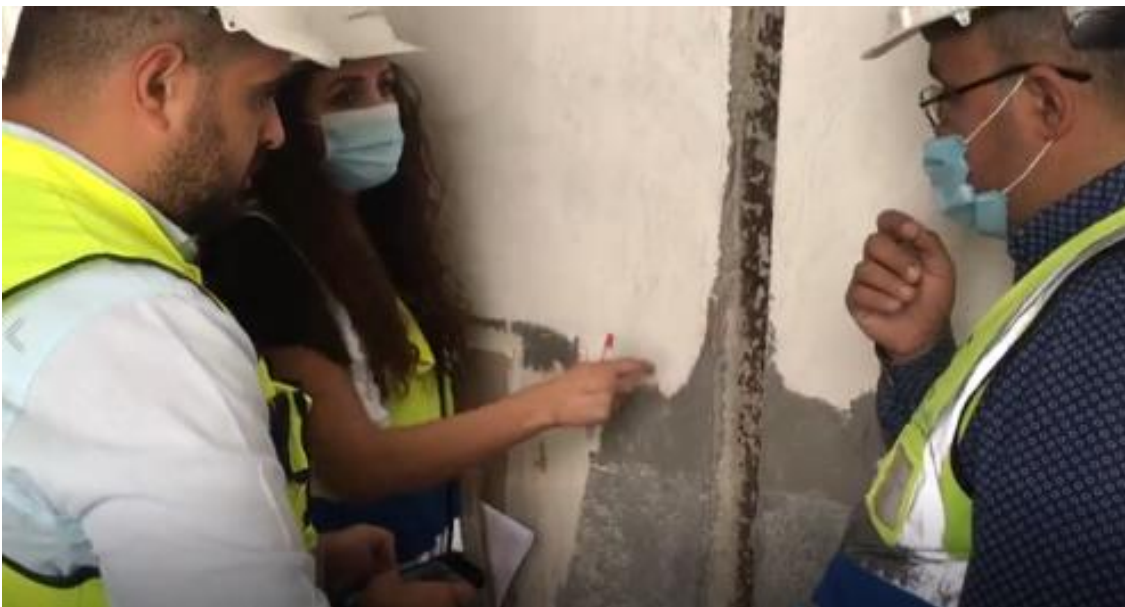
(Figure: 18)

The team discussed with the Contractor the details of finishing the expansion joints and the team will inspect the executed sample at Um Al-Dananir School

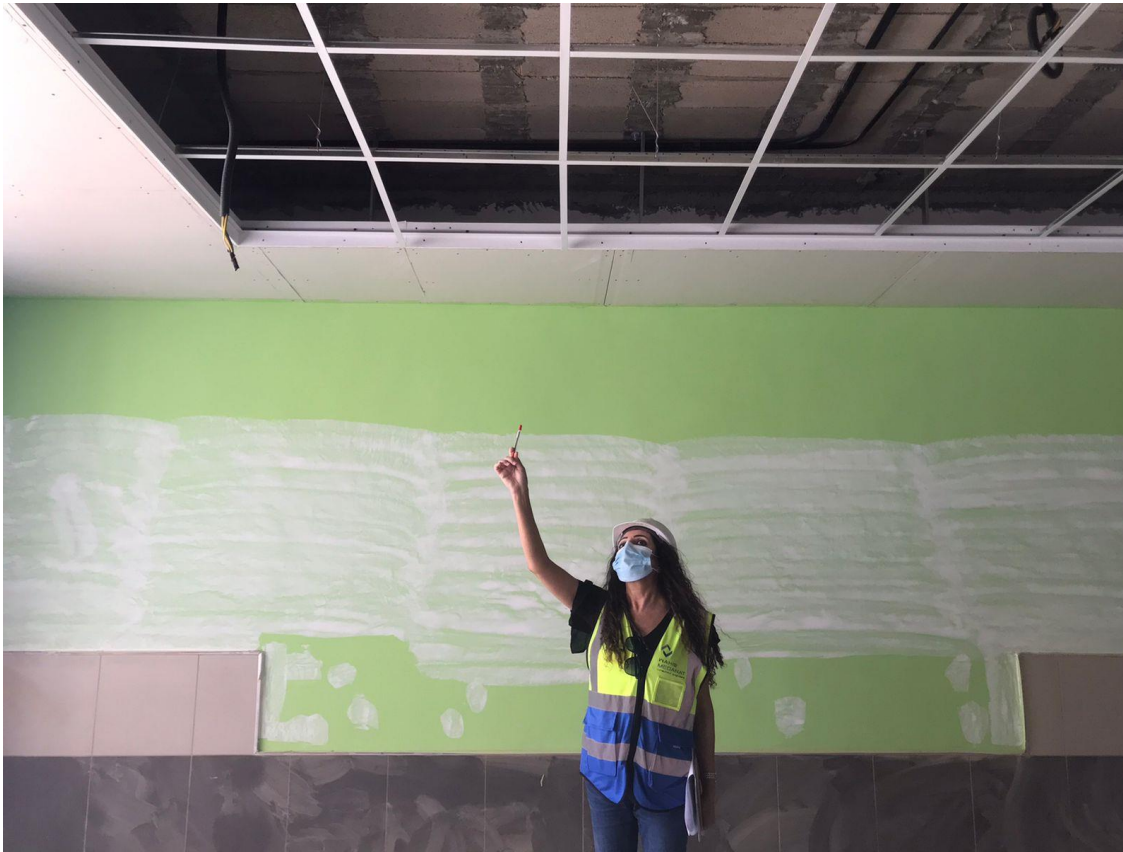
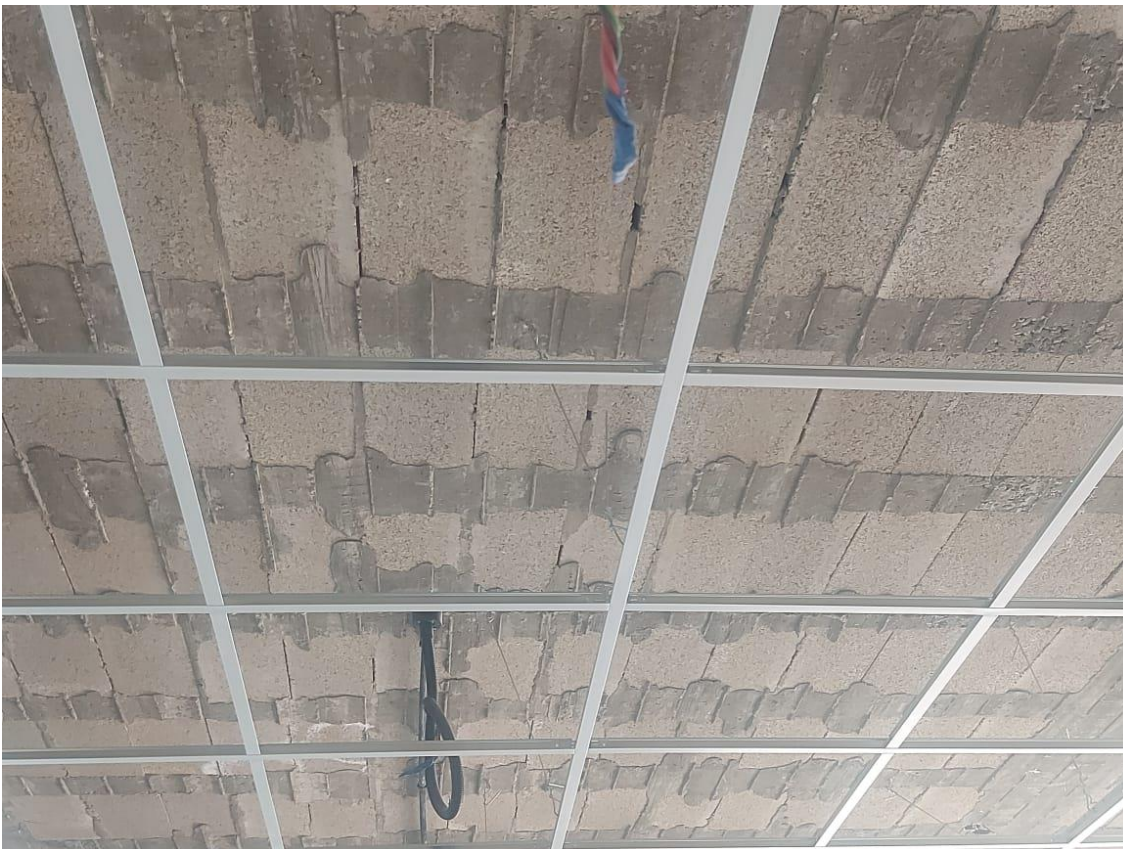
(Figure: 19 & 20)

The team observed that the hangers used to hold the suspended ceiling frame, some of them are not vertical. The Contractor was requested to ensure the verticality of those hangers

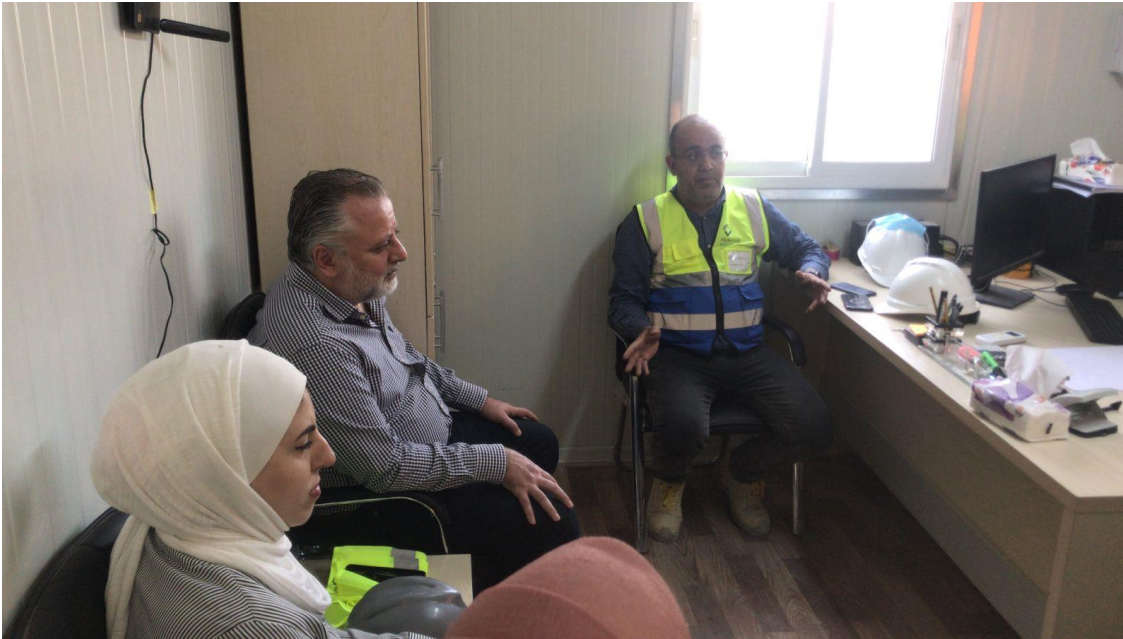
*(Figure: 21)*

A meeting was held at the site offices with the Designer to discuss the required details for the connection between Wall 4 & wall 5.
