Consultant	Wahib Medanat Consultant Engineer	Rep No.	12-12012022
Contractor	Derar Saraireh & Sons for Engineering & Contracting	Tender No.	(11/2019/USAID/SKEP/3/S) Schools for a Knowledge Economy Project (SKEP) - Phase (3) Package (1, 2)
Site Name	Al Khansa' Basic Mixed School- Al Balqa	Day/ Date	Wed. 12/01/2022
Duration of Project	450 Calendar Days	Total Project Budget	9,789,417.840 JD

Visit Notes

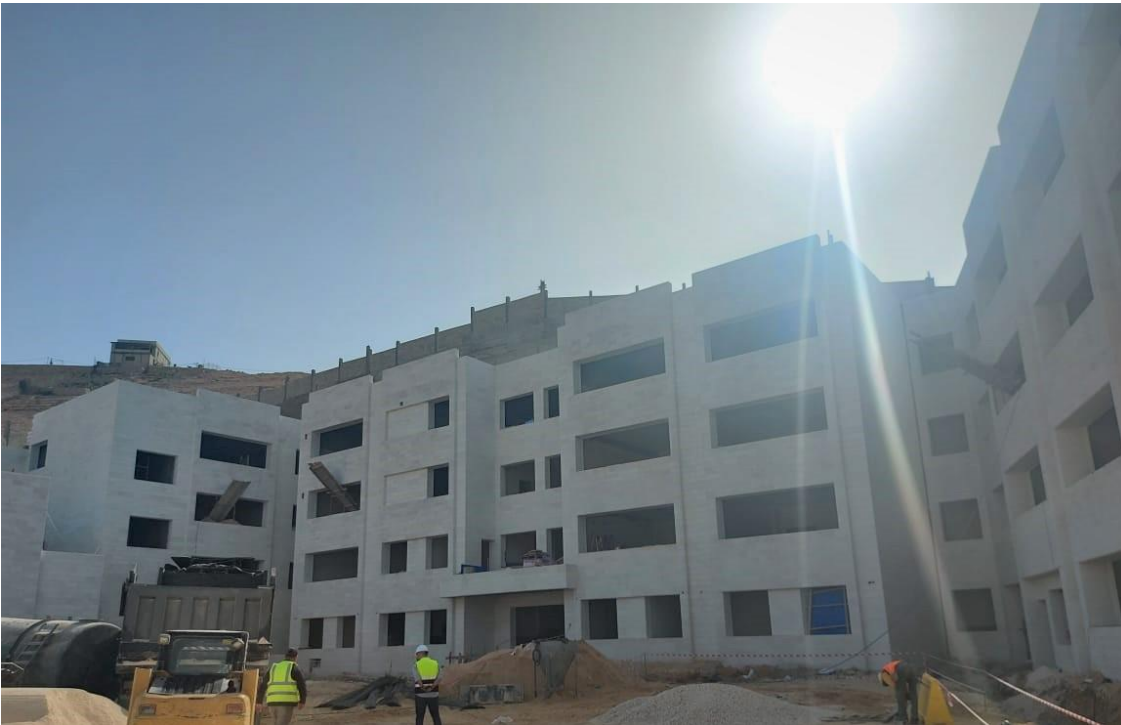
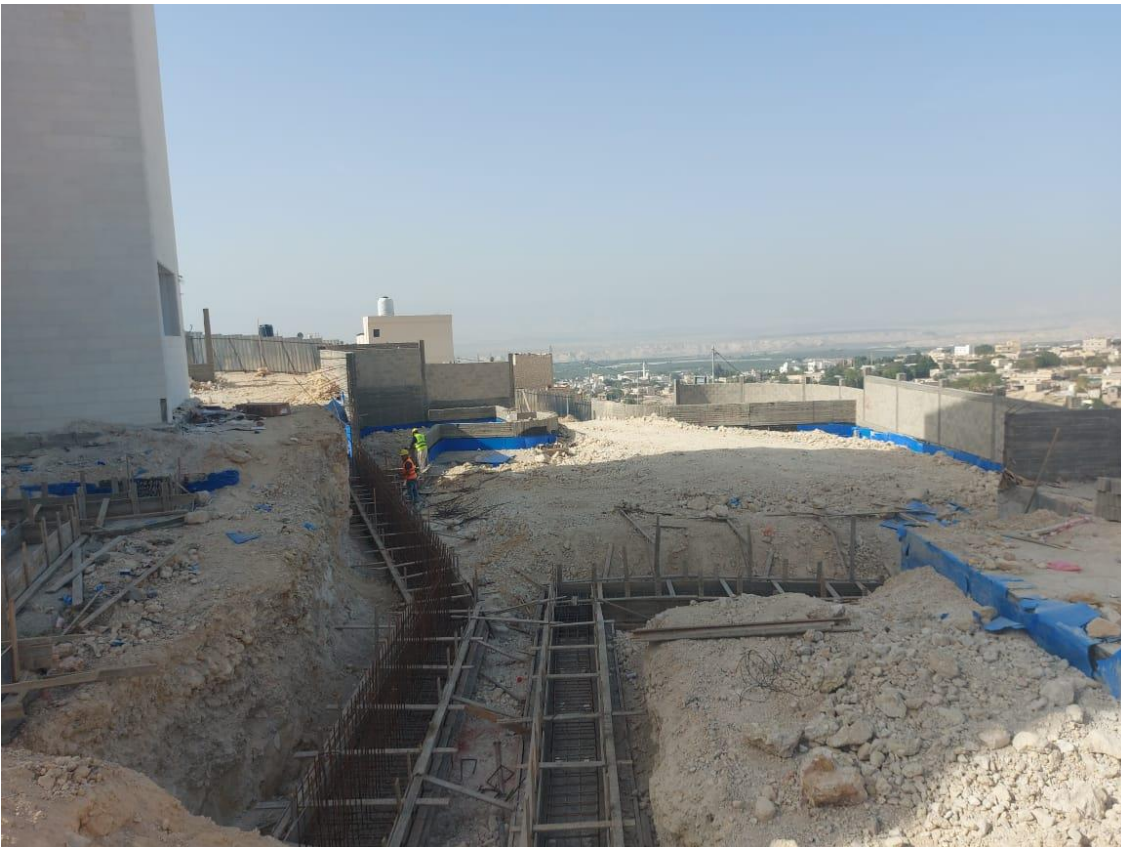
The supervision team observed that the installed carton boards and the waterproofing asphalt paint for the external footing have been damaged due to the excavation work. The Contractor promised to rectify and re-install accordingly

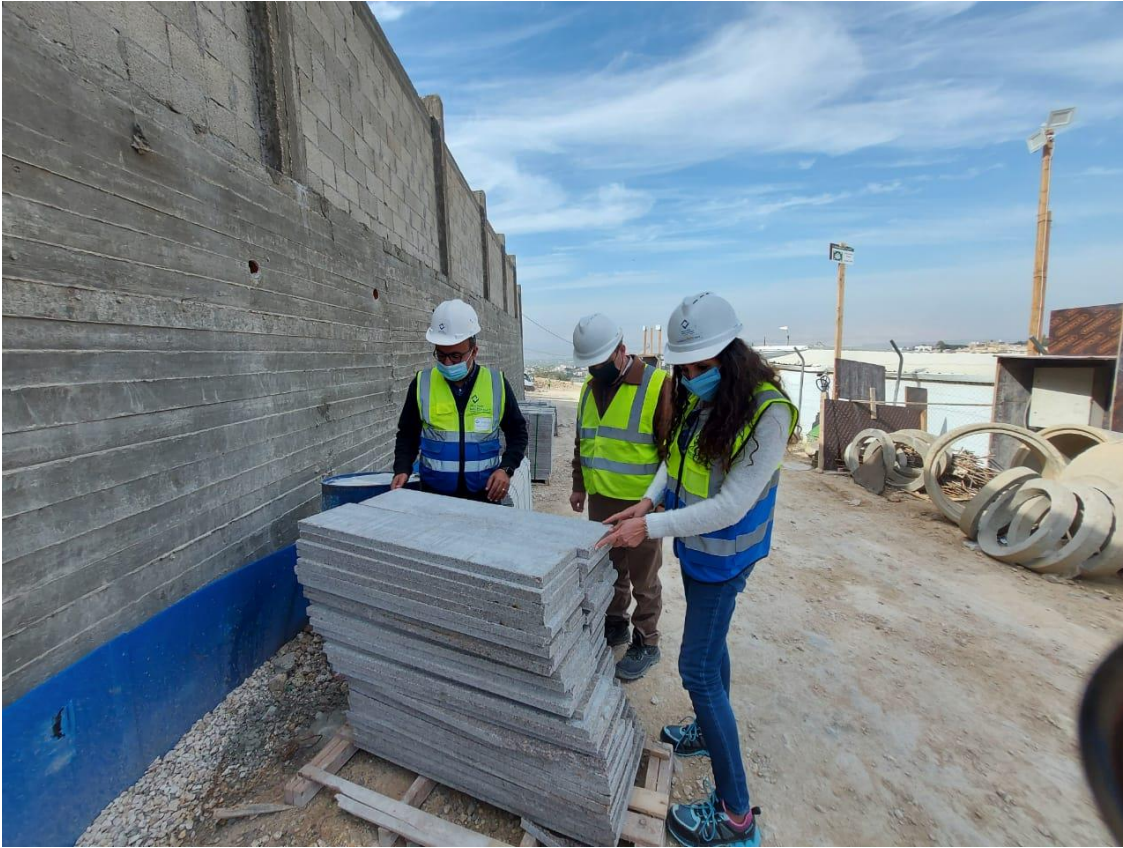
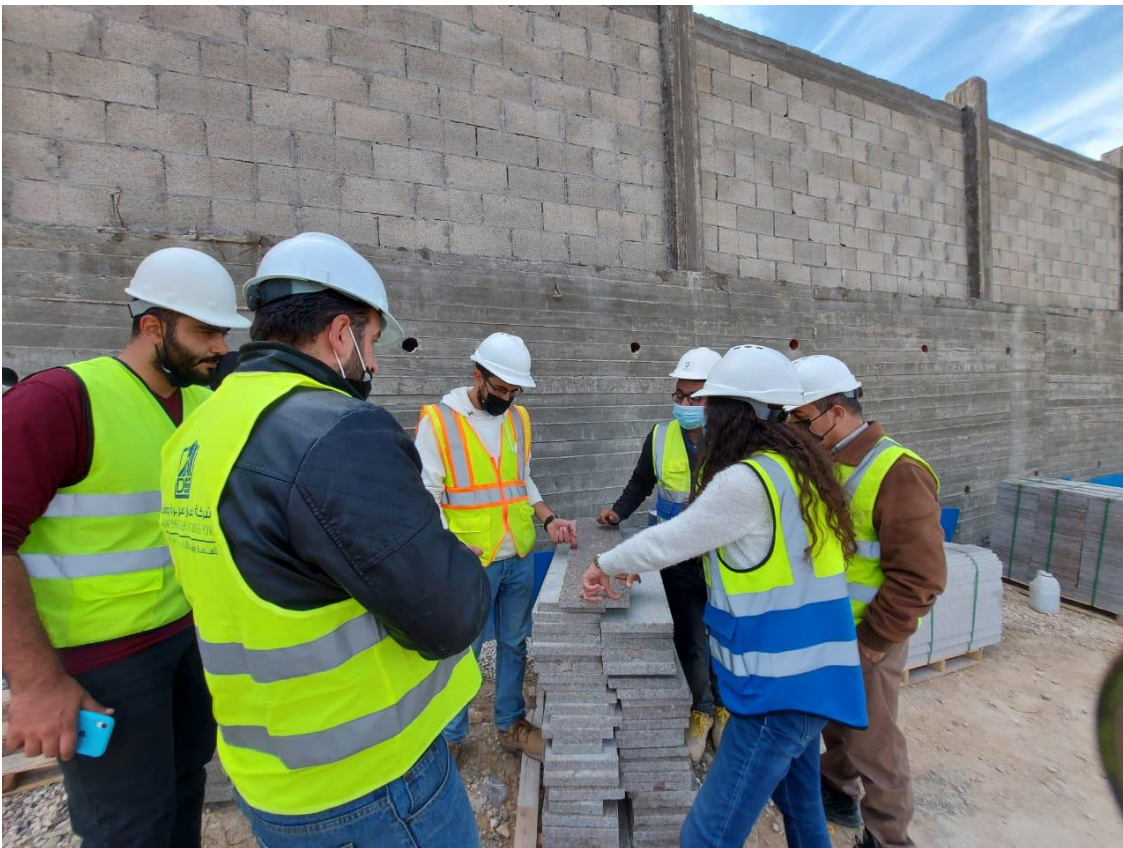
(Figure: 05 & 06)

The team inspected the delivered granite for the staircases and the Contractor informed the team that the stair treads have been returned to the factory in order to make the required grooves in those treads

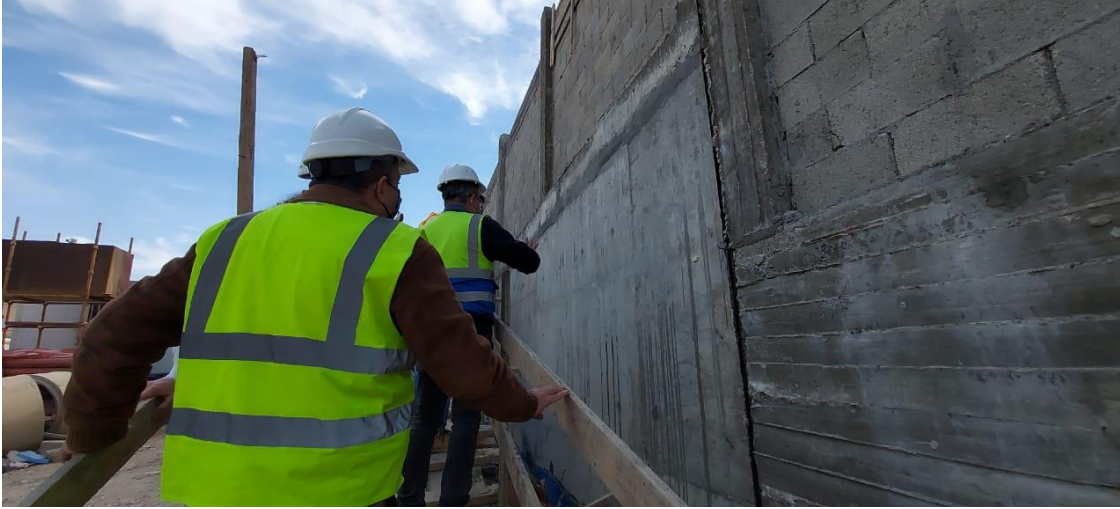
(Figure: 07)

The supervision team instructed the Contractor to make the surface of fair-face casted boundary walls rough by chipping step followed by plastering

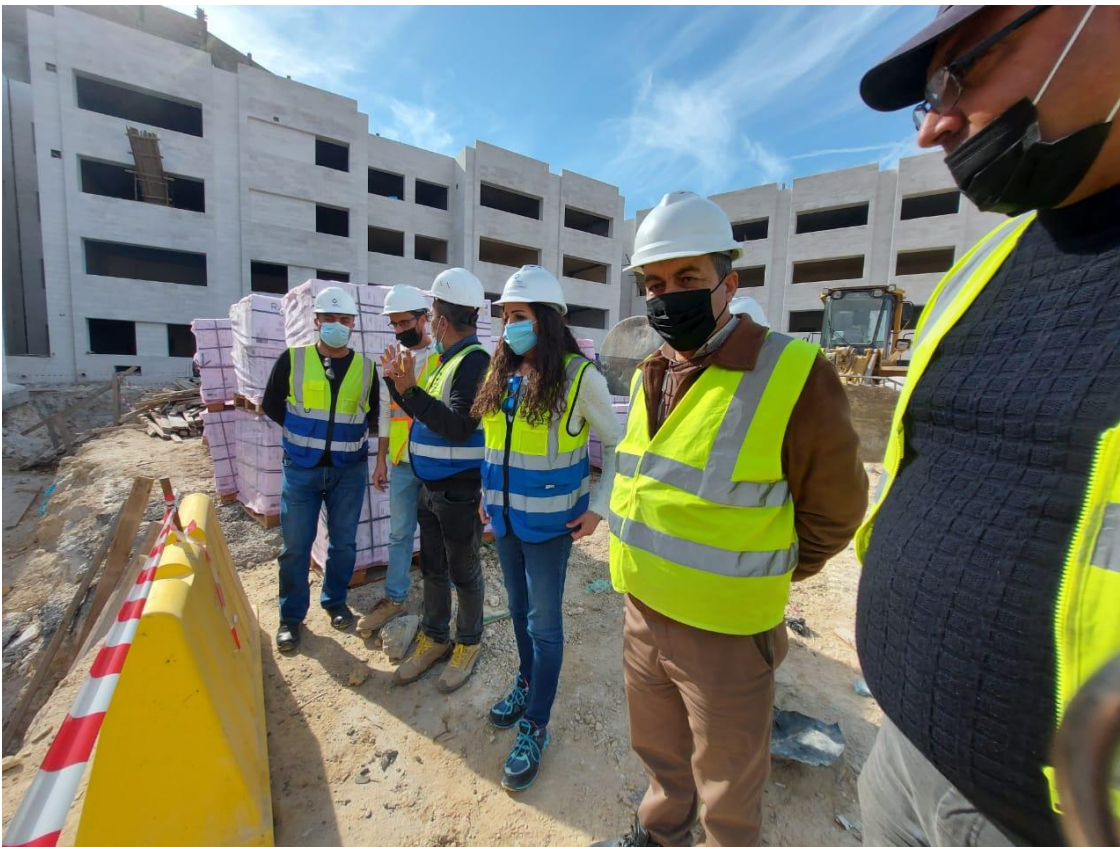
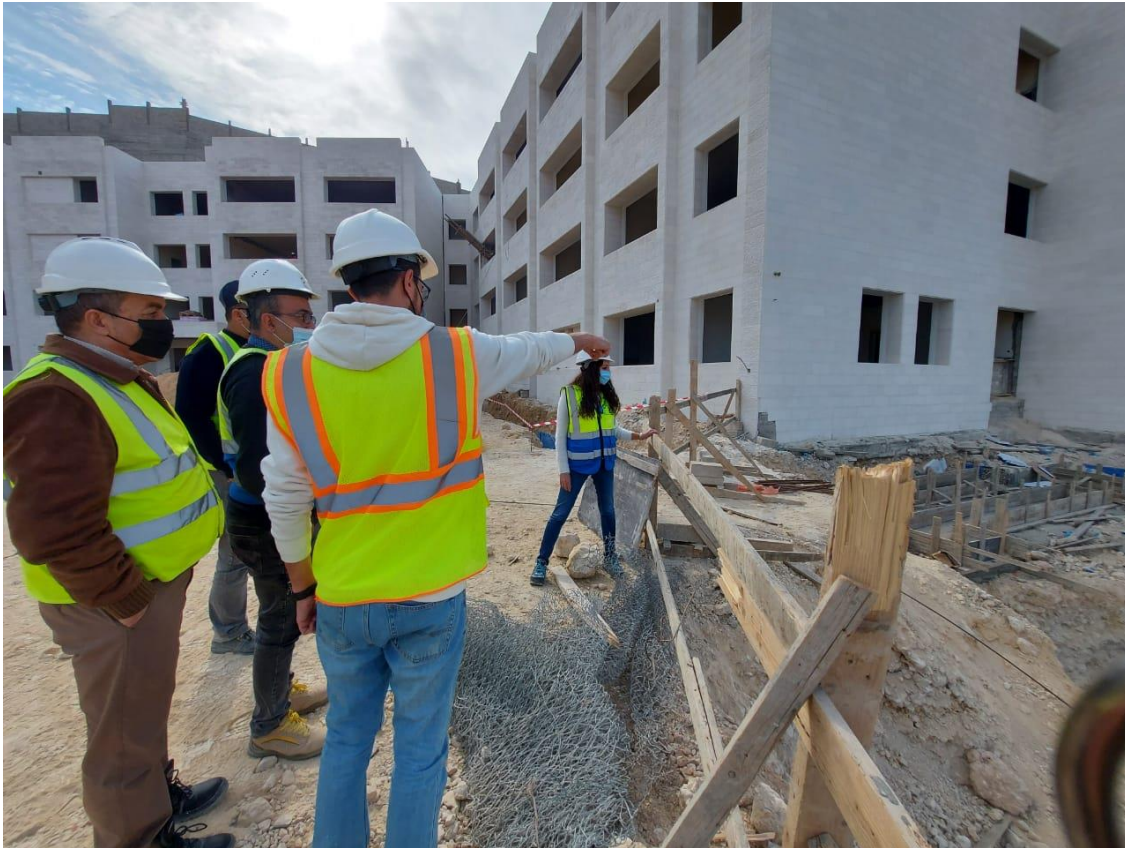
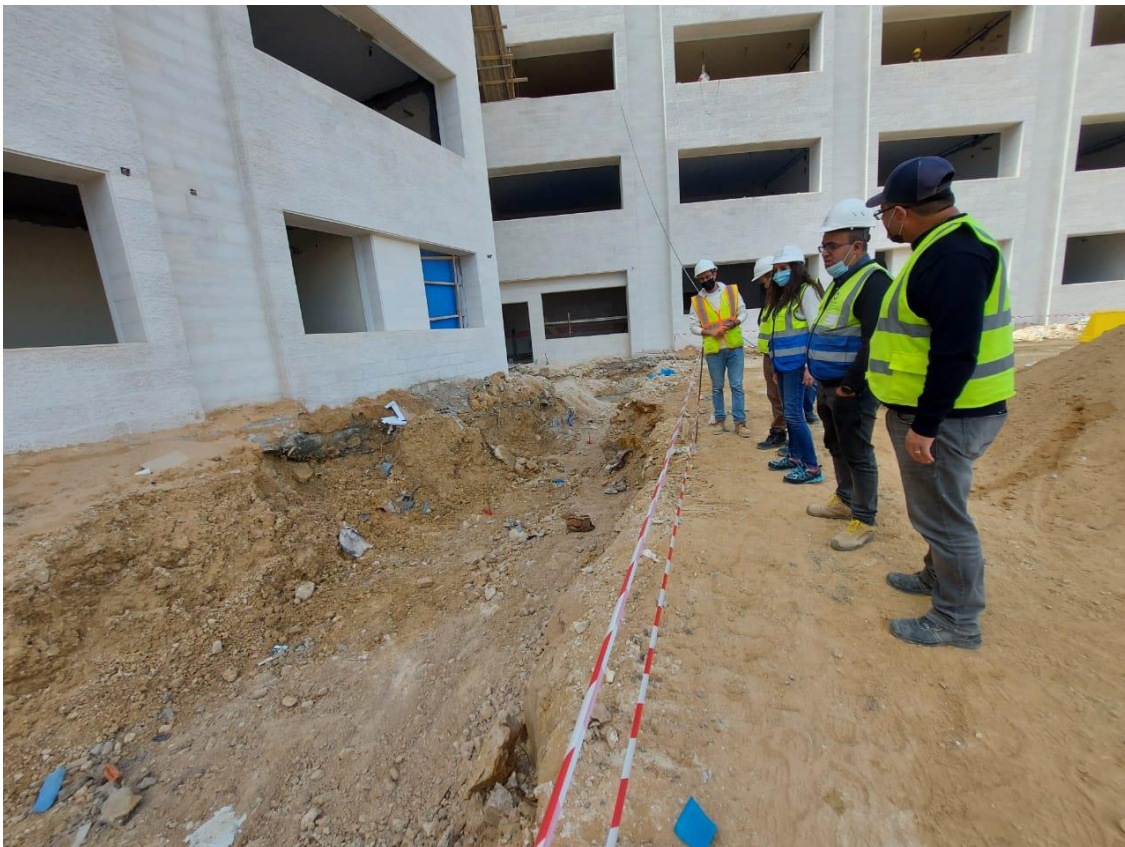
(Figure: 08, 09 & 10)

It was observed that the Contractor has started with the excavation of the external sewage network and progressing in the excavation and concrete work for the external walls

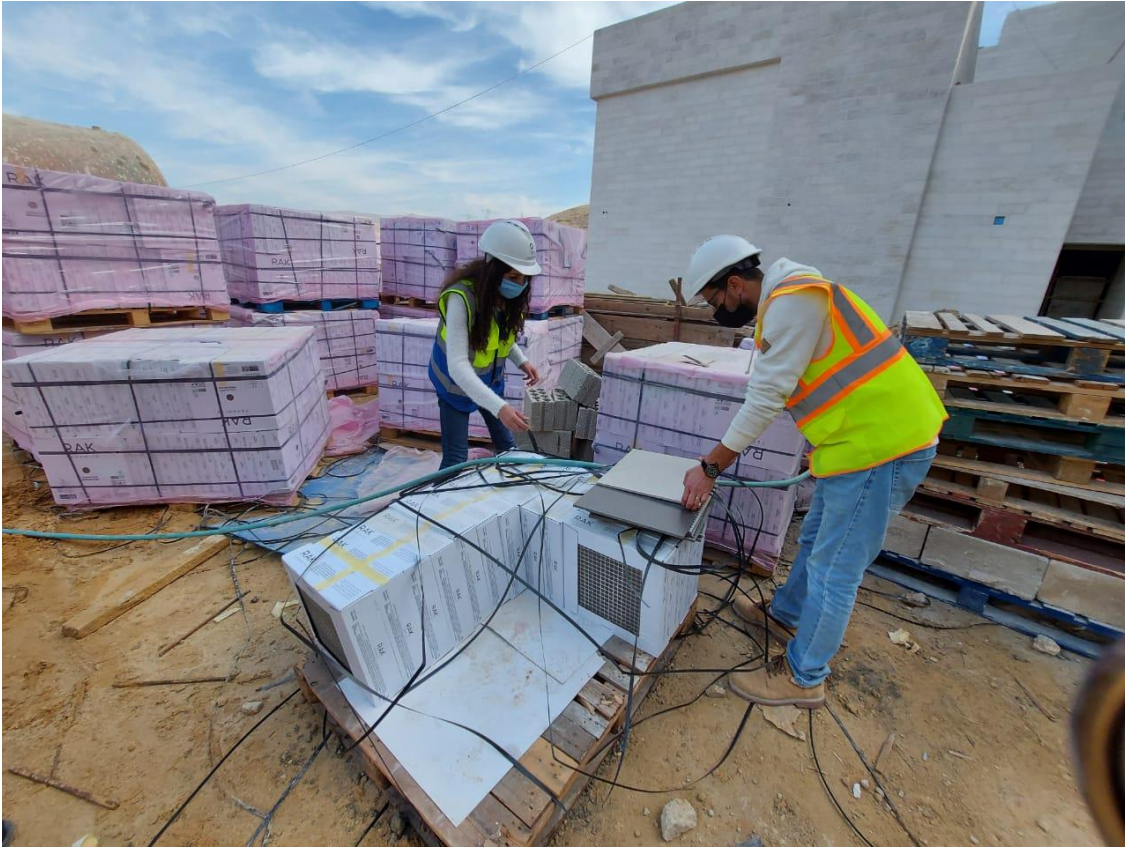
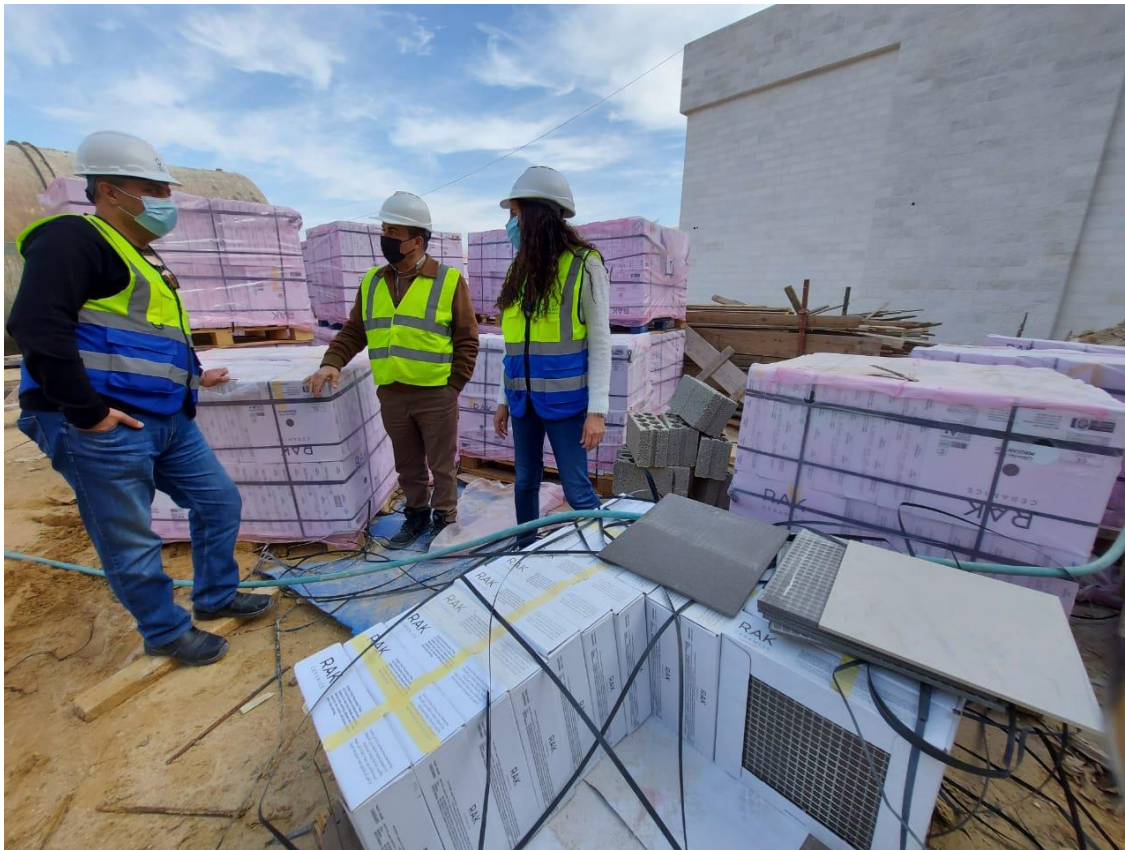
(Figure: 11 & 12)

The supervision team inspected the newly delivered porcelain floor tiles and observed that it is manufactured at UAE, (RAK)

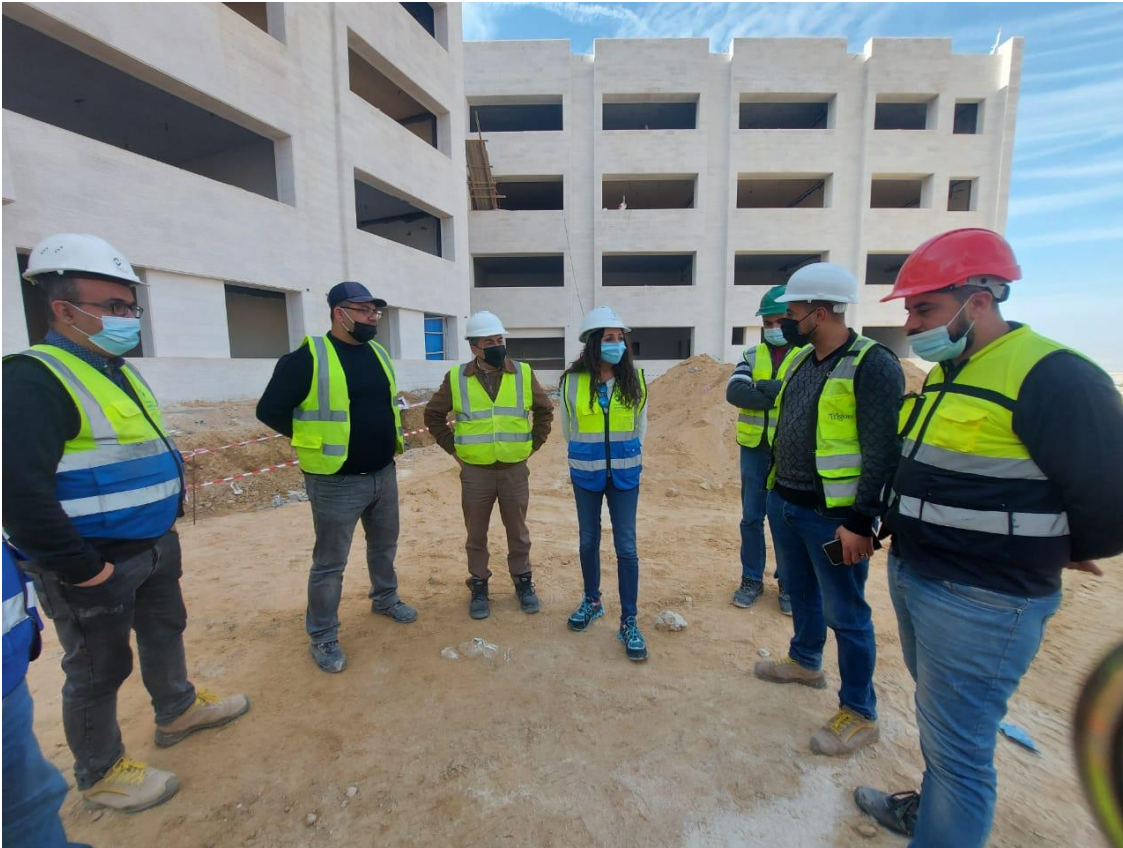
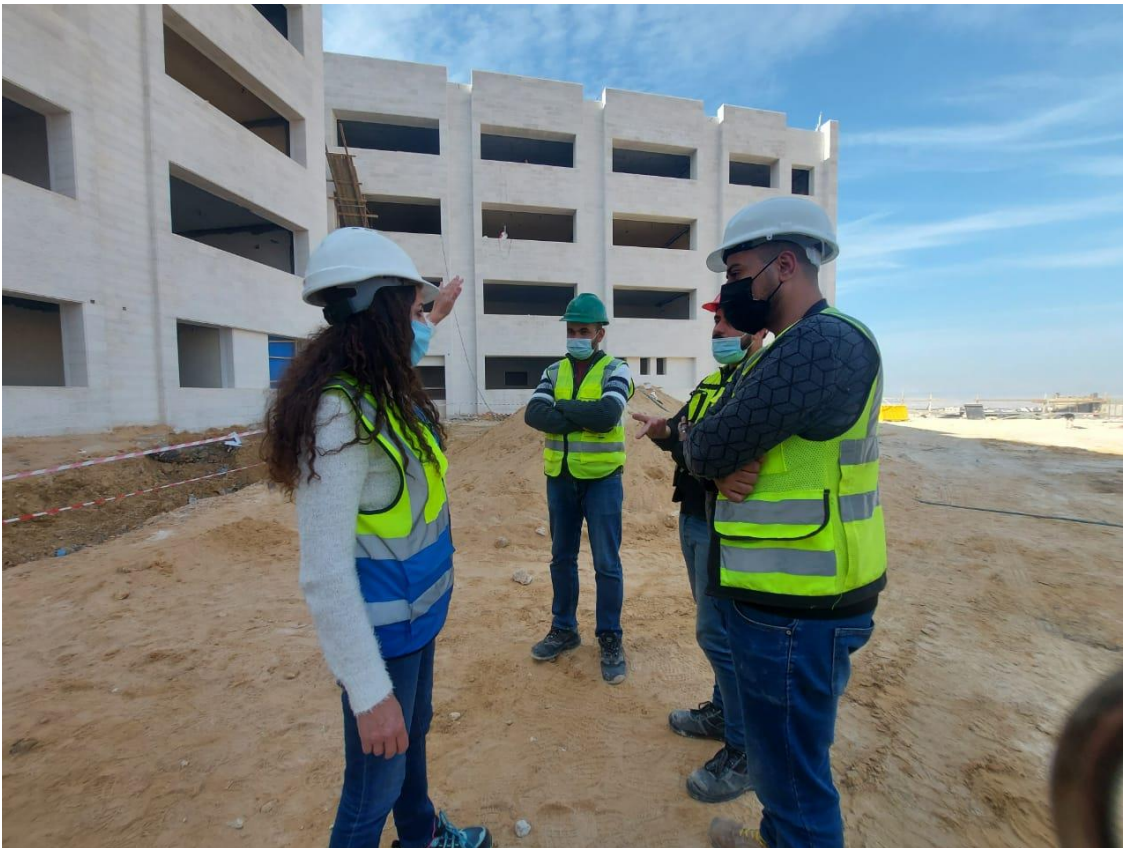
(Figure: 13 & 14)

The team and the Contractor met with the safety engineer of CMTO who was simultaneously on the site. The safety engineer clarified that some remarks related to the safety precautions in the site should be attended by the Contractor. The Contractor promised to work accordingly

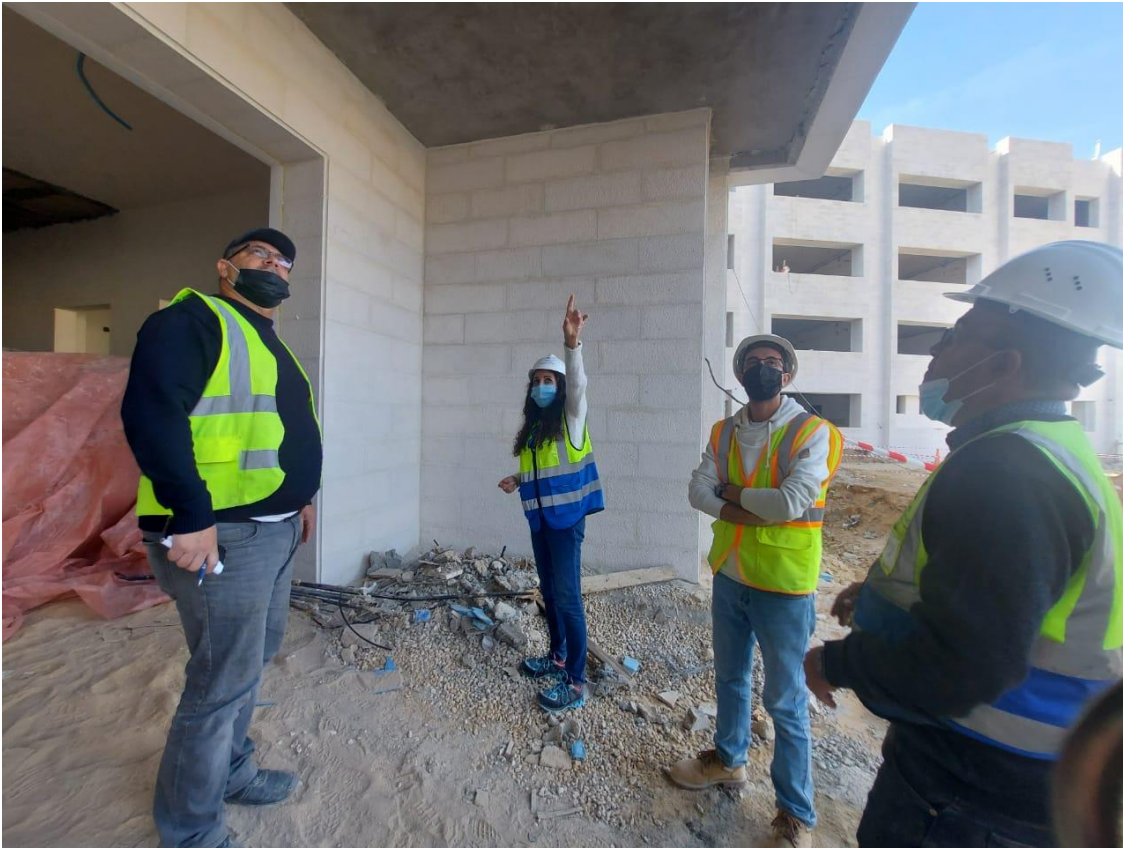
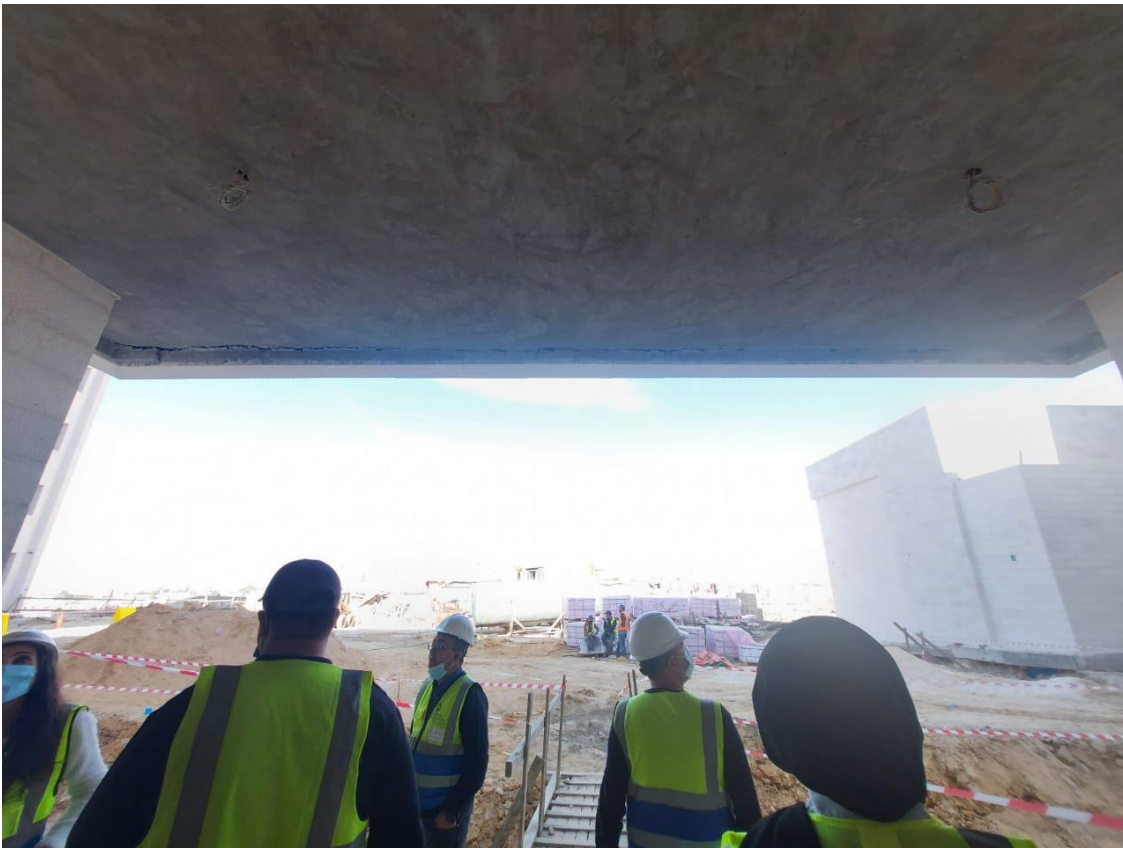
(Figure: 15 & 16)

The team instructed the Contractor to finalize the stone work around the main entrance canopy at zone "B"

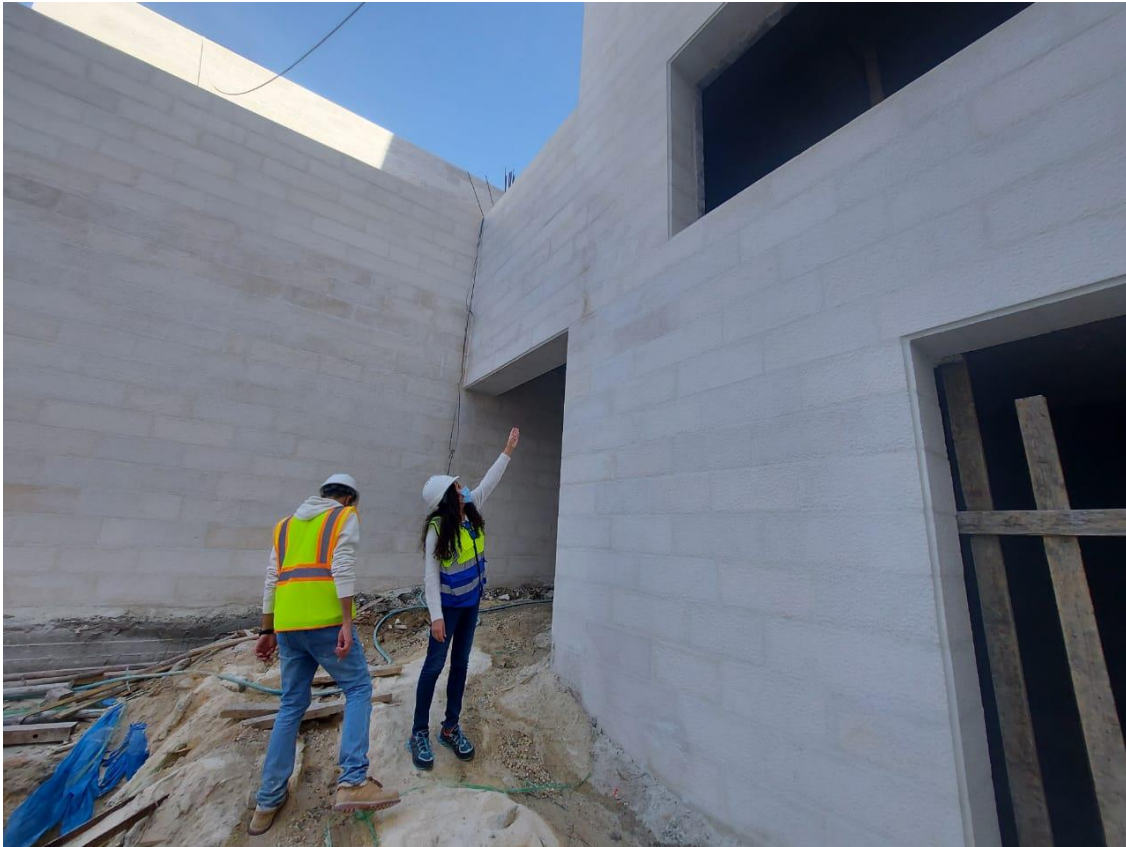
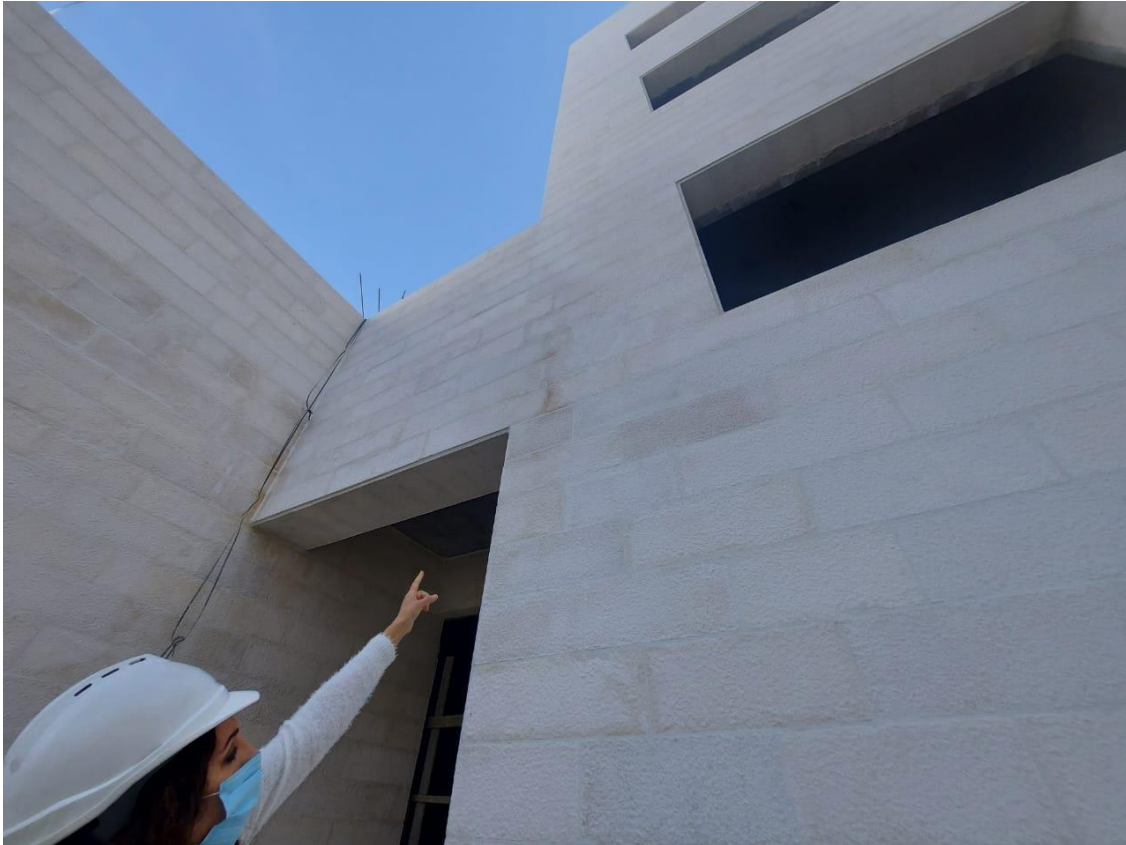
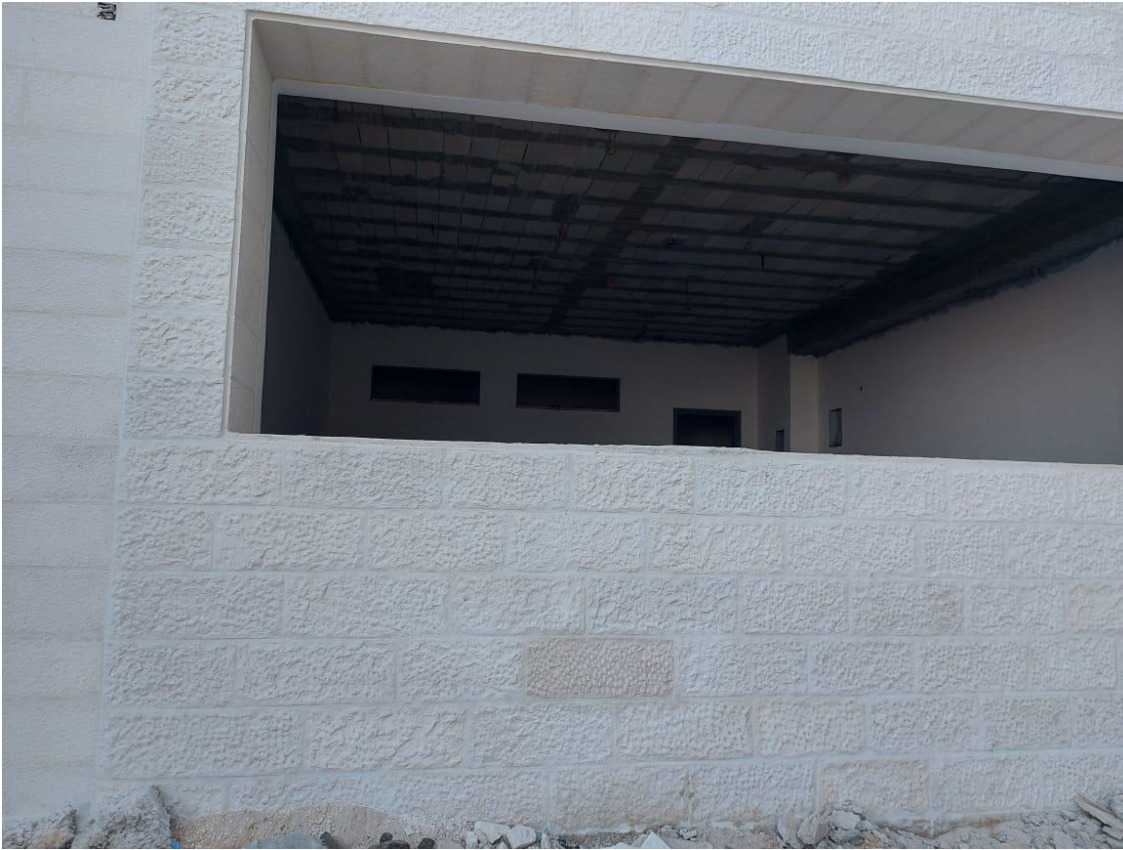
(Figure: 17, 18 & 19)

The Contractor was instructed to rectify the defects observed in stone at different locations in the facades

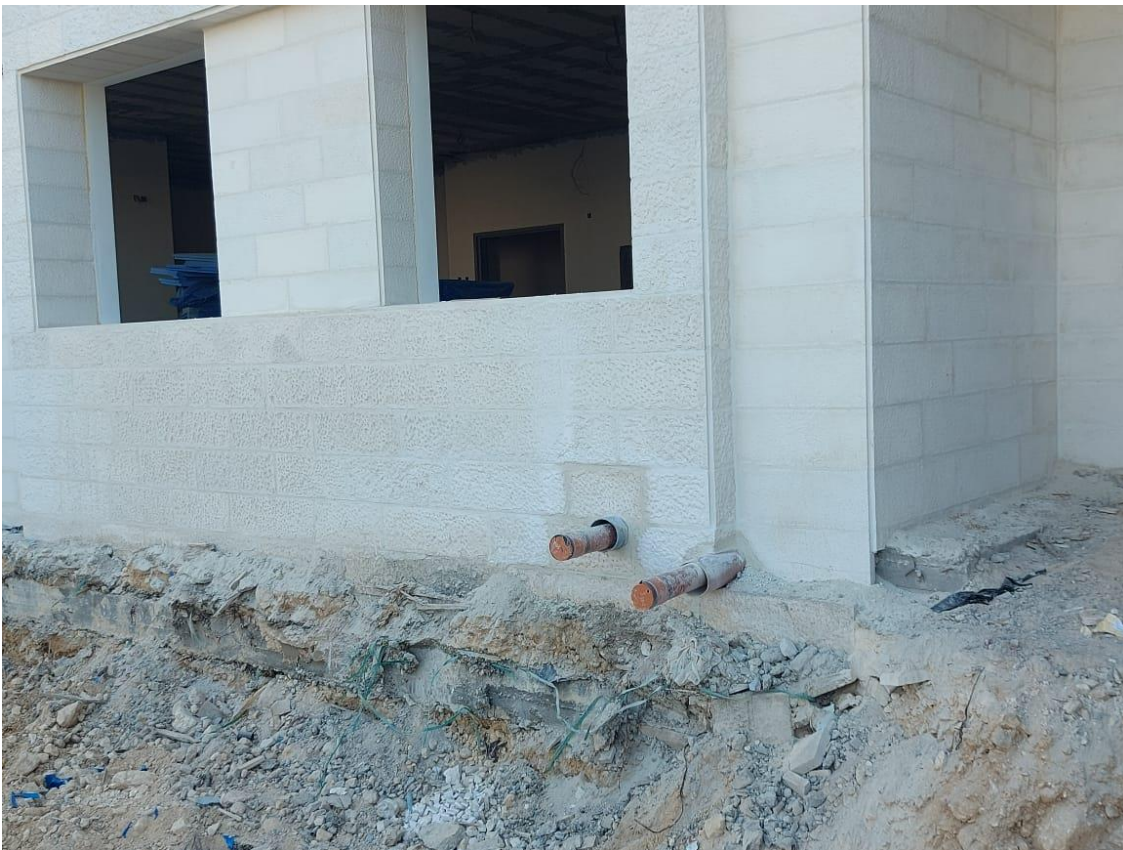
(Figure: 20)

It was observed that the Contractor rectified the defects in stone around the outlet of the rain water drainage pipes

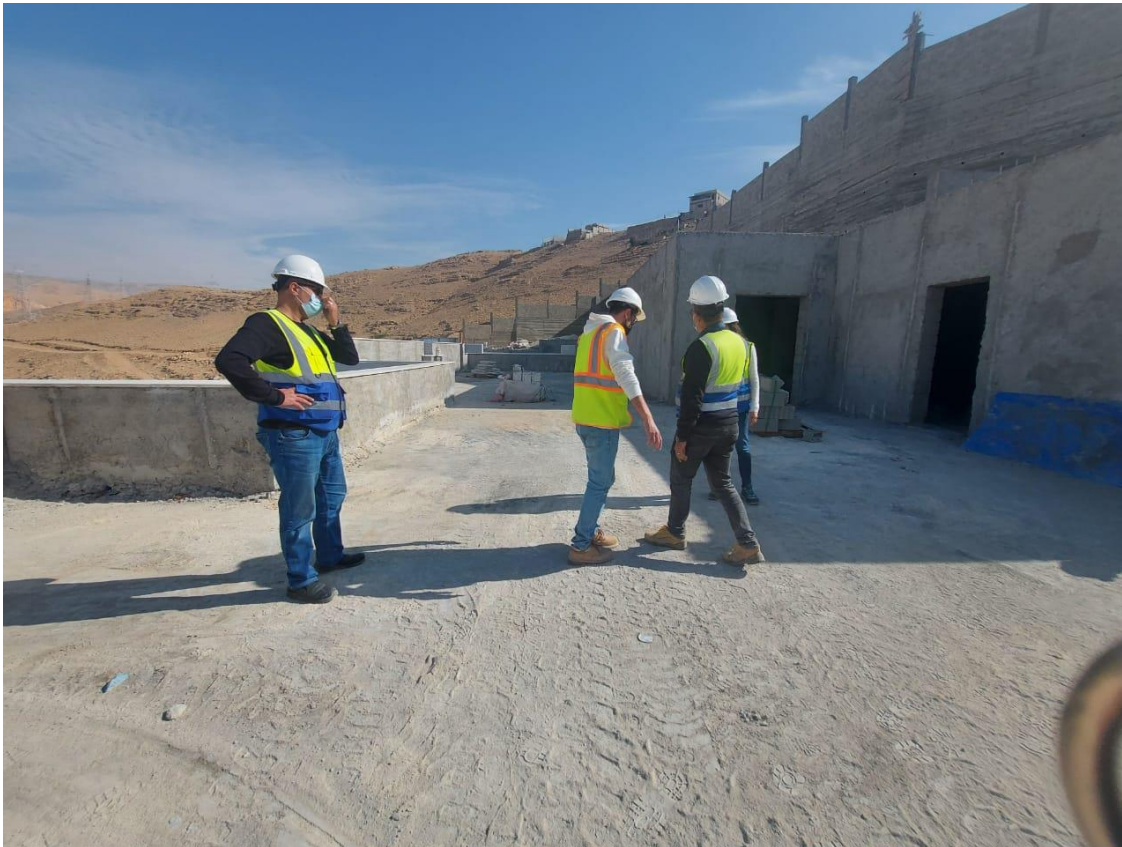
(Figure: 21)

The Contractor was instructed to accelerate the work in the bases of the mechanical equipment at the roof to allow for the work of waterproofing at zone "B"

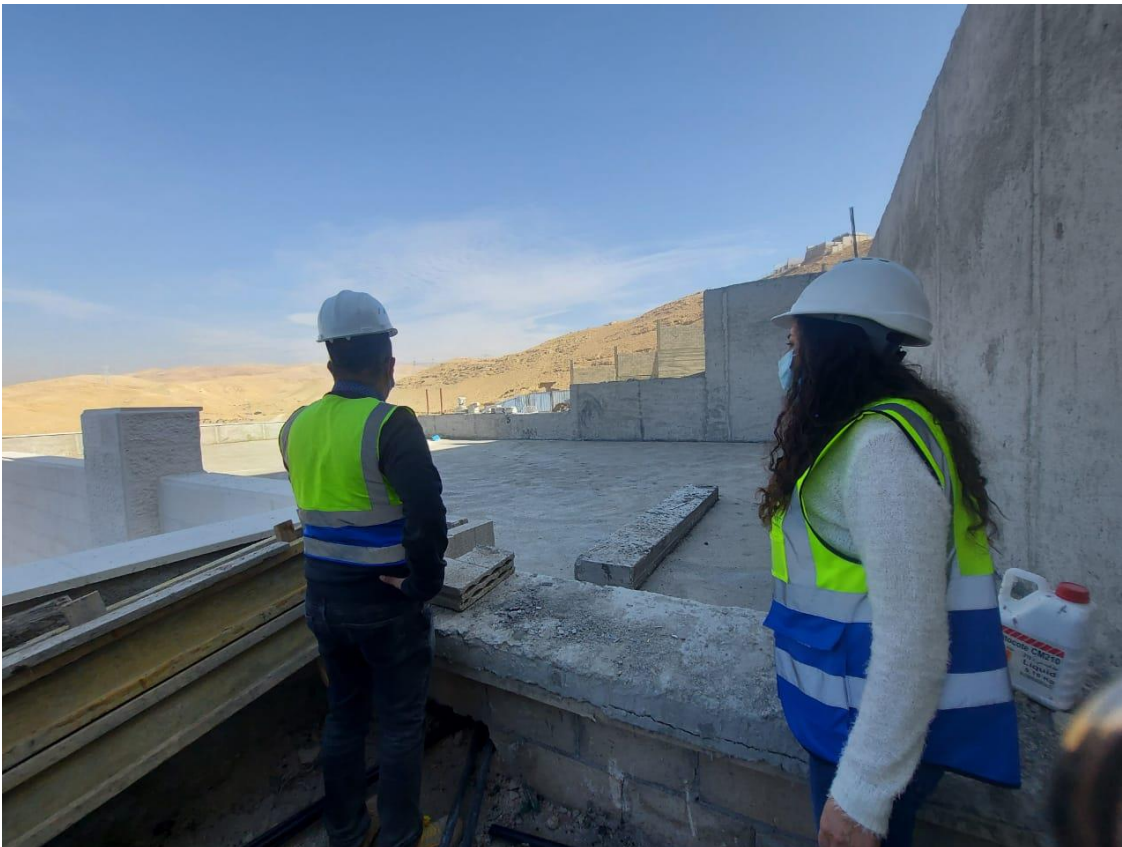
(Figure: 22)

It was observed that the Contractor executed the screed layer at the roof- zones "A" and "C"

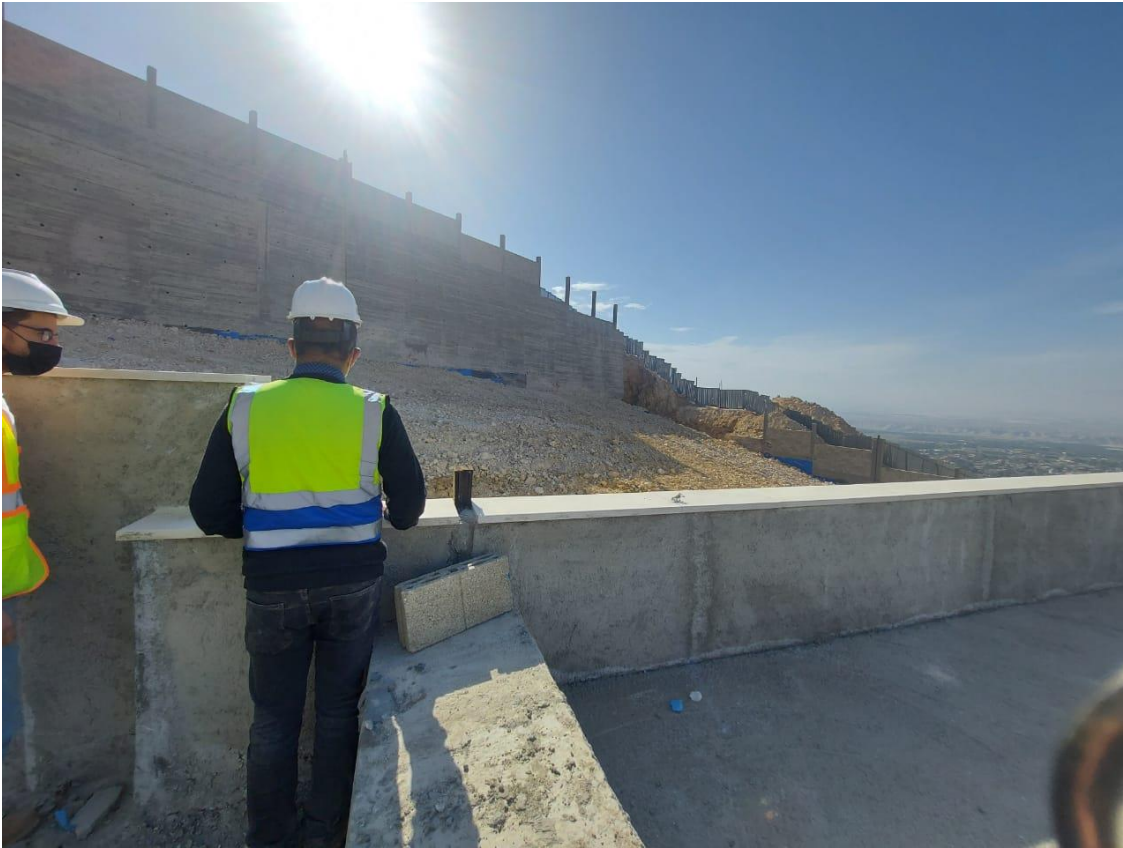
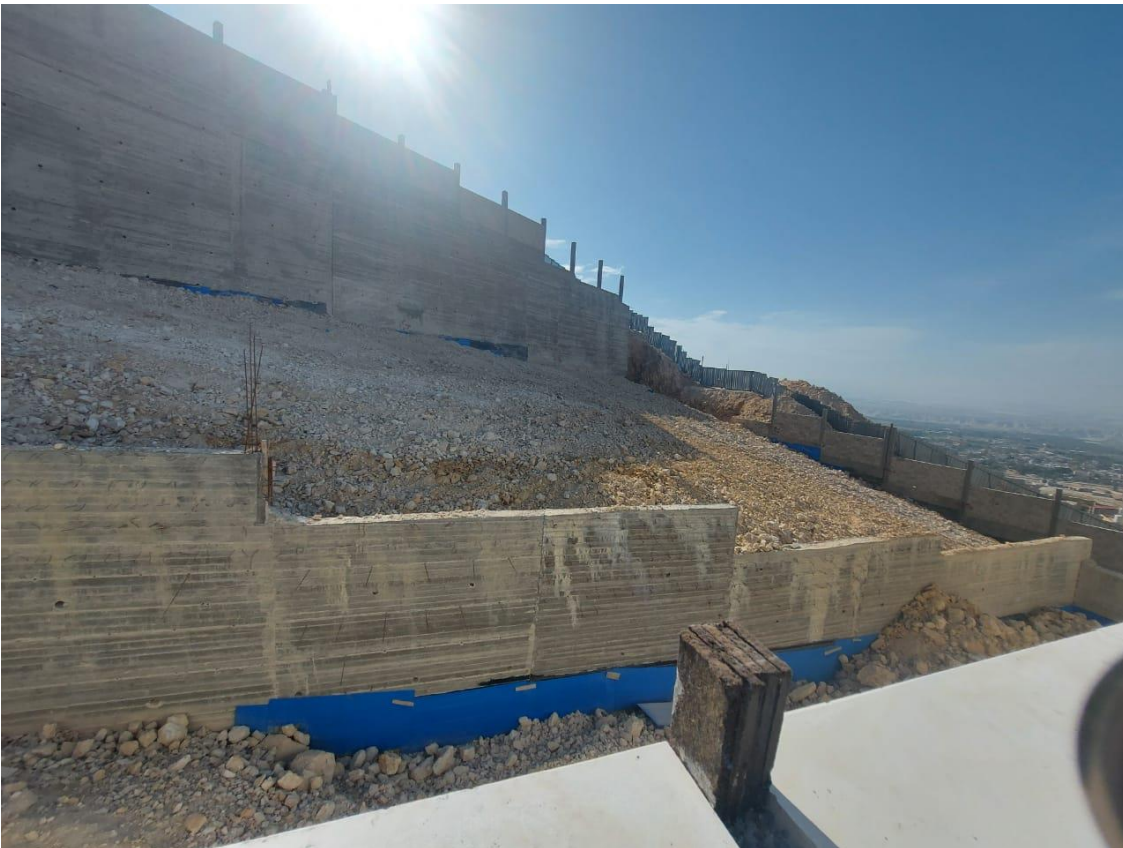
(Figure: 23 & 24)

The team discussed the status of the graded natural ground and requested the Contractor to submit for the supervision review a method statement for the plastering work of the high boundary walls to insure safe process for the workers

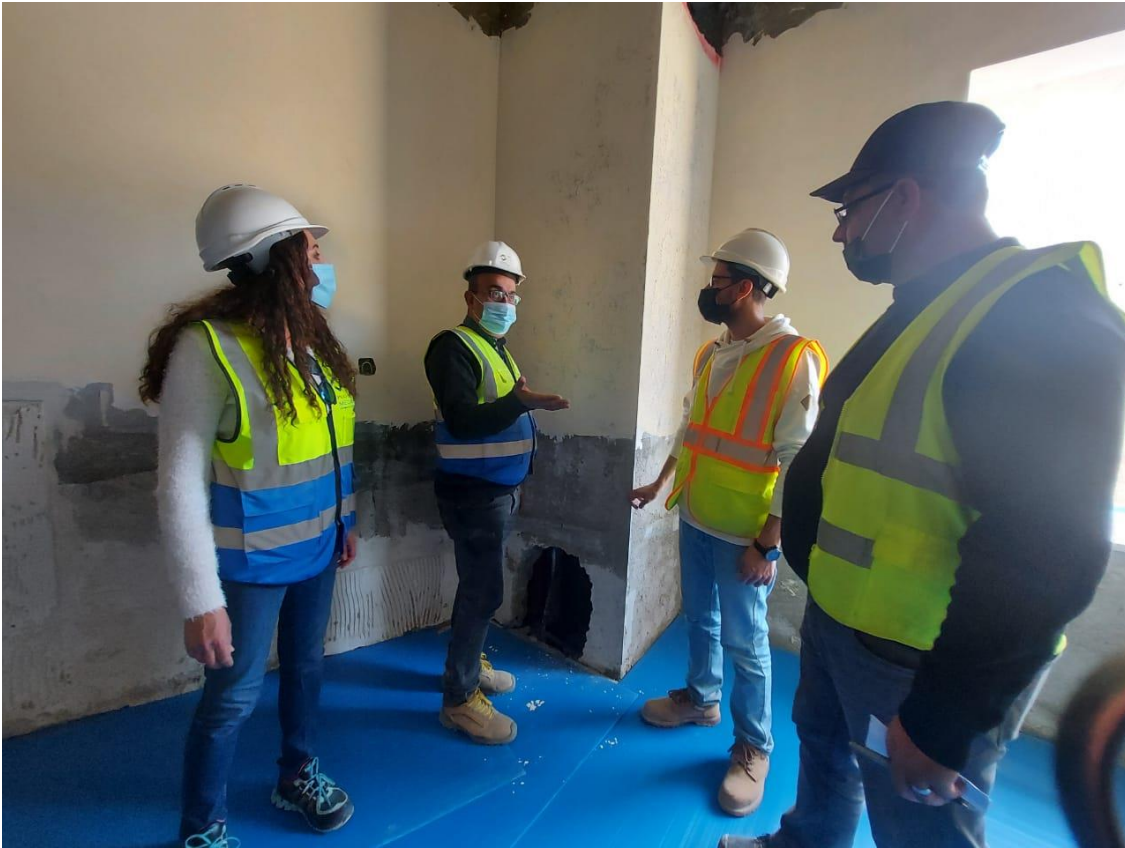
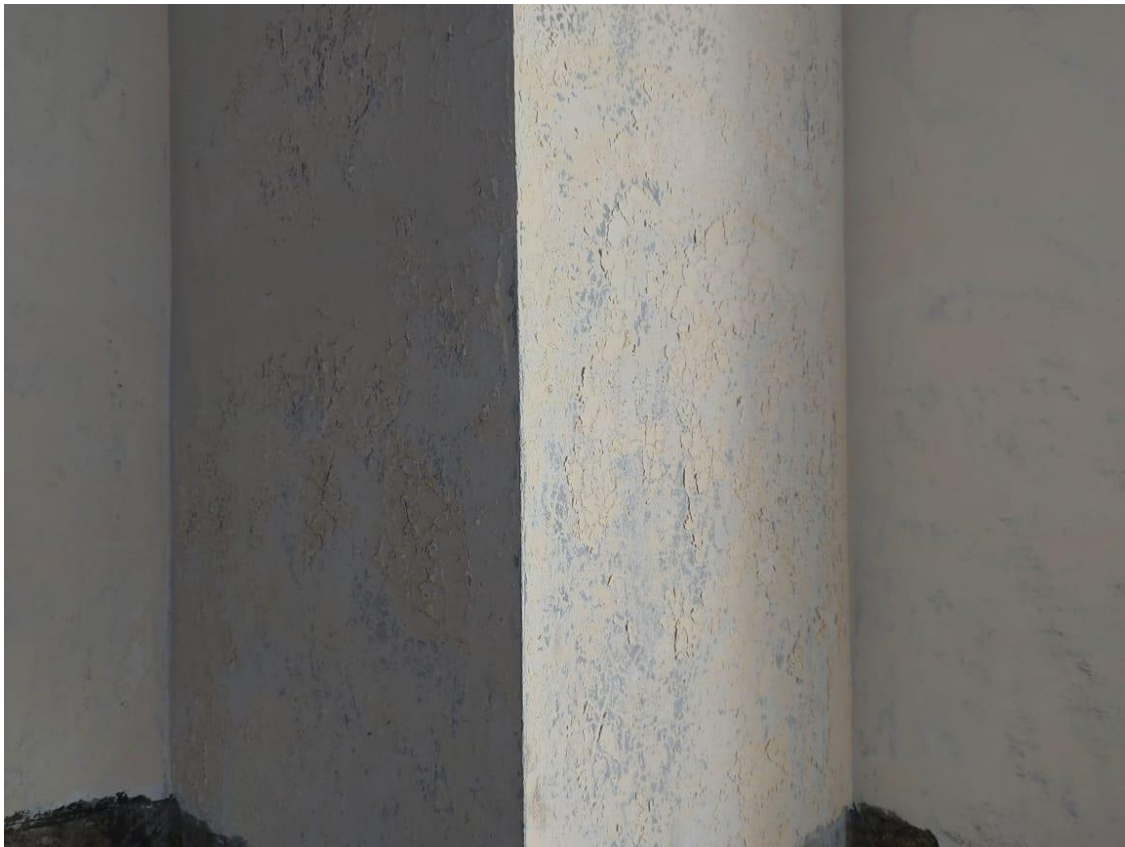
(Figure: 25 & 26)

Humidity and defects have been observed in the painted walls of the shafts due to rain water penetration. The Contractor was instructed to rectify the defects and accelerate the closing of those shafts
