Consultant	Wahib Medanat Consultant Engineer	Rep No.	12-12012022
Contractor	Derar Saraireh & Sons for Engineering & Contracting	Tender No.	(11/2019/USAID/SKEP/3/S) Schools for a Knowledge Economy Project (SKEP) - Phase (3) Package (1, 2)
Site Name	Al Khansa' Basic Mixed School- Al Balqa	Day/ Date	Wed. 12/01/2022
Duration of Project	450 Calendar Days	Total Project Budget	9,789,417.840 JD

Visit Notes

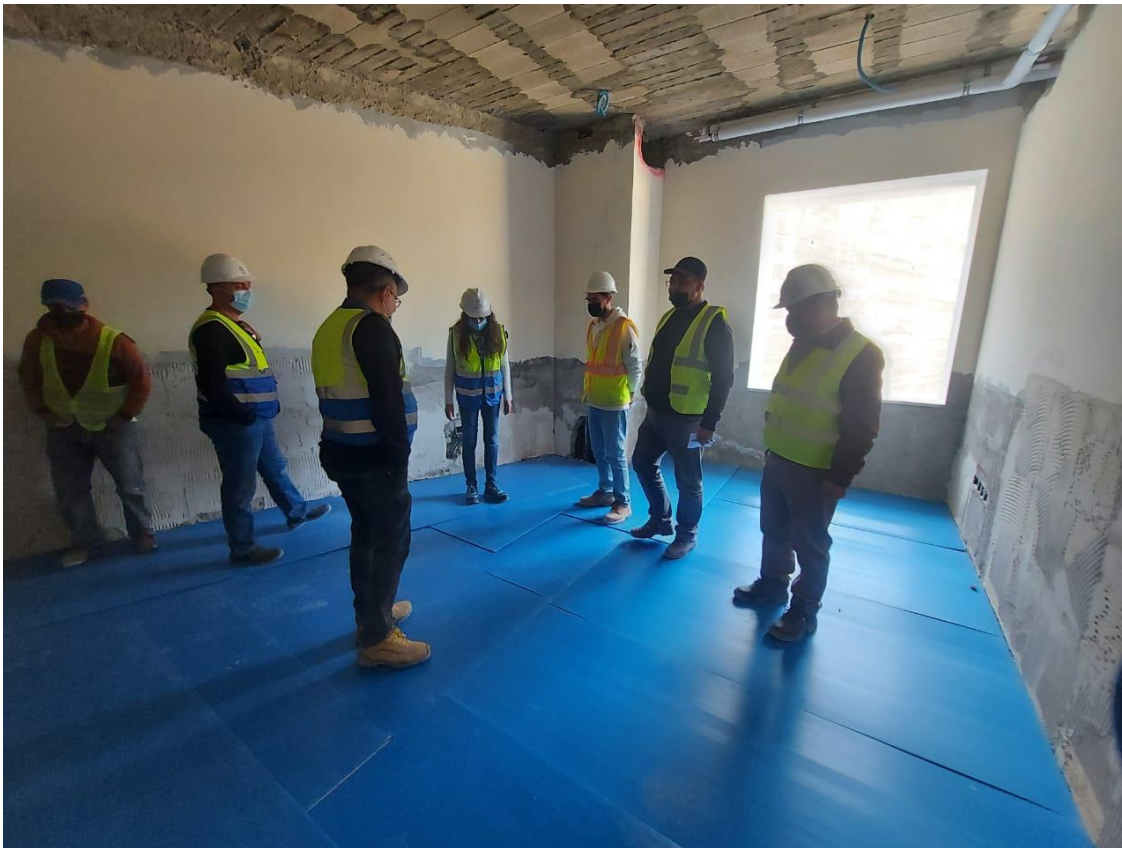
(Figure: 27)

The team observed that the Contractor applied protection to the floor tiling by laying cartonal boards on the tiled areas

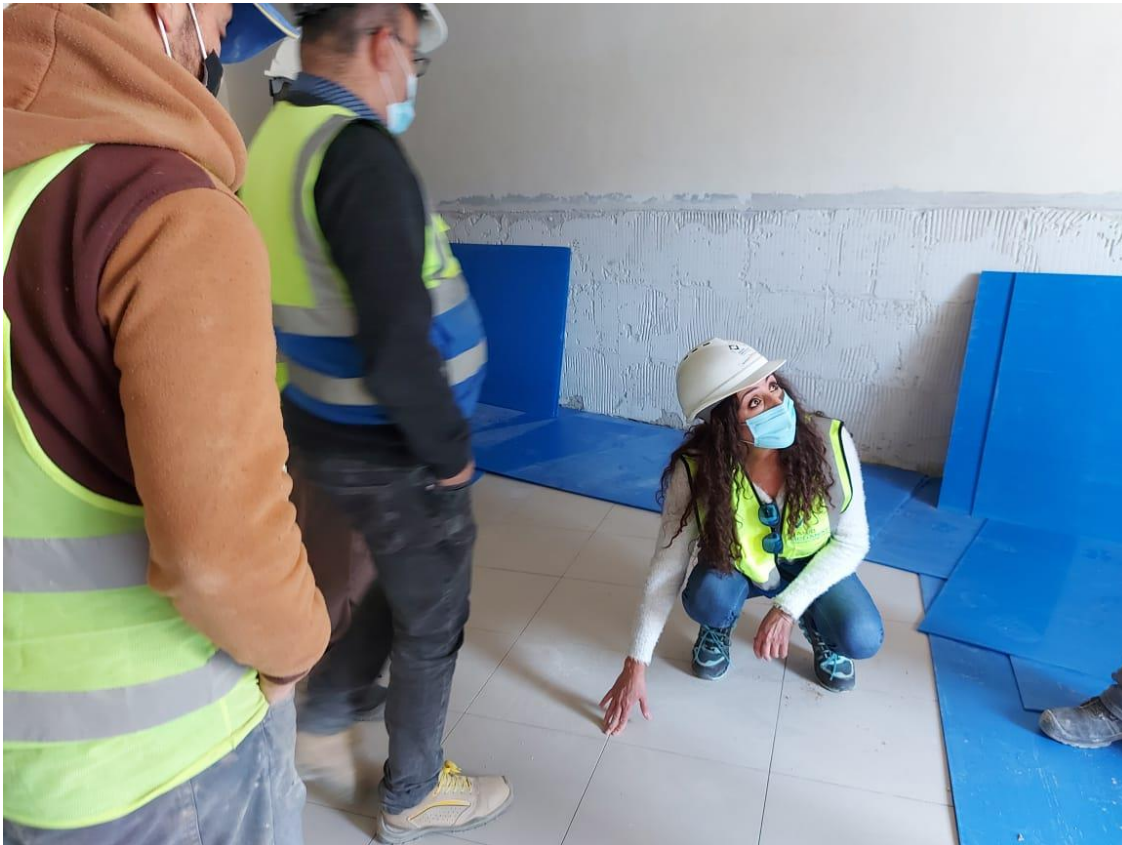
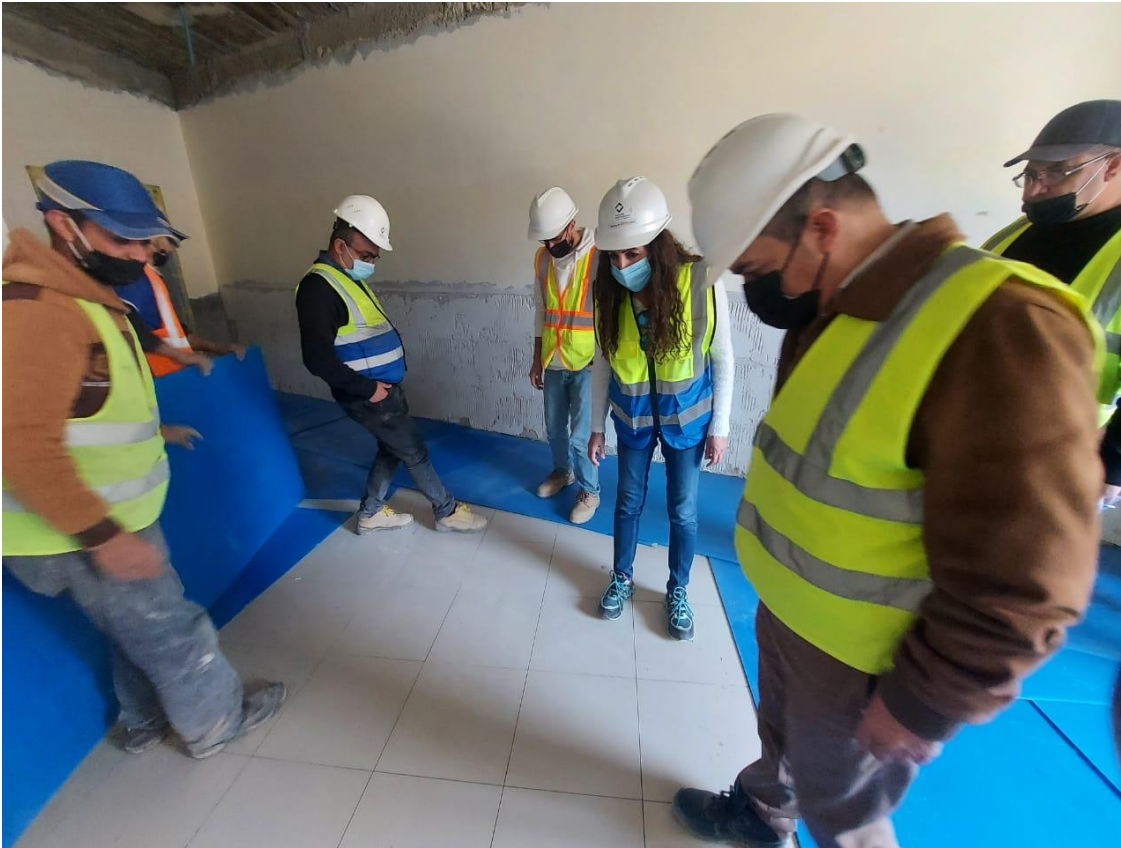
(Figure: 28 & 29)

The supervision inspected the porcelain floor tiling work using the new delivered tiles. The team observed that the quality of work is much better than before except some remarks the Contractor was instructed to rectify

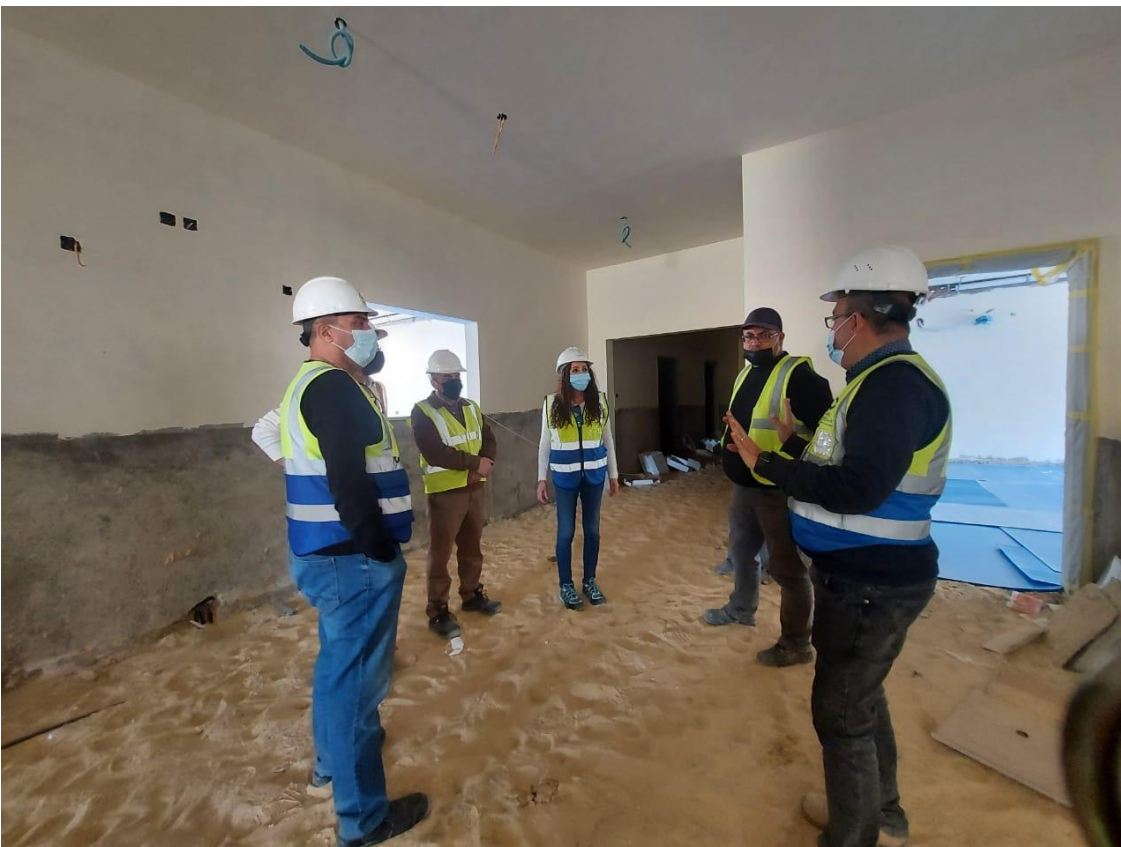
(Figure: 30)

Discussing the process of tiling at the corridors the distribution of colored tiles and the control of the cut-off pieces. The team instructed the Contractor to always submit AutoCAD drawings for the review of the supervision before the start of tiling

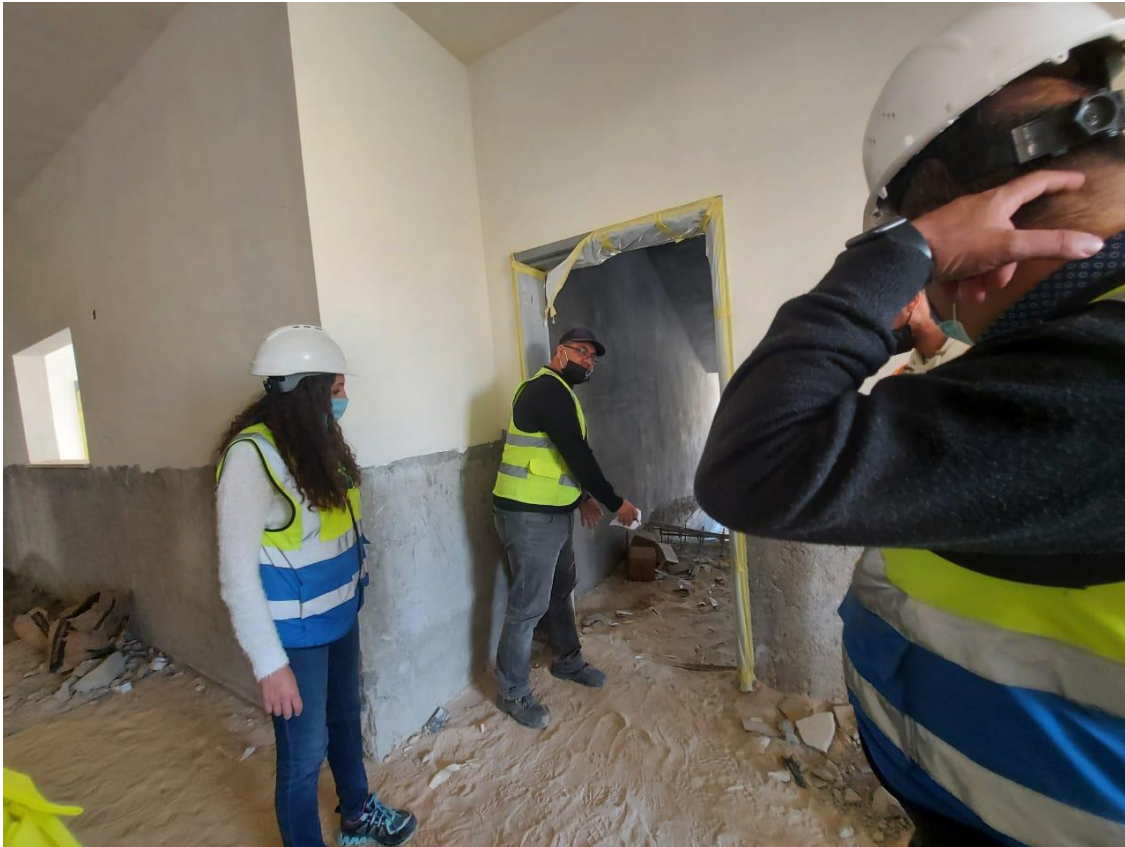
(Figure: 31)

The team discussed with the Contractor the dimension of the door threshold and its relation with the cut-off pieces of the porcelain floor tiles

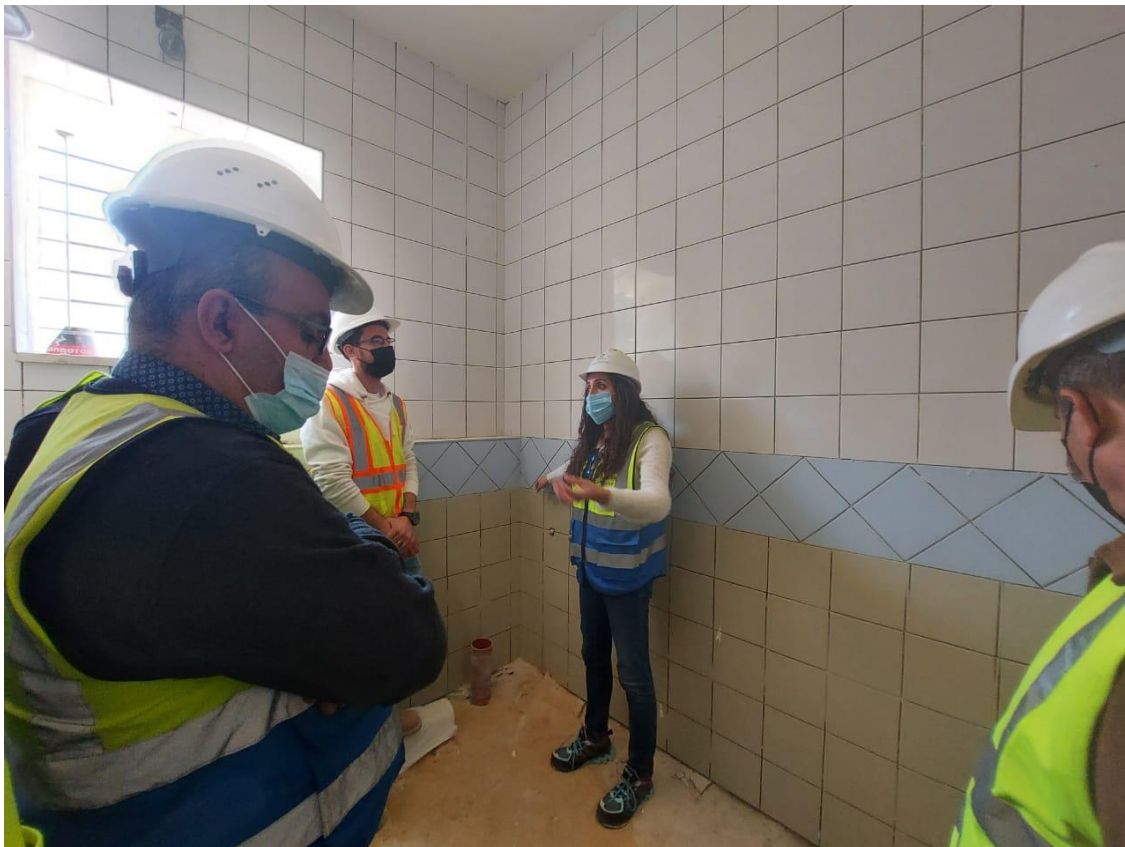
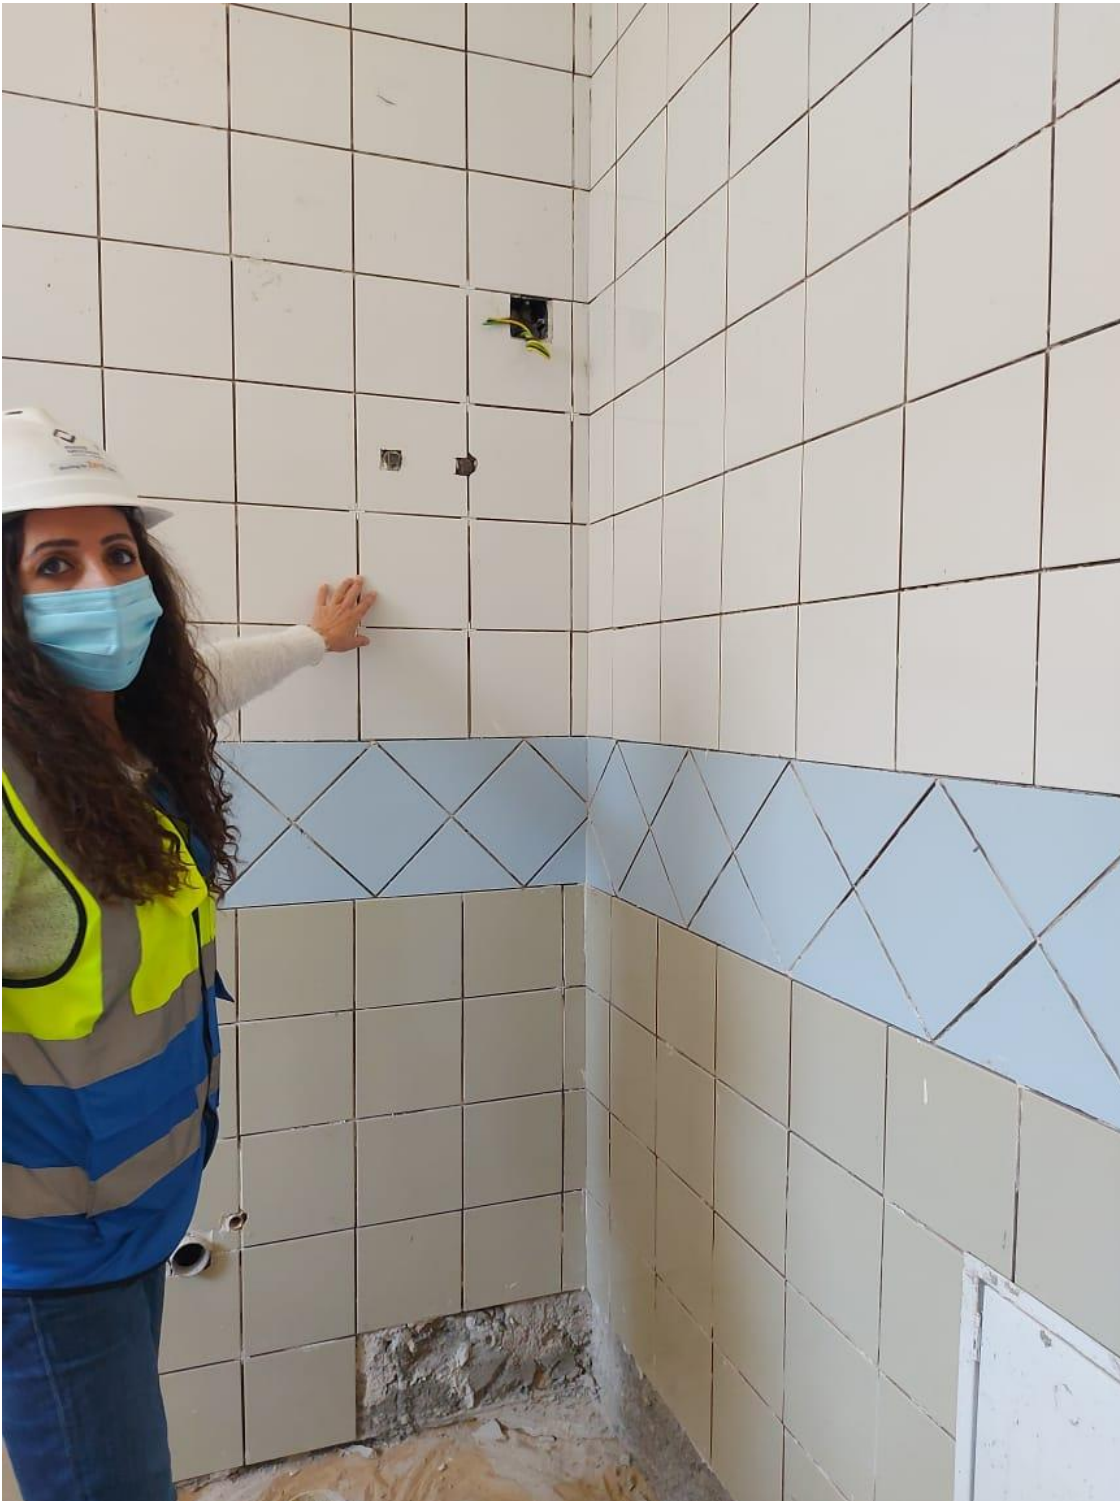
(Figure: 32 & 33)

The supervision team inspected the wall tiling work at the wet areas and observed the dimension of cut-off pieces in some places is considerably less than specified

The Contractor was instructed to remove the tiles installed at a number of walls and re-tile correctly

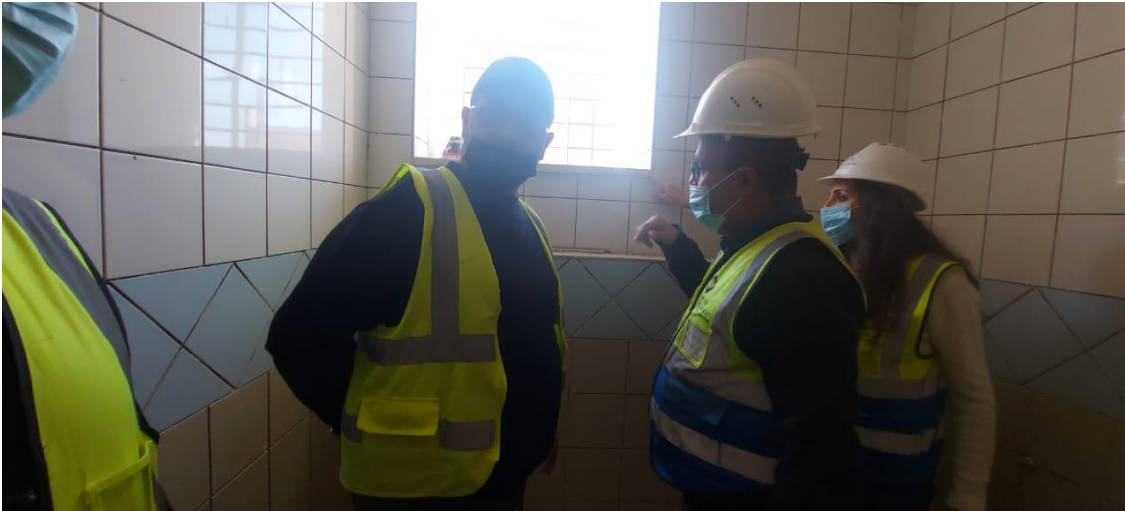
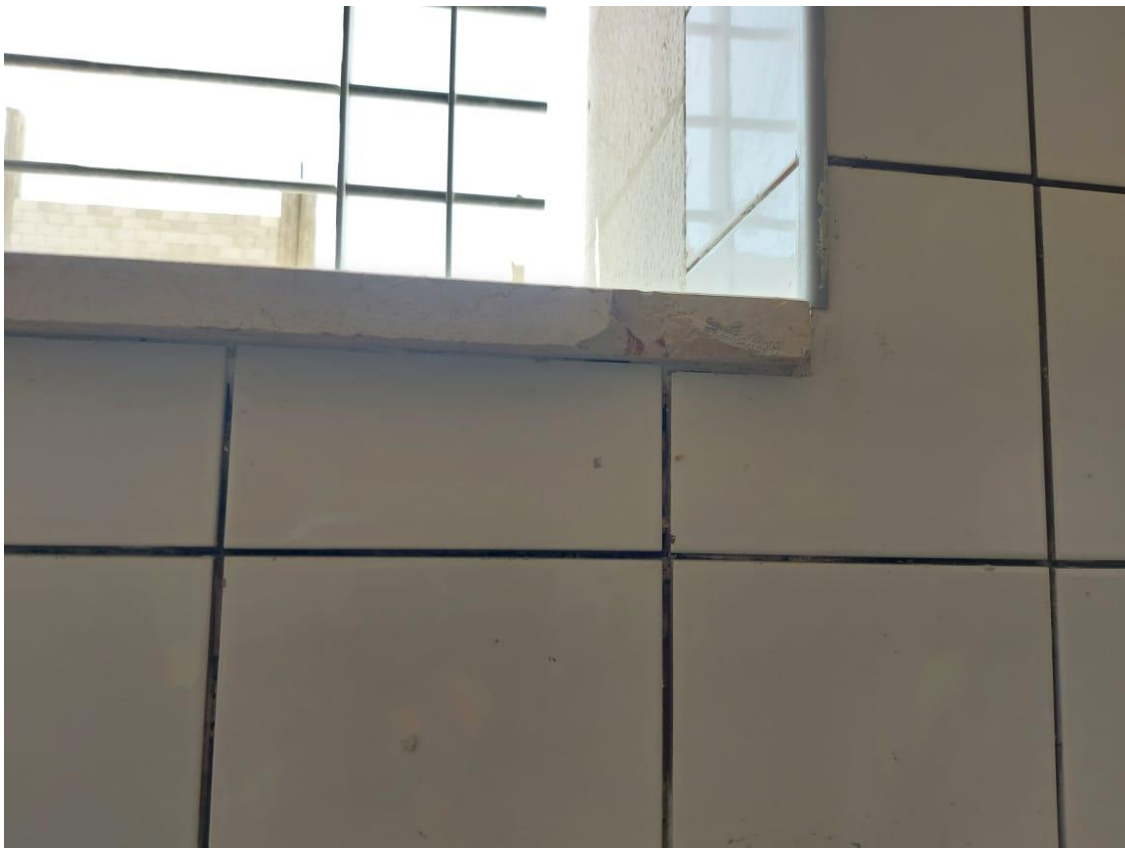
(Figure: 34 & 35)

The supervision team instructed the Contractor to replace the broken window sills and those with shorter dimensions than required

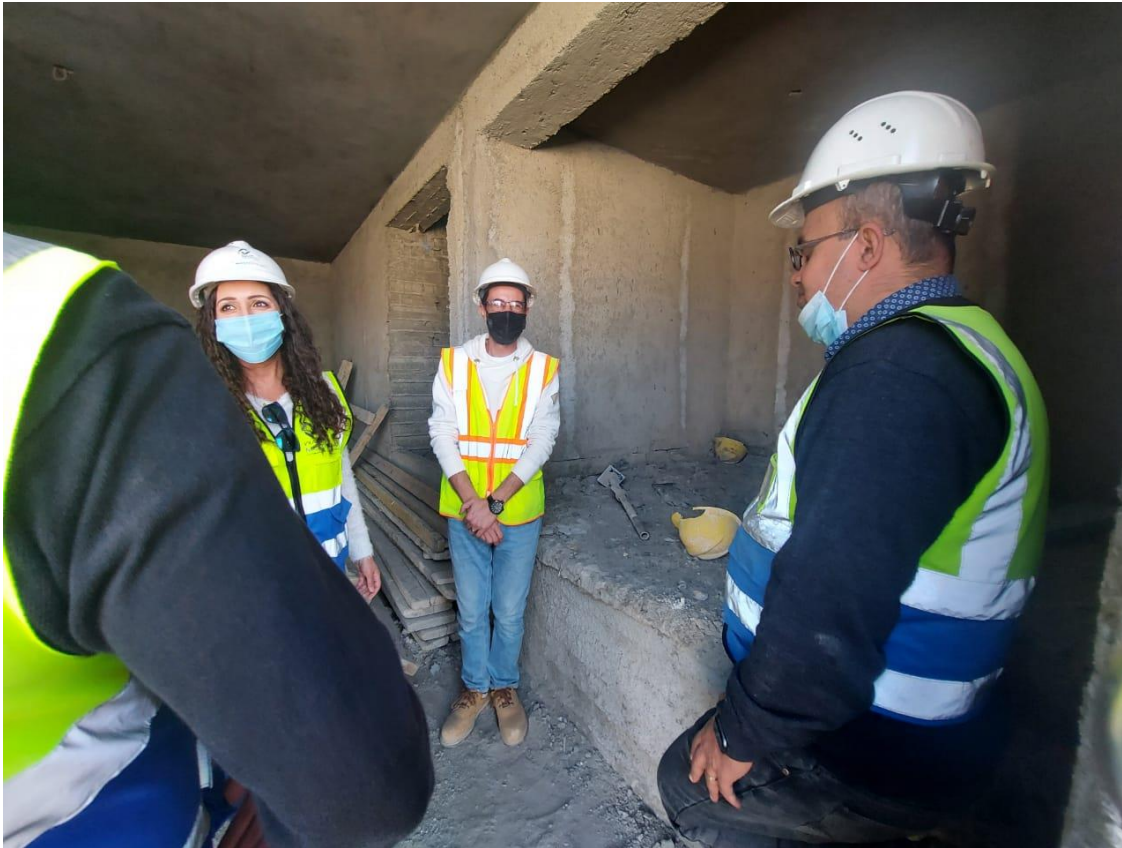
(Figure: 36)

The supervision team inspected the pumps room at the roof and instructed the Contractor to tile the said room with porcelain tiles as per requirements
