SKEP III Home Office Support Site Visit Report

Consultant	Wahib Medanat Consultant Engineer	Rep No.	23-14052022
Contractor	Dijlah Establishment Constr. Contracting	Tender No.	(11/2019/USAID/SKEP/3/S) Schools for a Knowledge Economy Project (SKEP) - Phase (3) Package (1, 2)
Site Name	Jumana Bint Abit Taleb Basic Mixed School - Jerash	Day/ Date	Sat. 14/05/2022
Duration of Project	450 Calendar Days	Total Project Budget	8,314,983.735 JD

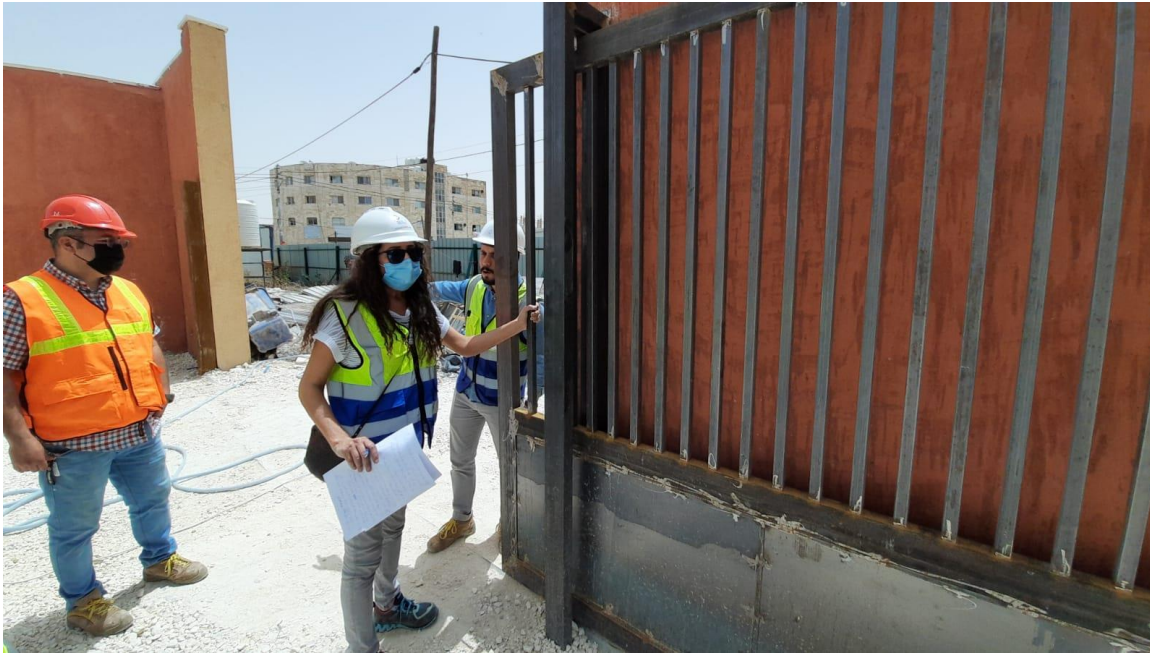
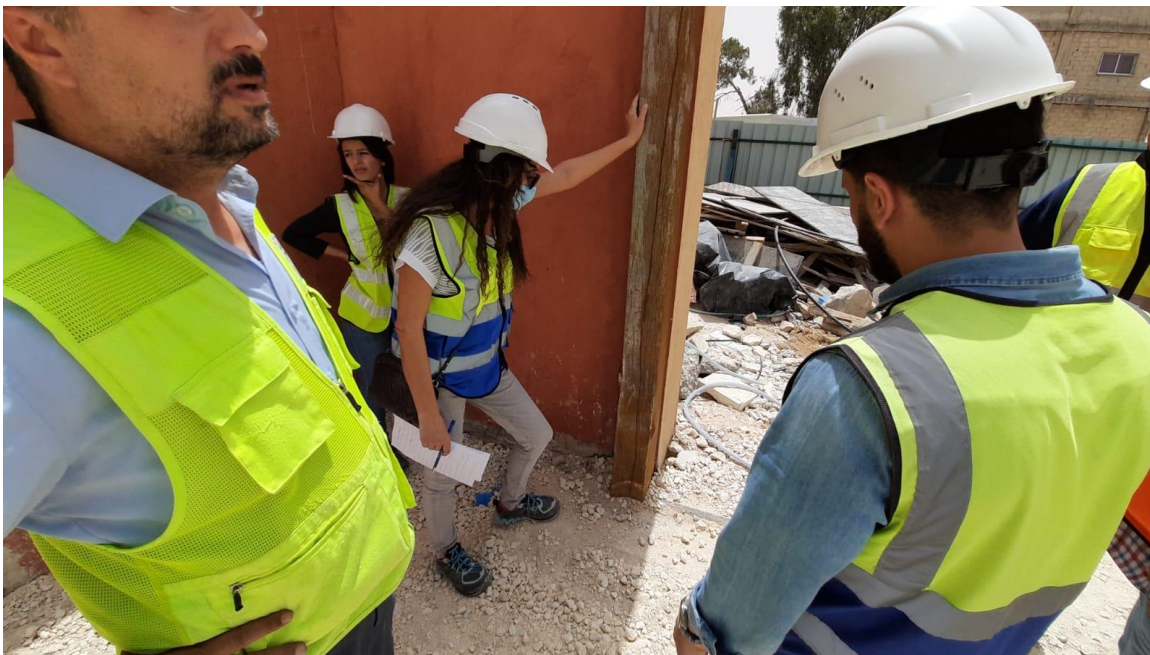
The team inspected the sliding gate at one of the school entrances and informed the Contractor with no objection to continue the work at this item after replacing the damaged stopper tube at the closing end

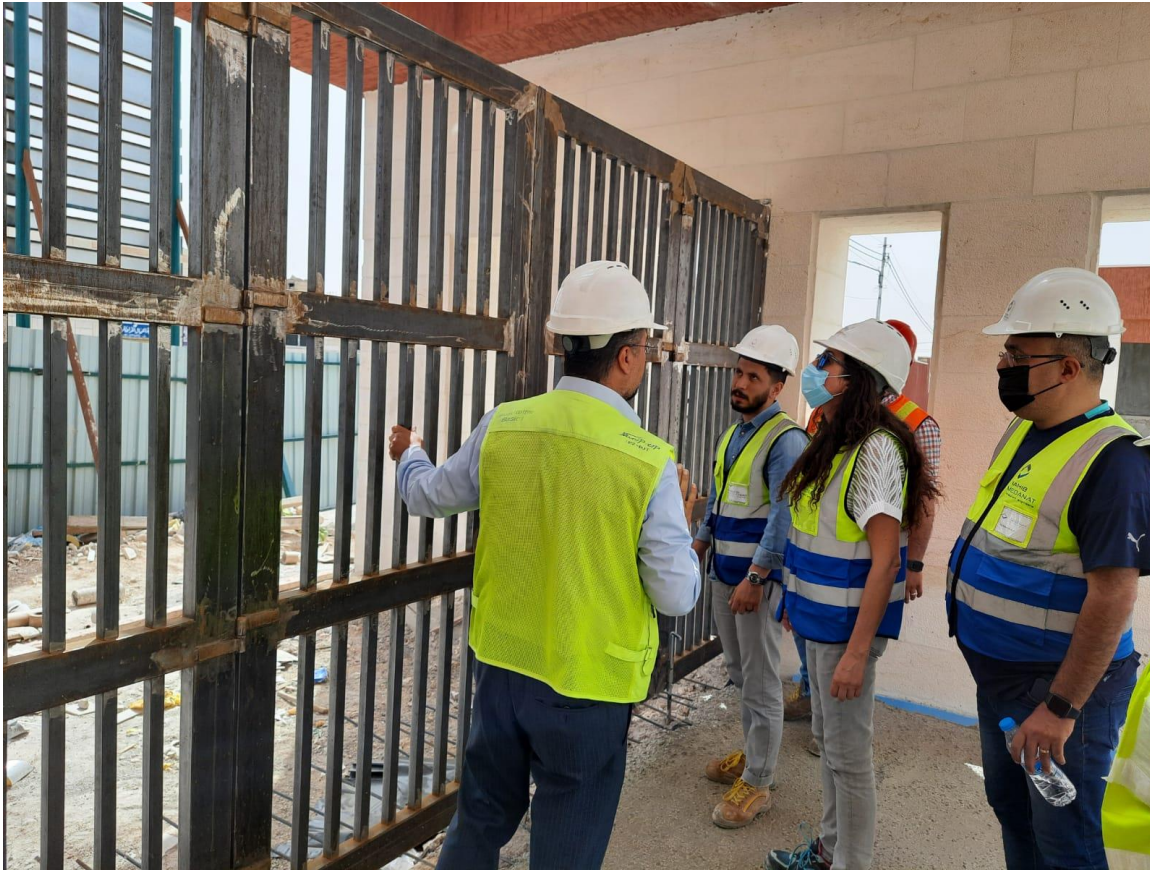
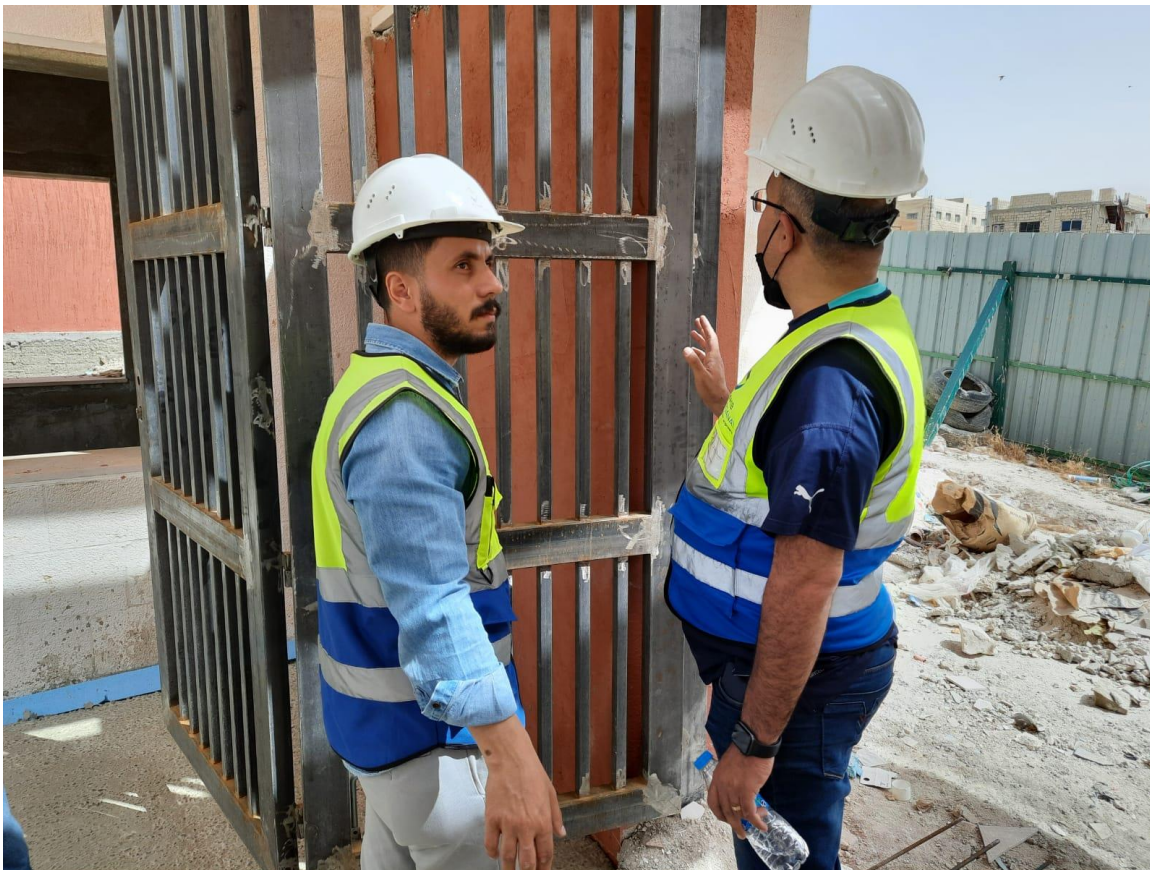
The supervision team inspected the (initial) installation of the main gate of the school and informed the Contractor with the following remarks:

- The door frame has to be shifted inside to end at the internal edge of the jamb to allow the gate to open freely (180-degree angle) without damaging the jamb.
- The workmanship of the sample is acceptable.
- The Contractor was requested to install.

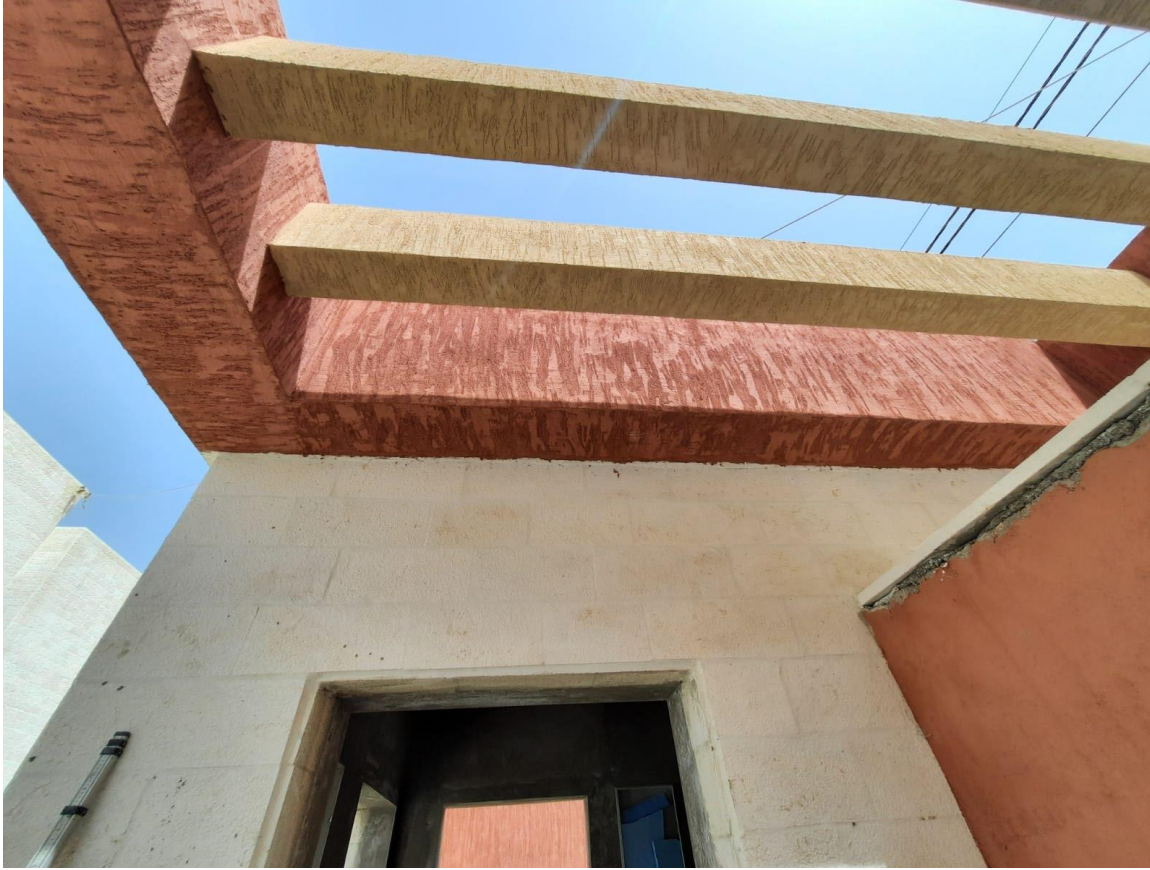
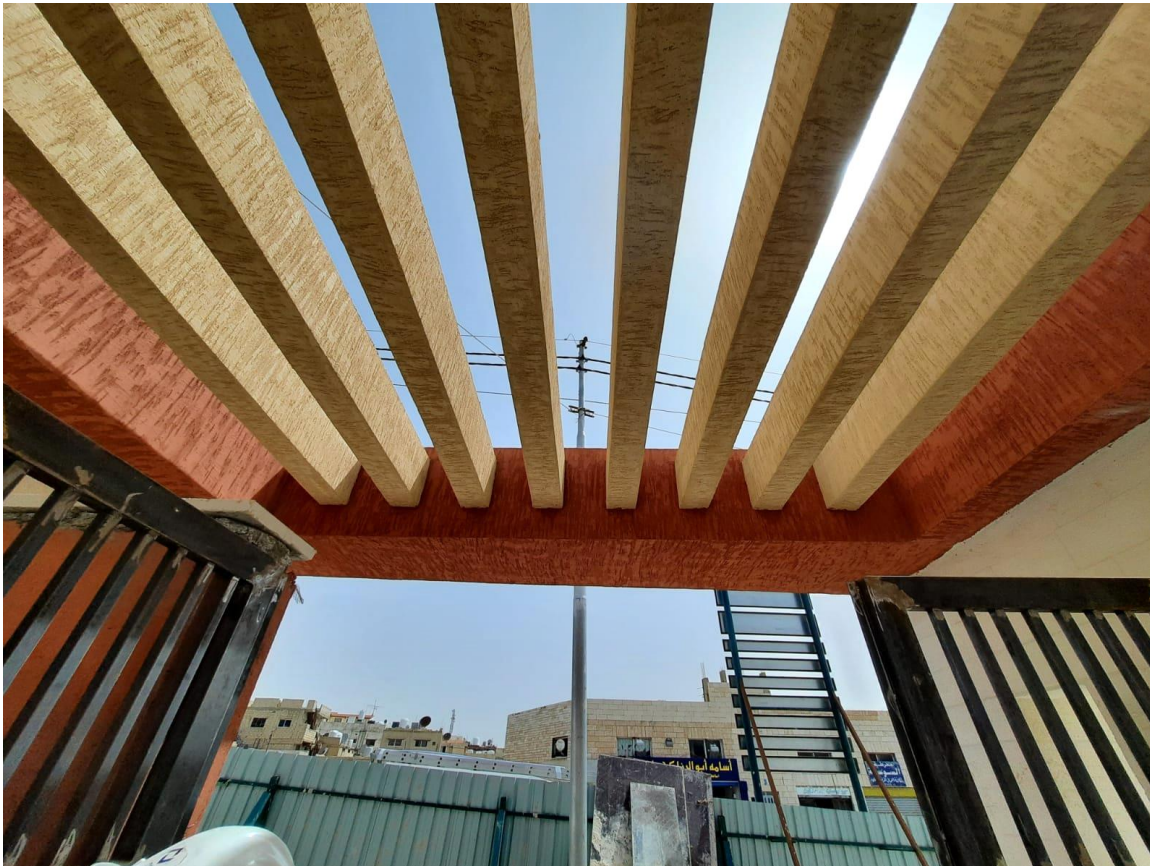
The team inspected the external colored plastering for the guard house and requested the Contractor to rectify the texture for some parts

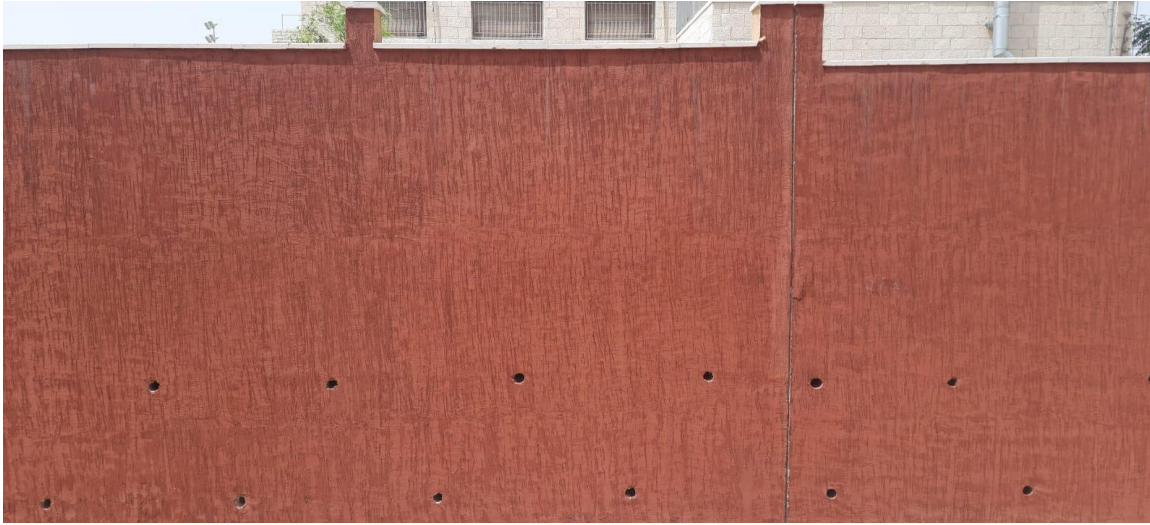
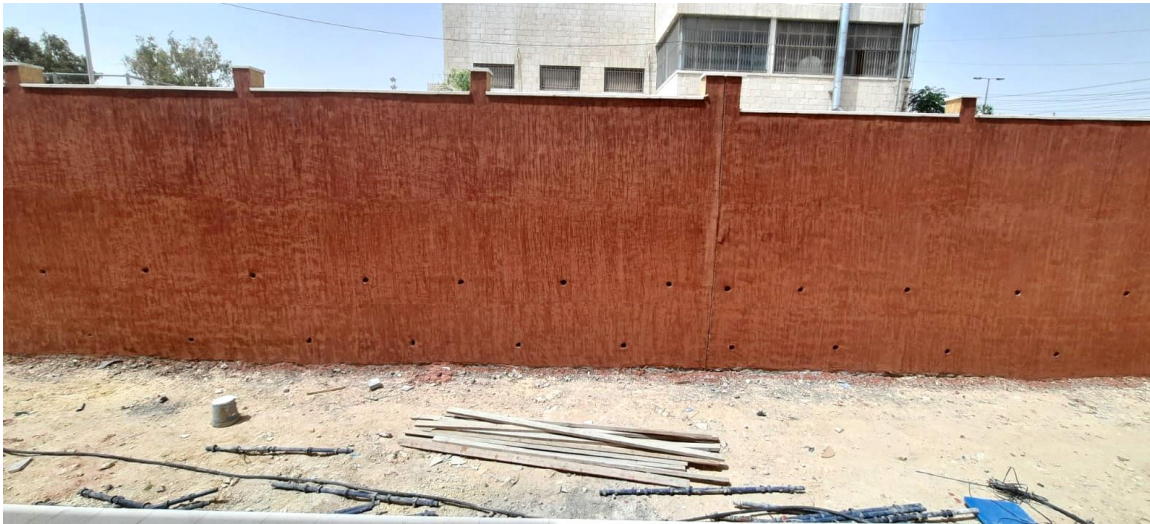
The team inspected the colored plastering of the boundary walls and requested the Contractor to clean all the dirt with different colors and finish all layers as required and finally to apply the protective coating at the top as required in the contract

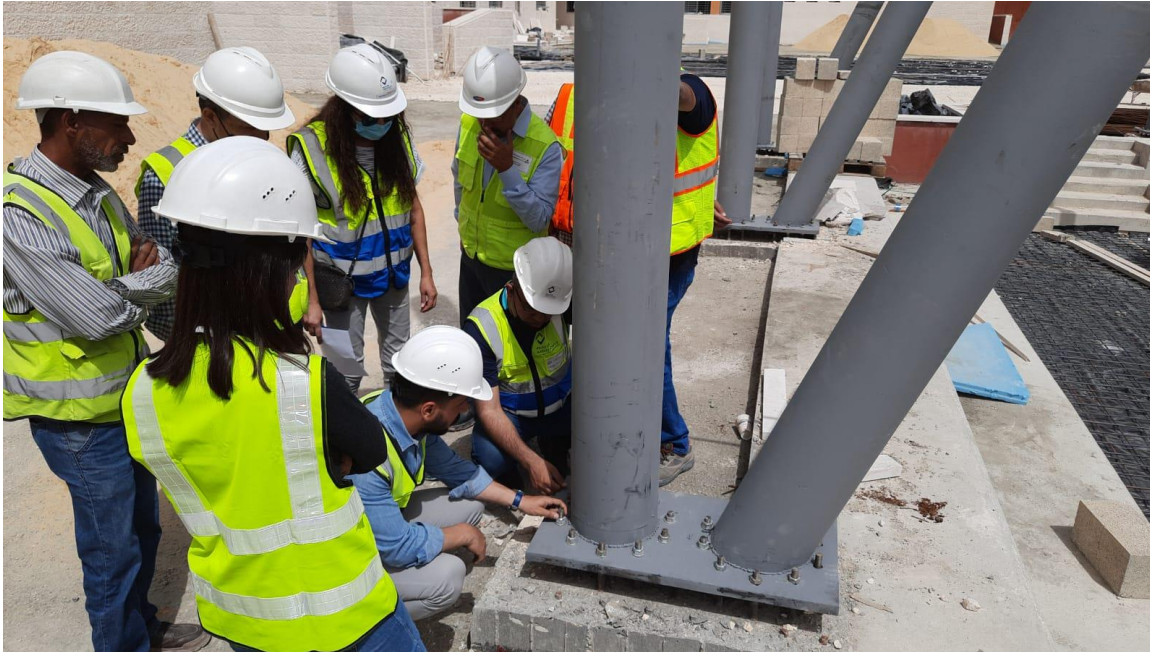
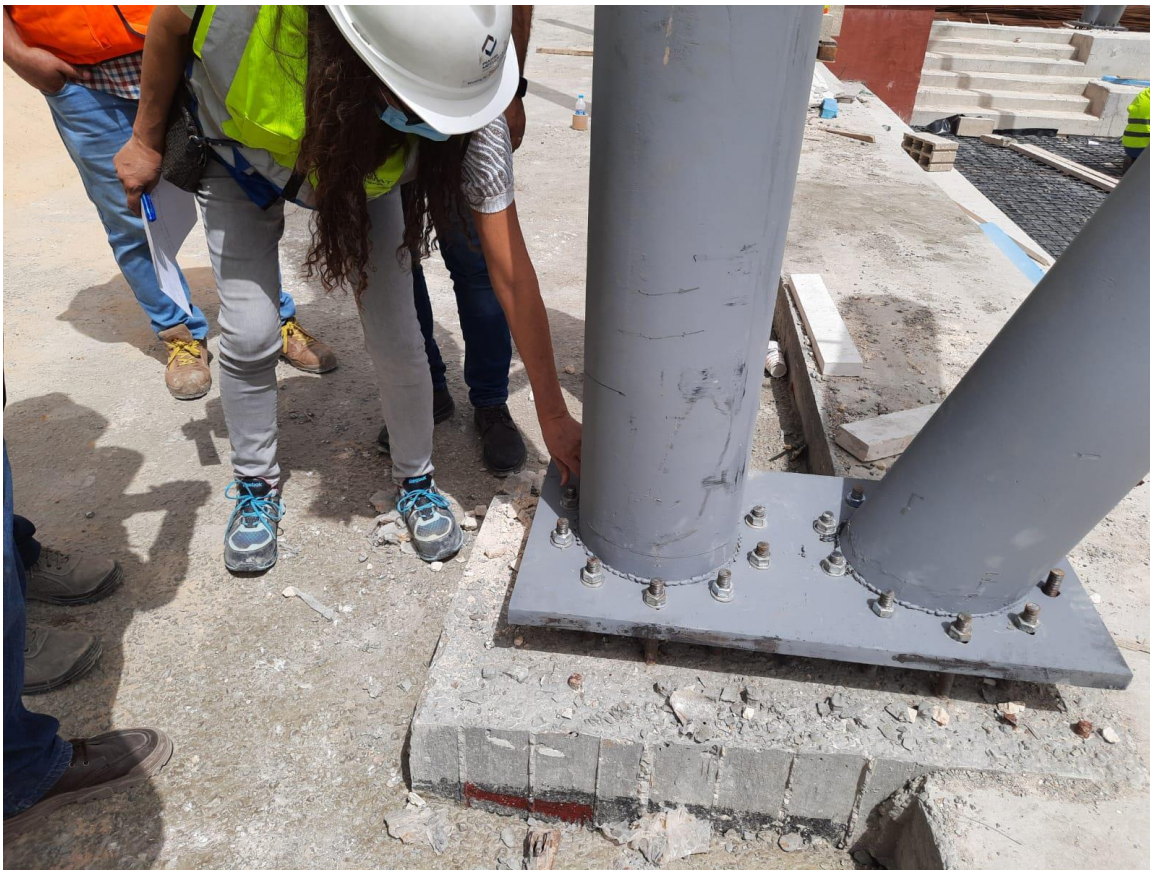
The team inspected the steel columns of the pergola at the yard and requested the Contractor to propose plastic caps to be fixed at the top of fixation bolts for safety purpose of the students

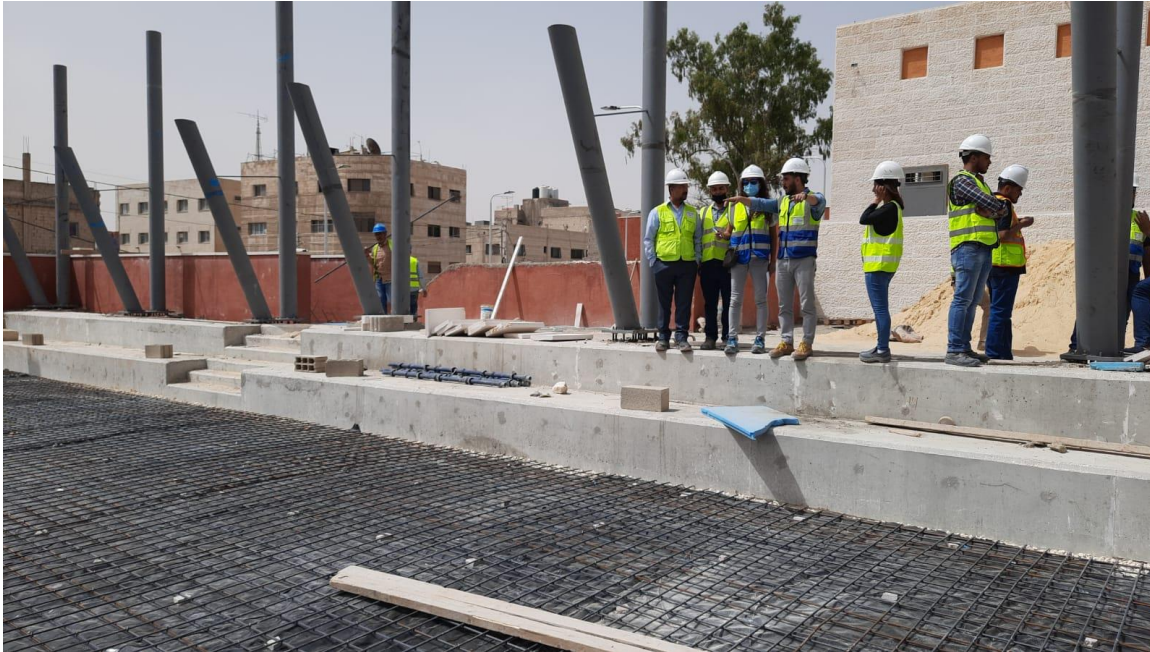
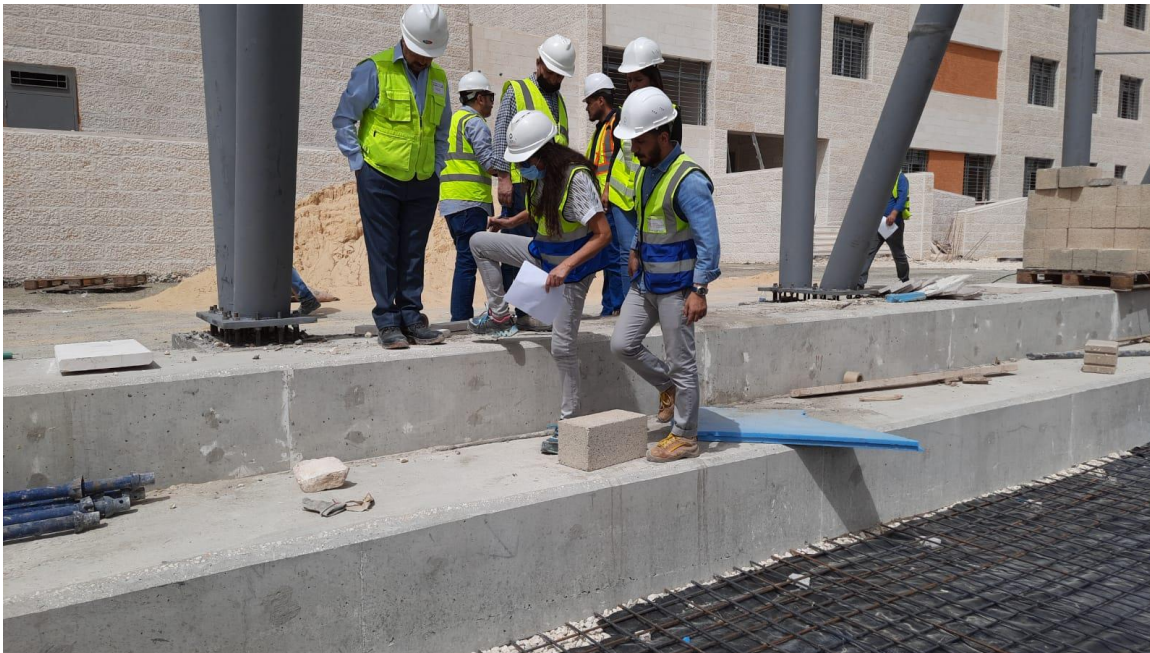
The team inspected the executed the amphitheater concrete seats and requested the Contractor to repair the observed voids at the concrete surface

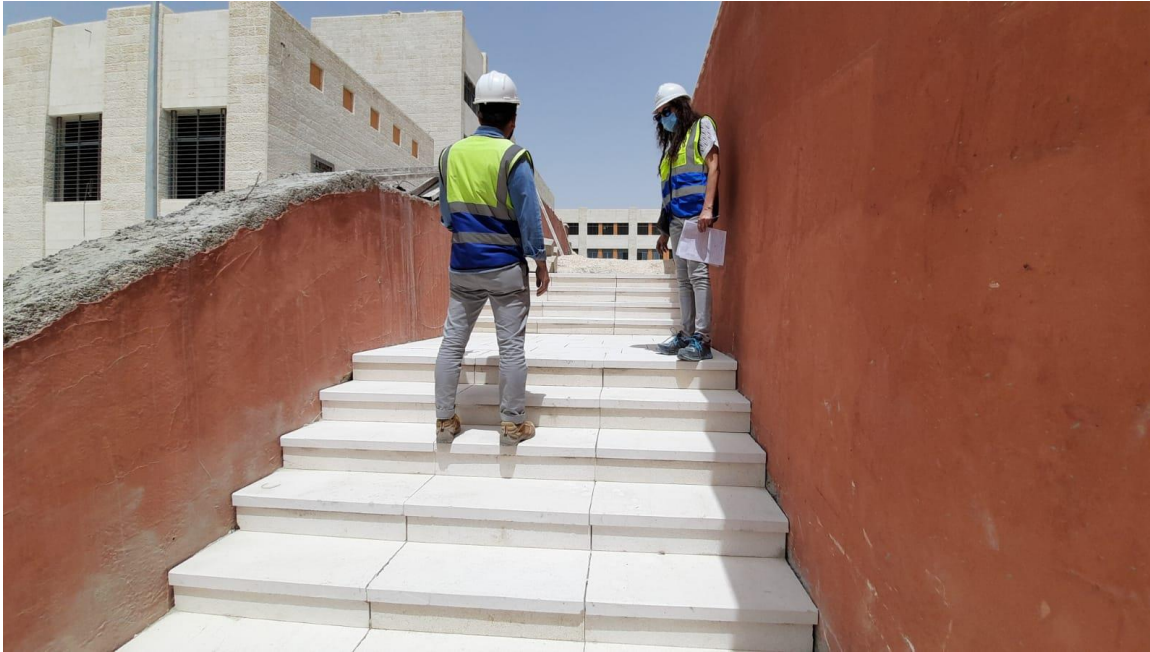
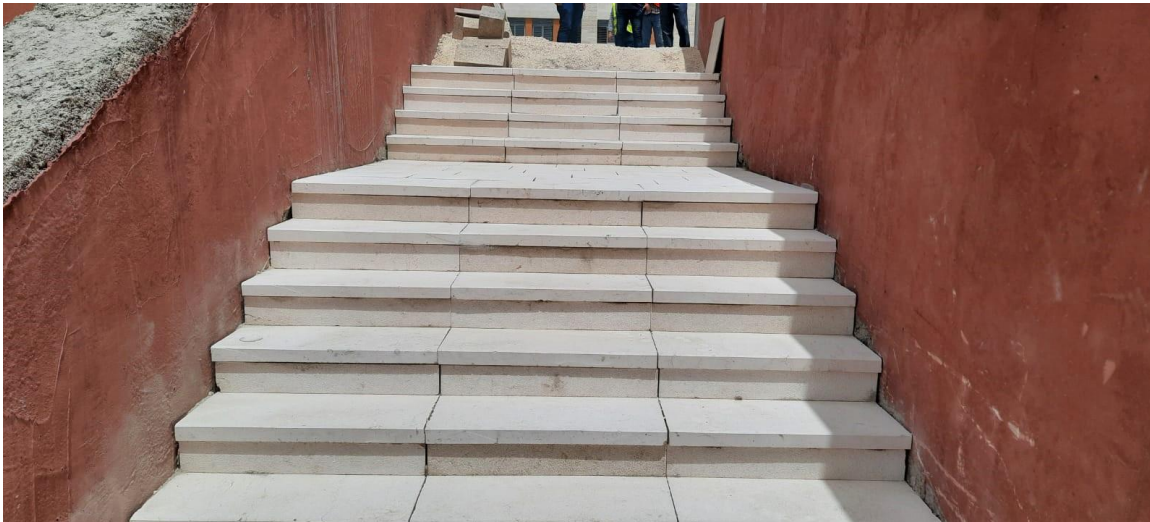
The team inspected the executed external stone steps. Notes were given to the Contractor to rectify

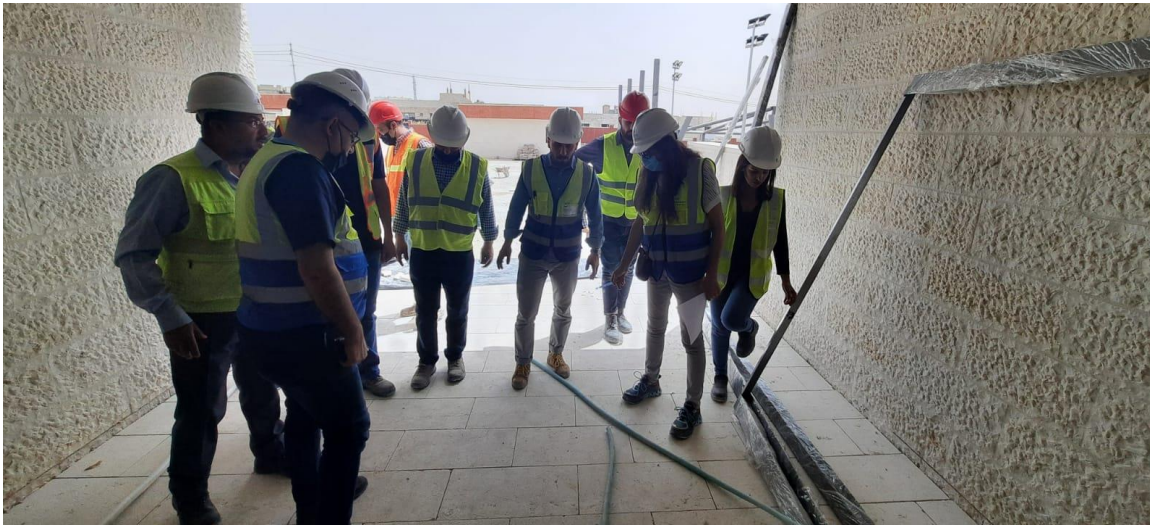
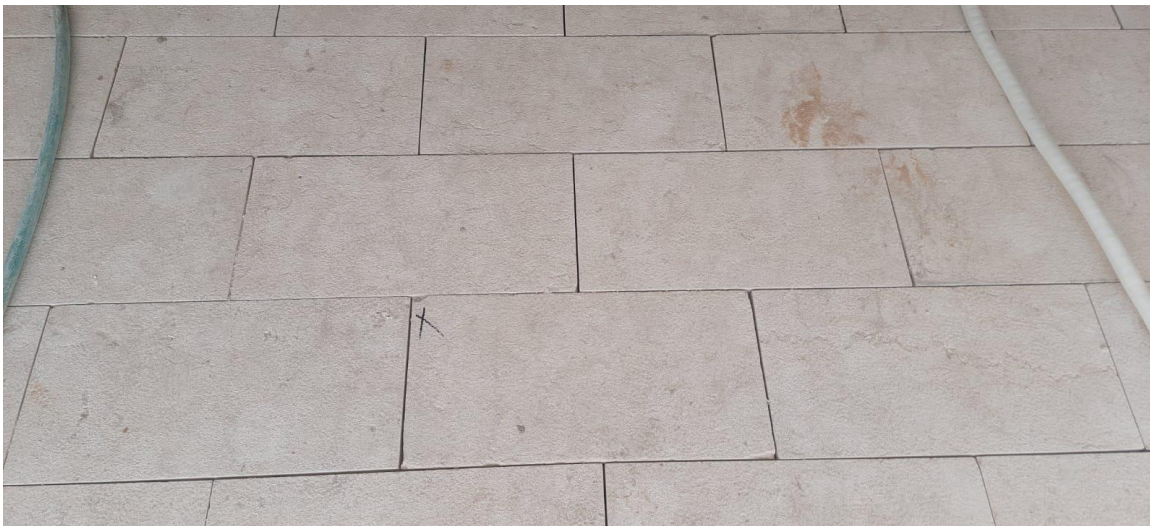
The team inspected the executed stone floors at the entrance of the school and requested the Contractor to replace a number of broken stones

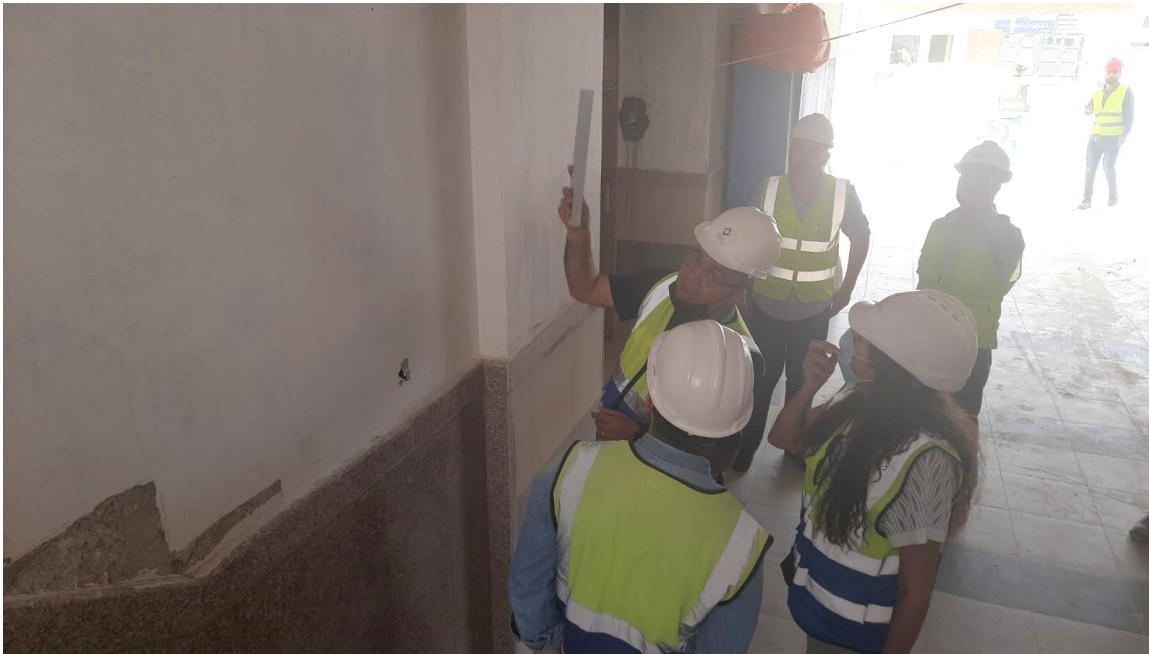
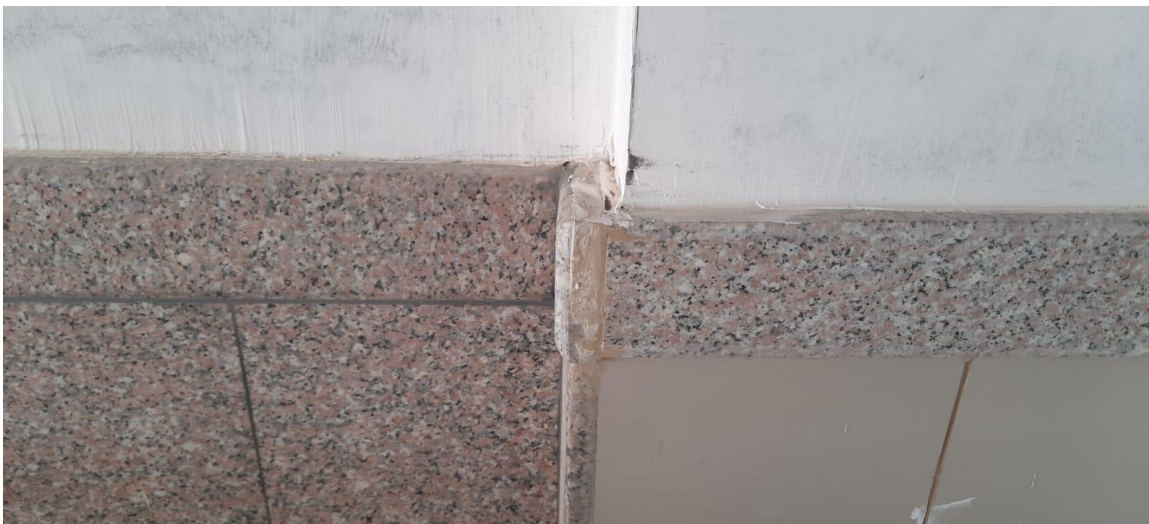
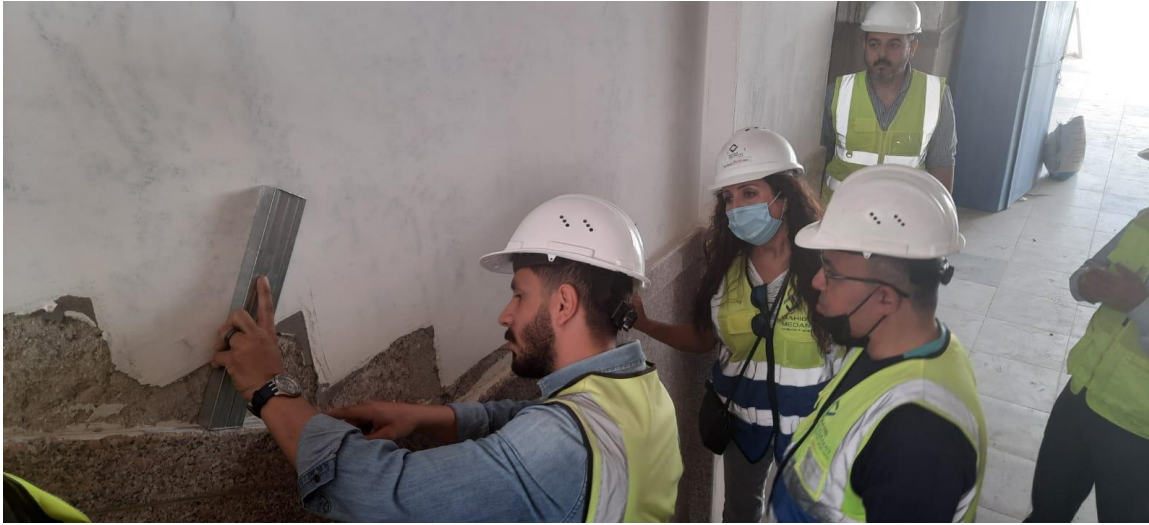
The team inspected the granite coping at the corridors and staircase. Defects were observed related to the large gap between the granite coping and the plastered wall.

The team reminded the Contractor that the granite coping should be installed within the plastering layer not over it.

The Contractor was requested to rectify accordingly and ensure the verticality of the coping pieces

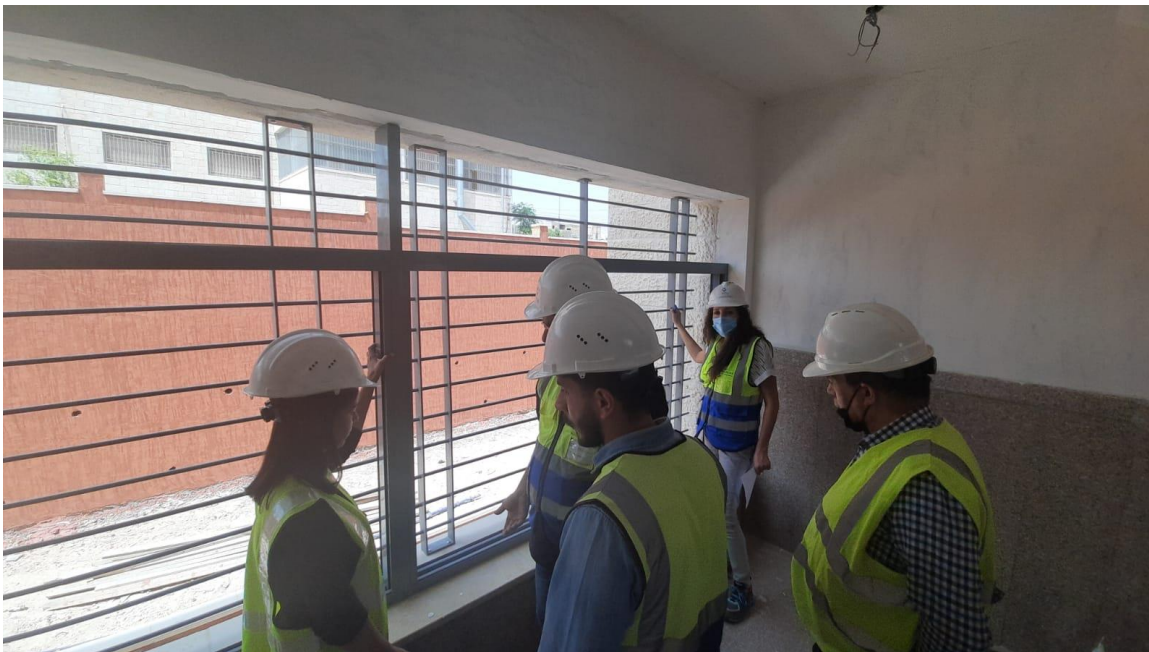
(Figure: 24)

The team inspected the installed steel protection screens for windows and requested the Contractor to rectify before installing the aluminum window glass

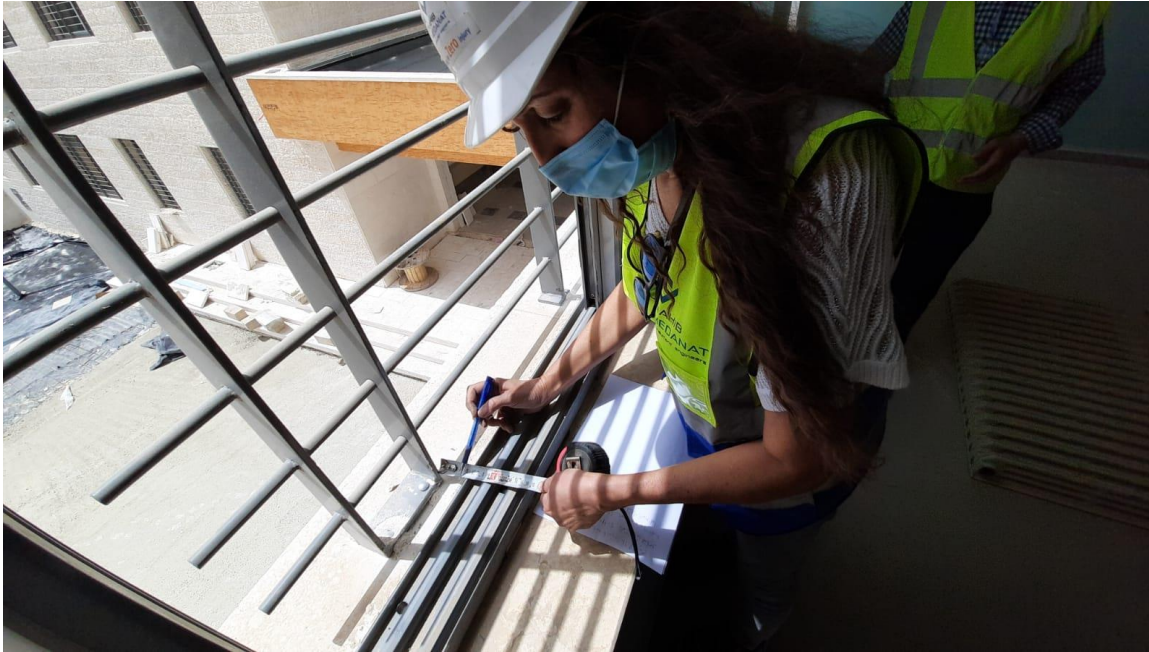
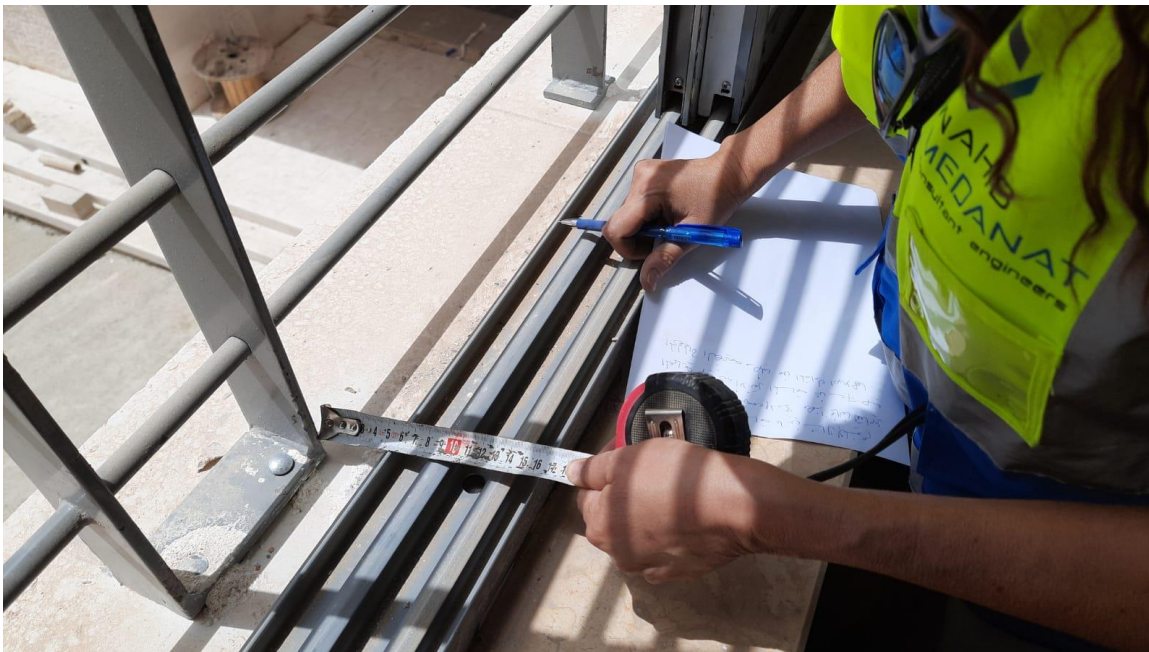
The team checked the space between the aluminum windows and the steel protection screens and observed insufficient space (3cm-4cm) for a number of windows. The team reminded the Contractor that in

accordance to the architectural drawings, the space should not be less than 7cm. The Contractor shall propose a method of rectification to be reviewed and approved by the Engineer

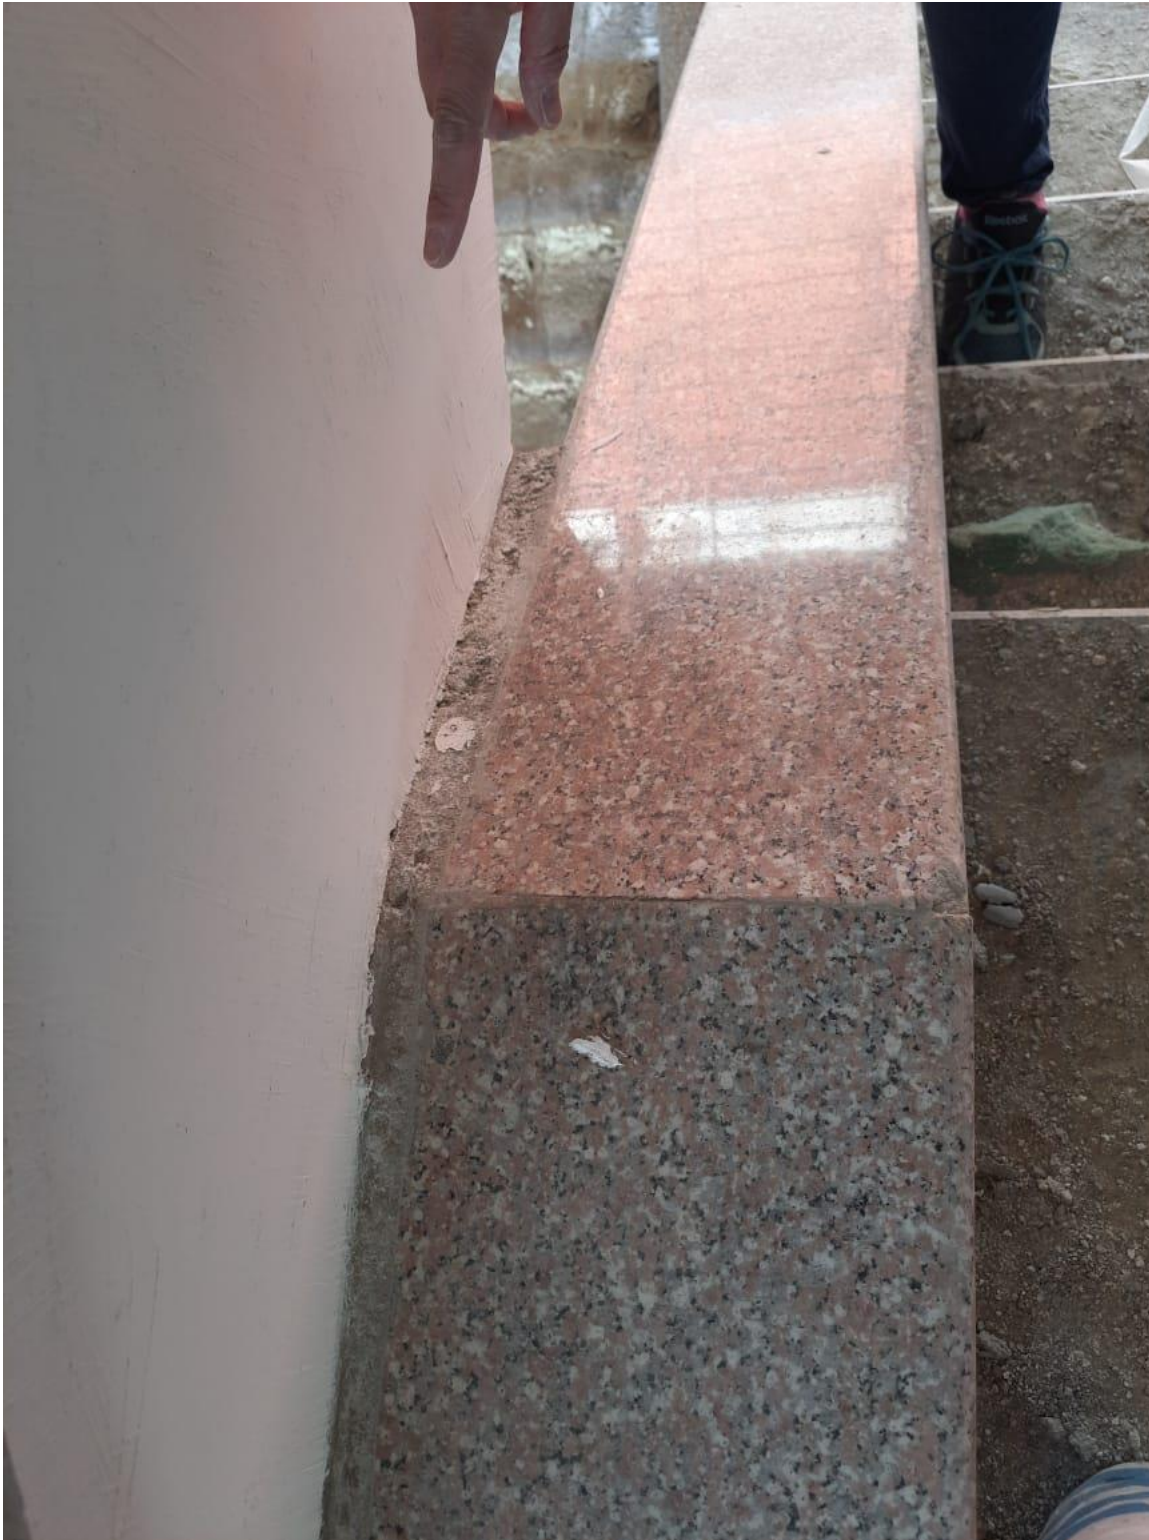
(Figure: 27)

The team observed defects in the straightness of the plastering/ granite coping of the staircase at the landing between the ground and first floors. The Contractor was requested to check and rectify as needed (previous report)

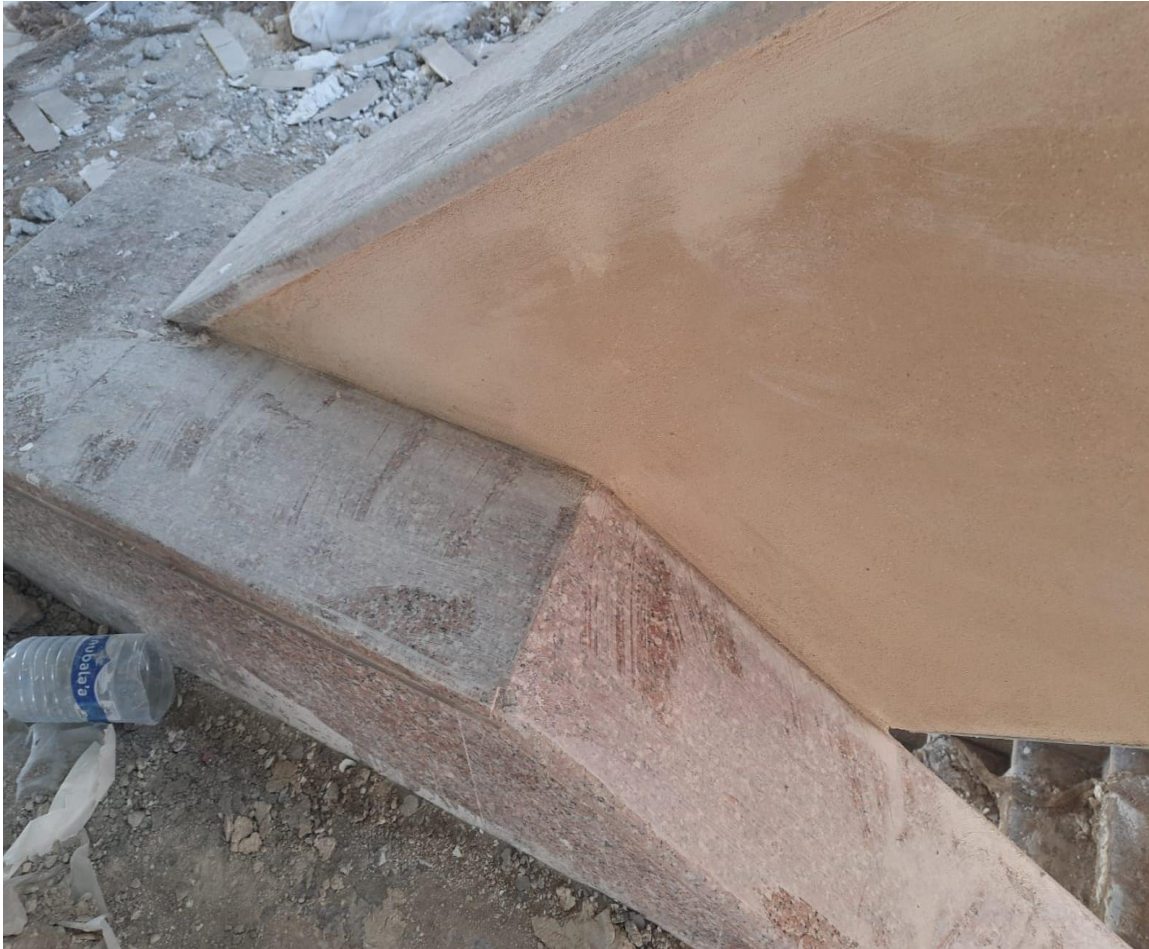
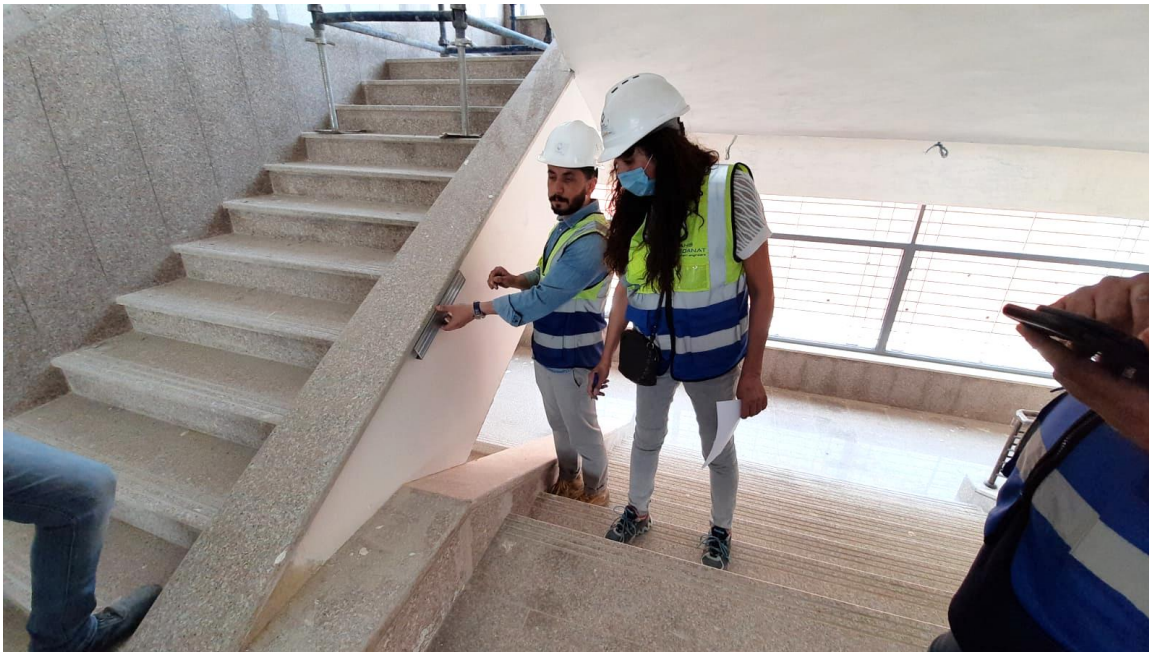
The team observed that the defects at the granite parapet at the staircase have been repaired by the Contractor and the granite pieces, plastering, verticality and finishing are acceptable

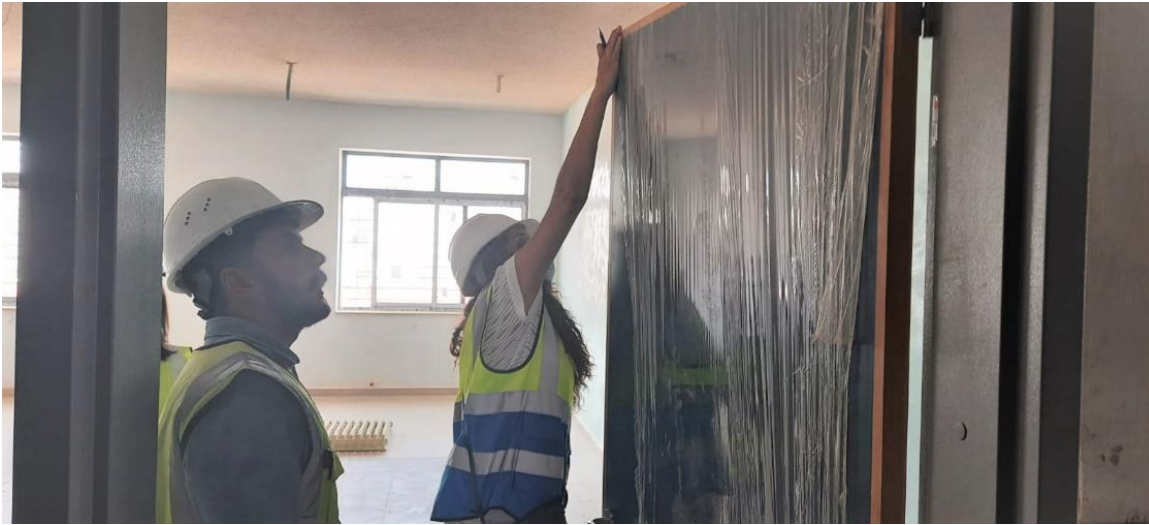
(Figure: 34)

The team inspected the wooden doors and reminded the Contractor with the necessity of protecting their edges in particular

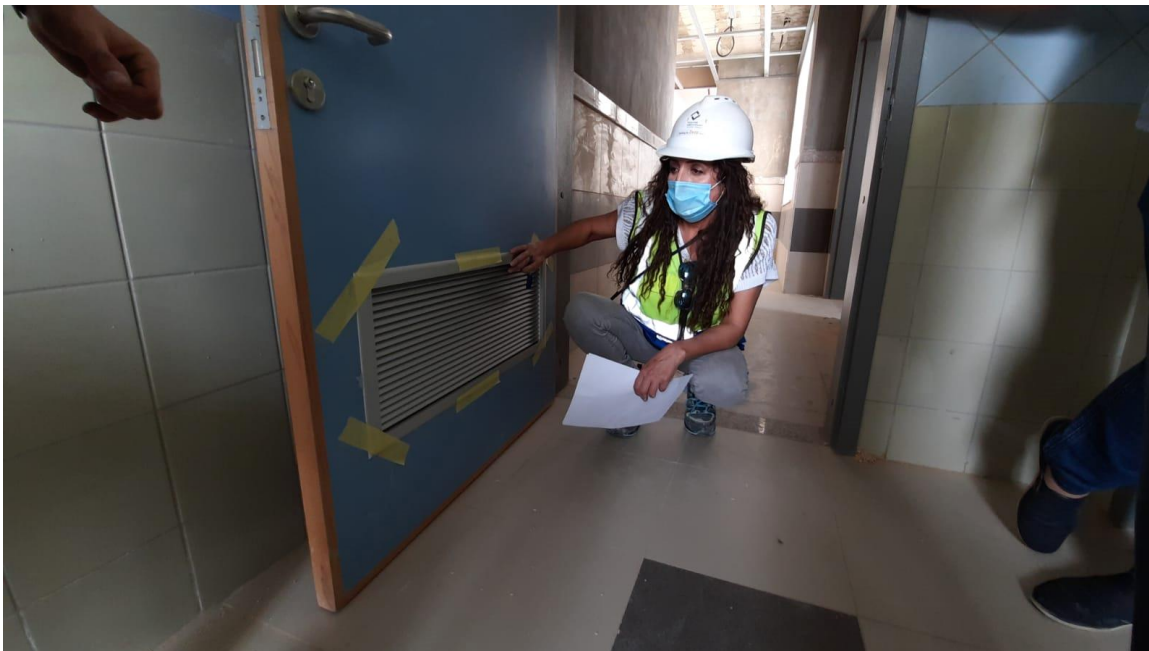
(Figure: 35)

The team inspected the installed sample of aluminum louvre at the wet areas doors. Further details will be checked by the site engineer
