# SKEP III Home Office Support Site Visit Report

Consultant	Wahib Medanat Consultant Engineer	Rep No.	22-16062022
Contractor	Dijlah Establishment Constr. Contracting	Tender No.	(11/2019/USAID/SKEP/3/S) Schools for a Knowledge Economy Project (SKEP) - Phase (3) Package (1, 2)
Site Name	Thahr Al Sarow Basic School for Boys- Jerash	Day/ Date	Wed. 16/06/2022
Duration of Project	450 Calendar Days	Total Project Budget	8,314,983.735 JD

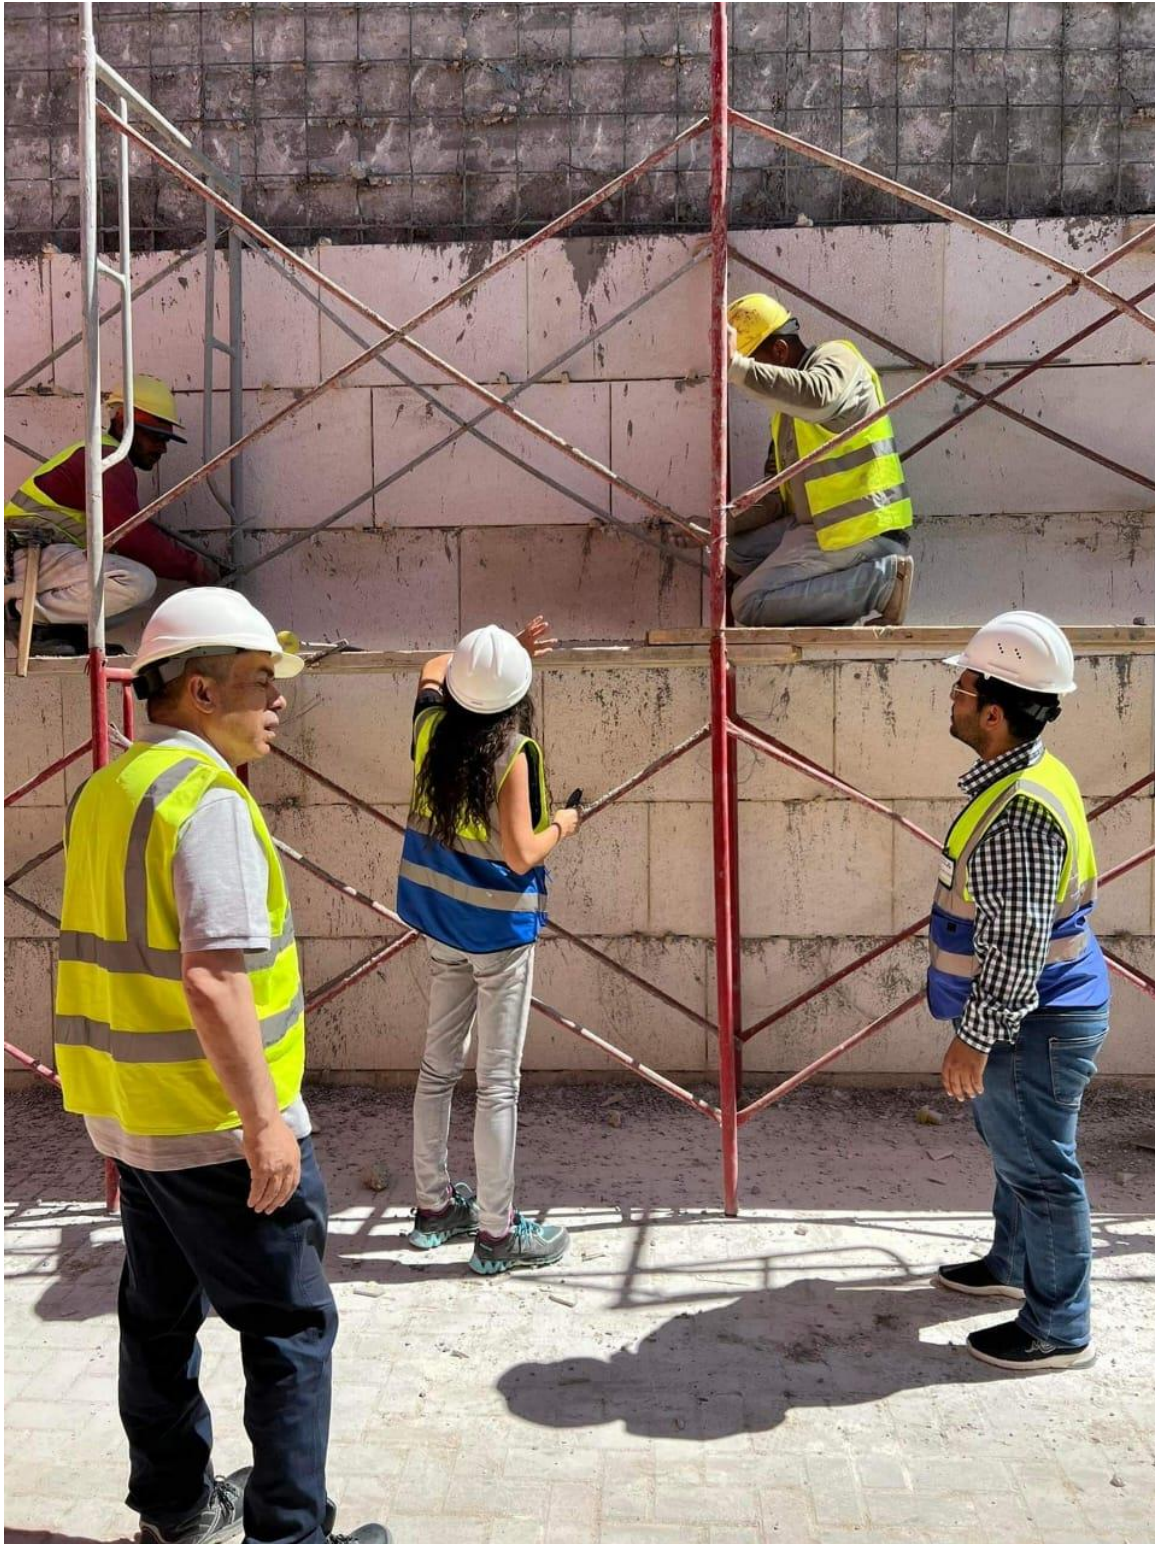
(Figure: 06)

Complete removal of the built defected stones for the front façade

(Before)

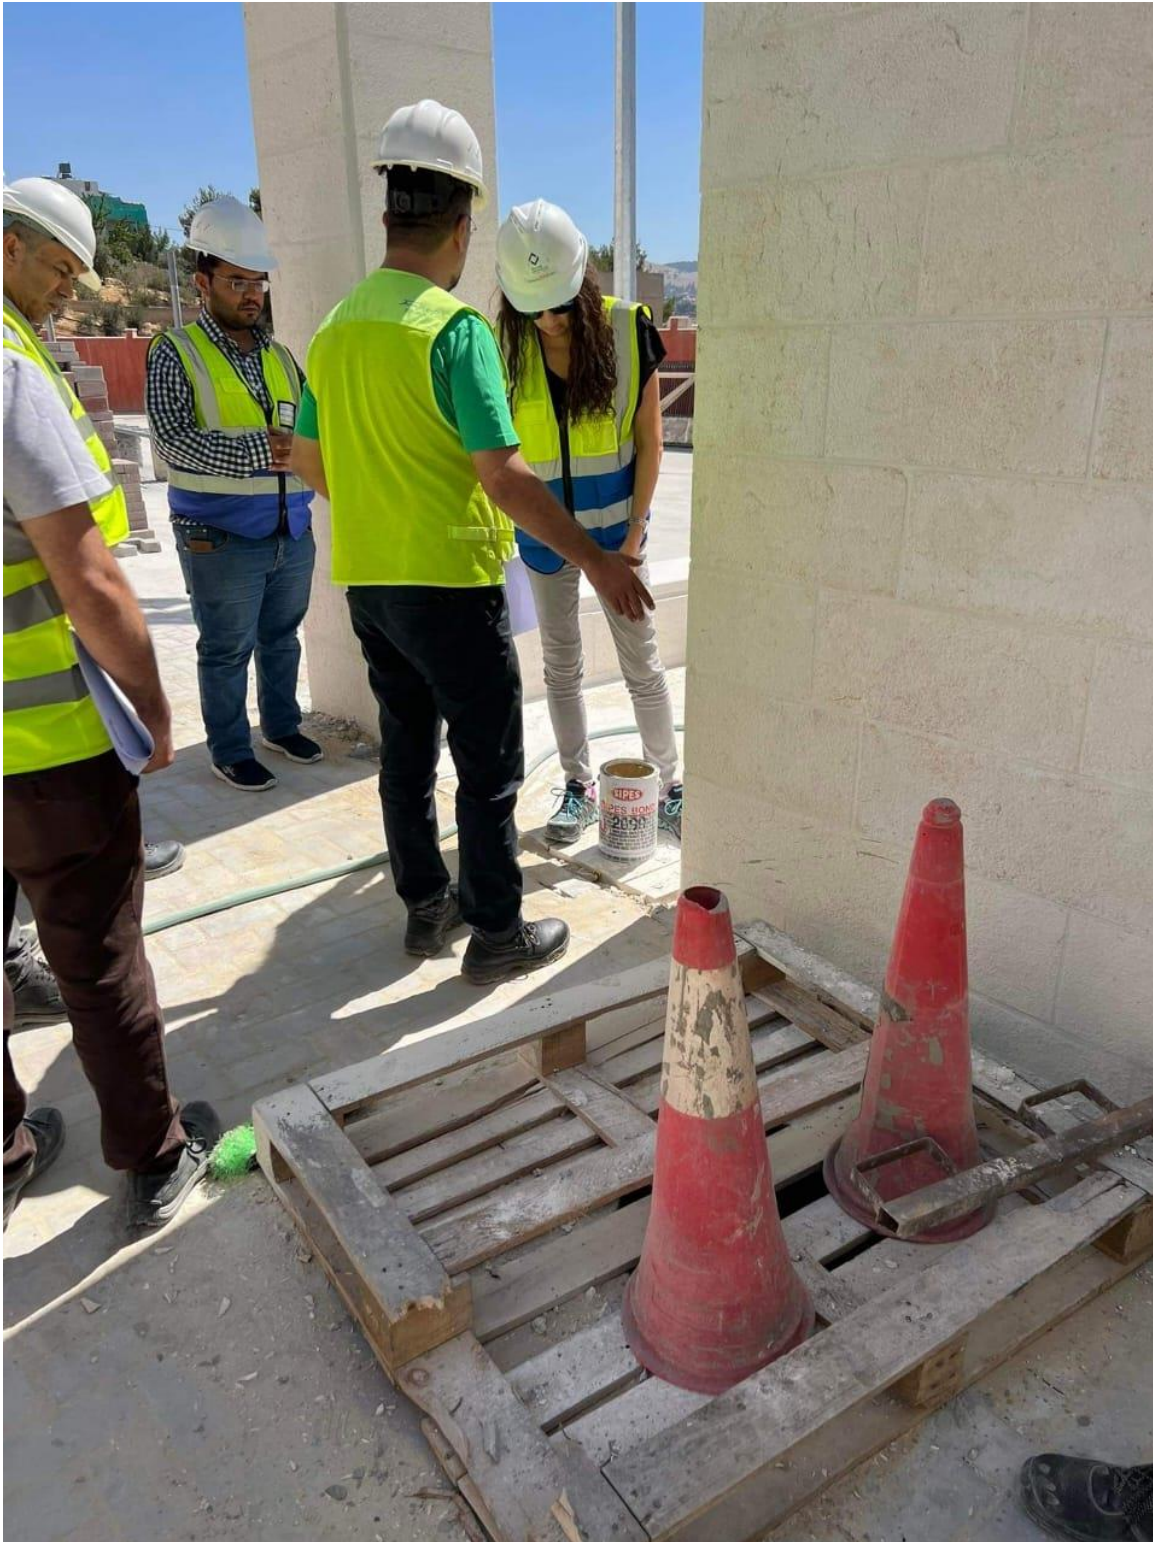
(Figure: 07)

The supervision team inspected the stone re-building for one façade after removing completely the previously built defected stones for the said façade. The team requested the Contractor to replace one defected built stone (After)

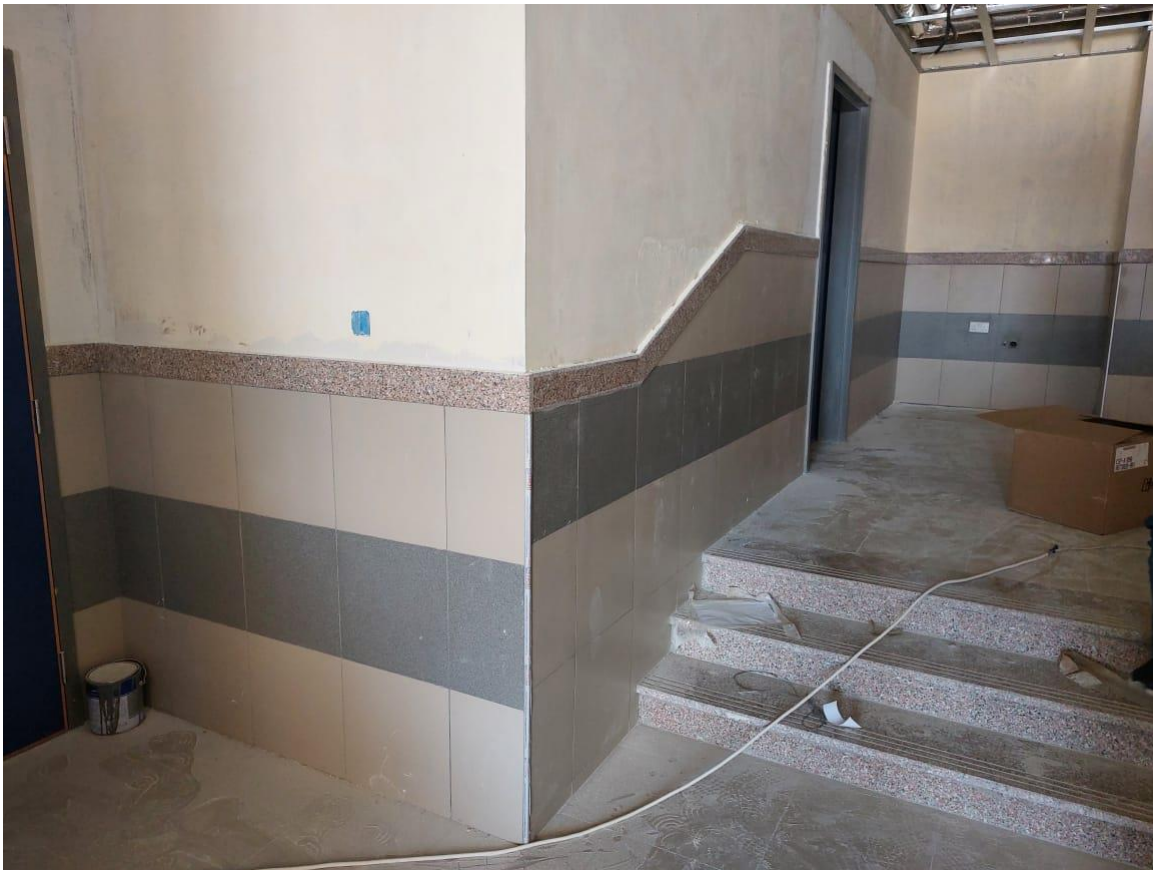
(Figure: 12)

The team observed that the Contractor executed the porcelain wall tiles at the building entrance- ramp area. The team requested the Contractor to remove the tiled porcelain and submit workshop drawings to be reviewed and approved by the Engineer pointing out that the tiled walls do not comply with approved workshop drawing. Possible solutions to the shape and tile color distribution were discussed

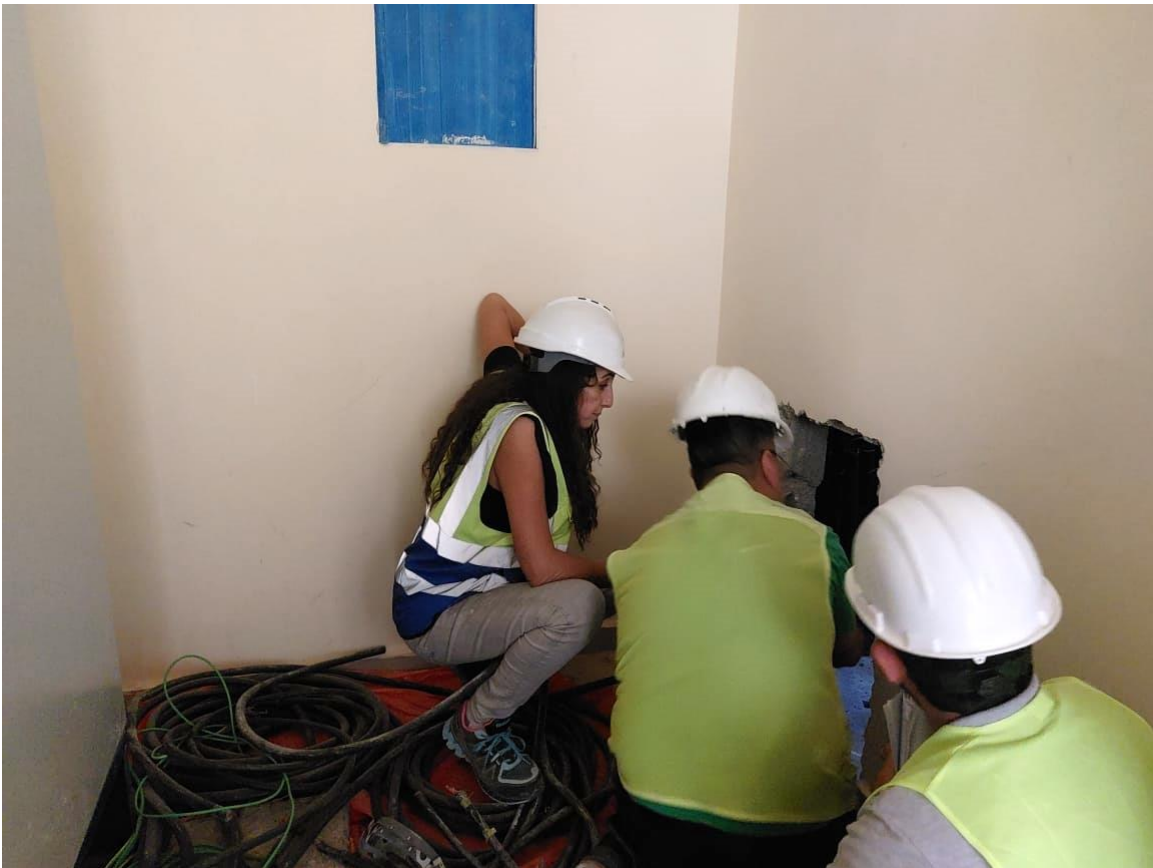
(Figure: 14)

The team inspected the installation of the main distribution board in the electrical room in the presence of the supervision electrical engineer

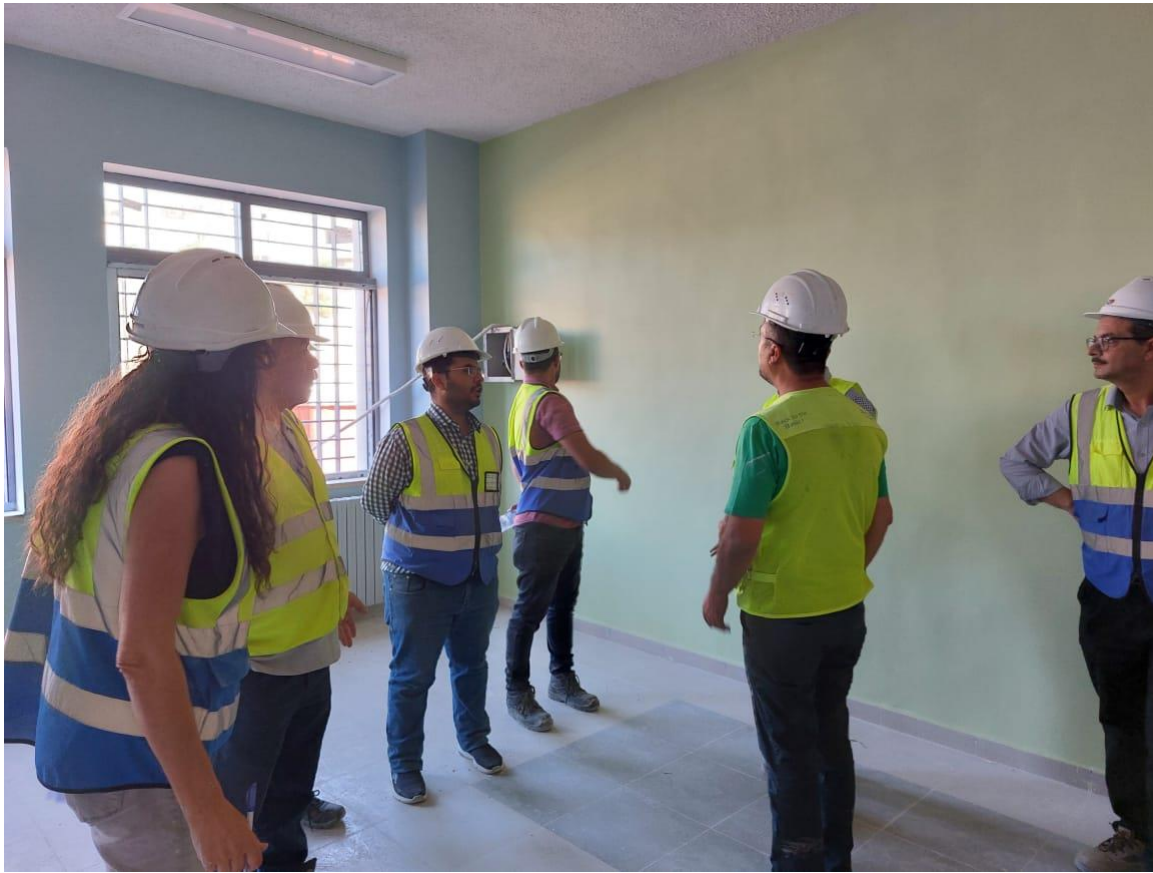
(Figure: 15)

The team observed that the Contractor to this date has not executed the blockwork partition between the Data cables and the electrical cables at the shaft. The team stressed on the Contractor to execute the said partition without delay

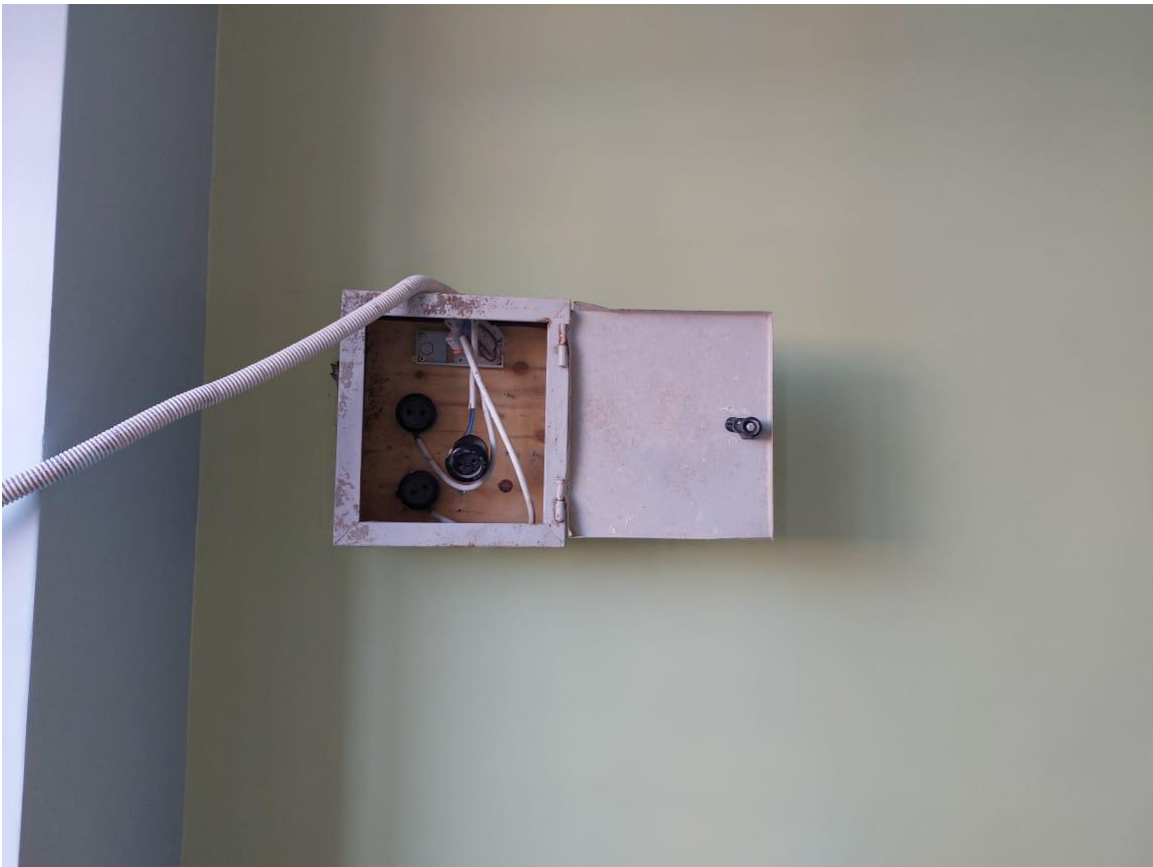
(Figure: 16)

The team observed that the Contractor is using a temporary electrical board fixed at one wall inside the building. The team requested the Contractor to remove the said board to ensure a well painted finish. The board might be fixed at a special stand for the purpose of work execution
