Consultant	Wahib Medanat Consultant Engineer	Rep No.	11-16042022
Contractor	Derar Saraireh & Sons for Engineering & Contracting	Tender No.	(11/2019/USAID/SKEP/3/S) Schools for a Knowledge Economy Project (SKEP) - Phase (3) Package (1, 2)
Site Name	Um Al Dananir Basic Mixed School- Al Balqa	Day/ Date	Sat. 16/04/2022
Duration of Project	450 Calendar Days	Total Project Budget	9,789,417.840 JD

Visit Notes

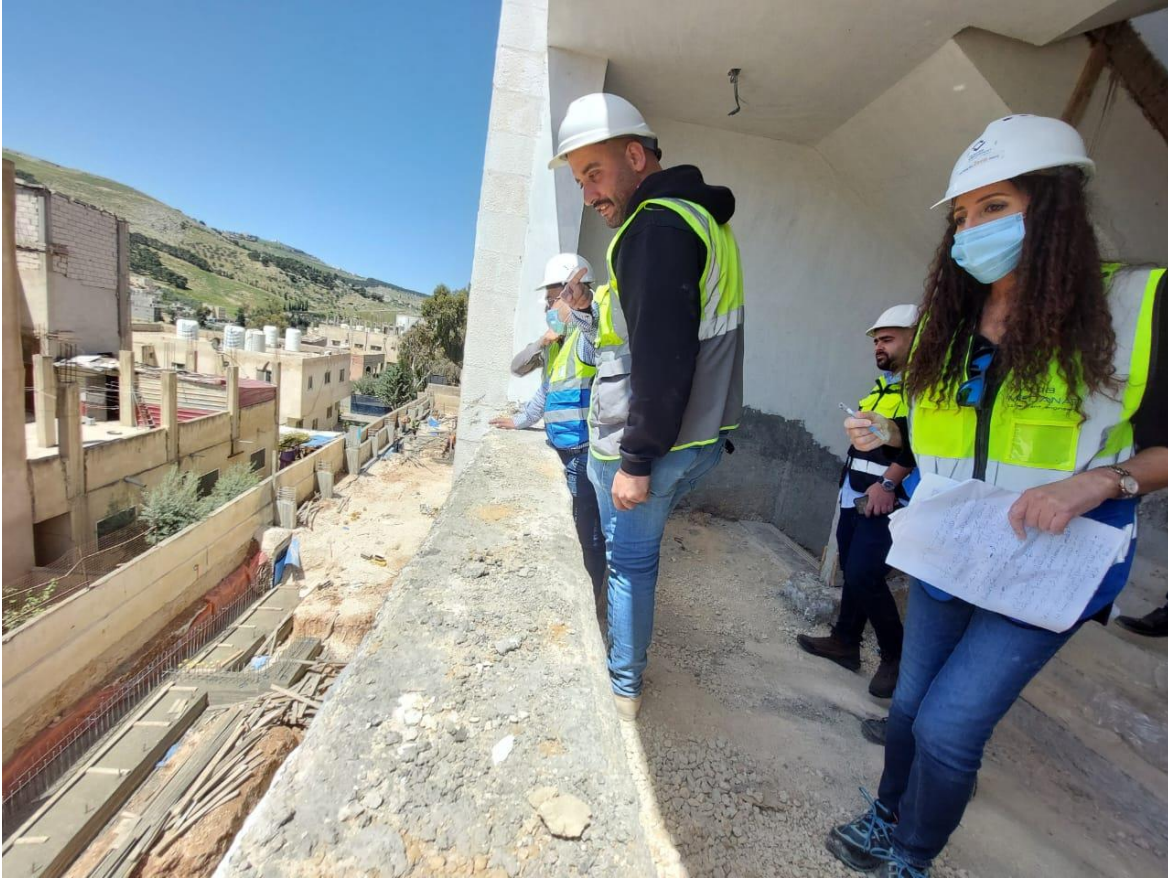
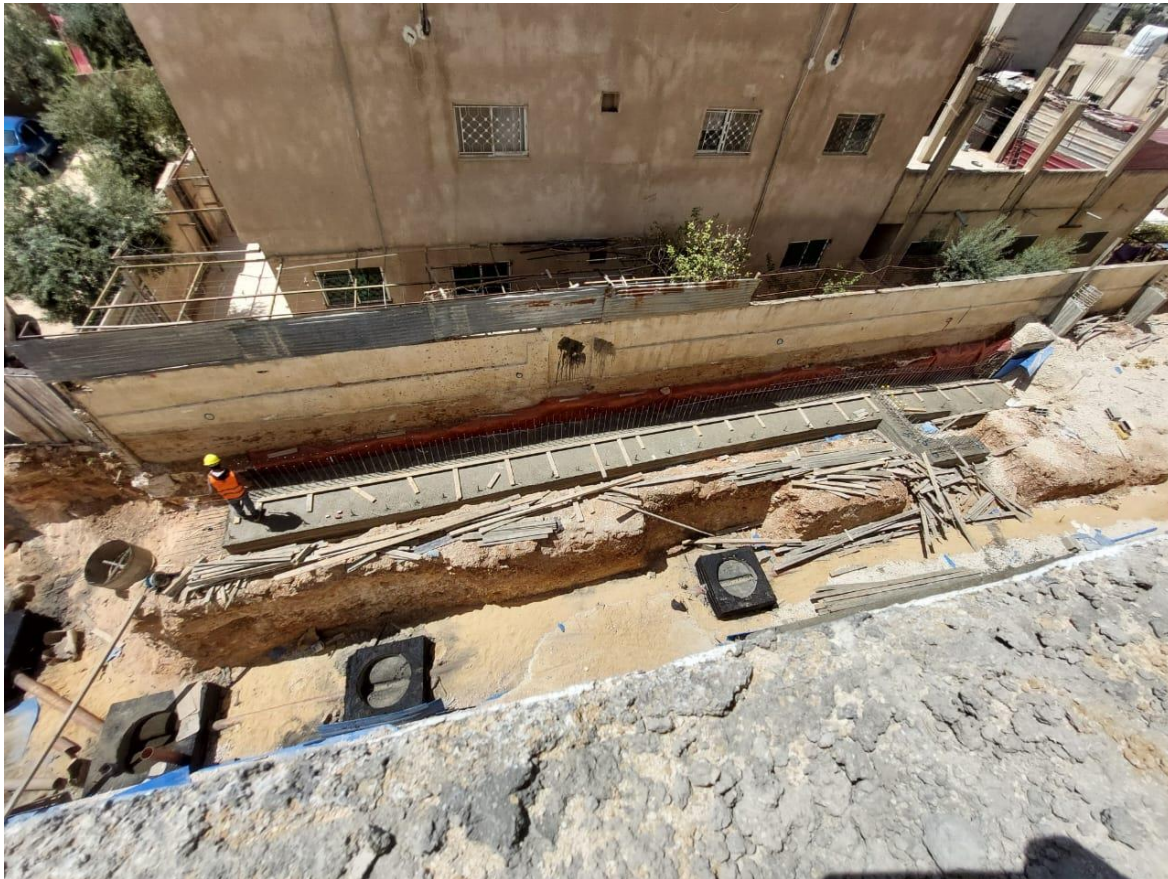
(figure:08 & 09)

The team discussed with the Contractor the sewage network at the southern end of the site and the connection to the public network.

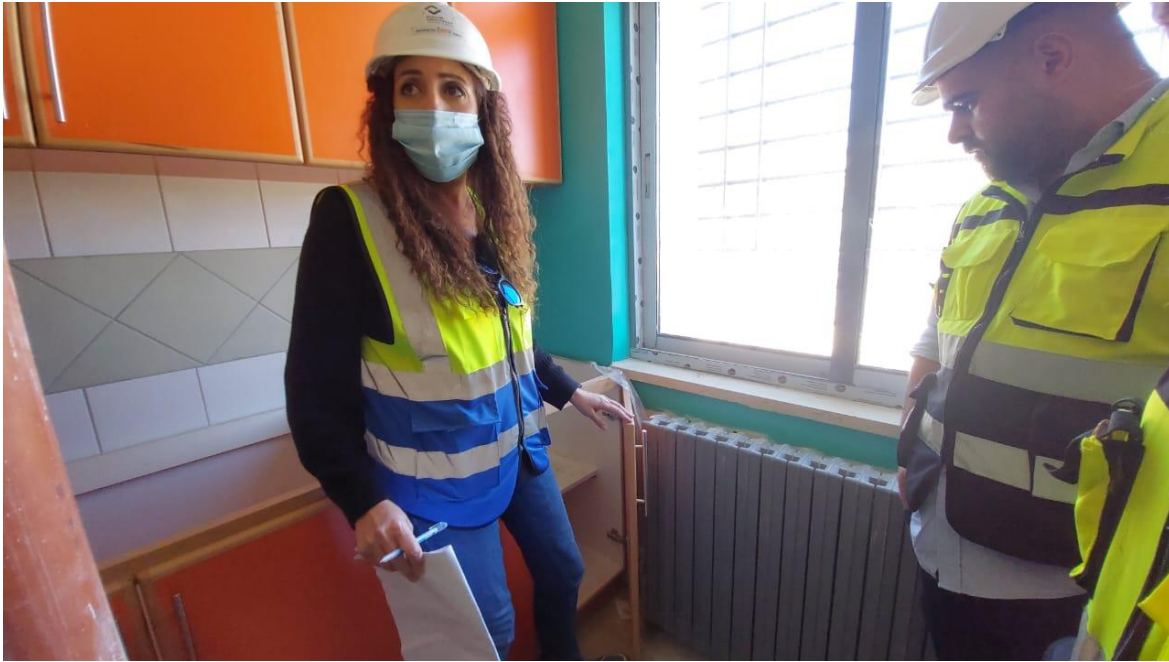
(figure:10)

the team observed that radiators adjacent to the cabinets in the kindergarten have to be shifted 20-30 cm to allow easy open/close to the cabinets doors

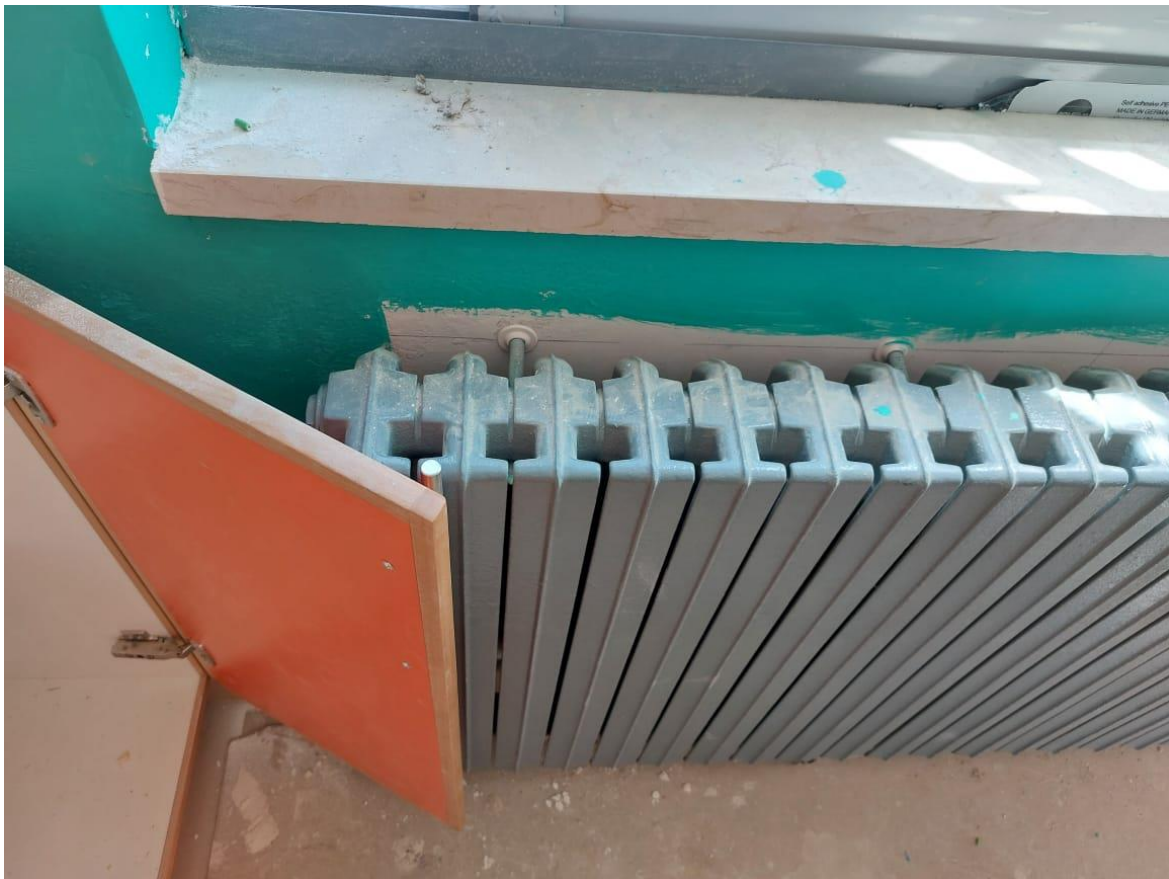
(figure:11)

Discussing with the Contractor the preliminary installation of radiators (unpainted). The final installation shall be installed after the completion of painting works for the radiators and the related internal walls

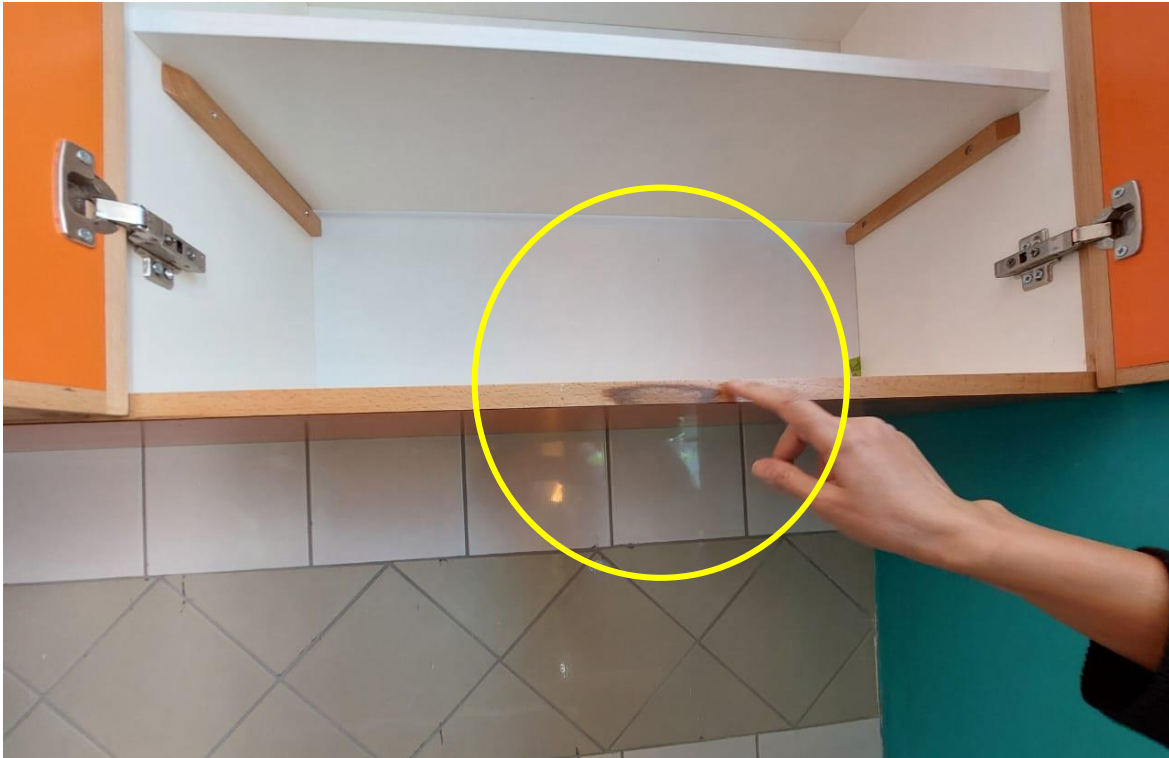
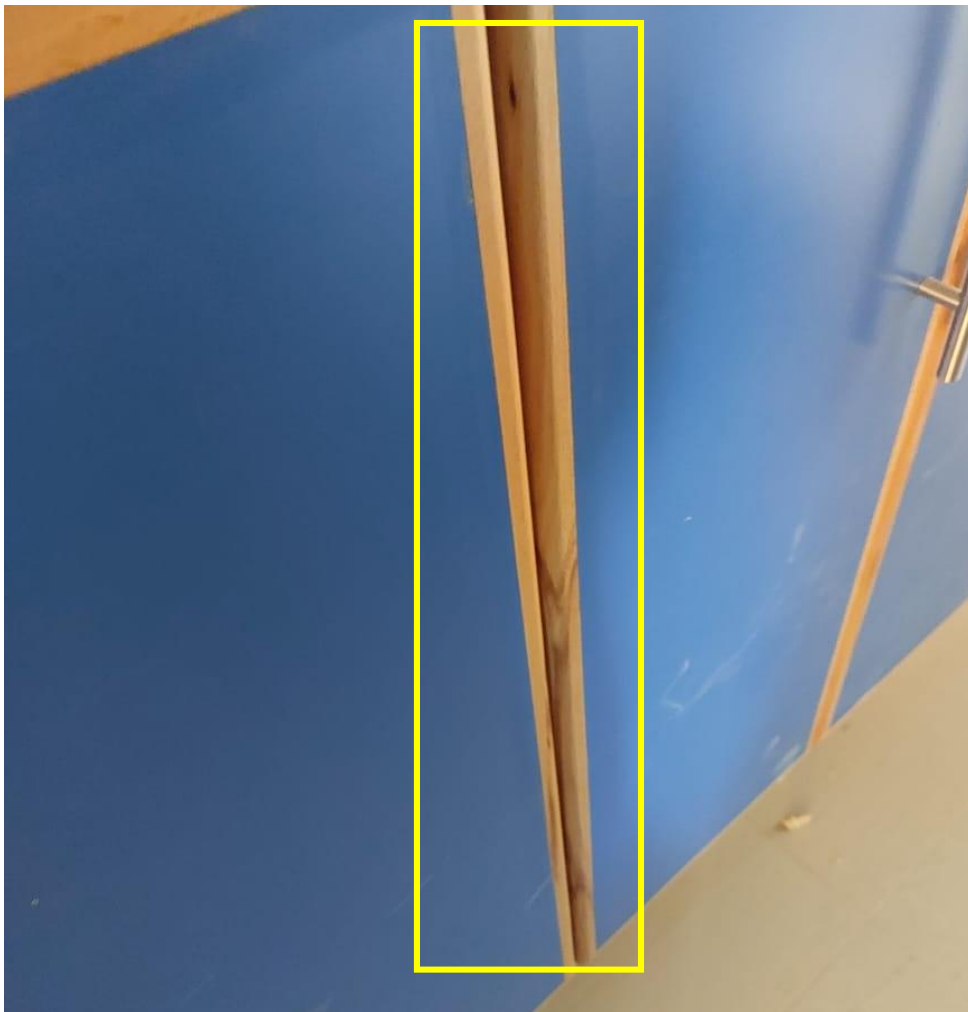
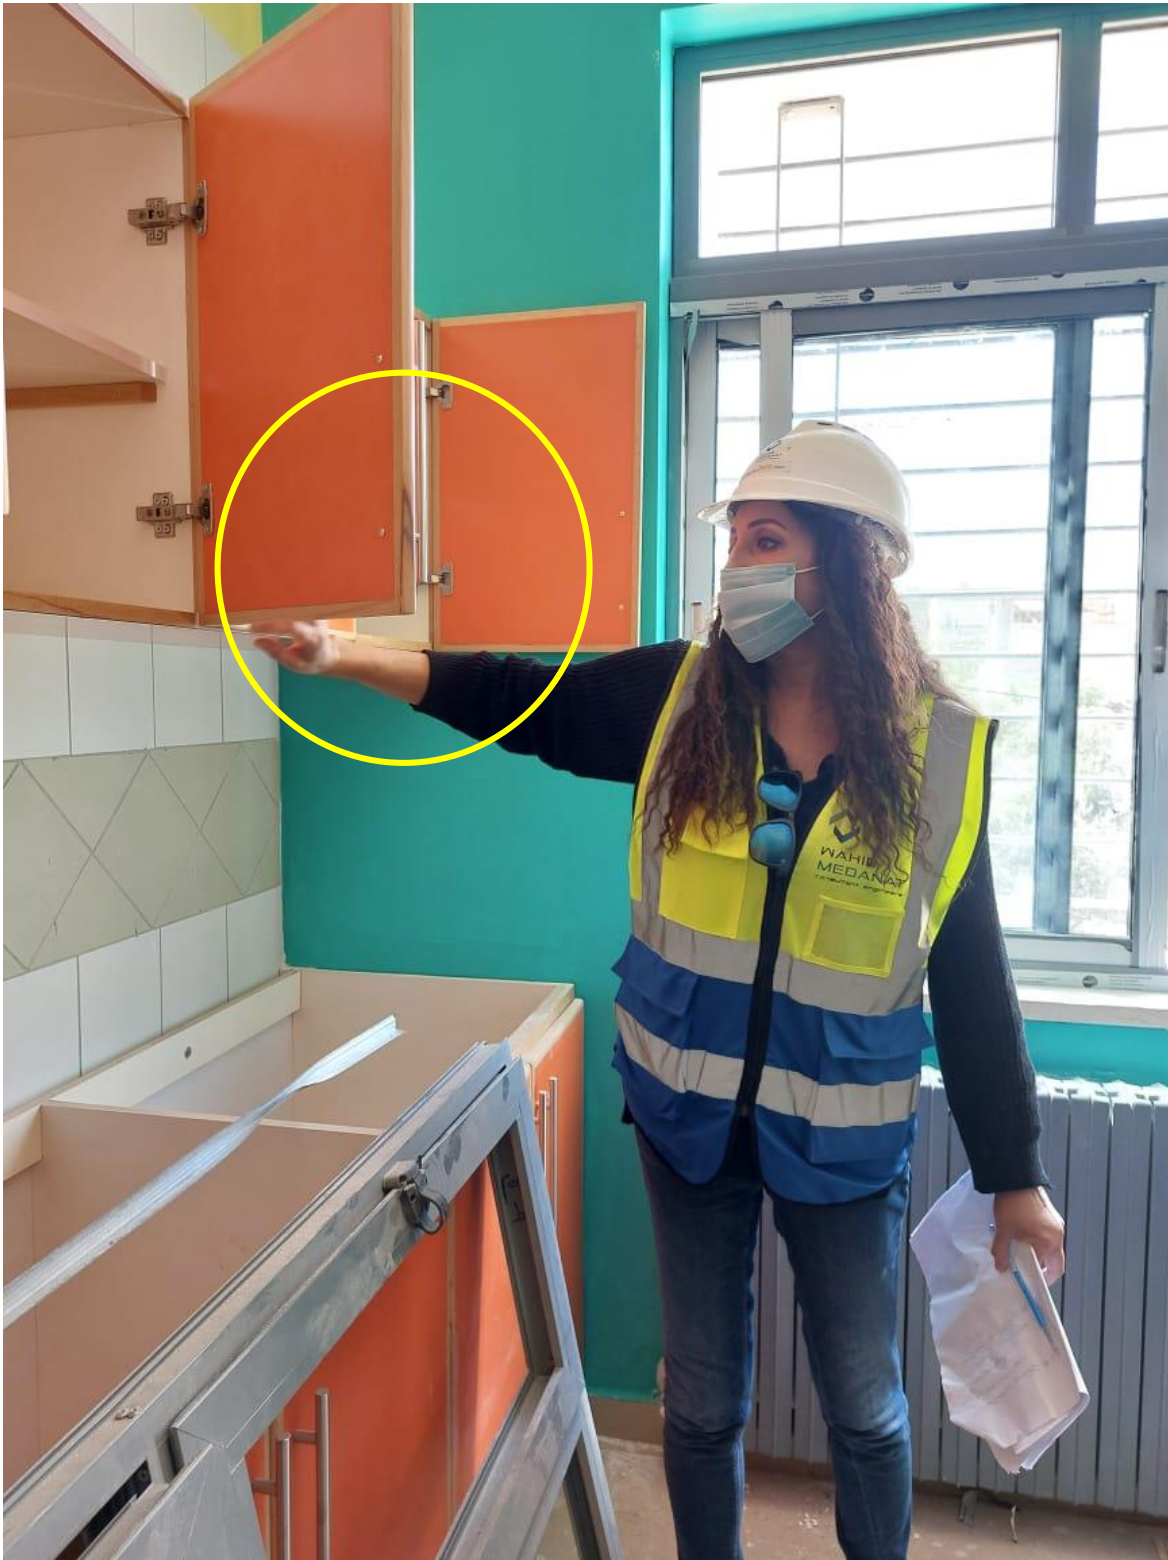
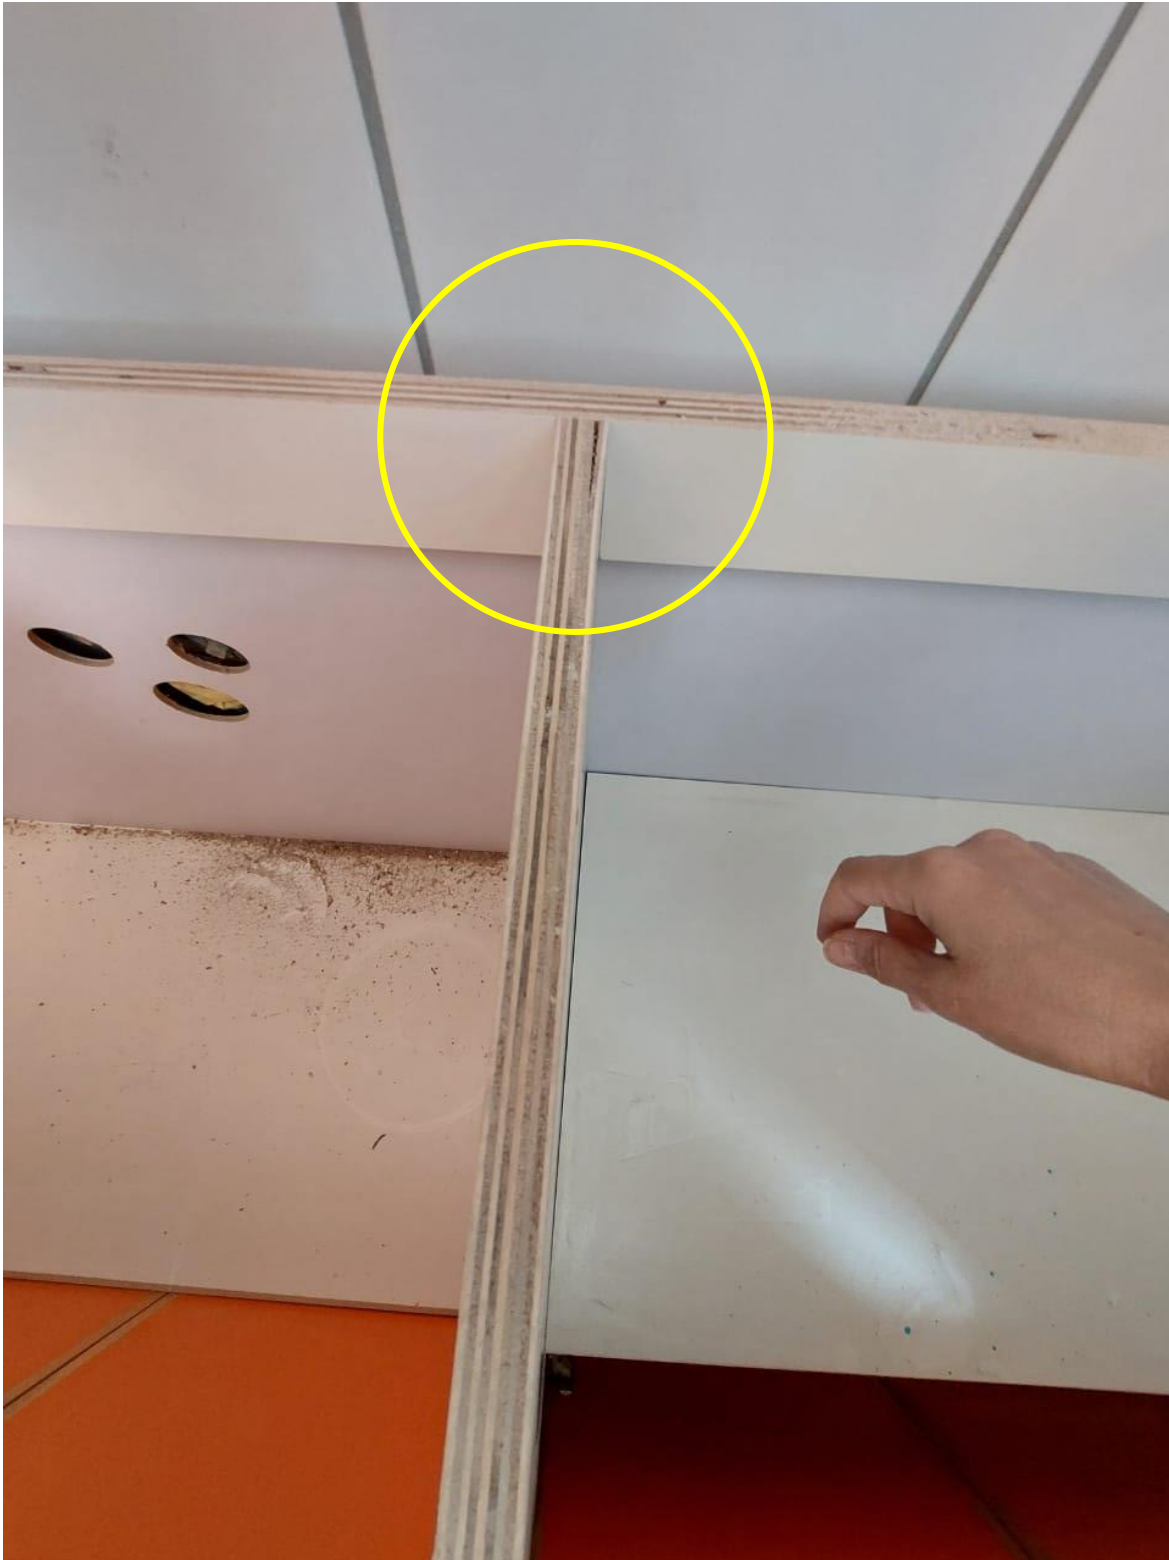
(figure:12, 13, 14 & 15)

The team inspected the quality of installed cabinets at the kindergarten and observed defects in those cabinets such as defects in the beech wood frame and broken partitions (laminated faces)

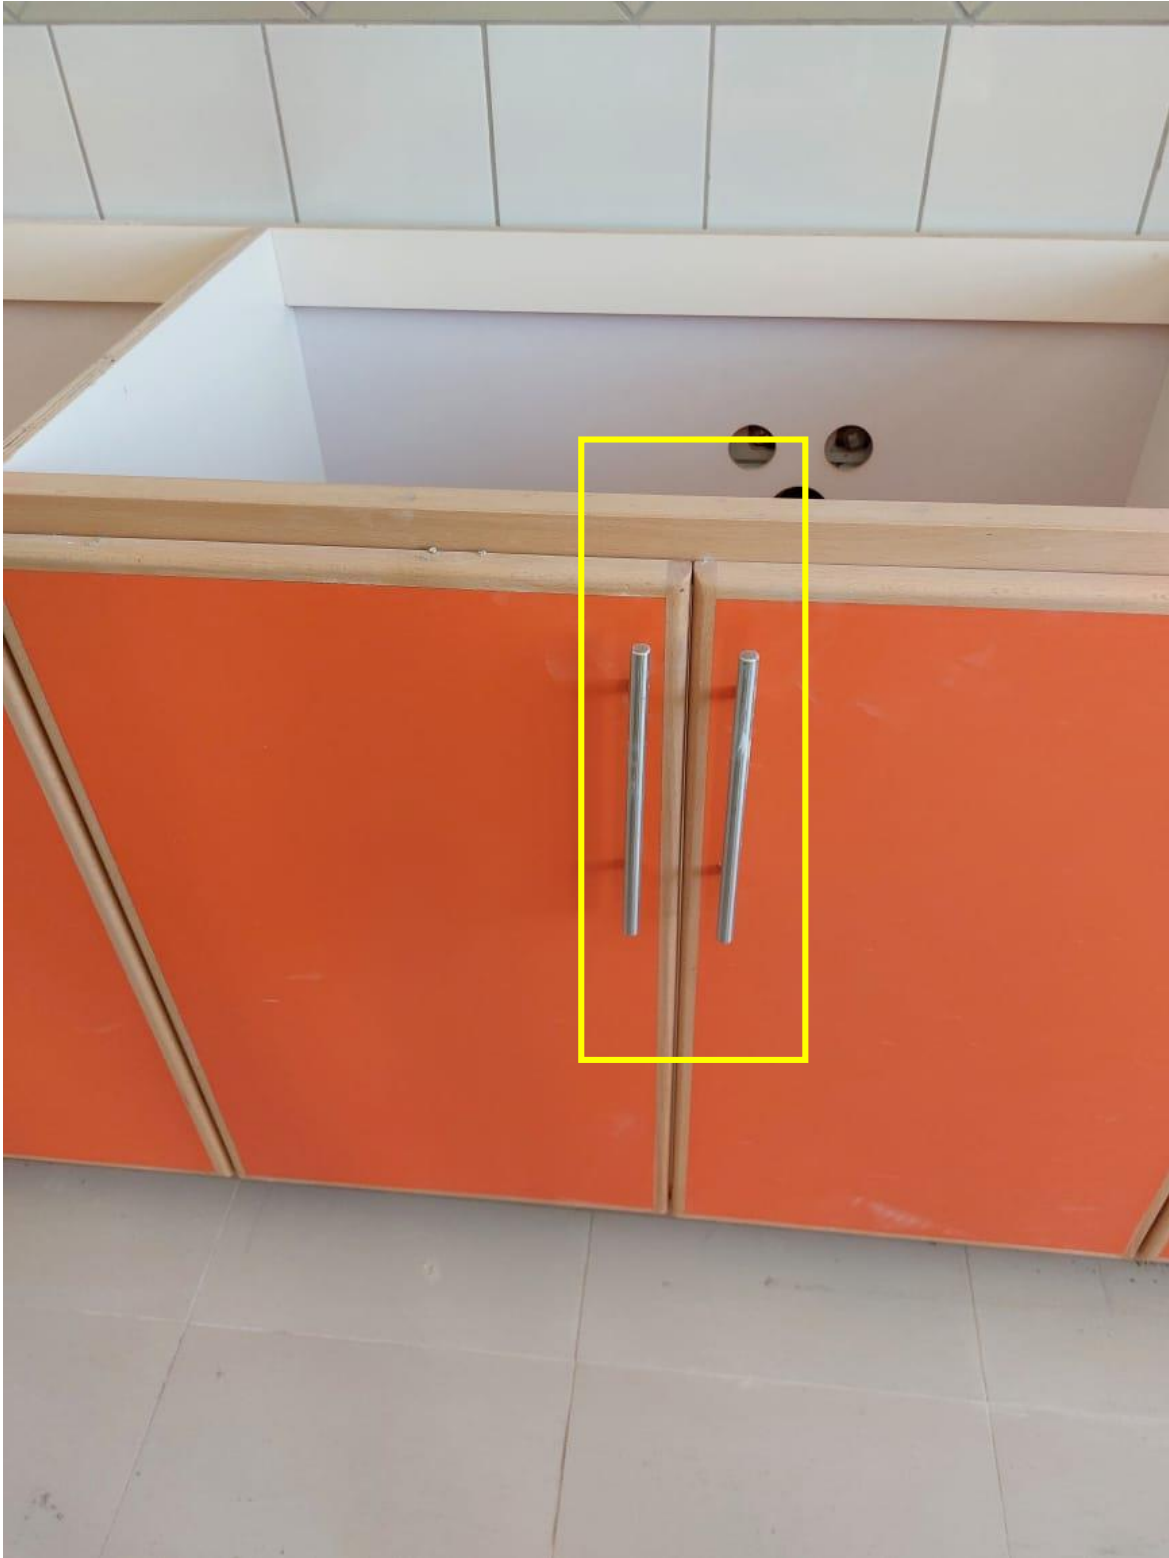
(figure:16)

The team requested the Contractor to check the verticality of handles of the cabinets since one handle was observed not vertical. The Contractor was requested to perform all needed repairs to the cabinets in the kindergarten before preliminary handing over to the supervision site staff

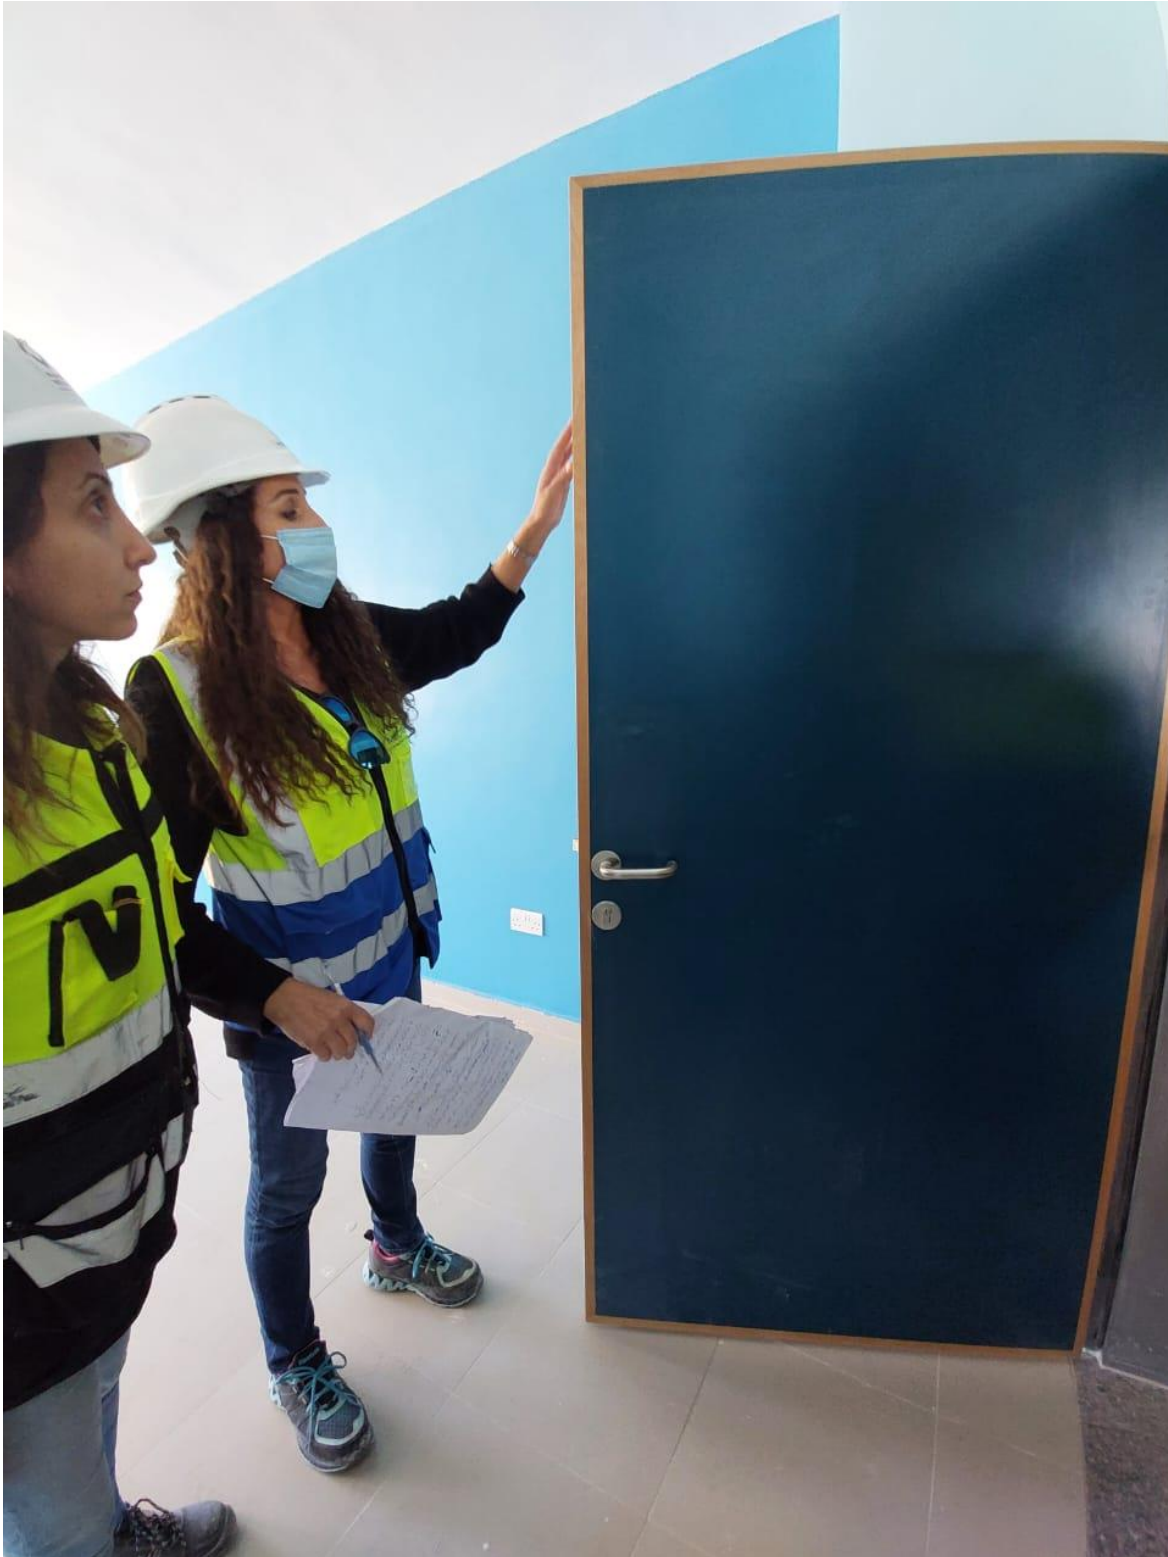
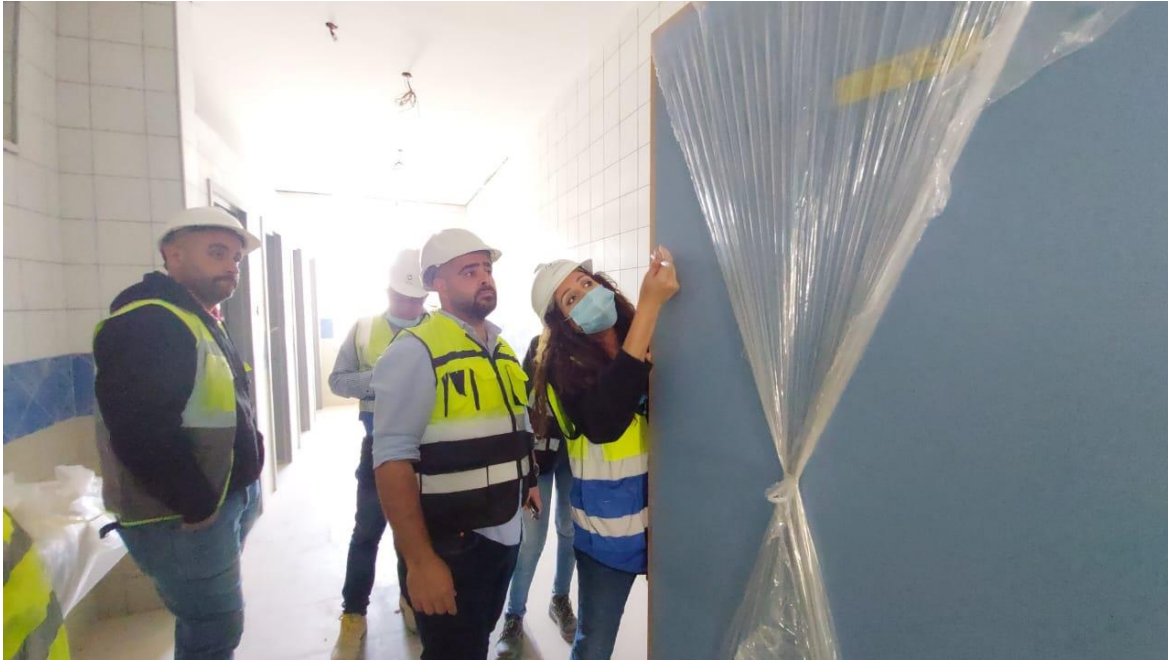
The team requested the Contractor to apply protection means to the imported wooden doors since defects were observed in some parts of those doors
(figure:17 & 18)

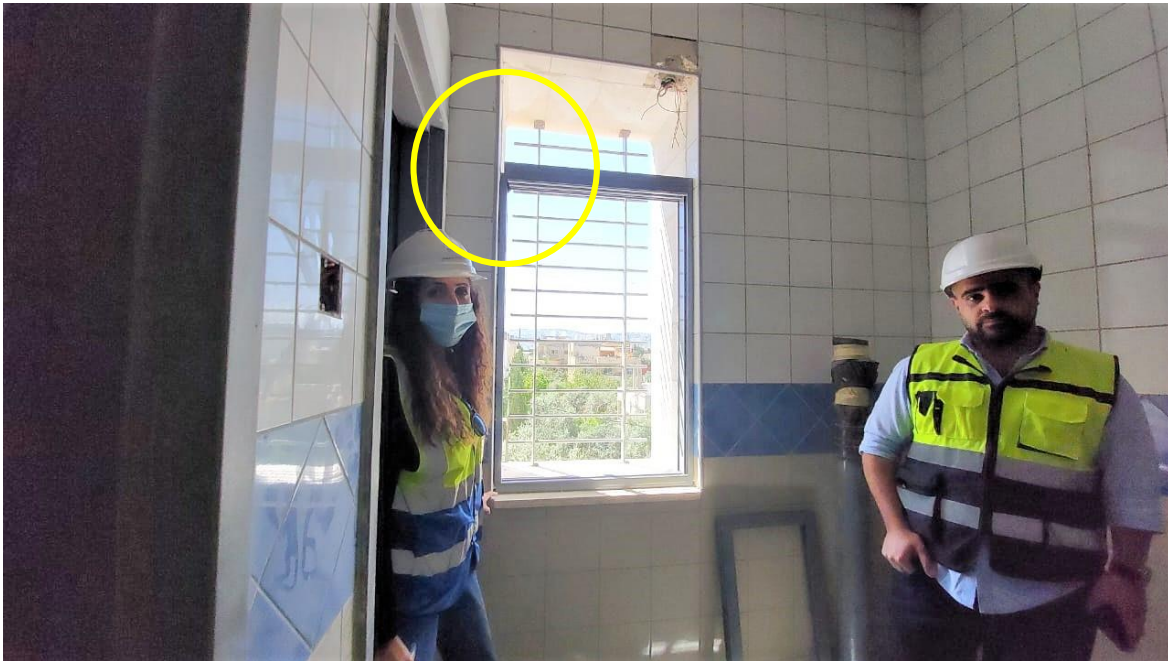
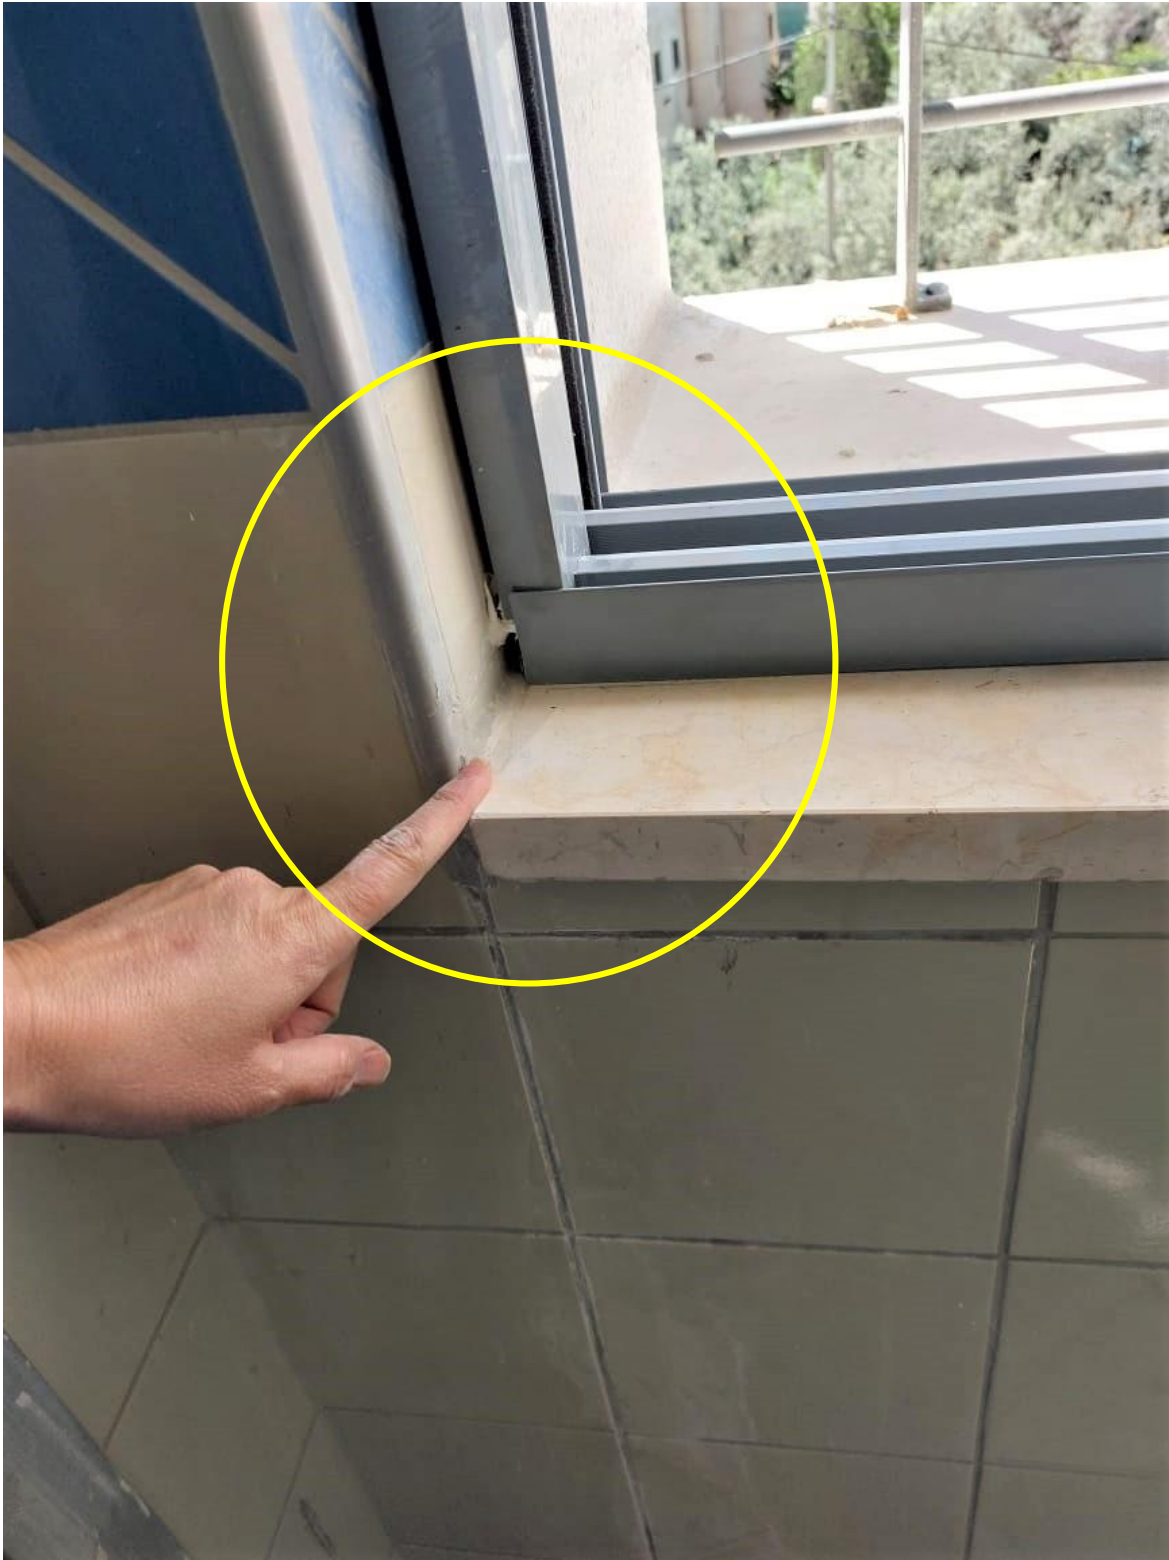
(figure:19 & 20)

The team observed a number of windows frames and found some having wrong dimensions and requested the Contractor to replace

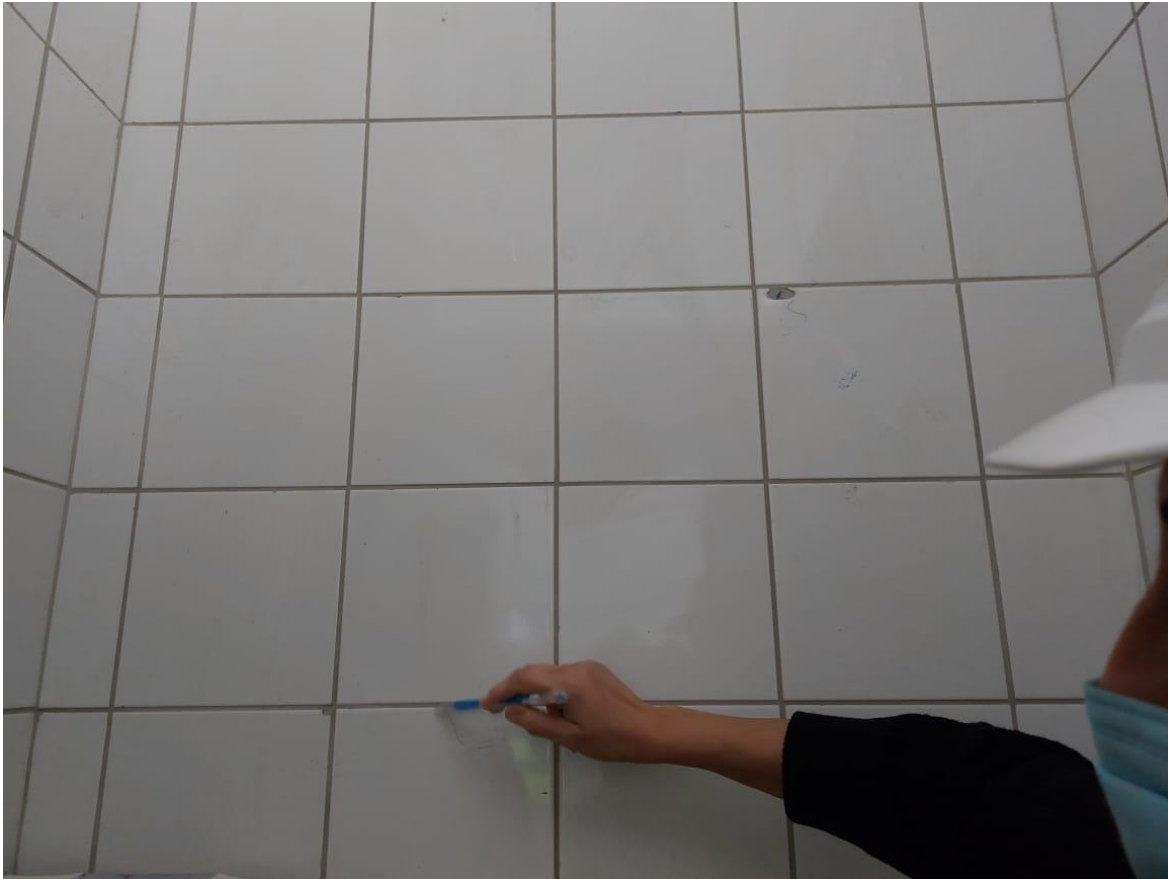
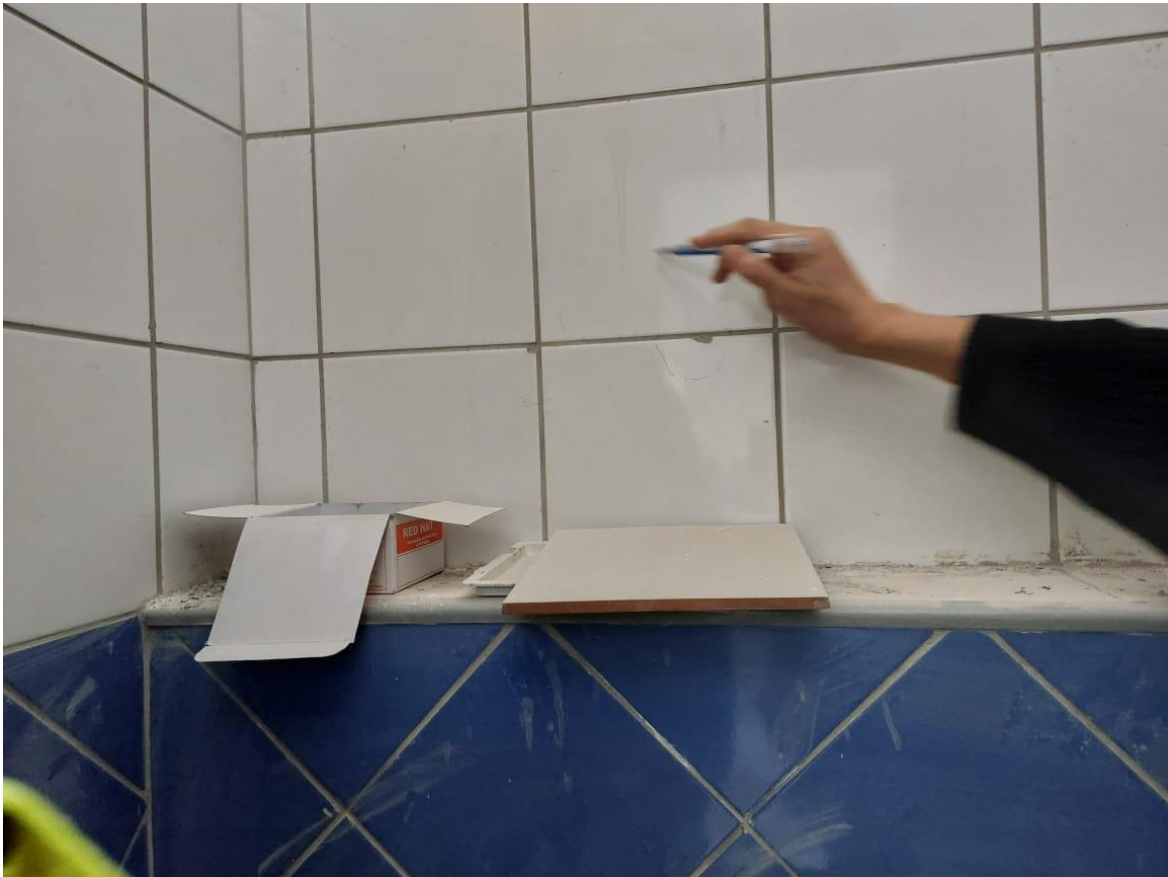
(figure:21 & 22)

The team observed a number of broken ceramic tiles at the walls in the wet areas. The Contractor was requested to replace

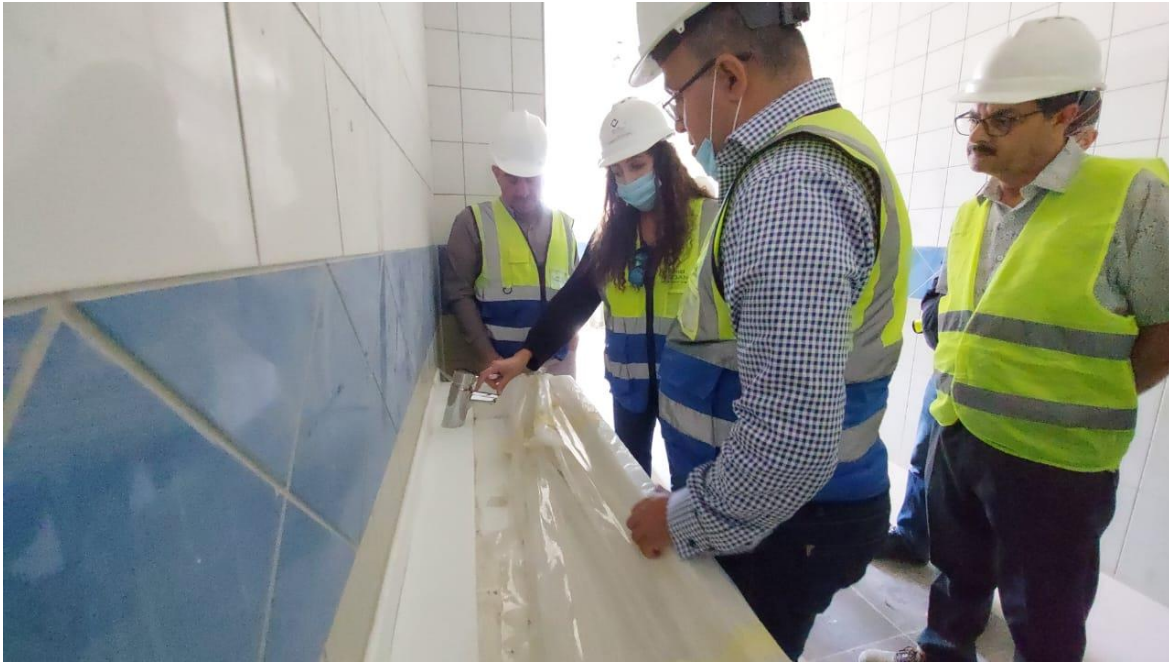
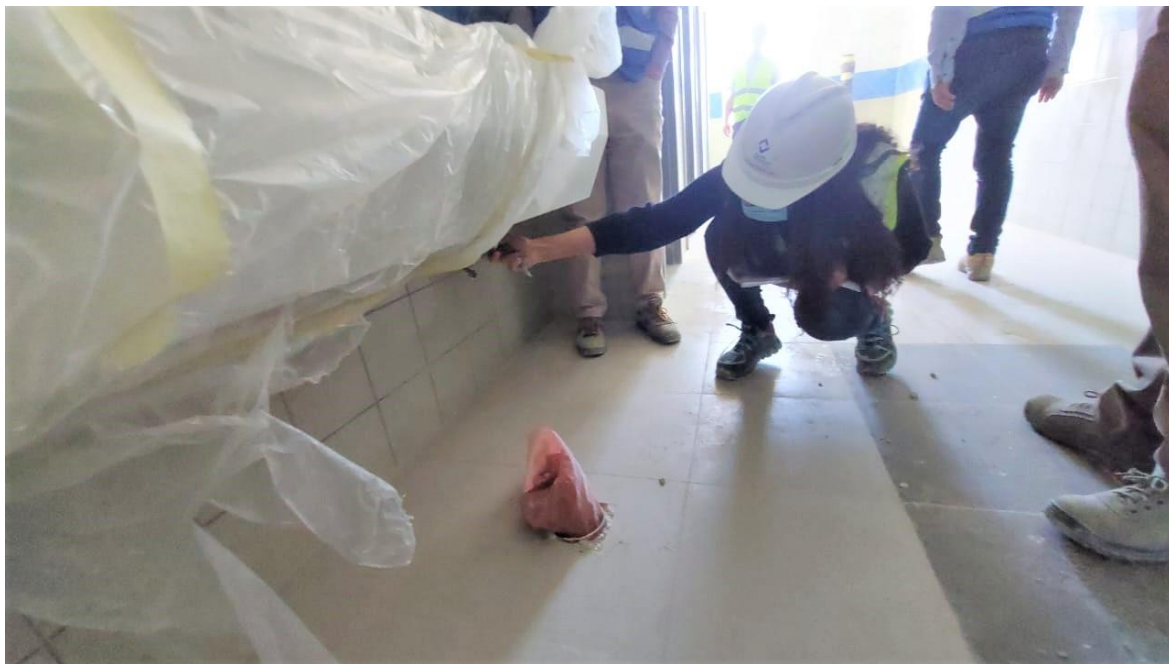
(figure:23 & 24)

The team inspected the drainage accessories for the installed sample of wash trough at the wet area

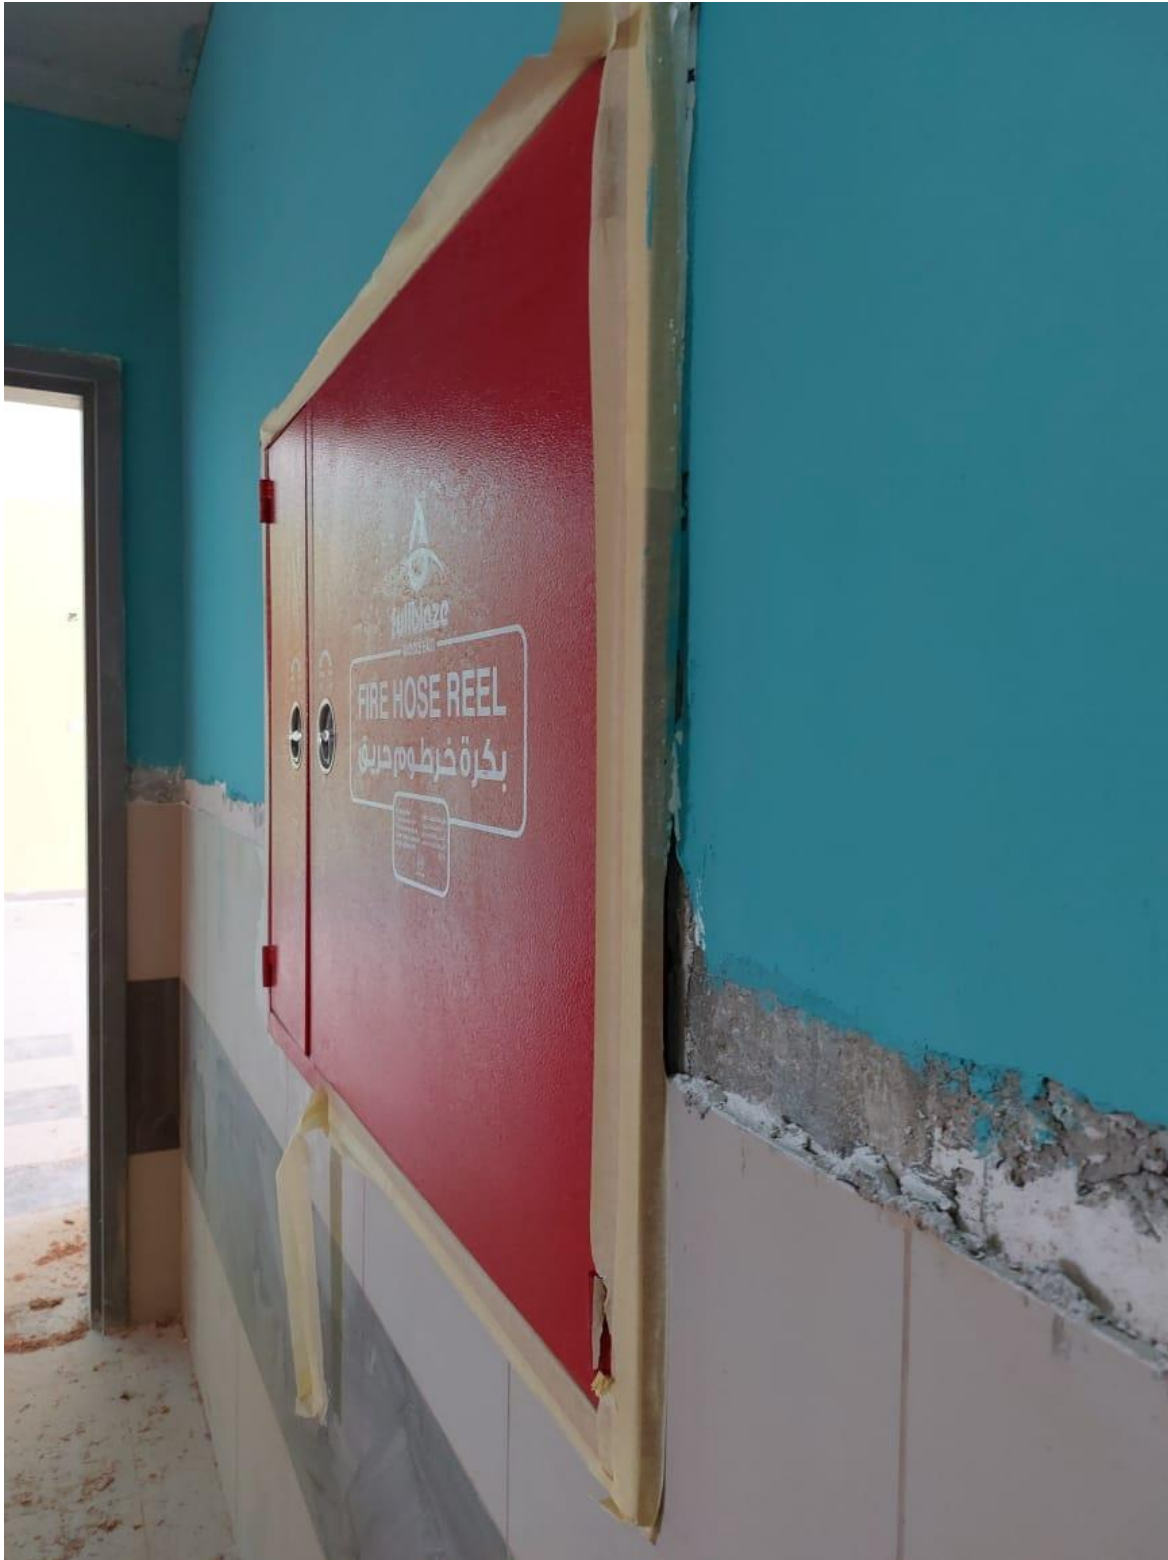
(figure:25)

The team reminded the Contractor to prepare a sample to close the gap between the walls and the fire hose cabinets
