Consultant	Wahib Medanat Consultant Engineer	Rep No.	11-16042022
Contractor	Derar Saraireh & Sons for Engineering & Contracting	Tender No.	(11/2019/USAID/SKEP/3/S) Schools for a Knowledge Economy Project (SKEP) - Phase (3) Package (1, 2)
Site Name	Um Al Dananir Basic Mixed School- Al Balqa	Day/ Date	Sat. 16/04/2022
Duration of Project	450 Calendar Days	Total Project Budget	9,789,417.840 JD

Visit Notes

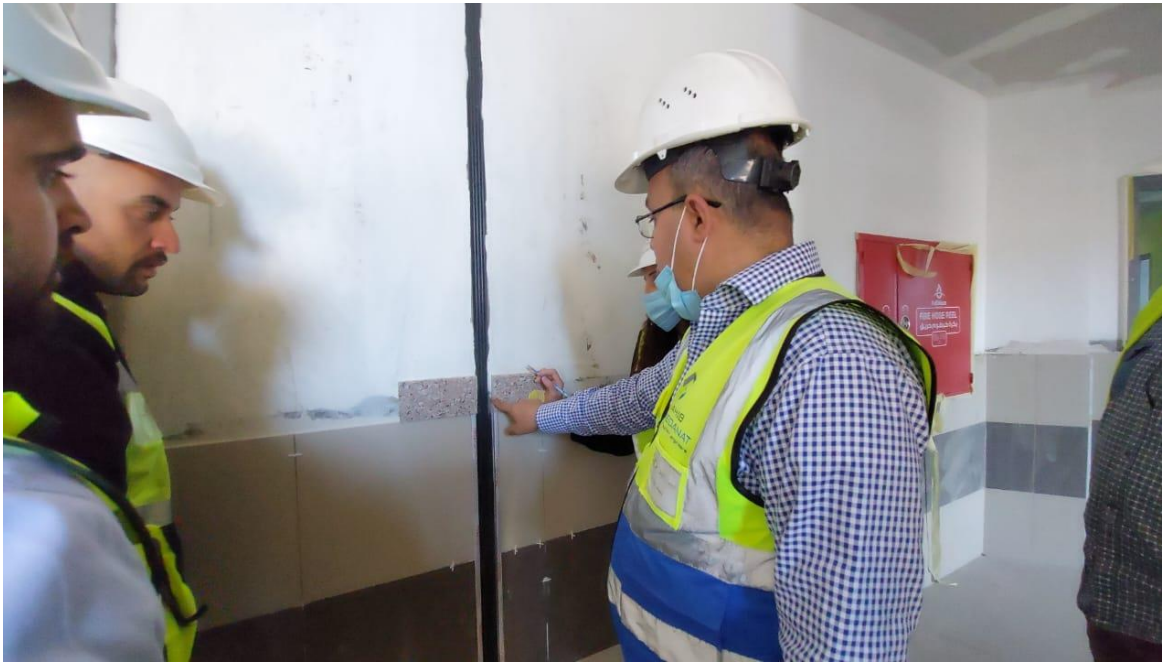
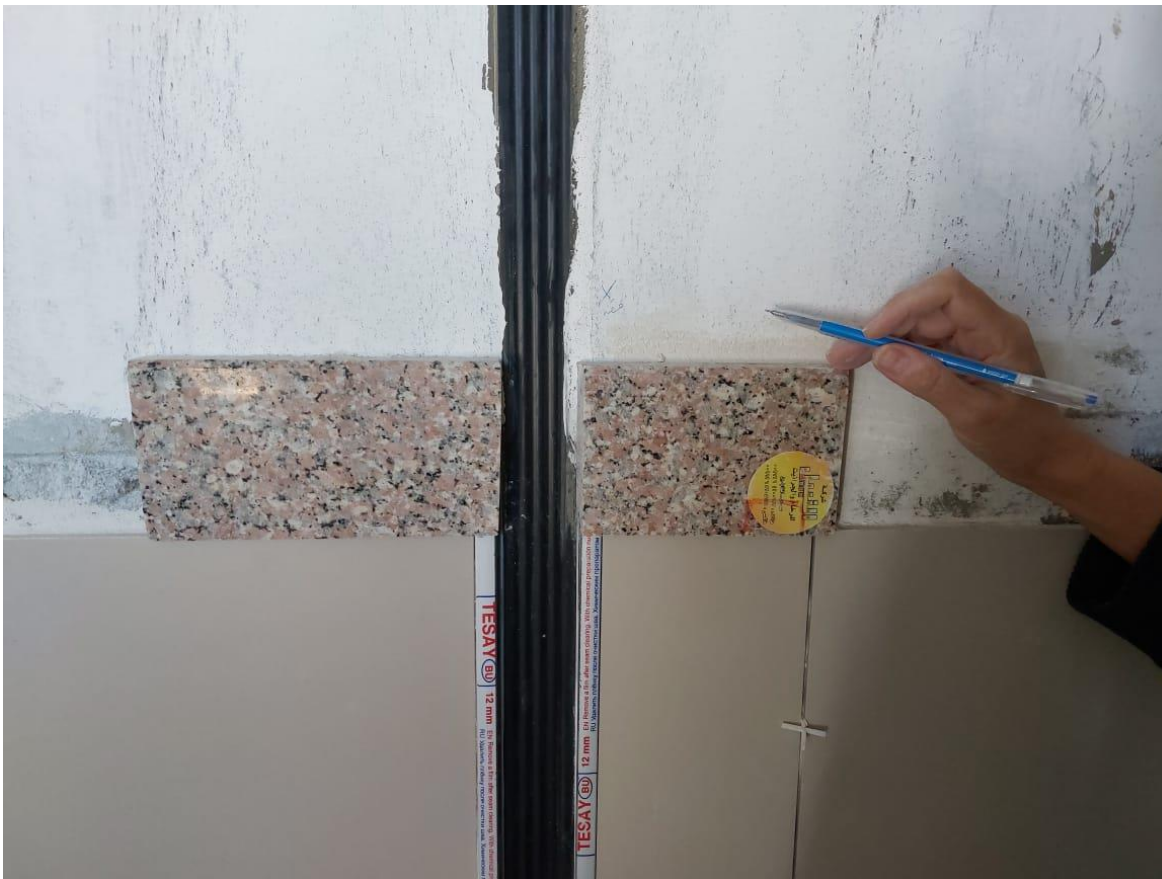
(figure:26 & 27)

The team inspected the prepared sample of the expansion joints finishing and provide the Contactor with a number of remarks:

- Ensuring that the plastering work for the wall at the two sides and the expansion joint match together
- Chamfering of the granite coping
- Ensuring the installation of beads at the two sides of the expansion joint

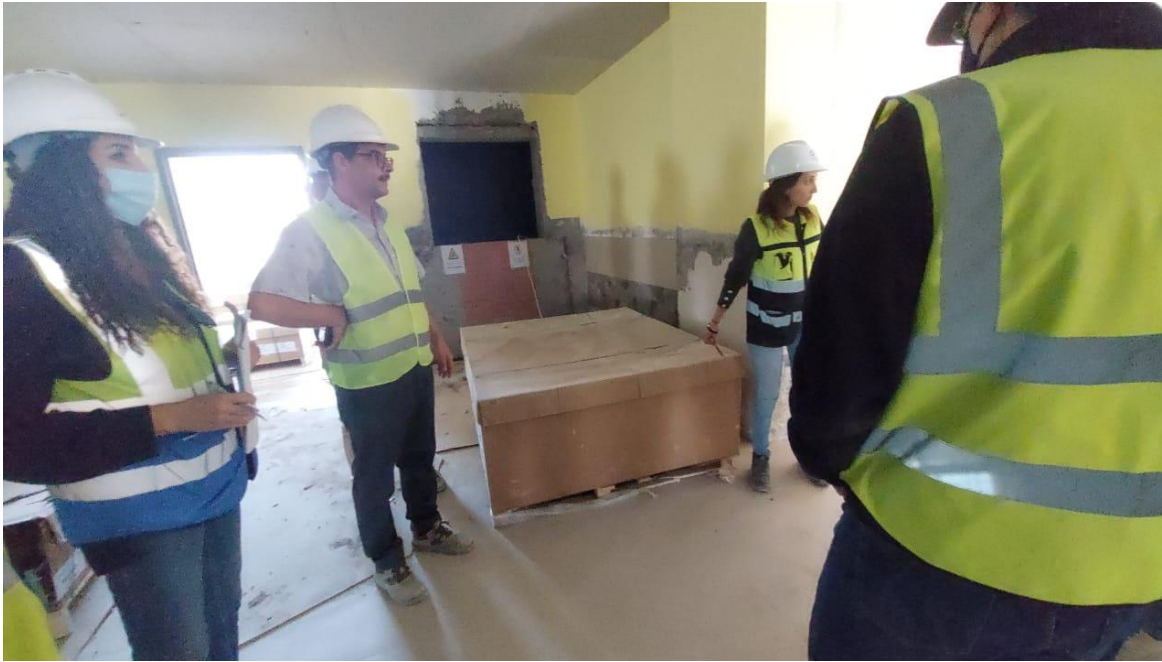
(figure:28)

The team requested the Contractor to store the equipment of the elevators in an appropriate way since the current location is not convenient and might lead to defects in the equipment
