# SKEP III Home Office Support Site Visit Report

Consultant	Wahib Medanat Consultant Engineer	Rep No.	13-16082021
Contractor	Derar Saraireh & Sons for Engineering & Contracting	Tender No.	(11/2019/USAID/SKEP/3/S) Schools for a Knowledge Economy Project (SKEP) - Phase (3) Package (1, 2)
Site Name	Khadija Bint Khwailed Basic Mixed School- Shouna Janoubia	Day/ Date	Mon. 16/08/2021
Duration of Project	450 Calendar Days	Total Project Budget	9,789,417.840 JD

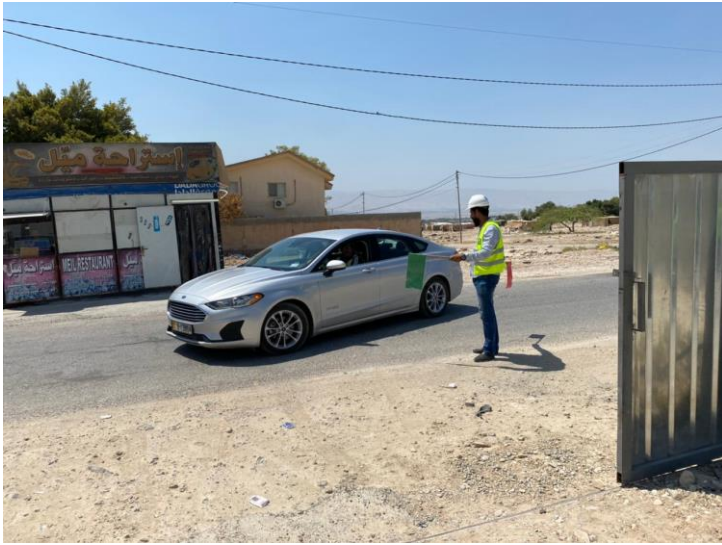
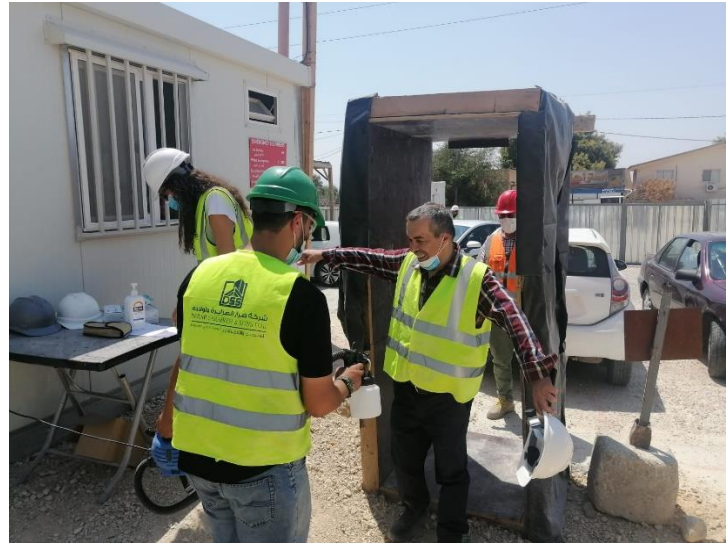
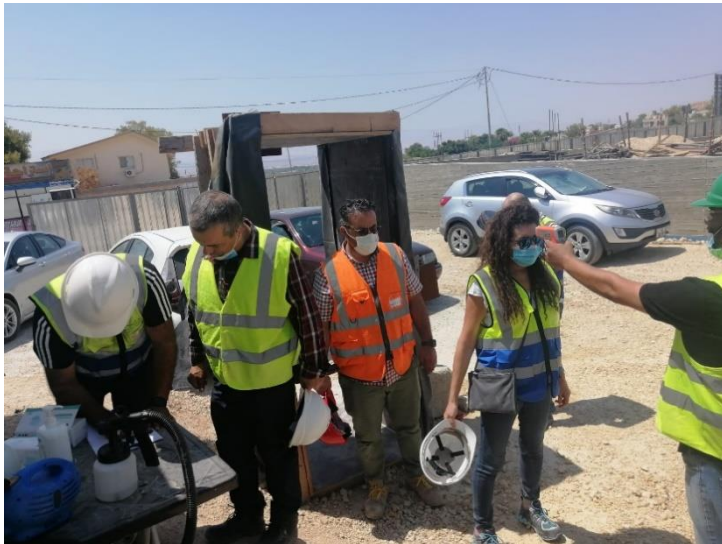
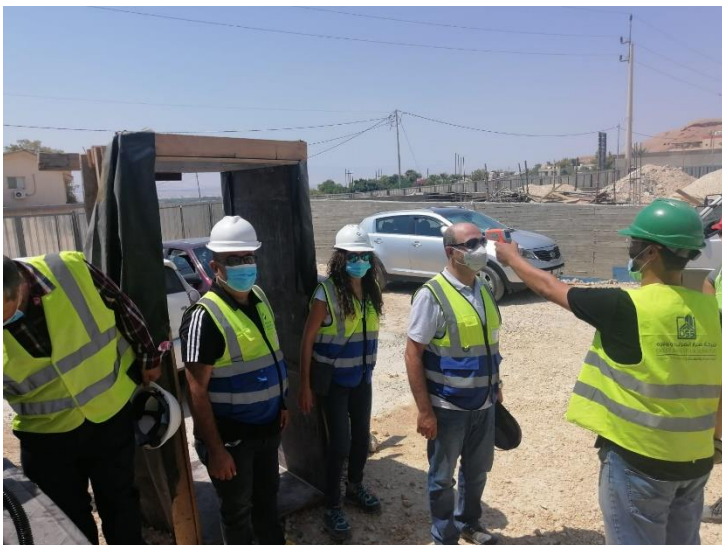
Temperature check, sterilization and signing visitors' attendance sheet at the entrance of the site, complying with Covid-19 Protocol

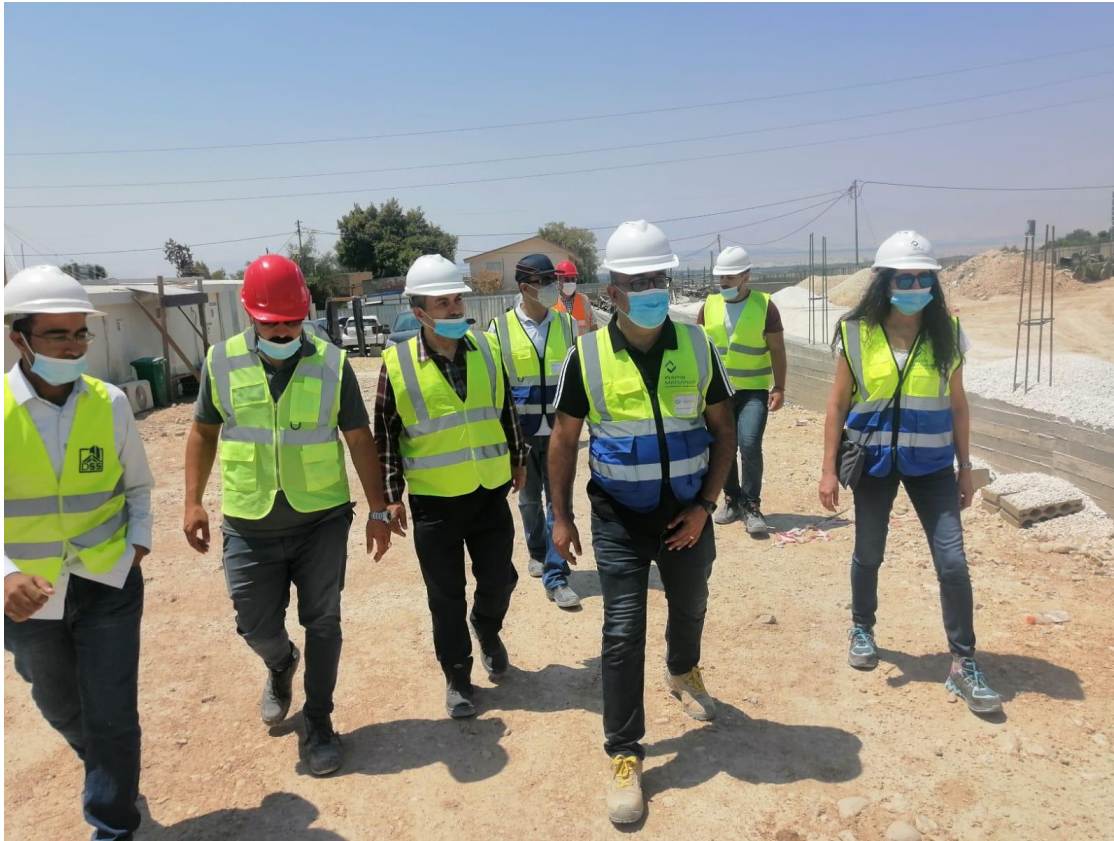
(Figure: 17)

A tour inside the site was conducted

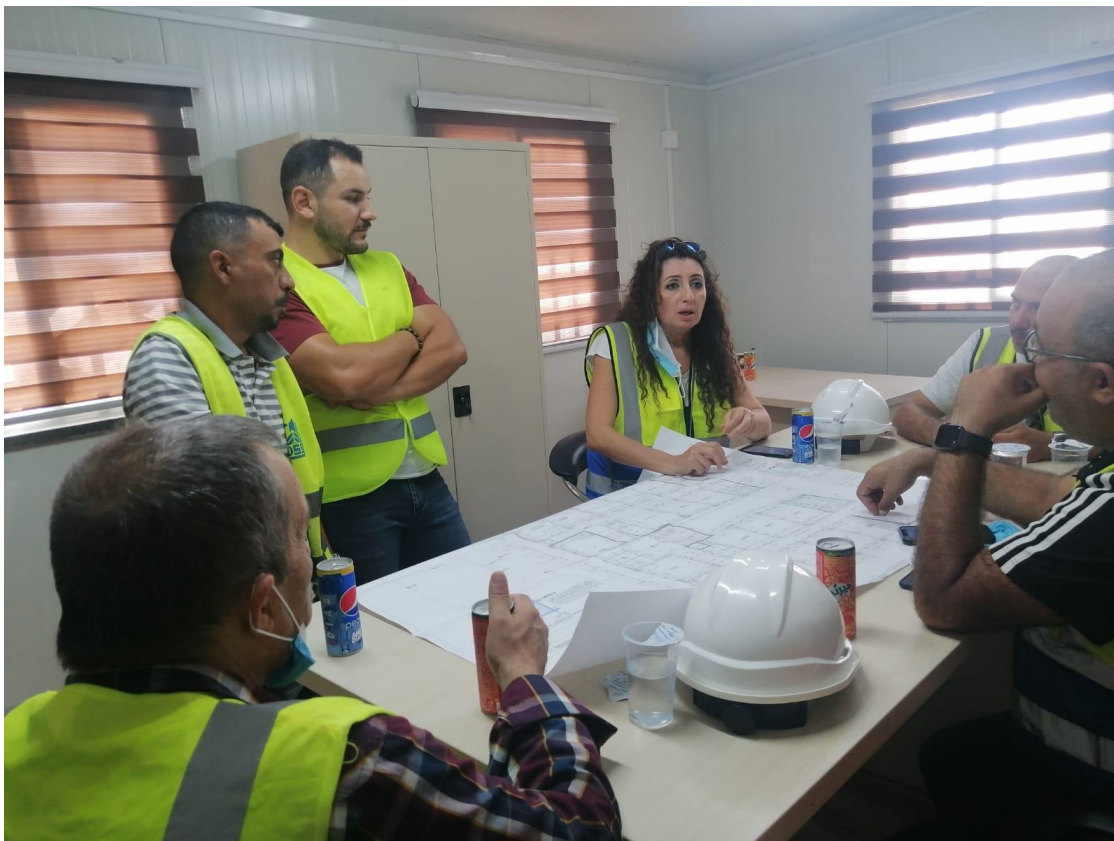
(Figure: 18)

After the site visit a meeting was held in the site offices in the presence of Engineer's representatives and Contractor's representatives to discuss work progress, quality and safety issues
