# SKEP III Home Office Support Site Visit Report

Consultant	Wahib Medanat Consultant Engineer	Rep No.	21-15112021
Contractor	Dijlah Establishment Constr. Contracting	Tender No.	(11/2019/USAID/SKEP/3/S) Schools for a Knowledge Economy Project (SKEP) - Phase (3) Package (1, 2)
Site Name	Hay Al Iskan Basic Mixed School- Jerash	Day/ Date	Mon. 15/11/2021
Duration of Project	450 Calendar Days	Total Project Budget	8,314,983.735 JD

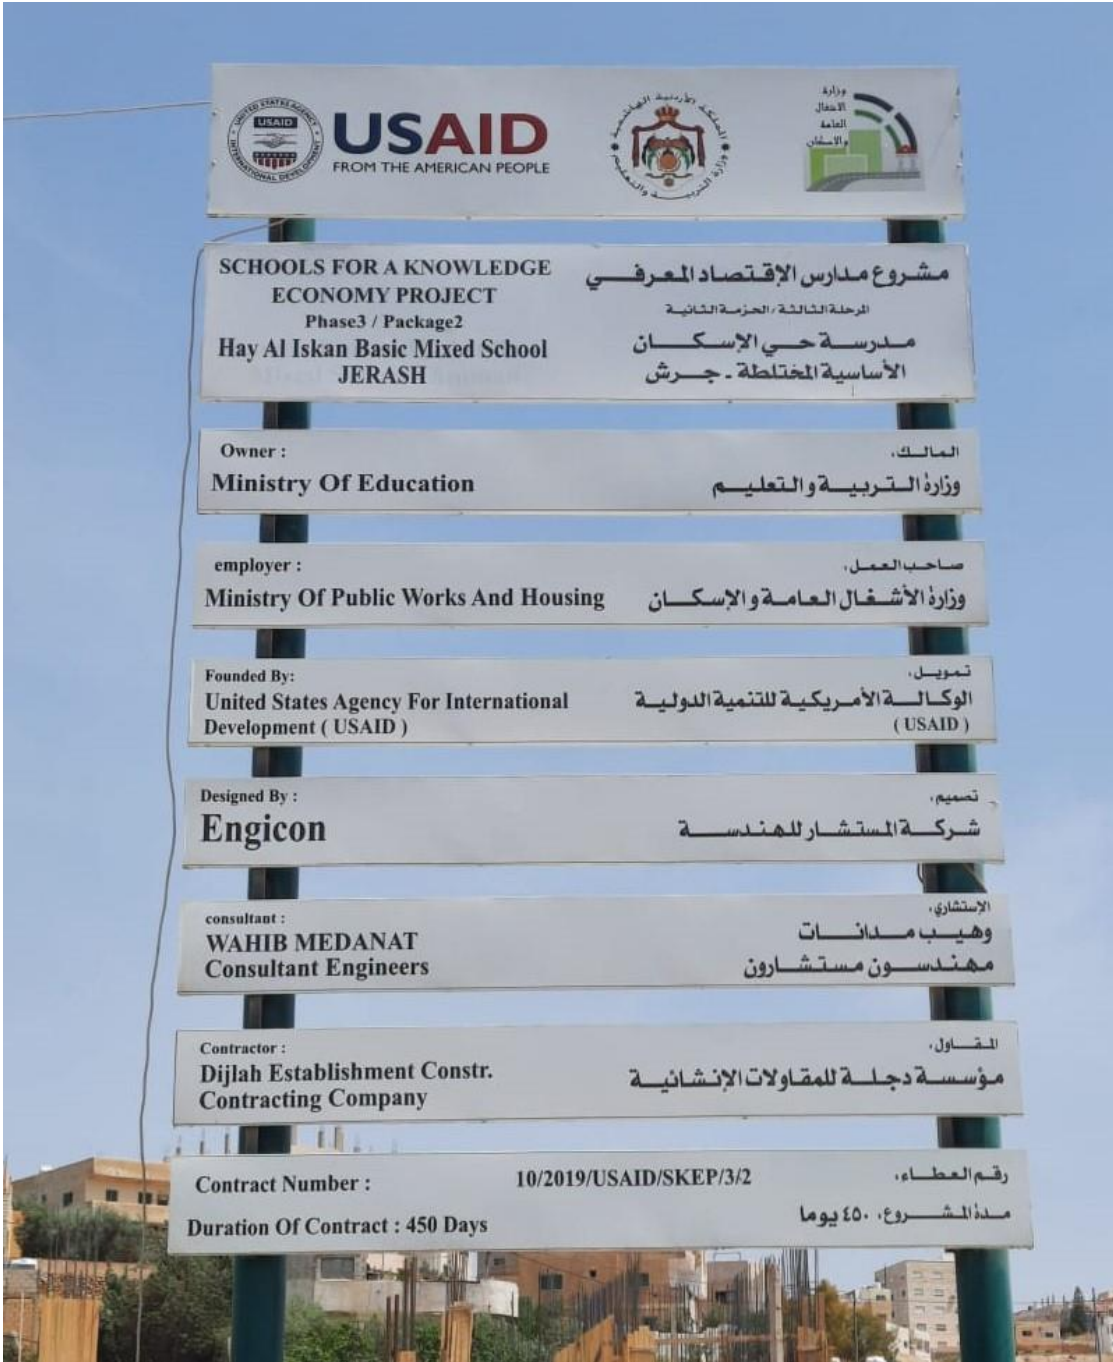
Project ID  
Sign on  
Site

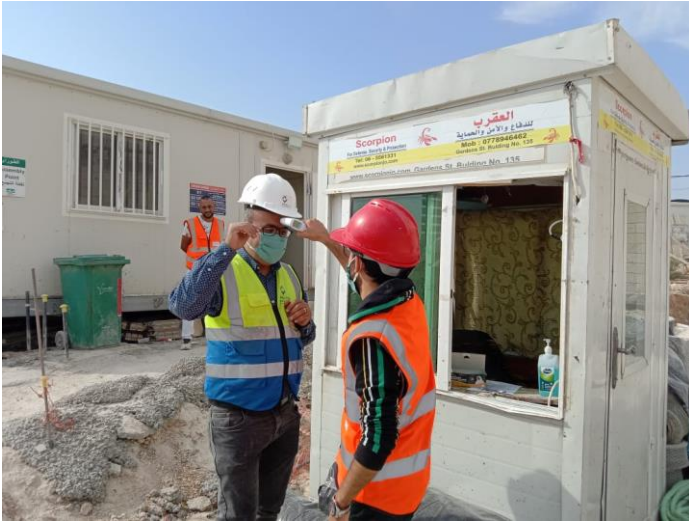
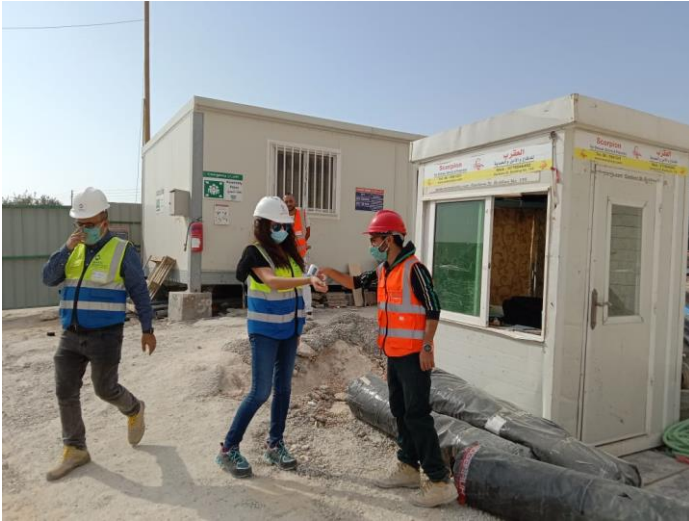
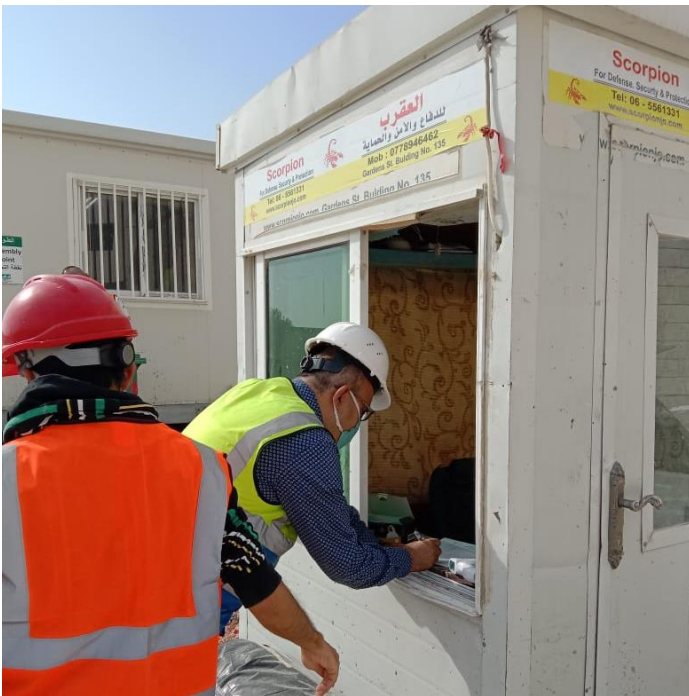
(Figure:  
01)

Temperature check, sterilization and signing visitors' attendance sheet at the entrance of the site, complying with Covid-19 Protocol

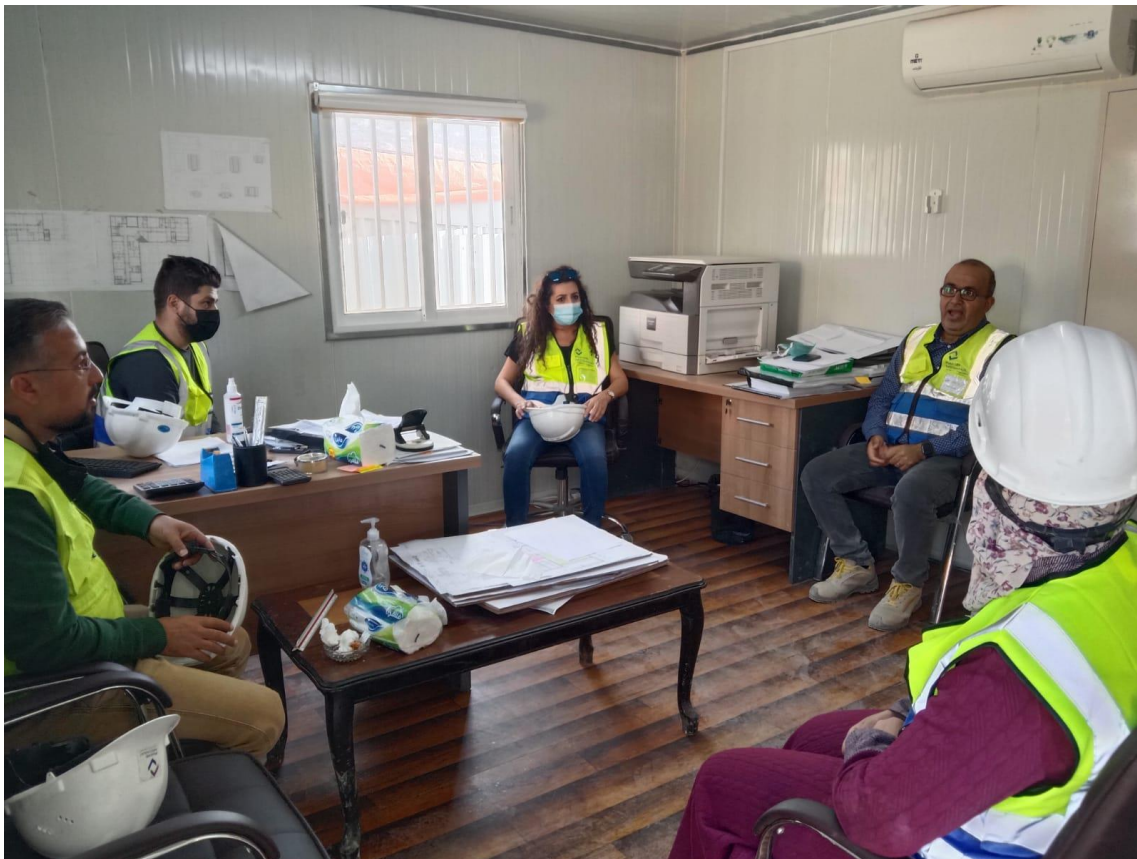
(Figure: 30)

a meeting was held at the supervision site offices, in which the excavations for the water tank were discussed
