SKEP III Home Office Support Site Visit Report

Consultant	Wahib Medanat Consultant Engineer	Rep No.	22-02012022
Contractor	Dijlah Establishment Constr. Contracting	Tender No.	(11/2019/USAID/SKEP/3/S) Schools for a Knowledge Economy Project (SKEP) - Phase (3) Package (1, 2)
Site Name	Thahr Al Sarow Basic School for Boys- Jerash	Day/ Date	Sun. 02/01/2022
Duration of Project	450 Calendar Days	Total Project Budget	8,314,983.735 JD

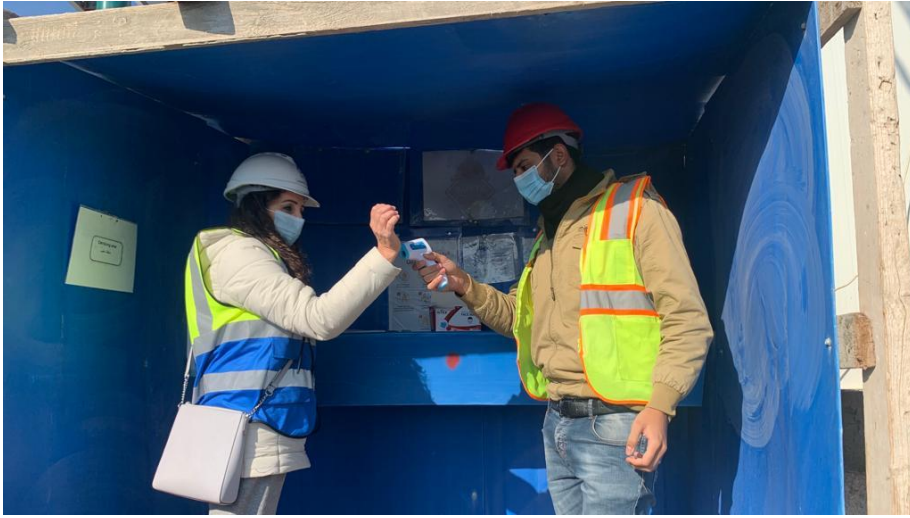
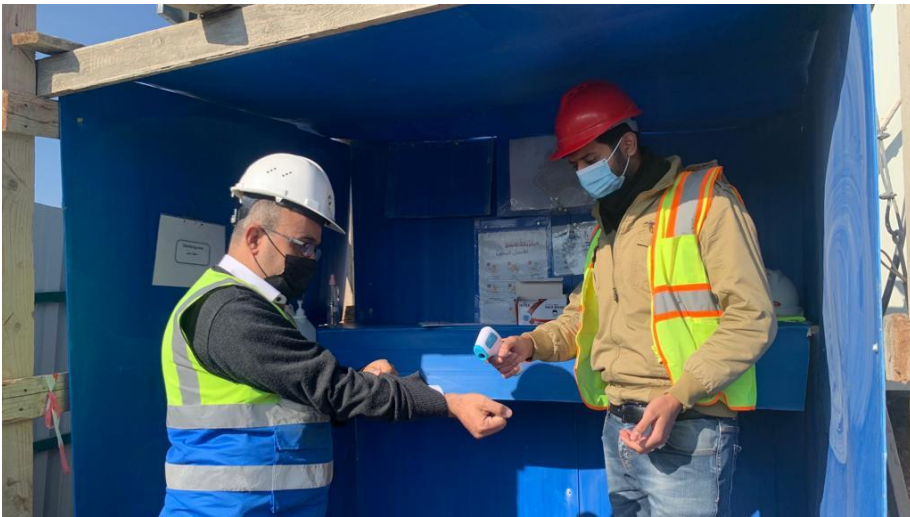
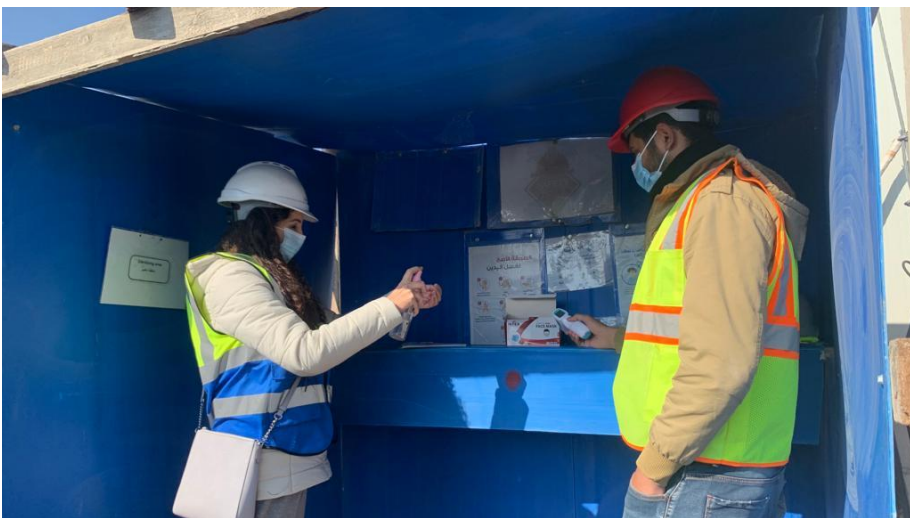
Temperature check, sterilization and signing visitors' attendance sheet at the entrance of the site, complying with Covid-19 Protocol

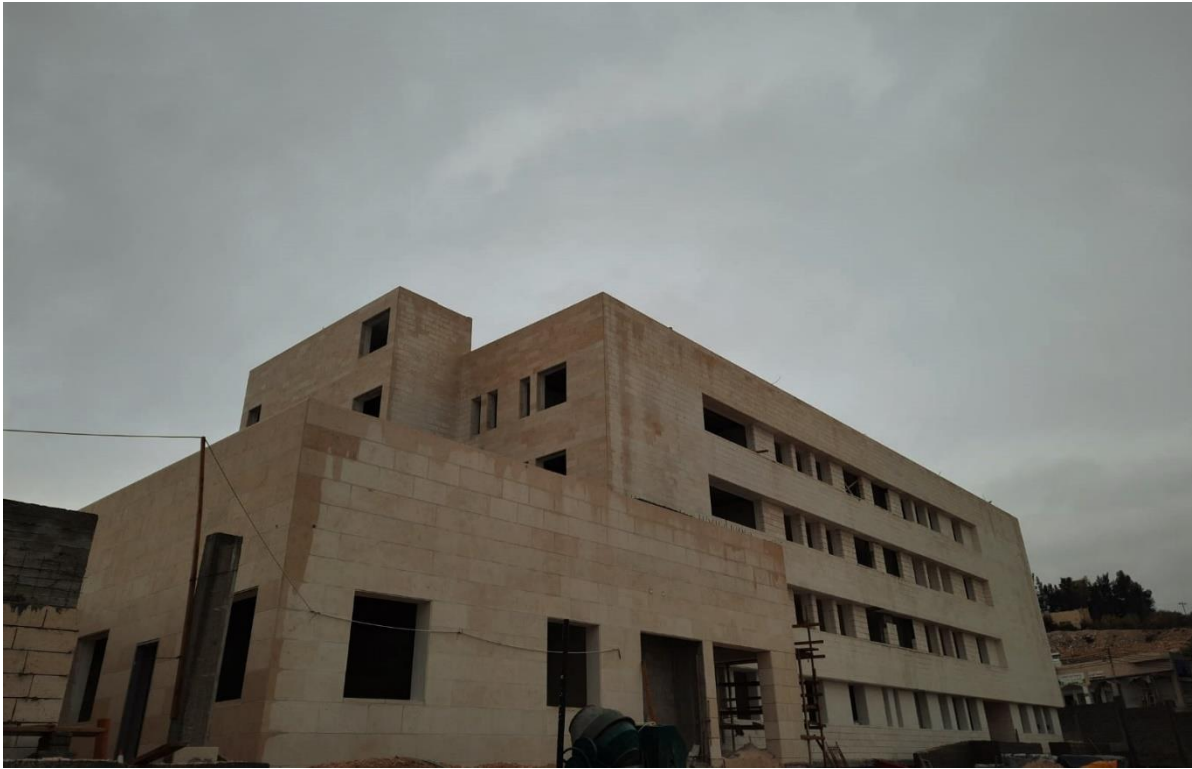
(Figure: 01)

General view
of the project
(Figure: 01, 02 & 03)

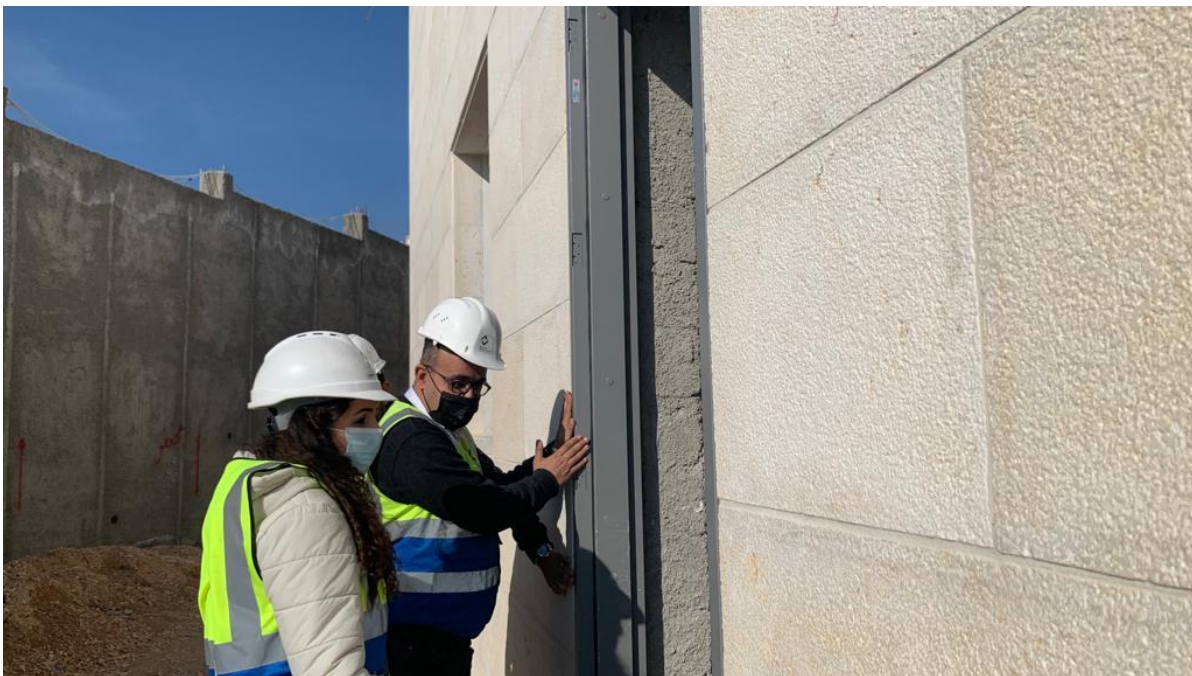
(Figure: 04)

No.	Description
1	The supervision team conducted the necessary inspection on the prepared sample by the Contractor for the installation of the steel door frames. After inspecting the sample in the presence of the Contractor's representative, it was agreed that the door frame shall protrude 1cm from the stone face to show appropriate view.

The supervision team conducted the necessary inspection on the prepared sample by the Contractor for the installation of the steel door frames
