SKEP III Home Office Support Site Visit Report

Consultant	Wahib Medanat Consultant Engineer	Rep No.	21-22022022
Contractor	Dijlah Establishment Constr. Contracting	Tender No.	(11/2019/USAID/SKEP/3/S) Schools for a Knowledge Economy Project (SKEP) - Phase (3) Package (1, 2)
Site Name	Hay Al Iskan Basic Mixed School- Jerash	Day/ Date	Tue. 22/02/2022
Duration of Project	450 Calendar Days	Total Project Budget	8,314,983.735 JD

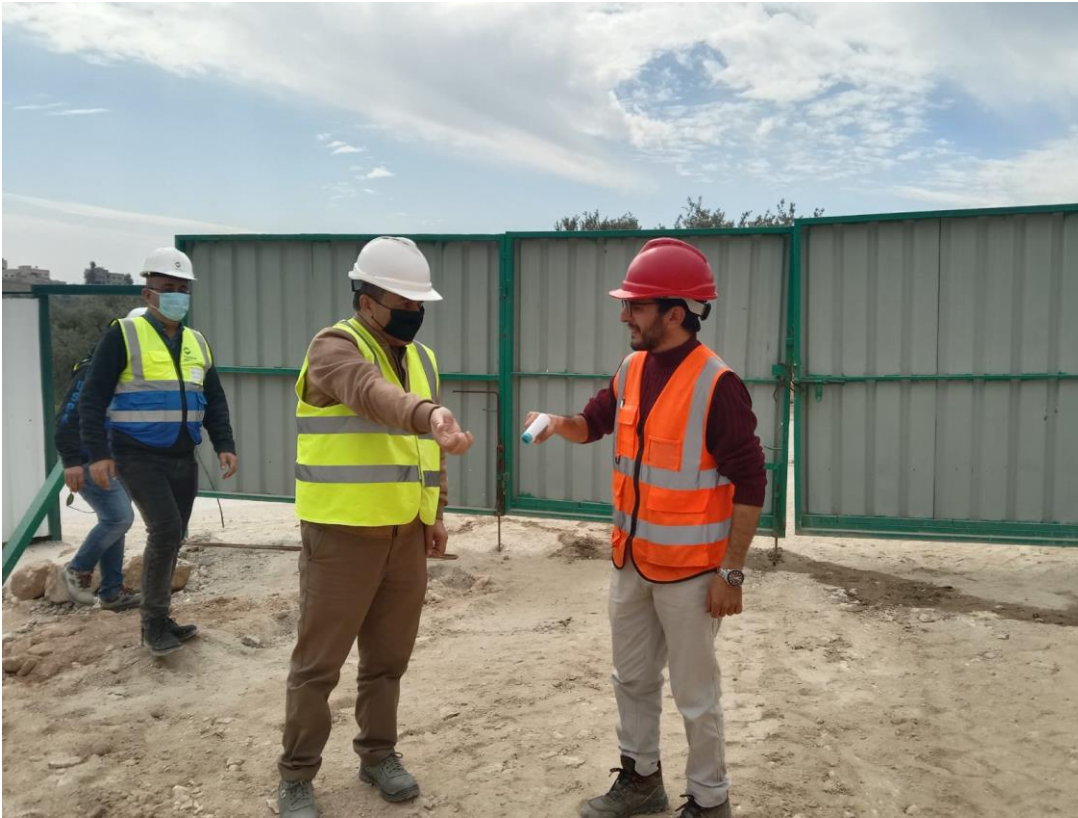
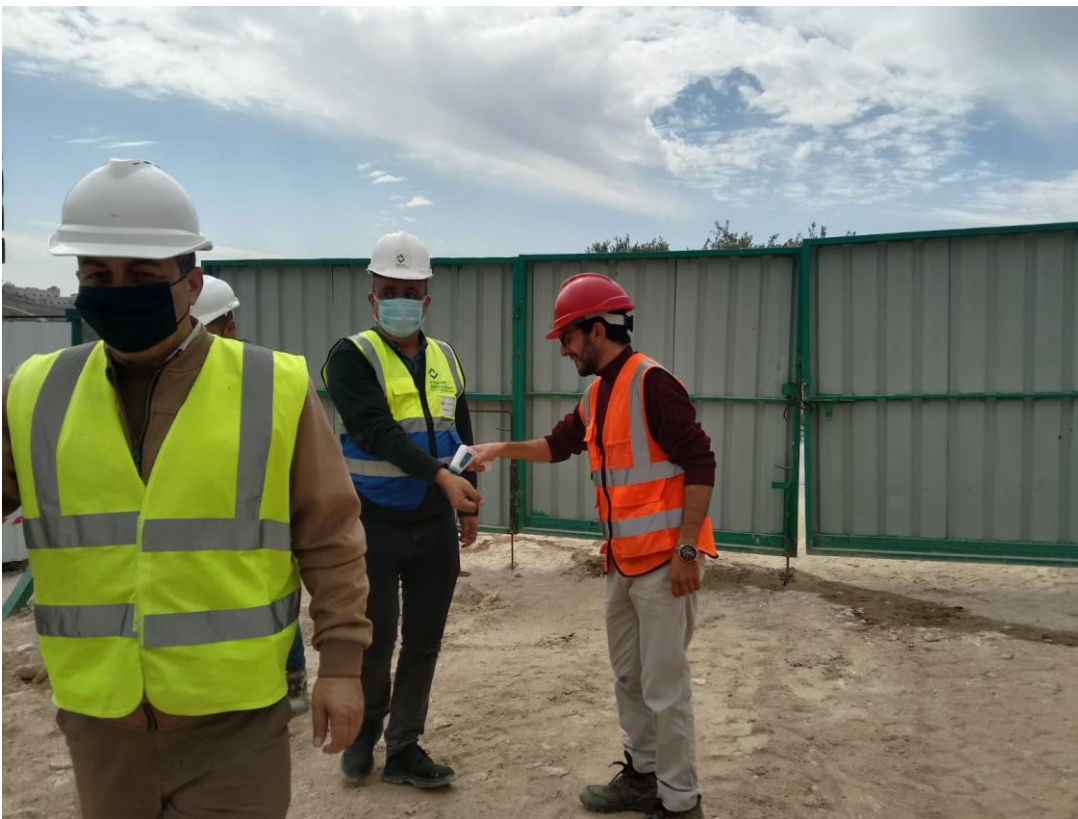
Temperature check, sterilization and signing visitors' attendance sheet at the entrance of the site, complying with Covid-19 Protocol

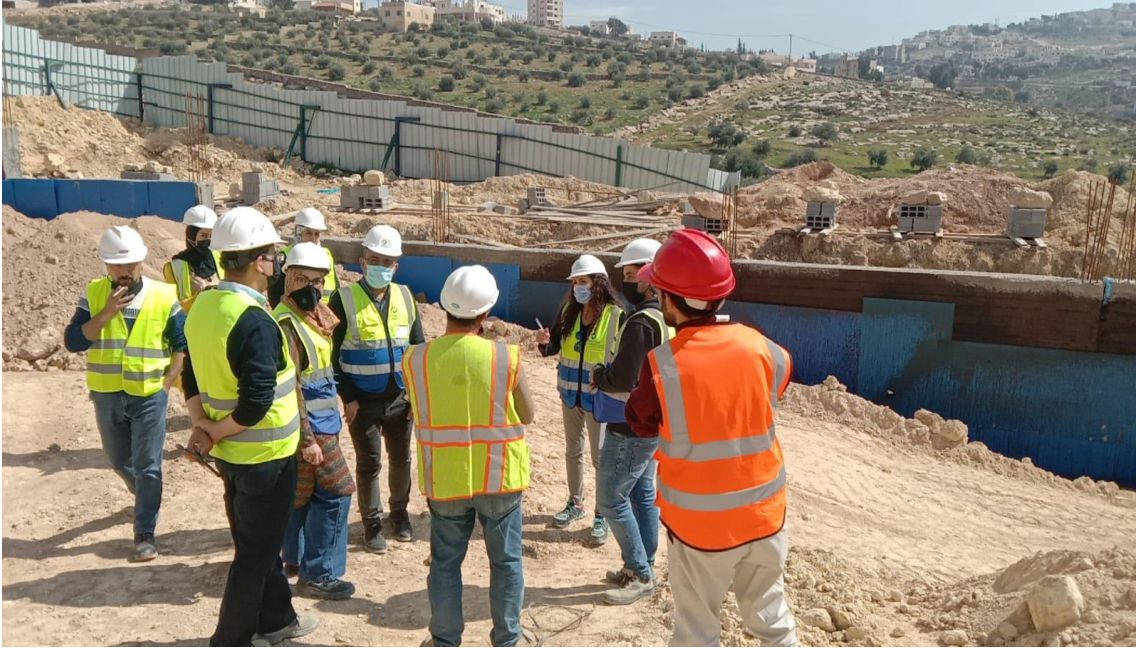
(Figure: 04)

A tour inside the site was conducted
