Consultant	Wahib Medanat Consultant Engineer	Rep No.	12-12012022
Contractor	Derar Saraireh & Sons for Engineering & Contracting	Tender No.	(11/2019/USAID/SKEP/3/S) Schools for a Knowledge Economy Project (SKEP) - Phase (3) Package (1, 2)
Site Name	Al Khansa' Basic Mixed School- Al Balqa	Day/ Date	Wed. 12/01/2022
Duration of Project	450 Calendar Days	Total Project Budget	9,789,417.840 JD

Visit Notes

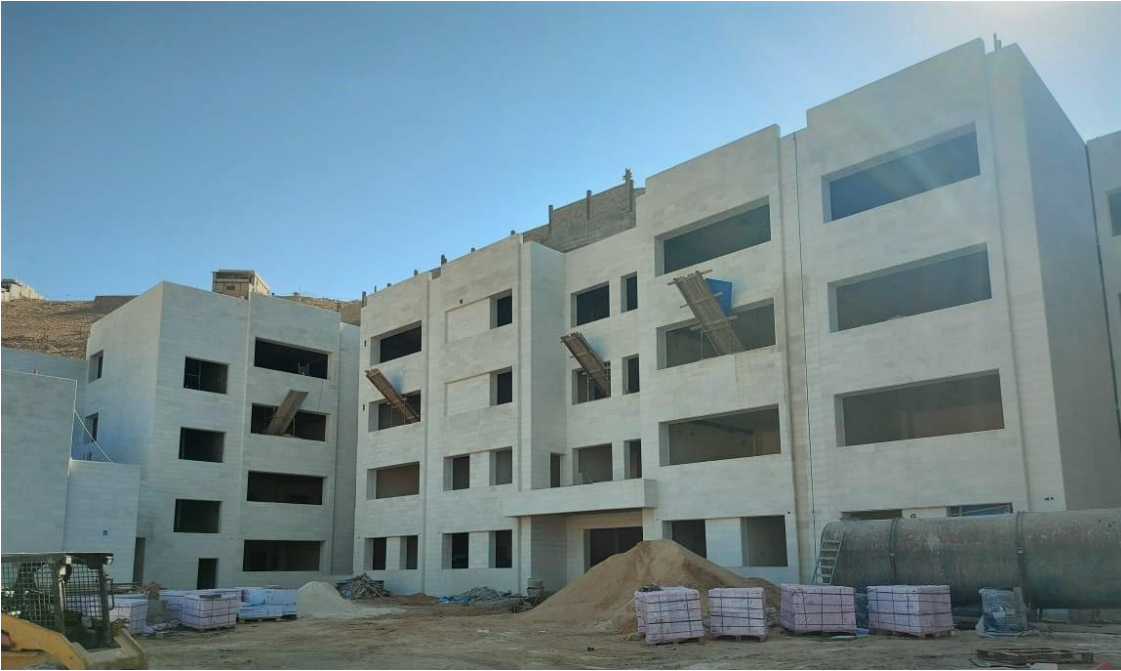
(Figure: 01)

General view of the project site
